# **Perspectives on the Implementation of Fukushima Lessons Learned**

**David Lochbaum**

# **Implementation? Or Illusion?**

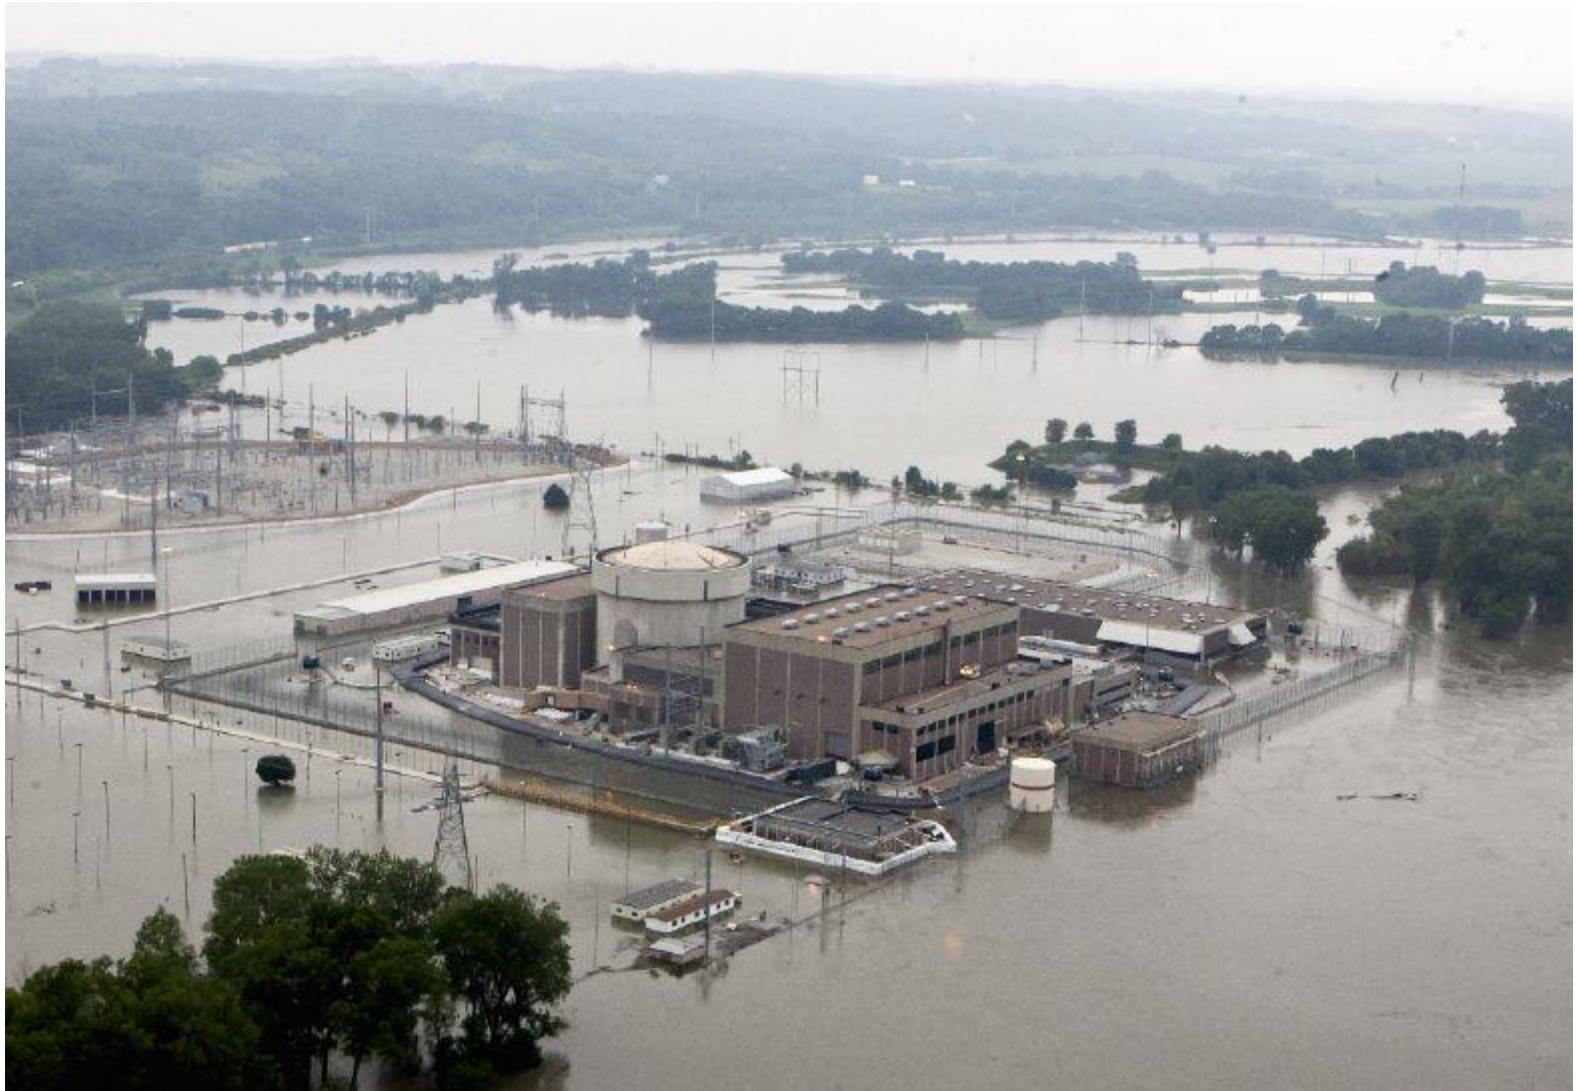
# NRC Got Fort Calhoun There

**Source: ML120400493**

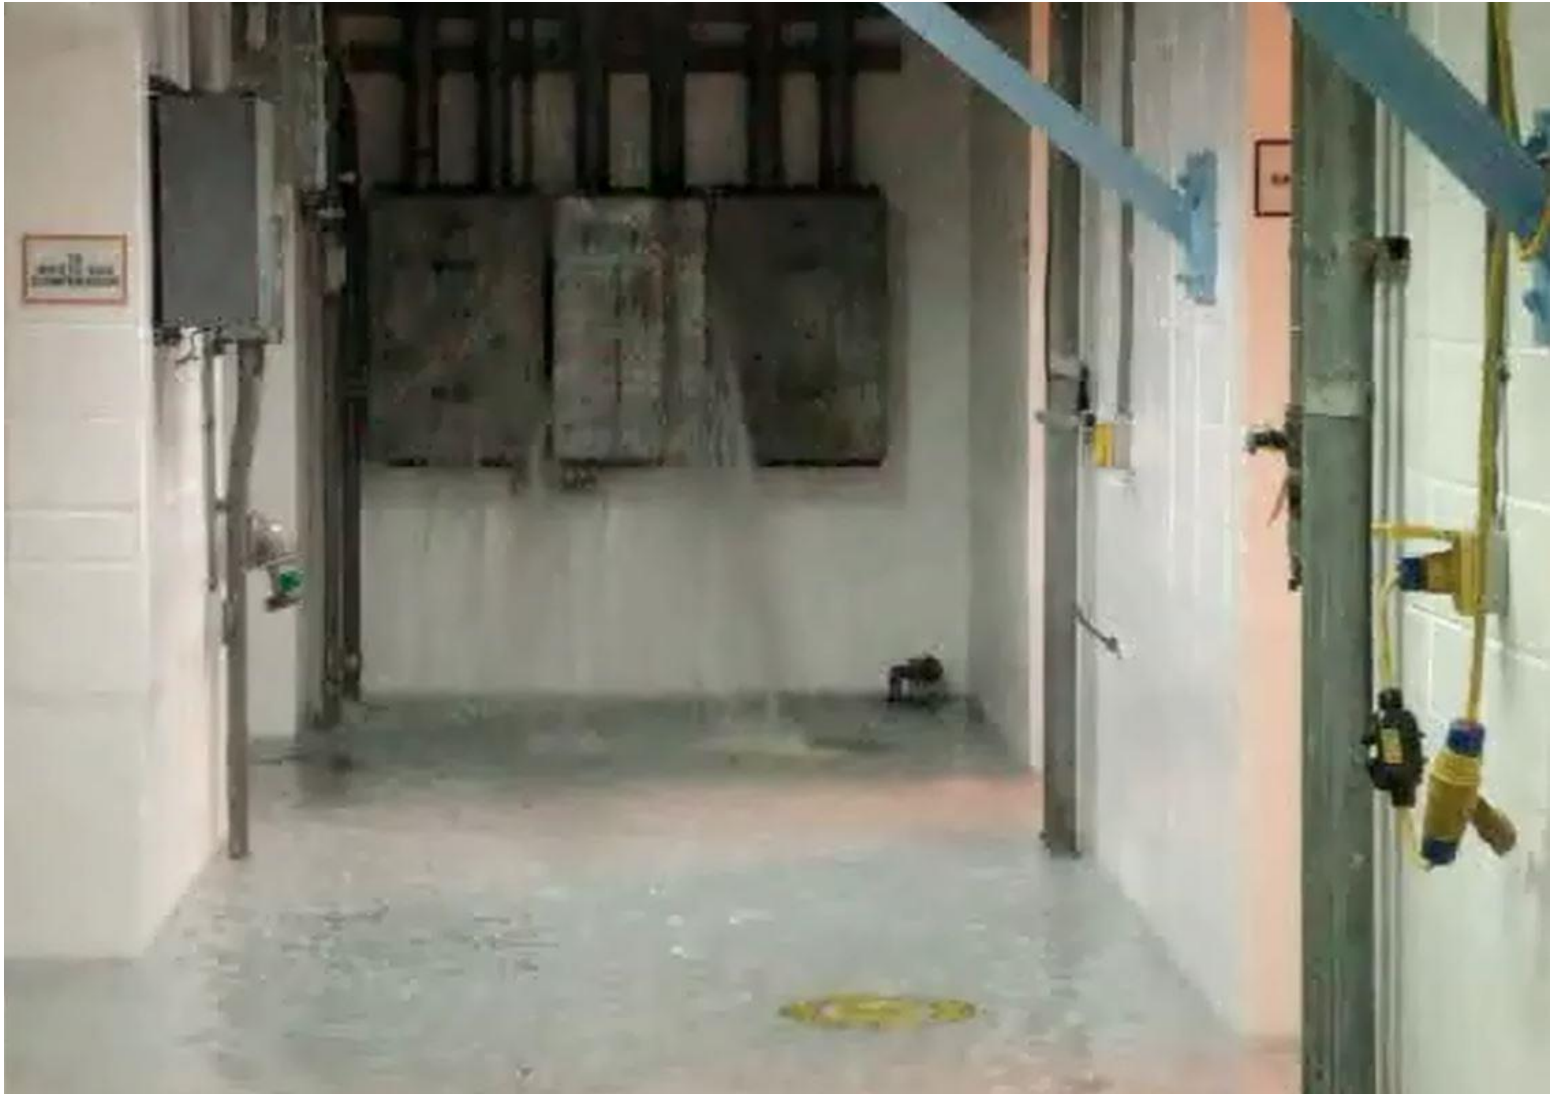
# St. Lucie Was Not There

**Source: ML16236A019**

- **“Approximately 50,000 gallons of water entered the -0.5 foot elevation of the RAB through two degraded conduits in the ECCS pipe tunnel which were severely corroded and lacked internal flood barriers.”**
- **“After the [January 9, 2014] event, the licensee identified four additional conduits in the ECCS pipe tunnel without internal flood barriers...”.**

- **“The licensee evaluated the missing flood barriers and concluded that a design basis external flood event would have allowed water to enter the Unit 1 RAB and potentially impact both trains of high head and low head ECCS pumps.”**
- **“The licensee also concluded that modifications implemented in 1978 and 1982 had installed the six conduits below the design basis flood elevation without internal flood barriers.”**
