# NRC INSPECTION MANUAL

Temporary Instruction 2515/142

## DRAINDOWN DURING SHUTDOWN AND COMMON-MODE FAILURE (NRC GENERIC LETTER 98-02)

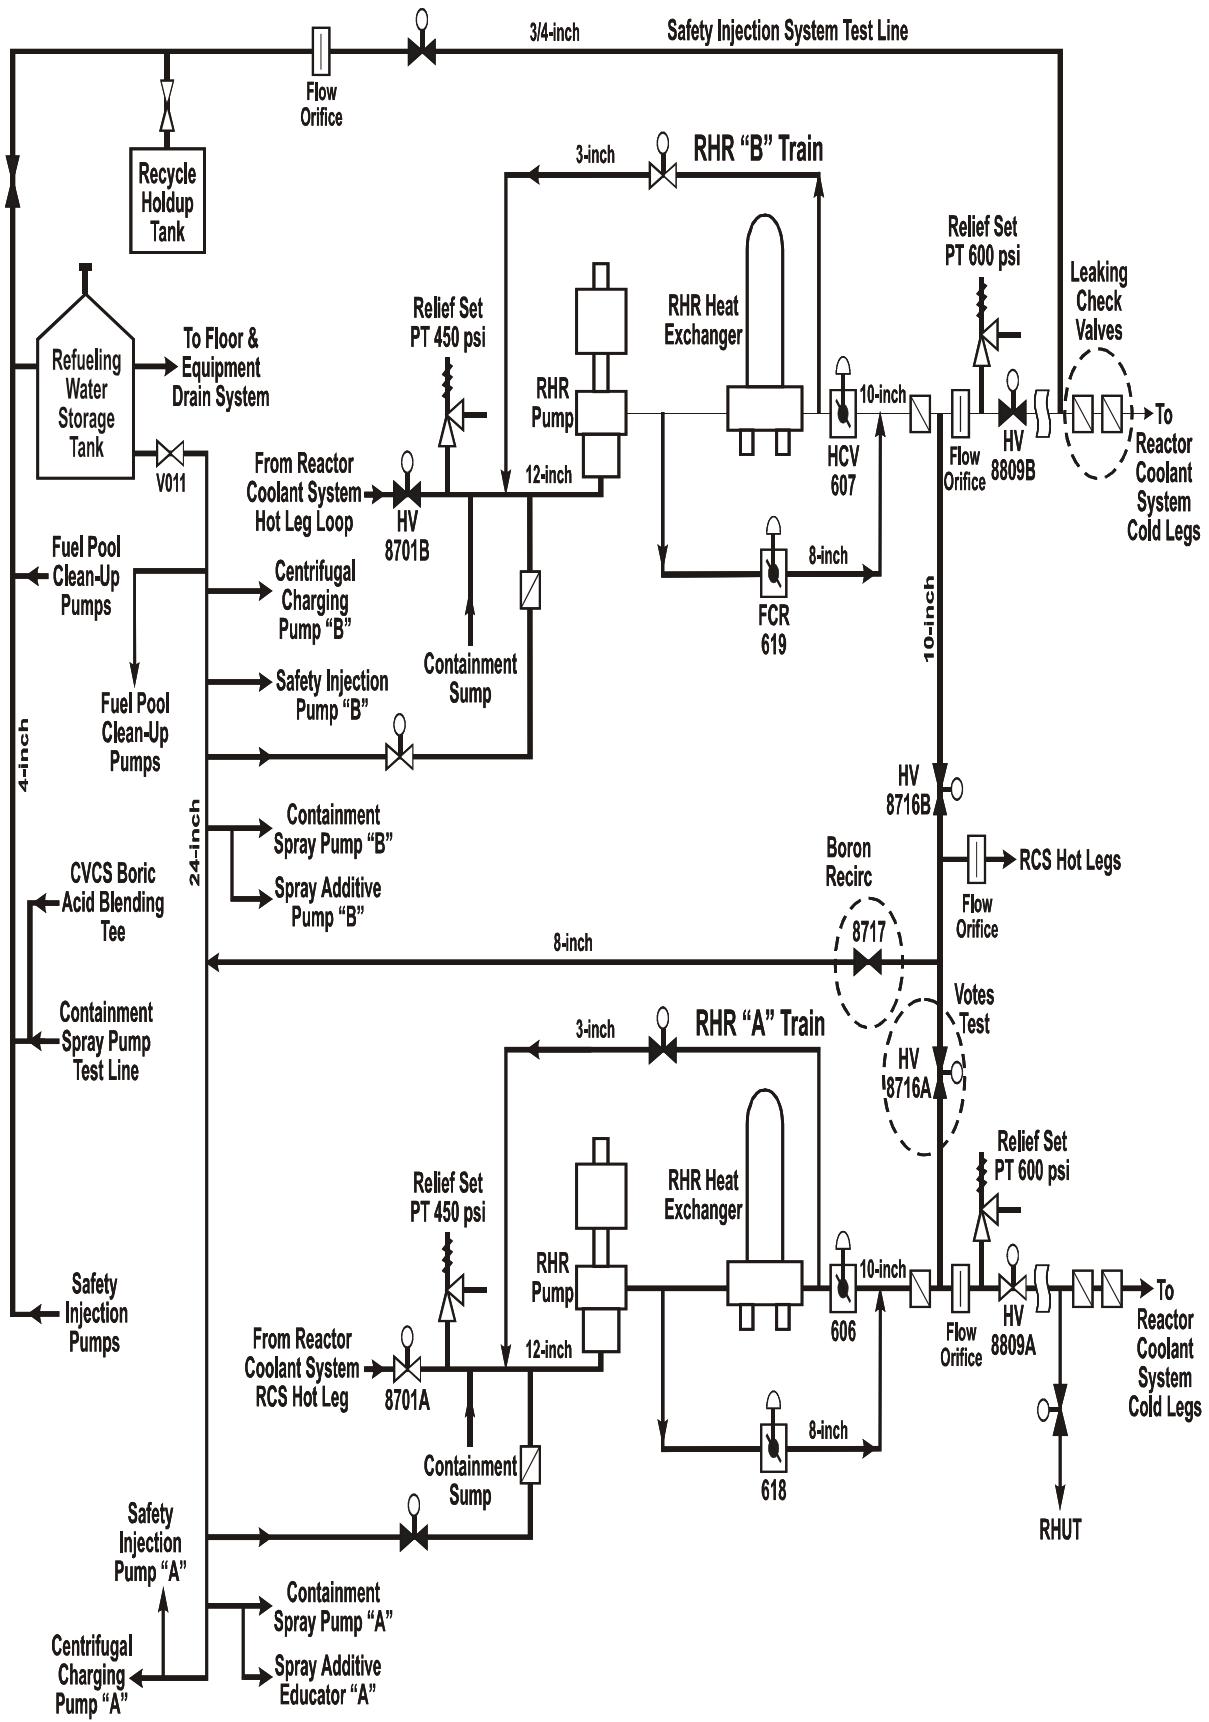
**Figure 1. Simplified residual heat removal-refueling water storage tank**

At Wolf Creek, all RHR and ECC system pump suction lines are supplied by a common suction header. When the draindown event occurred, hot RCS water was introduced into this common suction header between the RWST and the RHR and ECC system pumps. This hot

water flashed to steam, resulting in a steam/water mixture in the header. Had an ECCS actuation occurred, this mixture would have been introduced into the suction of the ECCS pumps. If operators had not been able to terminate the event, the hot water in the RWST suction piping might have led to steam binding, which could have adversely affected the pumps in both ECCS trains. In addition, water flashing to steam in the header and the RWST could have caused serious mechanical damage to the RHR piping and the RWST as a result of water hammer. Finally, the flow path from the RCS through the RWST establishes a containment bypass path.
