Cable Insulation Resistance Measurements Made During Cable Fire Tests

Sandia National Laboratories

**U.S. Nuclear Regulatory Commission
Office of Nuclear Regulatory Research
Washington, DC 20555-0001**

Prepared by
F. J. Wyant, S. P. Nowlen

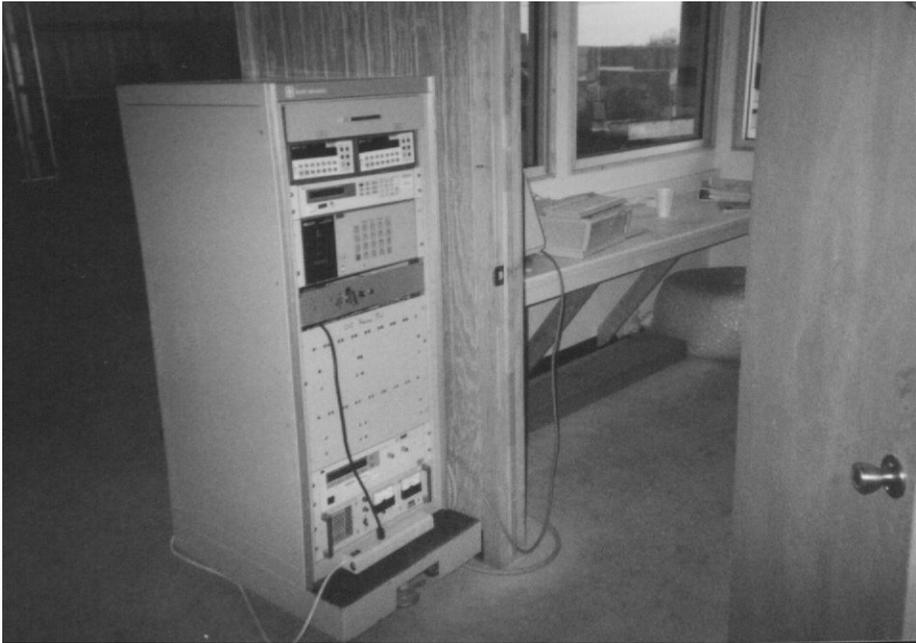
Figures 3-9 and 3-10 show the IR measurement system instrument rack front and rear views, respectively. Part of the computer for the system can be seen through the doorway to the right of the instrument rack in Figure 3-9.

Figure 3-9. Front view of the IR measurement system instrument rack.

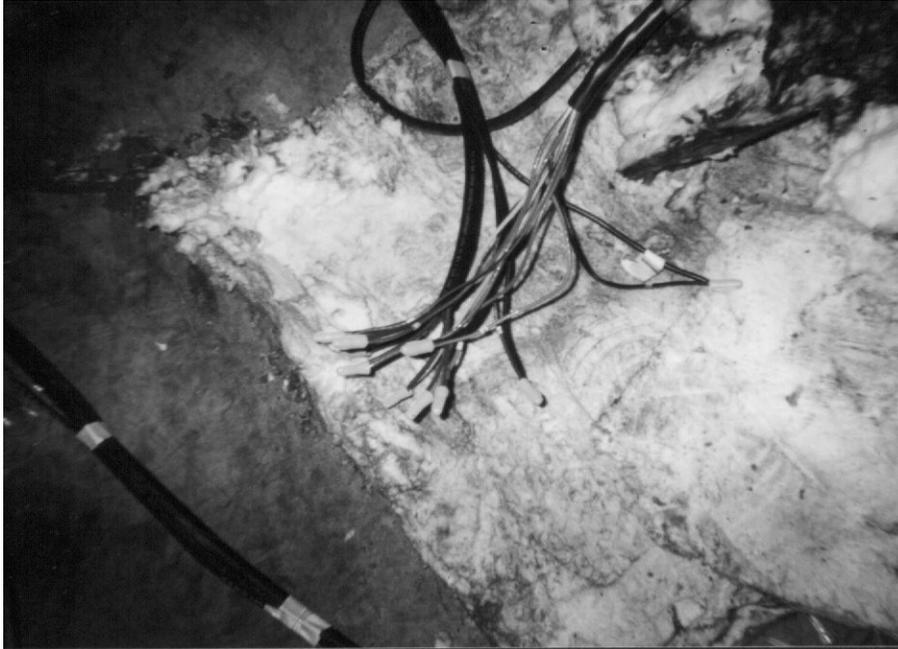
Connection of the wiring harnesses to the test cable was accomplished using commercially-available wire nuts (see Figure 3-11). It is important that each end of a specific conductor in the test cable be connected to the corresponding conductors in both wiring harnesses. For example, the conductors marked “1” in each wiring harness needed to be connected to the ends of the same conductor in the test cable. This also applied to the conductors marked “2” through “10” in the harnesses. Proper connections are checked by performing a continuity check of the pairs of harness conductors at the patch panel ends of the wiring harnesses.

Figure 3-11. IR measurement system “in” wiring harness connection to the test cable bundle.

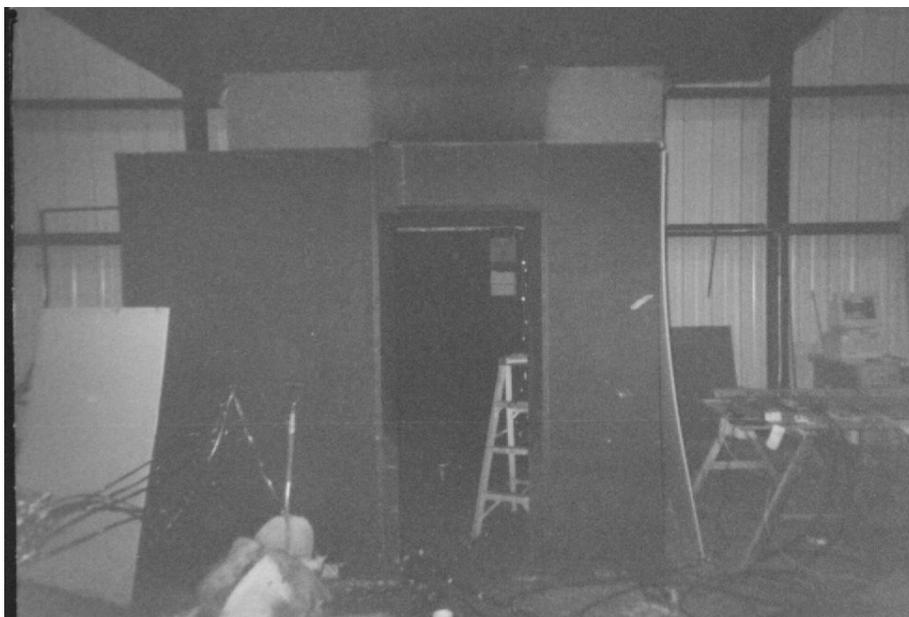
All of the 18 fire tests described here were conducted in a steel chamber measuring 3 m (10 ft) wide, 3 m (10 ft) deep, and 2.4 m (8 ft) high, shown in Figure 4-1. The chamber has an opening (door) ~76 cm (30 in.) wide by 2.1 m (7 ft) high in the center of one wall. The exposure fire was generated by flowing propane gas through a 30 cm (12 in.) × 30 cm (12 in.) diffusion burner (a “sand burner,” see Figure 4-2). The fire intensity was controlled by the flow rate of the propane through the burner and ranged from 70 to 350 kW.

Figure 4-1. Fire test cell.

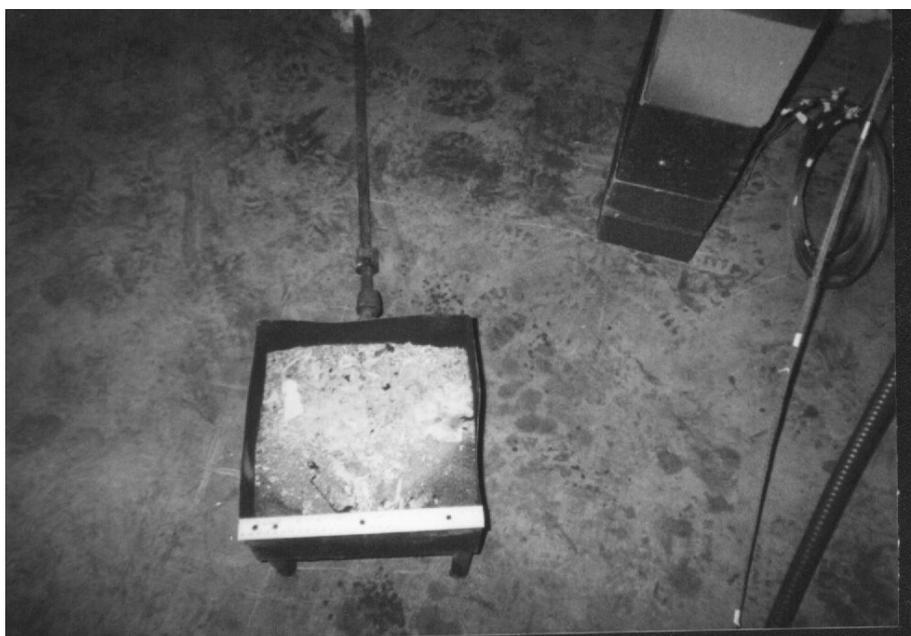
Figure 4-2. Diffusion burner—30 cm × 30 cm (12 in. × 12 in.).

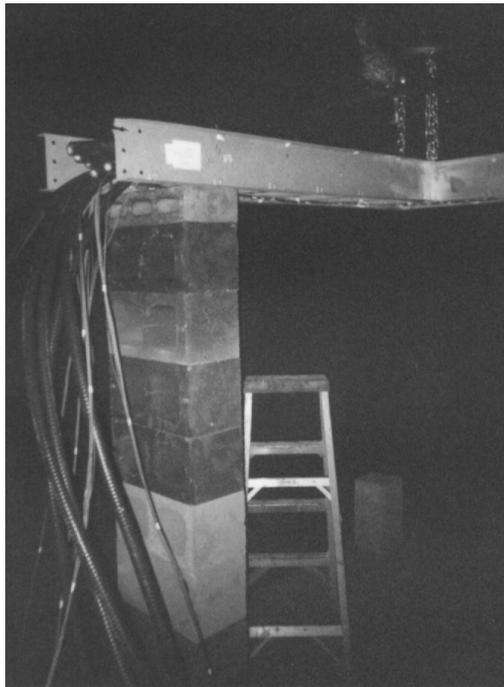
Figure 4-4. Tray, with cables, installed in fire test cell.

Most of the tests used a ladder-back type cable tray 30-cm (12-in.) wide, modified to create a sharp 90-degree bend at the center of the tray's length (Figure 4-3). The tray was positioned in the test cell in a horizontal plane at either 1.5, 1.8, or 2.1 m (5, 6, or 7 ft) above the floor, depending on the type of exposure desired for the test (plume or hot gas layer), as shown in Figure 4-4. One side of the tray was parallel to the back wall of the test cell and the other leg of the tray was parallel to the adjacent wall. Figure 4-5 is an overhead sketch of the horizontal tray arrangement in the test cell. The burner was positioned either directly below the corner of the tray for plume exposure tests or placed in the center of the test cell for the hot gas layer tests. A straight length of cable tray was used for the vertical fire test with the burner positioned 0.6 m (2 ft) behind the center of the tray (Figure 4-6).

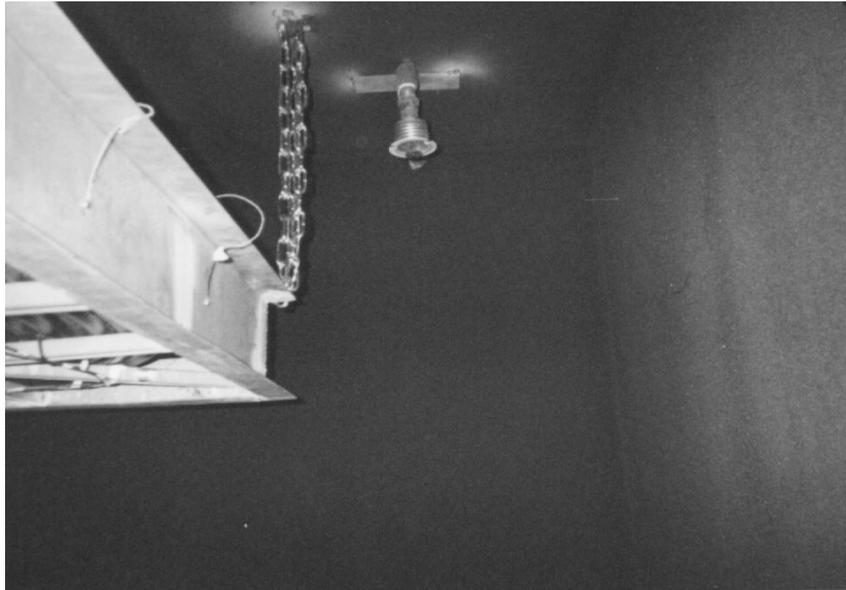
A water sprinkler head (Figure 4-7) was located in the top of the test cell to provide water spray at the corner of the tray after the flame had been extinguished. The water spray was conducted for one minute at the end of most tests.

Figure 4-7. Water sprinkler head inside fire test cell.
