Regulatory Effectiveness Assessment of Generic Issue 43 and Generic Letter 88-14

**U.S. Nuclear Regulatory Commission
Office of Nuclear Regulatory Research
Washington, DC 20555-0001**

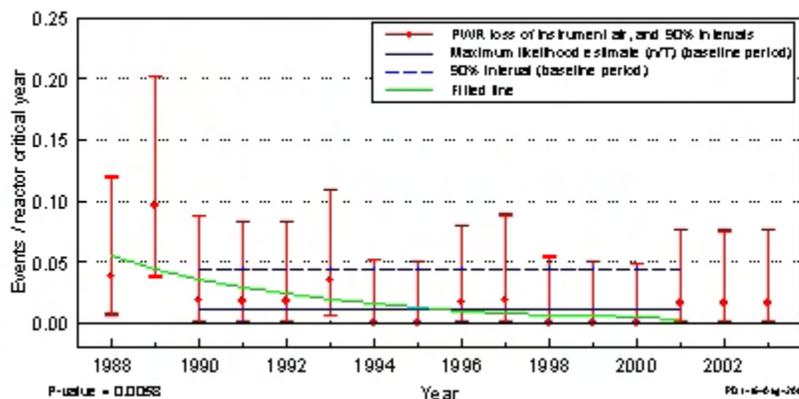
Figure 1. Frequency of PWR initiating events with loss of instrument air

In 2004, Idaho National Engineering and Environment Laboratory (INEEL) analyzed the initiating event frequencies at U.S. nuclear power plants (Ref. 8). As show in Figures 1 and 2, the historical frequency of initiating events with loss of instrument air has decreased for both boiling-water reactors (BWRs) and pressurized-water reactors (PWRs). INEEL concluded that the long-term trend is likely to represent more than mere random variation. Both BWRs and PWRs showed low baseline initiating event frequencies for loss of instrument air, with mean frequencies of 0.0083 and 0.0115 per reactor critical year for BWRs and PWRs, respectively. These baseline initiating event frequencies are significantly lower than the “pre-baseline” frequencies (before 1994 for BWRs and before 1990 for PWRs); however, the INEEL analysis did not provide reasons for the observed frequency changes.

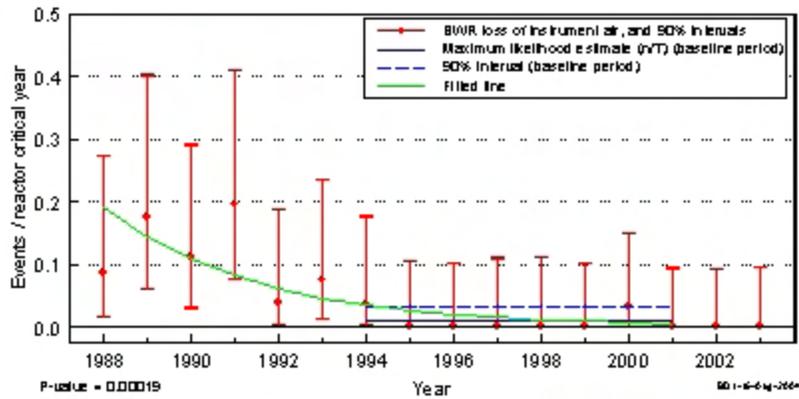
Figure 2. Frequency of BWR initiating events with loss of instrument air

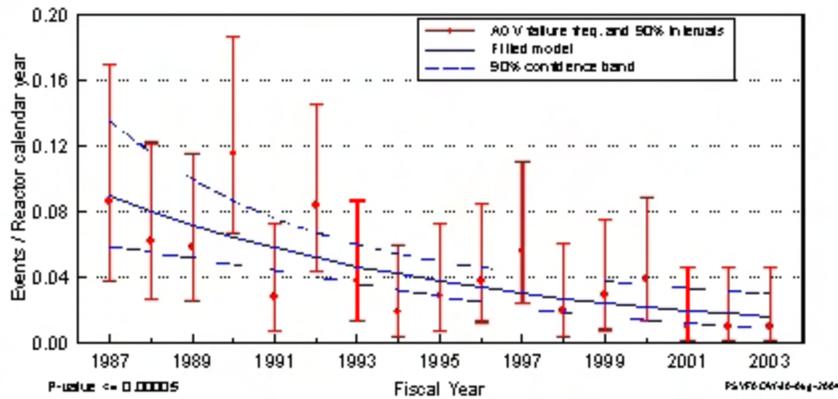
Figure 3. Frequency of failures (events per operating year), as a function of fiscal year

In 2004, INEEL also analyzed the component performance of air-operated valves (AOVs) at U.S. commercial reactors (Ref. 9). That analysis showed statistically significant improving trends for AOV performance in many areas, including overall failure frequency (Fig. 3), frequency of unplanned demands (Fig. 4), and probability of failure on demand (Fig. 5), each of which reduced by a factor of 3 or greater. The INEEL analysis did not provide reasons for the observed performance improvement.

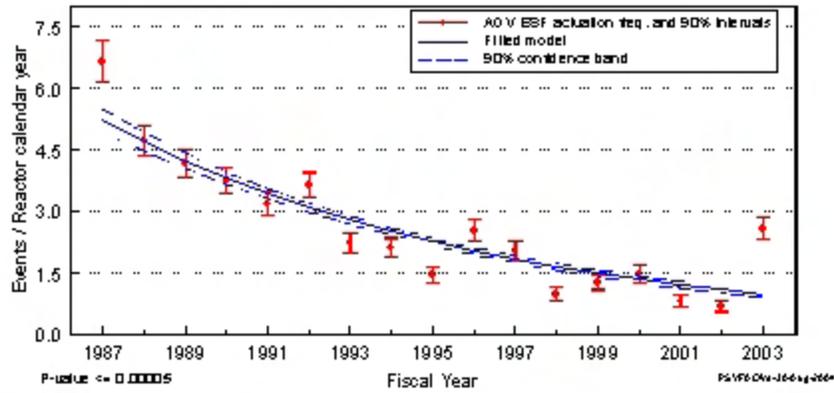
Figure 4. Frequency of unplanned demands (events per operating year), as a function of fiscal year

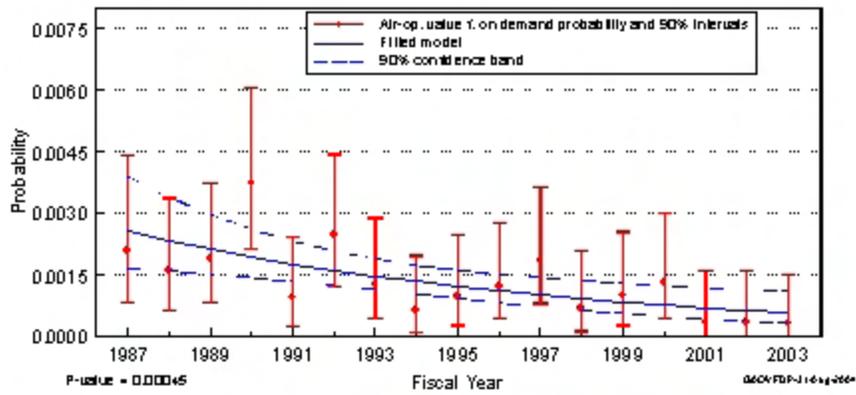
Figure 5. Probability of air-operated valve failures on demand
