Subject:Peach Bottom Atomic Power Station, Units 2 and 3Request for Exemption from 10 CFR 50, Appendix R,
Section III.F, "Automatic Fire Detection" for Specific Plant Locations

PEACH BOTTOM ATOMIC POWER STATION UNITS 2 and 3

Exemption Request From Requirements of 10 CFR Part 50 Appendix R, Section III

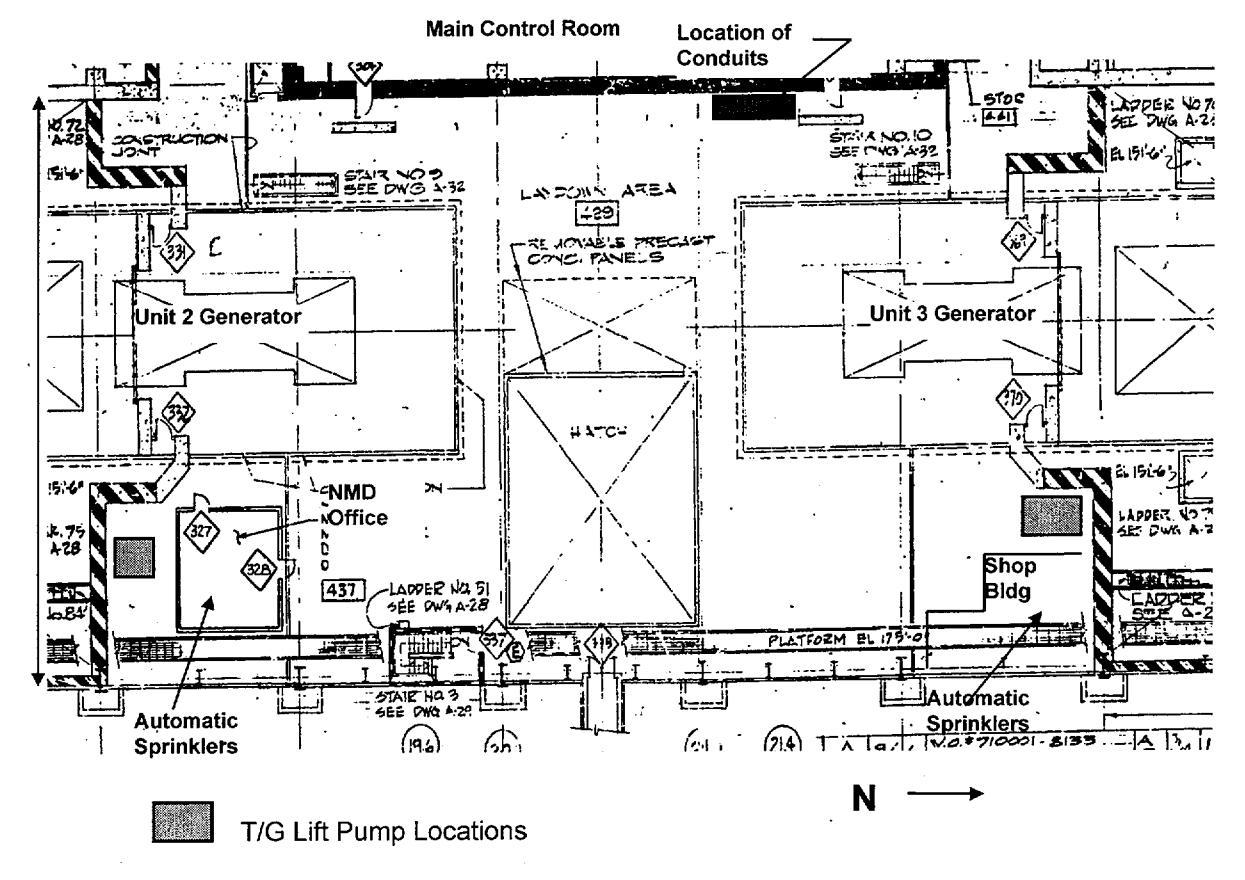
Figure 1

Plan View of Room 429 Turbine Building 165" elevation Laydown area

The cables associated with #343-SU routed in room 429 are located in conduits 2B1562, 2S933 and 2S934, which are located along the west wall of room 429 (this is the exterior wall of the control room). Conduit 2B1562 is a 3 inch conduit that comes out of a floor penetration and rises to a junction box approximately 16 feet above the floor. At that junction box 2 conduits (2S933 and 2S934) emerge and are routed north horizontally approximately 11 feet and 7 feet, respectively. These conduits then drop down approximately 4 feet into wall penetrations on the west wall of room 429. These conduits are located slightly north of the centerline of the turbine building, which puts them on the Unit 3 side of the operating floor. Figures 1, 2, 3 and 4 provide the relative location of these conduits in relation to other equipment within the room.

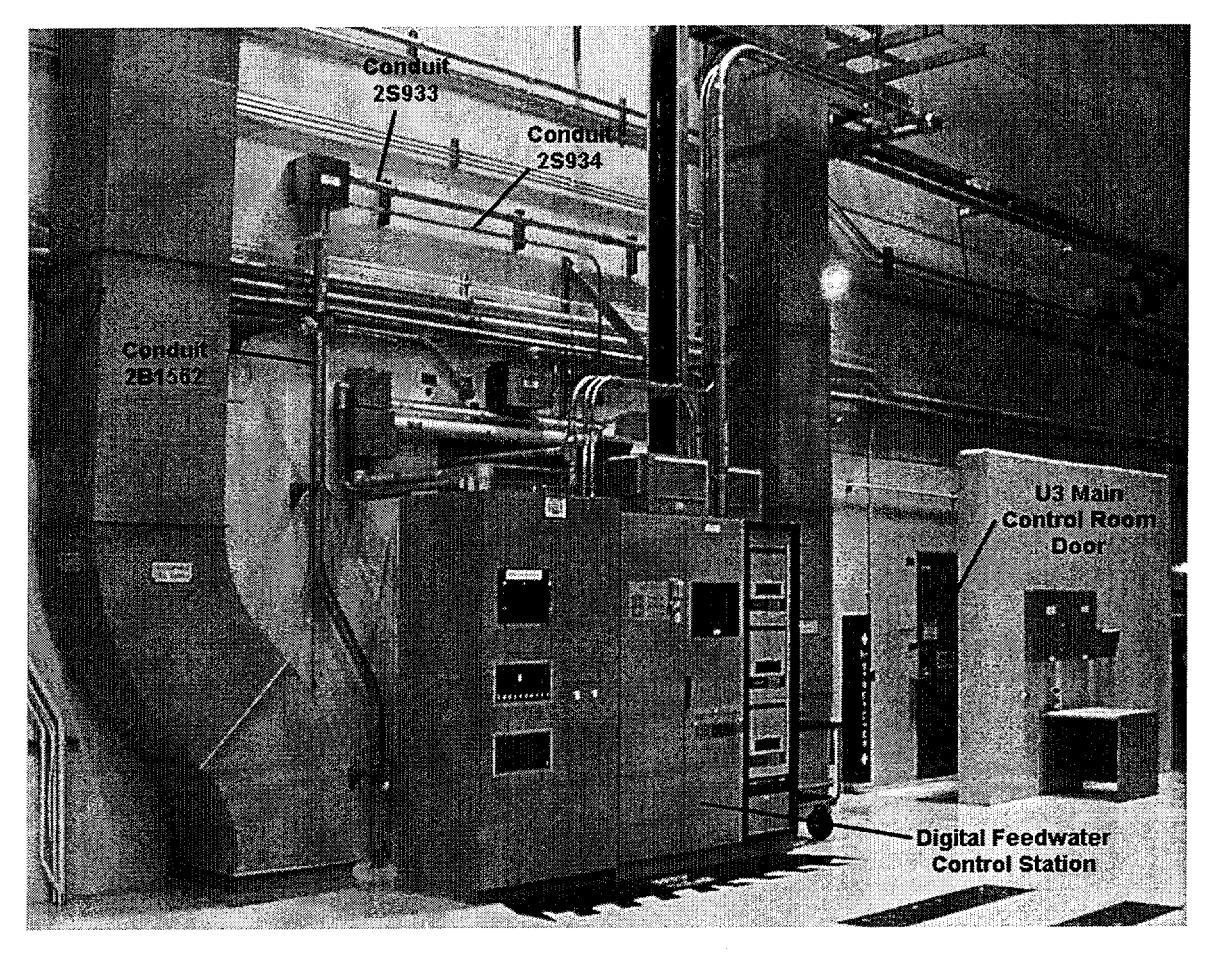
Figure 2

View (looking northwest) of the three conduits that contain the #343 SU 4kV control cables.

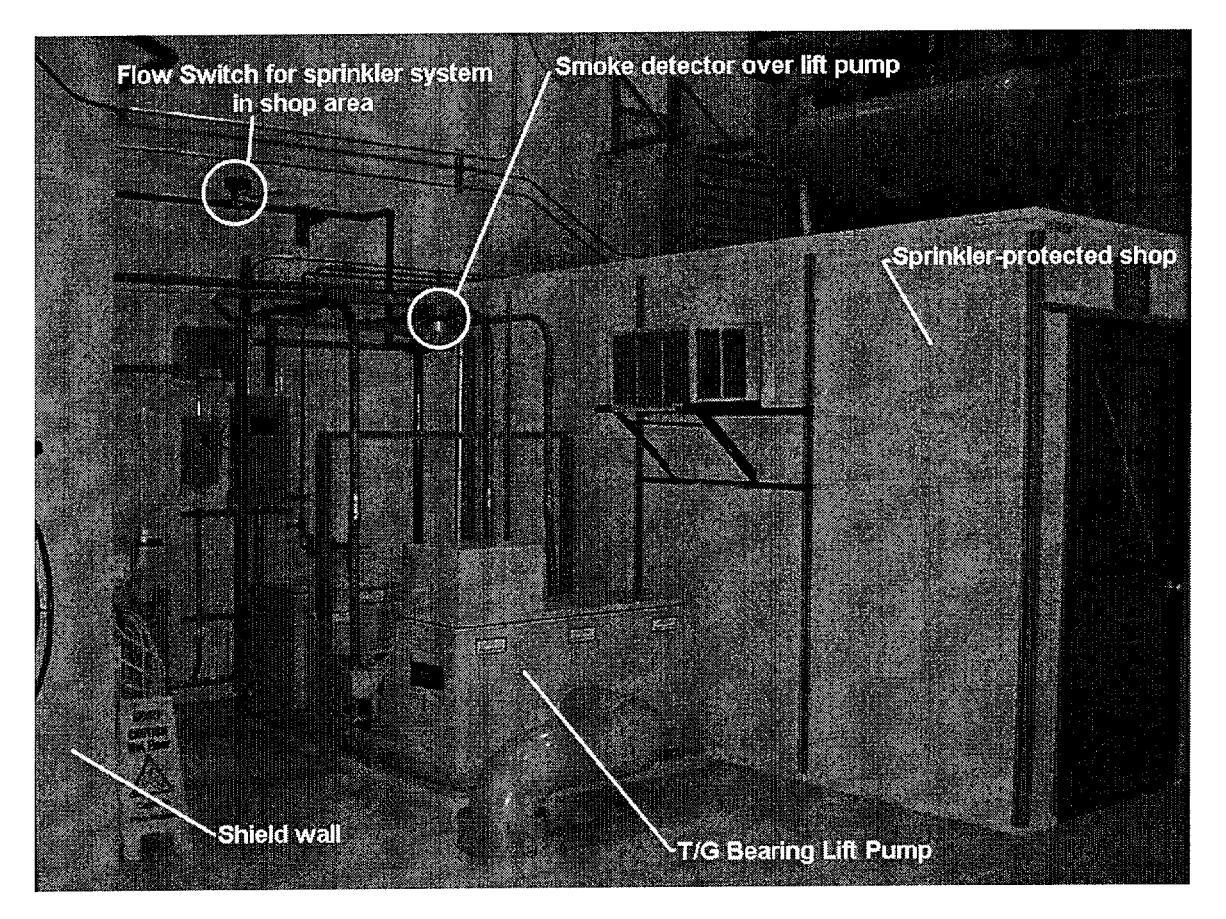
View of Unit 3 T/G bearing lift pump and smoke detector (looking northeast). Also the sprinkler piping to the shop area and the water flow switch. Note the wall on the left side. This is the shield wall that provides additional separation between these hazards and the conduits.

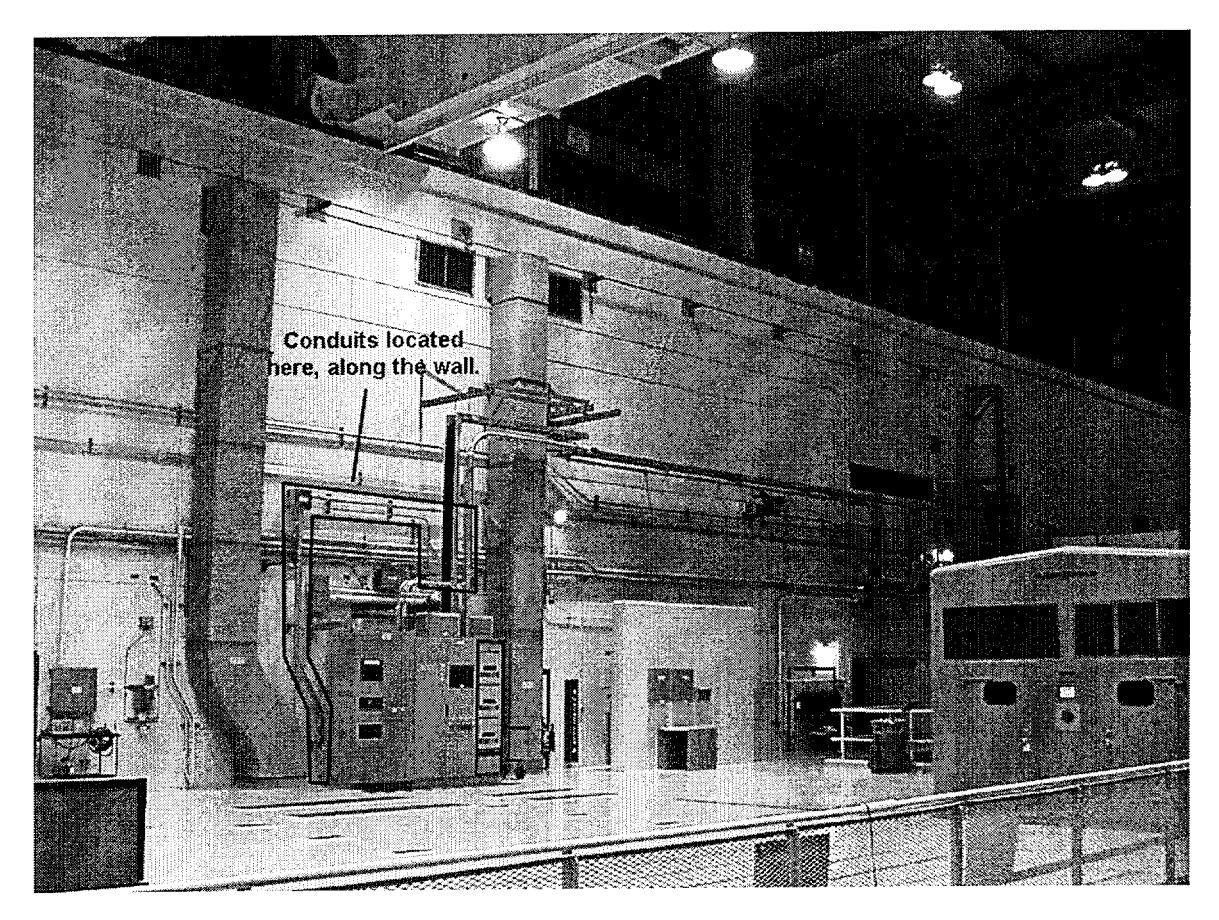
Figure 4

View of operating floor looking west and north. Exciter housing is at right. Further to the right and out of the picture is the Unit 3 T/G bearing lift pump and the shop building. The Unit 2 T/G bearing lift pump is behind the photographer.

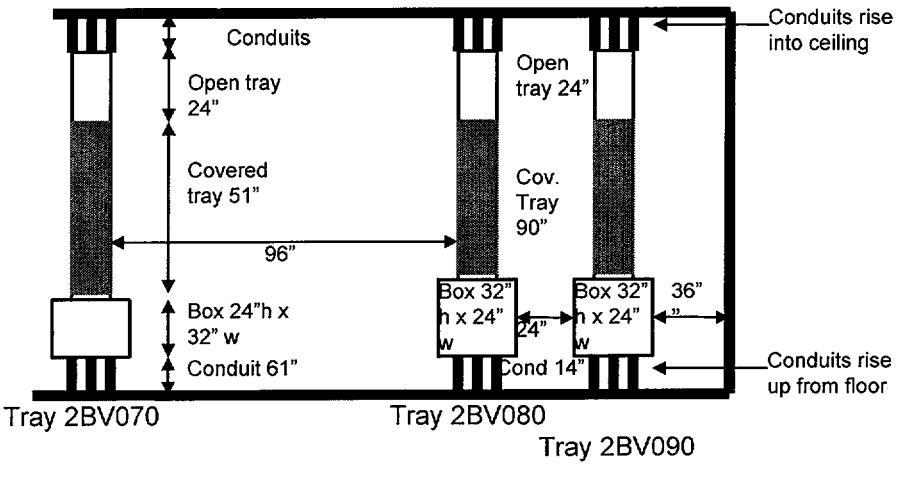
Figure 5

Elevation sketch of room 222 looking north. The trays are located directly against the north wall.

Room 222 is a feedwater heater room located on the 135' elevation of the Unit 2 Turbine Building. This room contains the third and fourth Unit 2 feedwater heaters. The concern listed by the NRC Staff in the Safety Evaluation Report (reference 3) for the exemption request was the presence of three open vertical trays in this room. The only combustible hazards in room 222 are the cables in three cable trays located along the north wall of the room. Examination of these trays during the last refueling outage (2R13) completed in October 2000, found that these are not completely open trays as described in the original exemption request submittal, but a combination of conduits, metal enclosures, covered trays, and a small section (approximately 24 inches) of open tray. Figures 5, 6 and 7 illustrate the configuration of these trays.

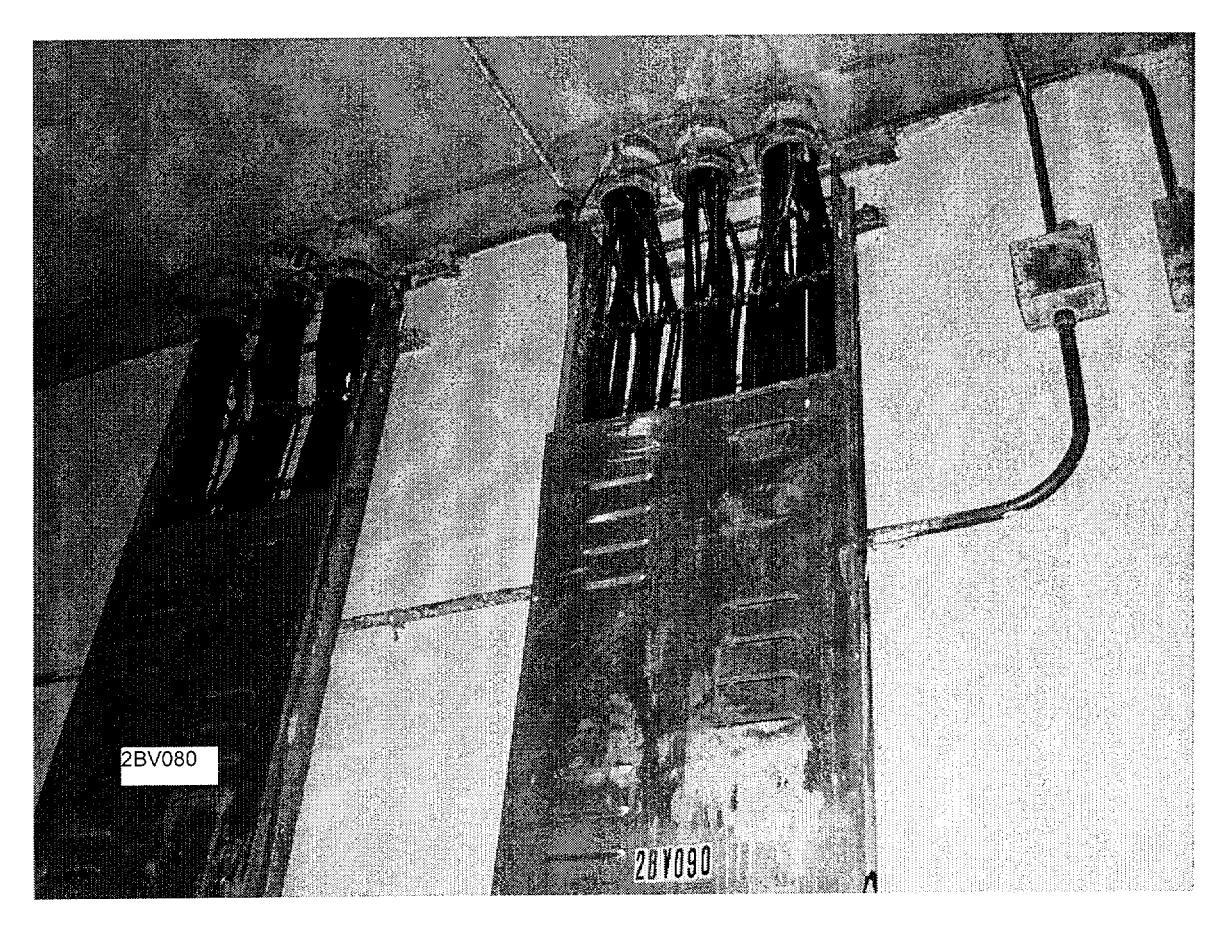
Figure 6

View of trays 2BV080 and 2BV090 looking at the north wall of room 222. Tray 2BV080 contains the control cable for #343SU offsite power source.

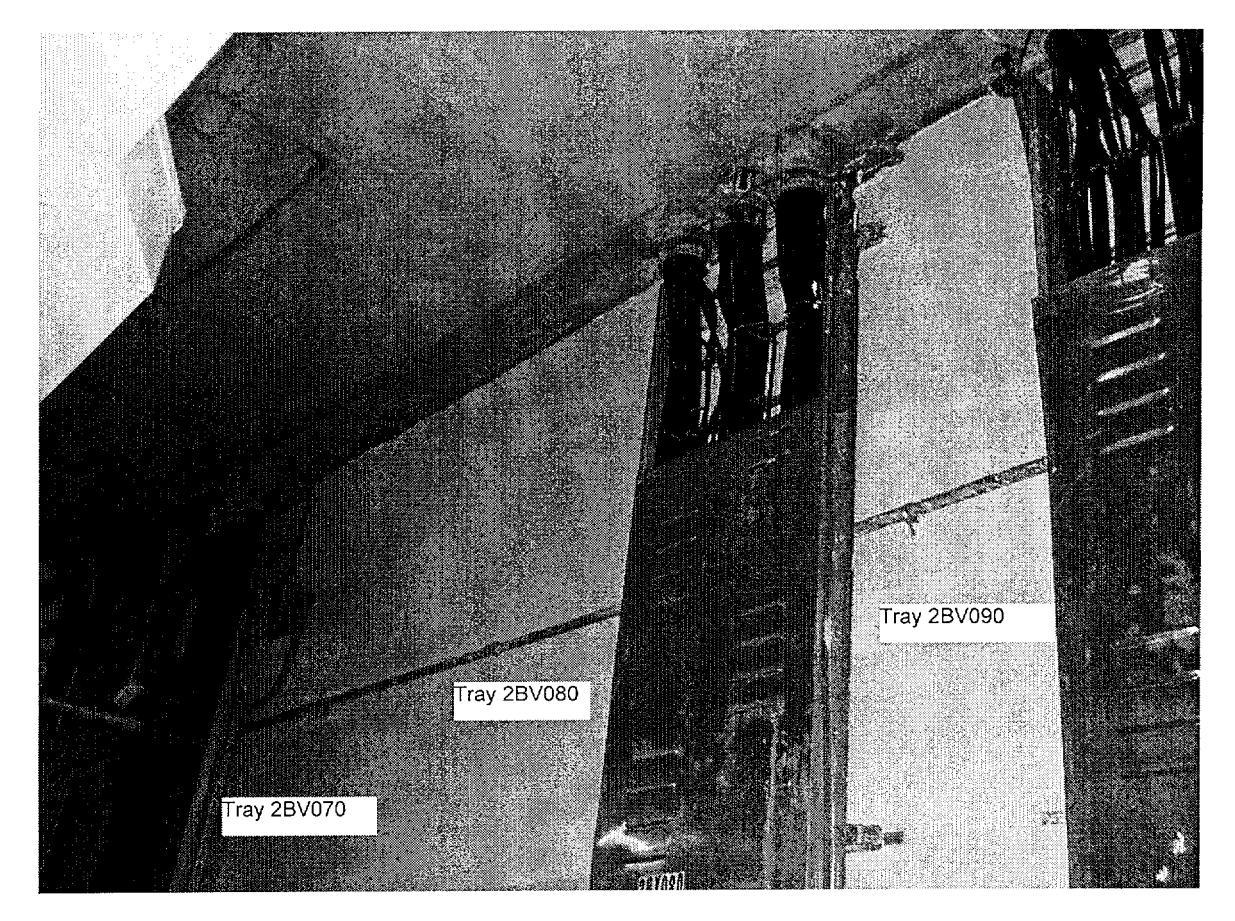
Figure 7

View of the relationship of the three trays along the north wall of room 222. Tray 2BV070 and Tray 2BV080 are separated by about 96". Trays 2BV080 and 2BV090 are separated by just over 24".
