MAINE YANKEE FINAL STATUS SURVEY RELEASE RECORD FD-3500 STORM DRAINS SURVEY UNIT 2

A. SURVEY UNIT DESCRIPTION

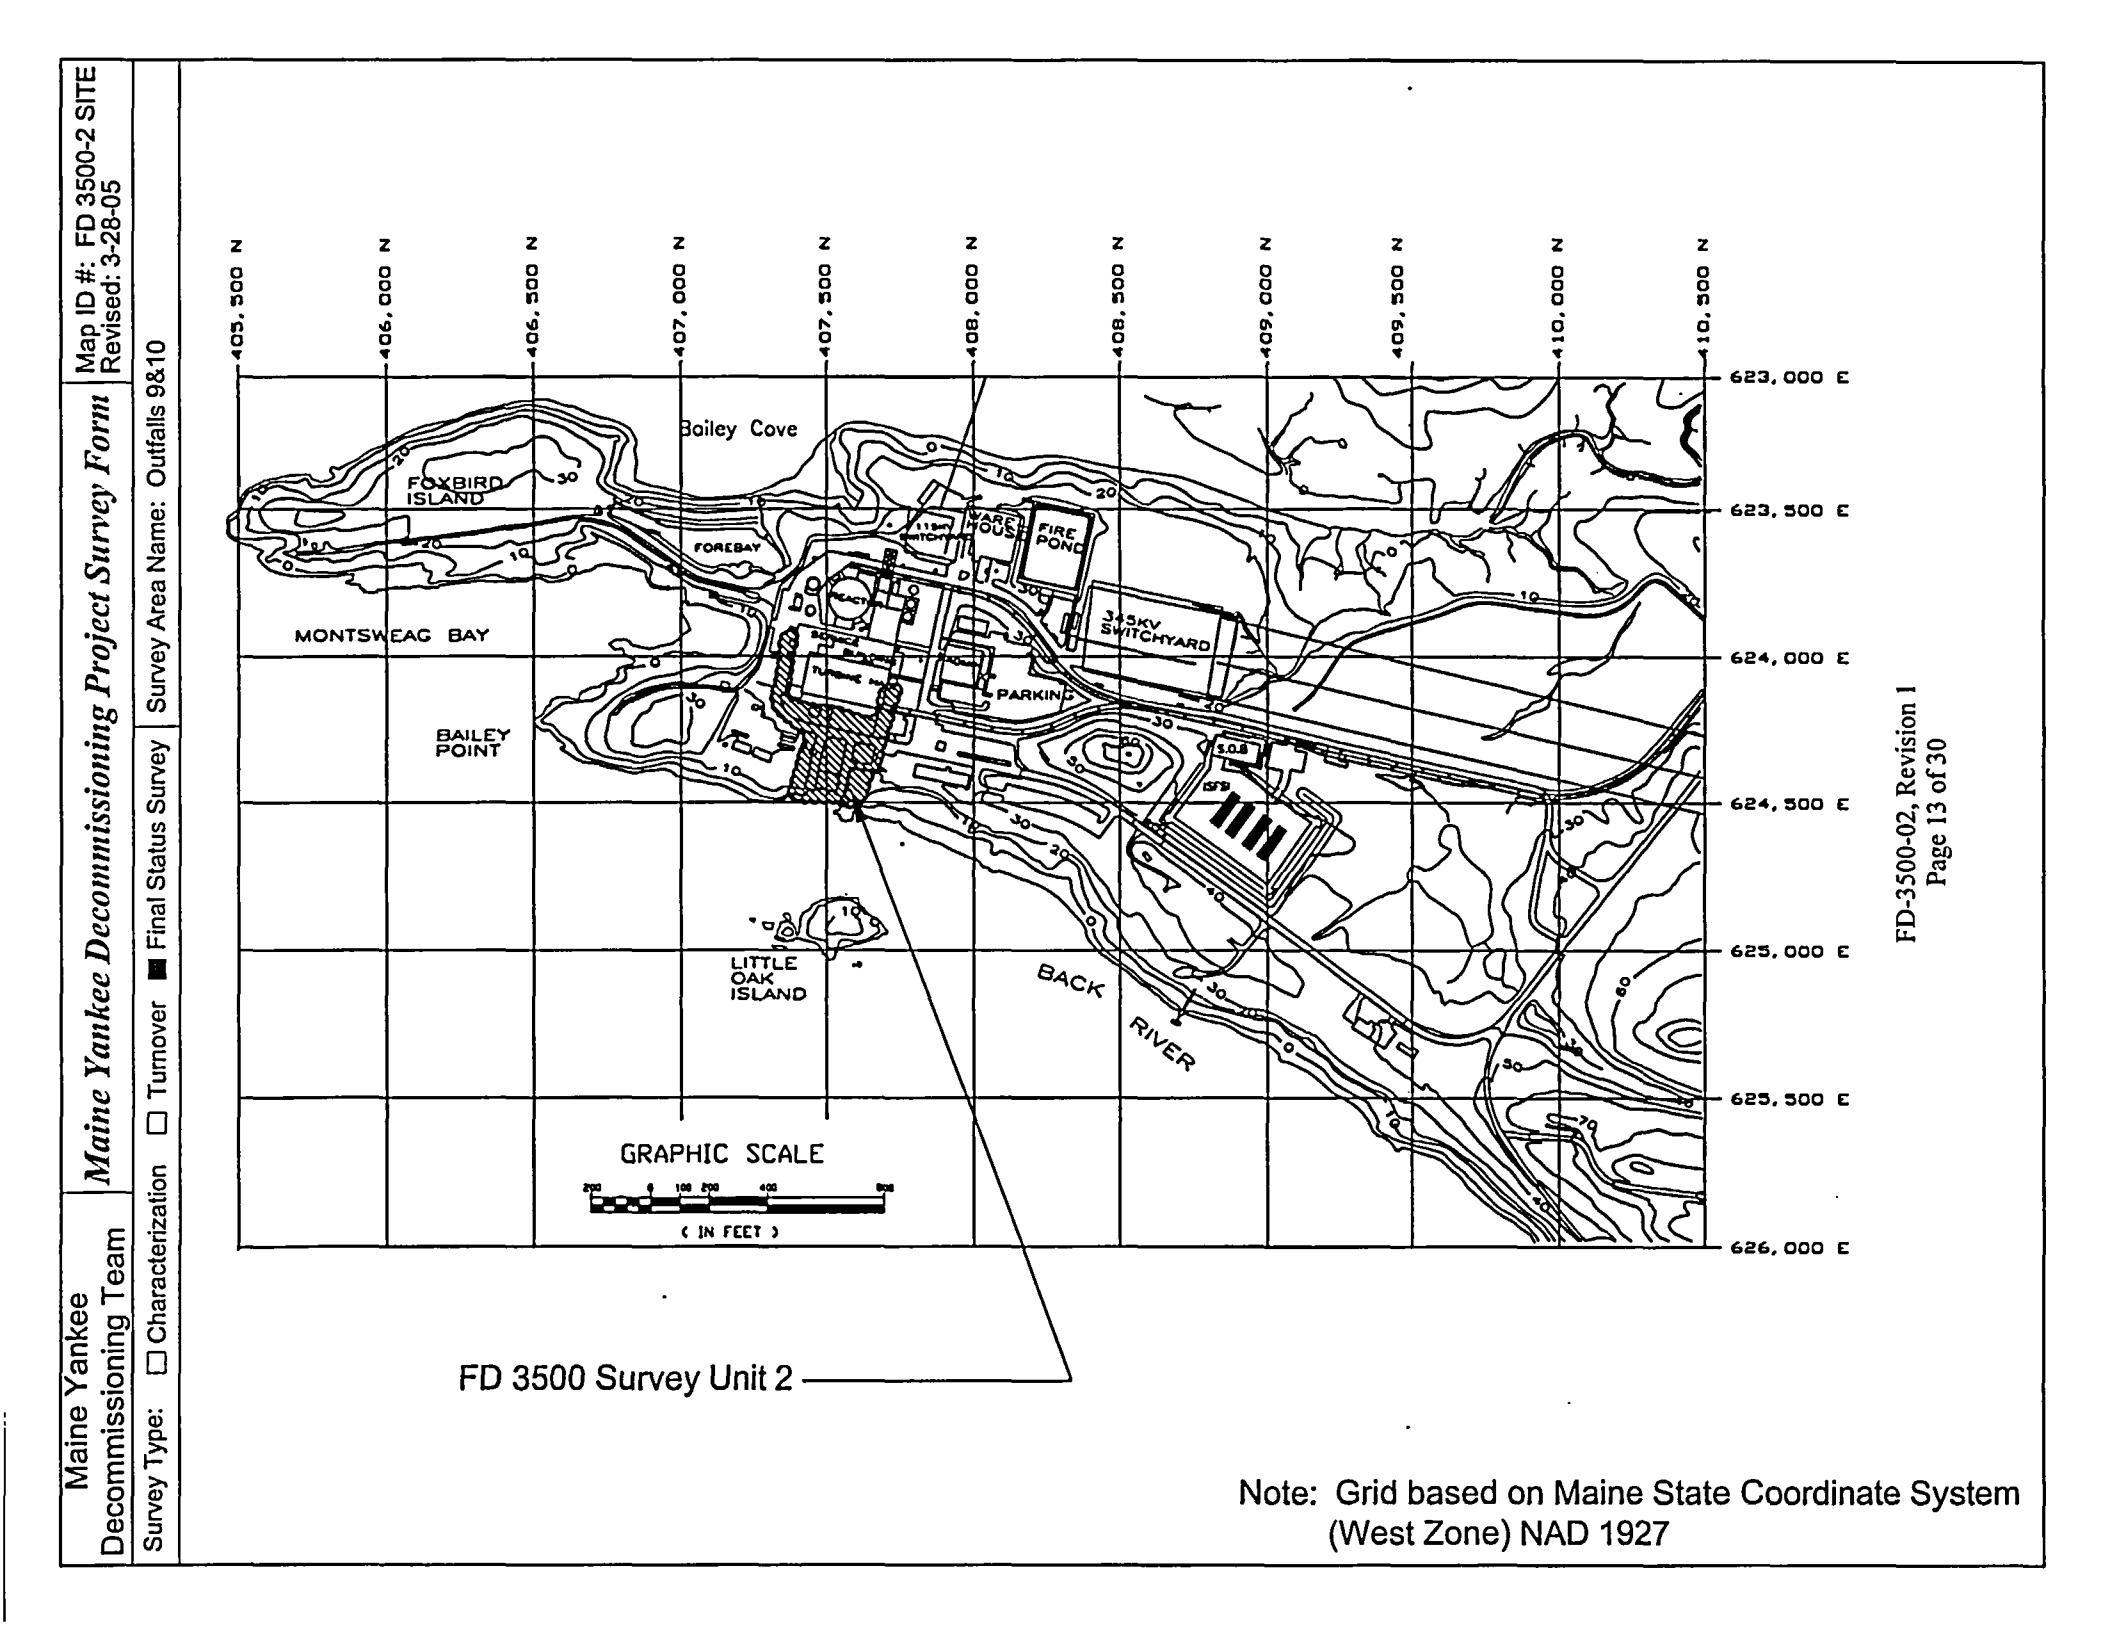
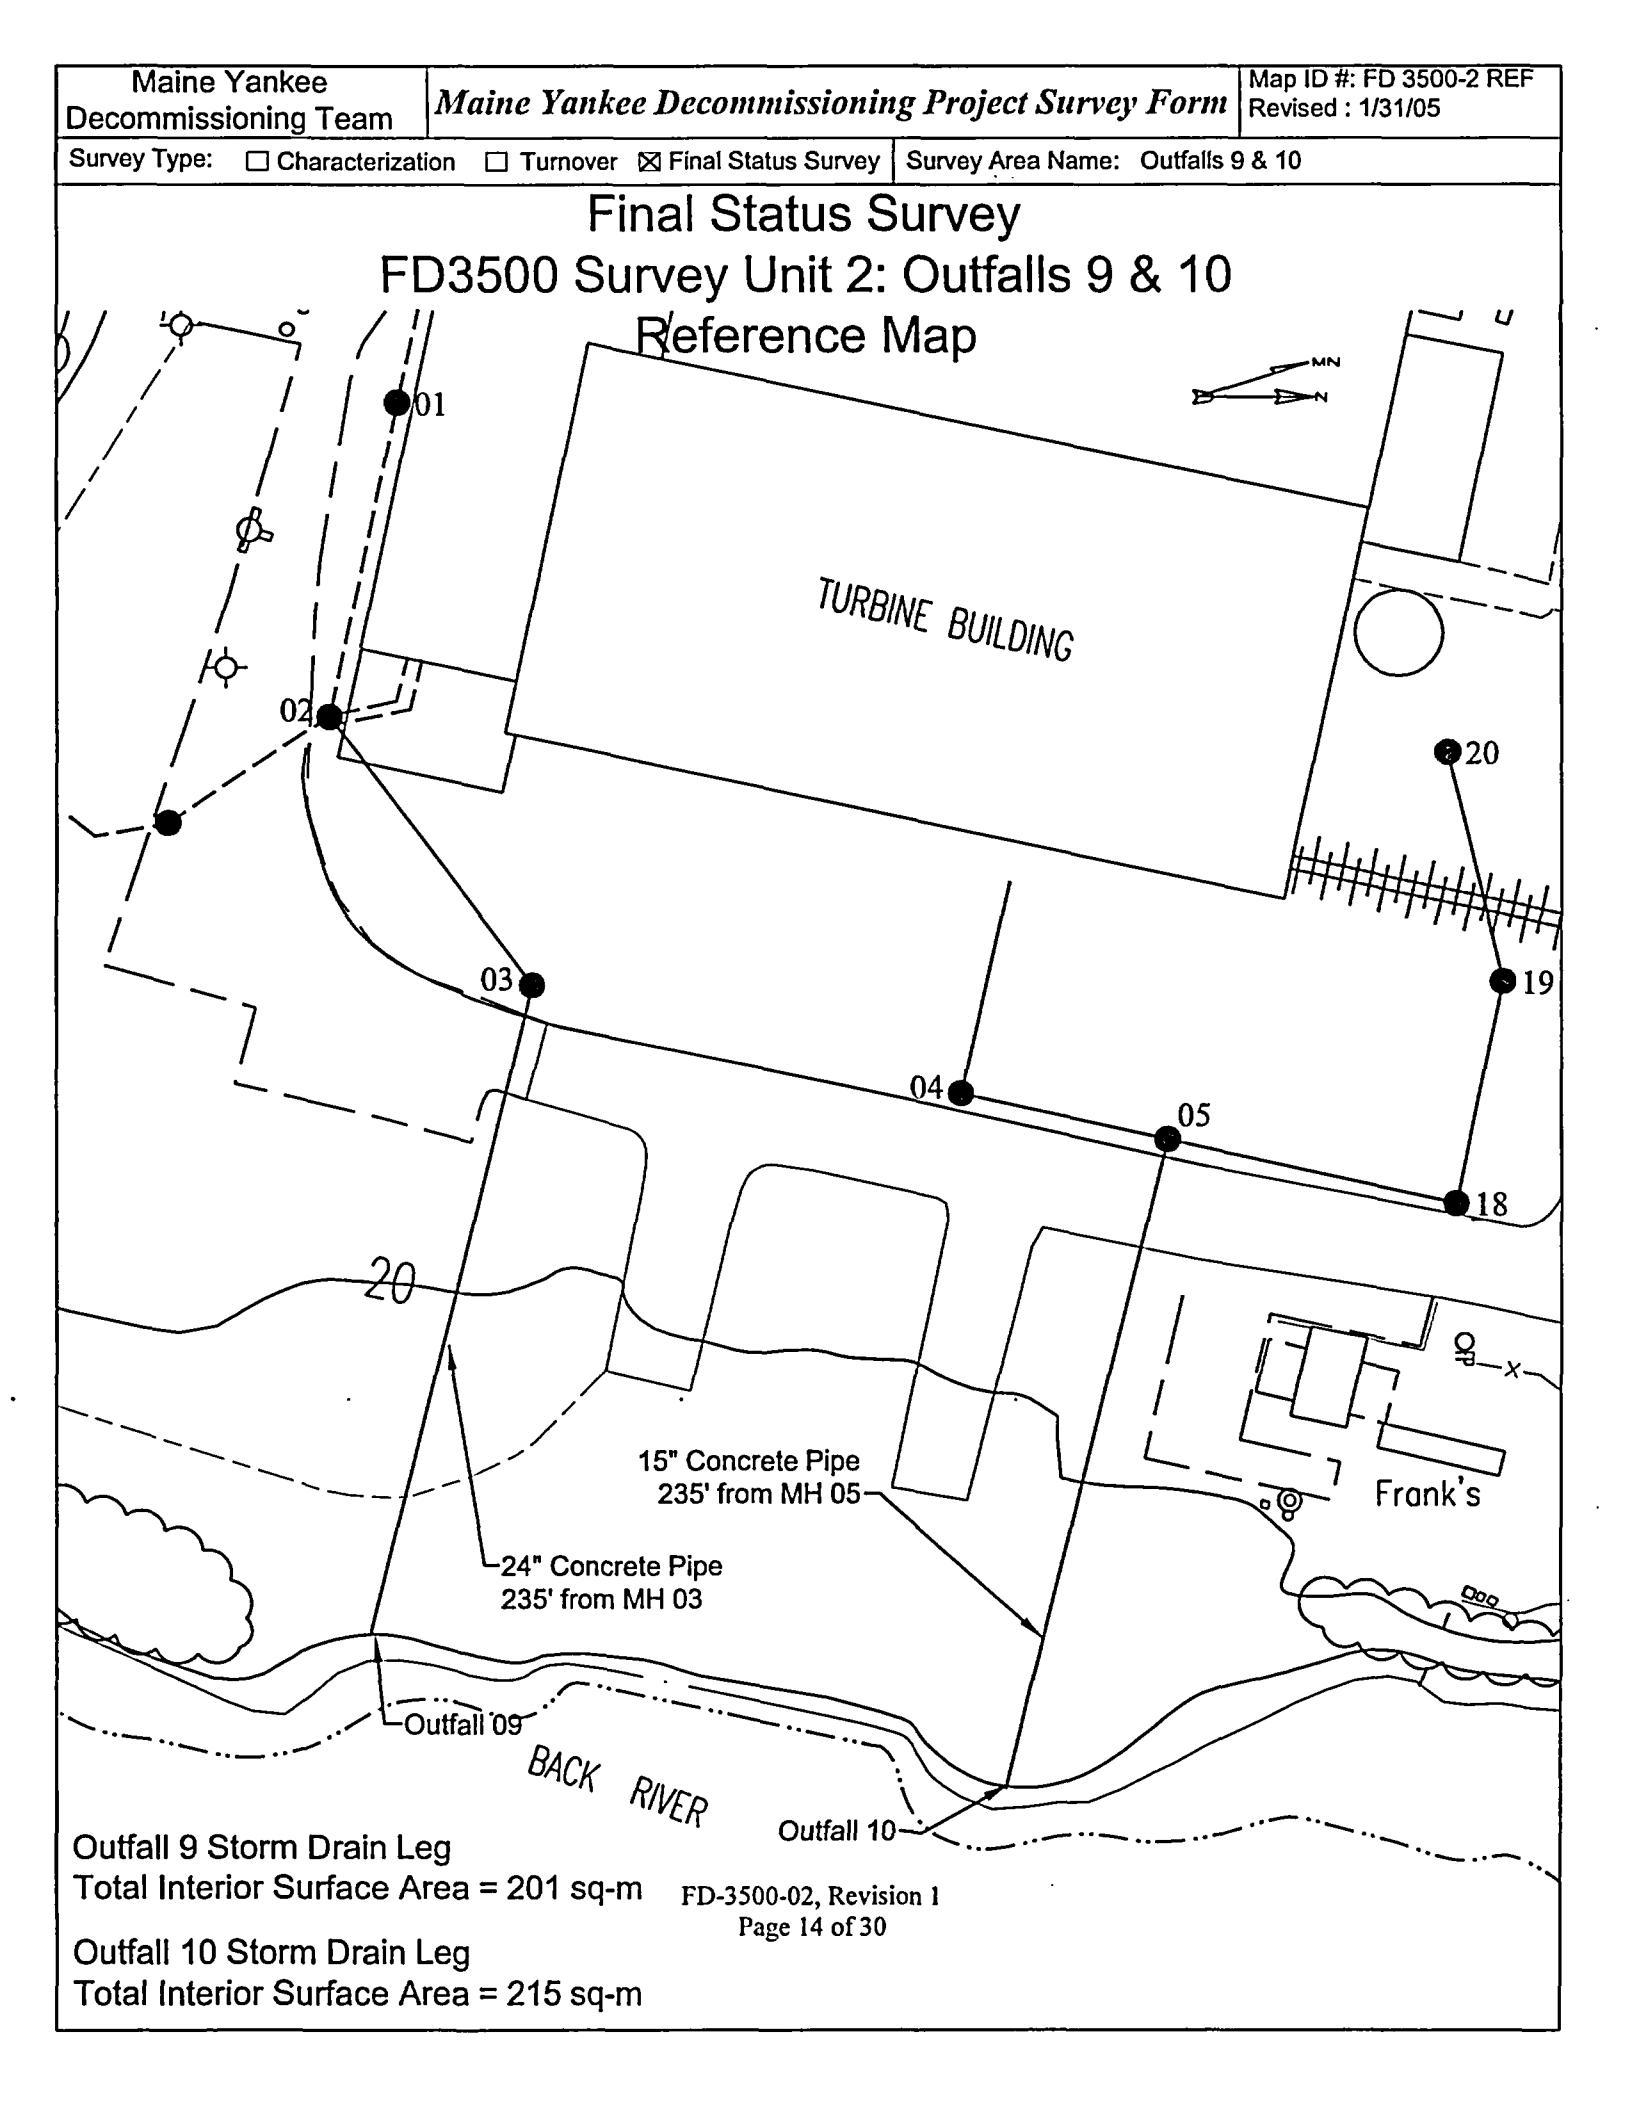
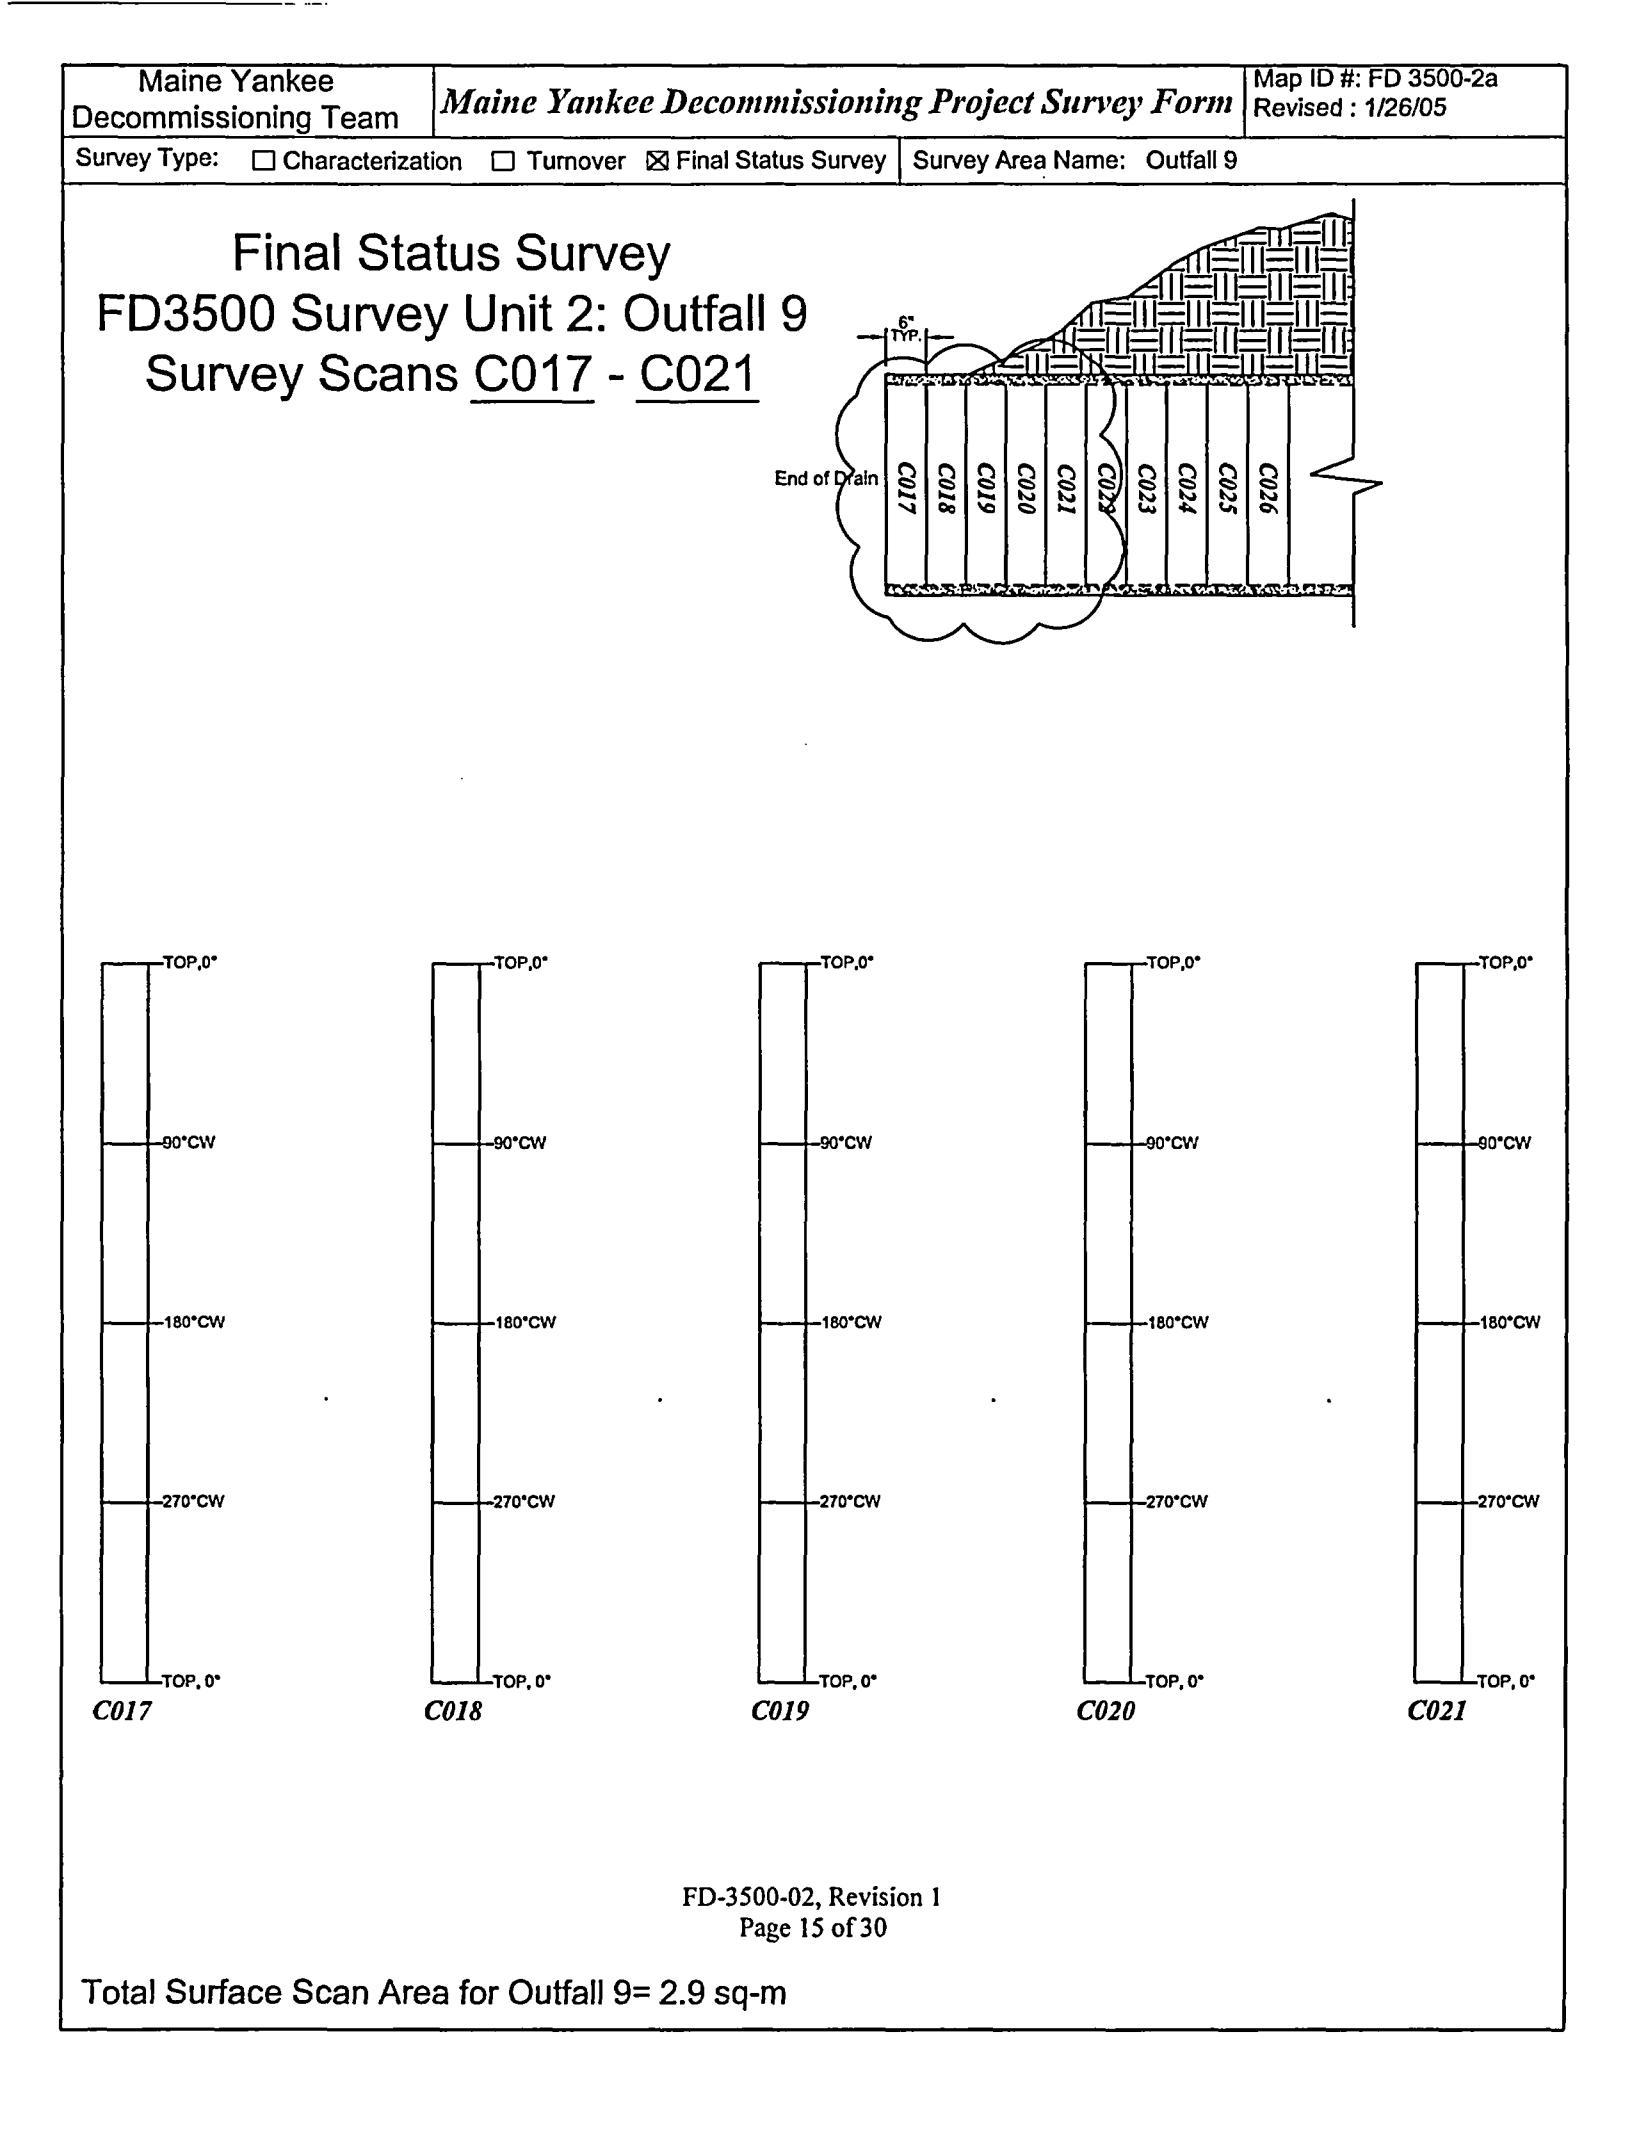
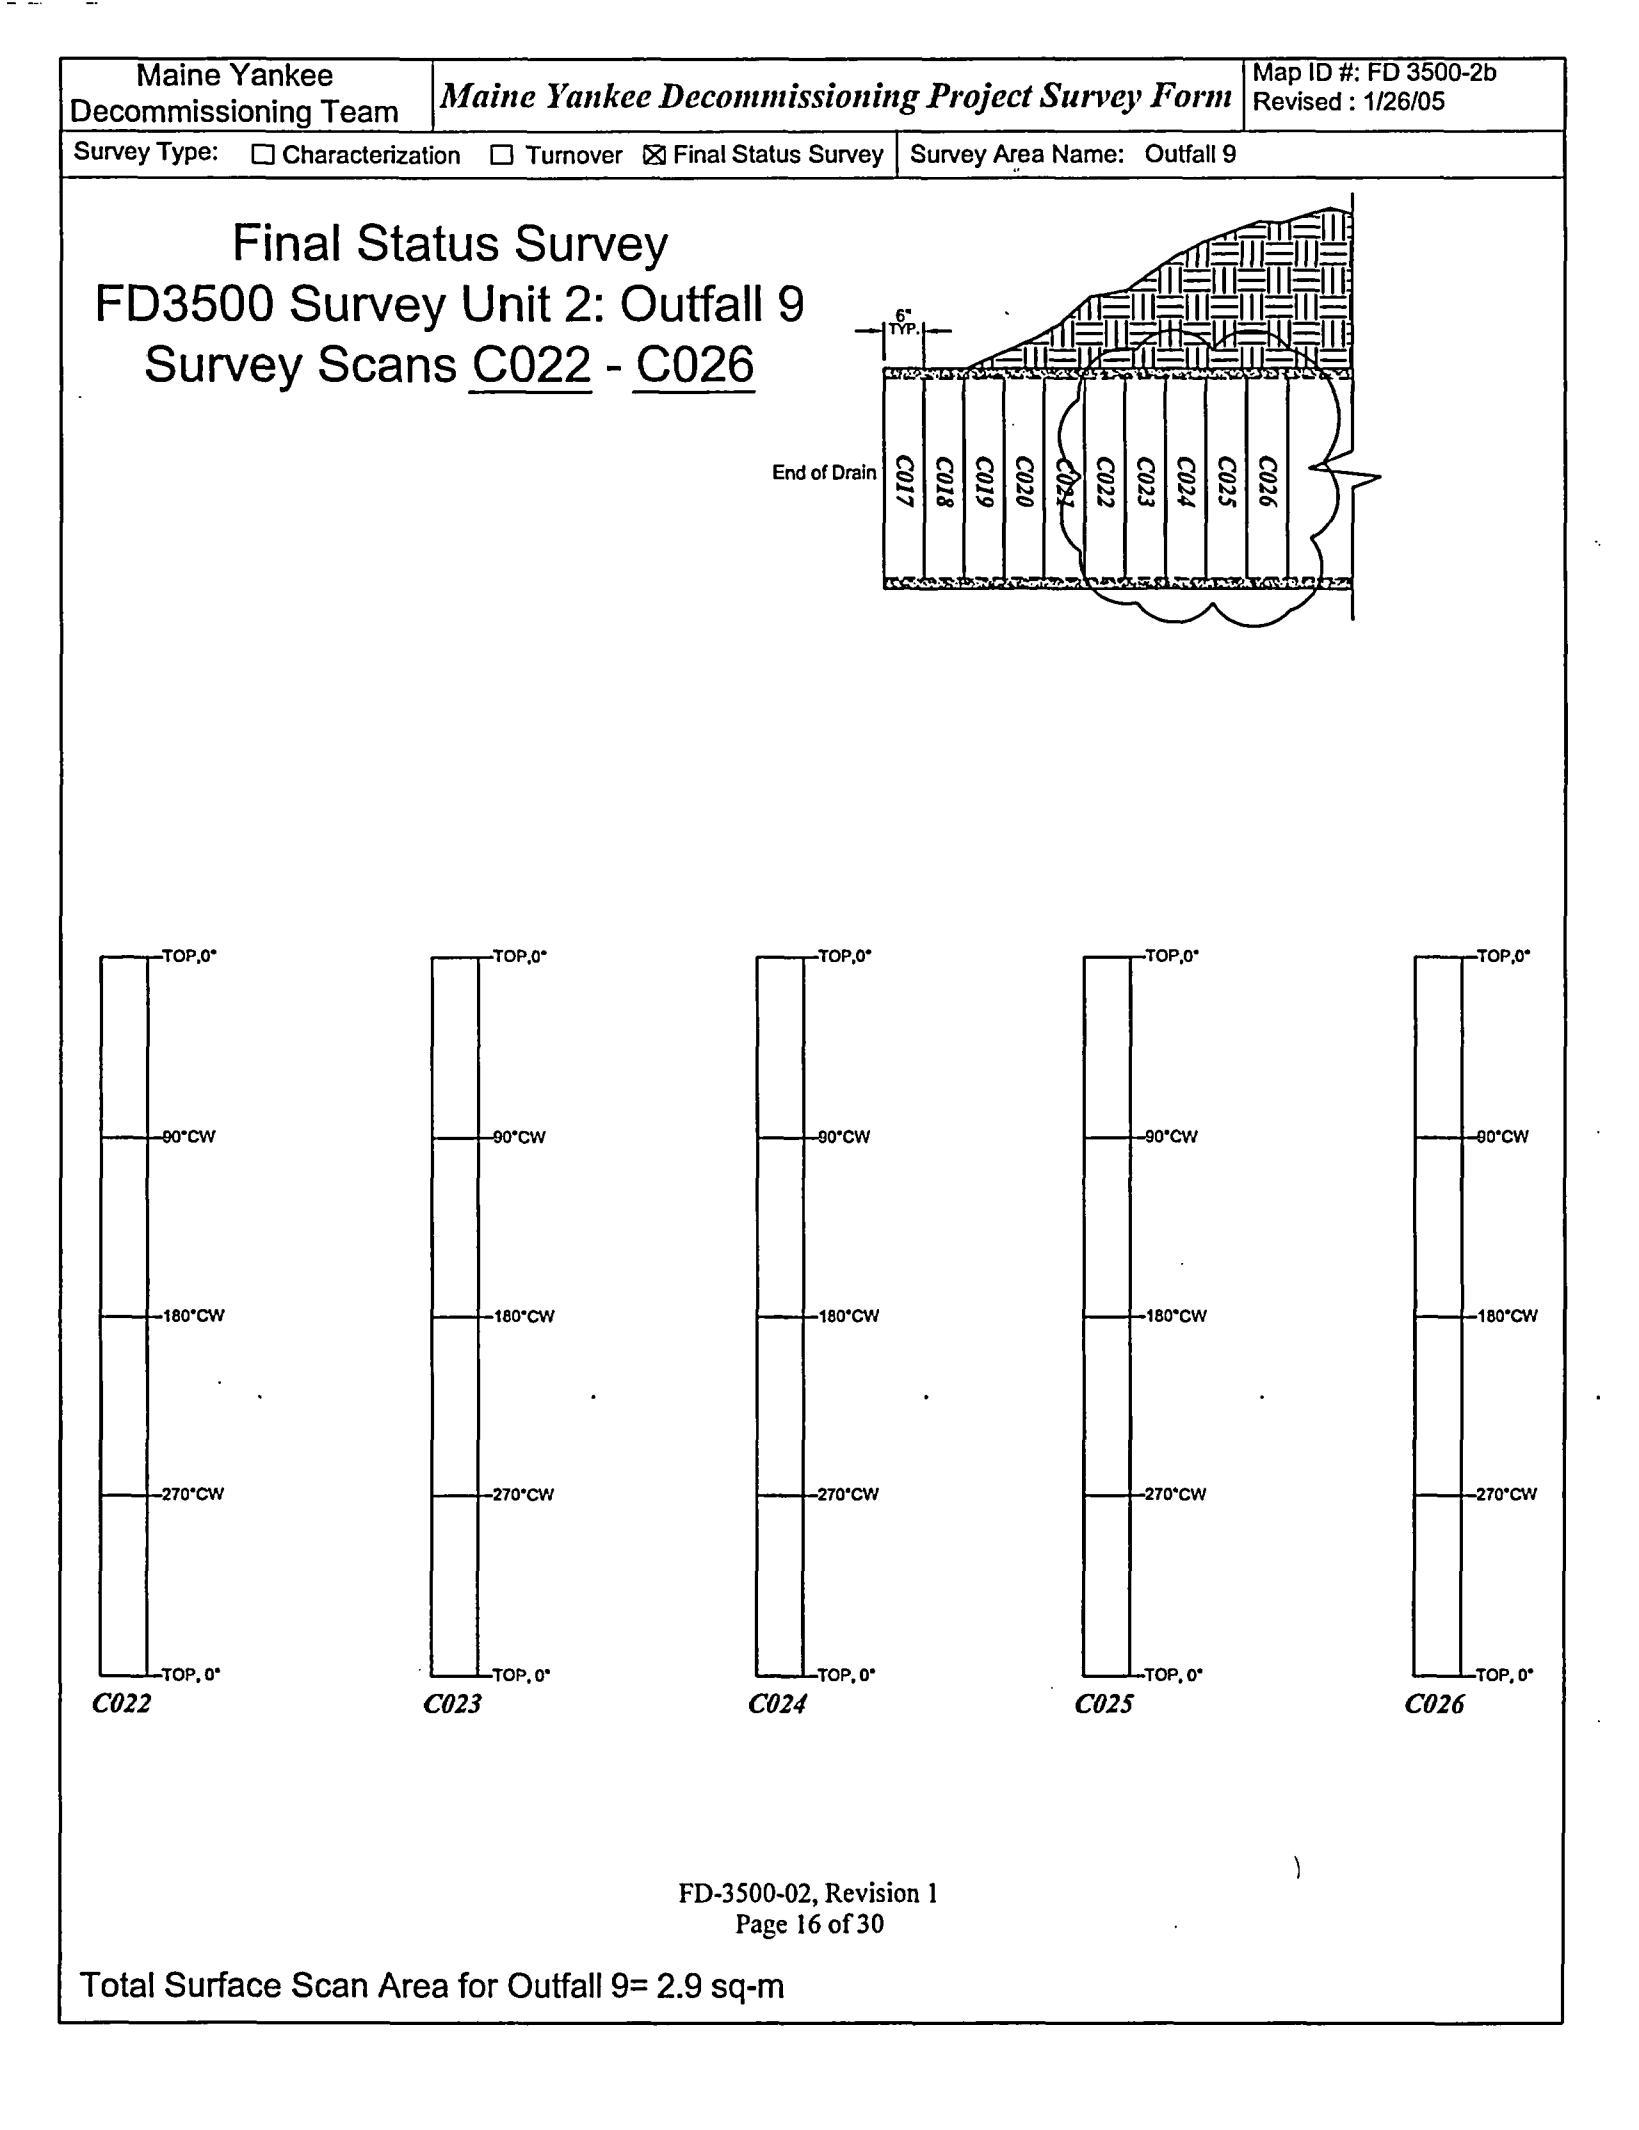
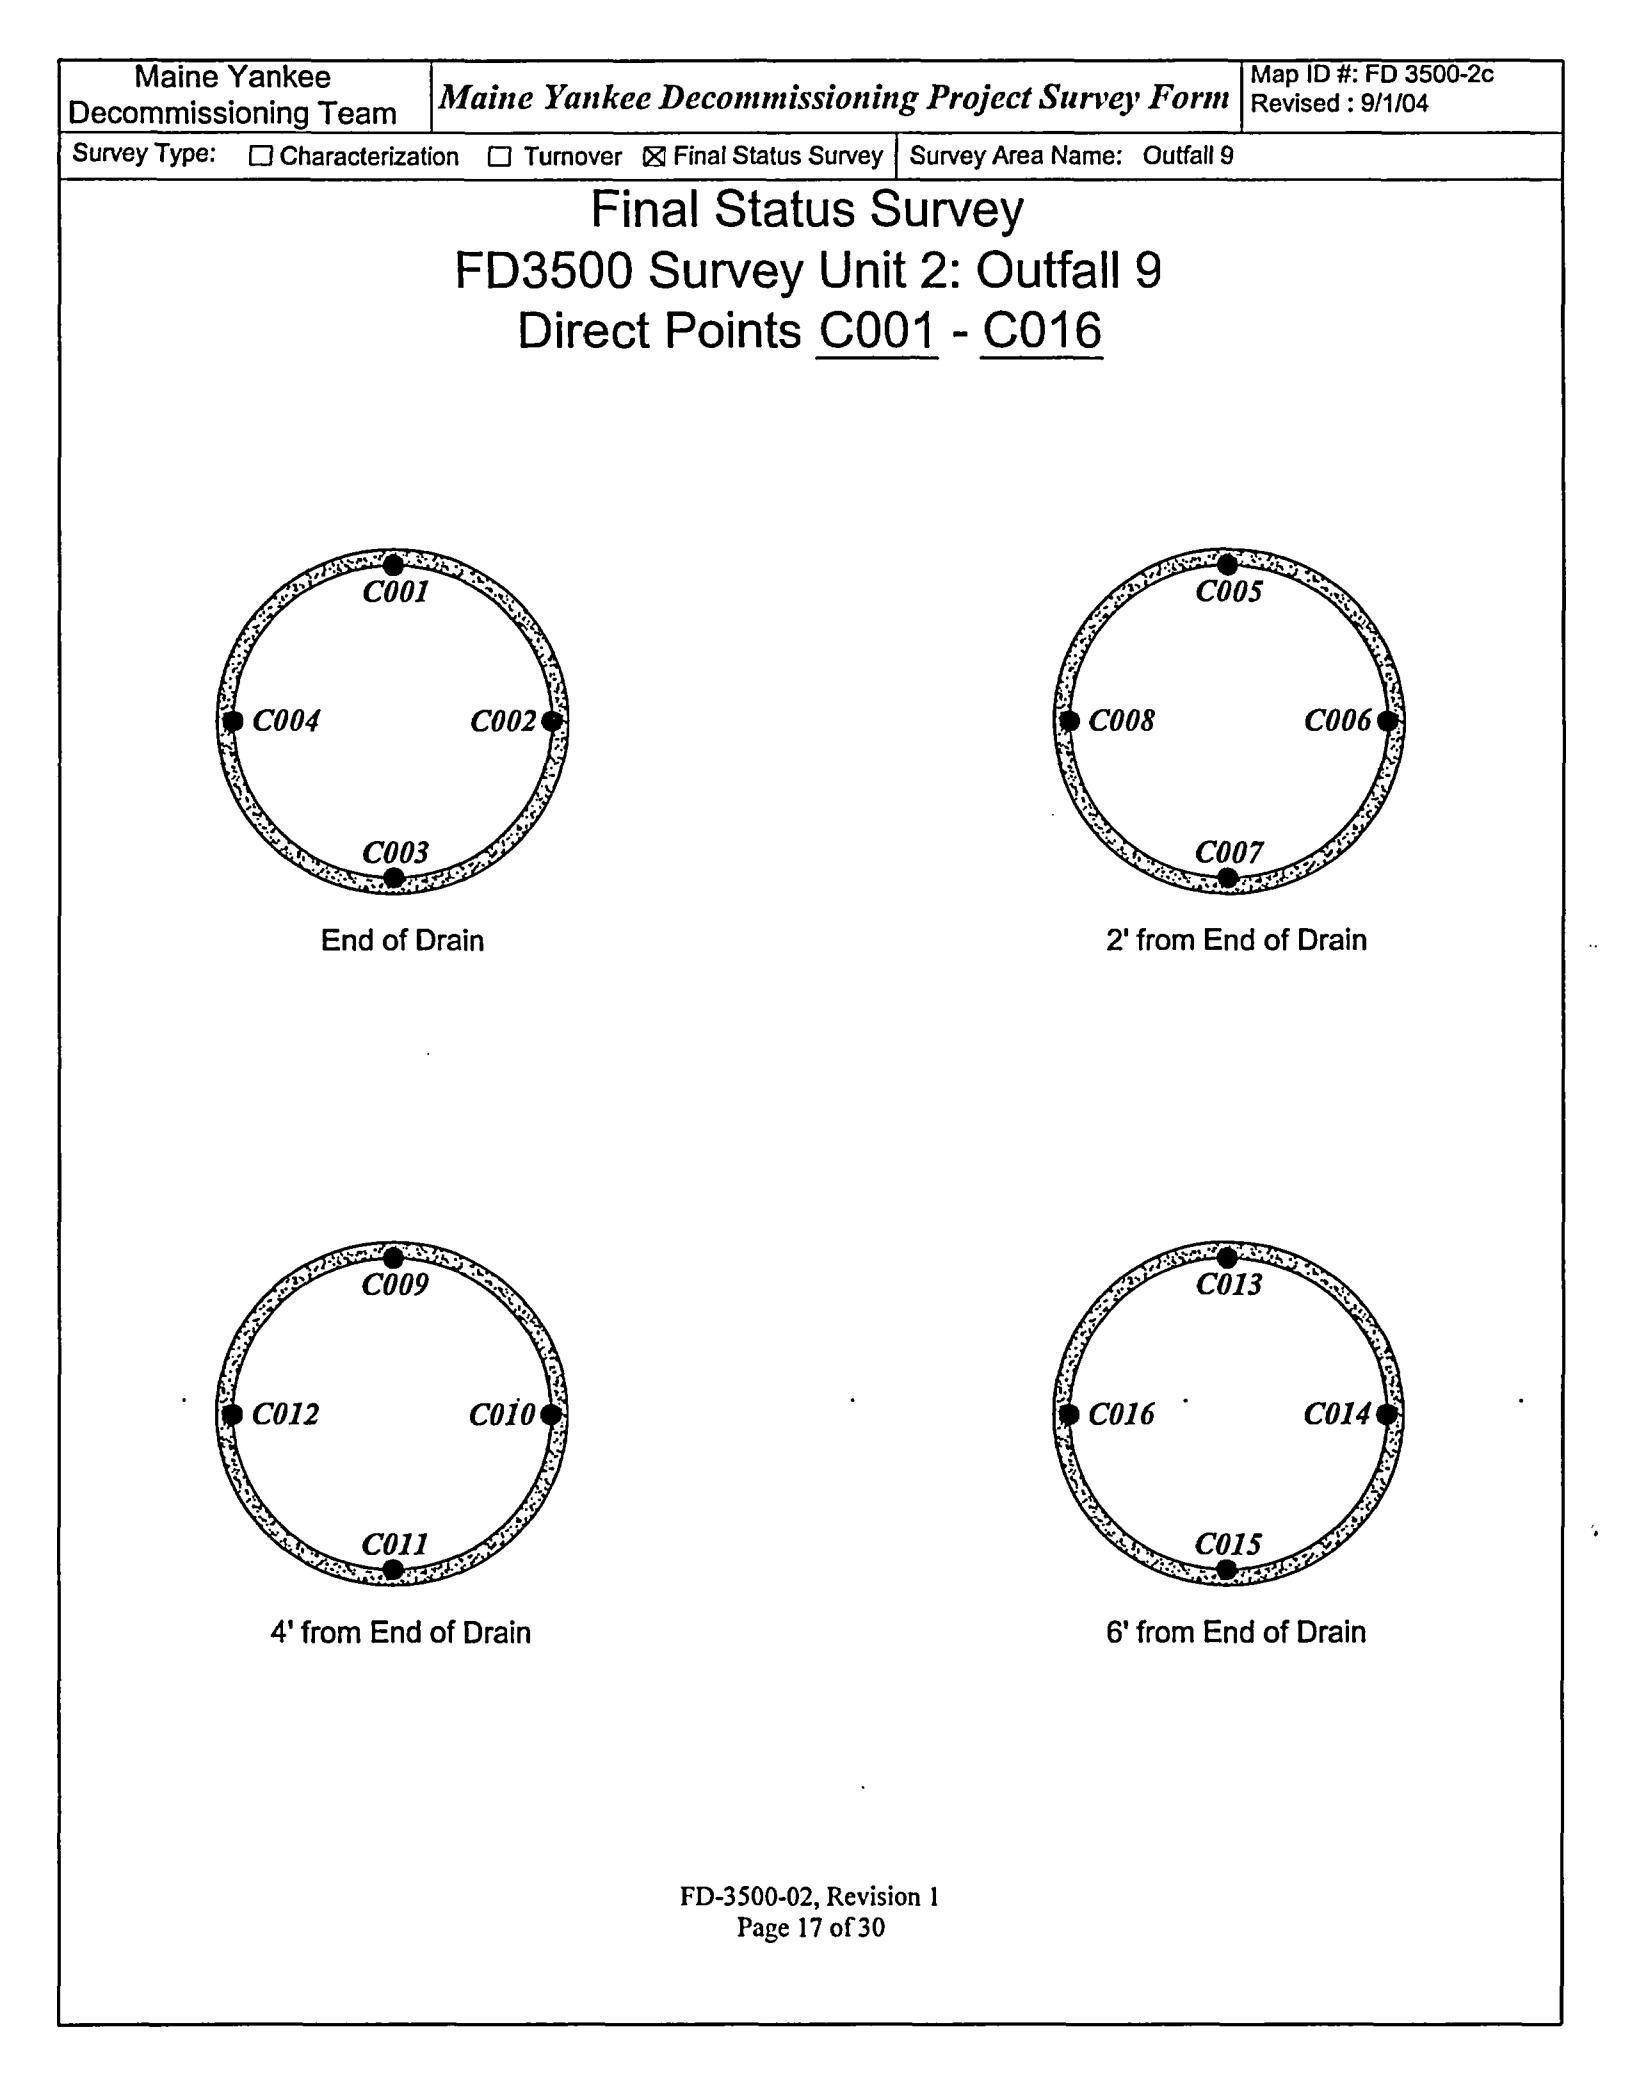
Survey Unit Maps

Measurement locations for outfalls 9 and 10 were determined by equally distributing the measurement locations along the circumference and length of the accessible areas of the piping at the outfall. Since the outfall is the lowest elevation of the survey unit, it is considered to be an appropriate location for sampling, as is suggested by the LTP as a key element of the survey design for Class 3 piping. Locations are illustrated on the maps FD 3500-2c and FD 3500-2f. Removable contamination samples were obtained at each measurement location.

The survey was also designed to include 20 scan grids for surfaces, each of approximately 0.3 m^2 or smaller area (see maps FD 3500-2a, FD 3500-2b, FD 3500-2d, FD 3500-2e). The total area scanned was approximately 4.7 m² which is 1.1% of the survey unit area. Instrument scan setpoints were set at the DCGL plus background, as shown in Table 2-2 (Attachment 2).

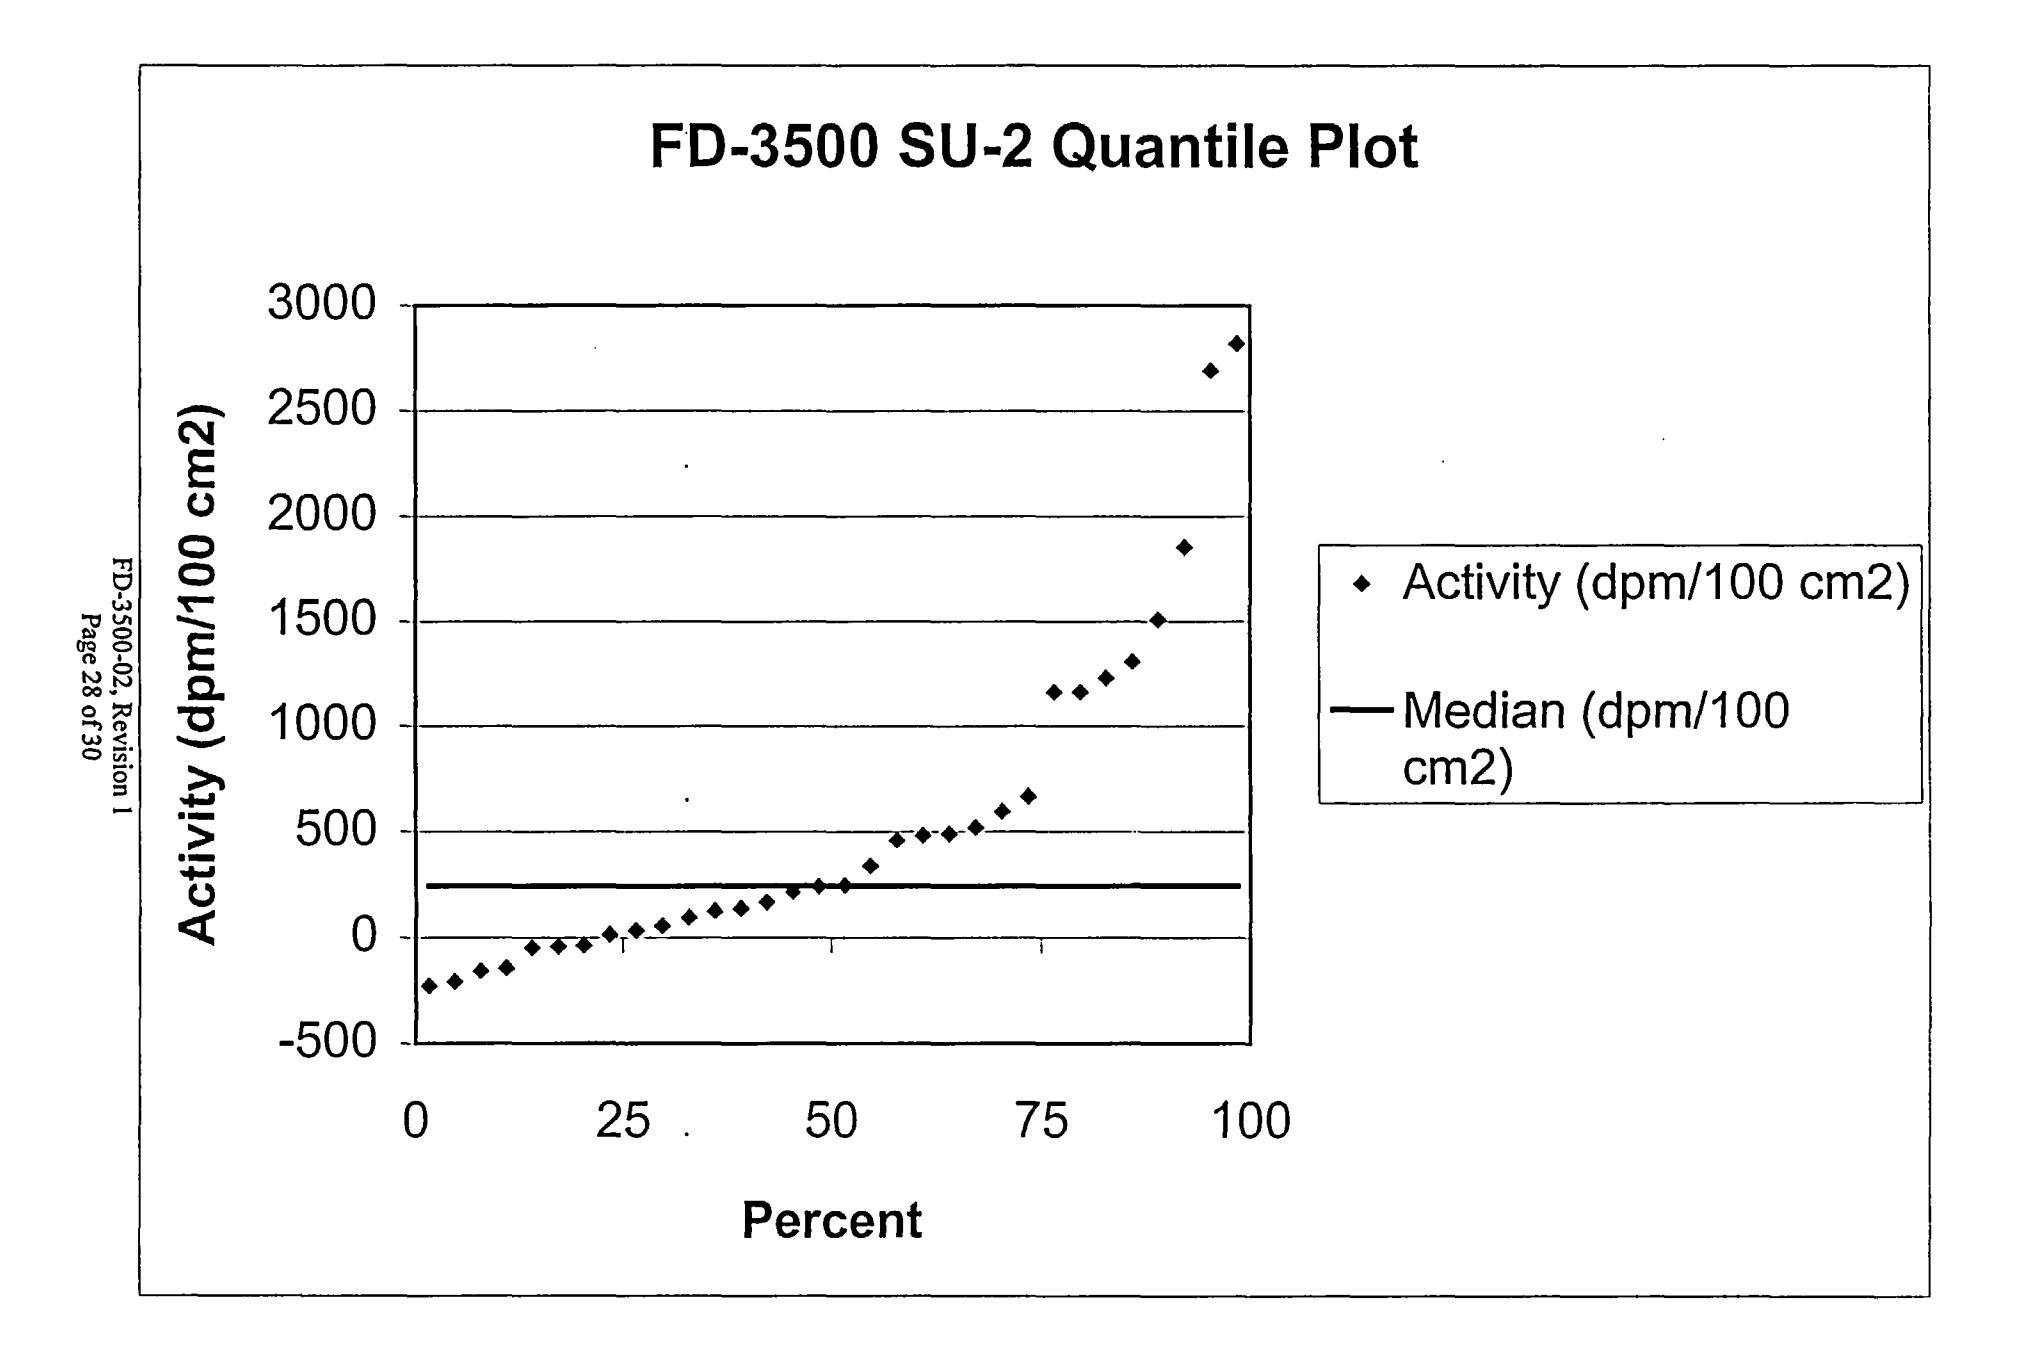
- 2. The Quantile Plot was generated from direct measurement data listed in Table 2 and indicates general symmetry about the median. The data set and plot are consistent with expectations for a Class 3 survey unit. There is no reason to conclude that the data set represents other than random variations in a Class 3 concrete surface survey unit. It also should be noted that the maximum net activity (2,820 dpm/100 cm² at location C009) is well below 50% of the DCGL.

- 3. A Histogram Plot was also developed based on the direct measurement values. This plot shows that the direct data were essentially a normal distribution.

- 4. A Retrospective Power Curve was constructed, based on FSS results. The curve shows that this survey unit having a mean residual activity at a small fraction of the DCGL, has a high probability ("power") of meeting the release criteria. Thus, it can be concluded that the direct measurement data support rejection of the null hypothesis, providing high confidence that the survey unit satisfied the release criteria and that the data quality objectives were met.
