SUBJECT: Transmittal of Final ASCG Report: Evaluation of the Alternate Supply System, Riverton, Wyoming

Evaluation of the Alternate Supply System

RIVERTON, WYOMING

July 2005

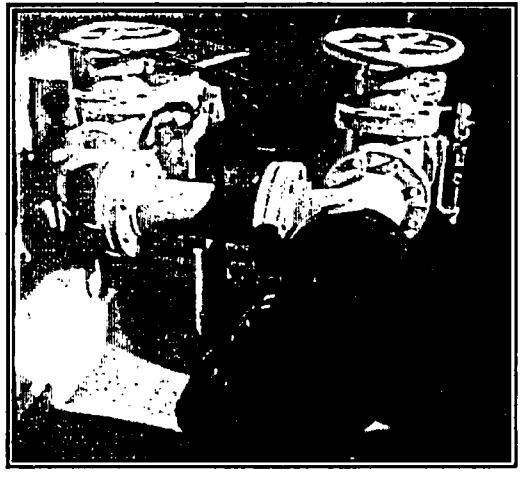
The well pump house was examined to determine the disinfection process and integrity of the well. The wells was observed to be in good condition, the wells are sealed and protected either fenced (Well #1) or within the well building (Well #2). Records for the well pumps

were requested. The well records, received on January 14, 2005, indicate the time and duration of pumping, the water tank level and the amount of sodium hypochlorite injected into the system. This information shows pump amounts and tank levels but not how the system is operated. During the site visit, it was described by the NAUO operators that the tank is visually checked by climbing to the top hatch of the tank and measuring the tank level by hand. If the tank reaches a low level, the operator returns to the well pump house and fills the tank by manually turning on the pumps. This is not an efficient or safe operational procedure.

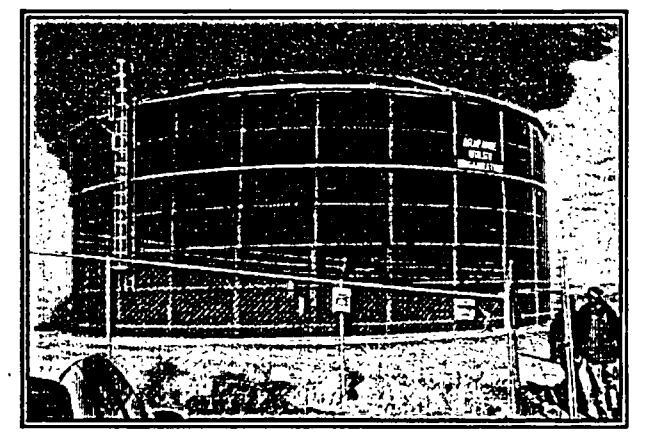
The one million gallon water tank is located between the water supply wells and the distribution system. The bolted steel glass lined tank was put in service in 2002 so it is relatively new and in fairly good condition. There are a number of areas on the exterior of the tank where the tank coating has been damaged, possibly from vandals throwing rocks. The

damage was pointed out to the NAUO personnel and advised that the damage may affect the tank interior glass lining as well. The tank is set at an elevation to provide adequate pressure for the distribution system.
