Environmental Survey and Site Assessment Program

#### FINAL REPORT

AUGUST 2005

Historical Site Assessment of Hammond Depot

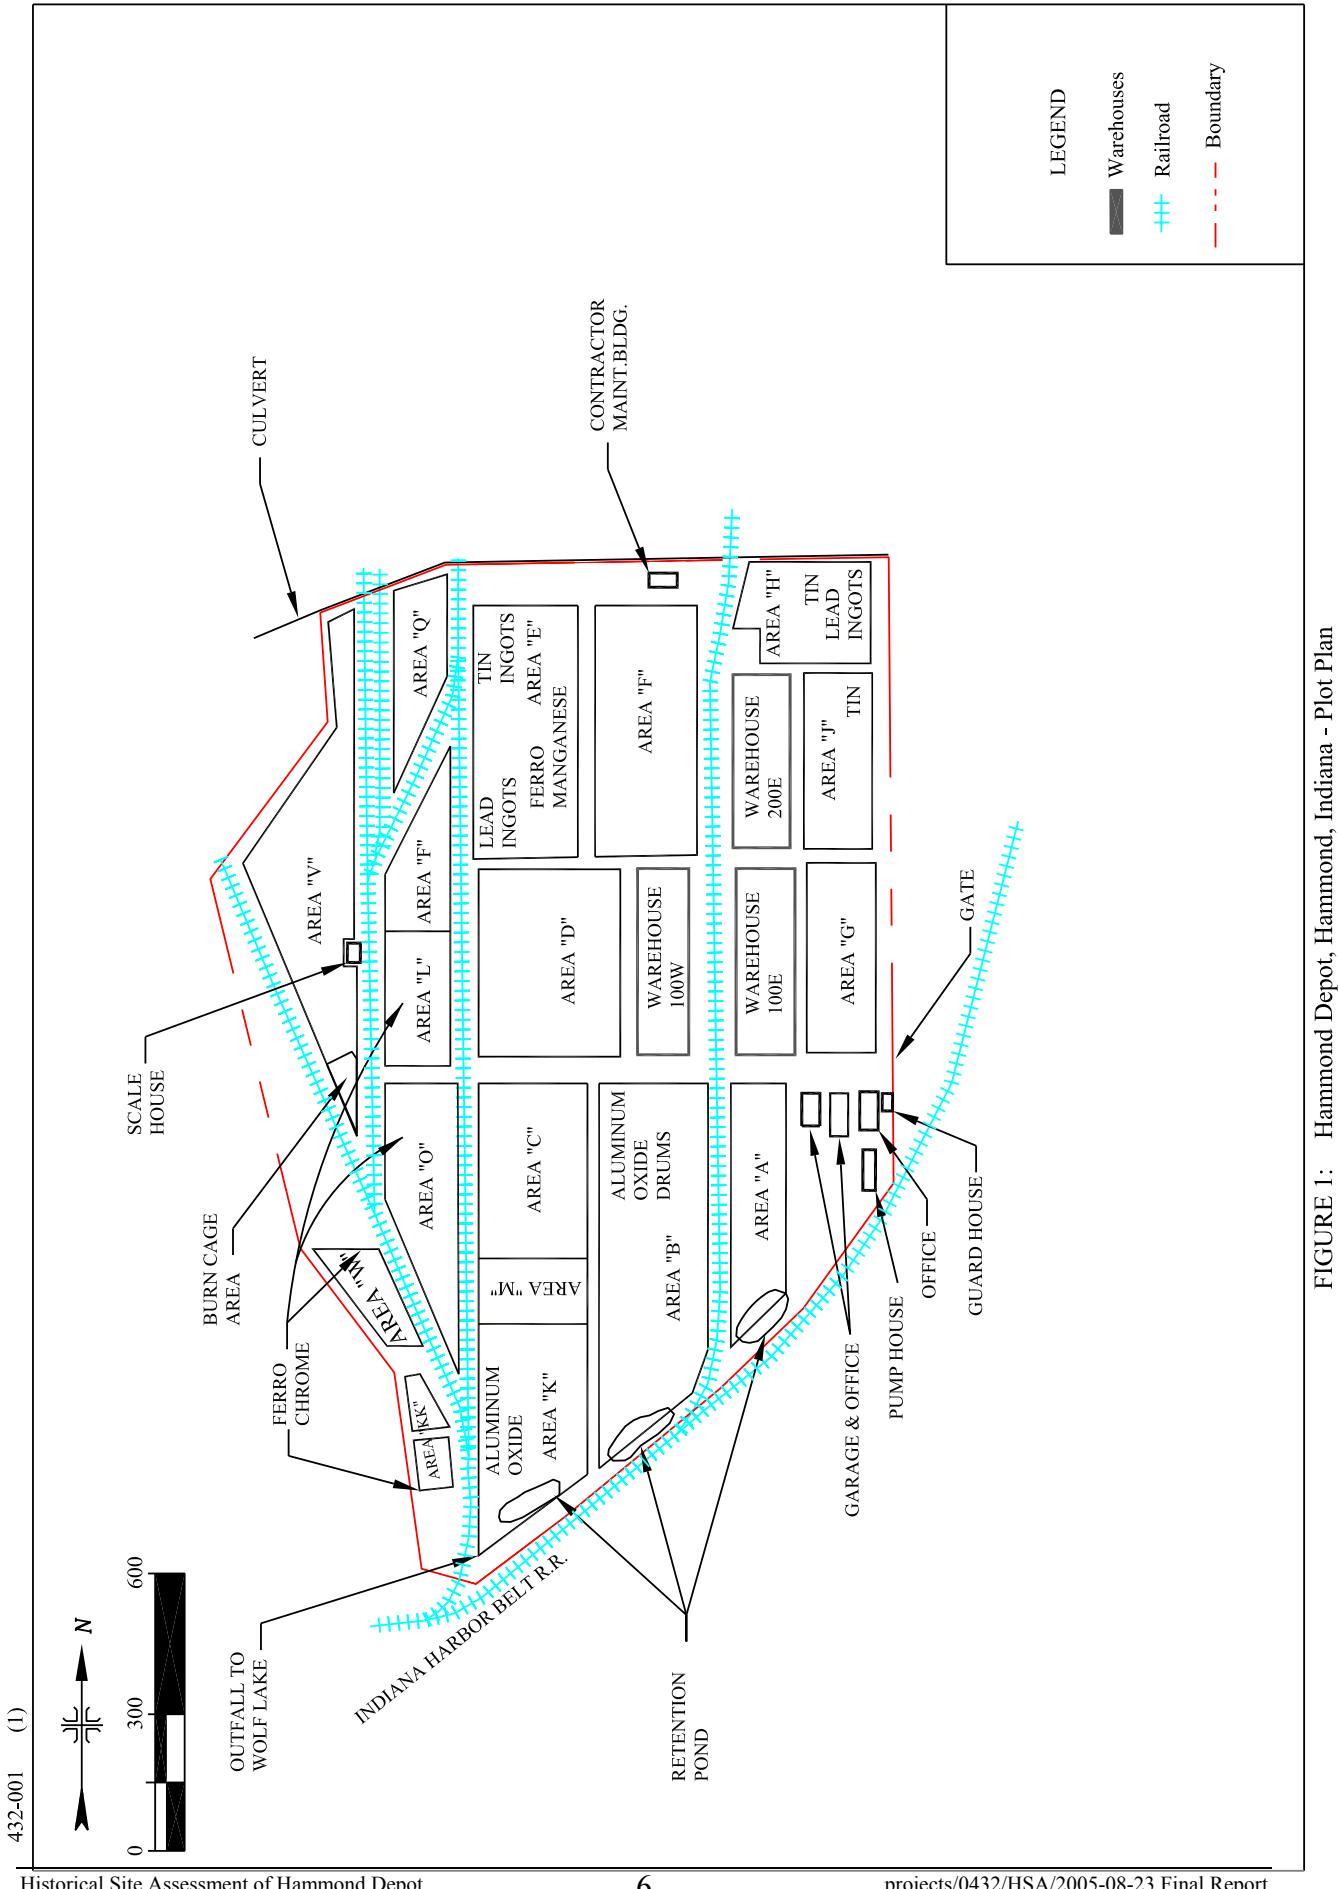
The Hammond Depot property consists of a 57.3-acre parcel of land located on the west side of Hammond, Indiana—about 490 feet east of the Indiana-Illinois state line, within the city limits of Chicago. The depot has eight buildings, mostly in good condition, including three warehouses that are used to store raw materials. Currently, approximately 120,000 ft<sup>2</sup> of the available 150,000 ft<sup>2</sup> of indoor storage space is occupied, as well as 60% of the outdoor storage space. Figure 1 indicates the location of buildings and warehouses at the Hammond Depot [4].

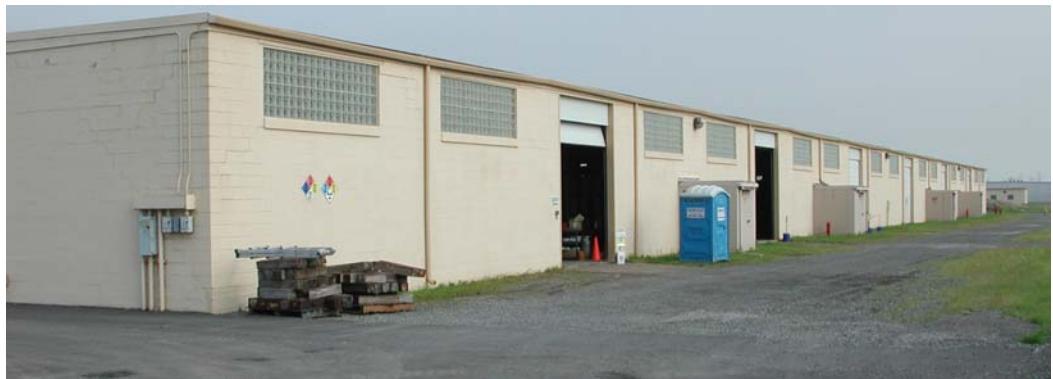
Figure 2 – Warehouse 100W

The warehouse is a concrete structure with dimensions of 401 ft by 126 ft. Exterior walls are cinder block with glass block windows, 14 overhead doors, and two personal doors on each end. The floor is concrete slab on grade and the structure is steel beams, columns, and roof joists. The roof deck is 3-ply gypsum board and the roofing is 3-ply built up asphalt with a smooth surface sloping to the perimeter gutters on the east and west elevations. Electrical conduits and light fixtures hang from roof joists. A dry pipe sprinkler system is installed [4, 13]. Figure 2 shows Warehouse 100W.

Four commodities listed on the NRC Source License STC-133 (in October 1997) were stored in this warehouse: thorium nitrate in Bays 8 through 16 B, C, and D; tantalum natural minerals and concentrates (tantalum pentoxide  $(Ta_20_5)$ ) in Bays 15 D, 16 D, 17 A through D, and 18 A through D; columbium tantalum source material (tantalum natural minerals) in Bays 7 B, 8 A, and 8 B; and columbium tantalum source material (columbium natural minerals) in Bays 8 E and 9 E [14].

From the "Hammond Depot History of Radiological Material Storage", Warehouse 100W currently is used to store ThN in Bays 8 through 16 B, C, and D. Past storage in this warehouse included tantalum pentoxide in Bays 15 and 16 D, 17 A through D, and 18 A through D. Columbium tantalum (columbium natural mineral) was formerly stored in Bays 8 and 9 E; columbium tantalum (tantalum natural minerals) was formerly stored in Bays 7 B, 8 A, and 8 B [15].

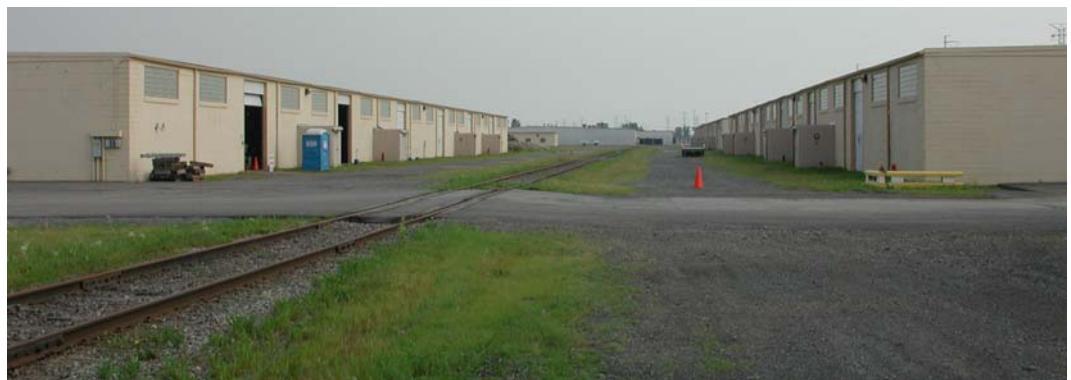
The warehouse is a concrete structure with dimensions of 401 ft by 126 ft. Exterior walls are cinder block with glass block windows, 14 overhead doors, and two personal doors on each end. The floor is concrete slab on grade and the structure is steel beams, columns, and roof joists. The roof deck is 3-ply gypsum board and the roofing is 3-ply built up asphalt with a smooth surface sloping to the perimeter gutters on the east and west elevations. Electrical conduits and light fixtures hang from roof joists. A dry pipe sprinkler system is installed [4, 13]. Figure 3 shows Warehouse 100E.

Figure 3 – Across the rail road tracks from Warehouse 100W (left) is Warehouse 100E (on the right).

No history of radioactive materials storage was noted for this building.

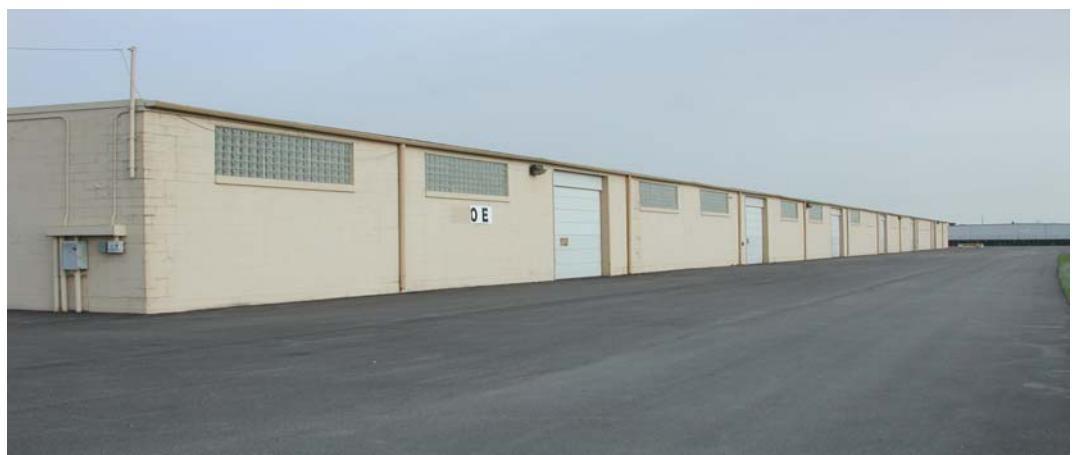
Figure 4 – Warehouse 200E

The warehouse is a concrete structure with dimensions of 401 ft by 126 ft. Exterior walls are cinder block with glass block windows, 14 overhead doors, and two personal doors on each end. The interior is divided into north and south sections by a cinder block partition firewall. The floor is concrete slab on grade except that the south side was completely covered with black-top after the top surface was remediated. The structure is steel beams, columns, and roof joists. The roof deck is 3-ply gypsum board and the roofing is 3-ply built up asphalt with a smooth surface sloping to the perimeter gutters on the east and west elevations. Portions of the roof gypsum board decking were replaced with metal decking after wind tore off the original roof. Electrical conduits and light fixtures hang from roof joists. A sheet metal return air duct is also hung below the roof deck in a north-south direction but is not operational. A dry pipe sprinkler system is installed [4, 13]. Figure 4 shows Warehouse 200E.

From the "Hammond Depot History of Radiological Material Storage", Warehouse 200E was used to store ThN in Bays 1 though 10 A, B, C, D and E [15]. Alpha survey records indicate that ThN drums leaked in this warehouse with residual contamination ranging from 100 to 500 dpm [18].

Monazite sand stored in 2,602 21-gallon drums was moved from this warehouse to Warehouse 100W [16]. Other records indicate 5,898 drums were stored in this warehouse [19]. Monazite sand was stored in areas where ThN was not stored [20].

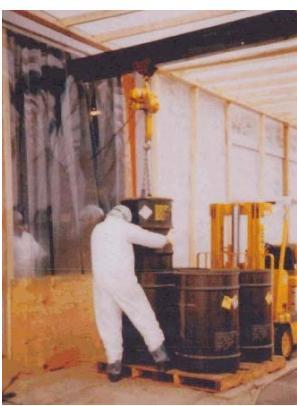
Figure 5 – Overpack Project

Thorium drums were overpacked from 55 to 85 gallon drums in an area west of and adjacent to the building [21]. Right after the overpackaging, the drums were moved to Warehouse 100W [6]. Figures 5 through 7 show the overpack project.

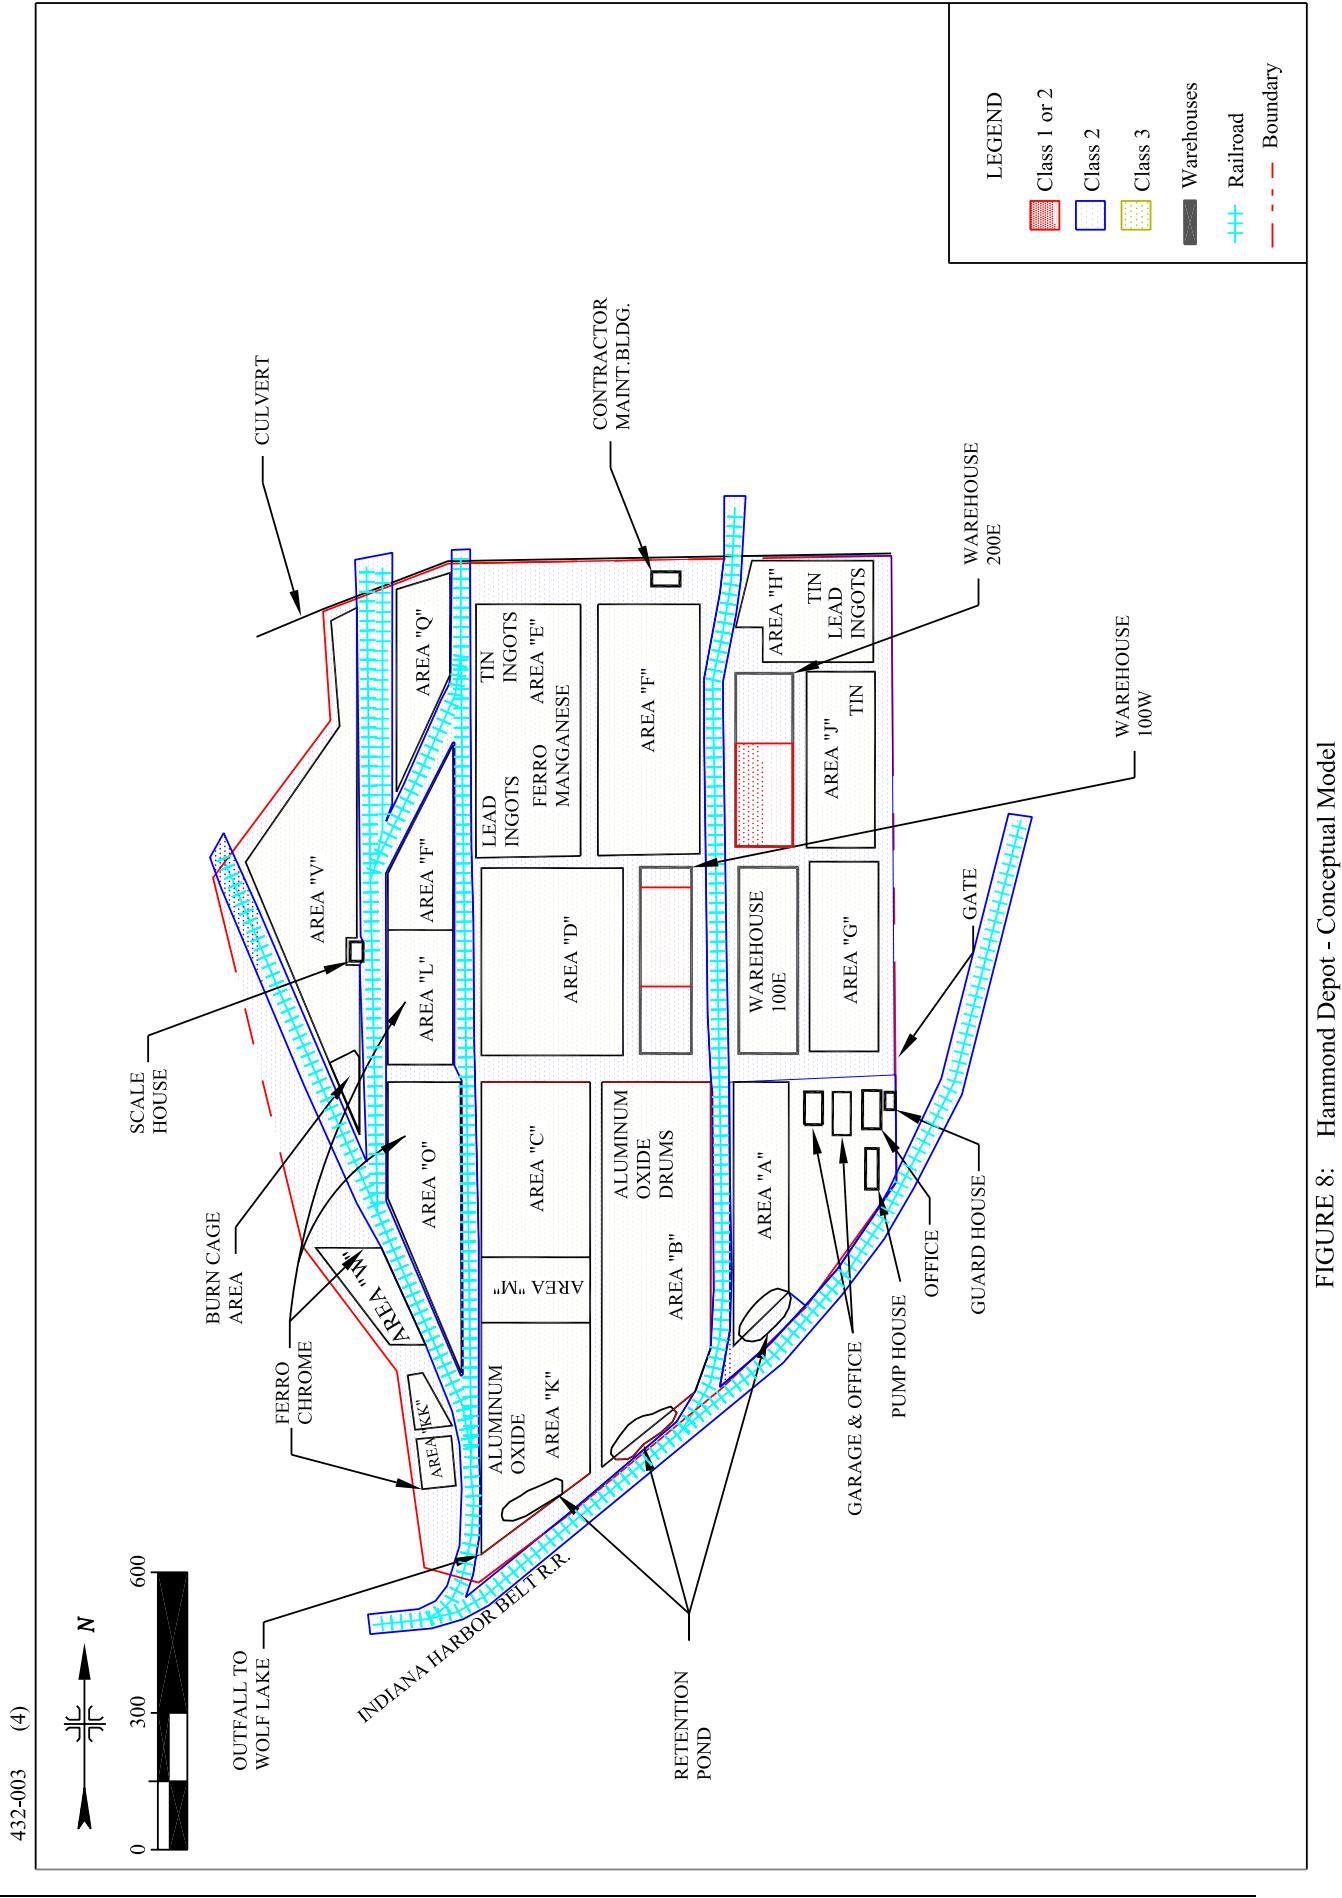
The conceptual site model is shown in Figure 8. The list below summarizes the conceptual model.

- Class 1 and 2 areas include areas that were previously contaminated and remediated (Warehouses 100W, 200E and the repackaging area outside 200E).
- Additional Class 2 areas that are considered to be potentially contaminated include the burn cage, existing roads and railroad lines, including where railroad lines have been removed, because they served as transportation routes.
- Class 3 areas include Warehouse 100E and the remaining land areas that are considered to have little potential for contamination, due to inadvertent spread of contamination.
