Memorandum

July 26, 2006

Subject: Oyster Creek, Drywell Liner Embedded Region Issues

Discussion of Differential Aeration Cell by Means of Evans Diagram

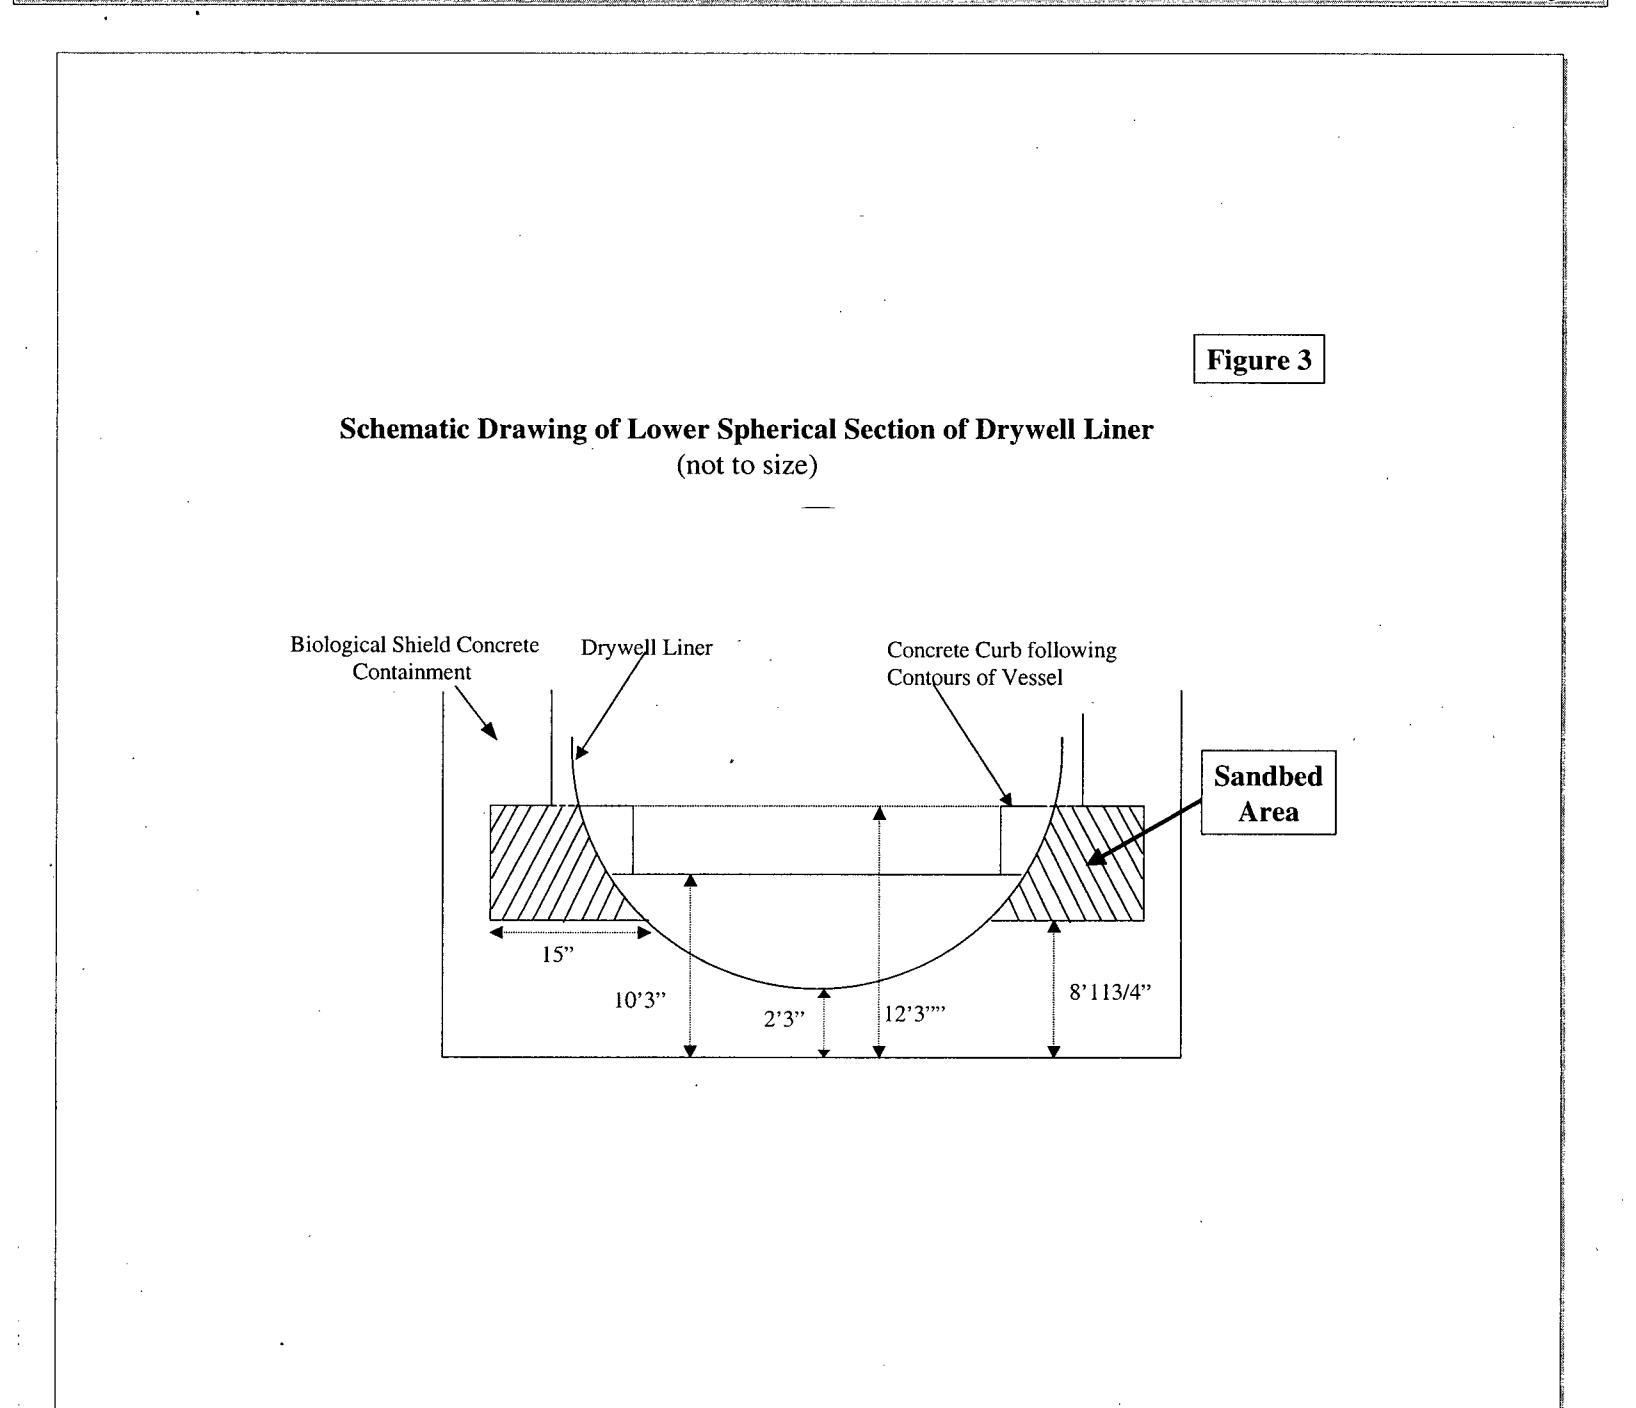
Figures 1 and 2 are sketches of the location of the sandbed area and its dimensions (Fig. 2). In view of the small access hole (20" diameter) and the even smaller sandbed dimensions (15" wide) and the resulting very confined work area one needs to wonder just how effective the repairs of the concrete floor and subsequent coating and sealing of the crevice might have been. Similarly, considering the extension of the sandbed area of 5 to 7 feet either side of the access hole, and its narrowness, one needs to ask just how thorough visual inspection can really be.

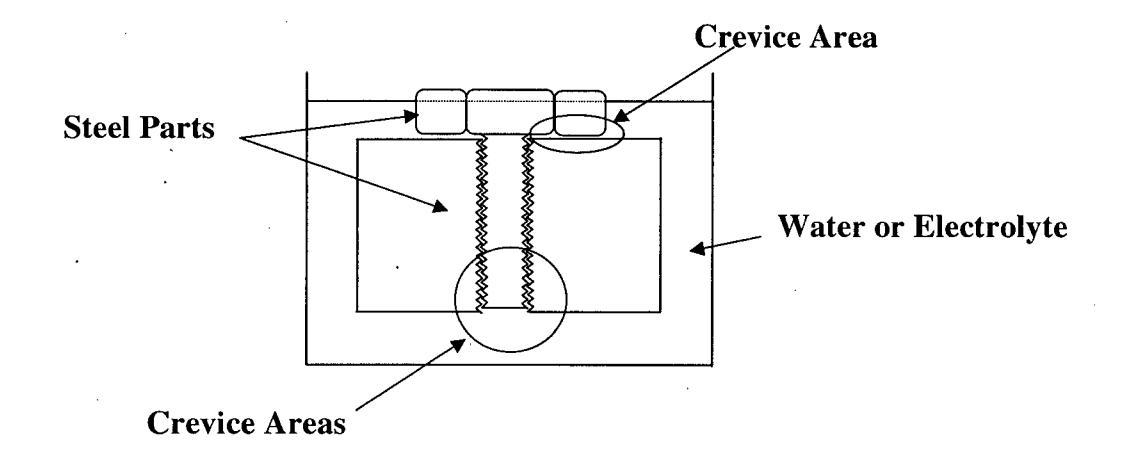
Figure A I-1

Formation of Crevice underneath Screw-head

However, physical observations are quite in tune with the above explanation. Crevice corrosion, as for instance in bolt threads, under washers, etc. is commonly observed. Ground rods corrode a few inches below the surface of earth or mud in which they are embedded. Applied to the sandbed it is indeed observed that corrosion does not occur on top of the sandbed where aeration is greatest, but in fact in an area below that surface. The question then arises as to why the corrosion rate should not be greatest at the very

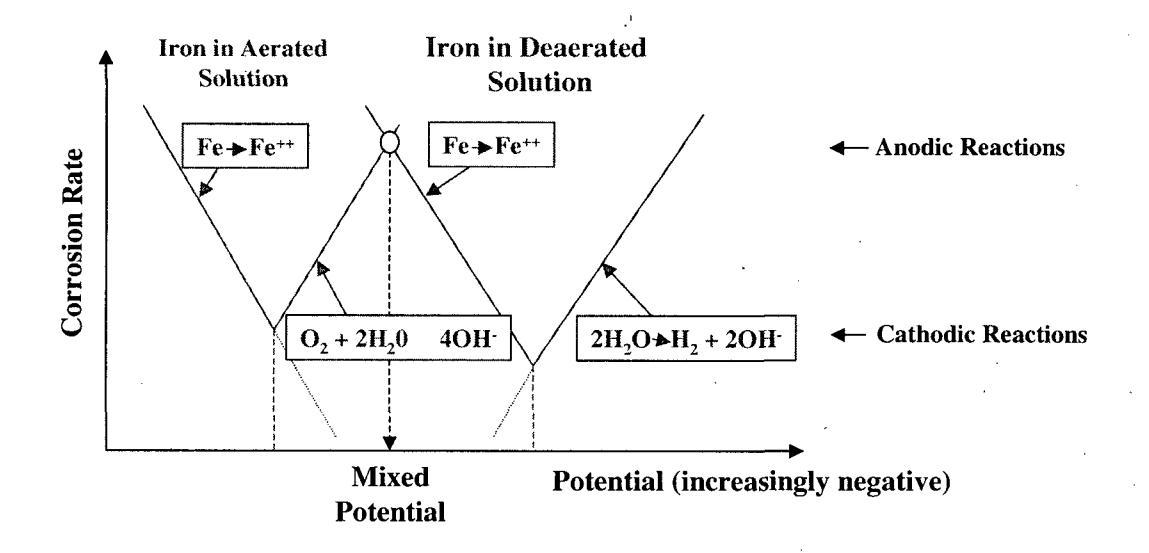
Figure AI-2

Evans Diagram for Coupling of Iron in Aerated Solution With Iron in Deaerated Solution

Such situations can be theoretically discussed by means of polarization diagrams presented in the form of an Evans diagram as in Fig. A I-2. The diagram describes separately the polarization behaviors of the two parts of the iron piece as if they were disconnected and then defines a mixed potential as well as the resulting anodic and cathodic corrosion rates at the mixed potential.

The steel immersed in aerated solution will assume a fairly positive potential (depending on pH perhaps about + 200 mV vs. SCE). The cathodic reaction will be the reduction of oxygen to hydroxyl ions while the anodic reaction is the oxidation of iron to iron ions. The current potential relationships describe the rate of the respective reactions when the potential is moved (for instance by external means) in the negative or positive direction. At the point where anodic and cathodic reactions (currents) are equal is the corrosion potential and the associated corrosion current (corrosion rate). For the part of the steel immersed in the deaerated solution the potential is more negative (depending on pH perhaps on the order of -400 mV vs. SEC). The anodic reaction is the same while in the absence of oxygen water is reduced to hydrogen and hydroxyl ions.

In reality, however, the two pieces of metal are in electrical contact and are furthermore wetted by the same solution (i.e. in electrolytic contact as well). Under these conditions the metal must assume one potential and one potential only, namely the mixed potential. As can be seen from Fig. A I-2 this is only possible if the cathodic reaction rate of the aerated side increases which then forces the anodic reaction of the deaerated side to increase as well. To a certain extent this result may be counter intuitive in that now the area that is starved in oxygen is corroding while the oxygen rich side is, as is often said as well, cathodically protected by the corroding side.
