Run1hl - Side

3.4 Run1hh - Side

3.5 Run2e - Corner

Y/LF-717/Rev 1/Ch-2/ES-3100 HEU SAR/sc/11-15-06

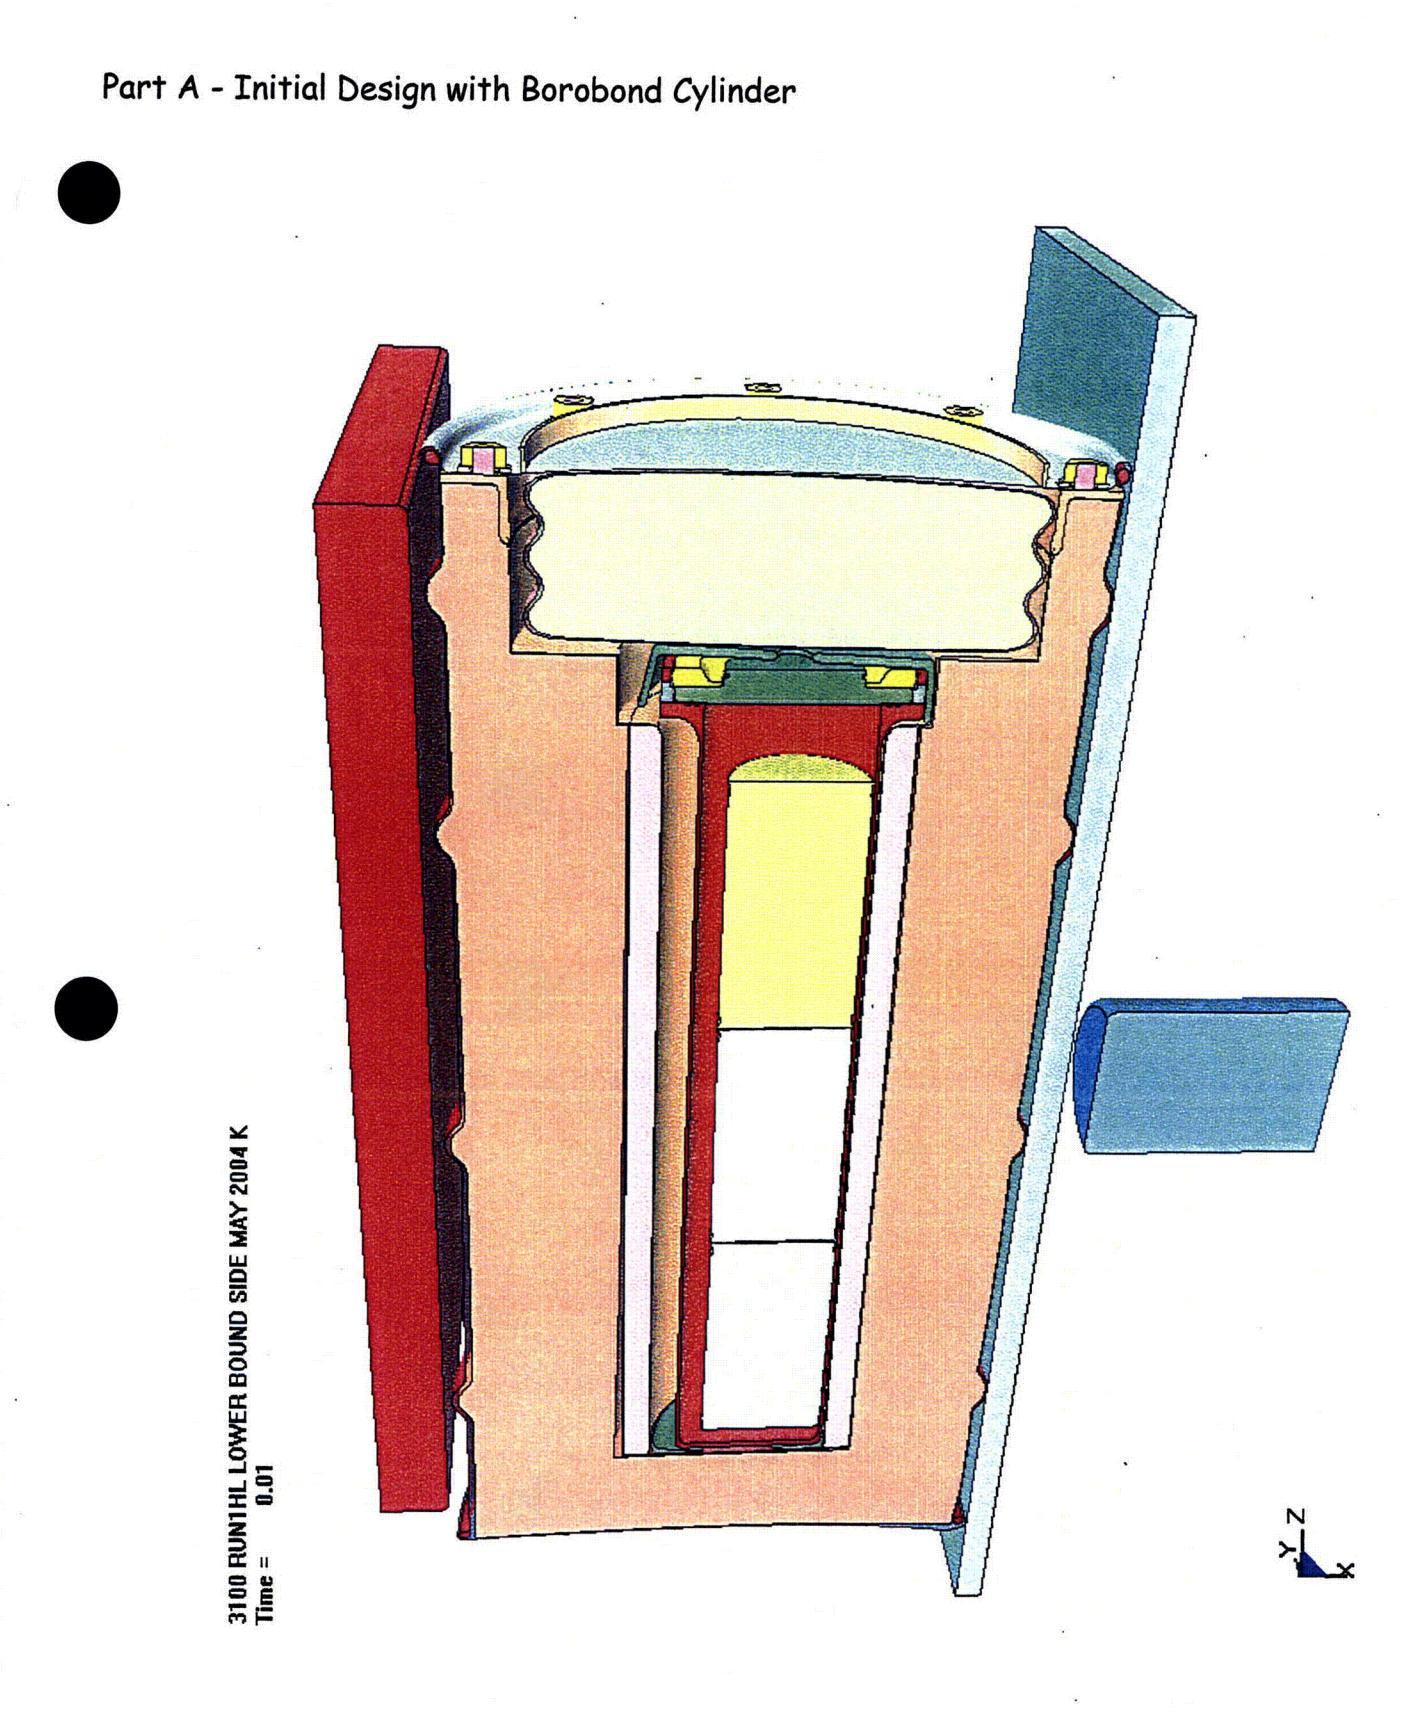
Figure 3.3.1 - Run1hl, 4-Foot Impact, Final Configuration

Run1hl is the lower bounding kaolite run $(100^{\circ}F)$. It is basically the run1g model, but with kaolite properties of section 2.3.5.2. It is a run with a 4-foot impact (time = 0 to 0.01 seconds), followed by a 30-foot impact (0.01 to 0.02 seconds), followed by a 30-foot crush impact (0.02 to 0.04 seconds), finally followed by a 40-inch punch impact (0.04 to 0.055 seconds). The initial configuration of run1hl is similar to Figure 3.1.1. The configuration after the 4-foot impact is shown in Figure 3.3.1. Figure 3.3.2 and 3.3.3 show the configuration at the extremes of the package.

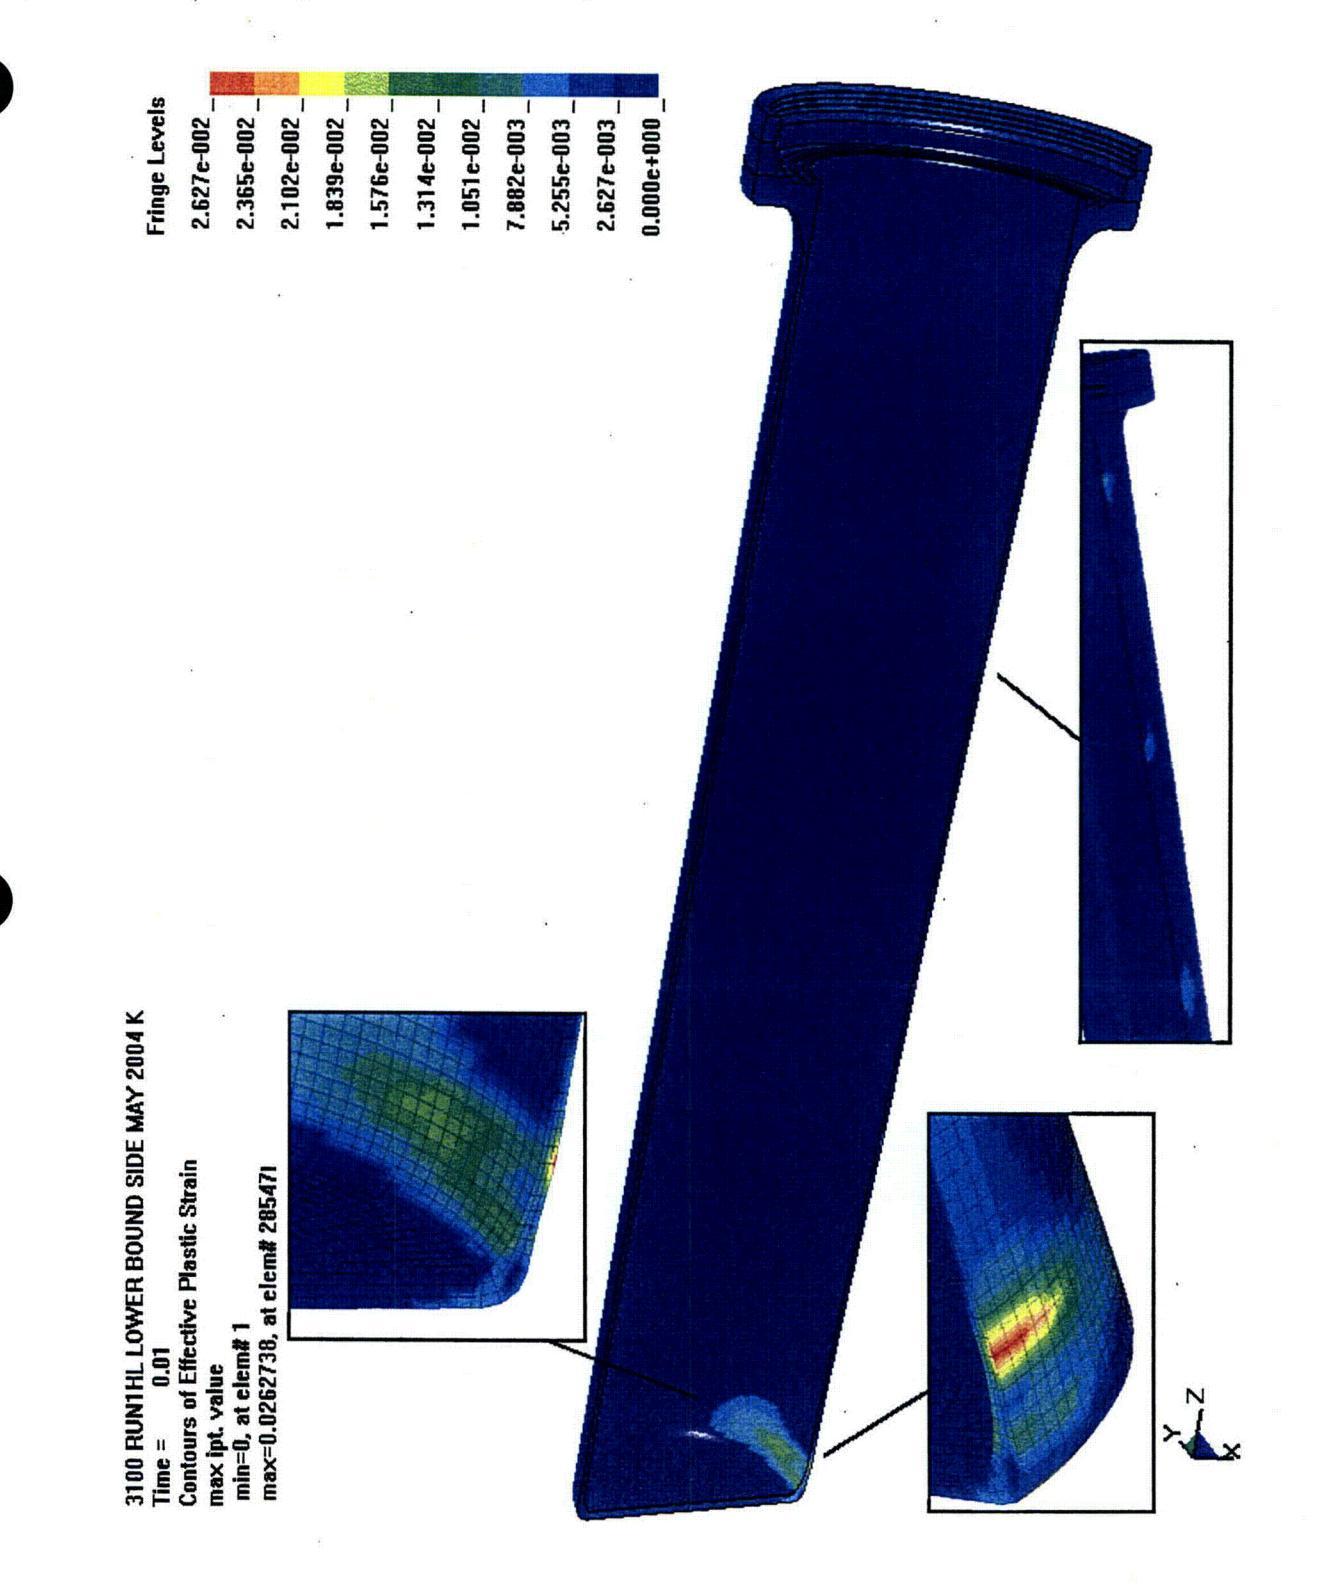
Figure 3.3.4 - Run1hl, 4-Foot Impact, Effective Plastic Strain in the CV Body

The CV body undergoes plastic deformation in the 4-foot impact. The effective plastic strain in the CV body is shown in Figure 3.3.4 to have a maximum of 0.0263 in/in. The elevated plastic strain levels are near the CV bottom head. The CV lid and nut ring remain elastic during the 4-foot impact. The plastic strain in other components for the 4-foot impact are given in Table 3.3.1.

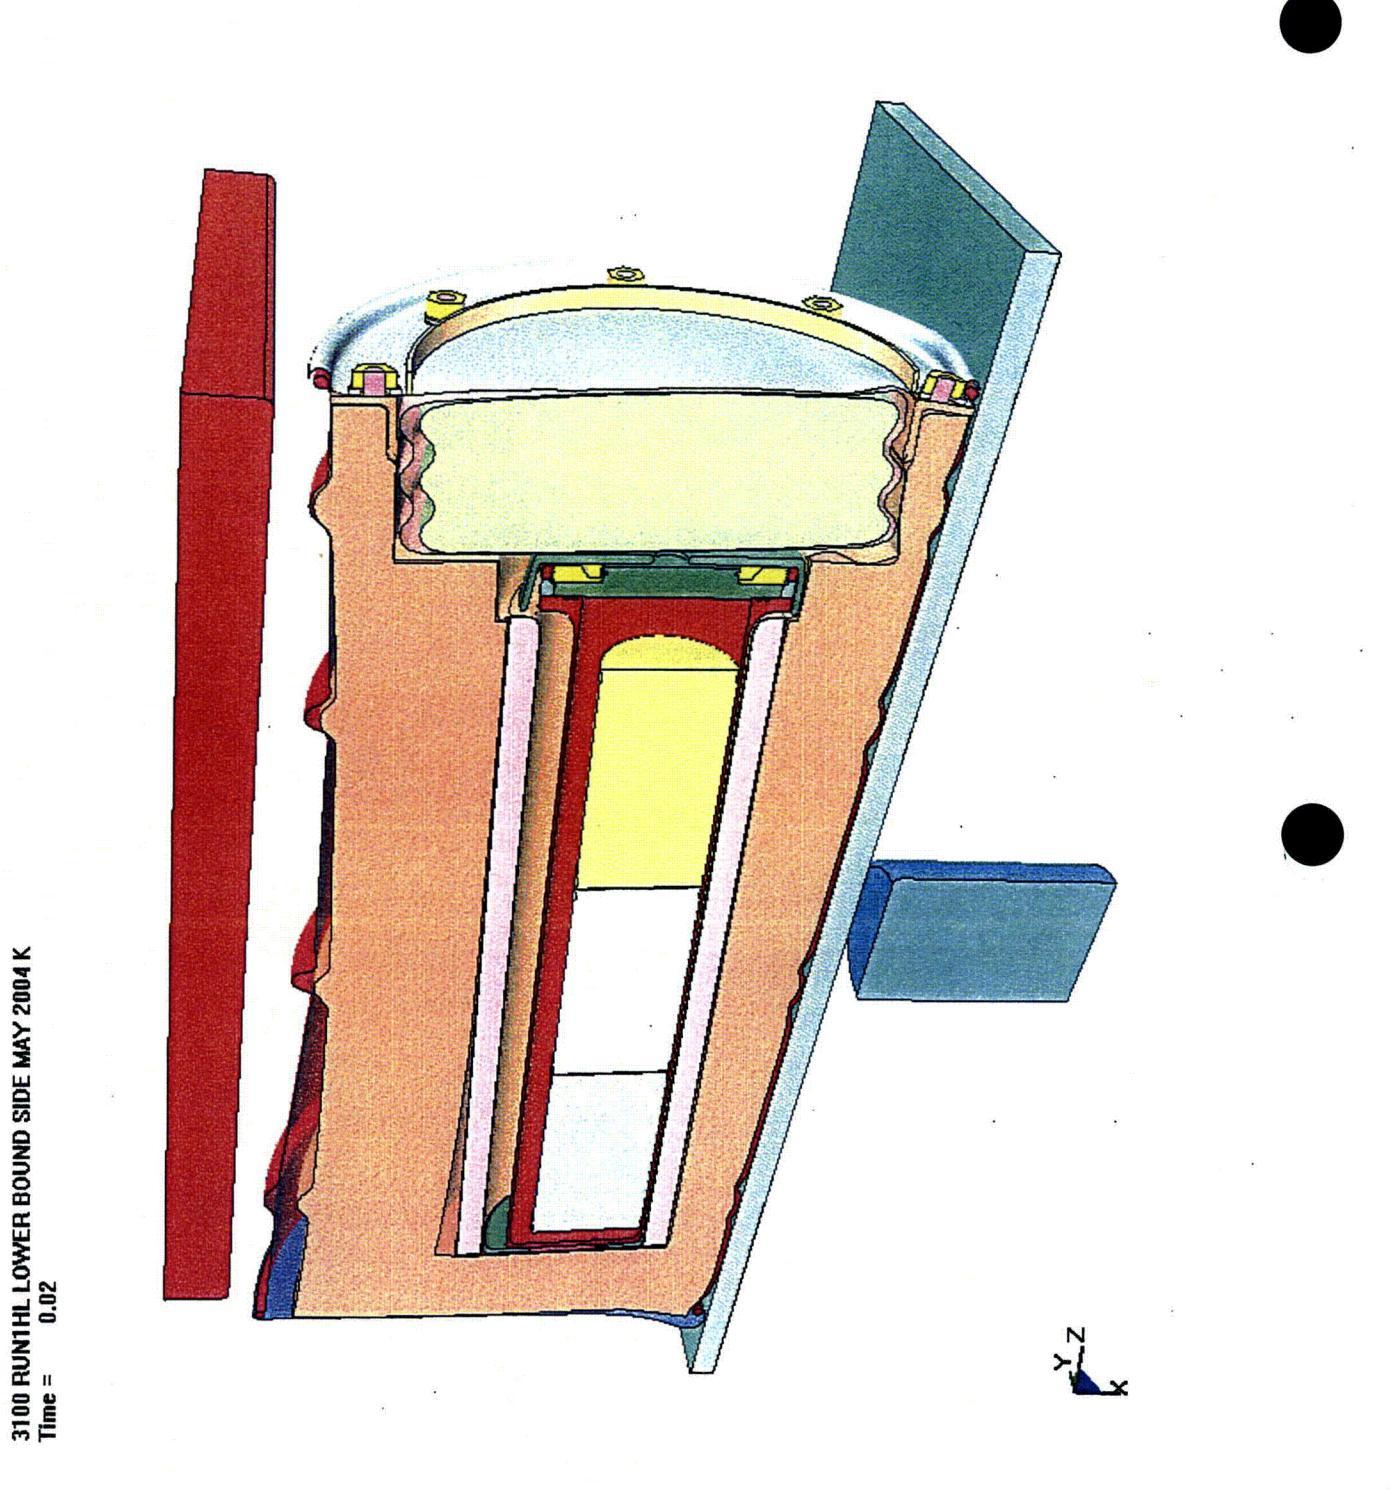
Figure 3.3.5 - Run1hl, 30-Foot Impact, Final Configuration

Figure 3.3.5 shows the final configuration for the run1hl 30-foot impact. Figures 3.3.6 and 3.3.7 show the configurations for the package extremes.

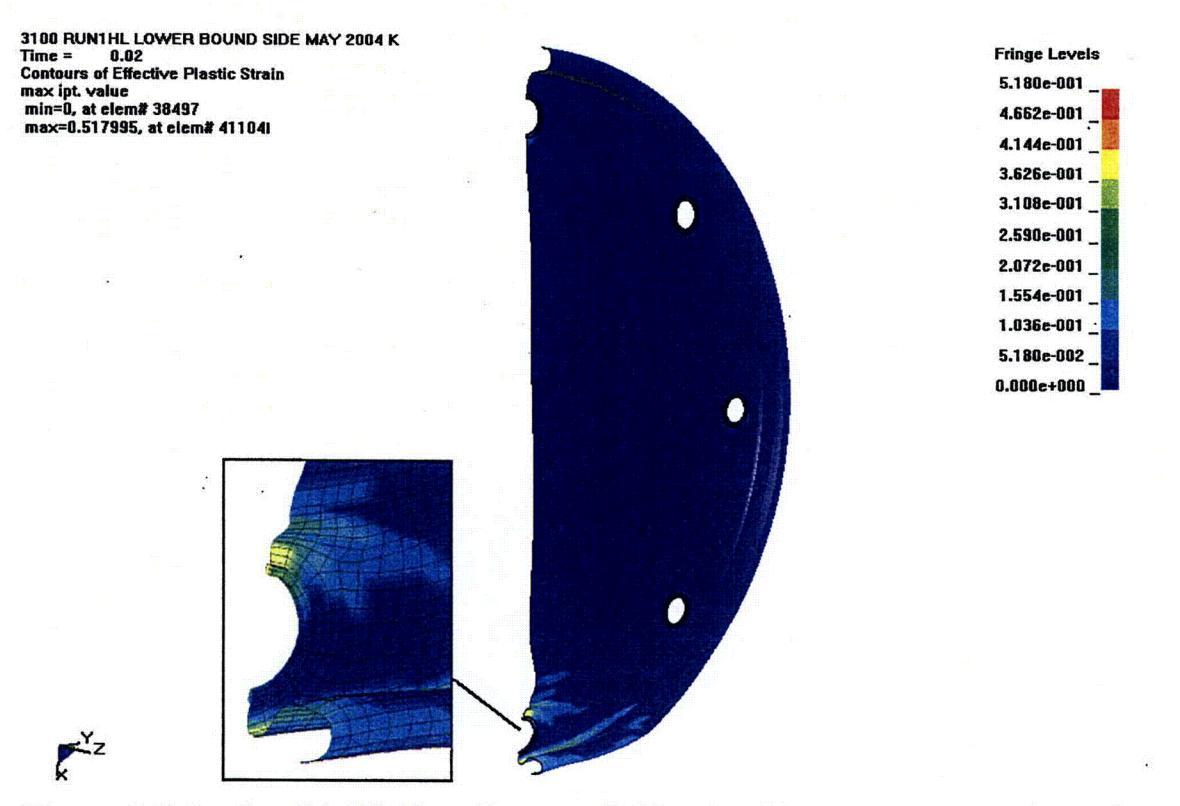
Figure 3.3.9 - Run1hl, 30-Foot Impact, Effective Plastic Strain in the Lid

is shown to be 0.5180 in/in in Figure 3.3.9. The maximum lid strain is a surface strain at the stud hole nearest the rigid surface (0°). The membrane effective plastic strain component is 0.4026 in/in in the localized region near the stud hole. Effective plastic strain levels in other components for the 30-foot impact are given in Table 3.3.2.

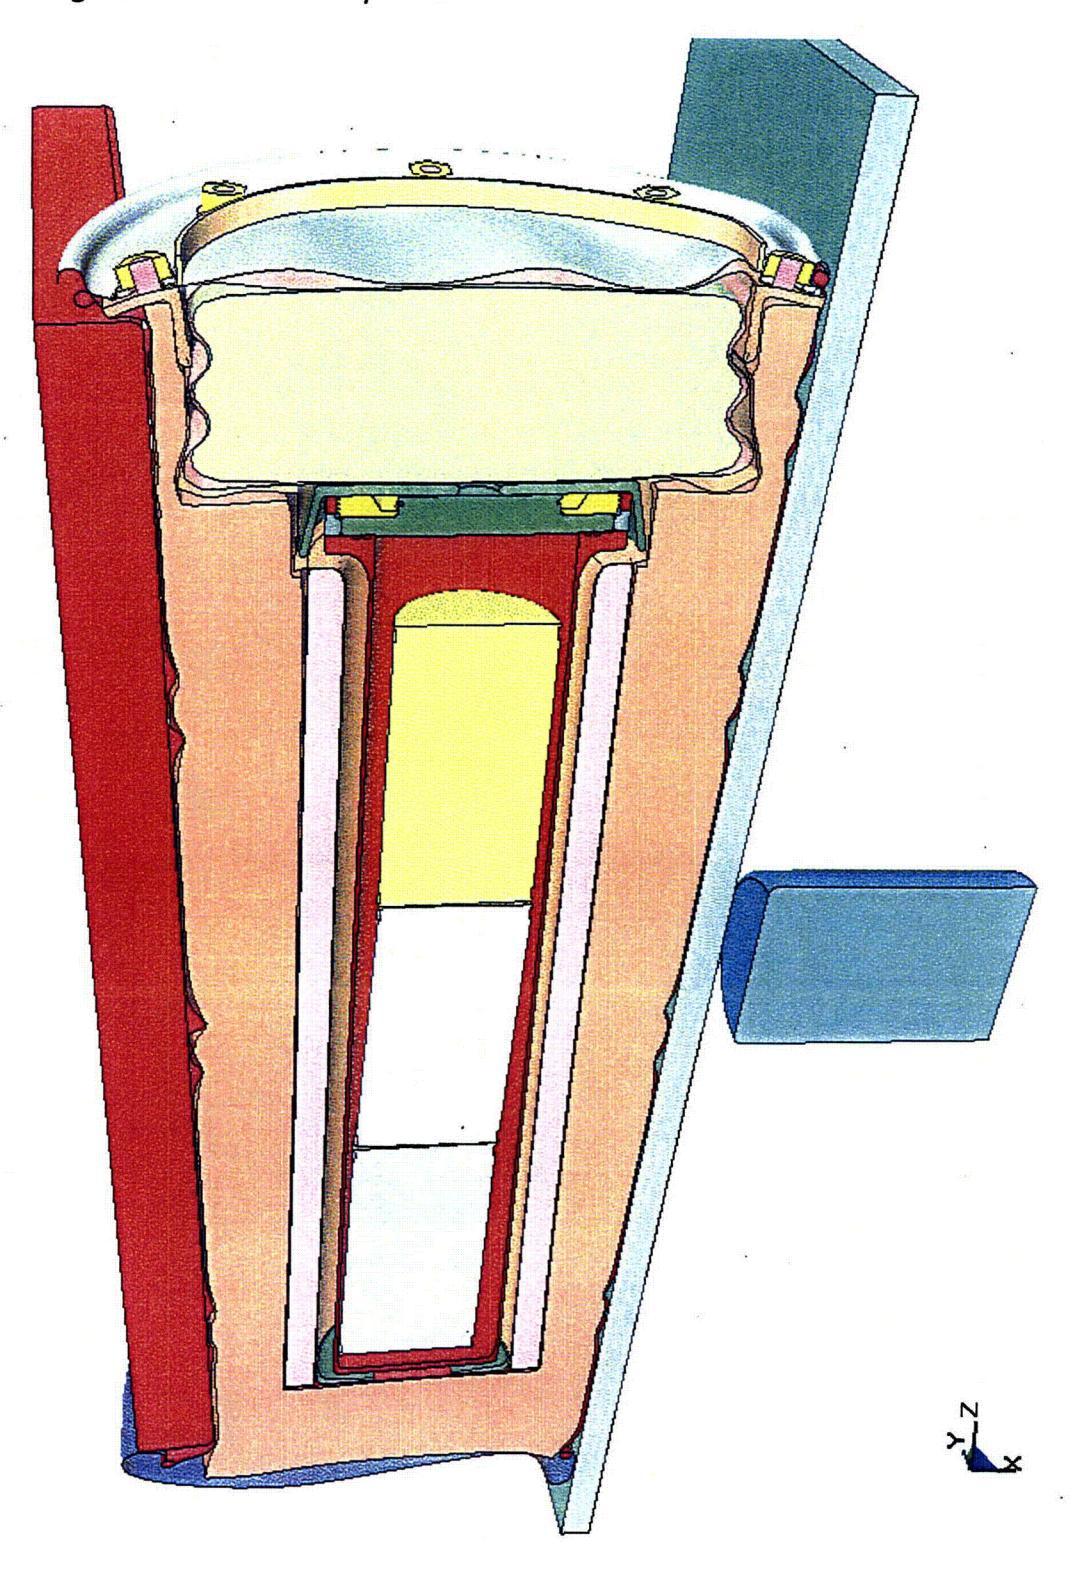
Figure 3.3.10 - Run1hl, Crush Impact, Final Configuration

The final configuration for the crush impact is shown in Figure 3.3.10. The configuration at the package extremes are shown in Figure 3.3.11. The maximum effective plastic strain in the CV body is 0.0287 in/in as shown in Figure 3.3.12. The maximum effective plastic strain in the drum for the crush impact is 0.5309 in/in (surface strain). The maximum in the drum occurs near the angle on the crush plate side of the drum as shown in Figure 3.3.13. The maximum membrane effective plastic strain at this location is 0.3616 in/in.

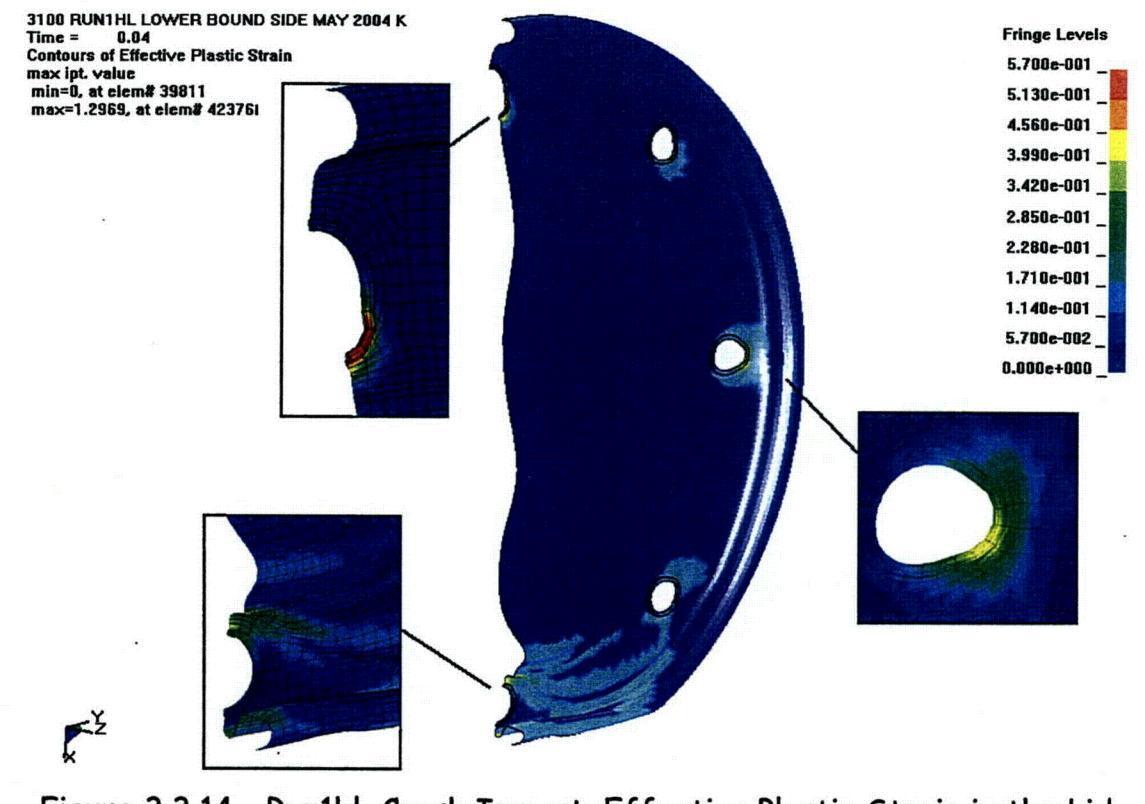
Figure 3.3.14 - Run1hl, Crush Impact, Effective Plastic Strain in the Lid

The maximum effective plastic strain in the lid is 1.2969 in/in (surface strain) and occurs just below the upper stud hole (hole nearest the crush plate, 180°) as shown in Figure 3.3.14. The maximum membrane effective plastic strain in this region of the lid is 0.8995 in/in. A time line investigation during the crush impact shows that the lid exceeds 0.57 in/in strain in bending at about 0.0228 seconds at the 180° stud hole. The crush impact started at about 0.0200 seconds, so the lid reaches failure level near the start of the crush impact. The membrane levels in the lid reach 0.57 in/in at about 0.0236 seconds.

The elevated effective plastic strain levels in the lid are localized in the region just mboard of the upper stud.

Considering the strain levels in the lid and the studs, some tearing in the lid at the 180° stud hole would be expected. But the tearing would be localized to the stud hole due to the extent of the strain patterns. Failure of the stud to restrain the lid due to this tearing is not expected. The lid stiffener would limit any tearing from the stud at 180° and the large washer would be expected to restrain the lid.

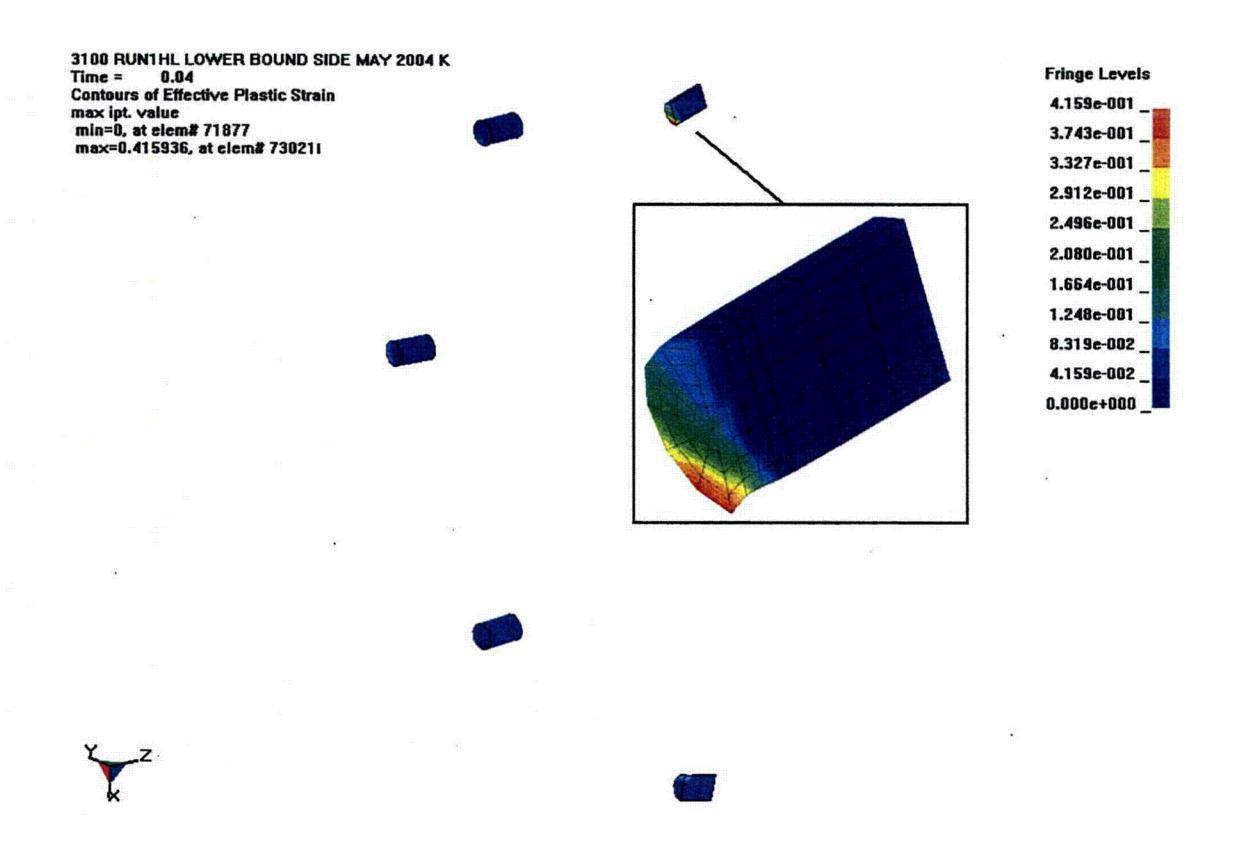
Figure 3.3.15 - Run1hl, Crush Impact, Effective Plastic Strain in the Studs

The effective plastic strain in the drum studs is 0.4159 in/in and occurs in the upper stud at the bearing of the lid onto the stud (180°). The elevated strains in the stud are localized on the inner surface. Effective plastic strain levels throughout the thickness of the stud are generally 0.25 in/in or less.

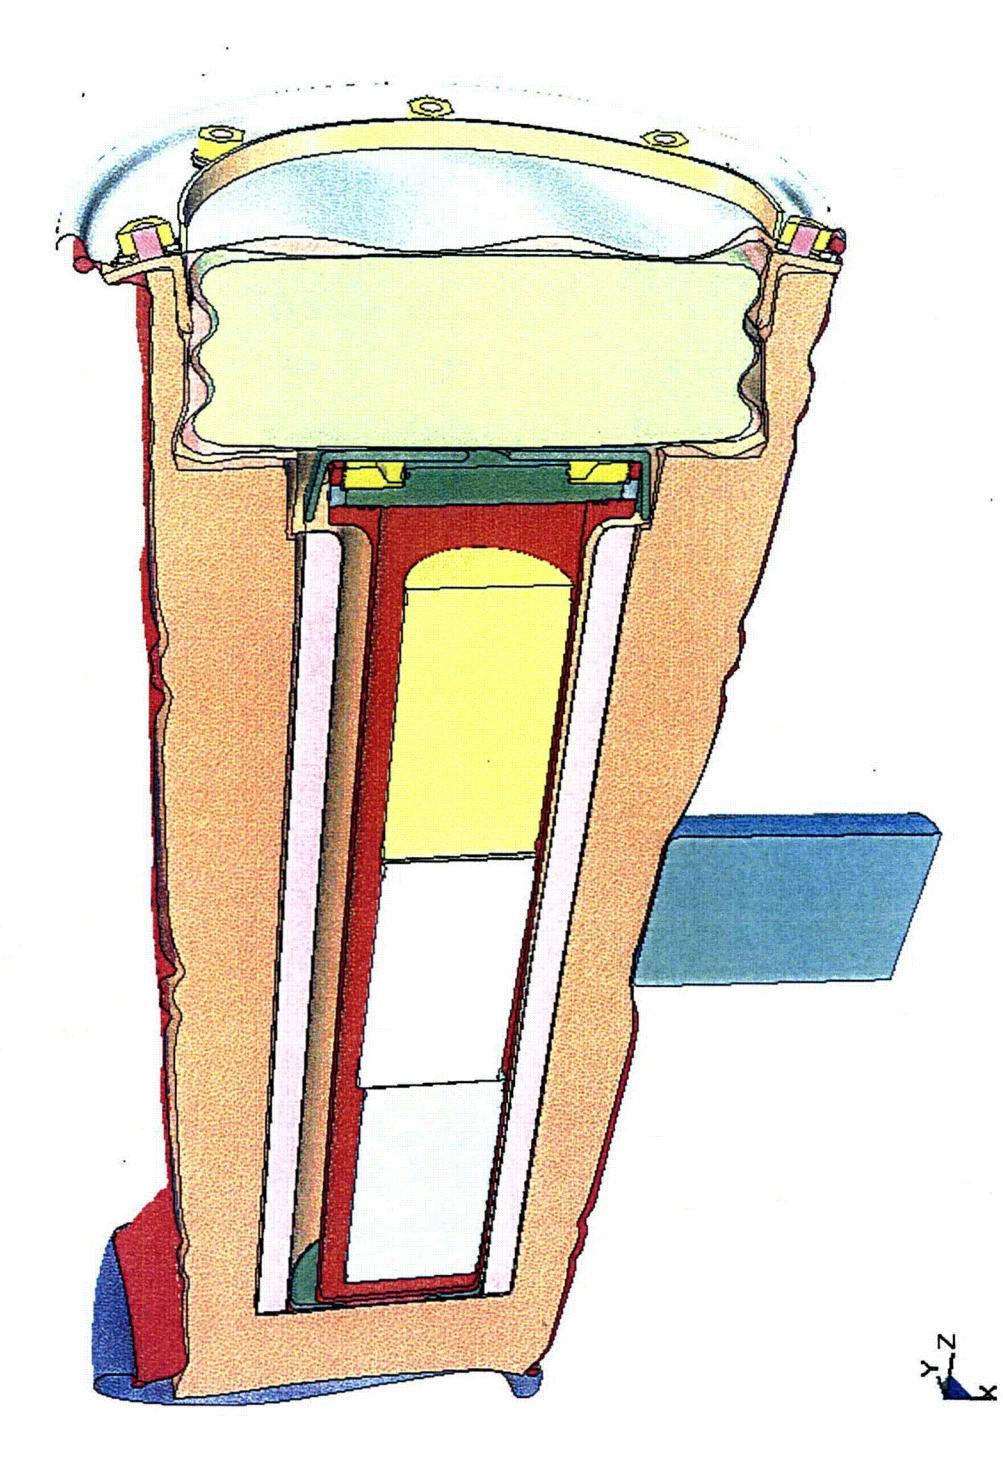
Figure 3.3.16 - Run1hl, Punch Impact, Final Configuration

The final configuration after the punch impact is shown in Figure 3.3.16. The effective plastic strain level in the CV body is shown in Figure 3.3.6. The maximum strain is 0.0299 in/in and is located near the bottom head. The effective plastic strain level in the drum after the punch impact remains at 0.5309 in/in as shown in Figure 3.3.18. The maximum effective plastic strain in the other package components for the punch impact are sted in Table 3.3.4.

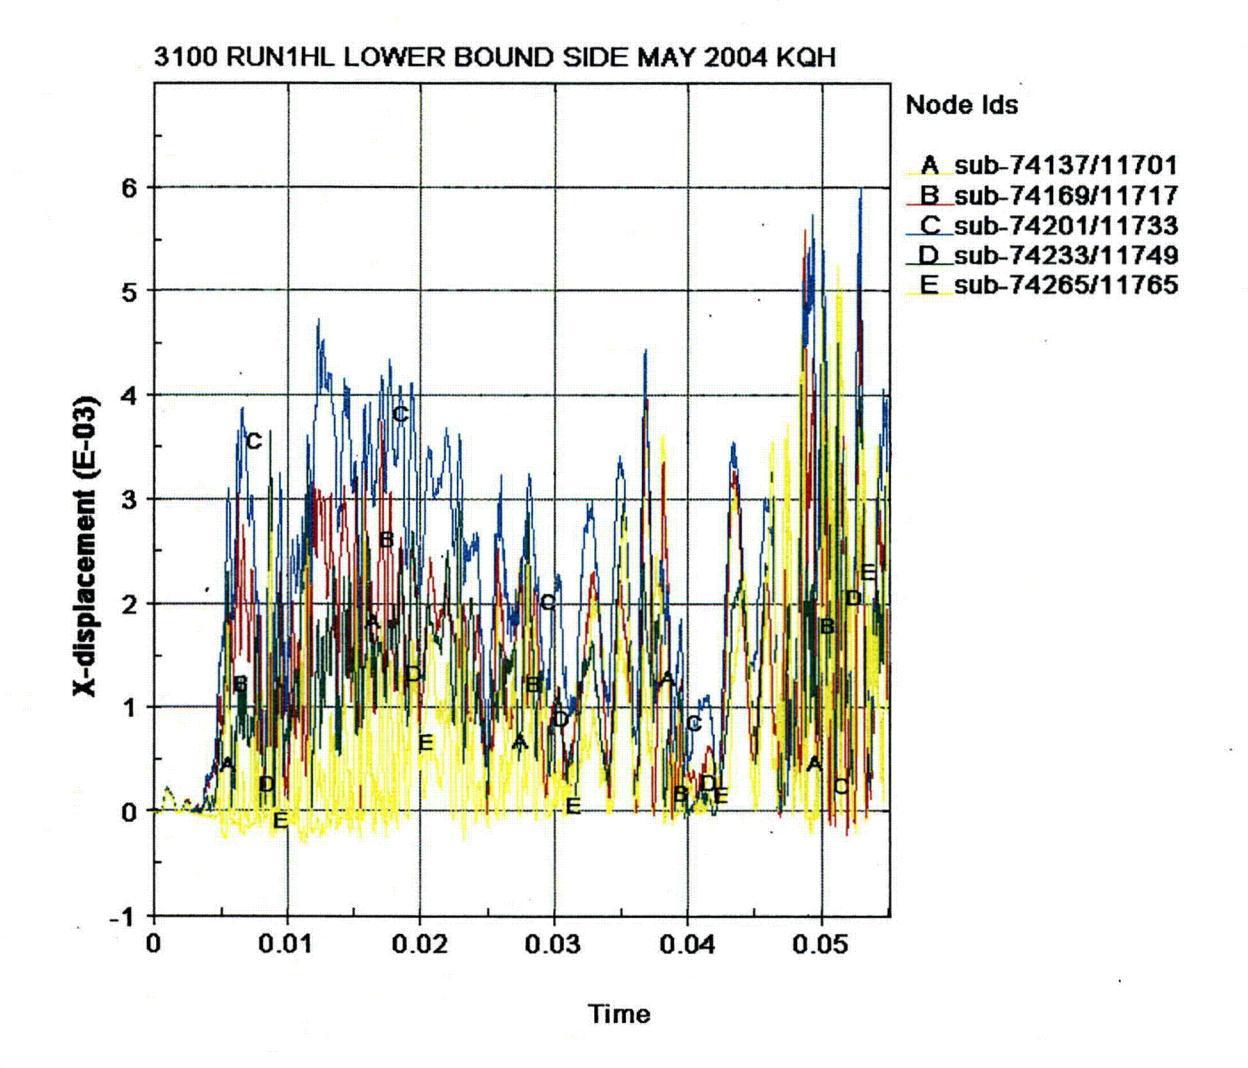
Figure 3.3.19 - Run1hl, CV Lid Separation Time History

Figure 3.3.19 shows the lid separation time history for all the impacts. The CV lid separation shows a maximum spike separation of about 0.006 inches occurs during the punch. The spike is a response to the rebounding impact of the CV/weights. An average value of .003 in or less is demonstrated in the response when the solution is stopped.

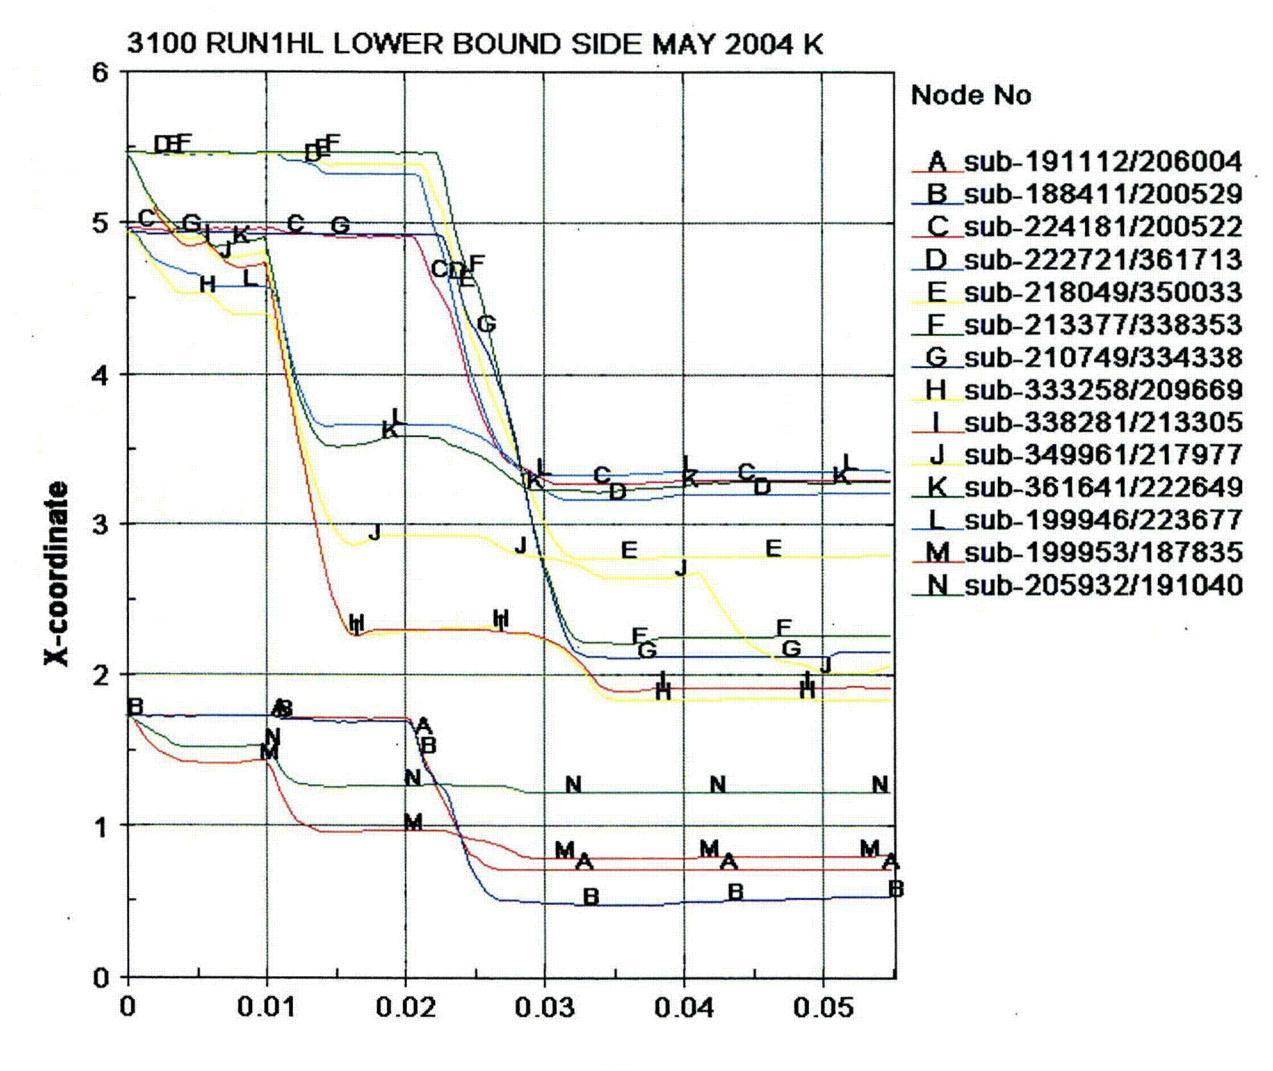
Figure 3.3.20- Run1hl, Kaolite Thickness Time History

Figure 3.3.20 shows the time history for the kaolite thicknesses. The nodal locations for nodes shown in Figure 3.3.20 are shown in Figure 3.1.32.

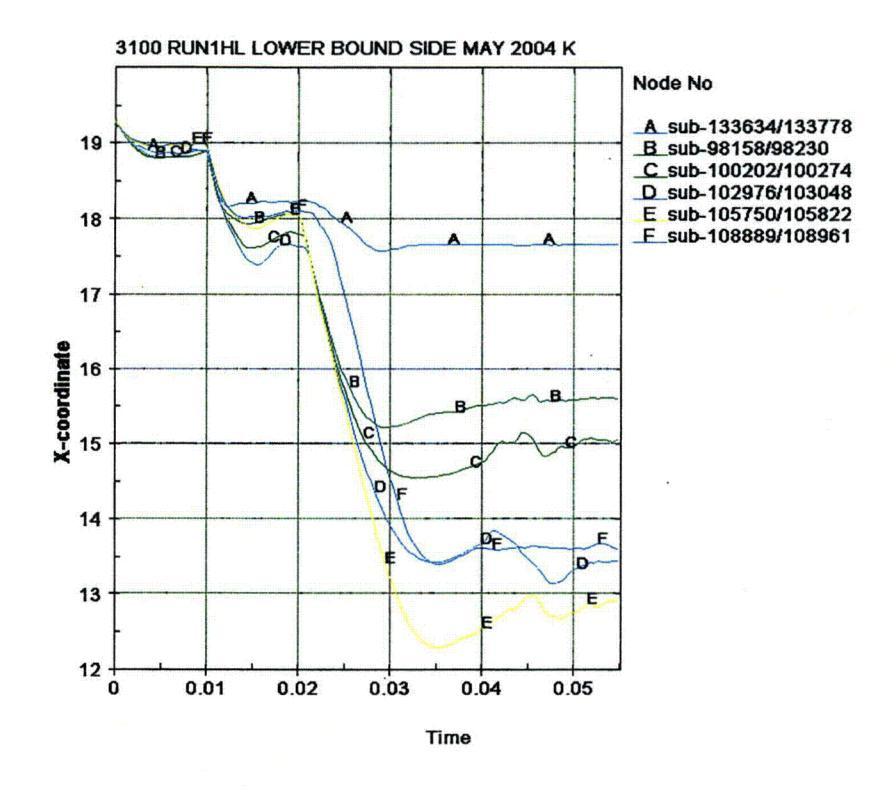
Figure 3.3.21 - Run1hl, Drum Dimension Time History in the X-Direction

Figure 3.3.21 shows the diameter changes in the drum in the model X direction. Figure 3.3.22 shows the radial changes in the Y direction (normal to the impact directions). The nodes are defined in Figure 3.1.34.

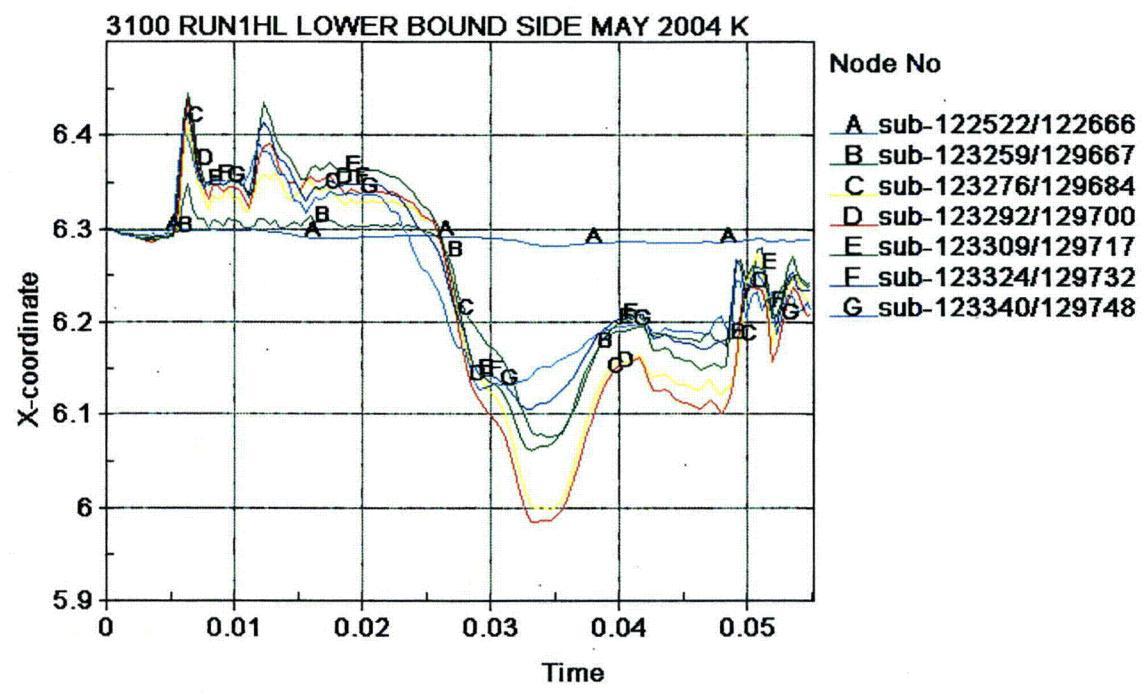
Figure 3.3.23 - Run1hl, Liner Diameter Time History

Figure 3.3.23 shows the liner diameter time history. The node pair locations are shown in Figure 3.1.37 and Table 3.1.3.

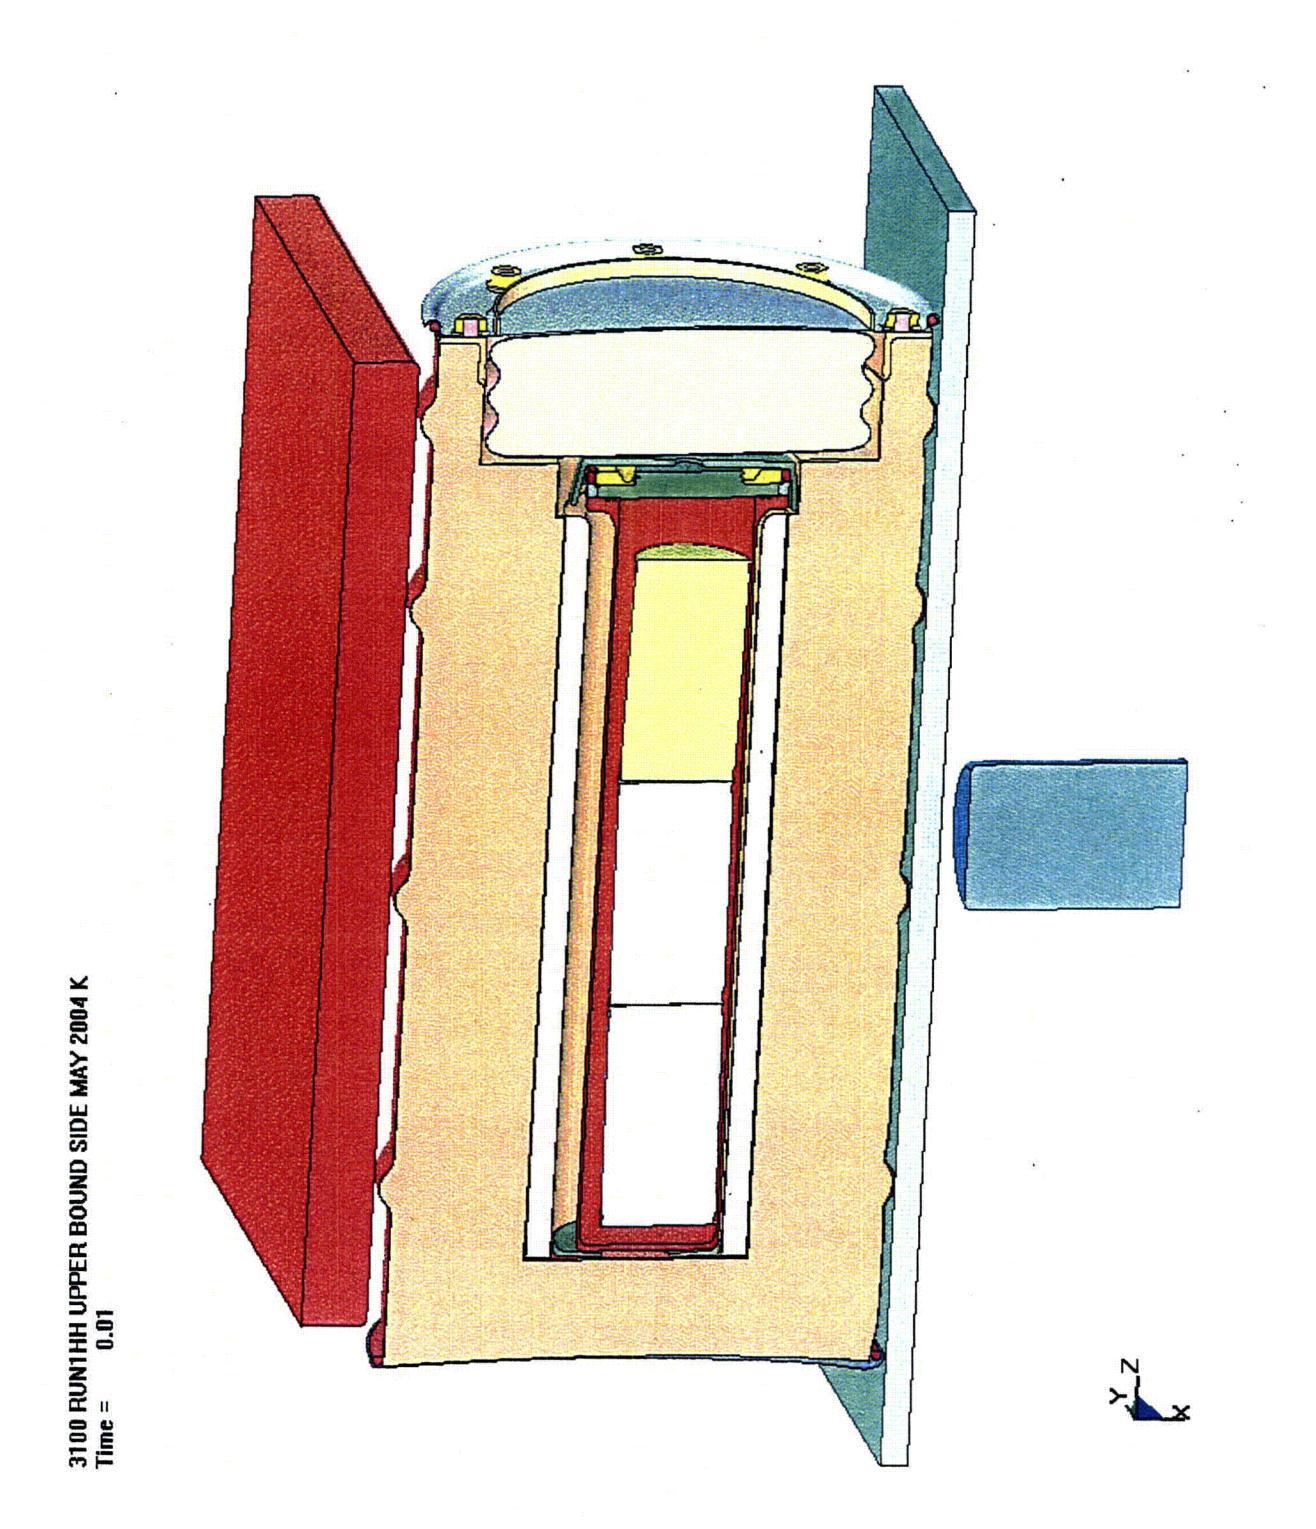
Figure 3.4.1 - Run1hh, 4-Foot Impact, Final Configuration

The final configuration for the 4-foot impact is shown in Figure 3.4.1. Figures 3.4.2 and 3.4.3 show the configuration at the corners of the shipping package. The effective plastic strain in the CV body for the 4-foot impact is shown in Figure 3.4.4. The maximum effective plastic strain is shown to be 0.0298 in/in near the bottom head. The effective plastic strain in other package components for the 4-foot impact are listed in Table 3.4.1.

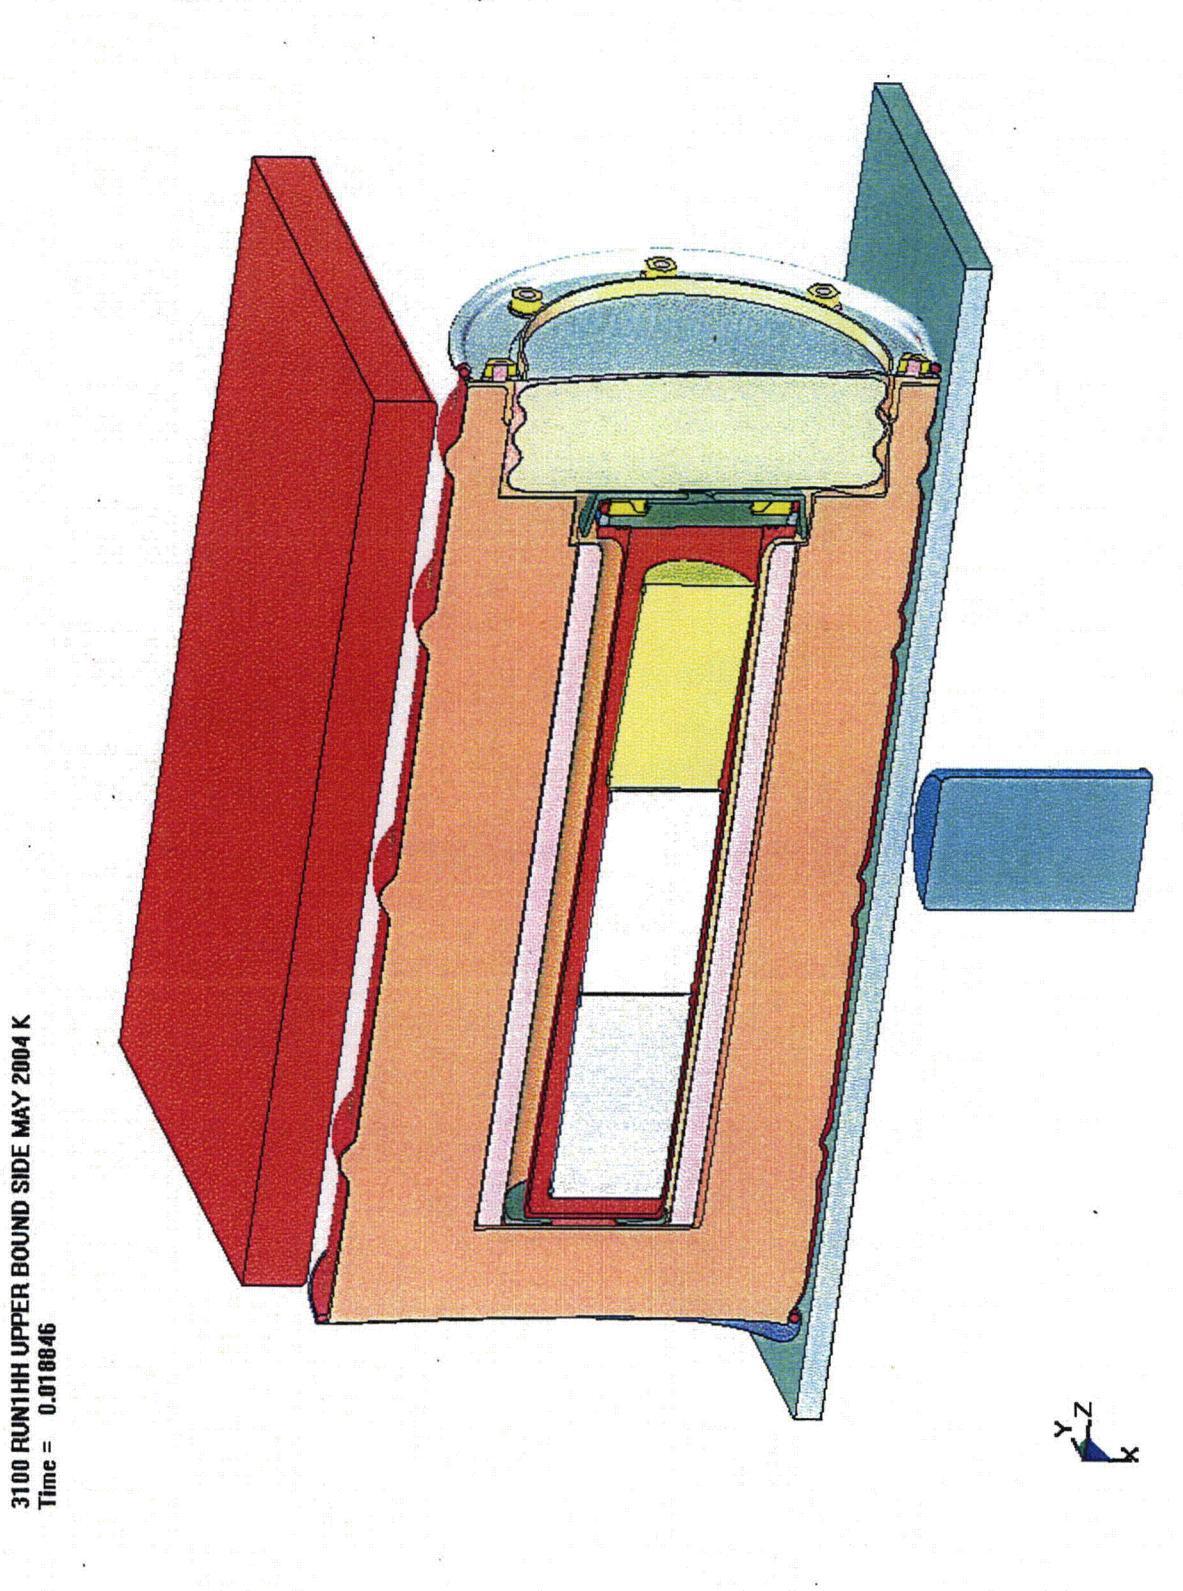
Figure 3.4.5 - Run1hh, 30-Foot Impact, Final Configuration

The final configuration for the 30-foot impact is shown in Figure 3.4.5. Figures 3.4.6 and 3.4.7 show the configuration at the corners of the package. The maximum effective plastic strain for the 30-foot impact in the CV Body is 0.0386 in/in near the bottom head. The maximum effective plastic strain in the drum lid is 0.4073 in/in near the rigid plane.
