Run1hl - Side

3.4 Run1hh - Side

3.5 Run2e - Corner

Y/LF-717/Rev 1/Ch-2/ES-3100 HEU SAR/sc/11-15-06

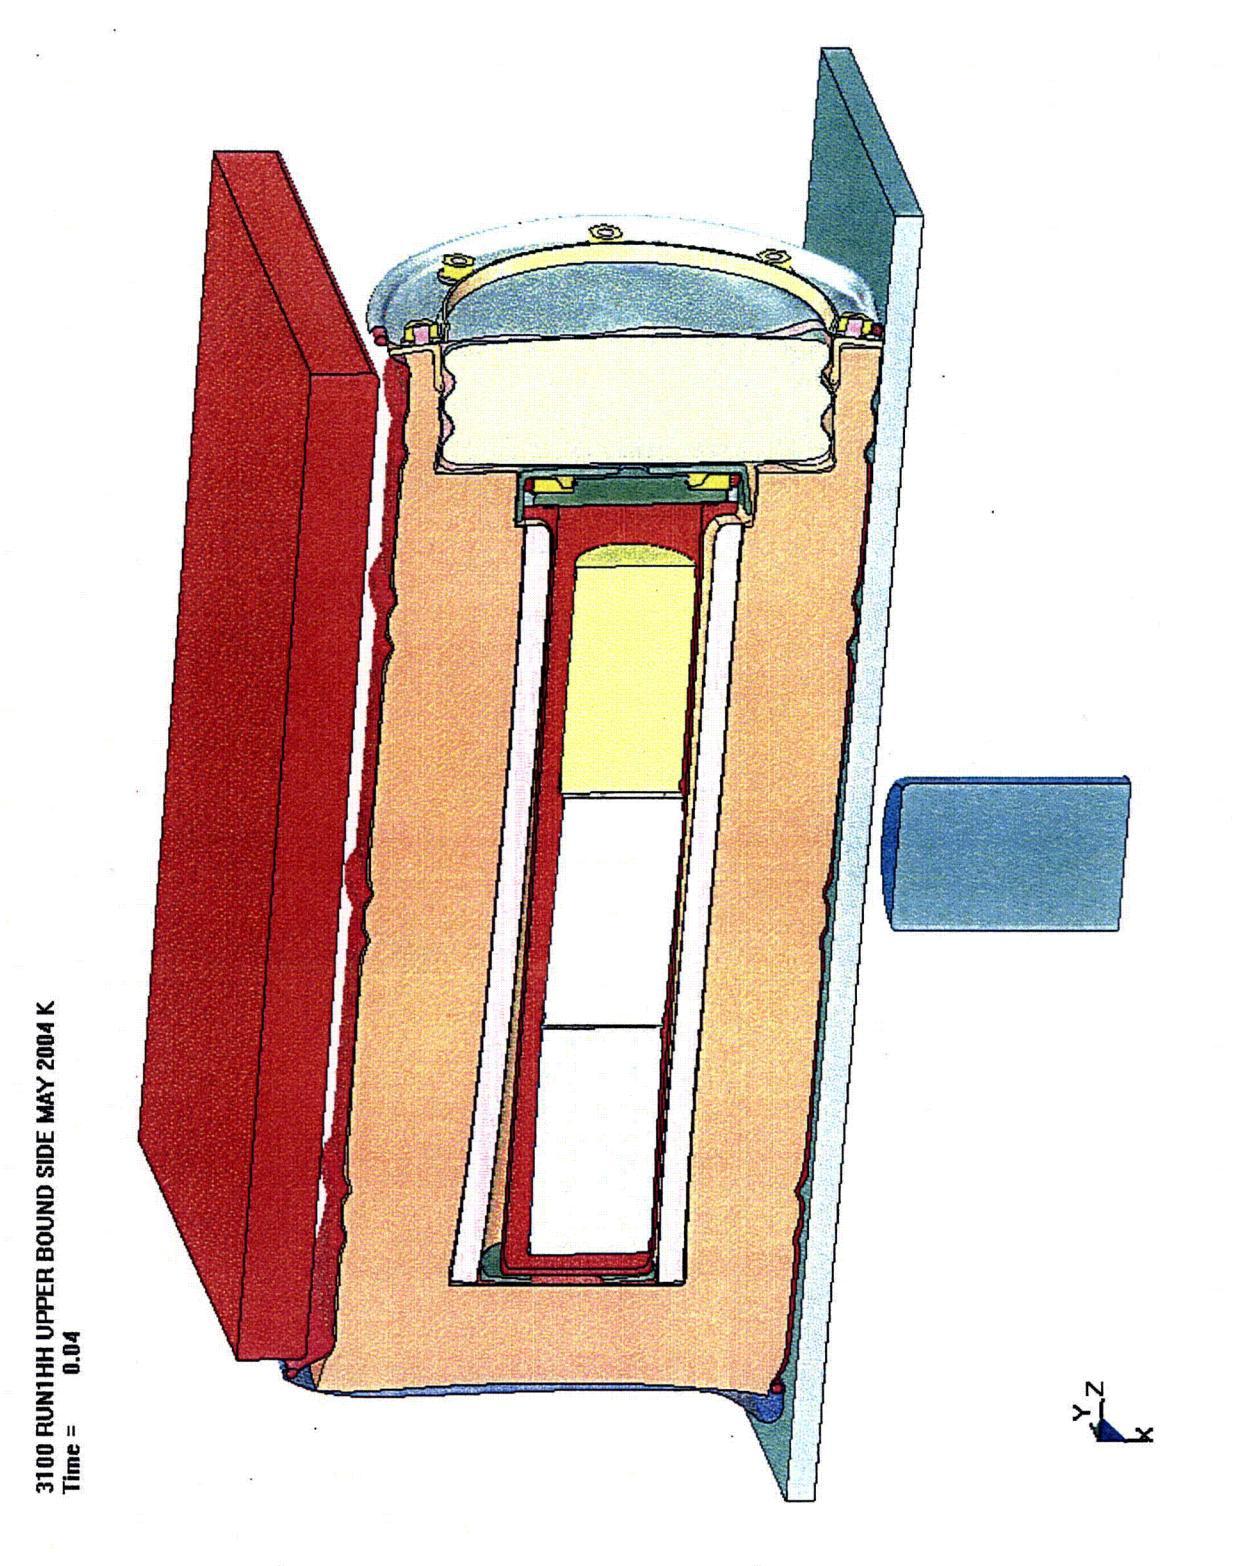
Figure 3.4.10 - Run1hh, Crush Impact, Final Configuration

The final configuration for the crush impact is shown in Figure 3.4.10. The configuration at the extremes of the package are shown in Figure 3.4.11. The maximum effective plastic strain for the crush impact in the CV body is 0.0462 in/in, on the crush plate side near the lid end of the top inner weight as shown in Figure 3.4.12. The maximum effective plastic strain in the drum is 0.2623 in/in near the angle and the rigid plane (Figure 3.4.13). The maximum effective plastic strain in the drum lid is 0.6411 in/in (surface strain), Figure 3.4.14. The maximum occurs at the lid hole for the stud closest to the crush plate(180°). The membrane effective plastic strain is 0.4922 in/in at this location. The effective plastic strain in the stude is 0.1753 in/in as shown in Figure 3.4.15. The effective plastic strain in other components are listed in Table 3.4.3 for the crush impact.

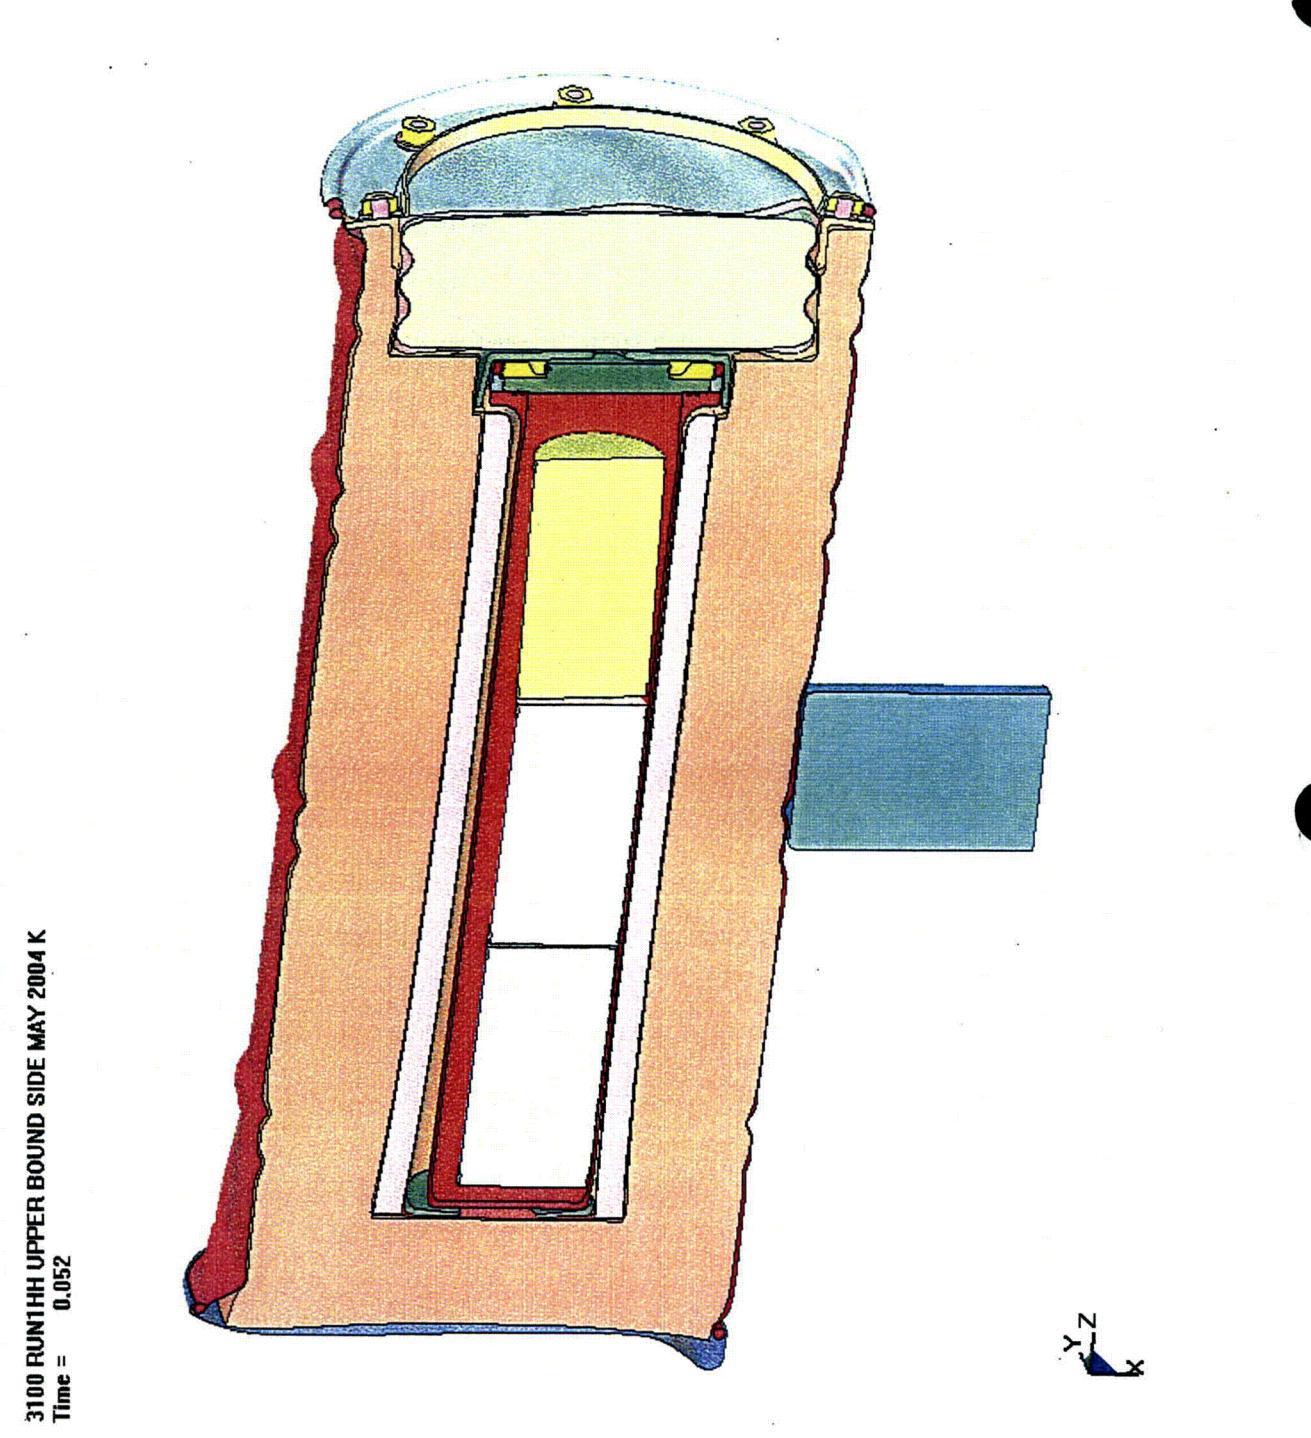
Figure 3.4.16 - Run1hh, Punch Impact, Final Configuration

The final configuration for the punch impact is shown in Figure 3.4.16. The maximum effective plastic strain in the CV body after the punch impact is shown to be 0.0599 in/in in Figure 3.4.17. The maximum effective plastic strain in the drum is 0.2623 in/in (surface strain) and is located near the angle at the rigid surface. The maximum effective plastic strain in elements local to the punch impact is 0.1382 in/in (surface strain) as shown in the insert in Figure 3.4.18. The maximum effective plastic strain for the lid and other package components at the end of the punch impact are listed in Table 3.4.4.

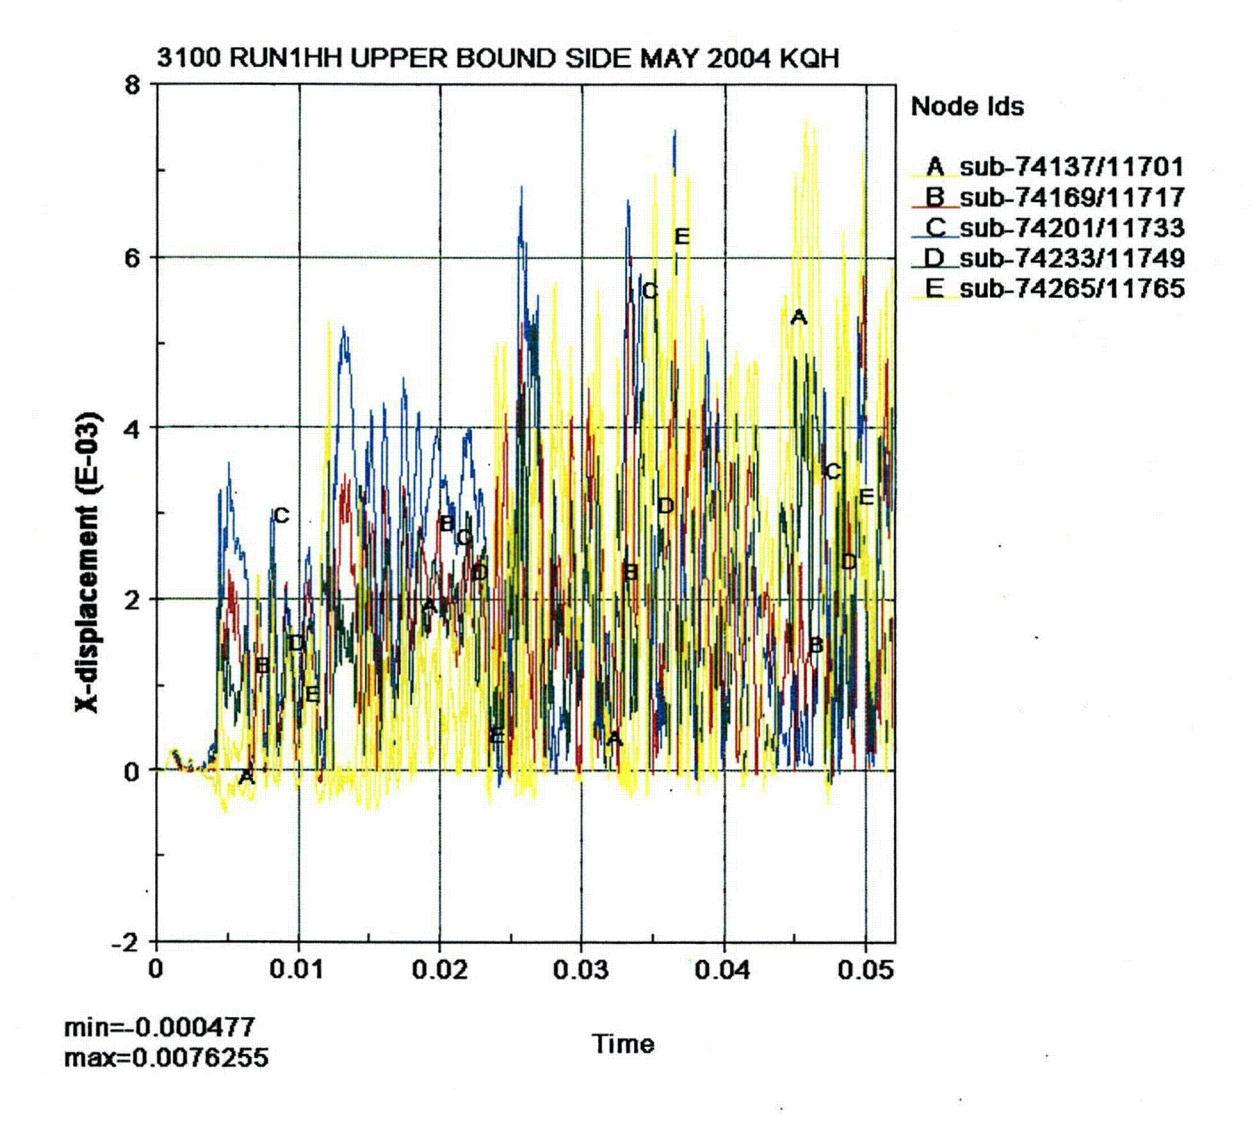
Figure 3.4.19 - Run1hh, CV Lid Separation Time History

Figure 3.4.19 shows the CV lid separation for all the impacts. A maximum spike for the lid separation of less than 0.008 inches is found. At the end of the impacts, the maximum separation is on the order of 0.006 in, with the response being oscillatory in nature. Average separation of 0.003 inches or less is shown to be expected after the successive impacts.

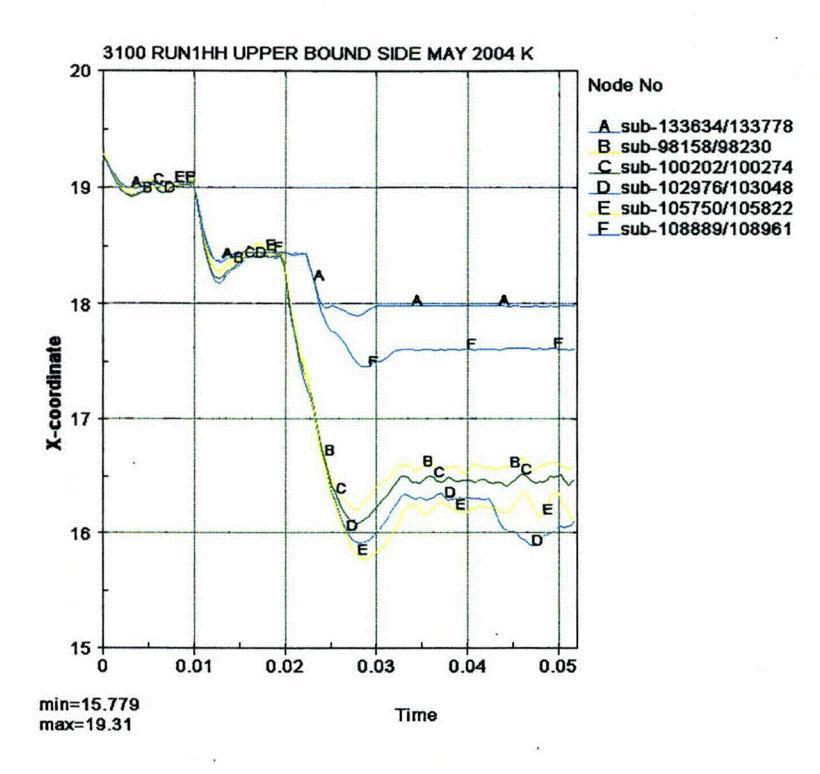
Figure 3.4.20 - Run1hh, Diameter of the Drum in the Direction of the Impacts

Figure 3.4.20 shows the drum diameter time history response to the impacts in the X direction (direction of the impacts). Figure 3.4.21 shows the Y direction radial response (normal to the impact direction). The drum nodes are defined in Figure 3.1.34.

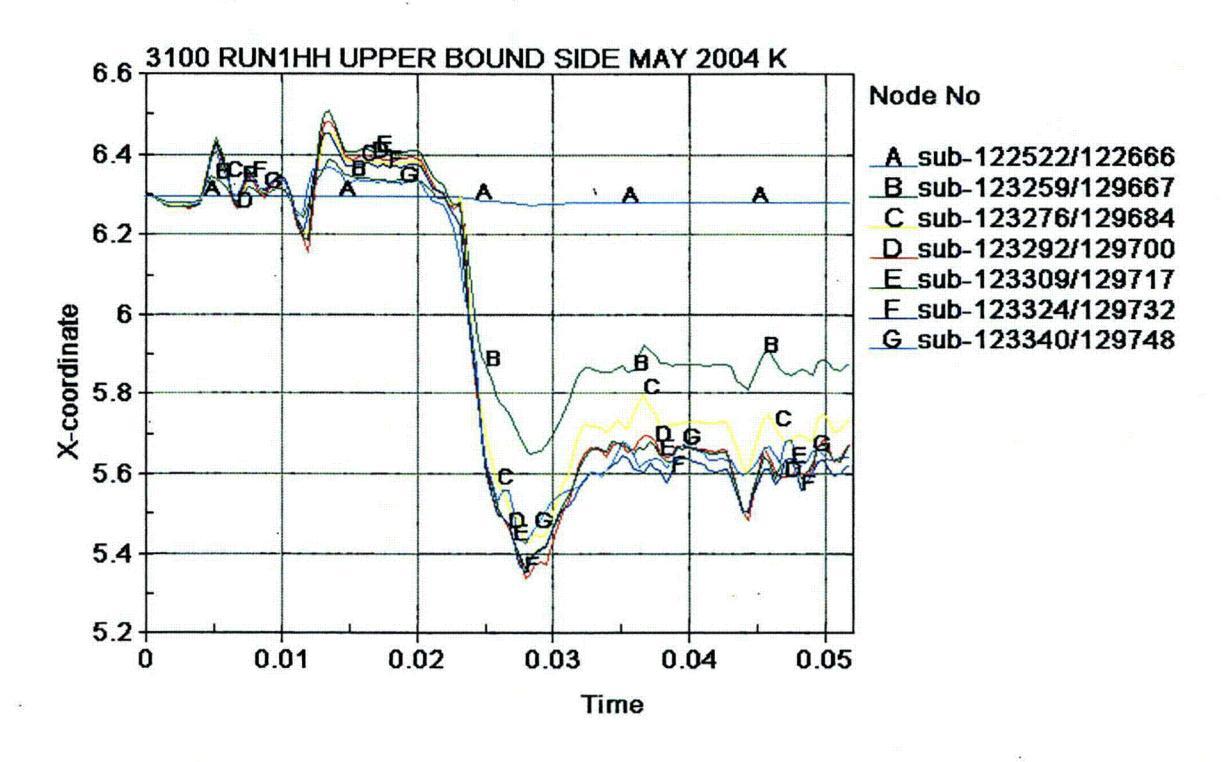
Figure 3.4.23 - Run1hh, Liner Diameter Time Histories

Figure 3.4.23 shows the liner diameter time history along its length. The nodal pairs are defined in Figure 3.1.37 and Table 3.1.3.

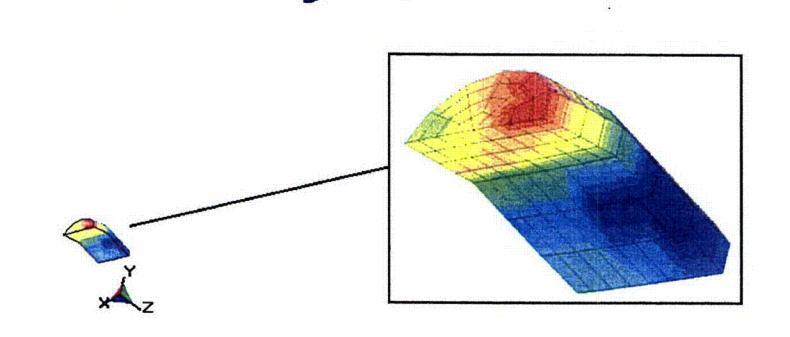
Figure 3.5.2 - Run2e, 30-Foot Impact, Effective Plastic Strain in the Drum Studs

The configuration after the 30-foot impact is shown in Figure 3.5.1. The maximum effective plastic strain in the lid studs is in the stud at the impact with the rigid plane (0°) and is 0.5197 in/in as shown in Figure 3.5.2. It can be seen from the insert in Figure 3.5.2, that strains near the maximum exist across the thickness of the stud. Therefore, it should be noted that slight differences between the modeled length and actual length of the stud could be significant relative to possible failure of the stud. Other differences such as friction and local flexibility in the test pad armored plate (stud "digging in") could also significantly effect this stud and cause failure. The maximum effective plastic strain of other components for this impact are listed in Table 3.5.1.

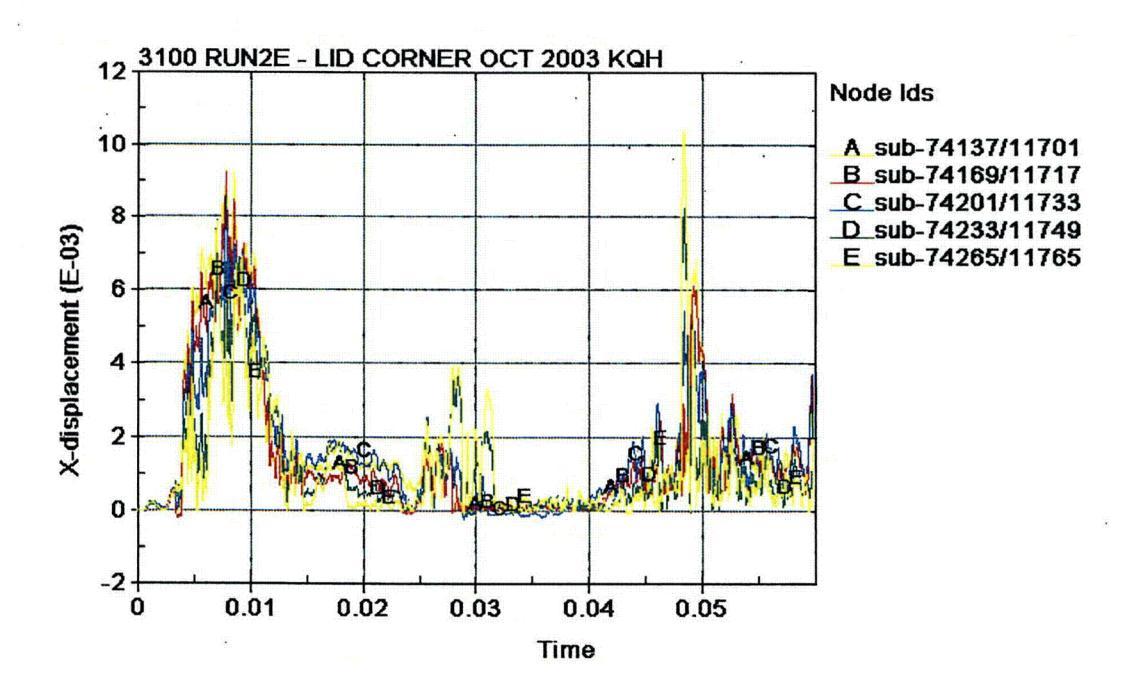
Figure 3.5.8 - Run2e, CV Lid/Body Separation Time History

The lid separation time history is given in Figure 3.5.8. A spike separation occurs in the crush impact with a maximum gap of about 0.010 inches. The run2e was extended to about 0.06 seconds so that the ringing associated with the gap at 0.05 seconds could relax. From the figure it is seen that an average value of gap would be 0.002 inches, or less due to the oscillatory nature of the gap response.

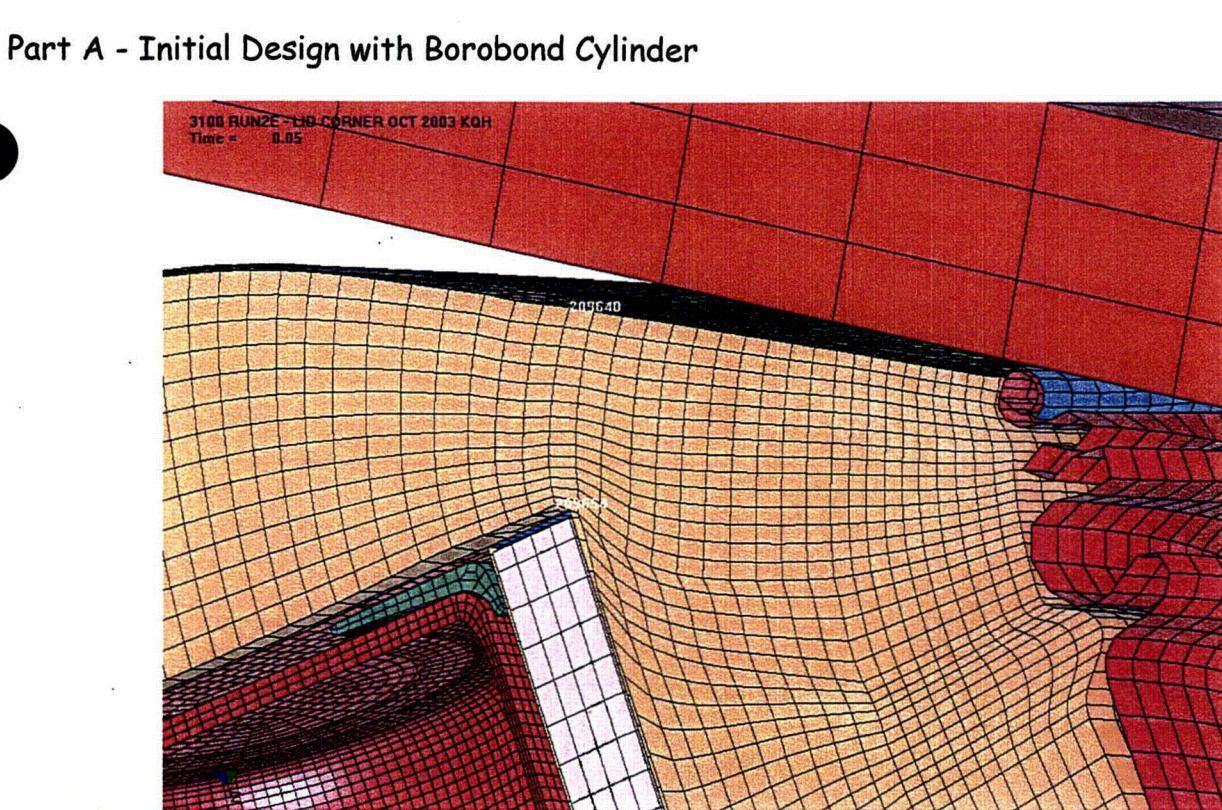
Figure 3.5.9 - Run2e, Location of Kaolite Nodes at the Bottom for Thickness Evaluation

Figure 3.5.9 shows the location of the nodes used to obtain the minimum koalite thickness in the package bottom. The time history thickness is shown in Figure 3.5.10 for the bottom kaolite. A minimum thickness of about 1.8 inches is shown.

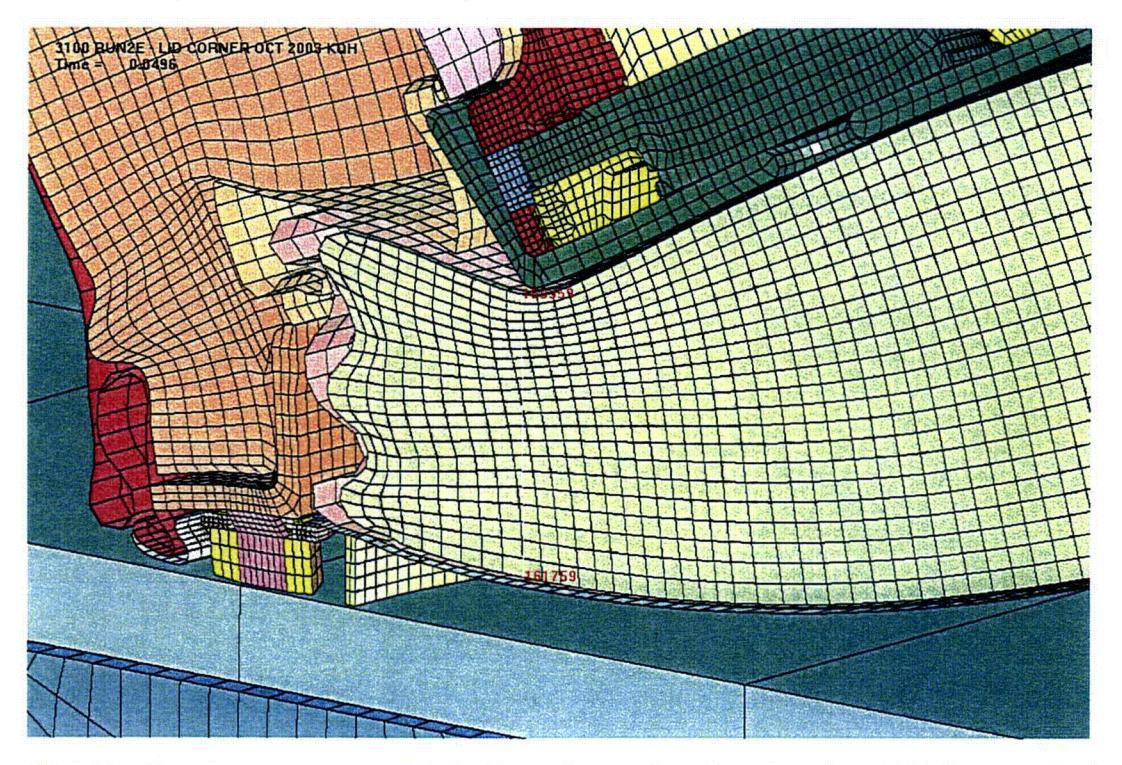
Figure 3.5.11 - Run2e, Location of Kaolite Nodes in the Plug for Thickness Evaluation

Figure 3.5.11 shows the location of the nodes used to obtain the minimum kaolite thickness in the plug. Figure 3.5.12 shows the distance time history with the minimum being about 2.8 inches.

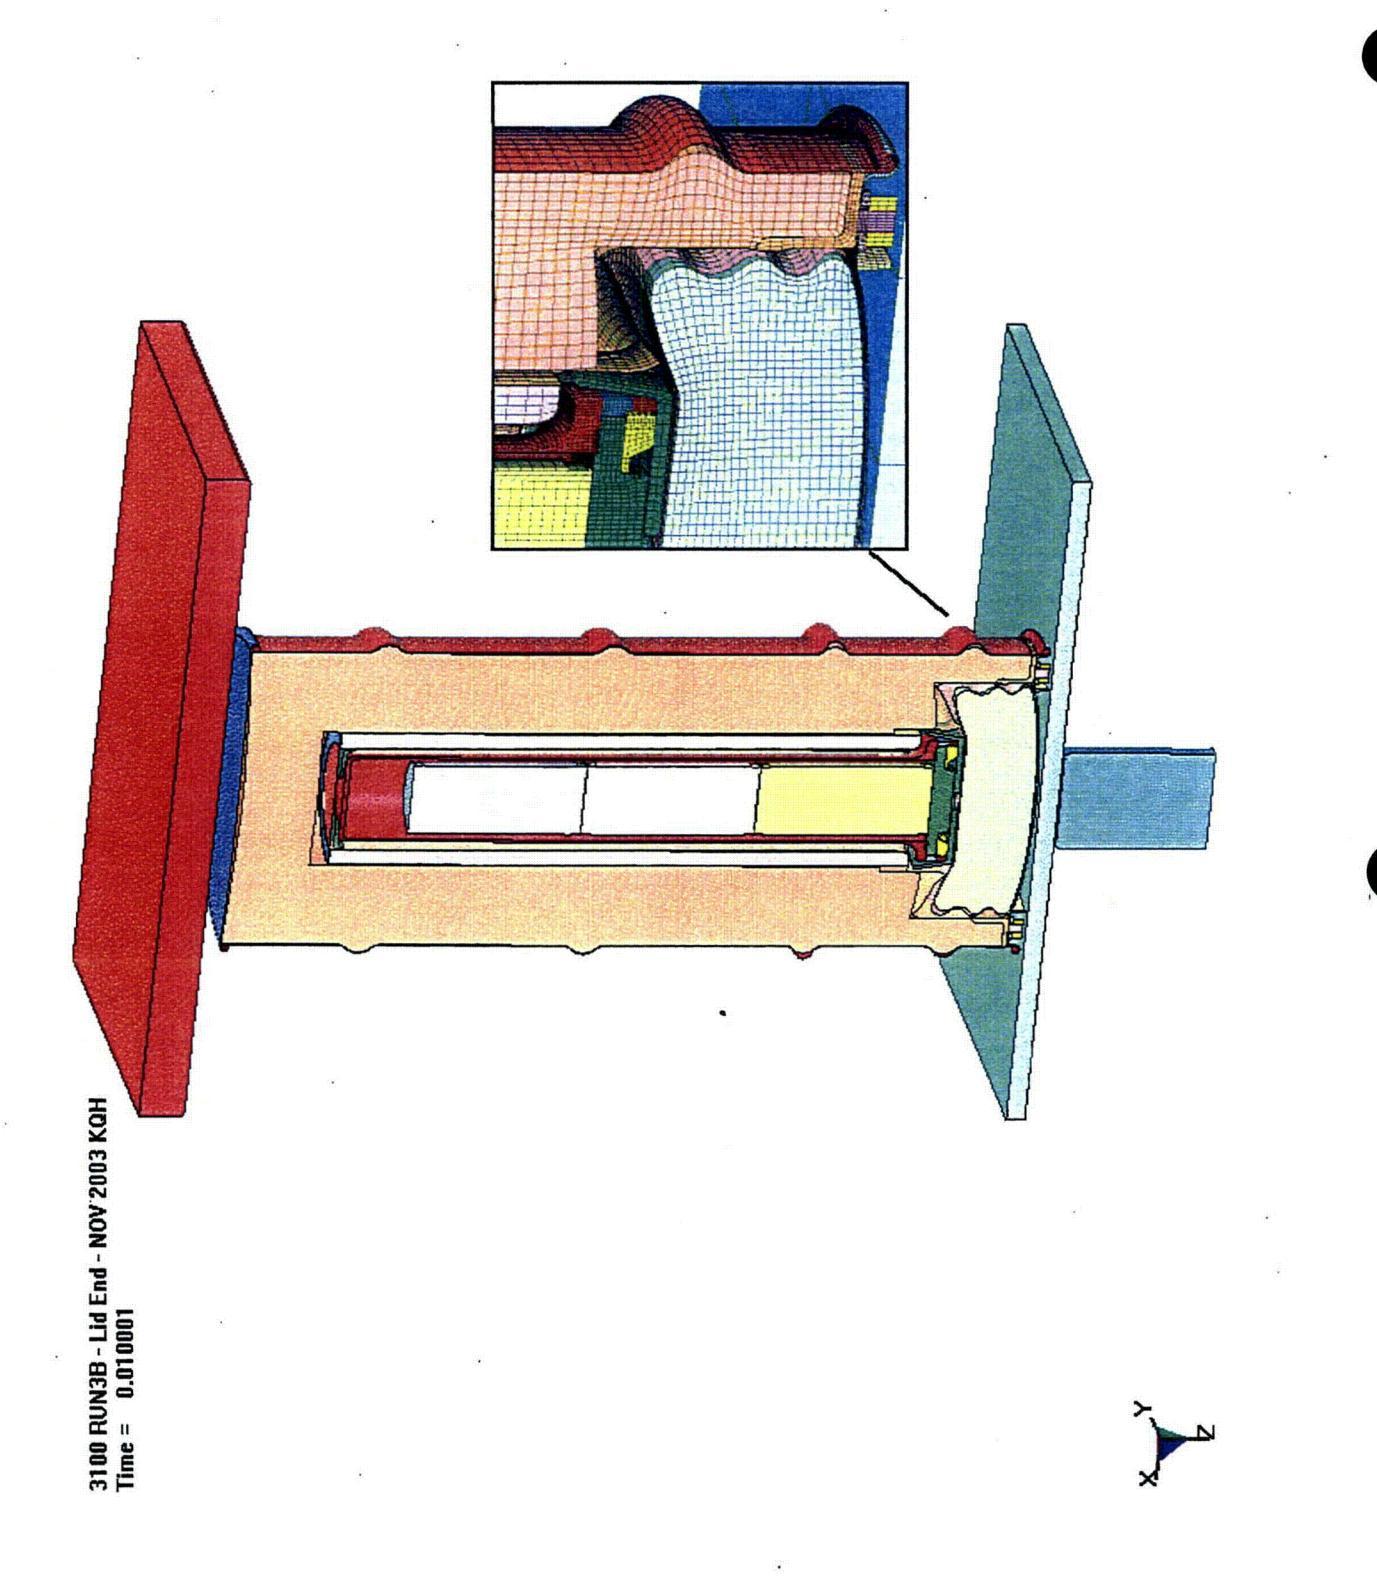
Figure 3.6.1 - Run3b, Configuration After the 30-Foot Impact

Run3b is a 30-foot lid end impact (time = 0 to 0.010 seconds) followed by a crush impact onto the package bottom (0.010 to 0.028 seconds). Figure 3.6.1 shows the final configuration for the 30-foot impact. Because of the relatively low demand placed on the components, no strain plots are presented for the 30-foot impact. Table 3.6.1 summarizes the maximum effective plastic strains in the package components.

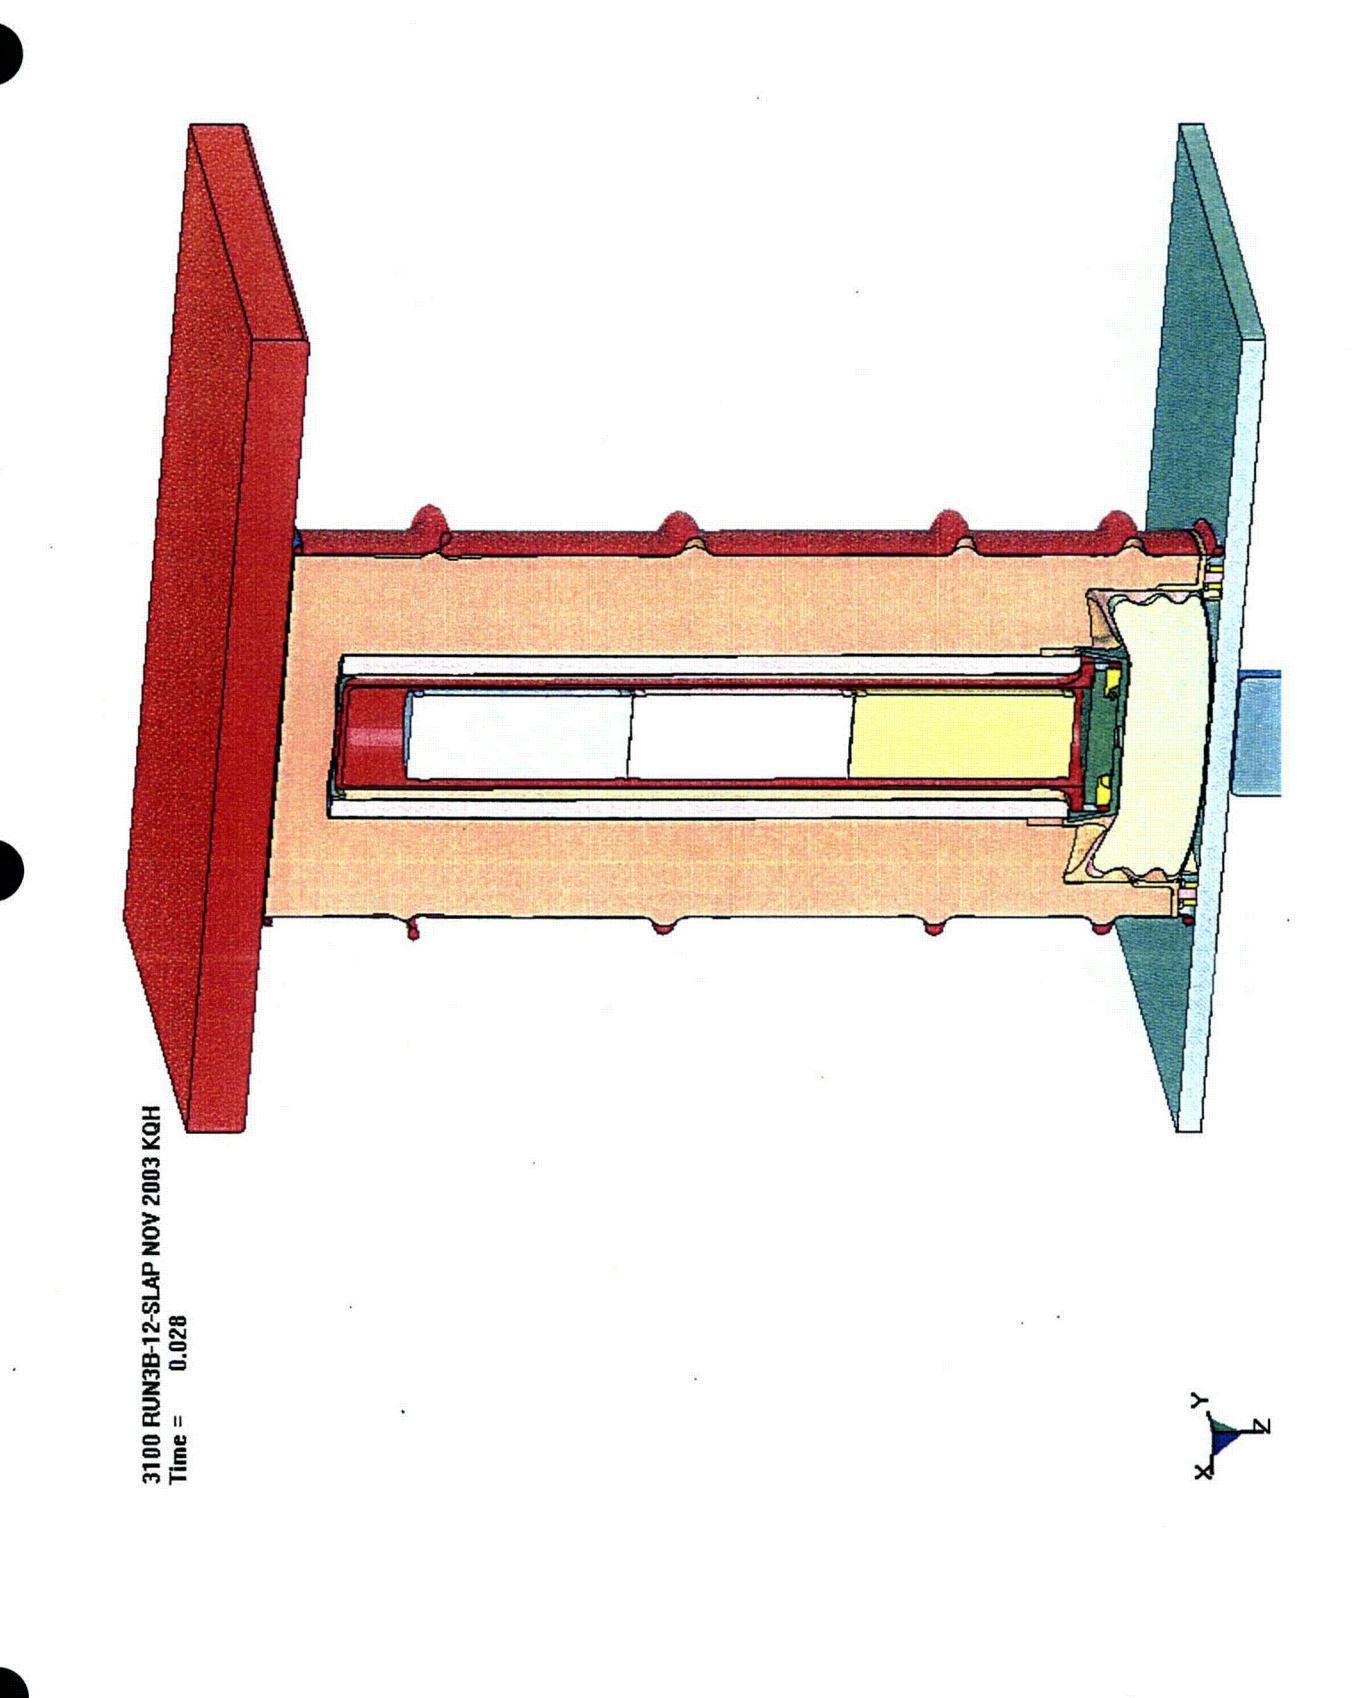
Figure 3.6.2 - Run3b, Crush Impact, Final Configuration

Figure 3.6.2 shows the final configuration for the 30-foot impact and the successive crush impact. Figure 3.6.3 shows that the maximum effective plastic strain in the CV body is 0.0053 in/in. The maximum occurs in the bearing of the body flange onto the lid (at the O-ring seals). The magnitude of effective plastic strain is questioned due to the fact that the elevated strains occur at single nodes and are not symmetric (see the insert in Figure 3.6.3). The maximum effective plastic strain in the bottom region of the CV body is found to be 0.0035 in/in and does exhibit a symmetric characteristic as is shown in Figure 3.6.3.

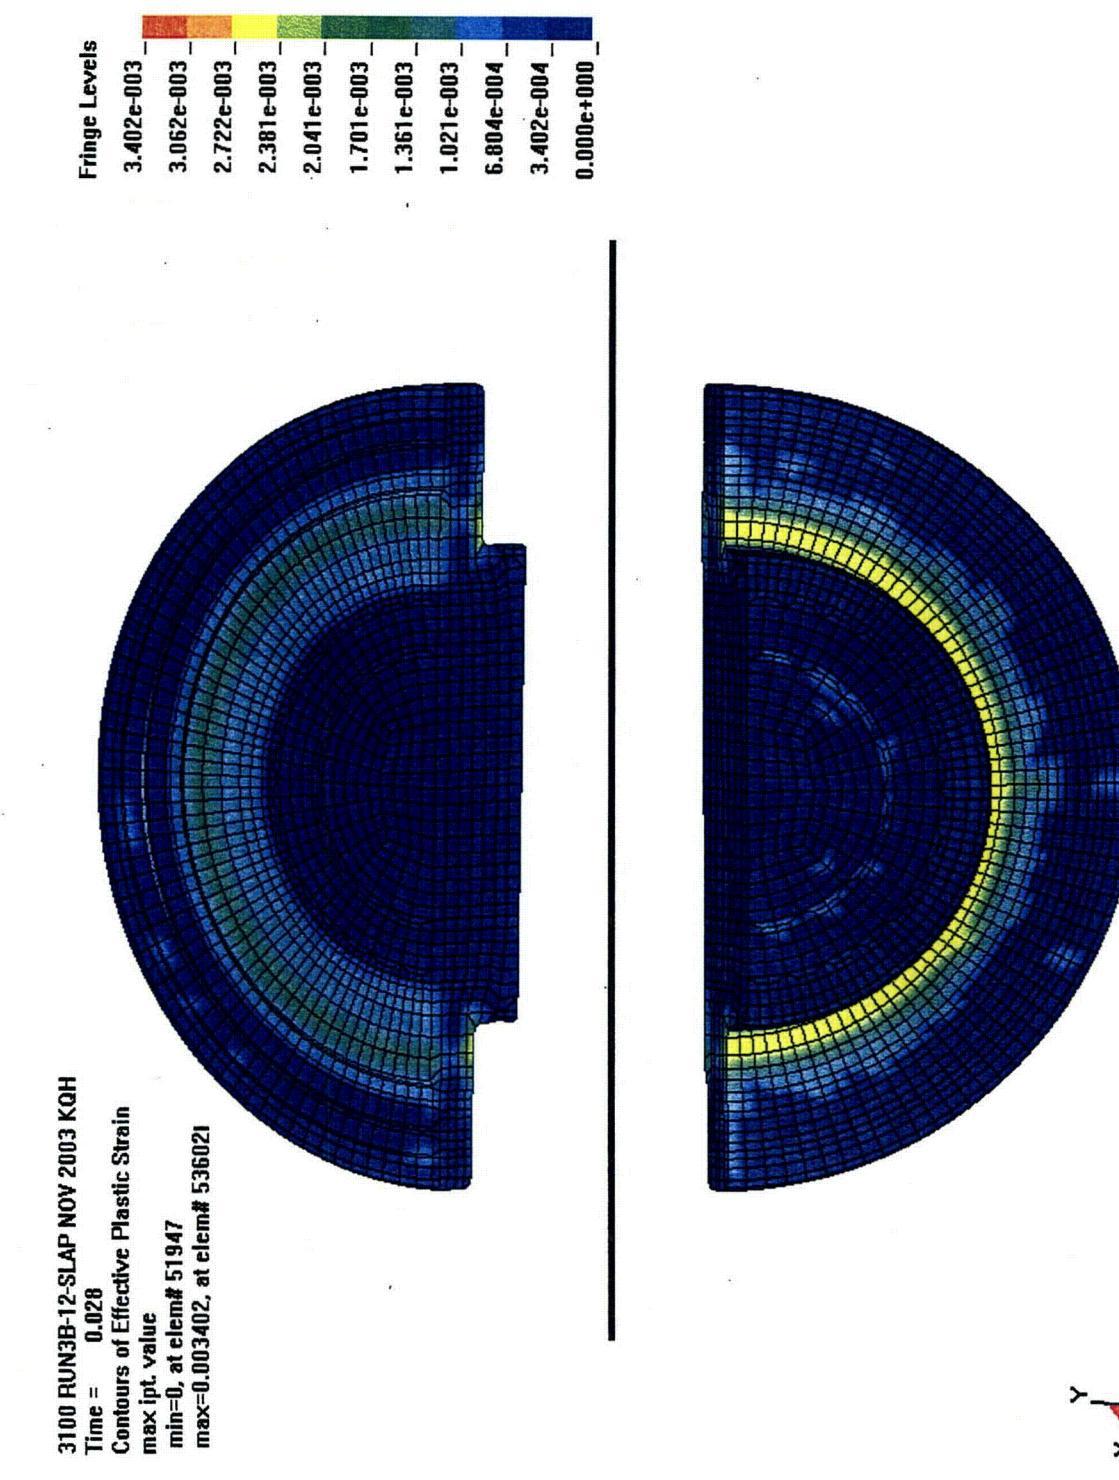
Figure 3.6.4 - Run3b, Crush Impact, Effective Plastic Strain in the CV Lid

The CV lid effective plastic strain fringes are shown from both sides in a split image in Figure 3.6.4. The maximum effective plastic strain in the lid is shown to be 0.0034 in/in in the figure. The other components are summarized in Table 3.6.2.

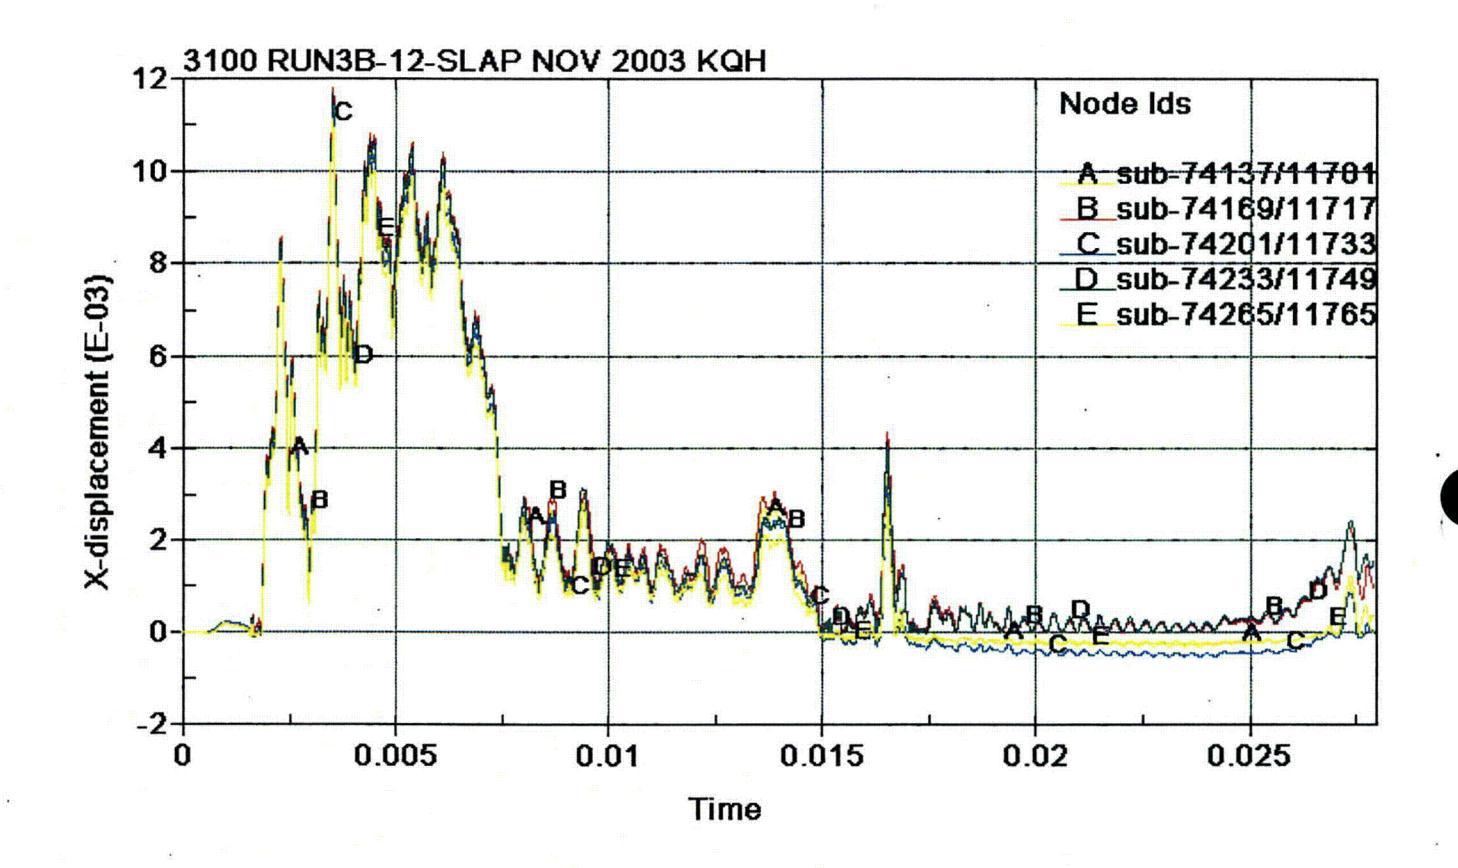
Figure 3.6.5 - Run3b, CV Lid Separation Time History

The CV lid separation time history is shown in Figure 3.6.5. The response during the 30-foot impact is a spike separation of about 0.012 inches, which relaxes to a maximum value of 0.003 inches for the remainder of the 30-foot impact. During the crush impact it is seen that separation is spikes to a maximum of about 0.004 inches, but the average remains at about 0.002 inches or less at the end of the impact.

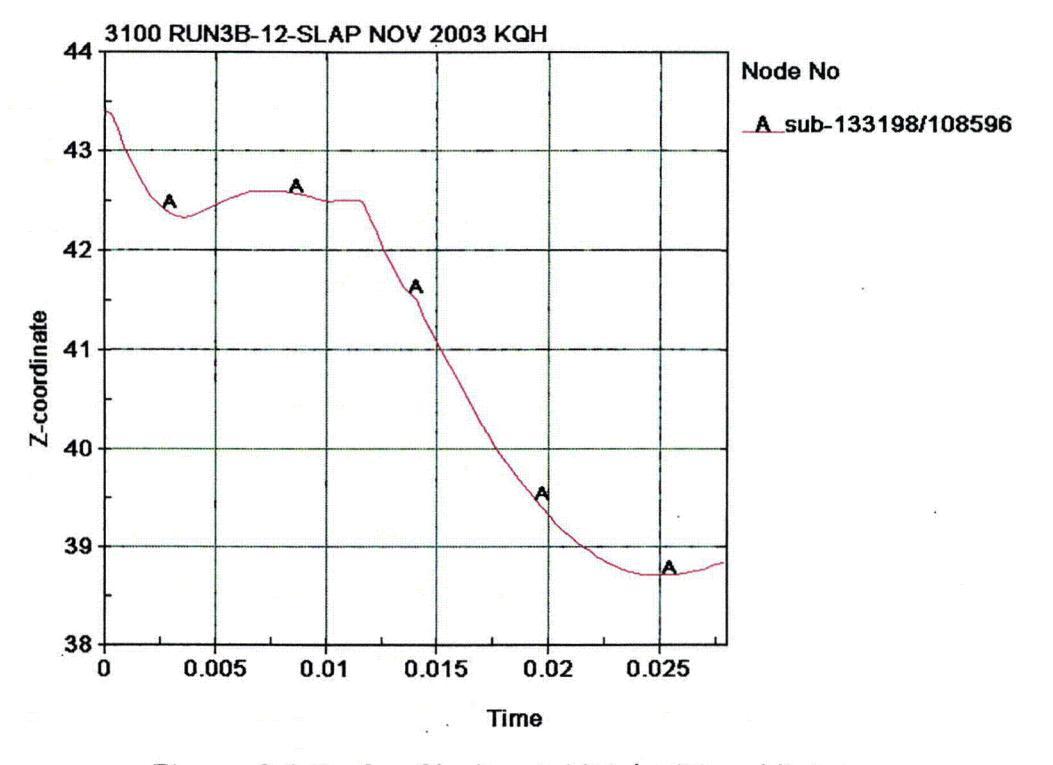
Figure 3.6.7 - Run3b, Drum Height Time History

Figure 3.6.6 shows the nodes chosen to obtain the drum height and kaolite thickness time history data. Figure 3.6.7 shows the drum height time history. From the figure it is seen that the overall height would be approximately 39 inches. Figure 3.6.8 shows the thickness time histories in the kaolite for the plug and the bottom. The curve A in the figure is for the bottom kaolite thickness, and it reaches about 2.2 inches as a final value. Curve B, is for the plug and it reaches about 3.4 inches for the final kaolite thickness.
