WCAP-12778

Structural Evaluation of Sequoyah and Watts Bar Units 1 and 2 Pressurizer Surge Lines, Considering the Effects of Thermal Stratification

December 1990

WESTINGHOUSE ELECTRIC CORPORATION Nuclear and Advanced Technology Division P.O. Box 2728 Pittsburgh, Pennsylvania 15230-2728

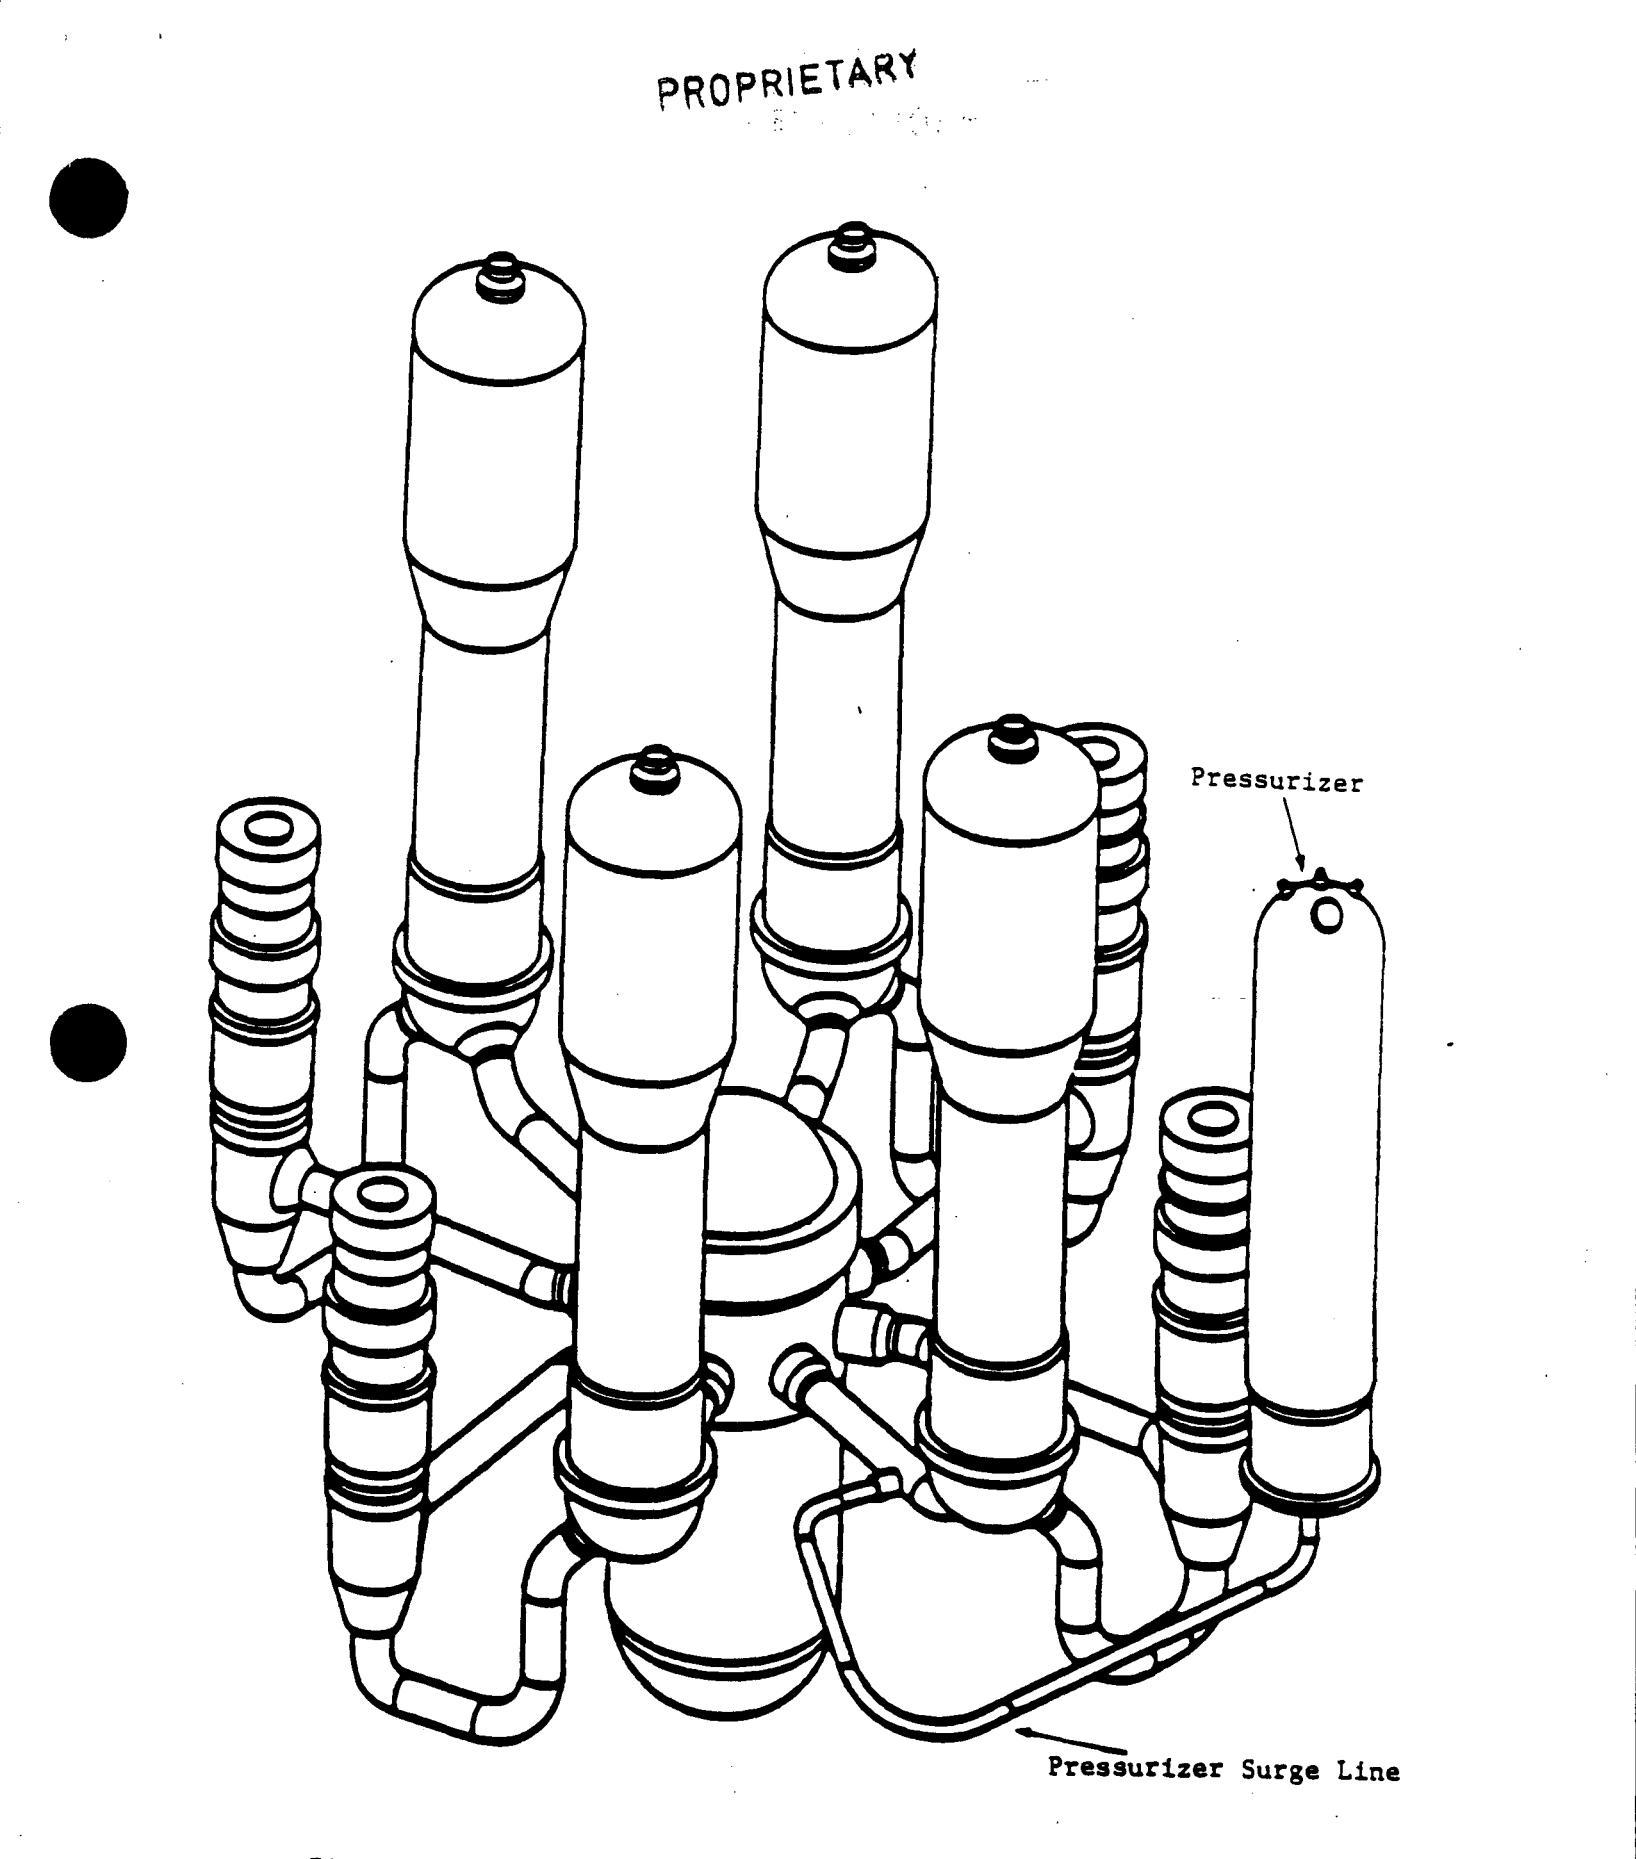
Figure 1-1. Typical A Loop Plant Component Layout

The operation of a pressurized water reactor requires the primary coolant loop to be water solid, and this is accomplished through a pressurizer vessel, connected to the loop by the pressurizer surge line. A typical four loop arrangement is shown in Figure 1-1, with the surge line highlighted.

As illustrated in figure 1-1, the bottom of the pressurizer vessel is connected to the hot leg of one of the coolant loops by the surge line, a 14 inch schedule 160 stainless steel pipe, a portion of which is almost horizontal, but slightly pitched down toward the hot leg.

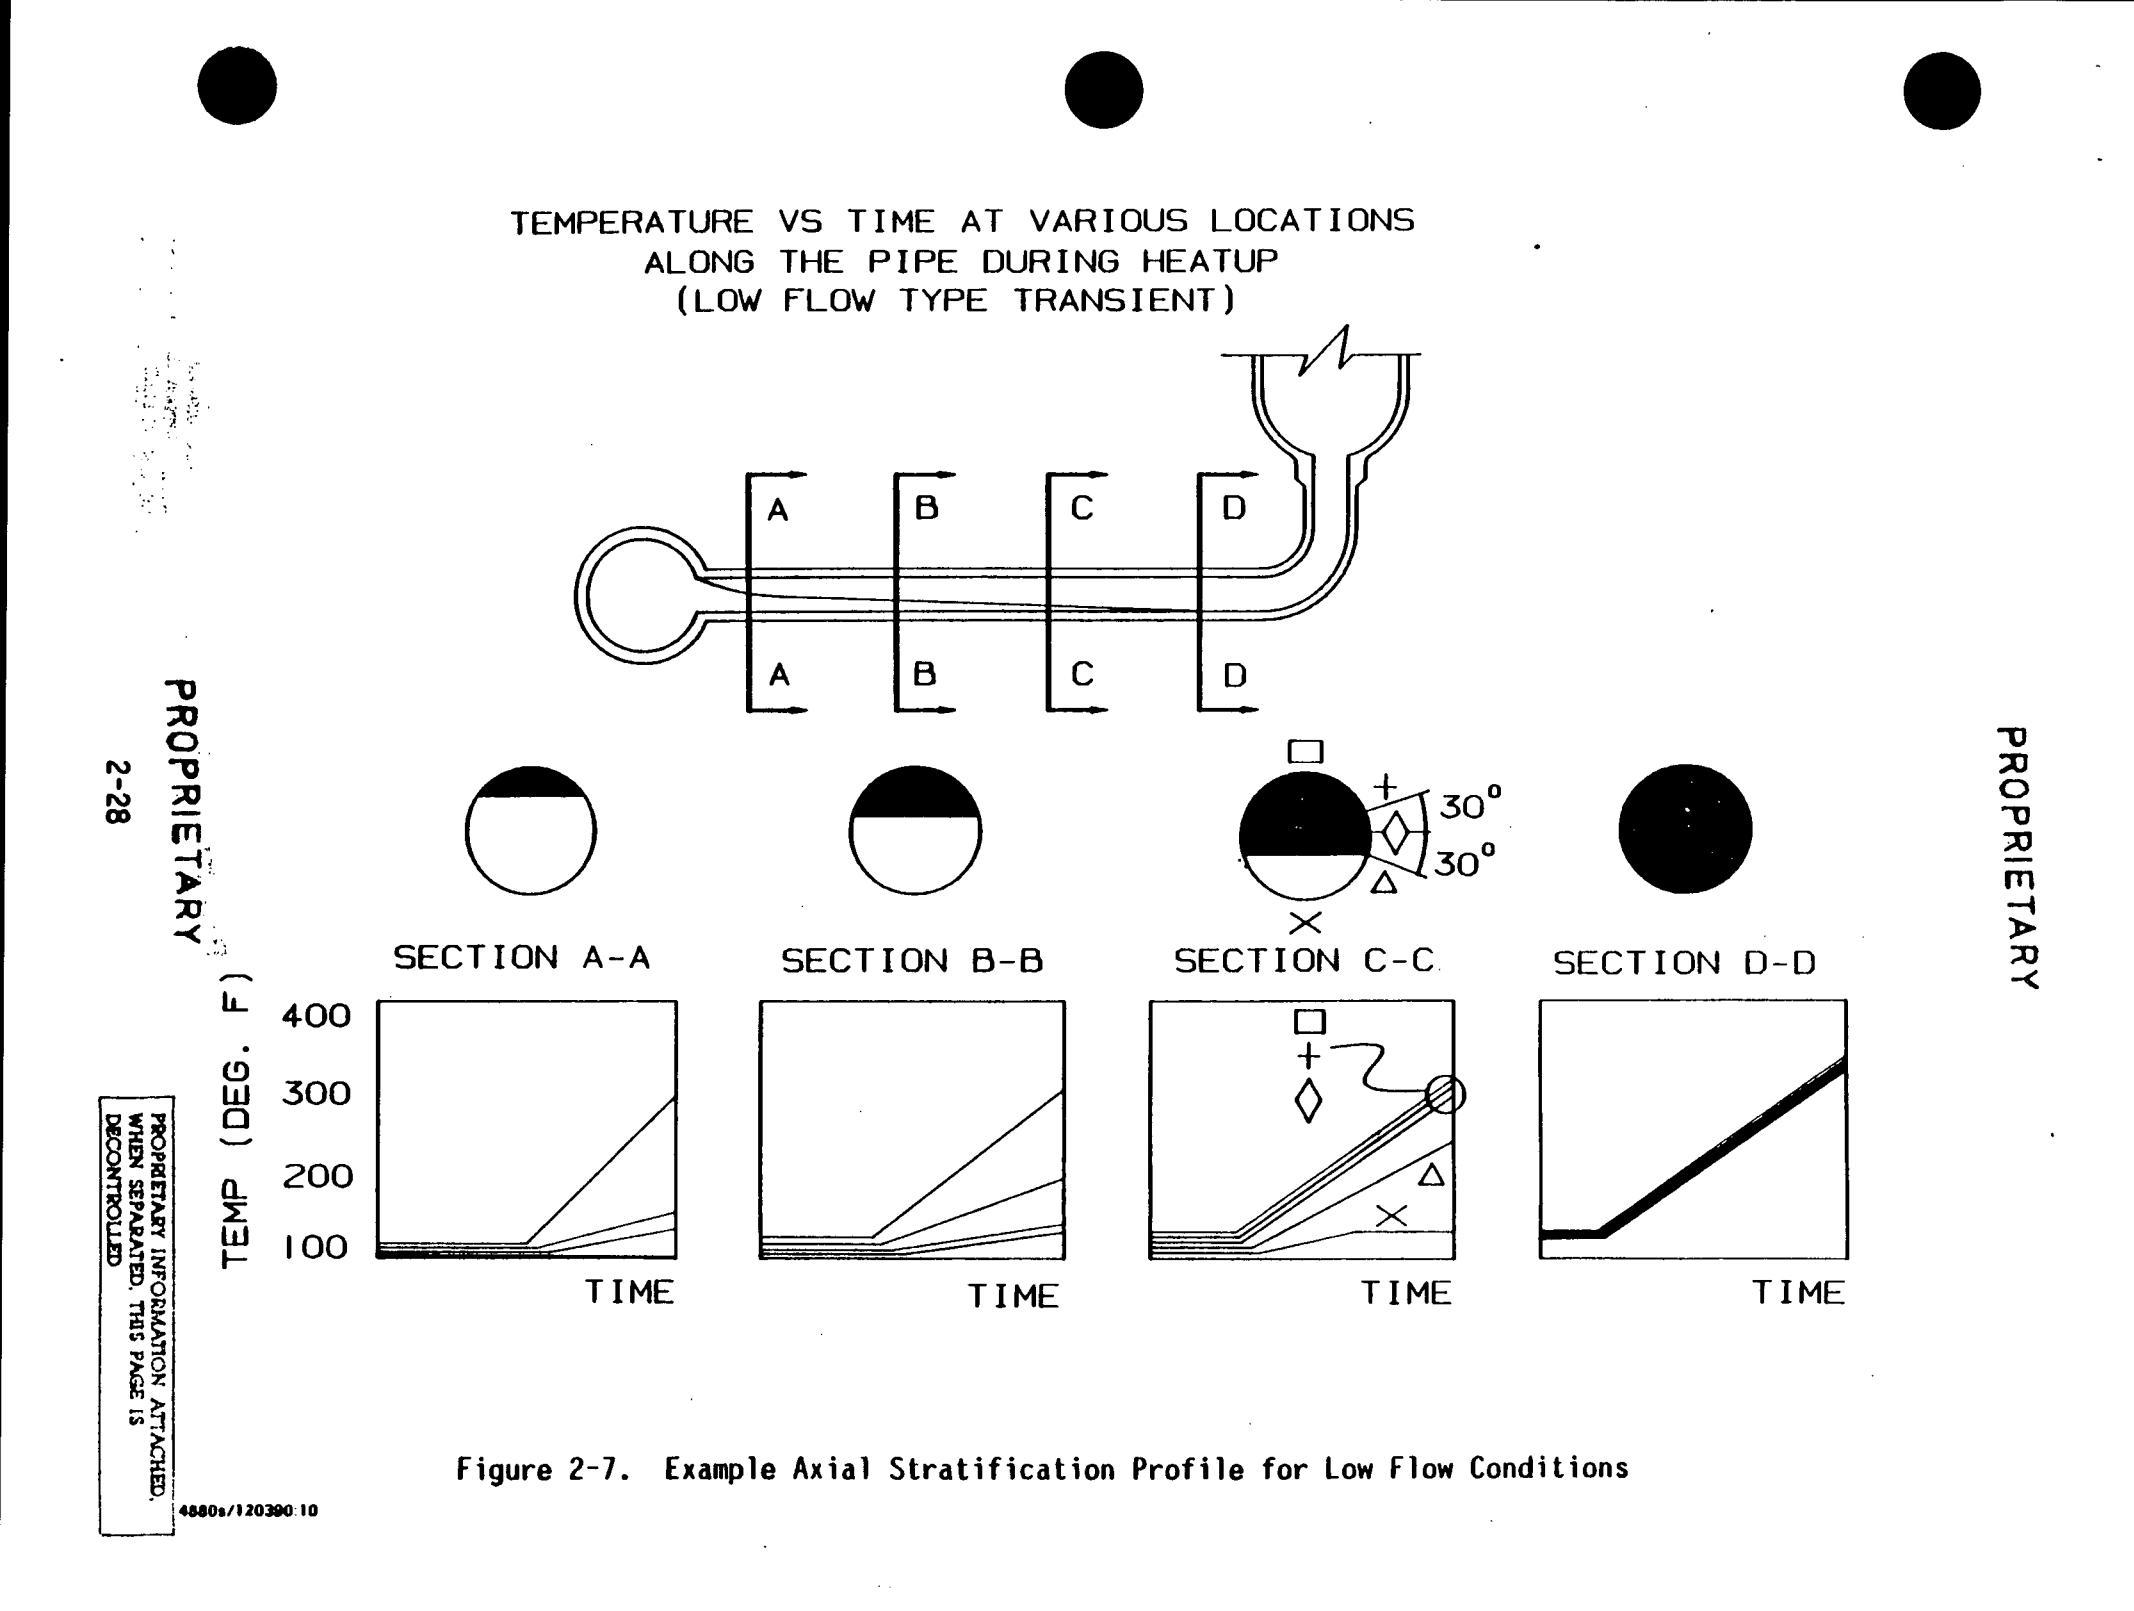
Figure 2-8. Temperature Profile for Low Flow Conditions in the Sequoyah and Watts Bar Units 1 and 2

For the Sequoyah and Watts Bar surge lines, two steady state low flow profile conditions are considered. The first condition considers the RCL surge nozzle stratified. Due to the immediate rise out of the loop piping by the surge line the axial length of the axial profile is very short and terminates before reaching the elevated horizontal segments of the line. Therefore, the surge line as a whole has a uniform axial temperature distribution and is modeled as a normal thermal expansion case without stratification. The second condition considers a state where the elevated horizontal section of the surge line is stratified. For this condition the RCL surge nozzle is at RCS temperature. This low flow profile is shown in Figure 2-8.

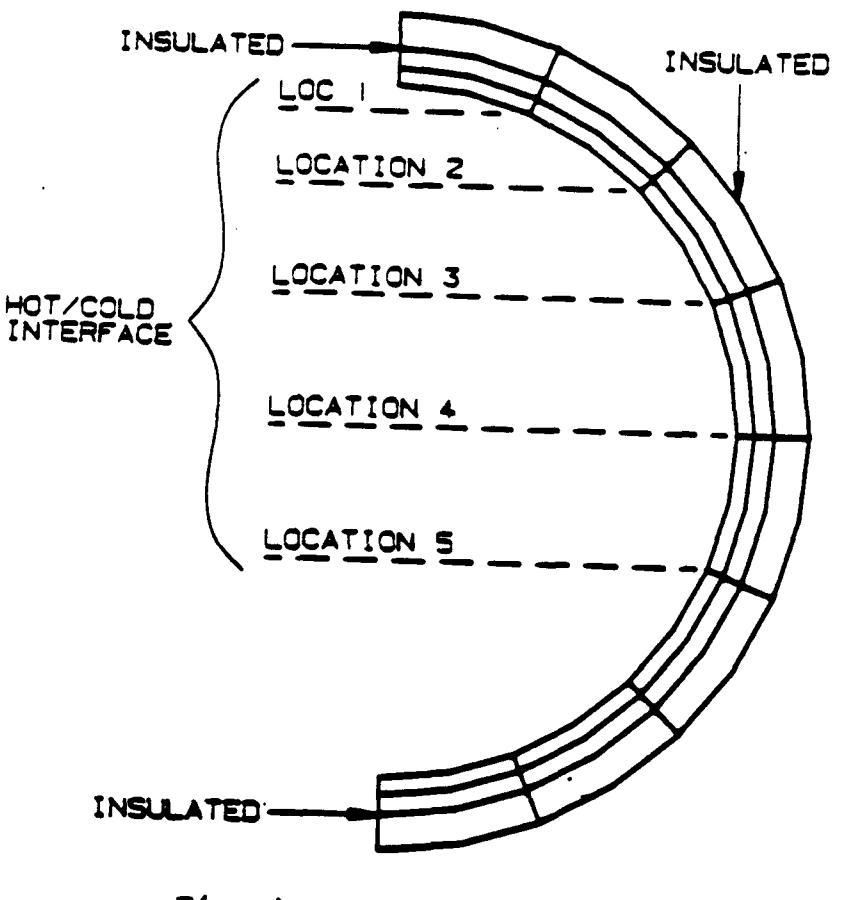
A short description of the pipe finite element model is summarized below. The model with thermal boundary conditions is shown in figure 3-5. Due to symmetry of the geometry and thermal loading, only half of the cross section was required for modeling and analysis. [

T(hot)= 420 °F T(cold)= 160 °F H(hot) = 207 BTU/HR-FT2-FH(cold) = 104 BTU/HR-FT2-F

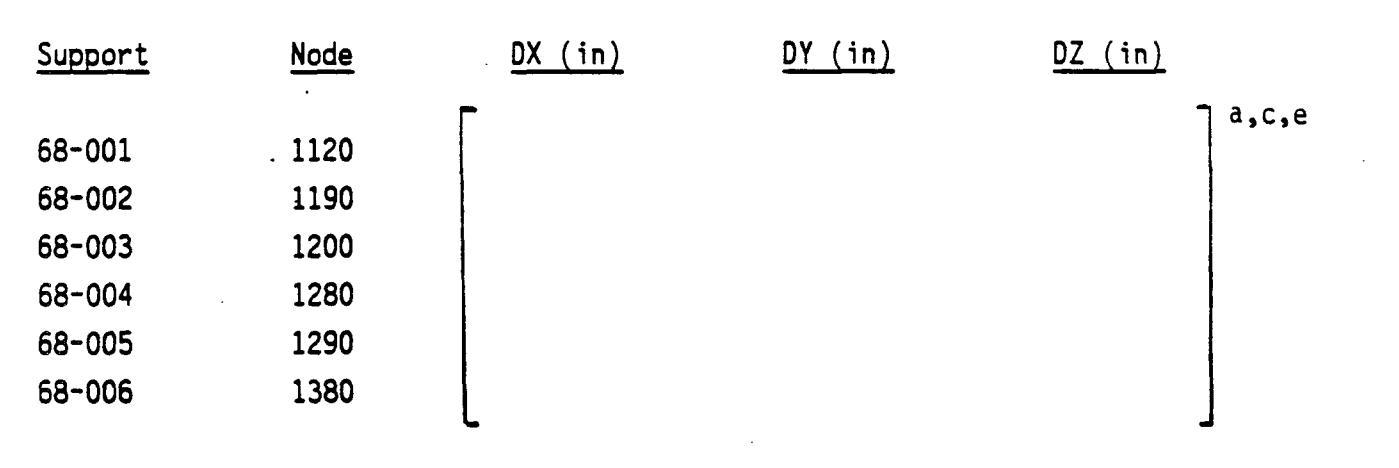
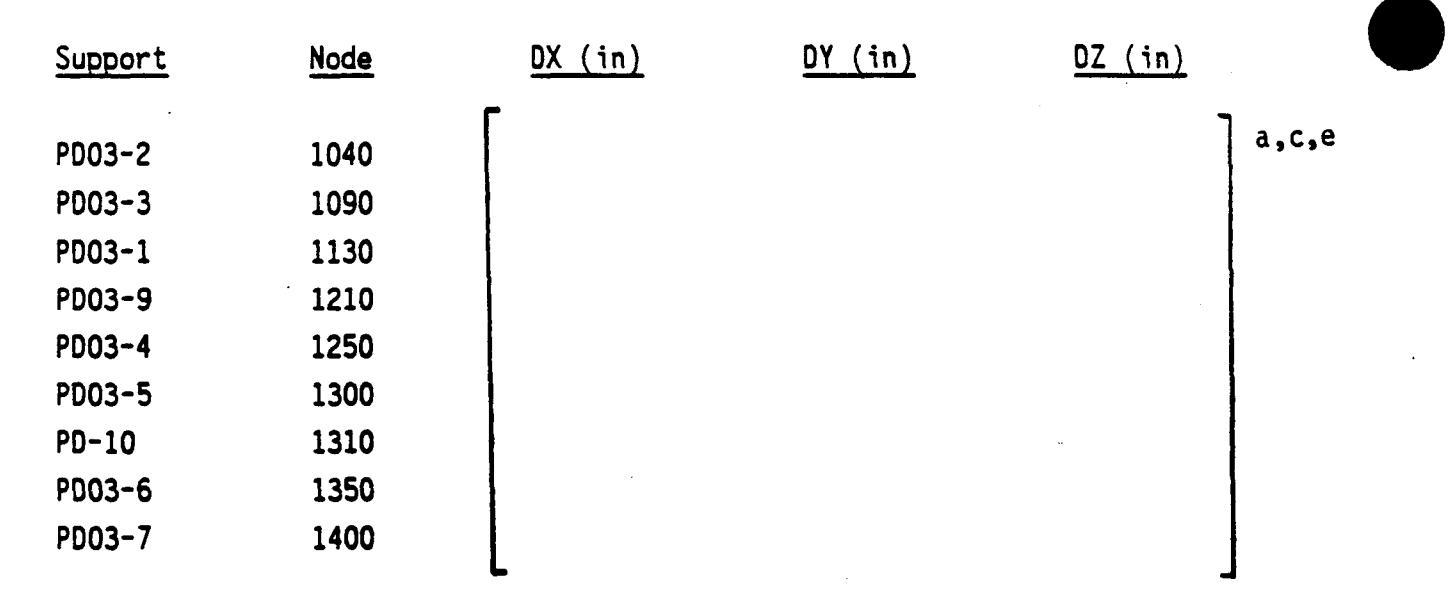
Watts Bar Maximum Support Displacement* Under Thermal Stratification

Displacements at Support Locations

Displacements at Restraint Locations

* With pipe whip restraint removed configuration and system ΔT=320°F; Unit 1 model; and X along plant North Y vertically upward and Z by the right hand rule

All support displacements listed in Table 4-1 should be verified, to ensure that the spring hangers have enough travel allowance. Insufficient allowance would result in an unevaluated condition for thermal stratification. For the displacements at pipe whip restraint locations, enough gaps should be maintained between the pipe outside surface and the whip restraint surface so that the pipe will be free to move during all normal and stratified thermal conditions.
