Indian Point 3 Nuclear Power Plant P.O. Box 215 Buchanan, New York 10511

July 24, 1992 IP3-NRC-92-053

• •	· · .		:			• .		• •				
FACILITY	NAME (1)			• .				· · · .		DOCKET NUMBER	(2)		PA(3E (3)
Indian Point Unit 3															
Emergency Diesel Generator Blown Control Power Fuse During CO2 System Testing															
EVE	NT DATE	(5)		LER NUMBER (B)	RE	PORT DAT	E (7)		OTHER	FACILITIES INVO	VED	(8)		· .
MONTH	 PAY	YEAR	YEAR	NUMBER	NUMBER	MONTH	DAY	YEAR		FACILITY NA	MES	DOC	KET NUMBER	(8)	
									·····			0.	5 0 0	0	
					<u>-</u>				, .						
06	2 5	92	92	одо		07	2 4	9 2	<u> </u>			0	5 0 0		
OPE	RATING		THIS RE	PORT IS SUBMITTE	D PURSUANT	TO THE R	LOUIREM	ENTS OF 1	D CFR &: /(Check one or more	of the following) (1	••			
MC		N	20	402(b)	- 1 (-	20.406(c)			50.73(a)(2)(iv)	•		73,71(b)		
POWER			20	405(a)(1)(i)	· · · · · · · · · · · · · · · · · · ·	50.36(c)(1)	• •		50.73(a)(2)(v)			73,71(e)	•	e de la composición d Composición de la composición de la comp

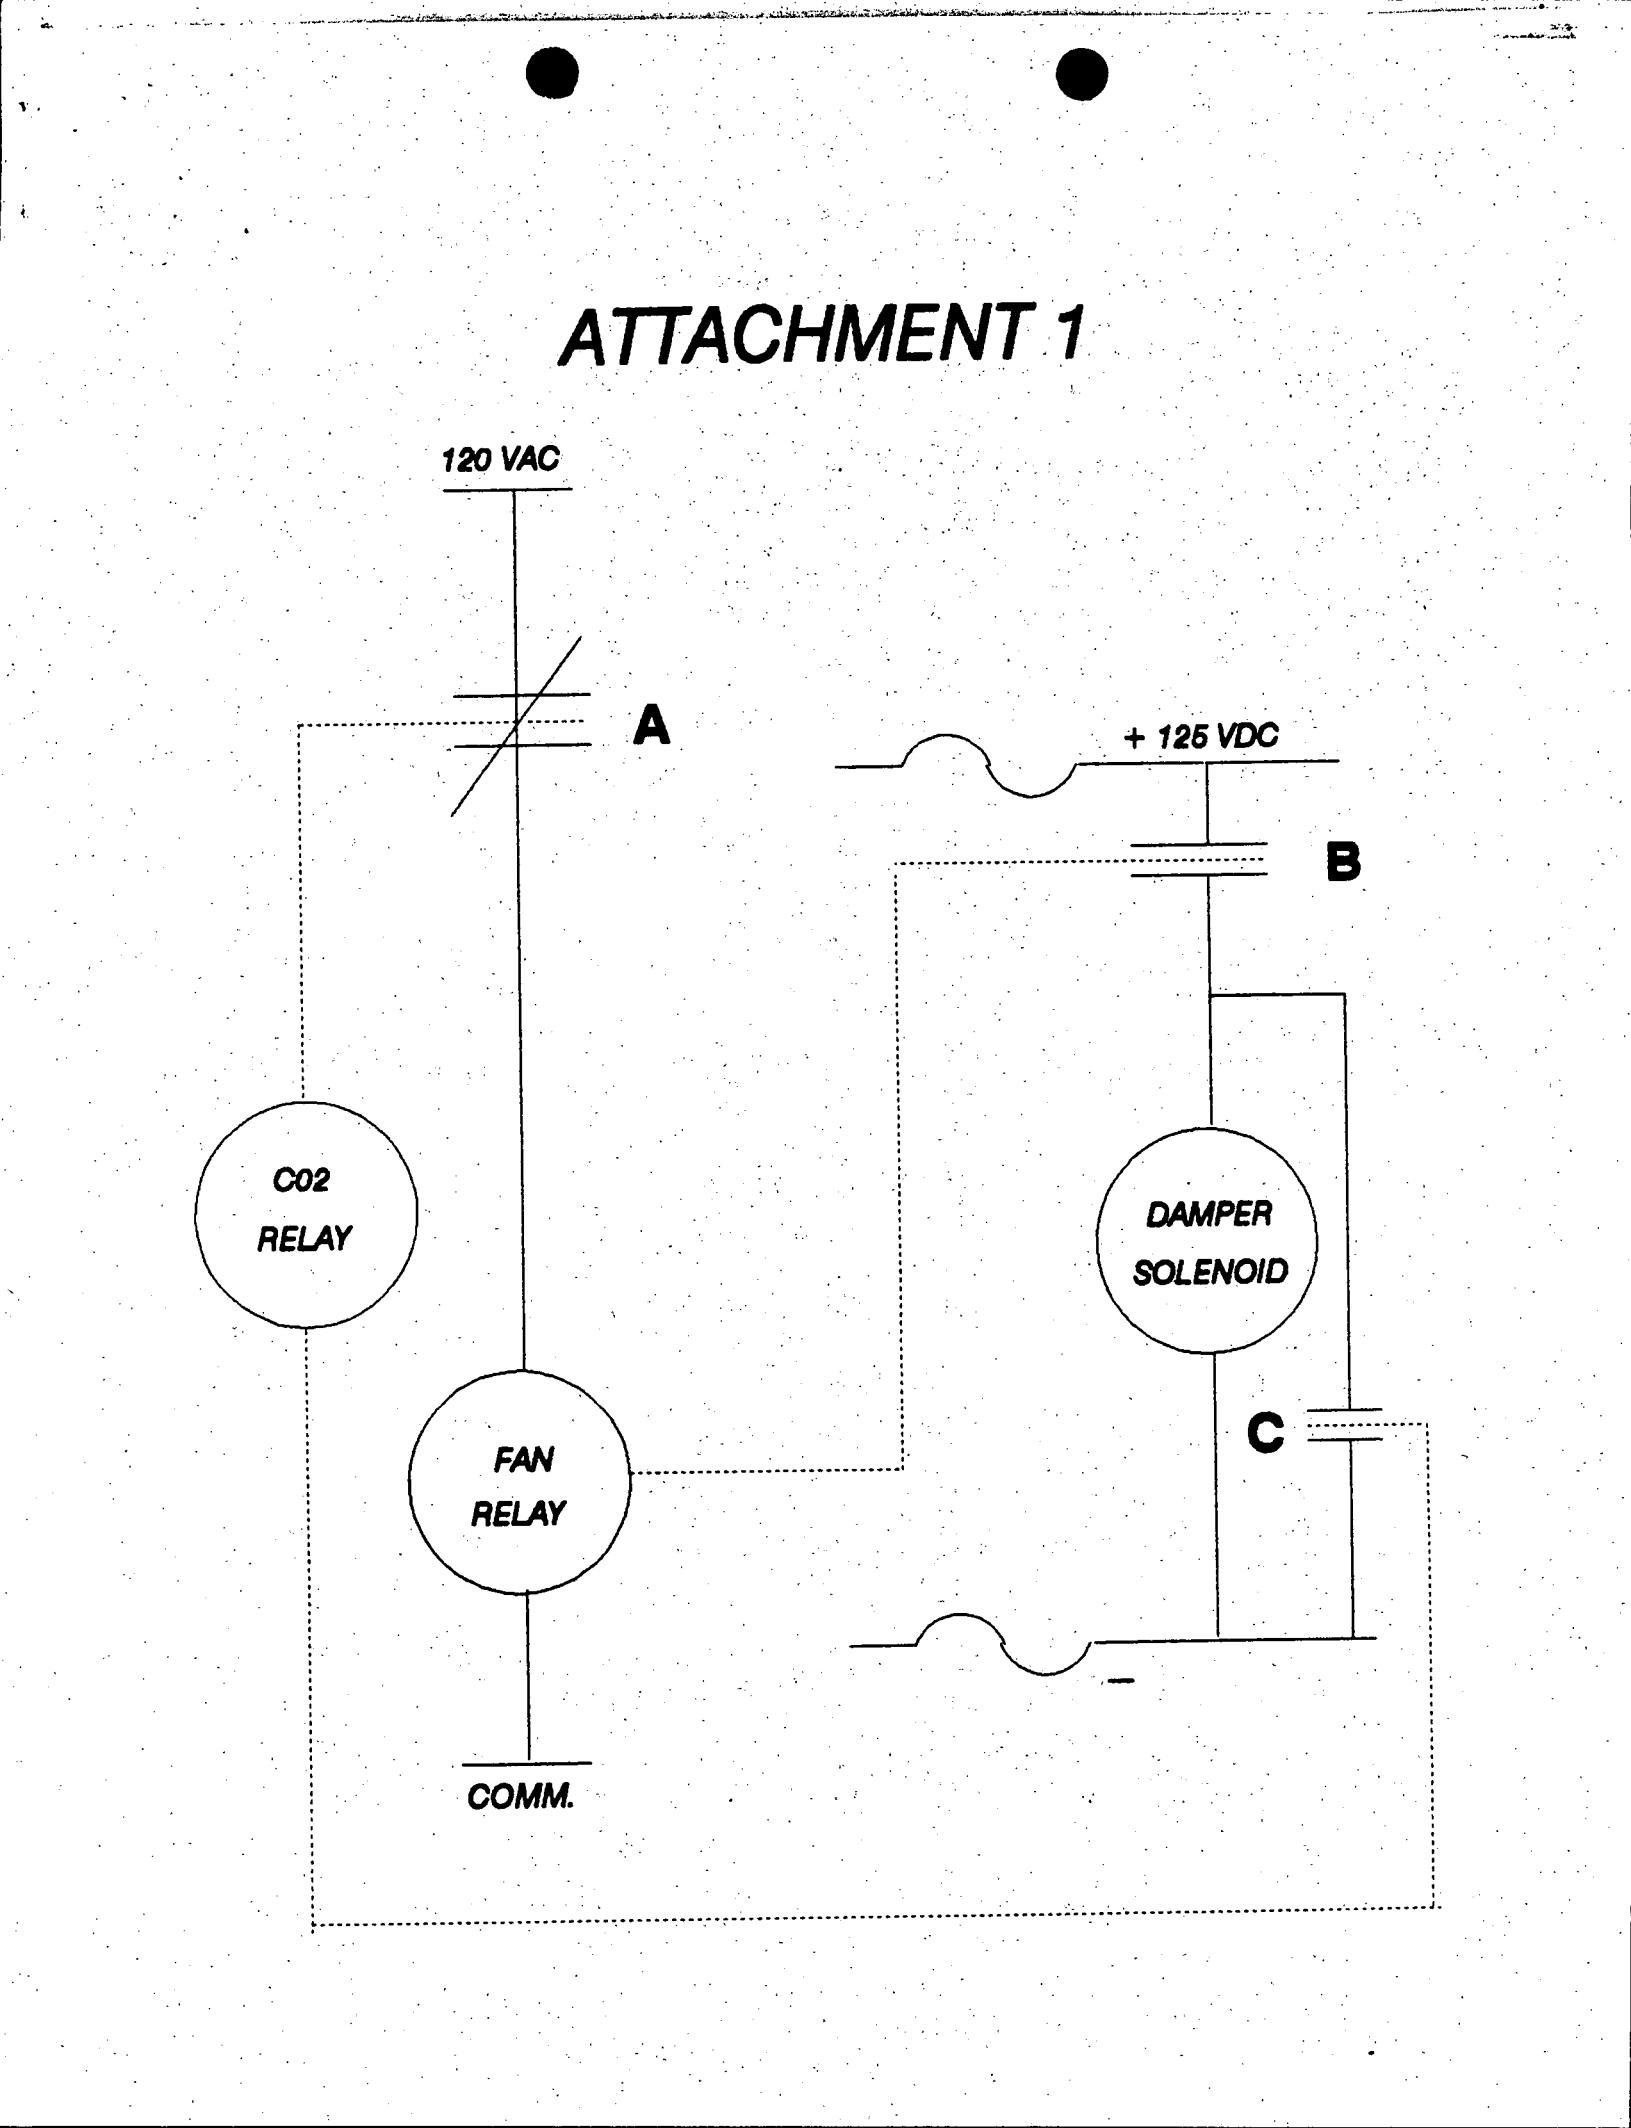
Investigation by I&C Engineering revealed that if a CO2 actuation occurs in an EDG cell while the exhaust fans for that cell are in operation, the respective EDG control fuse will blow. This is caused by a contact that closes during a CO2 actuation which can create a short across DC control power to the EDGs when the exhaust fans are in operation.

Investigation revealed that this condition was the result of a design deficiency that occurred when the CO2 system was originally installed in 1980 (under IP3 Modification 80-03-020-FP). Apparently, a contact was added to the exhaust fan circuit to close the exhaust dampers in the EDG cells upon a CO2 actuation.

(Refer to Attachment 1.) Contact C was added to the circuit when the CO2 system was installed. When the exhaust fans are in operation the fan relay is energized, closing contact B to energize the damper solenoid which opens the dampers. When a CO2 actuation occurs, the CO2 relay energizes to open contact A (de-energizing the fan relay) and close contact C (de-energizing the damper solenoid). Contact C is unnecessary because when the fan relay is de-energized it opens contact B to de-energize the damper solenoid. A momentary short across the DC power supply to the EDGs can occur if contact C closes before contact B opens.

The identified design deficiency was corrected on June 30, 1992 under IP3 RES 92-3-205 by removing the unnecessary set of contacts in each EDG exhaust fan circuit.
