Pilgrim Nuclear Power Station - Petitioner's Request for Review of the Petition Review Board Denial 2.206 Regarding Request Require Hydrological-Geological Subsurface Study (EDATS: OEDO-2010-0929)

## PILGRIM NUCLEAR POWER STATION- PETITIONER'S REQUEST FOR REVIEW PRB DENIAL 2.206 PETITION REGARDING REQUEST REQUIRE HYDROLOGICAL-GEOLOGICAL SUBSURFACE STUDY AT PNPS

## NRC's INSPECTION REPORT 05000293/2010004 (October 16, 2010)

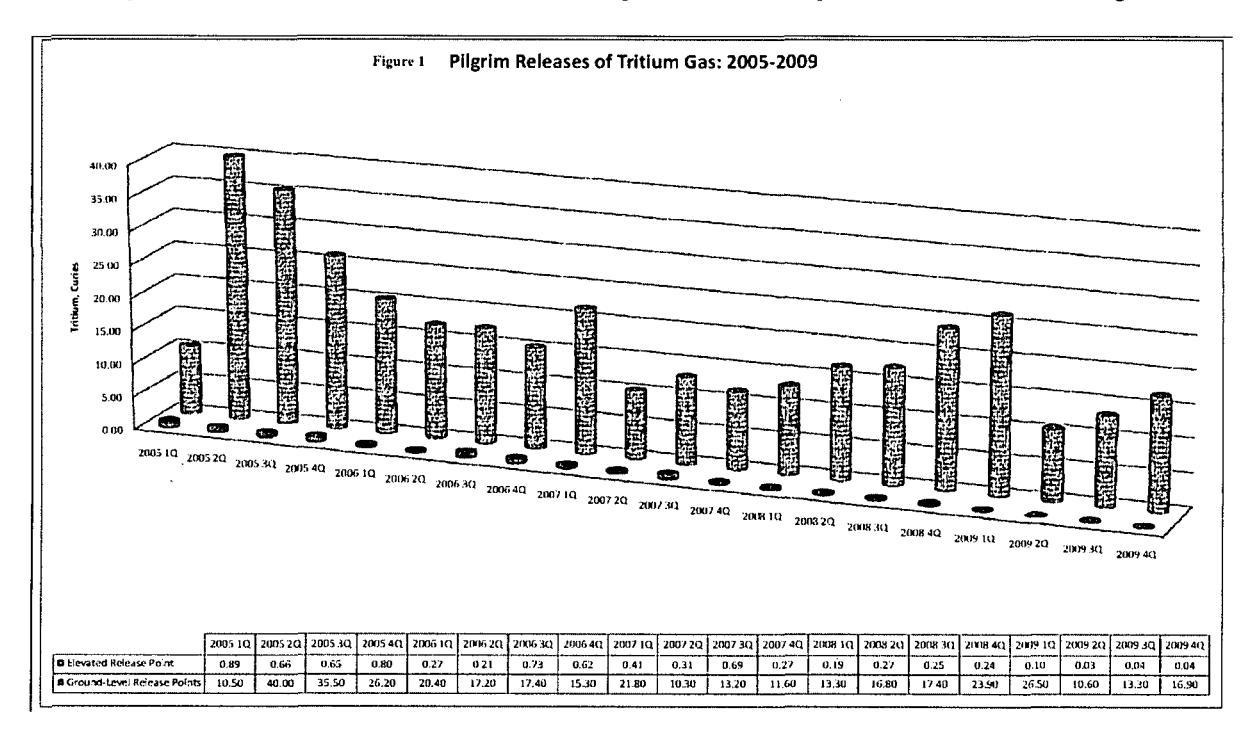
Some facts support this tritium precipitation theory. According to radiological release information submitted by Pilgrim's owner each year to the NRC, approximately 98 percent of the tritium in gaseous form is discharged from the plant via ground-level release points. Only about 2 percent of the gaseous tritium is discharged via the 300-plus feet tall stack at Pilgrim.

The drawing of the ventilation system for Pilgrim's reactor building (available in NRC's ADAMS library under Accession No. ML060470360) shows that water evaporating from the spent fuel pool inside the reactor building is normally exhausted from a vent mounted to the building's roof. The spent fuel pool water contains tritium in high concentrations.

Collectively, this information indicates that the majority of the nearly 400 curies of tritium discharged in gaseous form by the Pilgrim plant in the five year period from 2005 to 2009 left through the vent on the reactor building roof.
