# **AREVA NP Inc.**

Document No.: 51 - 9170751 - 000

GSI-191 FA Test Report for PWROG – Low Particulate-to-Fiber Ratio Tests - NP

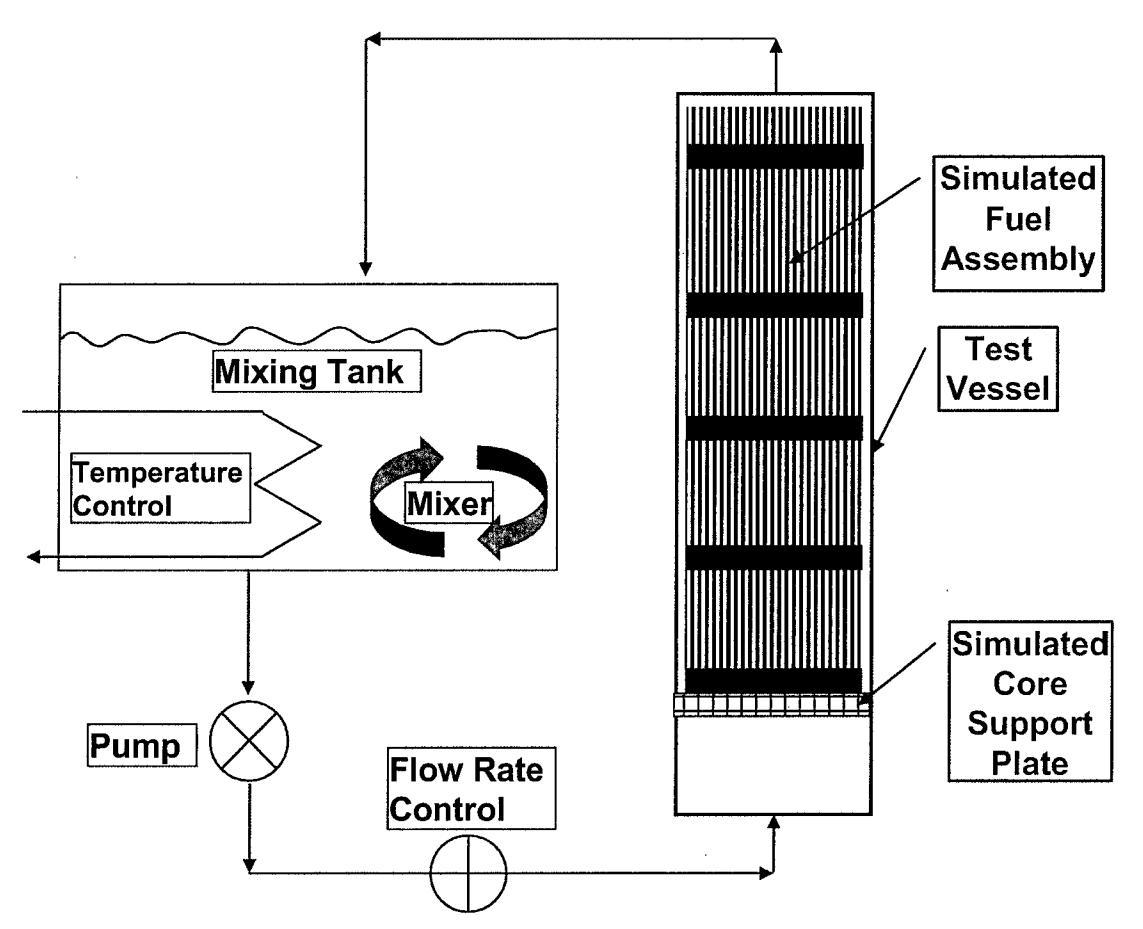
Figure 1-1: Conceptual Arrangement of Test Loop

The two facilities were similar in terms of general test loop architecture. A schematic of the test loop is shown in Figure 1-1
