FSAR UPDATE	
DIABLO CANYON ISFSI	
FIGURE 2.6-1	
LOCATION AND BOUNDARIES	OF
GEOLOGIC STUDY AREAS	;

FSAR UPDATE

DIABLO CANYON ISFSI

FIGURE 2.6-2 DIABLO CANYON POWER PLANT AND THE ISFSI AND CTF SITES

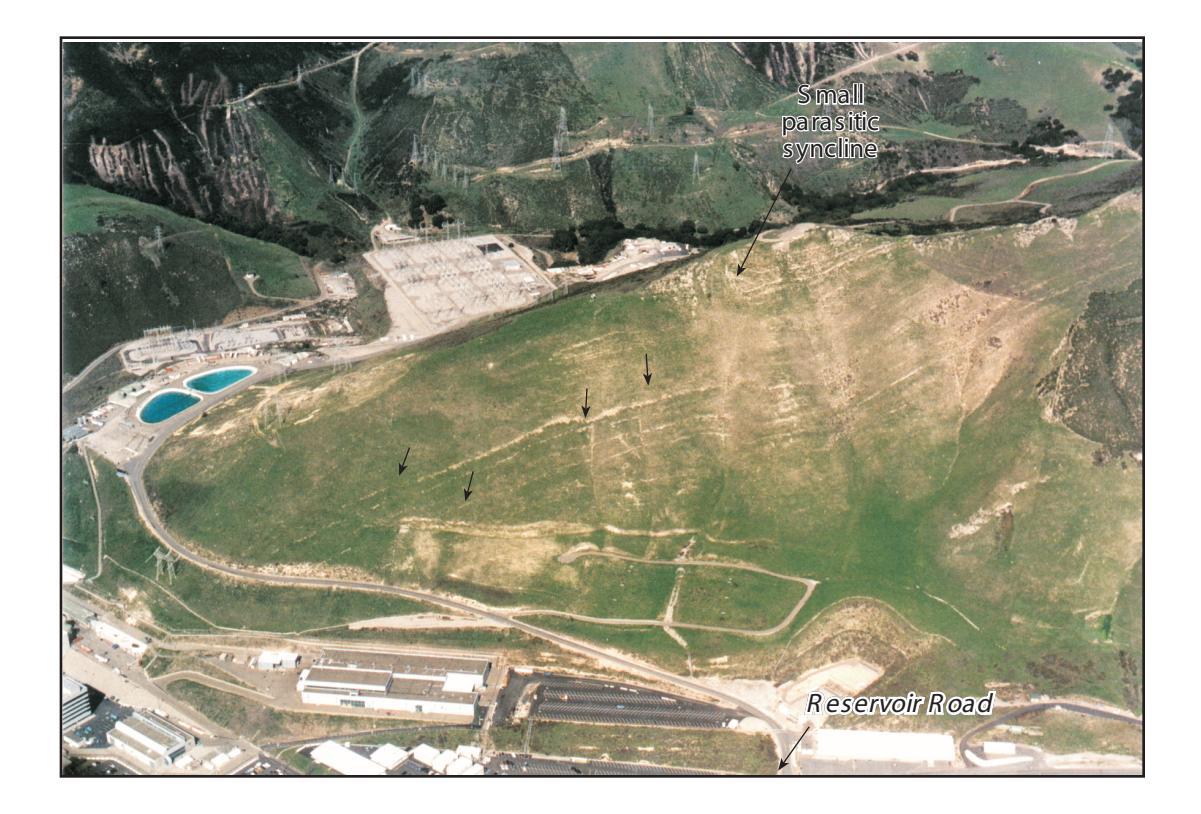
FIGURE 2.6-5 OBISPO FORMATION DOLOMITE AND SANDSTONE ON HILLSLOPE ABOVE RESERVOIR ROAD

Photo of Obispo Formation dolomite and sandstone strata exposed on the hillslope above the transport route on Reservoir Road. The ISFSI site is to the right of the raw water reservoir. Bedding dips into the hillslope on the west limb of the regional Pismo syncline and extends beneath the power block (off photo to lower left). A small parasitic syncline is manifest as the U-shaped strata directly below the ridge crest in the middle of the photo. Several debris-flow chutes (\downarrow) form the gullies on the slope above Reservoir Road. Photo roll JLB-2.

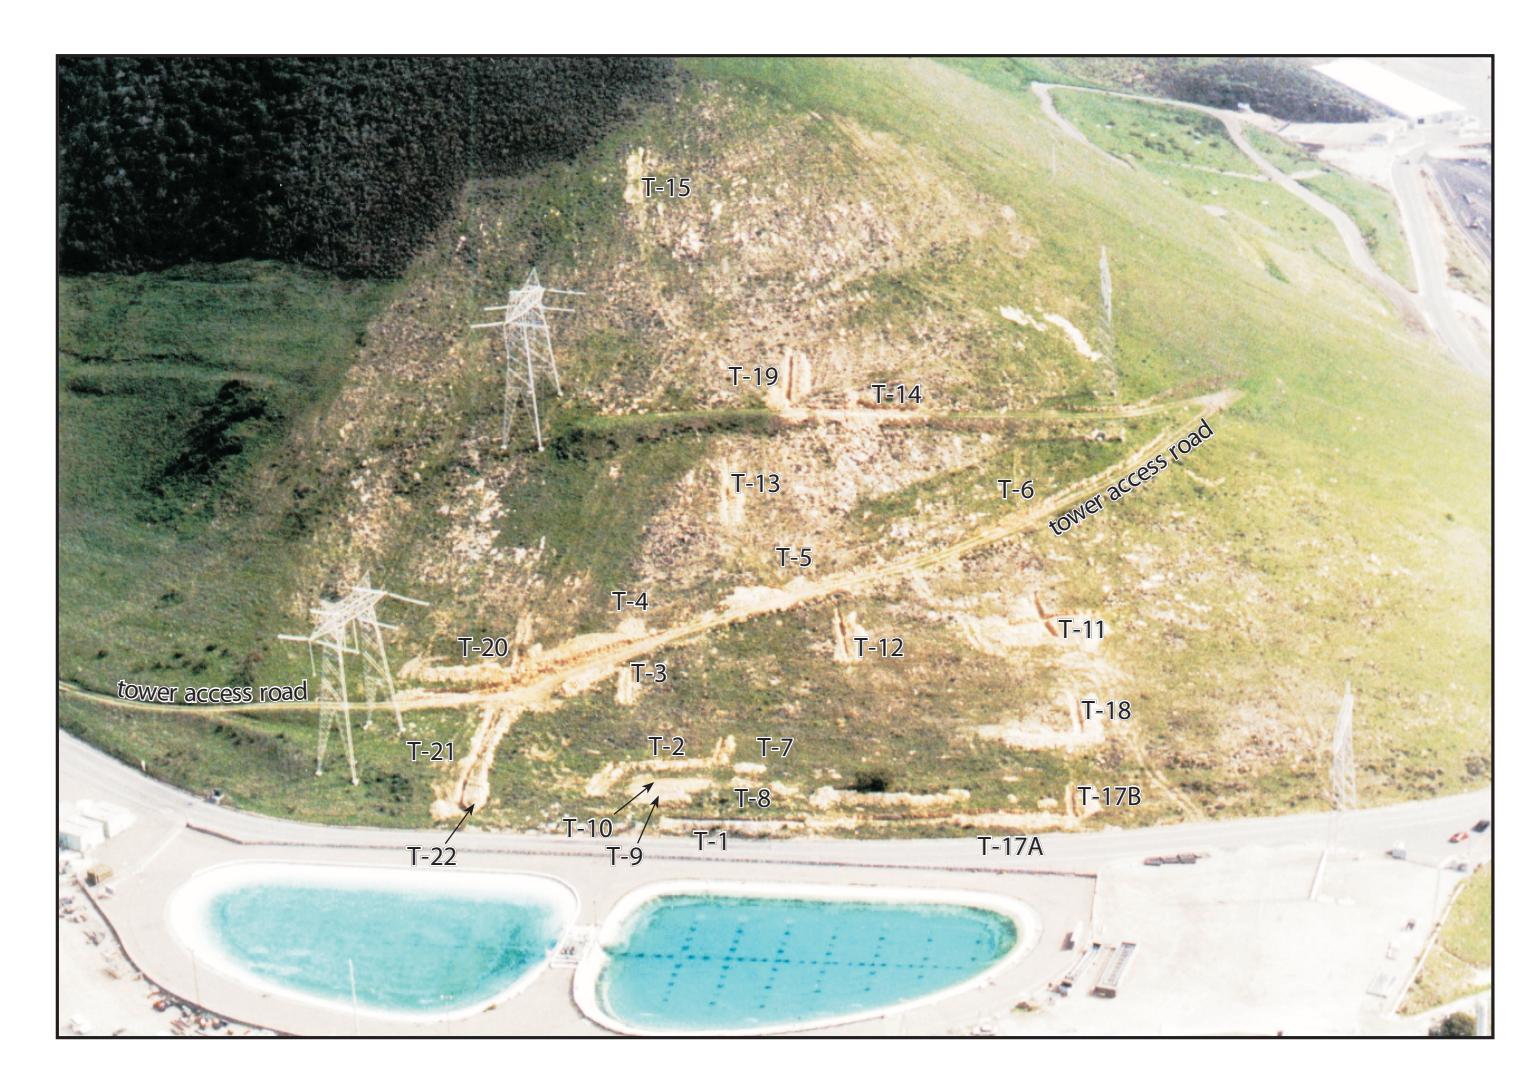
FIGURE 2.6-12 SOUTHWARD VIEW OF ISFSI STUDY AREA

Southward view of the ISFSI site, above the raw water reservoir. The 1971 borrow area cutslope is indicated by areas of bedrock exposure and brown grass. Trenches excavated for the ISFSI investigations are shown (trenches backfilled in A pril 2001). Trench T-16 is located to the left of the photo. Photo roll A R 3-25.
