2012 Enhanced Characterization and Monitoring Report Riverton, Wyoming, Processing Site

June 2013

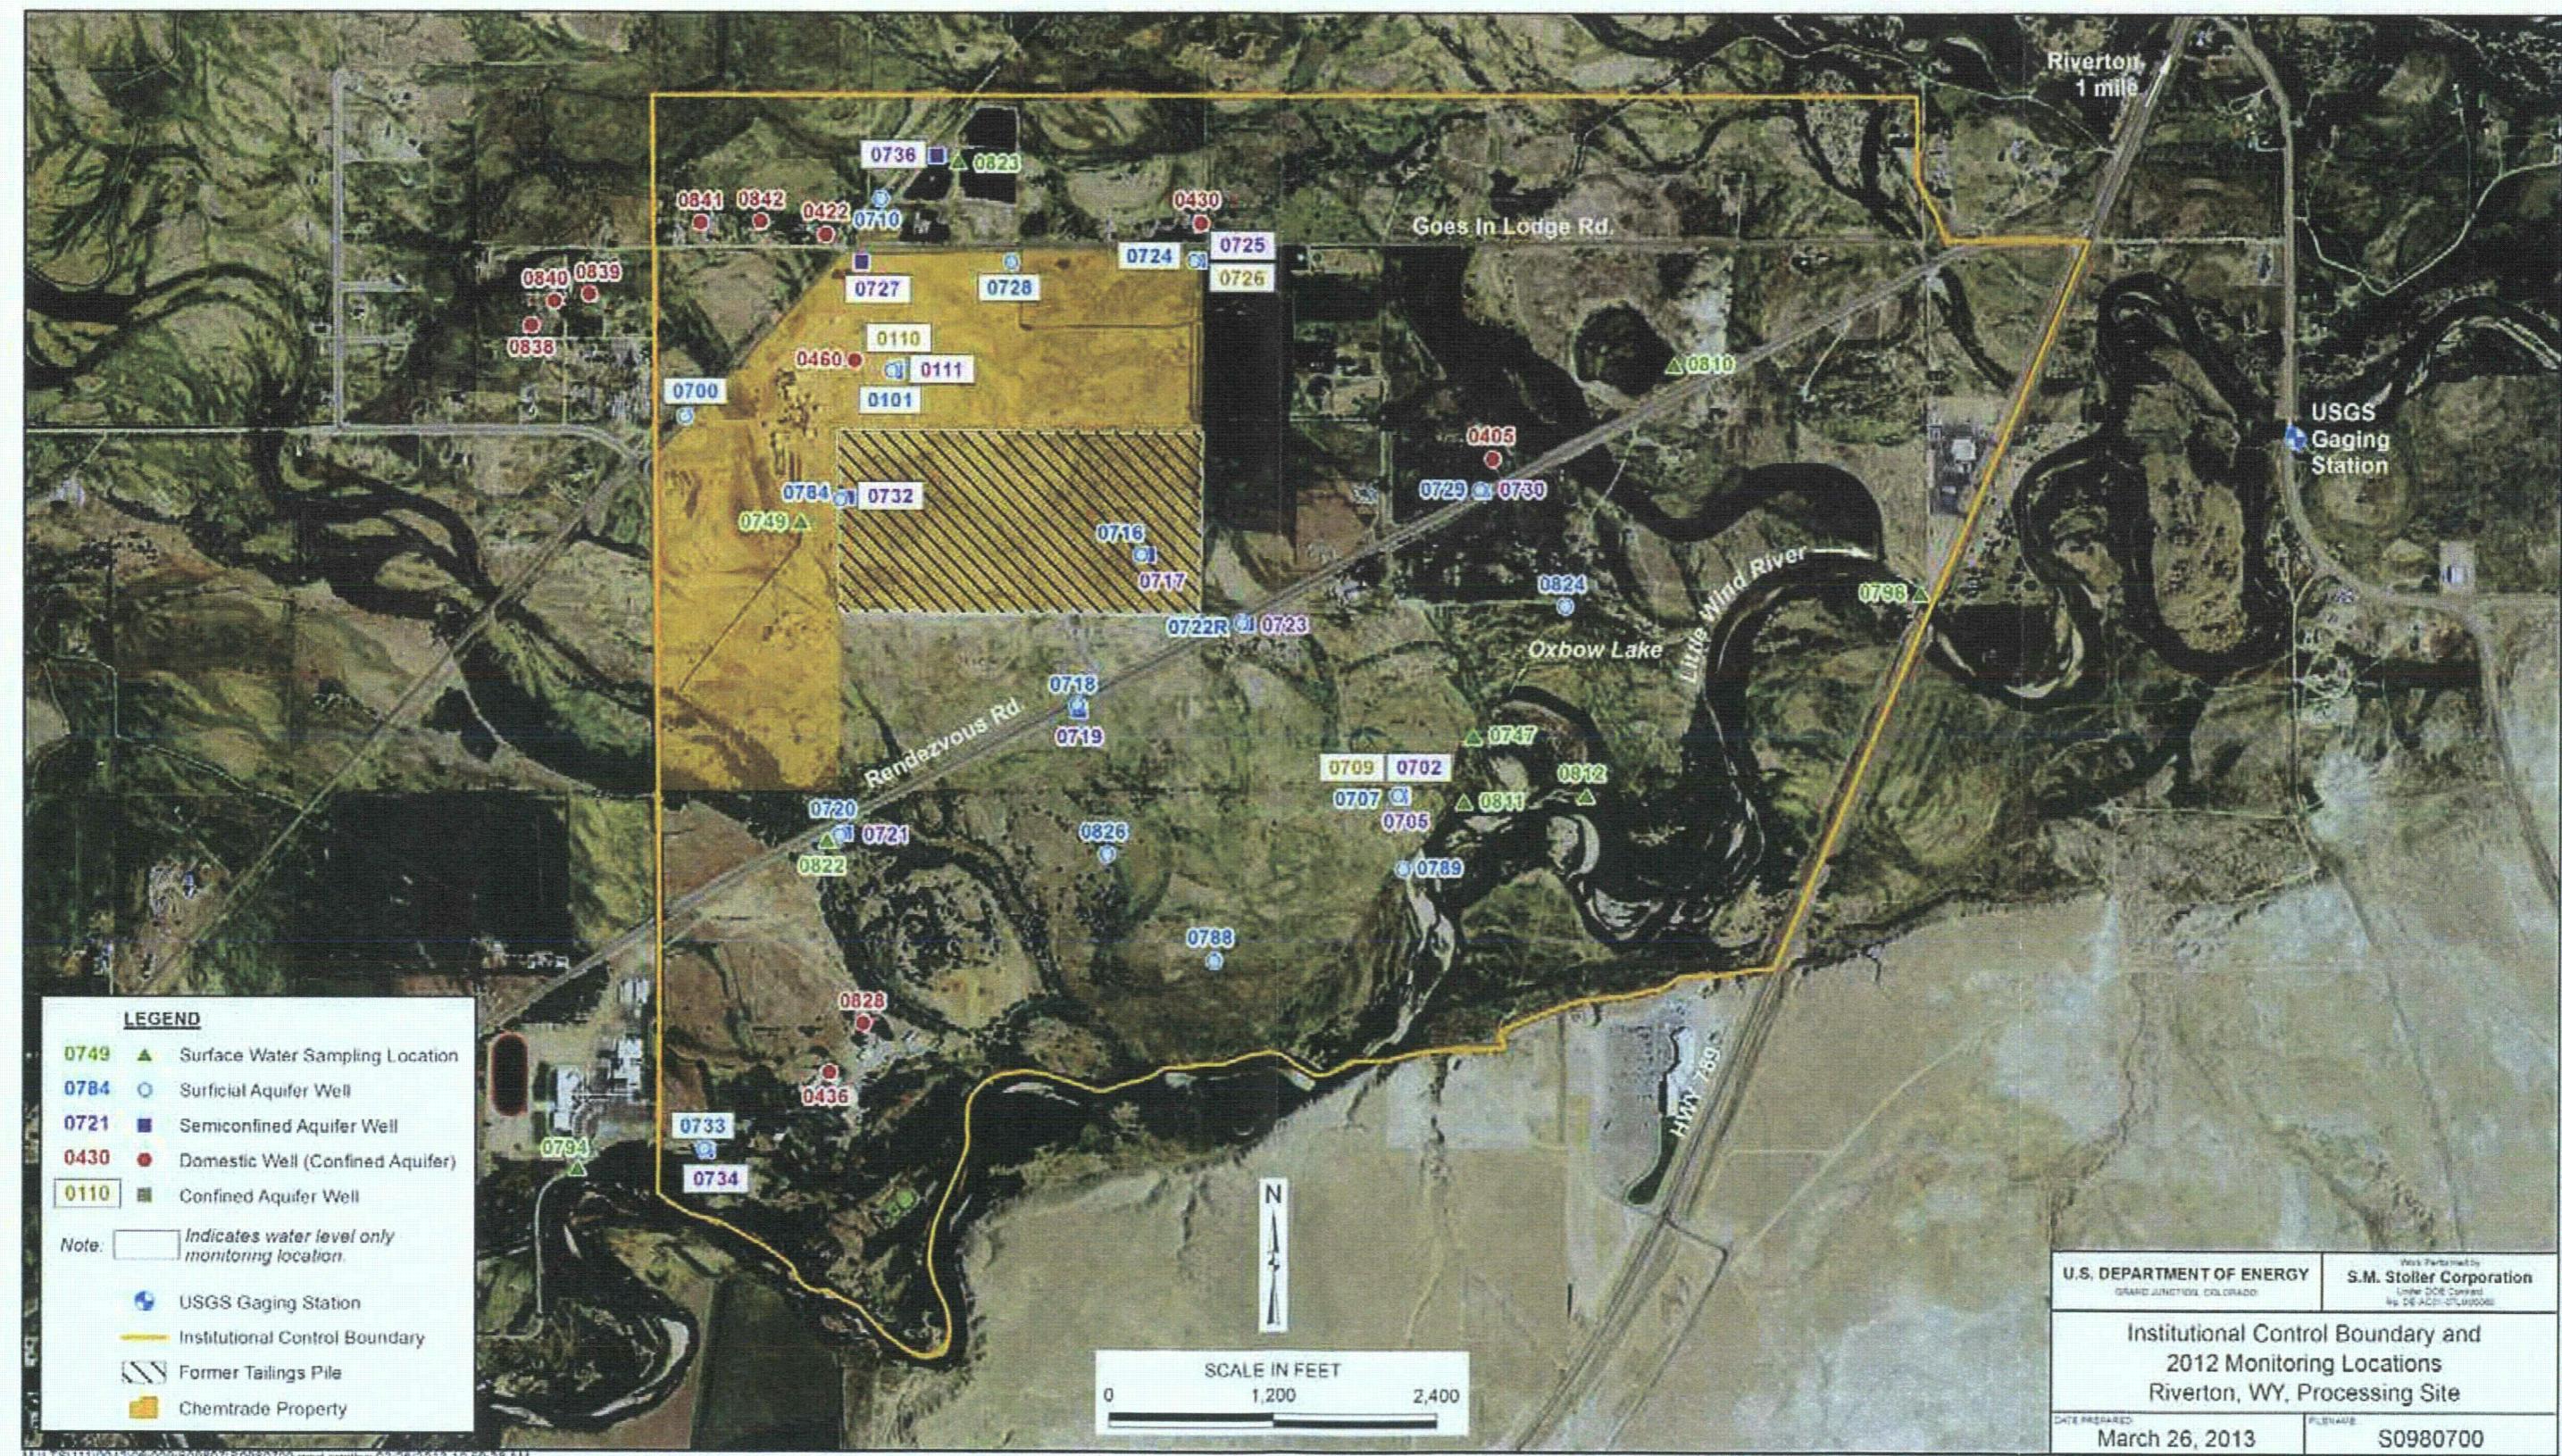
Figure 2. Institutional Control Boundary and 2012 Monitoring Locations at the Riverton Site

The verification monitoring program for 2012 consisted of 18 monitoring wells, 11 domestic wells, and 9 surface water locations, which are listed in Table 1 and shown in Figure 2. In addition, 7 AWSS hydrant locations and 4 AWSS tap locations were sampled and are listed in Table 1 and discussed in Section 2.3.3. Domestic wells 0838, 0839, and 0840 were sampled only in June at the request of the homeowners; these wells are outside the IC boundary and will not be included in the long-term monitoring program. Water levels were measured at 15 additional monitoring wells. Sampling events were conducted in June (groundwater, surface water, and domestic wells), October (AWSS), and December (groundwater, surface water, and domestic wells). Samples collected in June and December were analyzed for manganese, molybdenum, selenium (June only), sulfate, and uranium, and field measurements of temperature, pH, specific conductance, oxidation-reduction potential, dissolved oxygen, alkalinity, and turbidity were measured at each sampling location. Samples collected in October were analyzed for radium-226, radium-228, and uranium and field measurements of chlorine, temperature, pH, specific conductance, oxidation-reduction potential, dissolved oxygen, alkalinity, and turbidity.

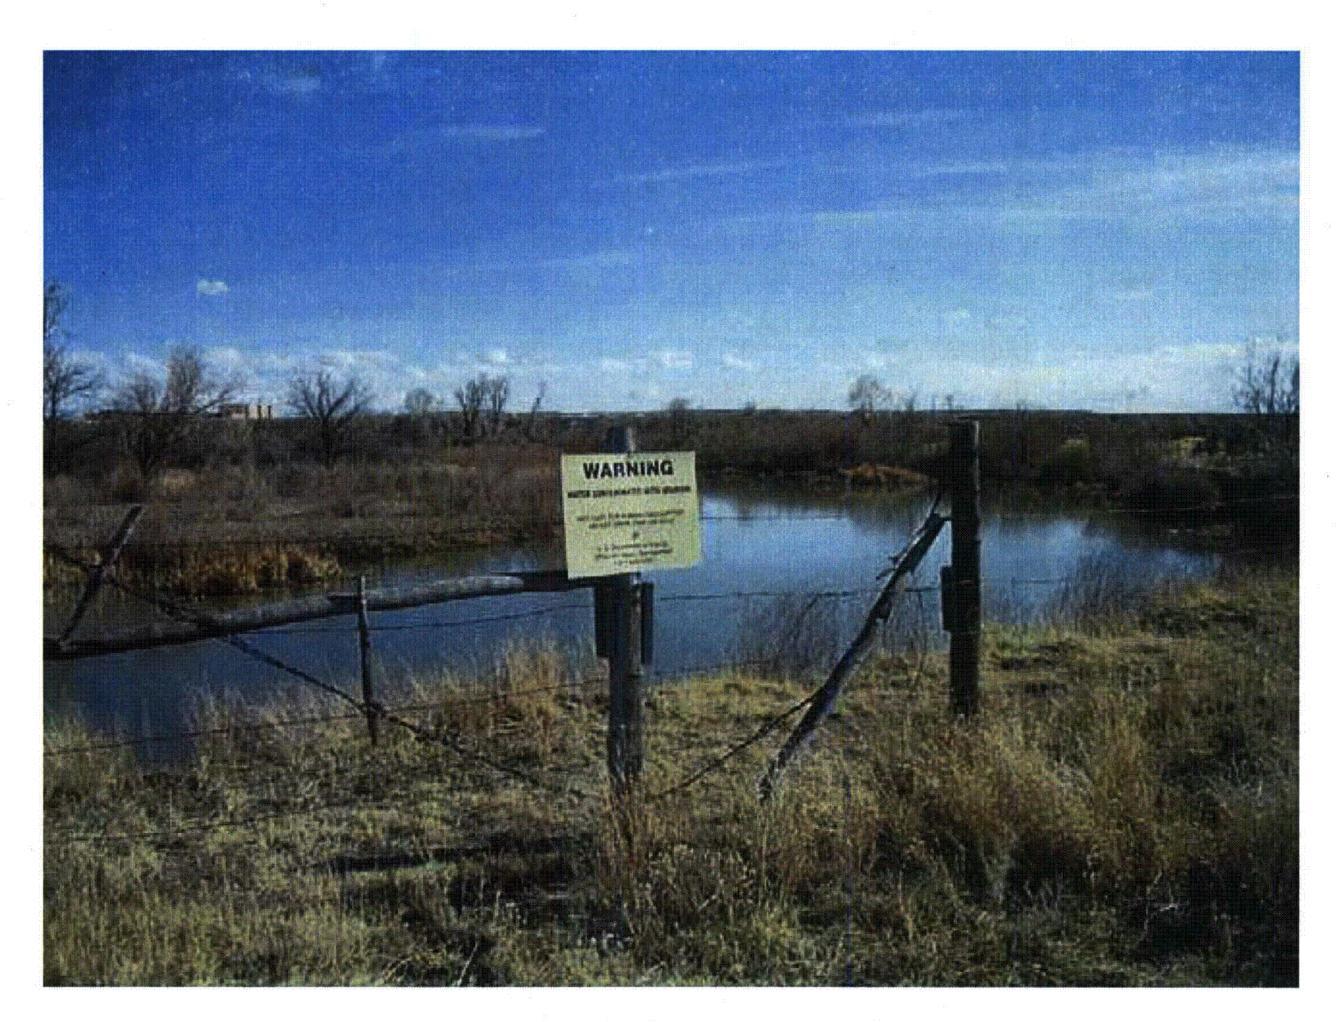
Figure 3. Warning Sign at the Oxbow Lake

- Warning signs installed around the oxbow lake (Figure 3) explain that the contaminated water is not safe for human consumption, with instructions not to drink from, fish in, or swim in the lake.

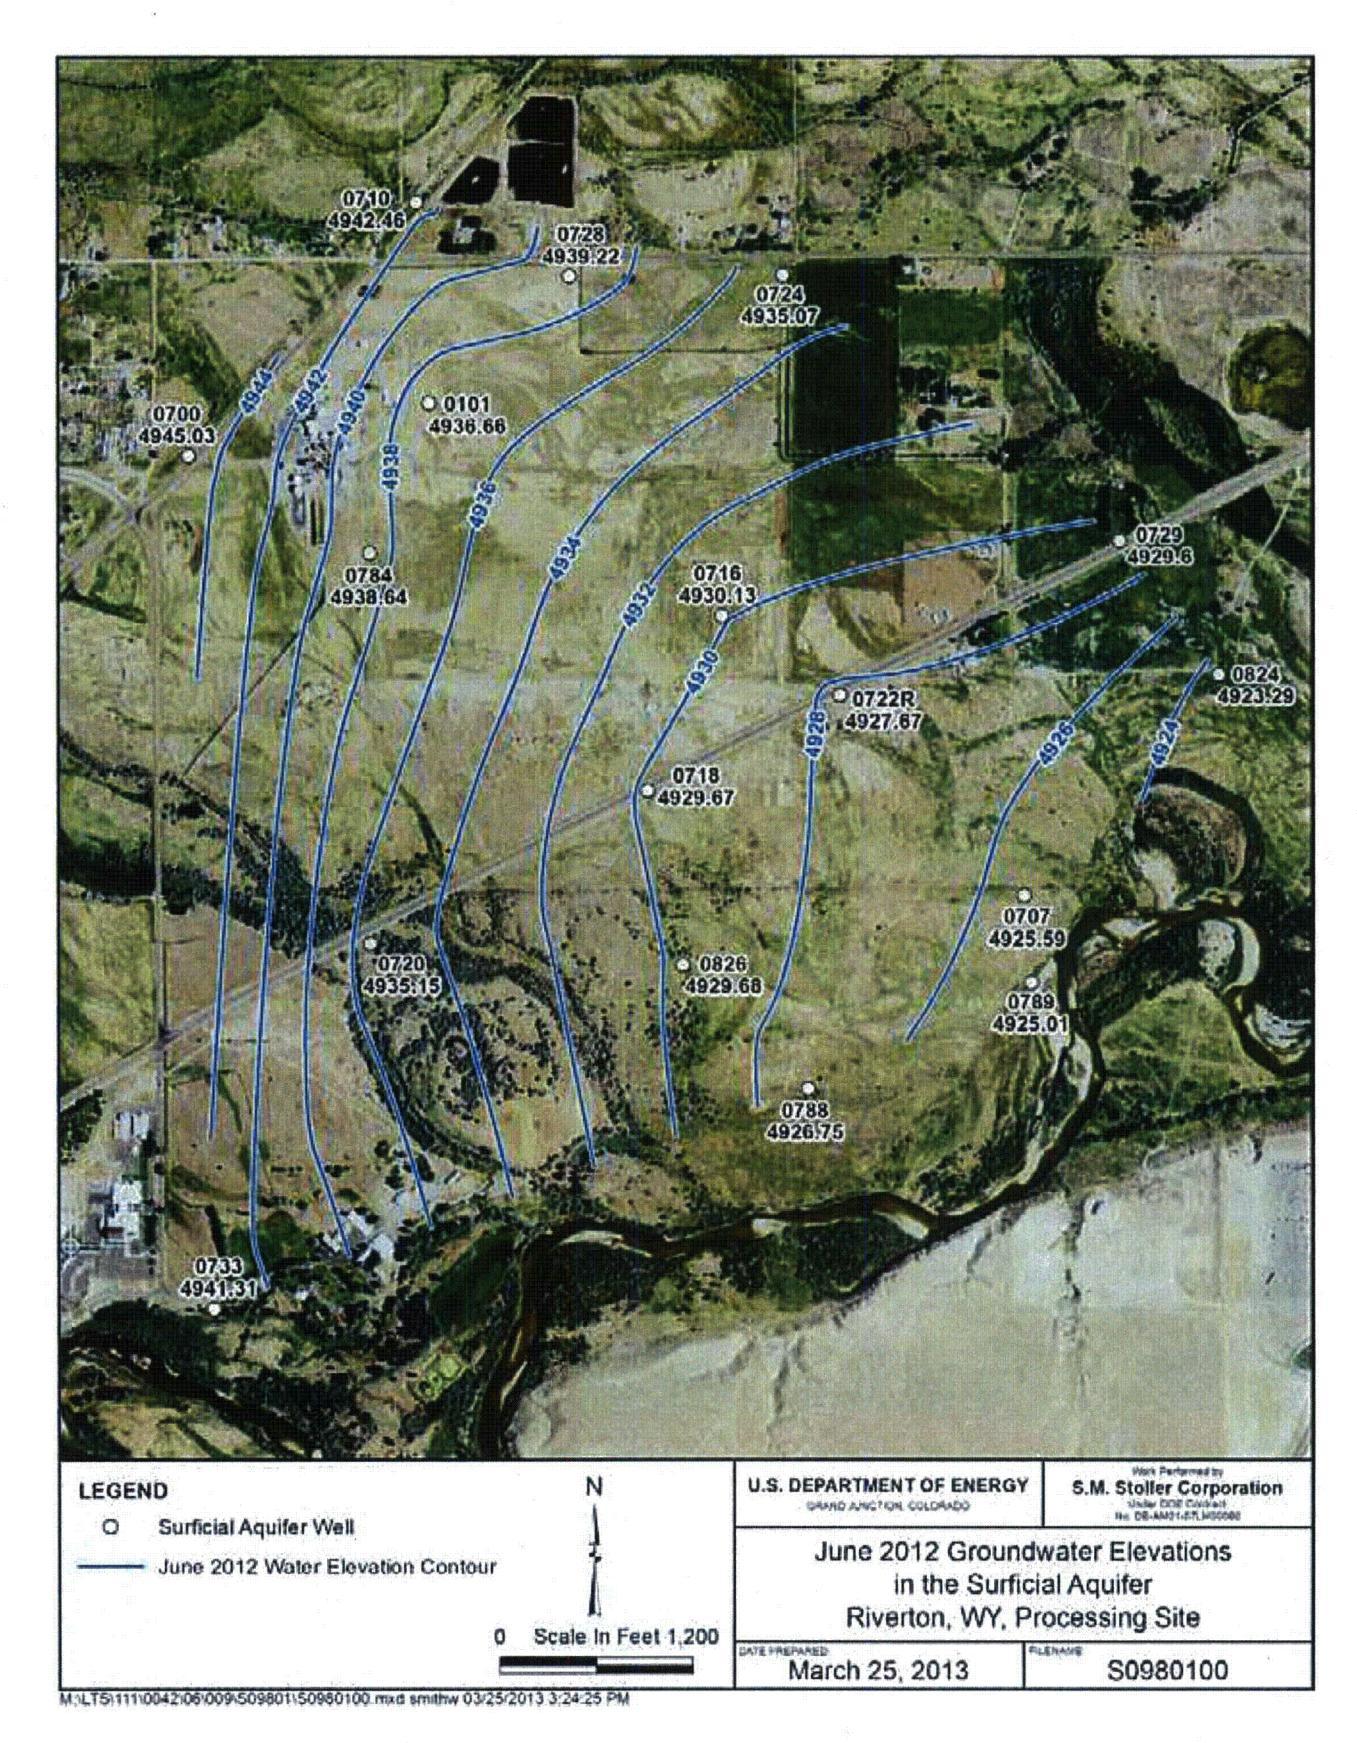
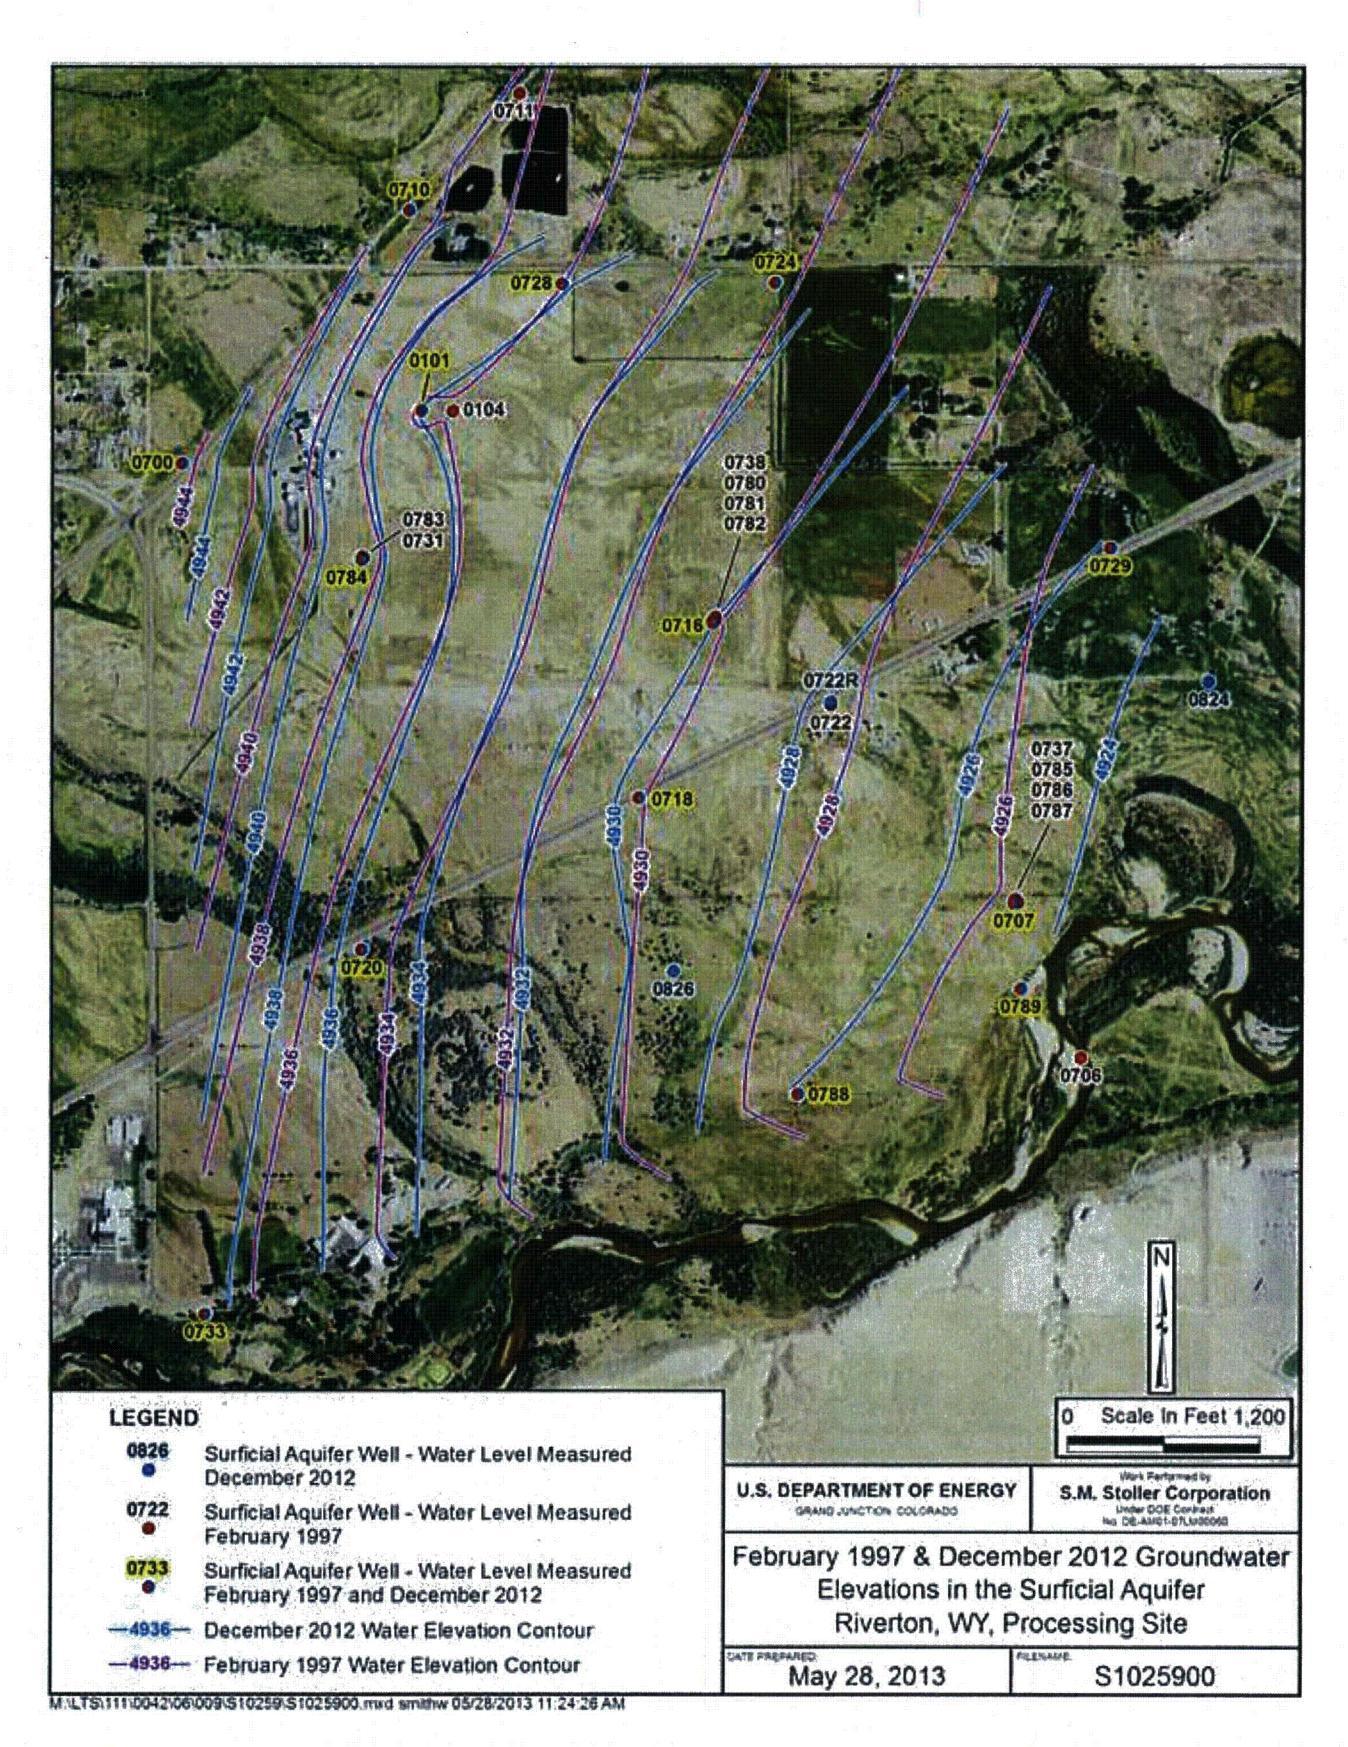
Figure 5. February 1997 and December 2012 Groundwater Elevations in the Surficial Aquifer at the Riverton Site

Assessment of horizontal groundwater flow direction in the surficial aquifer is required to ensure that the monitoring network is adequate for assessing contaminant plume movement and to ensure that the IC boundary provides a sufficient buffer to prevent access to contaminated groundwater. As shown in Figure 4 and Figure 5, groundwater elevation contours for the surficial aquifer indicate a general flow direction to the southeast in June and December. Water levels have been historically consistent as shown in Figure 5, which compares December 2012 and February 1997 water levels. Contaminant plume configurations tend to have a more southerly axis than the measured groundwater flow direction, which may be explained by different flow patterns during milling operations caused by groundwater mounding in the tailings area coupled by irrigation practices to the east of the site. In addition to water levels measured during each sampling event, continuous water-level measurements recorded by pressure transducers installed in wells along the groundwater flow path demonstrate that, based on groundwater elevations, the groundwater flow does not reverse direction throughout the year (Figure 6).

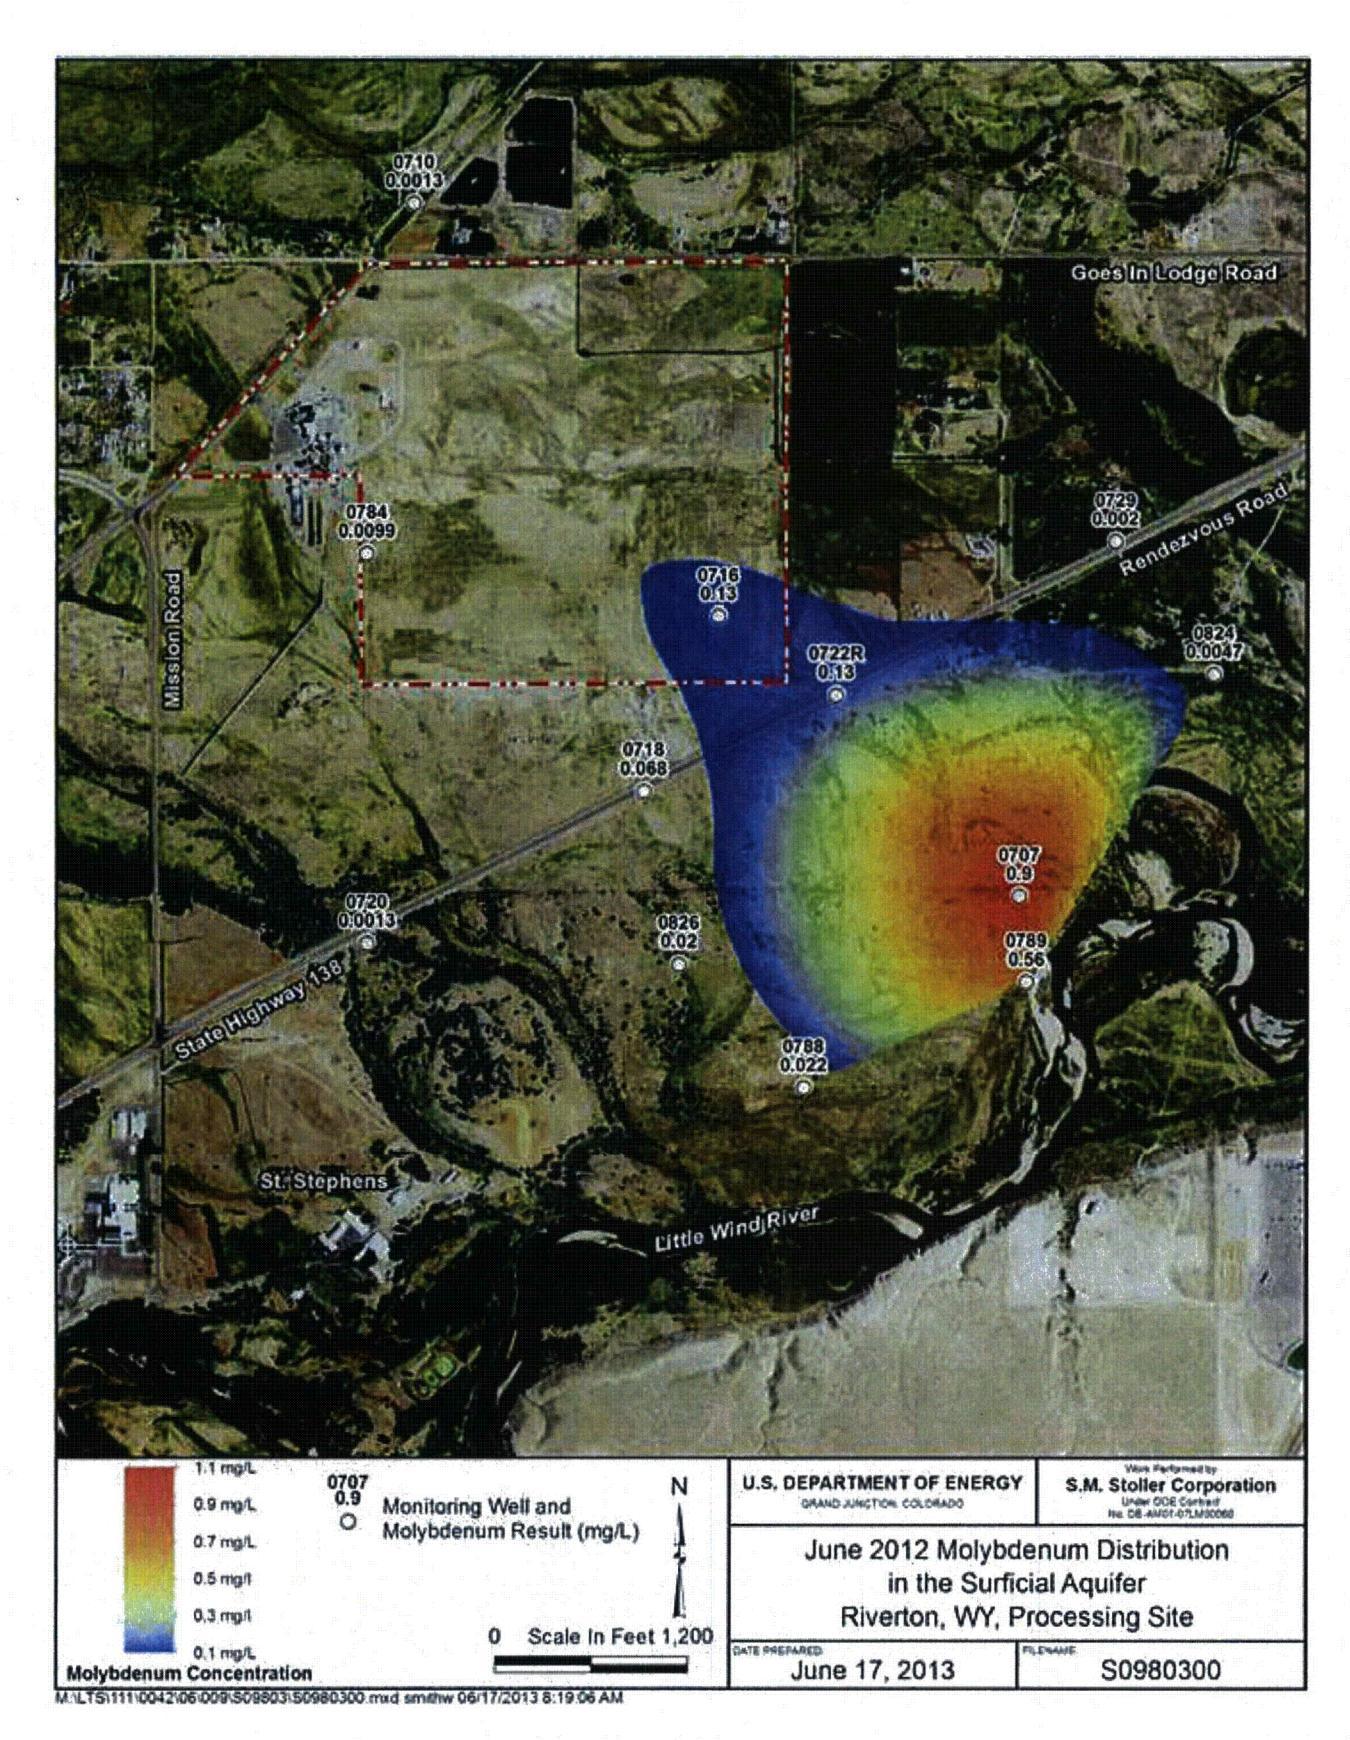
Figure 9. June 2012 Molybdenum Distribution in the Surficial Aquifer at the Riverton Site

Surficial aquifer data from the 2012 sampling events are summarized in the following plots and figures. Time-concentration plots for molybdenum in wells located within contaminant plumes and wells bordering the contaminant plumes in the surficial aquifer are shown in Figure 7 and Figure 8, respectively. The distribution of molybdenum in the surficial aquifer from the June

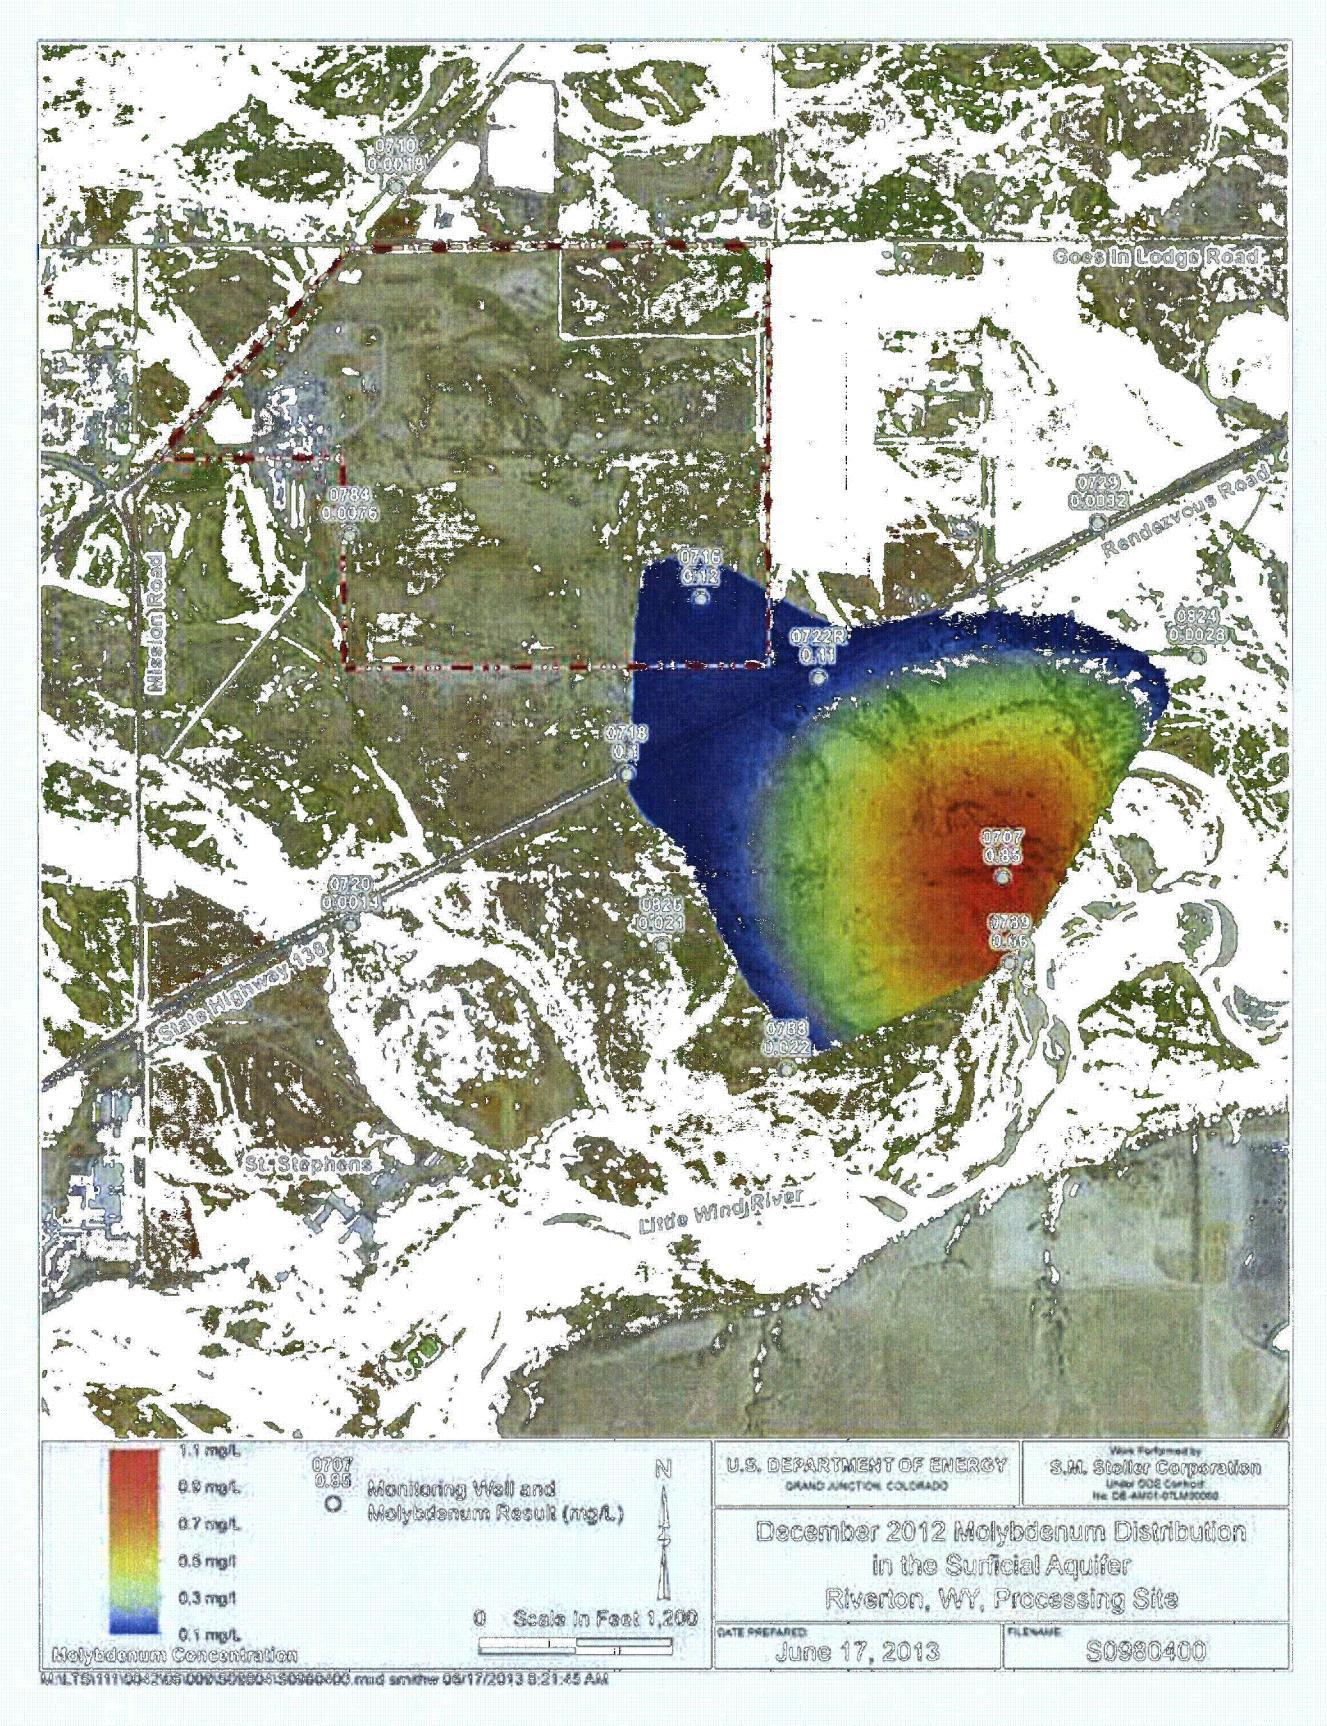
Figure 10. December 2012 Molybdenum Distribution in the Surficial Aquifer at the Riverton Site

and December 2012 sampling events is shown in Figure 9 and Figure 10, respectively. Timeconcentration plots for uranium in wells located within contaminant plumes and wells on the lateral edge of the contaminant plumes in the surficial aquifer are shown in Figure 11 and Figure 12, respectively. The distribution of uranium in the surficial aquifer, based on June and December 2012 sampling results, is shown in Figure 13 and Figure 14, respectively.

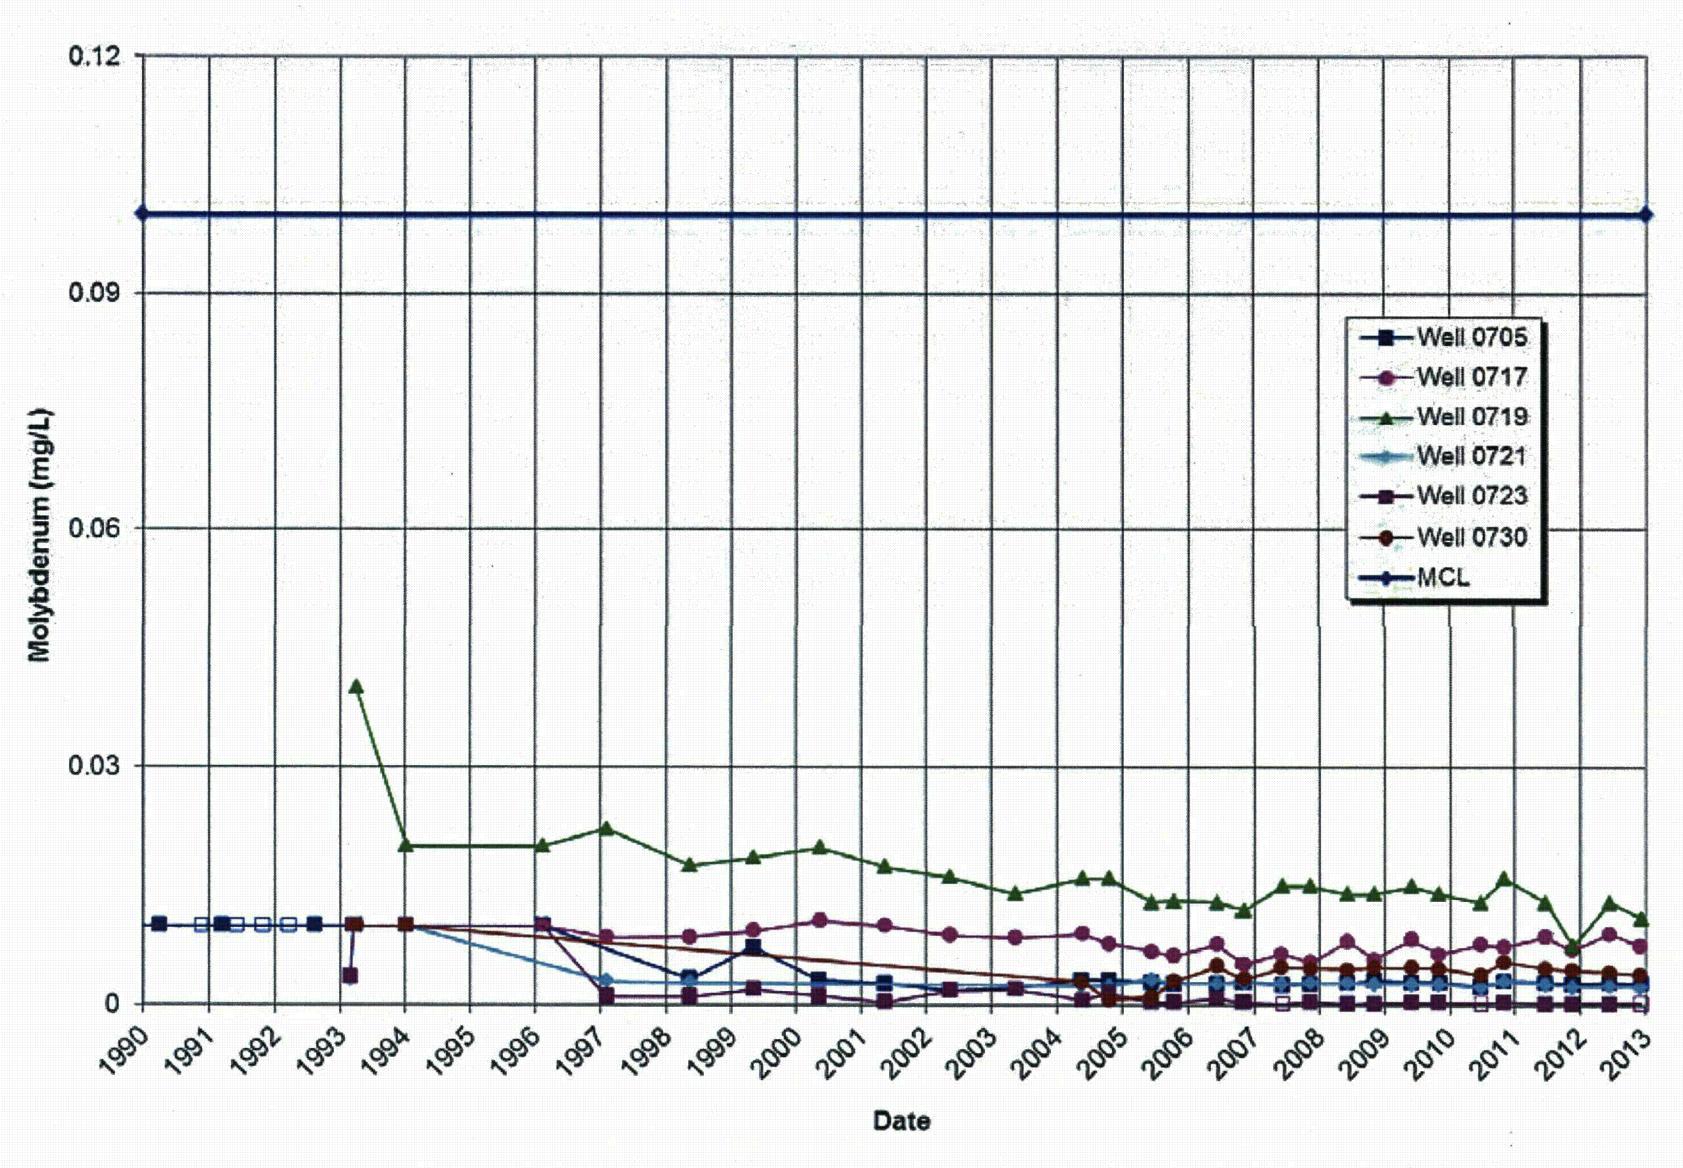
Figure 15. Molybdenum Concentrations in Semiconfined Aquifer Wells

Concentrations of molybdenum and uranium in groundwater in the semiconfined aquifer are still below corresponding MCLs in areas where the overlying surficial aquifer groundwater is contaminated, which indicate no significant impact from site-related contamination in this unit (Figure 15 and Figure 16).

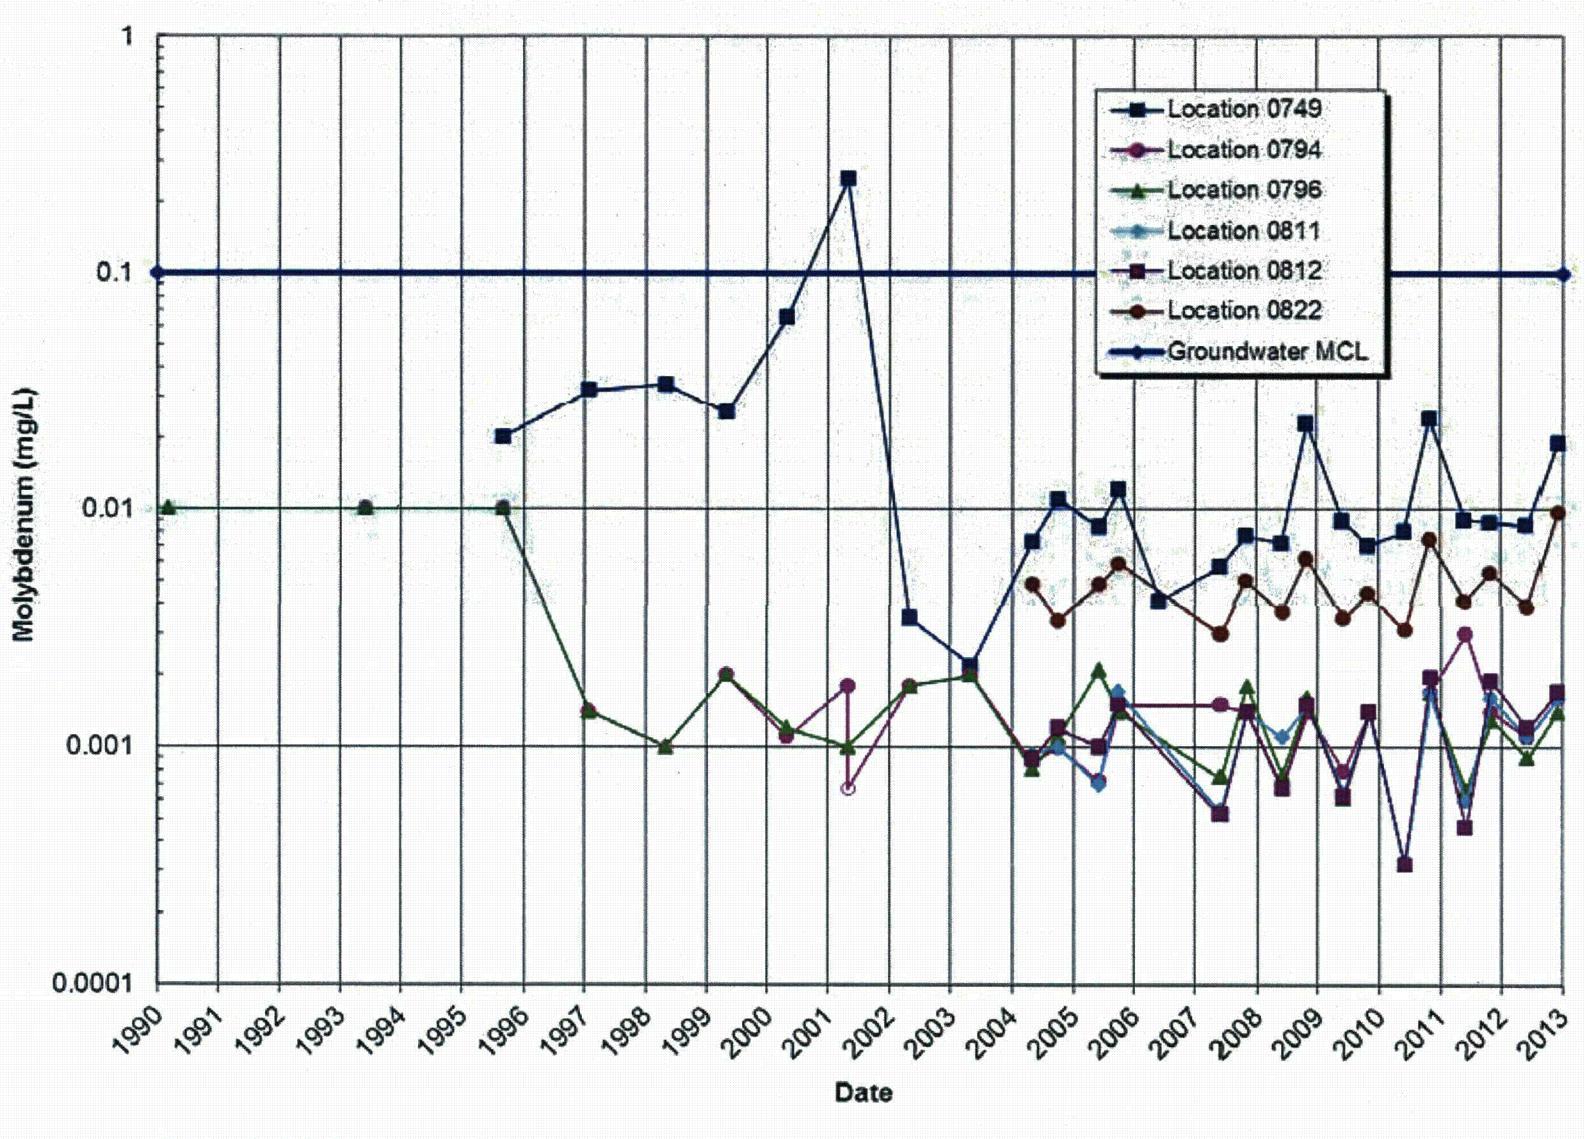
Figure 20. Molybdenum Concentrations in Creek and River Locations

Samples were collected at four locations on the Little Wind River (Figure 2), which flows generally from the southwest to the northeast adjacent to the site. Contaminated groundwater likely discharges to the Little Wind River, but there is no evidence that it impacts surface water quality in the river. Molybdenum and uranium concentrations measured in samples collected from river locations adjacent to and downstream of the groundwater plume (locations 0811, 0812, and 0796) are comparable to concentrations from river samples collected upstream of the groundwater plume (location 0794), as shown in Figure 20 and Figure 21, respectively.

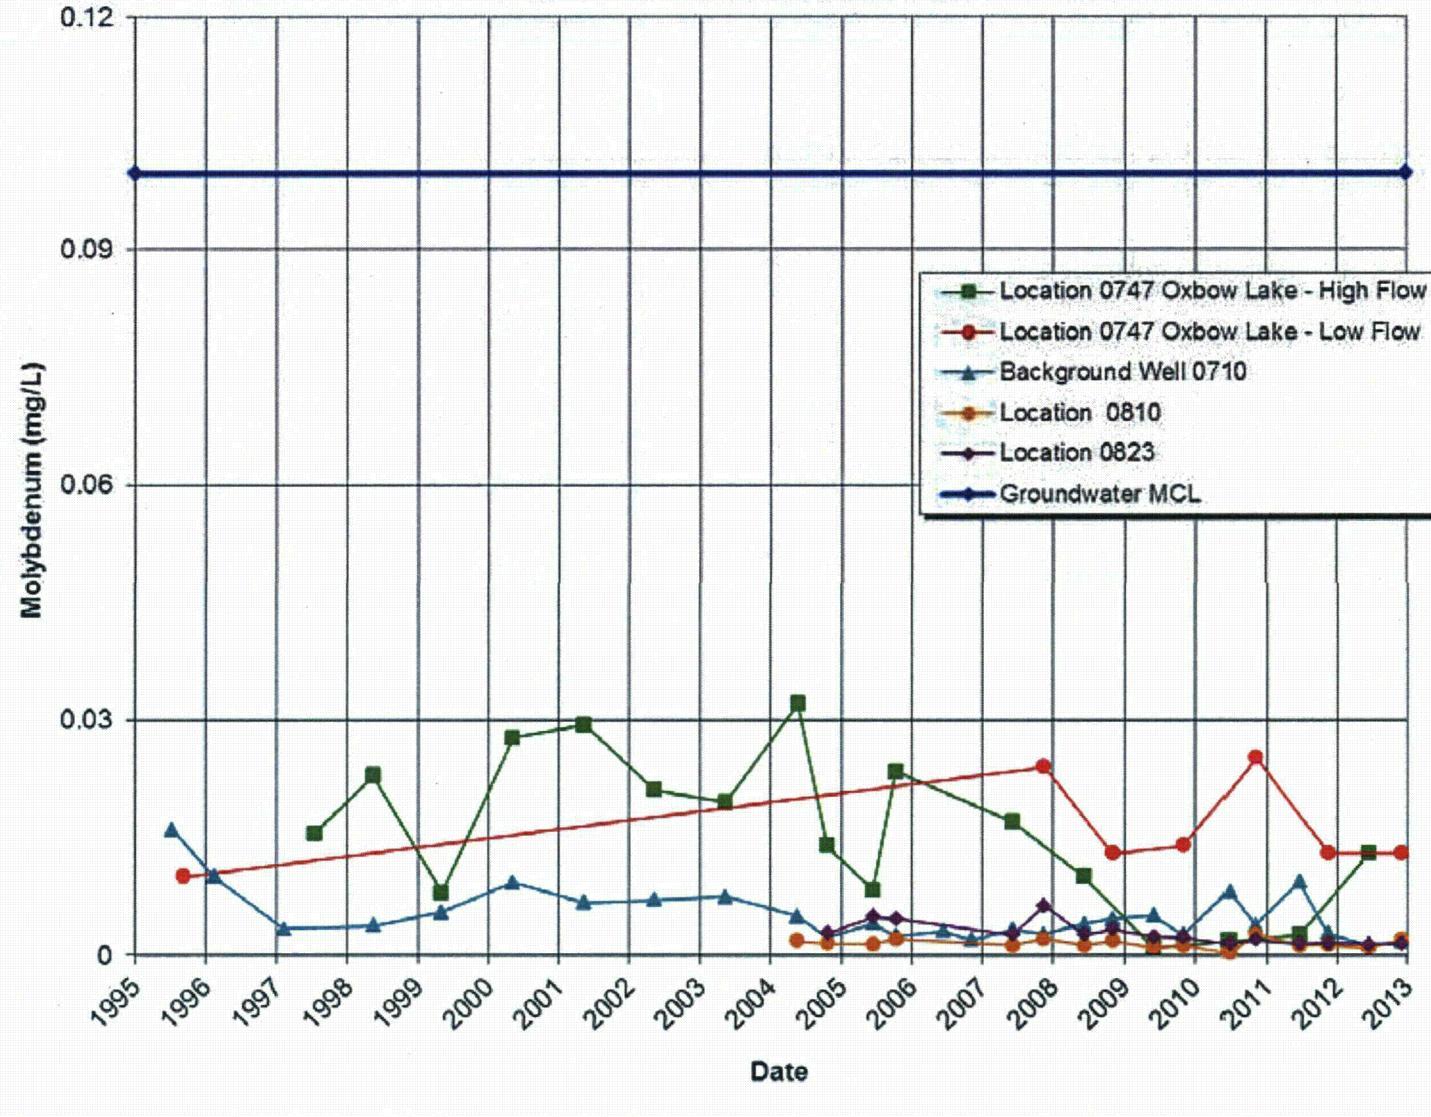
Figure 22. Molybdenum Concentrations in Ponds

Concentrations of molybdenum and uranium in the oxbow lake (location 0747) have varied over time. This variability is attributed to surface inflow (this does not occur every year; it depends on the river stage) to the lake from the Little Wind River during a high river stage, which causes a dilution of uranium concentrations. Hydraulic and water quality data indicate that the oxbow lake is fed by the discharge of contaminated groundwater; therefore, elevated concentrations are expected.

Figure 22 and Figure 23 split oxbow-lake sampling data into high-flow and low-flow events; the high-flow events reflect the potential for river inflow diluting analyte concentrations in the oxbow lake, and the low-flow events reflect a low potential for river inflow diluting analyte concentrations in the oxbow lake. In the June 2012 sampling event, the Little Wind River was not flowing into the oxbow lake and run-off was lower than normal; therefore, the uranium concentration in the sample collected from the oxbow lake was elevated. Uranium concentrations also were elevated in samples collected from the oxbow lake in December, as expected, because the river was not flowing into the lake at that time. Surface water quality data by parameter for locations sampled during 2012 are provided in Appendix D.
