2012 Enhanced Characterization and Monitoring Report Riverton, Wyoming, Processing Site

June 2013

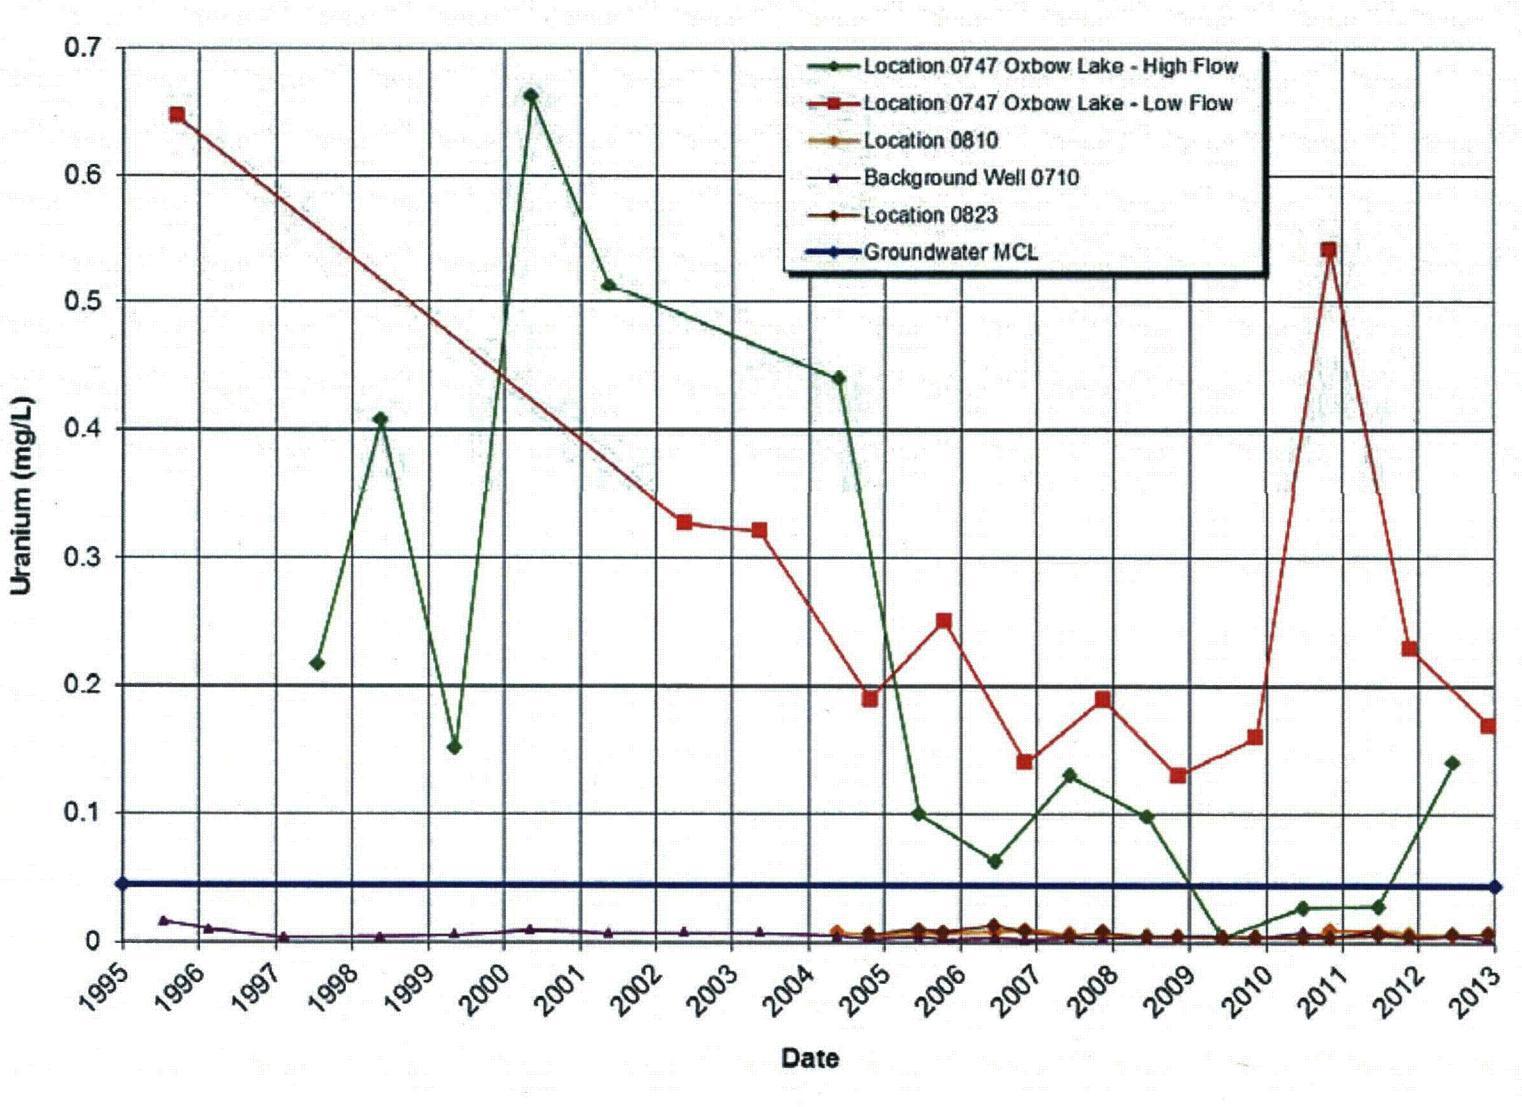
Figure 23. Uranium Concentrations in Ponds

Concentrations of molybdenum and uranium in the oxbow lake (location 0747) have varied over time. This variability is attributed to surface inflow (this does not occur every year; it depends on the river stage) to the lake from the Little Wind River during a high river stage, which causes a dilution of uranium concentrations. Hydraulic and water quality data indicate that the oxbow lake is fed by the discharge of contaminated groundwater; therefore, elevated concentrations are expected.

Figure 22 and Figure 23 split oxbow-lake sampling data into high-flow and low-flow events; the high-flow events reflect the potential for river inflow diluting analyte concentrations in the oxbow lake, and the low-flow events reflect a low potential for river inflow diluting analyte concentrations in the oxbow lake. In the June 2012 sampling event, the Little Wind River was not flowing into the oxbow lake and run-off was lower than normal; therefore, the uranium concentration in the sample collected from the oxbow lake was elevated. Uranium concentrations also were elevated in samples collected from the oxbow lake in December, as expected, because the river was not flowing into the lake at that time. Surface water quality data by parameter for locations sampled during 2012 are provided in Appendix D.

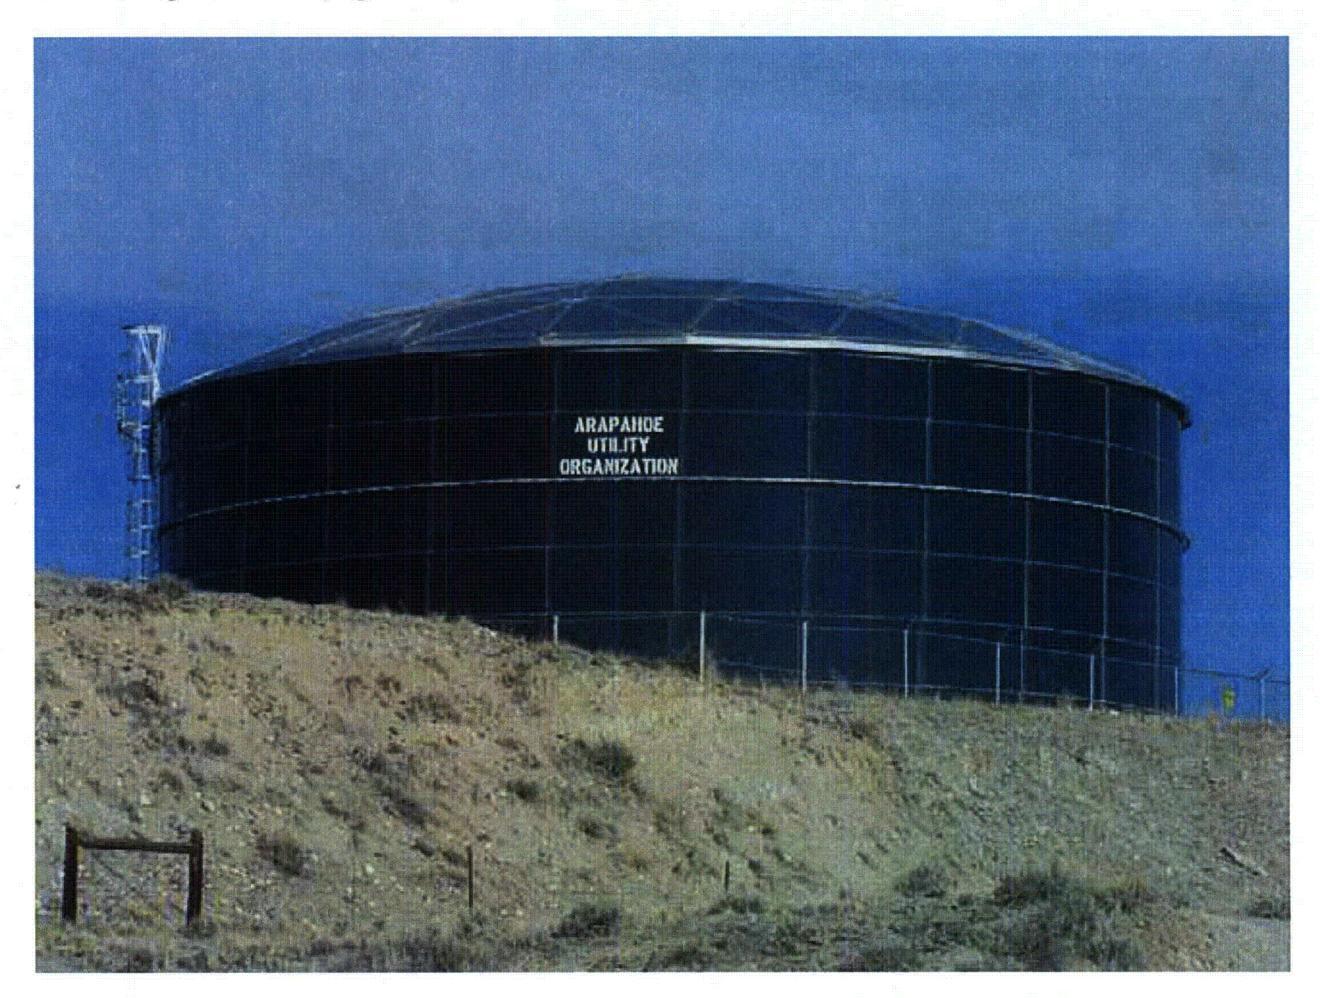
Figure 24. AWSS 1-Million-Gallon Tank

The AWSS was installed in 1998 by the Indian Health Service. DOE provided \$800,000 in funding, which included 25 percent of the cost of a new 1-million-gallon storage tank (Figure 24). As a component of ICs for the Riverton site, the AWSS is designed to supply drinking water to residents within the IC boundary in lieu of drinking groundwater that could potentially be impacted by the contaminated surficial aquifer. The AWSS is an addition to a pre-existing water supply system and consists of 8.5 miles of transmission pipeline running from the 1-million-gallon tank (Figure 25).
