NUCLEAR GENERATION SITE UNITS 2 AND 3 EFFECTIVE DATEJUL 0 9 1987

# STEAM EXTRACTION LINE EROSION

### MONITORING PROGRAM

### STEAM EXTRACTION LINE EROSION MONITORING PROGRAM

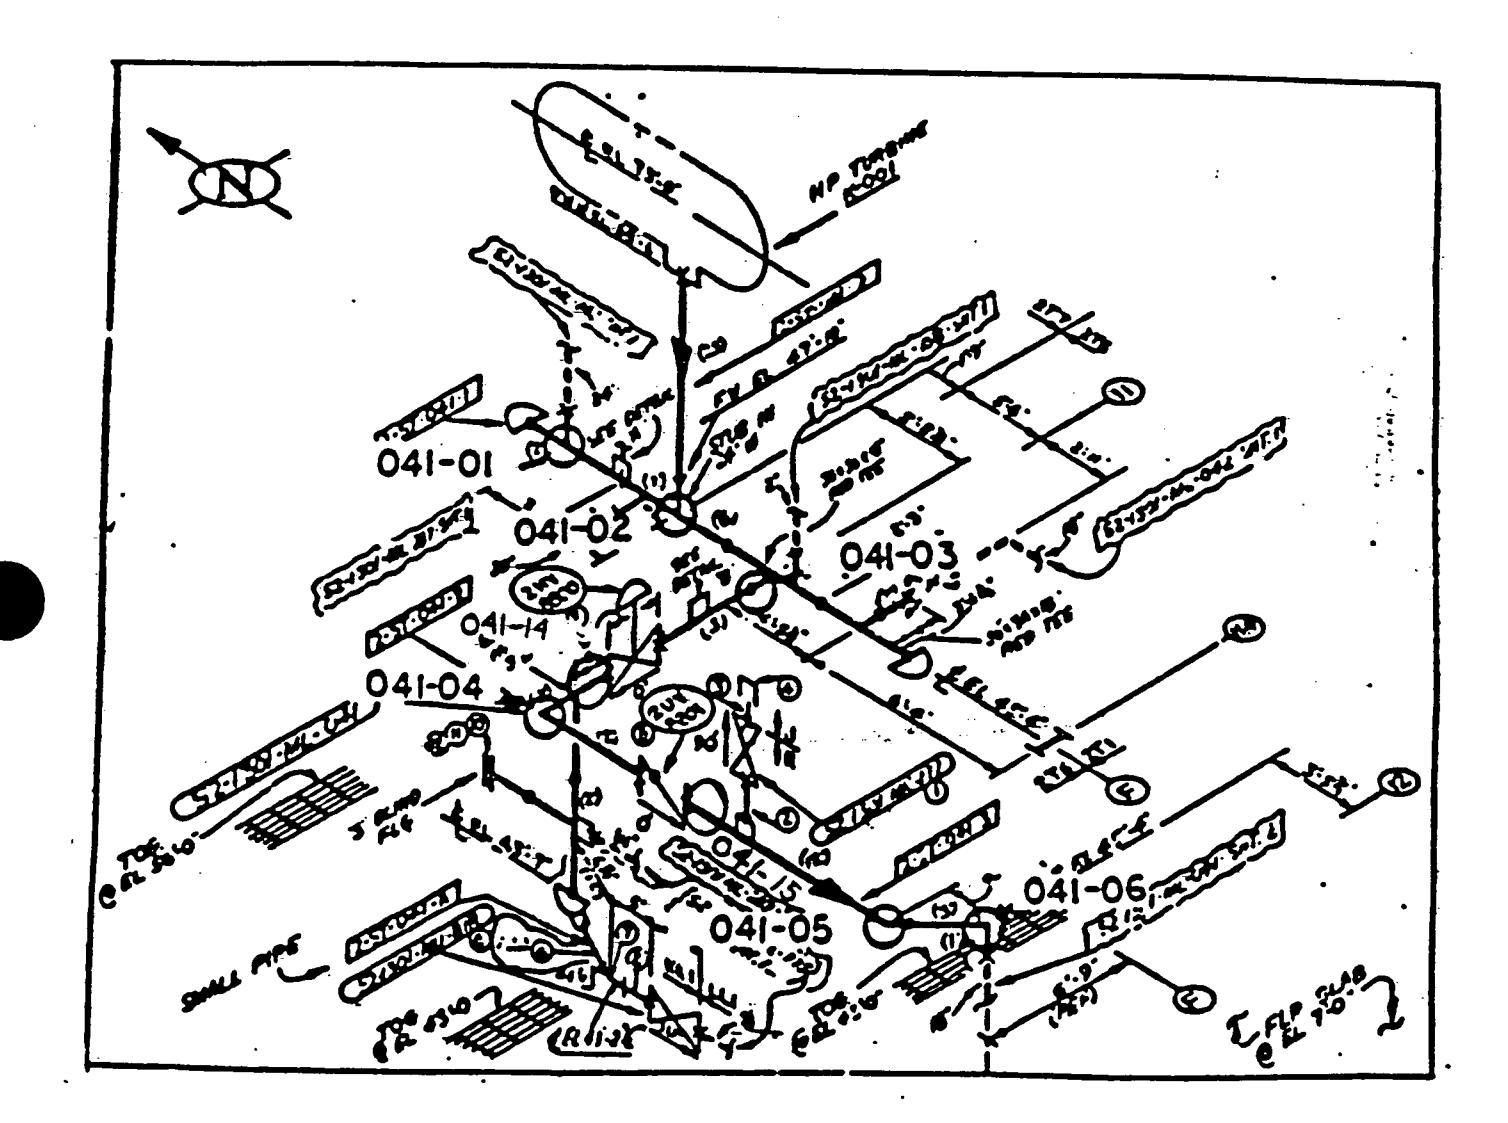
HP TURBINE K-001, SYS 1301 1 ST POINT HEATER E-037 SYS 1301 S2-1301-ML-041-36-R-KKI

The following areas as numbered on the attached marked up isometric drawings (Attachment 2) will be inspected in the Erosion Surveillance Program.

The configuration of these lines are mirror images for Units 2 and 3. For this reason, marked up isometrics for Unit 2 only have been attached. The same areas for Unit 3 will be inspected.

<u>    Li</u>	ne l	10.					Area	<u>a s</u>												<u> </u>
1301	ML	041	-	01,	02,	03,	04,	05,	11,	13,	14,	15,	16							
1301	ML	042	-	01,	02,	04,	05,	08,	10,	12,	13,	14								
1301	ML	043	-	01,	02,	03.	04,	* 07	, 10	, 11	, 13	14.	, 15							
1301	ML	044	-	01,	02,	03,	05,	07,	08,	11,	12,	14,	15							
1301	ML	287	-	01,	03,	04,	05,	09,	11,	13,	14,	15,	<u>16</u> ,	18,	20,	21,	22,	23,	24,	25
1301	ML	318	-	02,	04,	0 <del>5</del>														
1301	ML	319	-	02,	01,	04														
1301	ML	320	-	02,	01,	04														•
1301	ML	288	-	01,	02,	04,	09,	11,	13,	14,	15,	16,	18,	20,	21,	22,	23,	24,	25	
1301	ML	326	-	02,	05,	06														
1301	ML	327	-	02,	01,	04								a .						
1301	ML	328	-	02,	01,	04					·				••					
1301	ML	0 <del>95</del>	-	01,	02,	03														
1301	ML	104	-	01,	02,	03														
1301	ML	047	-	03,	02,	07,	08							*						
1301	ML	048	-	03,	02,	07,	08

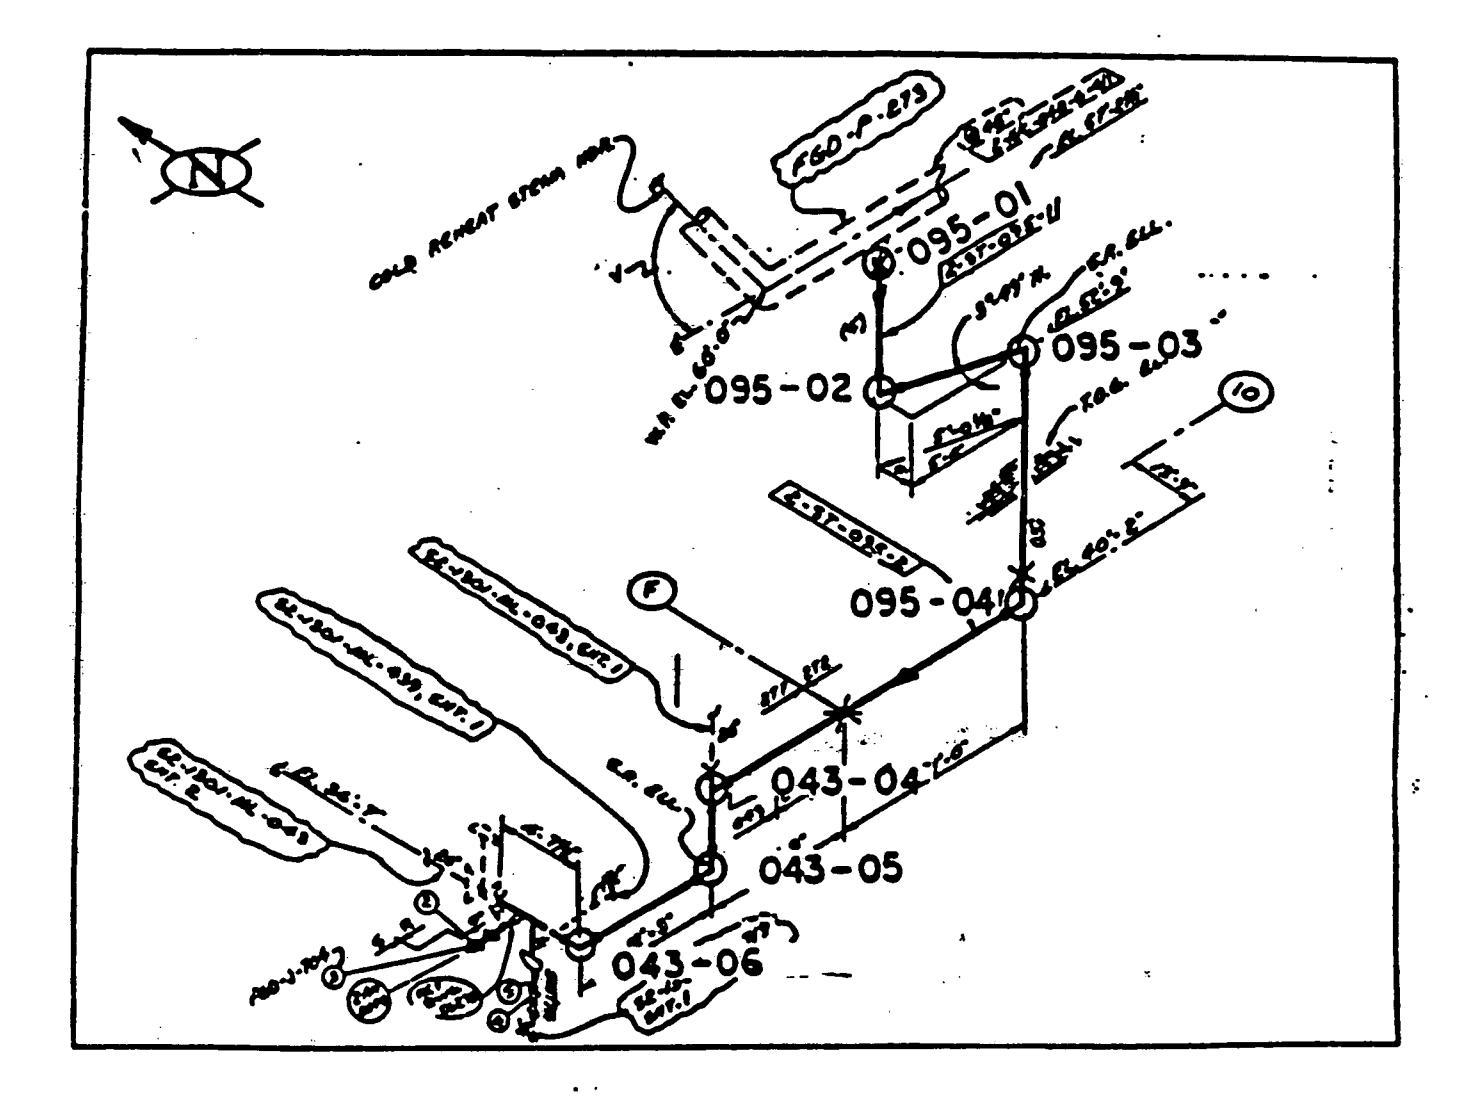
COLD REHEAT STEAM LINE (W) SYS 1301 LINE 043 SYS 1301 S2-1301-ML-095-20"-R-KK2

This inspection point is shown on the extension of line 043 found on 1301 ML 095 (page 30 of 35). K-

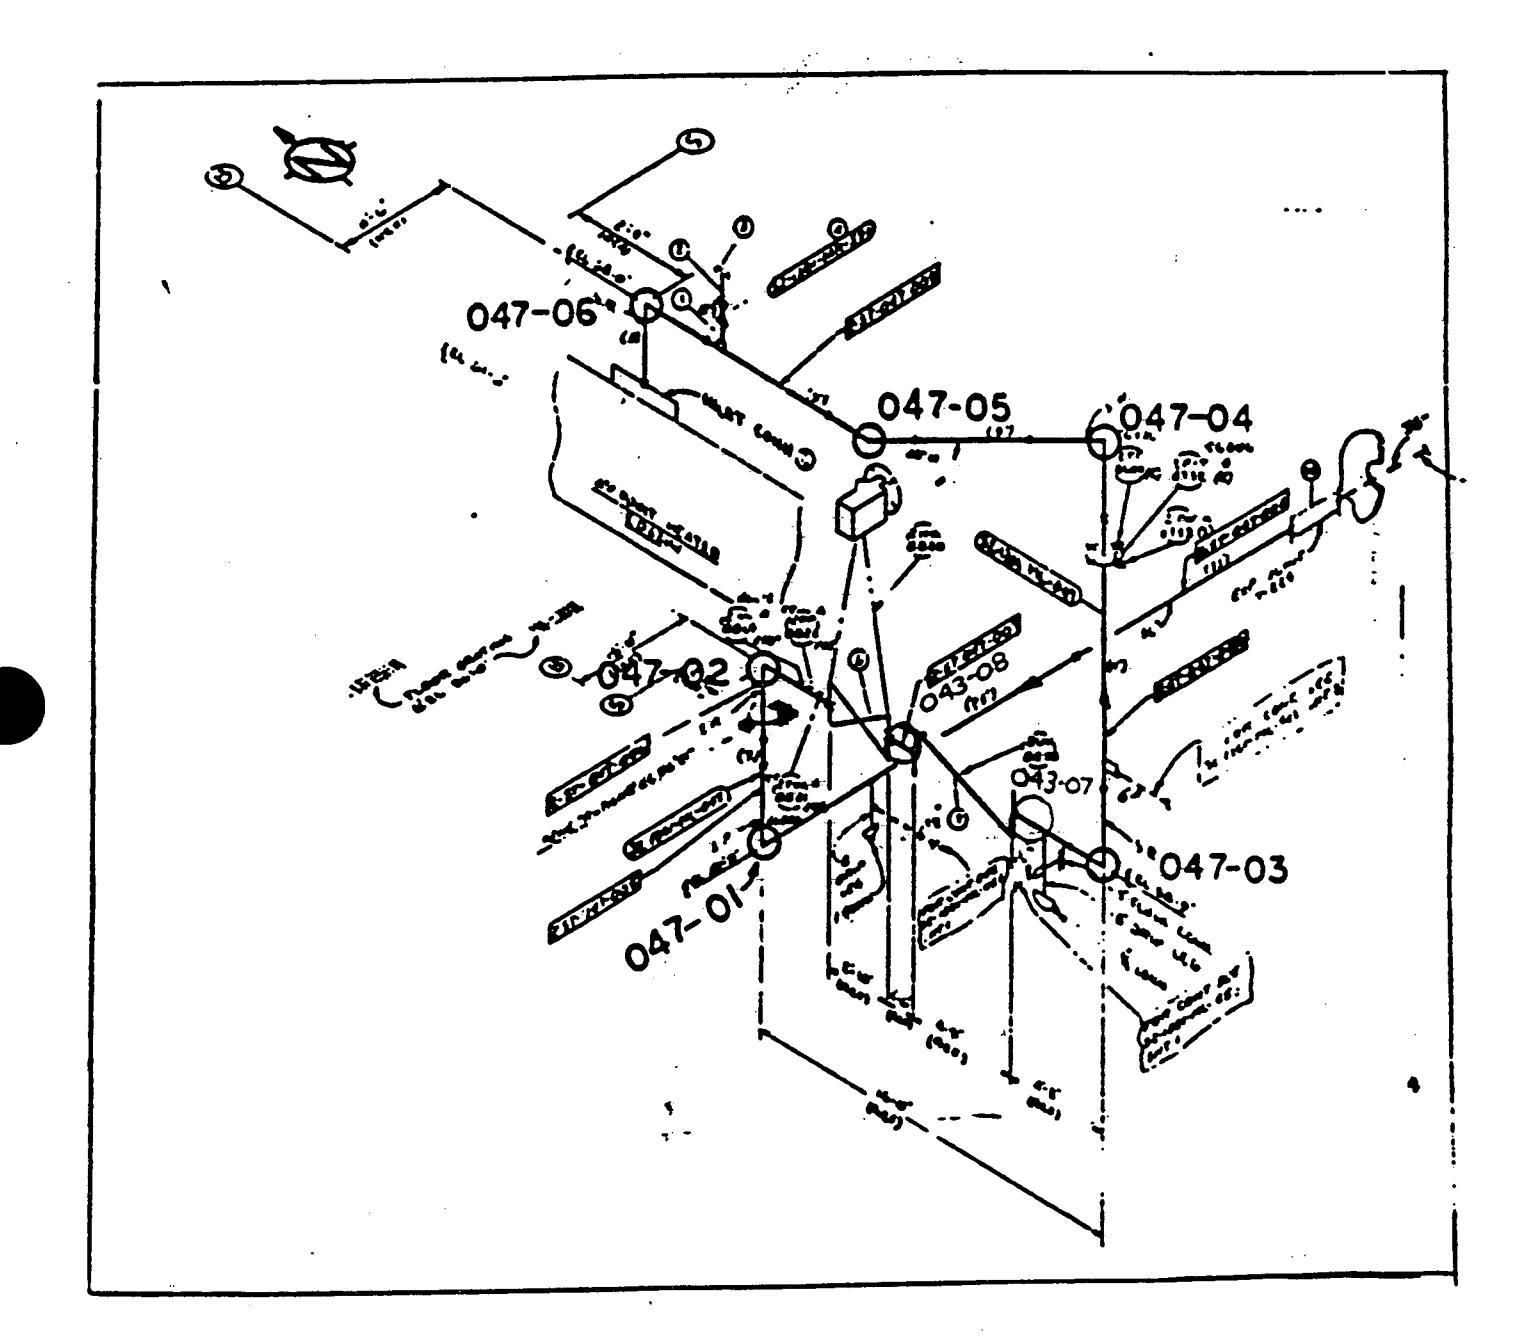
EXTRACTION STEAM IN CONDENSER NECK LINE S-2-1301-ML-047

- .1 Although no significant erosion may be expected in <u>low</u> pressure extraction lines, and the calculated PVX value is low, <u>two points in each line determined to be the</u> most susceptible to erosion will be inspected. This is due to the high steam velocity (181 ft/sec) and the relatively high moisture content (3.9%).

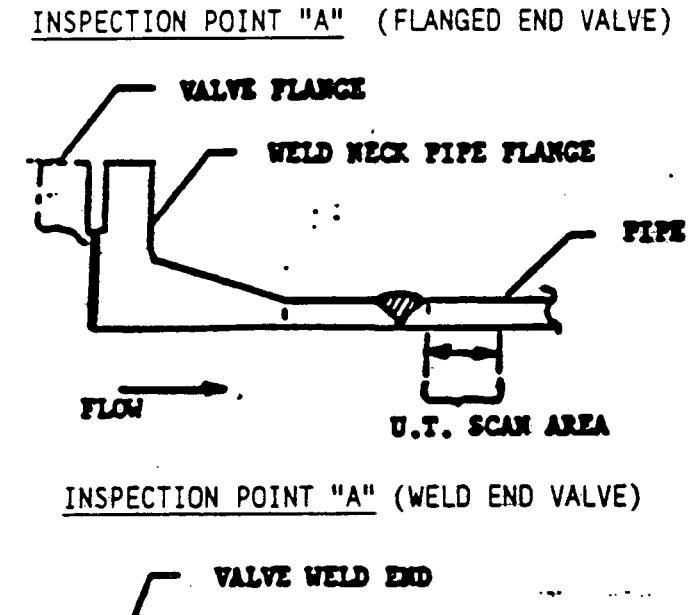
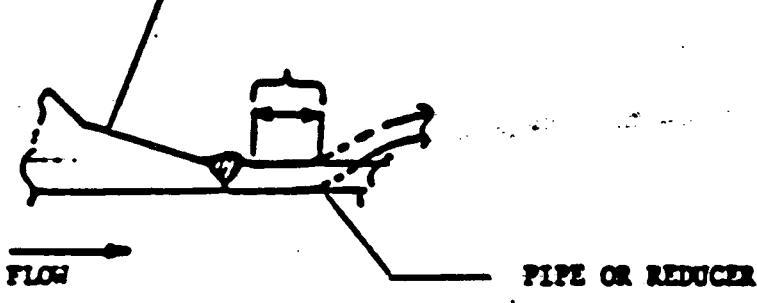
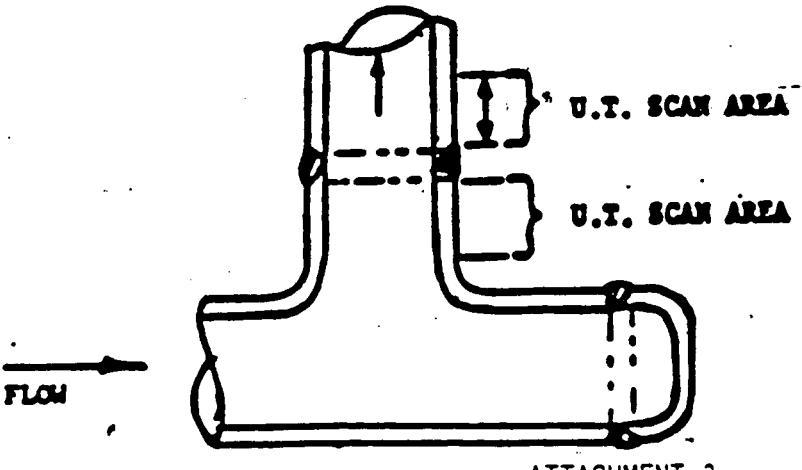
EXAMINATION AREAS

- .2 For <u>bends</u>, the entire area of the bend will be inspected. For <u>tees</u>, an area the length of two pipe diameters on each side of the tee will be inspected. An area three pipe diameters in length will be inspected downstream of <u>reducers</u>, <u>control valves</u>, <u>check valves</u>, and <u>flow orifices</u> whereever possible.

INSPECTION POINT "B" (CAPPED TEE OR LATERAL)

- 6.3.2 A rectilinear scan pattern shall be used to examine the entire area of concern, as shown in Attachment 3.
  - .1 Scanning over circumferential welds should be avoided since grinding of the weld surface would be required in most cases.

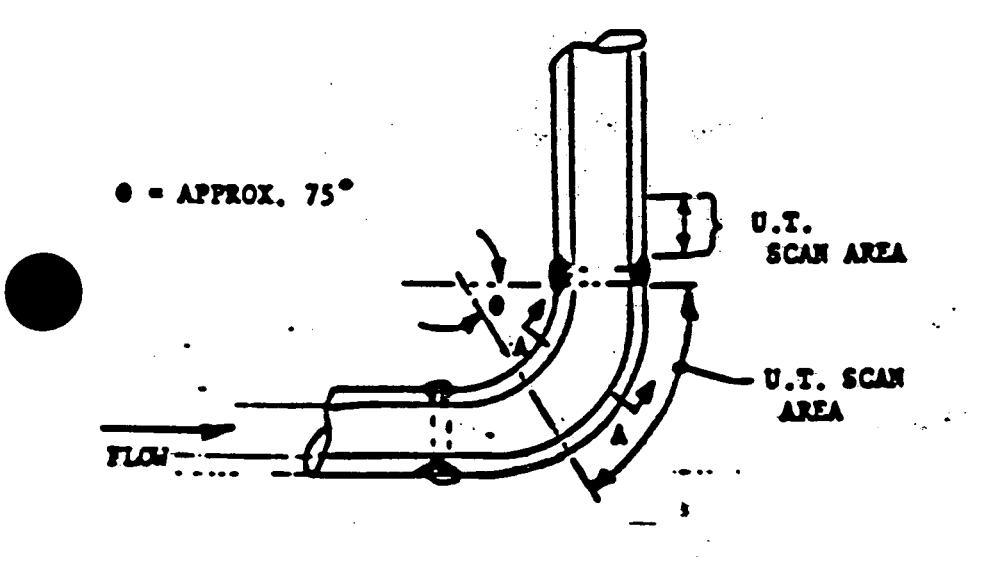
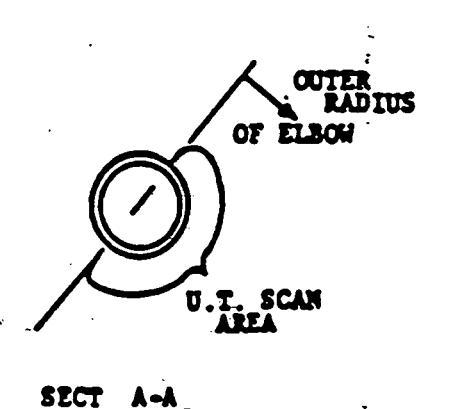
# EXAMINATION AREAS

NOZZLE (CONDENSER OR ELATER)

U.T. SCAN AREA

PIPE OR REDUCER

INSPECTION POINT "C"

INSPECTION POINT "B" (STANDARD ELBOW)
