CHLE-014: T2 LBLOCA Test Report

Document No: CHLE-014	Revision: 2	Page 1 of 36						
Title: T2 LBLOCA Test Report								
Project: Corrosion/Head Loss Experiment (CHLE) Program Date:12 January 2013								
Client: South Texas Project Nuclear Operating Company								
Summary/Purpose of Analysis or Calculation: The Large Break (LB) Loss of Coolant Accident (LOCA) tank test is one experiment within the Chemical Head Loss Experiment (CHLE) test program created to assess the generic safety issue (GSI) 191 chemical effects at the South Texas Project Nuclear Operating Company (STP) facility. The LBLOCA tank test is specifically designed to evaluate aluminum corrosion and the presence of chemical products formed as a function of key material corrosion and dissolution under STP conditions resulting from a 15"

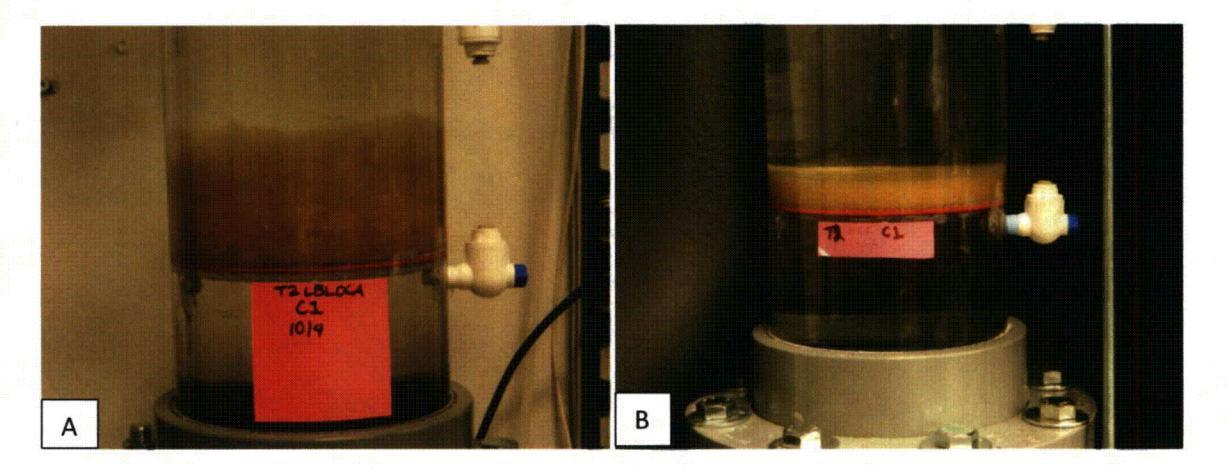
Figure 1: NEI-processed (A) and blender-processed (b) debris beds used in this test.

Head loss measurements across two types of indicator beds are a tool from a suite of diagnostics used in the CHLE testing series [4] to assess the formation of chemical products. The first indicator bed used was the NEI-processed debris bed, which is thought to be more representative of what would occur during a LOCA. It served as a nucleation site for or a filter of possible chemical products that may form during the 30-day test, Figure 1A. Then a blender- processed bed was used at the end of testing. After thirty days of testing, test solution was filtered for 48 hours through a base-lined blender-processed debris bed which is thought to be highly sensitive but not as likely to form as a function of test conditions, Figure 1B.

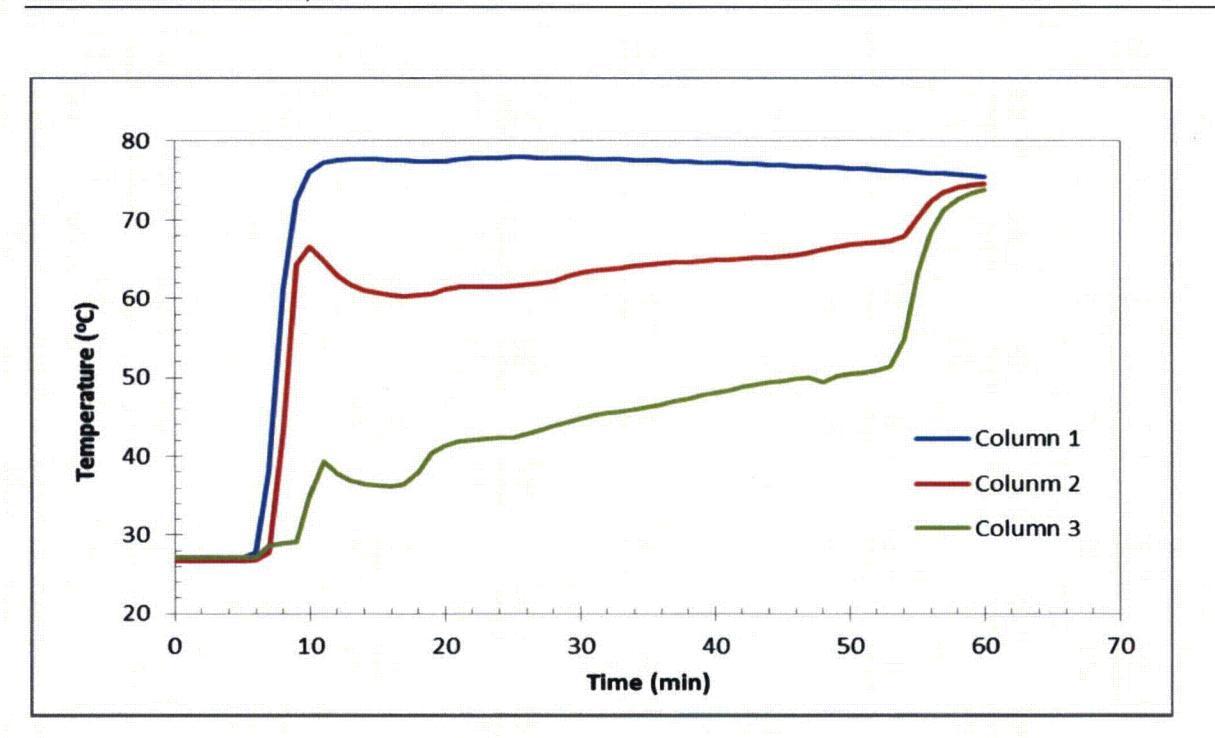
Figure 2: Temperature plot of columns during the first hour.

It should be noted that the test temperature associated with density in the above equation is not measured but estimated to be equivalent to the column temperature. However, this temperature is likely lower due to equipment configurations [4]. Therefore, a negative differential pressure measurement at test initiation is not unexpected since this is the time period where the column temperature is likely to be much greater than the solution temperature used to determine a differential pressure measurement. As the test proceeds, the difference in the column temperature and the solution temperature used to determine a differential pressure measurements significantly decreases. It should also be noted that during the first thirty minutes of testing, the columns as shown by Figure 2. Once the equipment configuration was adjusted to ensure equal flow through columns, the column temperature became equivalent at approximately one hour.

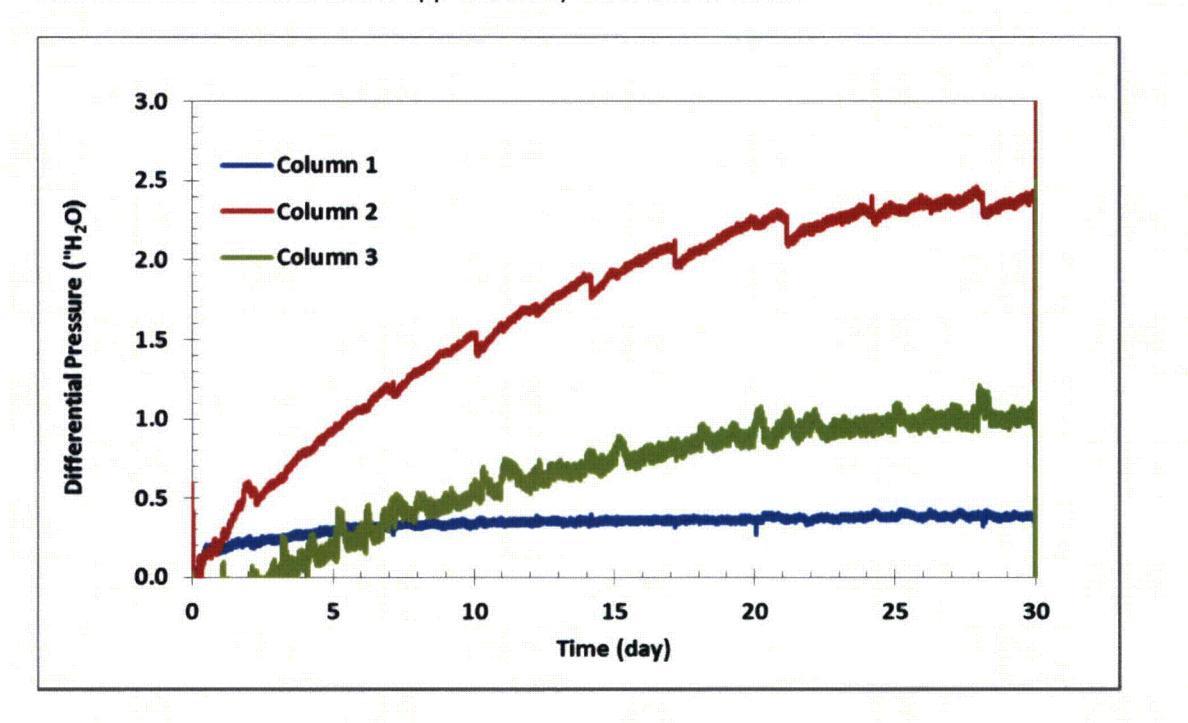
Figure 3: Temperature-corrected head loss through NEI-processed fiberglass debris bed.

As seen in Figure 3, all columns experienced an increase of head loss across the NEI-process debris bed as a function of time. Column 2 had the largest final head loss final value of approximately 2.5 inches of water, while column 1 had the smallest head loss value of about 0.4 inches of water. Column 3 had a final head loss measurement of approximately 1.2 inches of water.

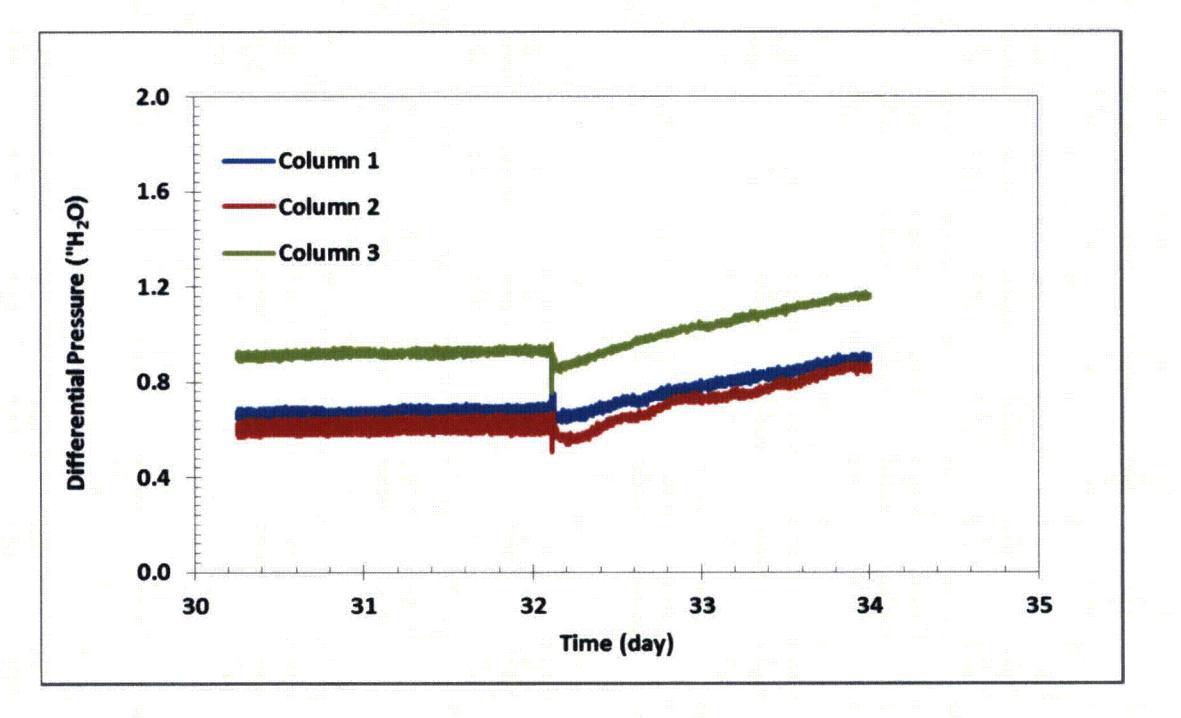
Figure 4: Temperature corrected head loss measurements produced by the blender-processed beds.

After 30 days of testing, the blender-processed beds were installed in the same manner as that was used during the MBLCOA test [4]. The base-line head loss measurements of all the columns experienced little to no change during the 2 days of isolation as shown in Figure 4. The baseline head loss measurements of columns 1 and 2 were equivalent,~ 0.65 inches of water, and approximately 0.3 inches of water less than the base-line measurements of column 3. After the columns were linked to the corrosion tank, the head loss measurements in all columns increased approximately 0.2 inches of water over two days.

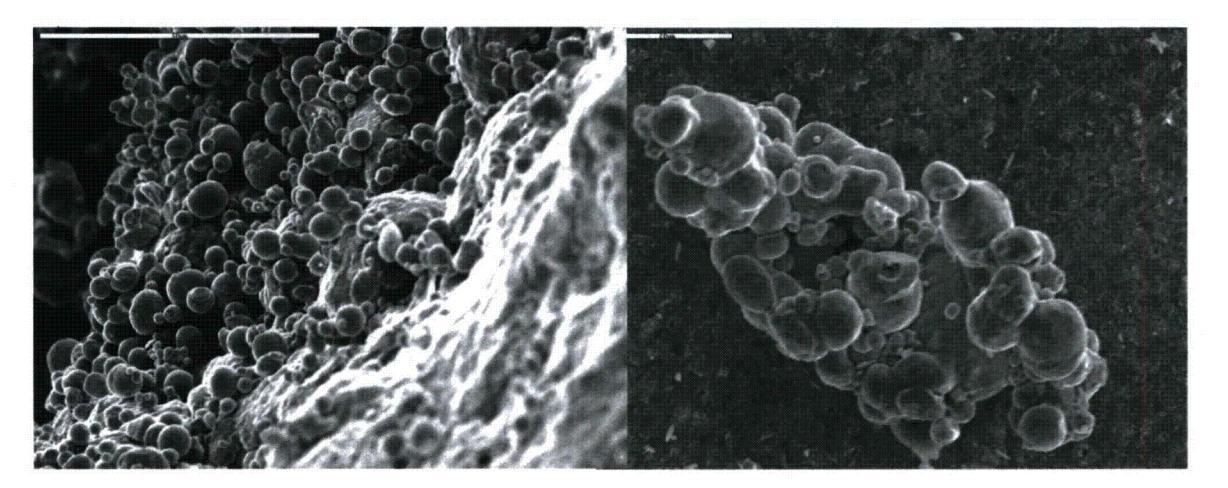
Figure 5: SEM image of zinc used in testing (left) and product captured in-line membrane filter taken after 24 hours of testing (right). EDX analysis of capture material indicates it is likely zinc granules

The increase of head loss is evident; however the source is not. Zinc granules enclosed in a stainless steel mesh envelope were used in testing. While every effort was made to eliminate granules smaller than the mesh, some granules escaped and were captured by the in-line membrane filter, Figure 5. Upon post-test analysis of the stainless steel mesh envelope, tears in the mesh were noted, Figure 6, which may have allowed granules larger than the mesh to also escape. While chemical products were observed and will be discussed further in later sections of this document, particulates (zinc granules) were circulating as early as test initiation and may have been caught in the debris beds influencing head loss measurements.

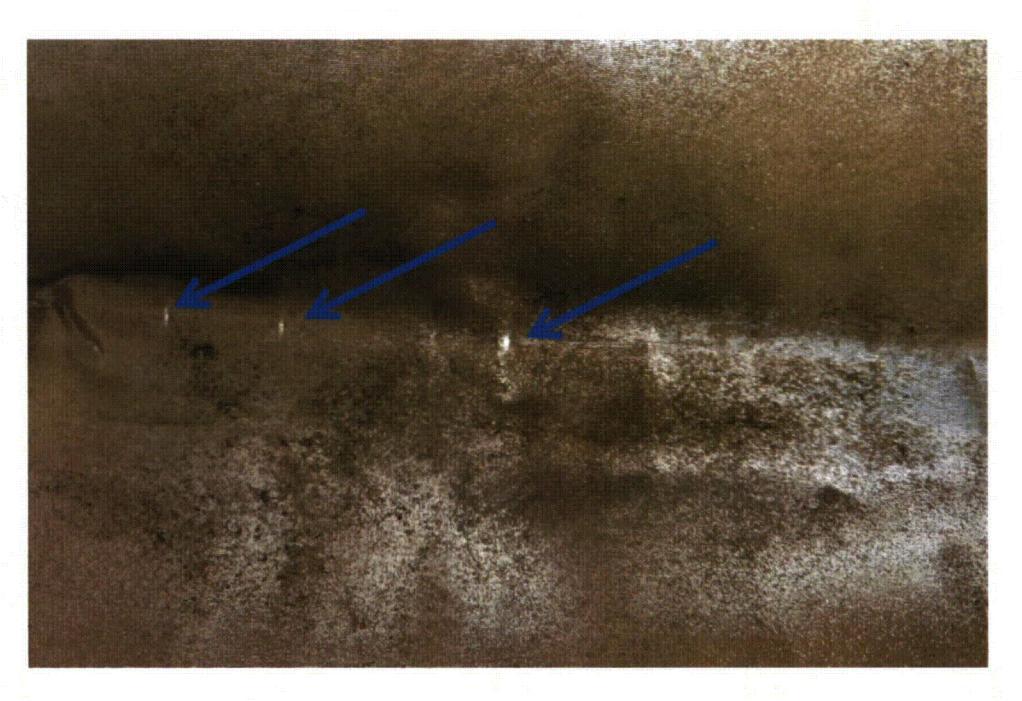
Figure 6: Small tears in zinc mesh bag along the seam.

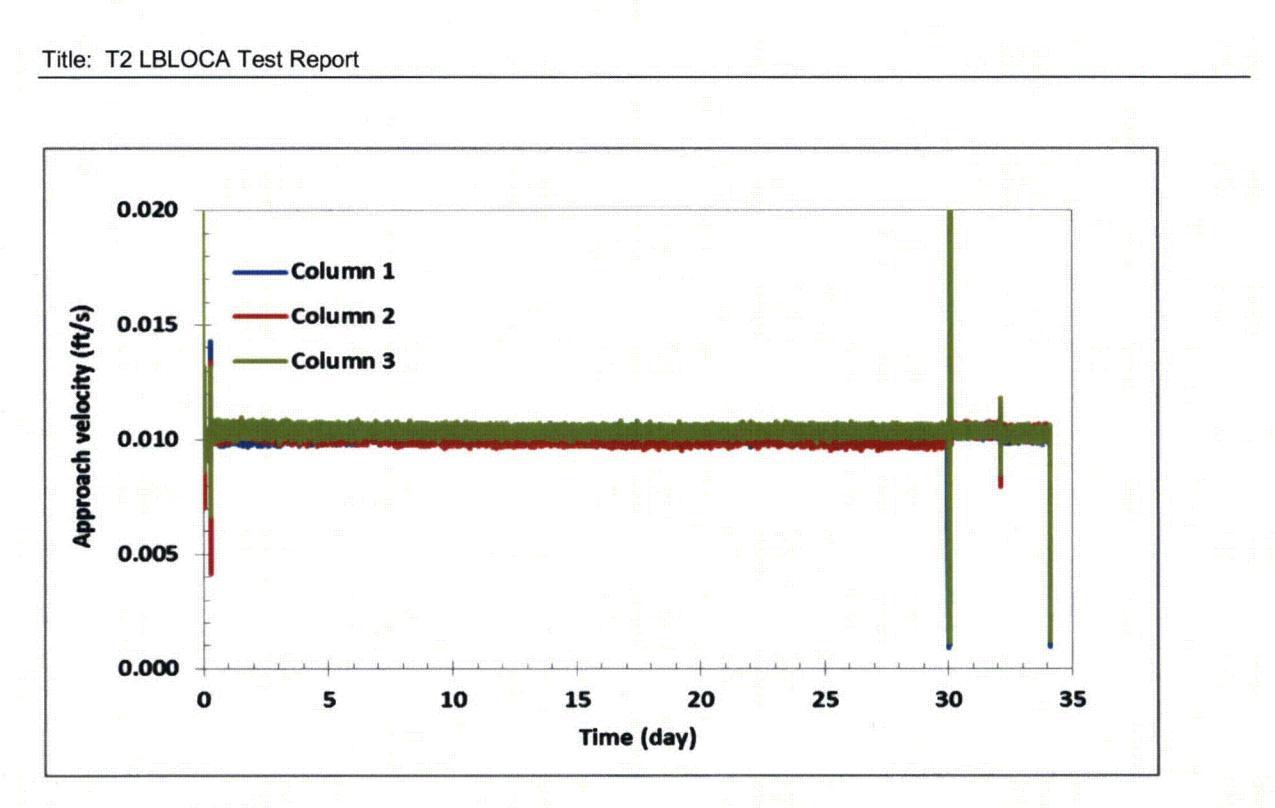
Figure 7: Superficial filtration velocity through fiberglass debris beds used in this test

The approach velocity was maintained near 0.01 ft/s in all three columns throughout testing, Figure 7. Approach velocity for each column was adjusted by throttling a valve on the discharge side of the centrifugal pump followed by adjustment of the variable speed drive. This approach in velocity control prevents fiber buildup for occurring within the valve resulting in minimal disturbance of the velocity during testing.

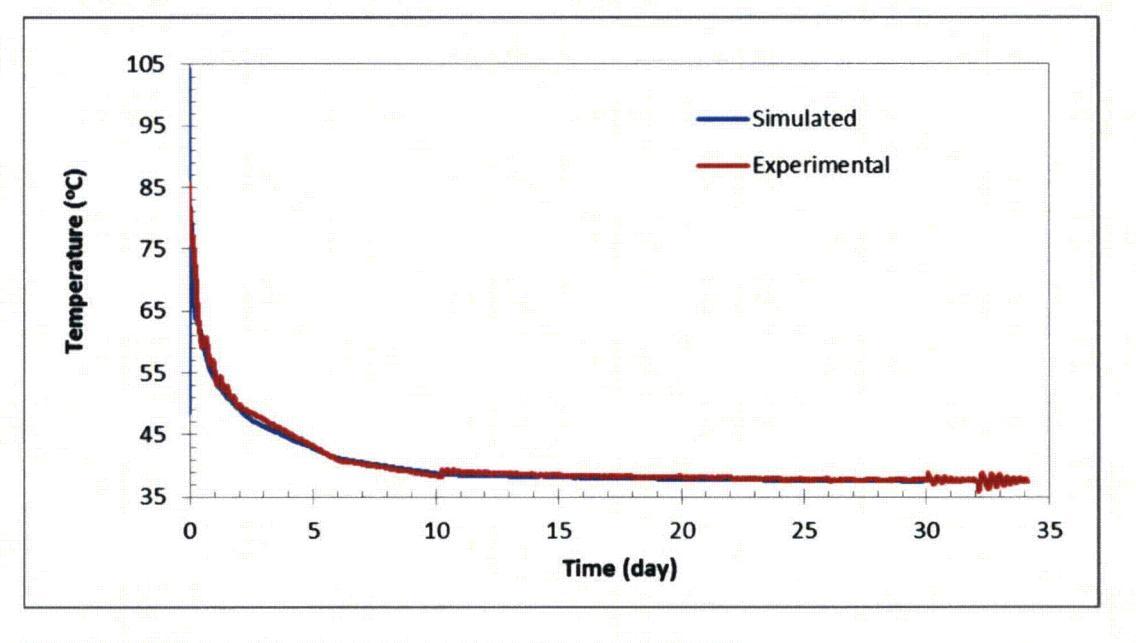
Figure 10: Comparison of simulated and experimental temperature profile.

Once the spray phase ended, the experimental profile linearly decreased to the simulated profile within hours and then traced the simulated profile for the duration of the test as shown in Figure 10. During day 28 to 34, the experimental temperature oscillates around the simulated profile temperature which is a result of non-optimized heater controller operation.

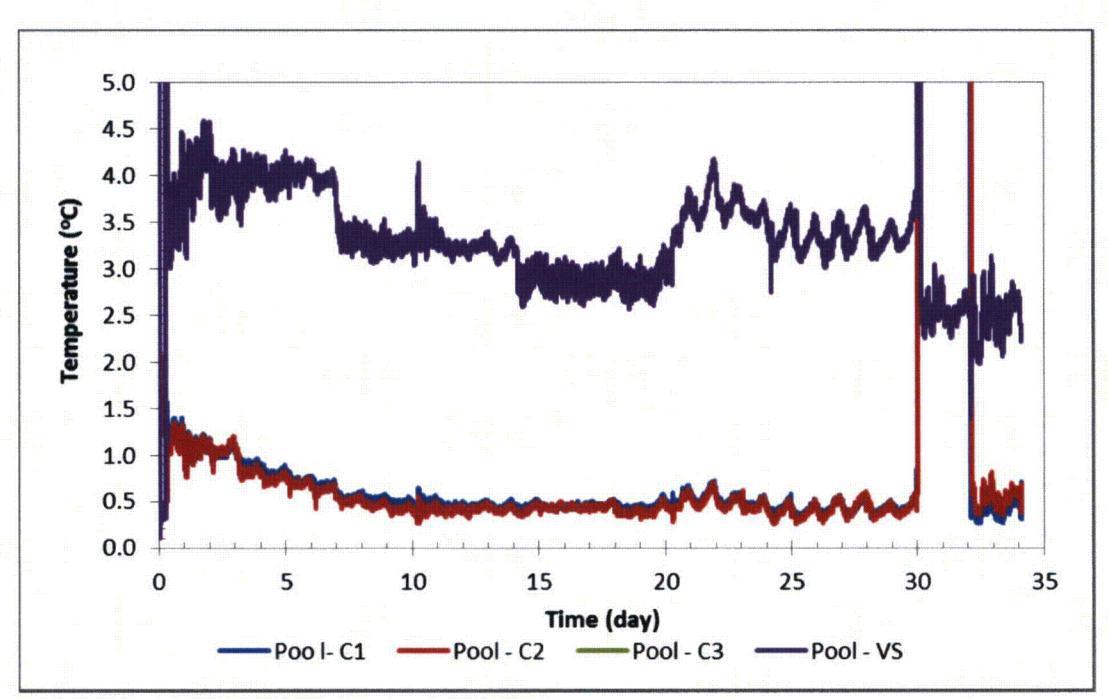
Figure 11: Difference between pool and columns and pool and vapor space temperatures over the test.

The pool temperature appears to be slightly higher than the column as indicated by Figure 11. However the difference in temperature is only greater than 1° C for the first four days. As explained in previous

A difference between the tank solution temperature and tank vapor temperature of up to 4.5°C is also shown by Figure 11. The cycling associated with this difference (~0.5°C) is attributed to the change in room temperature from day to night since the cycling period is approximately 24 hours. The large spikes in temperature differences at day 30 and 34 are due to the removal of the tank lid for experimental needs.

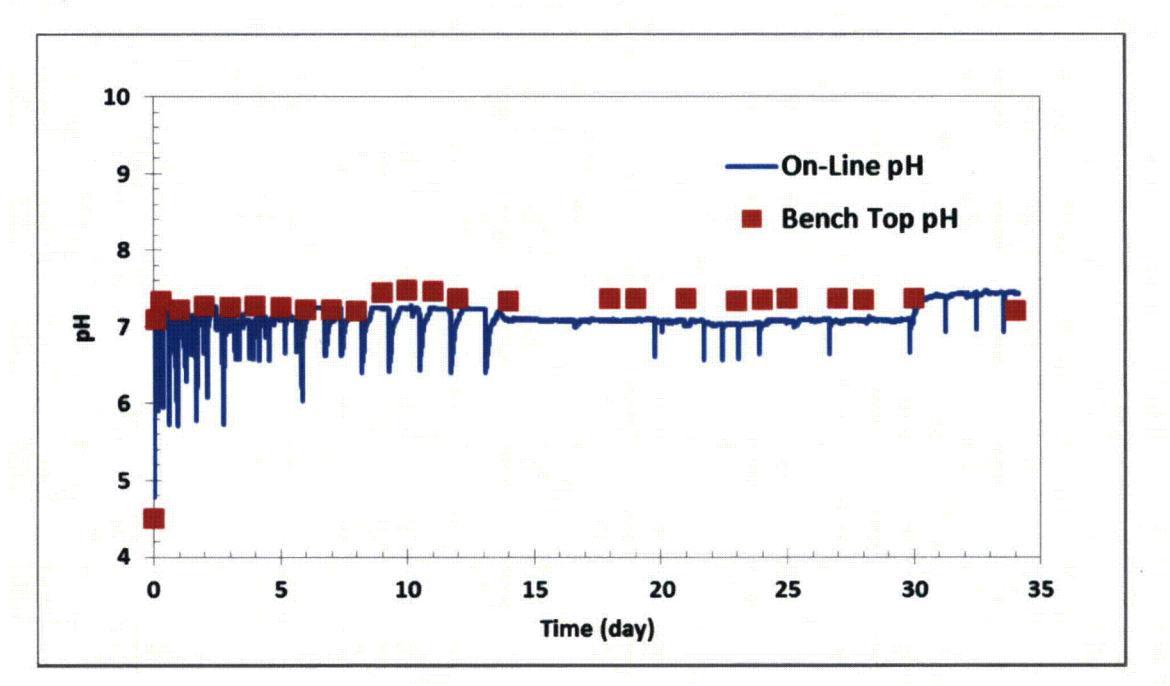
Figure 12: T1 solution pH measurements.

The solution pH was measured by both in-line and bench top automatic temperature correction (ATC) pH meters. The in-line pH meter only calibrates with a two-point curve and was calibrated using the pH 7 and the pH 10 standards. This two-point calibration results in unreliable measurements below pH 7 for this test. Therefore the starting solution pH was obtained using the bench top meter which was calibrated using a three point calibration of standard 4, 7 and 10. Above pH 7, the bench top and in-line pH results were within 0.1 pH units of each other. As determined by the bench top pH meter, the solution pH at test initiation was 4.5 and increased to 7.3 during the addition of TSP. The solution pH remained at 7.3 ± 0.1 for the duration of the test as shown by Figure 12. Post-test evaluation of the in-line pH meter showed that the in-line pH meter was not functioning correctly which provides explanation for the erratic behavior observed in Figure 12.

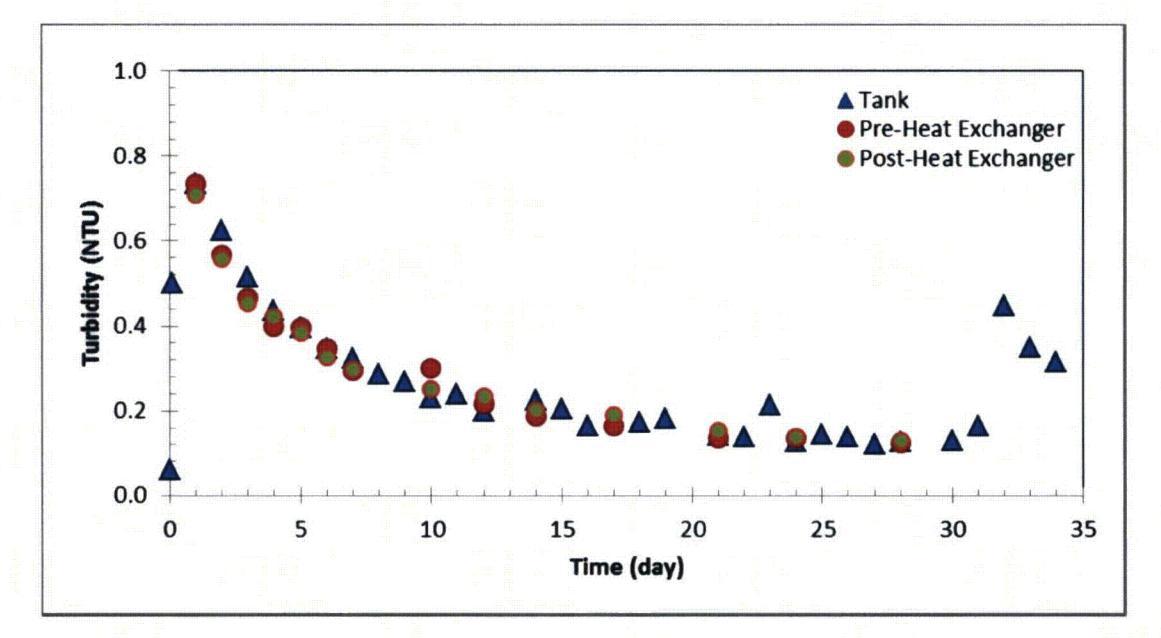
Figure 13: T2 solution turbidity measurements

turbidity when cooled by the heat exchanger remained relatively similar to the test-temperature solution turbidity, Figure 13.

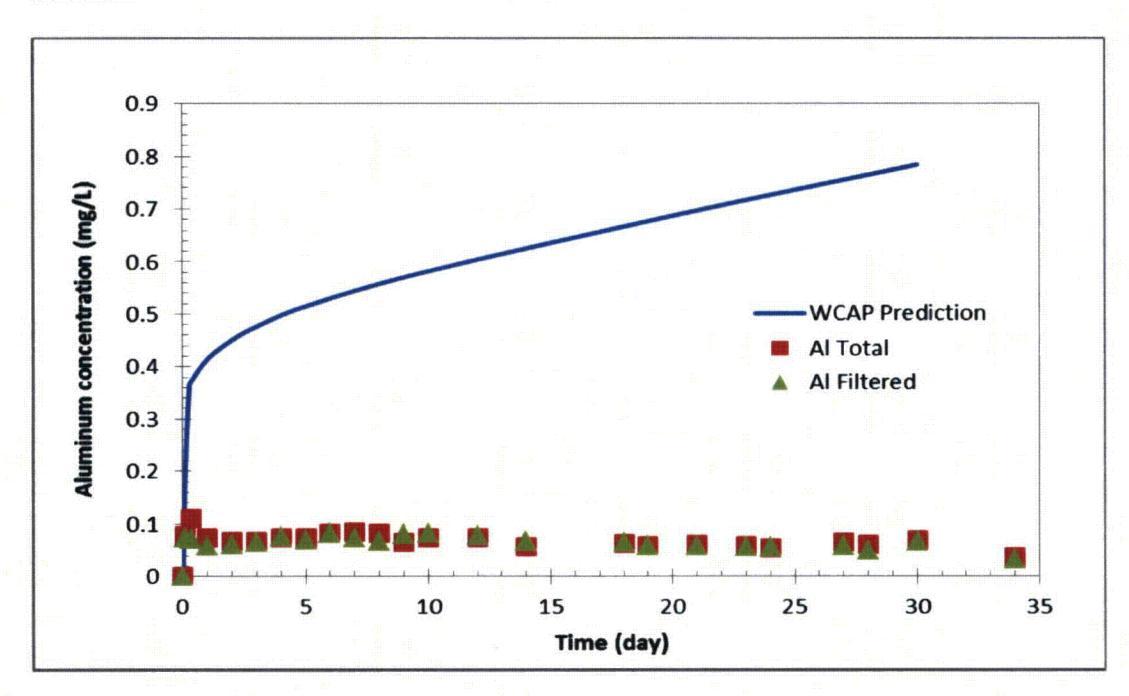
Figure 14: T1 measured and predicted aluminum concentration over time

The final measured aluminum concentration was approximately 0.07 mg/L and was present at this concentration by Day 1 as seen in Figure 14. The aluminum concentration reported is less than the reporting detection limit of 0.2 mg/L, but is above the equipment MDL. Therefore there is a degree of uncertainty associated with the absolute values in Figure 14. While the submerged aluminum surface area in this test (0.31 ft²) was about a third less than that in the MBLOCA test (0.47 ft²), there was much less aluminum detected in this test when compared to the MBLOCA test [4]. The T-statistic value listed in Table 3 was calculated from the analysis of the measured total and filtered aluminum concentration and is less than the T-critical value; therefore the total and filtered sample concentrations are

Also, the measured 30-day aluminum concentration is approximately eleven times less than that predicted by the WCAP equations [1]. This difference between the predicted and experimental release is much larger than that obtained when evaluating the MBLCOA test results with the same predictive tool. While the difference between the experimental and predicted aluminum increased significantly in the presence of zinc material during the LBLOCA test, predictions for both the MBLOCA and LBLOCA overestimated the aluminum material release. Although the predictive and experimental releases were

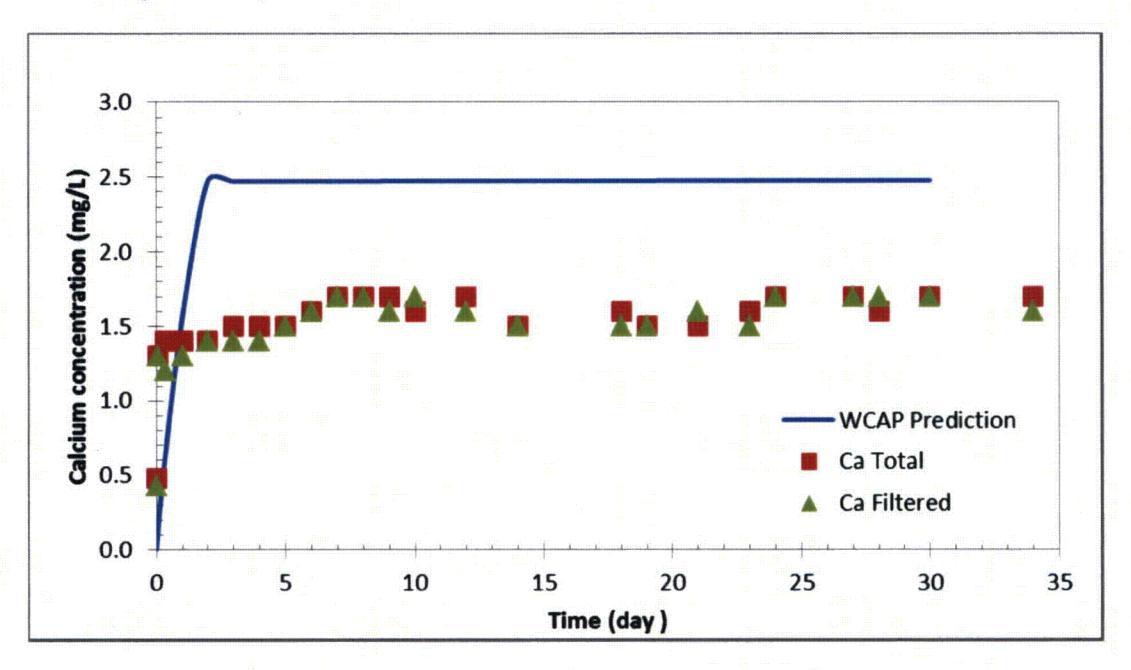
Figure 15: T1 measured and predicted calcium concentration over time

The calcium concentration after 30 days of testing was approximately 1.7 mg/L as shown by Figure 15. Although this test contained about 2.5 times more fiberglass than the MBLCOA test [4], this concentration was very close to that measured at the end of the MBLOCA test (1.8 mg/L). Statistically the filtered concentrations were equivalent to the total concentrations given that the T-statistic value was less than the T-critical value as listed in Table 4. Therefore it is likely that a calcium product greater than 0.45 μ m is not present in solution.

The experimentally obtained calcium concentration was approximately 70% of the predicted concentration obtained using the WCAP-16530 equations [1]. While the predictive equations under estimated the calcium release in the MBLOCA test [4], it over estimated the release of calcium in this test.

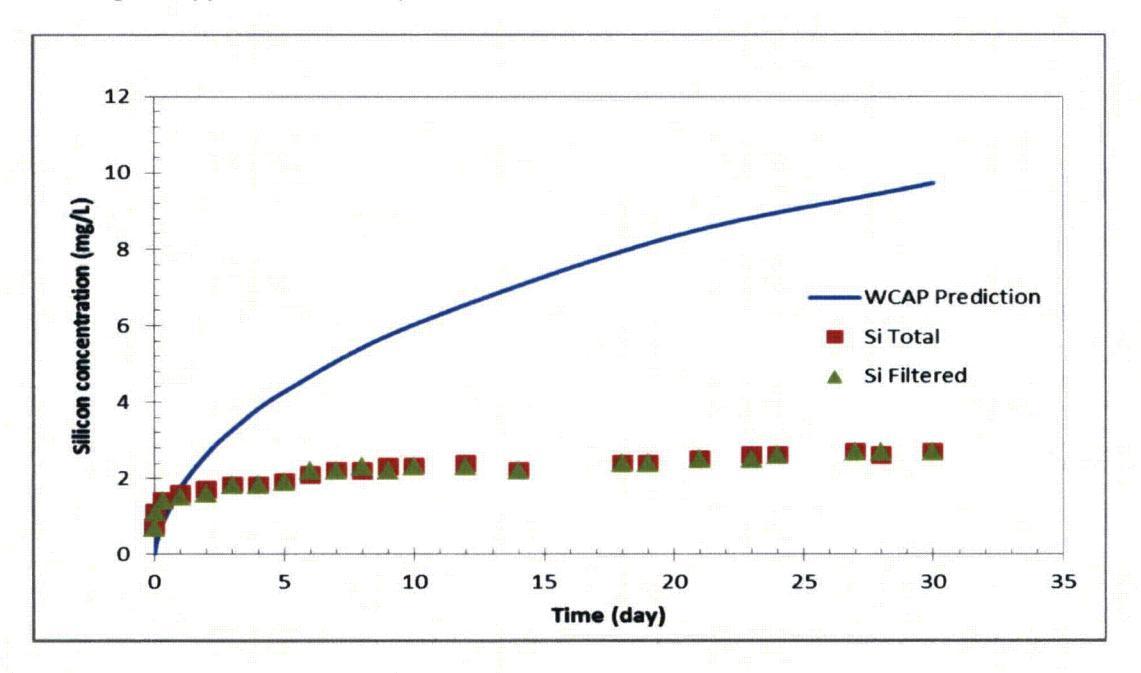
The measured silicon concentration was approximately 2.7 mg/L after 30 days of testing as shown by Figure 16. This concentration is approximately half of that measured at the end of the MBLCOA Test [4] even though there was approximately 2.5 times more fiberglass in solution. The silicon concentration increased continually over the 30 days of testing. Statistical evaluation of the total and filtered sample concentrations were equivalent given that the T-statistic value is less than the t-critical value. Therefore it is likely that a silicon product greater than 0.45 μ m is not present in solution. Also, the difference between the experimentally obtained and WCAP-16530 predicted [1]silicon concentration was large as opposed to the very small difference observed for the MBLCOA.

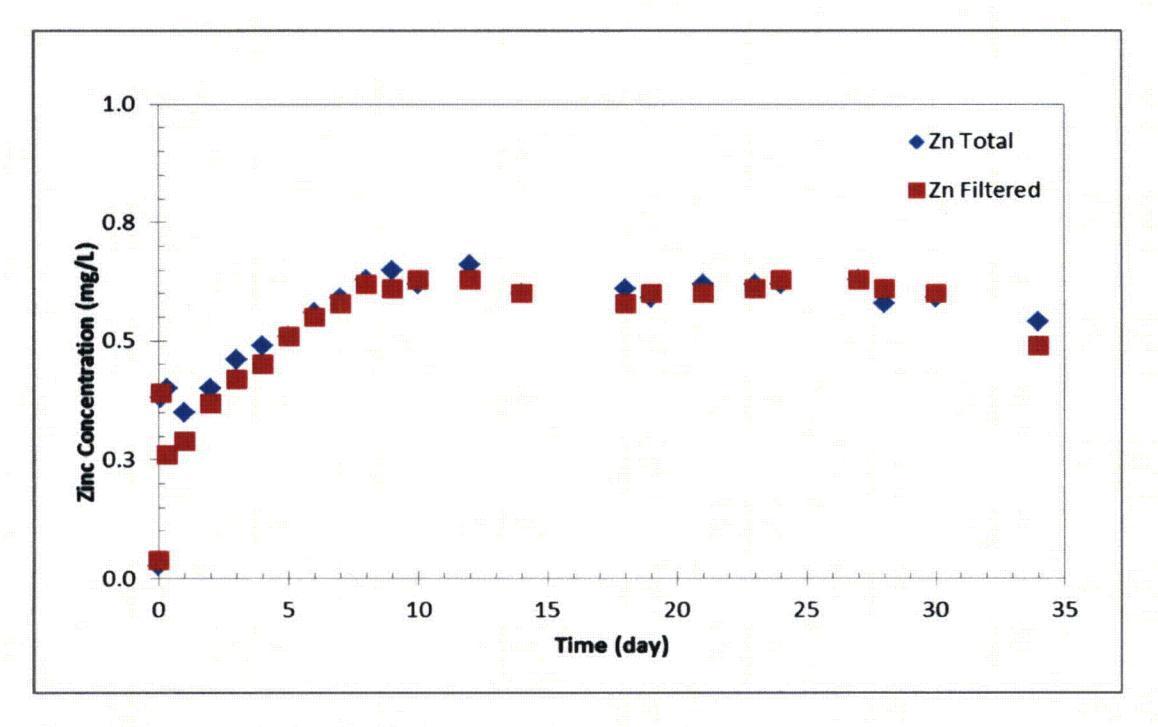
Figure 17: T1 measured and predicted zinc concentration over time

The zinc concentration peaked to 0.65 mg/L by day 9 and remained close to this concentration for the duration of testing as seen in Figure 17. Statistically, the filtered concentrations were different than the total concentrations given the t-statistic value is greater than the t-critical value as listed in Table 6. This may indicate that a zinc product (raw material or in-situ formed product) greater than 0.45 μ m existed in solution. Zinc products were captured by the in-line membrane filters, but it is unknown whether this product was formed on a surface and brushed into solution or if this product is the result of a solubility limit existing in solution. It is also possible the product is a zinc granule that escaped from the mesh envelope.

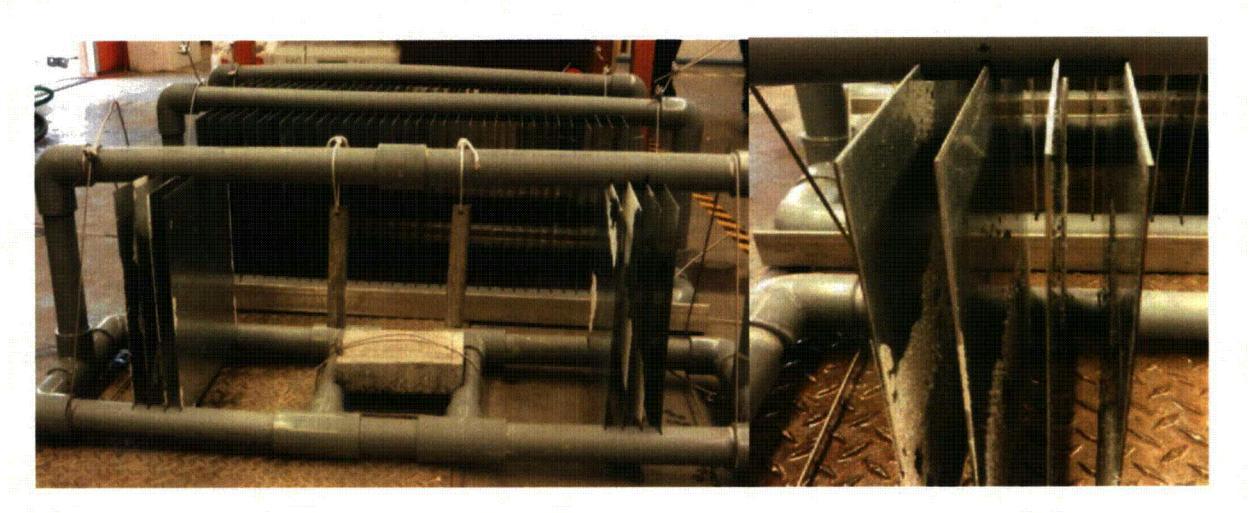
Figure 19: Submerged galvanized steel coupons with white chemical deposit

During testing, white product was observed on discrete areas of the submerged galvanized steel as shown by Figure 19 and on the tank floor below the submerged galvanized steel coupons as seen in Figure 20. After testing, a similar product was observed on small areas of the mesh envelope which housed the zinc granules as well as on the zinc granules themselves as shown by Figure 21. This product was not overtly evident on the fiber beds, therefore debris captured by the beds are not explored in this section. It should be noted that these type of white deposits on the galvanized steel or inorganic zinc coated coupon have been seen in past testing done under similar conditions [7] as shown by Figure 22. However these deposits observed in past testing [7] were not subject of rigorous analysis.

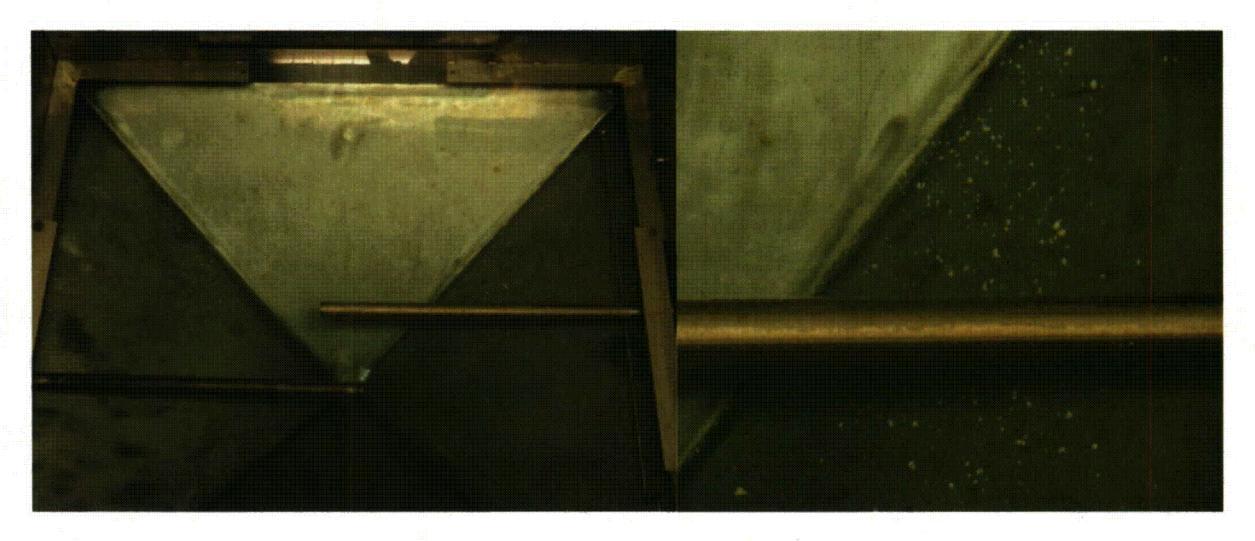
Figure 20: White chemical product located mainly in the areas directly below the submerged galvanized steel coupons

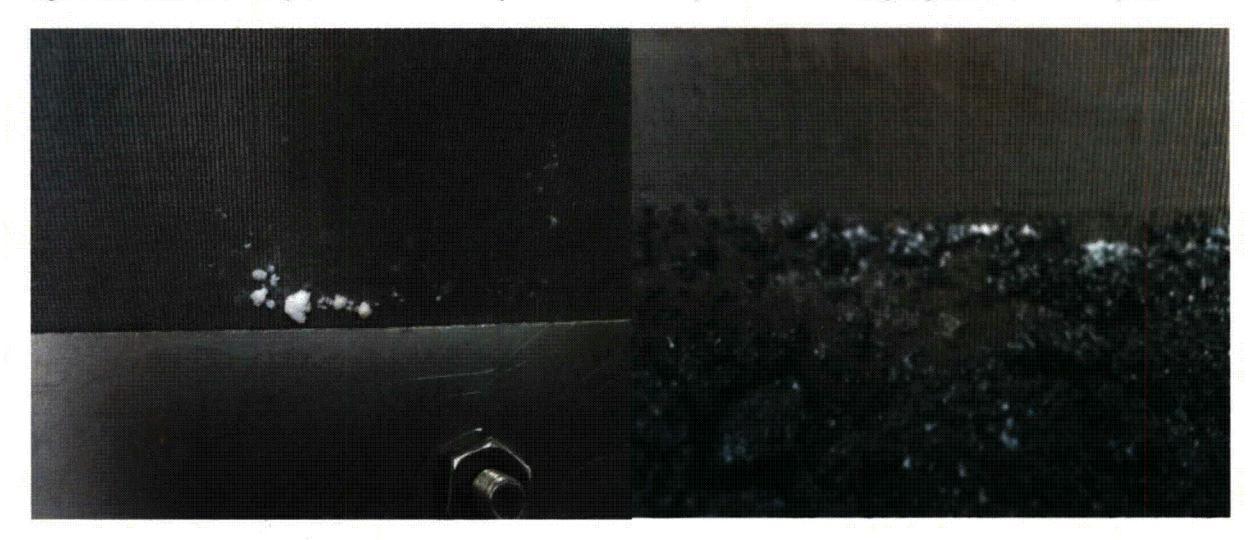
Figure 21: White chemical product on the mesh envelope and on the zinc spheres it contained

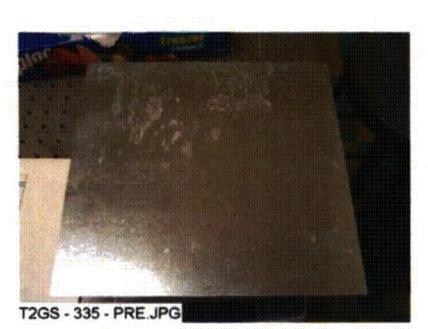
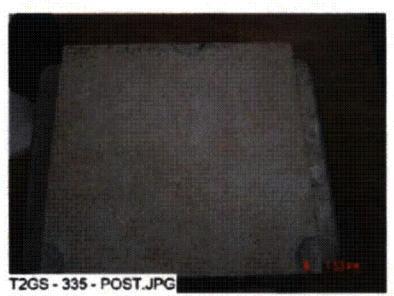
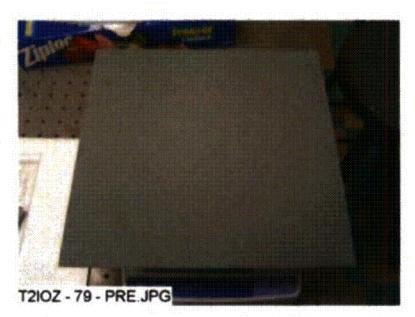
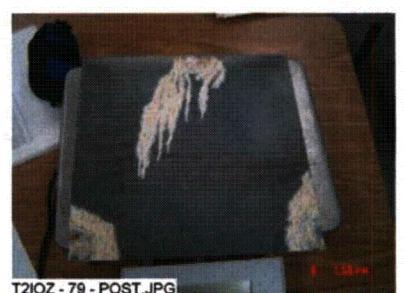
Figure 4-8. GS-335 submerged, pre-test.

Figure 4-9. GS-335 submerged, post-test.

Figure 4-14. IOZ-79 submerged, pre-test.

Figure 4-15. IOZ-79 submerged, post-test.

Figure 22: White chemical product galvanized steel and inorganic zinc coated steel observed in past testing[7]

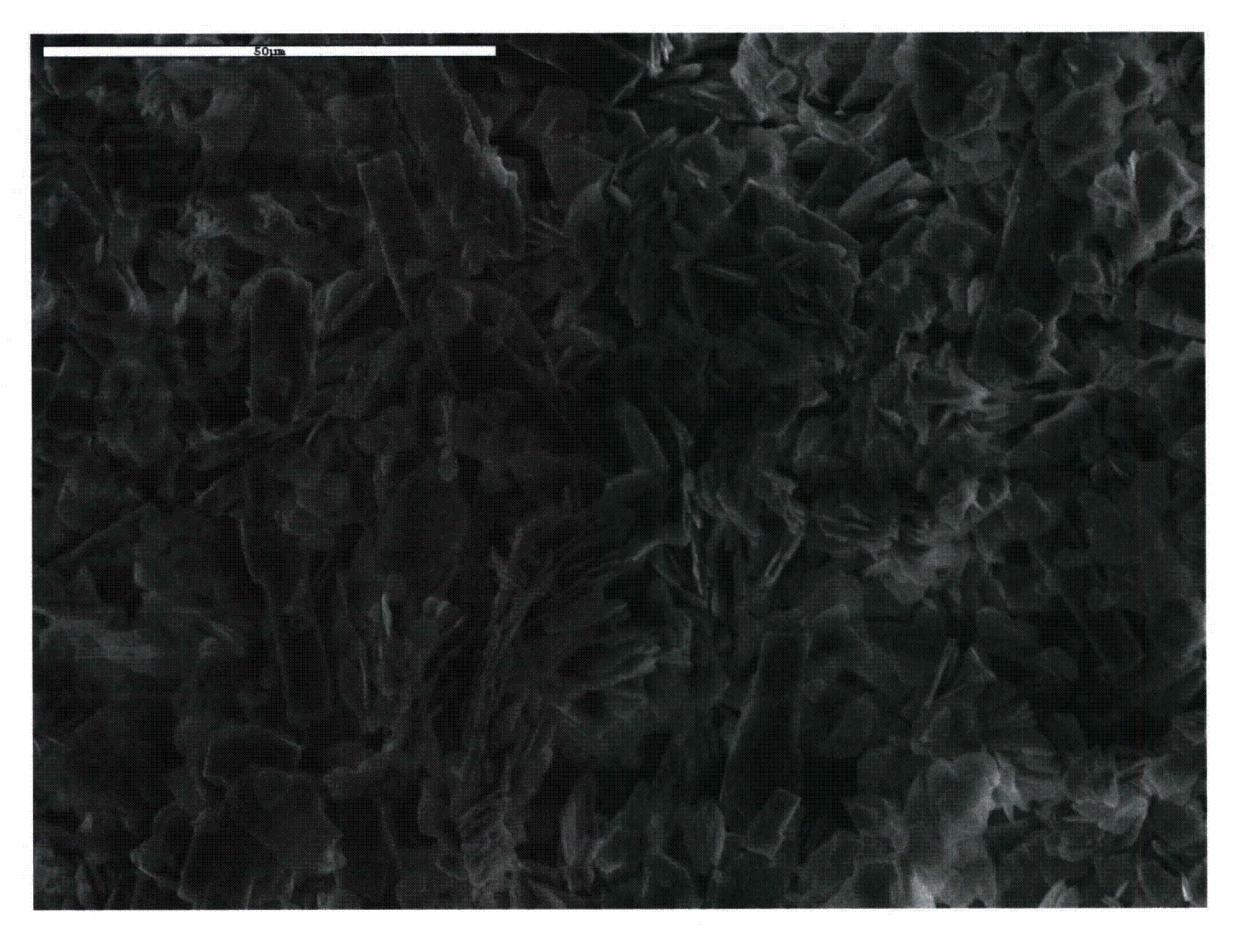
Figure 23: SEM image of white chemical product with a 50 μm scale bar

As seen in SEM image of the chemical product in Figure 23, it appears with a flake like consistency and has constituents of zinc (~25 atomic %), phosphorous (~19 atomic %), and oxygen (~56 atomic %). The size and shape of the product range and is likely a result of scraping the product from a surface. SEM analysis of in-line membrane (discussed in detail in the upcoming section) did capture rod shaped particulate with very similar composition to that of the material scraped from the coupons. These capture particulate were <10 μ m long and a 1-2 μ m wide. An example of this product is shown by Figure 24 and may indicate the shape and size of such product that may be traveling within solution. The ICP-AES results obtained from analysis of the digested product are in agreement that the metal associated with this material is zinc (99.7%). XPS analysis determined that the material was also composed of zinc (18.3 atomic %), phosphorous (8.4 atomic %) and oxygen (73.3 atomic %) but could not determine a stoichiometric formula from the biding energies.

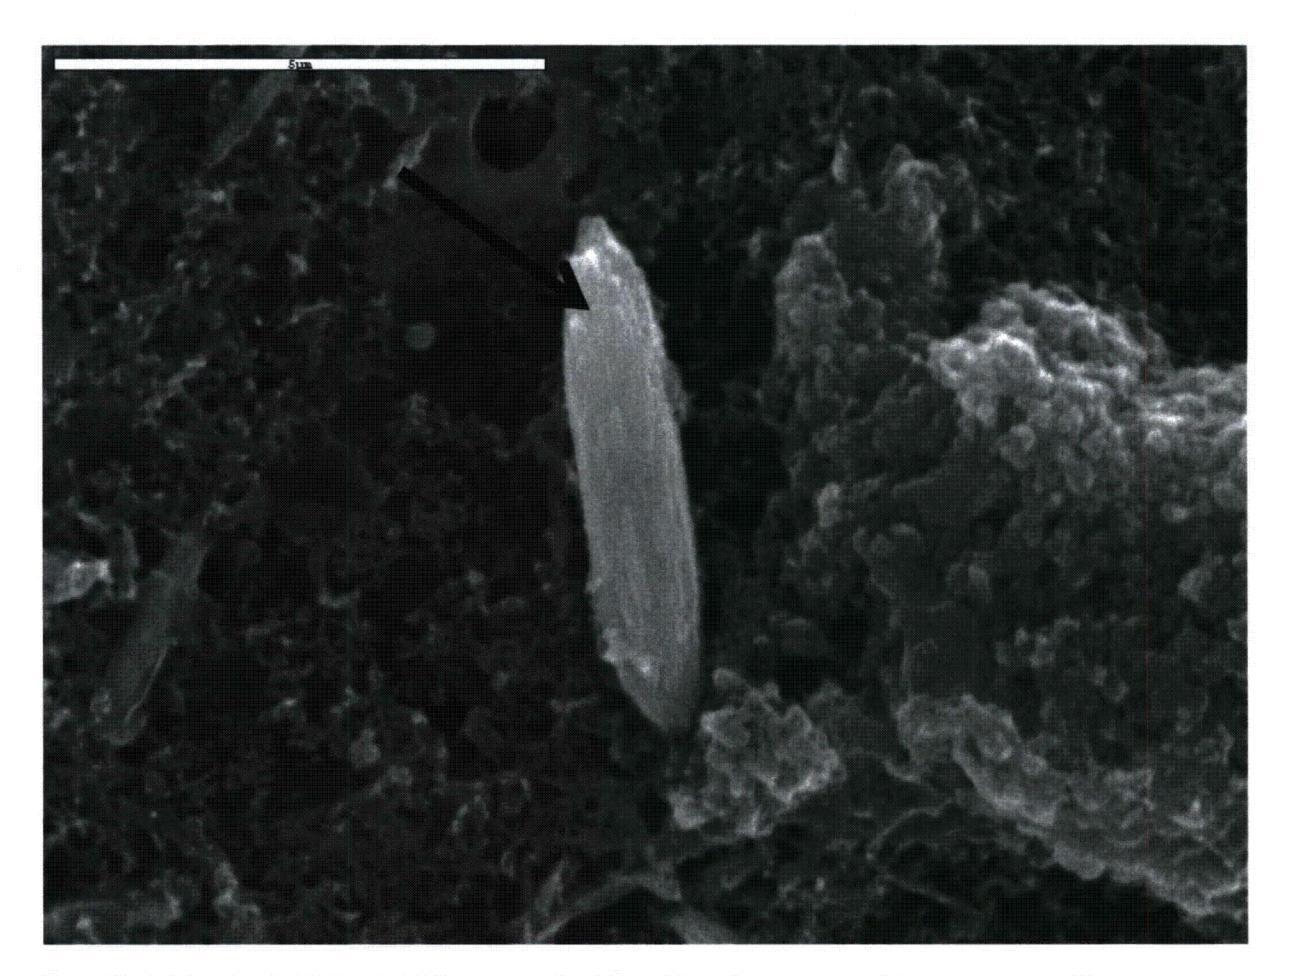
Figure 24: SEM image of rod shaped product captured on filter with equivalent composition as that scraped from coupons.

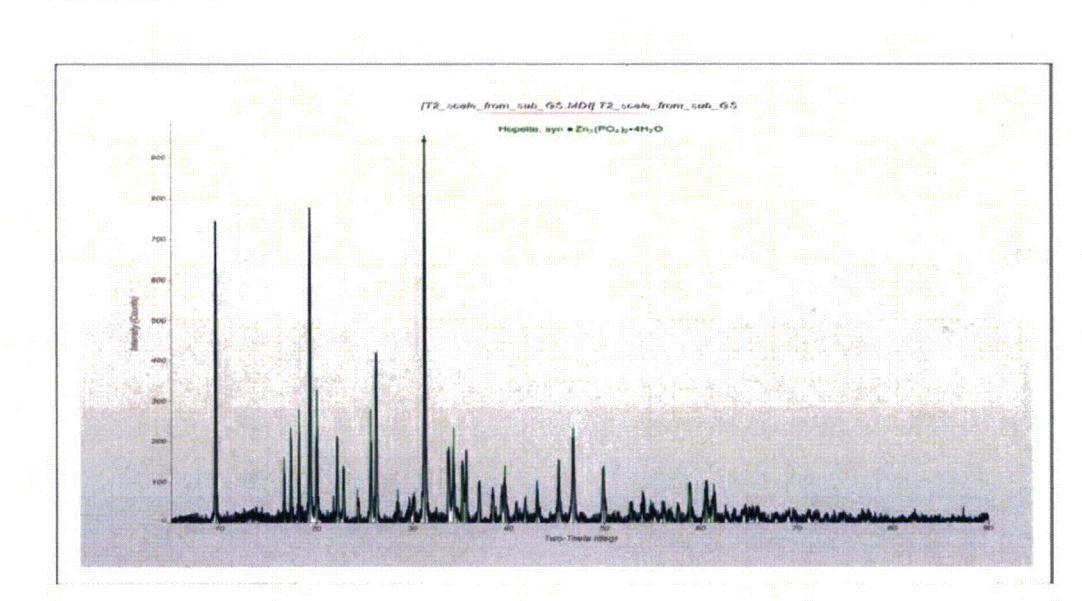
Figure 25: XRD result of chemical product obtained from submerged coupon

To further characterize the chemical product, it was evaluated by XRD analysis. The resulting diffraction patterns were analyzed using Jade 9.0 Plus software from by Materials Data, Incorporated. The Jade 9 software matches the diffractogram peaks obtained from the sample analyzed to standards found in the International Center for Diffraction Data (ICDD) database. It then assigns each match a Figure of Merit (FOM) value based on how well the experimental results compare to the standards. A FOM of zero indicates a perfect fit; while a FOM range of 0-20 is considered a close fit. The best FOM obtained from the analysis of the chemical product scraped from the submerged coupons was 9.6 and matched a synthetic Hopeite, $Zn_3(PO_4)_2$ ·4H₂O. As seen in Figure 25, the 2 Θ angle positions of the sample exactly match that of the standard and the sample intensity (indicated in black) slightly deviate from the standard intensities (indicated in green). This deviation in intensities is likely due to preferred particle orientation which explains why the FOM is not closer to 0. The stoichiometry of synthetic Hopeite, $Zn_3(PO_4)_2$ ·4H₂O, is also in close agreement with the percent atomic distribution determined by EDX analysis of the SEM image and the XPS results.

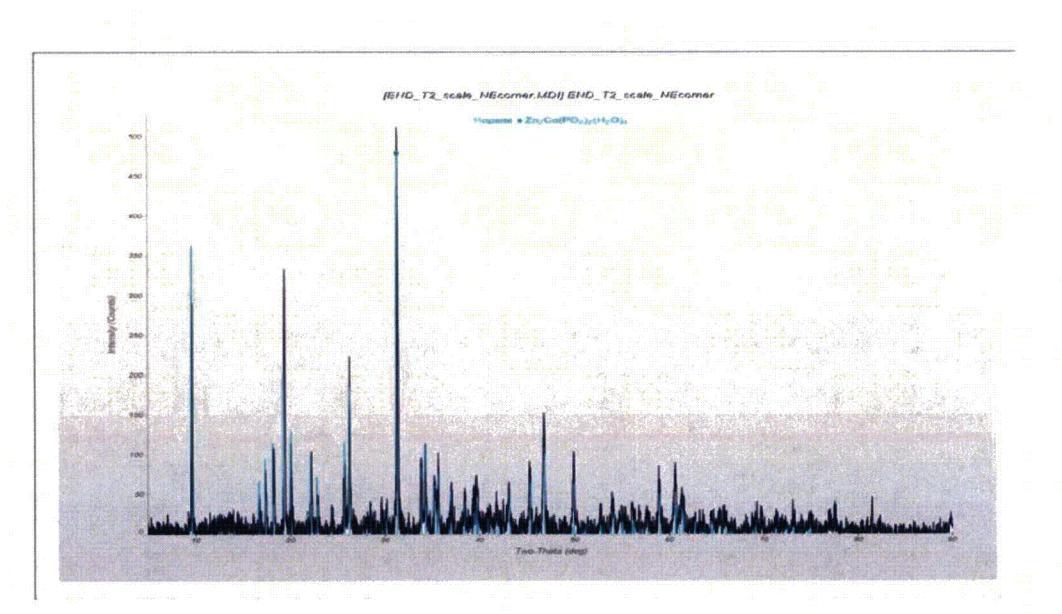
XRD analyses of samples taken from the north east, north west, and south west corners of the tank floor supports that the chemical product in these areas is equivalent to that found on the submerged coupons. It should be noted that the submerged galvanized steel coupons were located on the north side of the tank. The analysis of the product taken from the north east corner produced a diffraction pattern very close to synthetic hopeite (Figure 26) with a FOM of 9.6. The results obtained from the sample taken from the north west corner (Figure 27) also indicate that the product was hopeite. The best FOM of 2.9 determined from this match indicated that product was hopeite with a carbonate group, not the synthetic hopeite. However, the synthetic hopeite was also listed as a close match with a FOM of 4. The sample obtained from the south west corner was very close to the mass limit required for analysis and produced a FOM of 27.8. While this FOM indicates the match was between the sample and the identified standard was not very good, this was the best FOM obtained from the analysis and it identified the material as synthetic hopeite.
