CHLE-014: T2 LBLOCA Test Report

Document No: CHLE-014	Revision: 2	Page 1 of 36						
Title: T2 LBLOCA Test Report								
Project: Corrosion/Head Loss Experiment (CHLE) Program Date:12 January 2013								
Client: South Texas Project Nuclear Operating Company								
Summary/Purpose of Analysis or Calculation: The Large Break (LB) Loss of Coolant Accident (LOCA) tank test is one experiment within the Chemical Head Loss Experiment (CHLE) test program created to assess the generic safety issue (GSI) 191 chemical effects at the South Texas Project Nuclear Operating Company (STP) facility. The LBLOCA tank test is specifically designed to evaluate aluminum corrosion and the presence of chemical products formed as a function of key material corrosion and dissolution under STP conditions resulting from a 15"

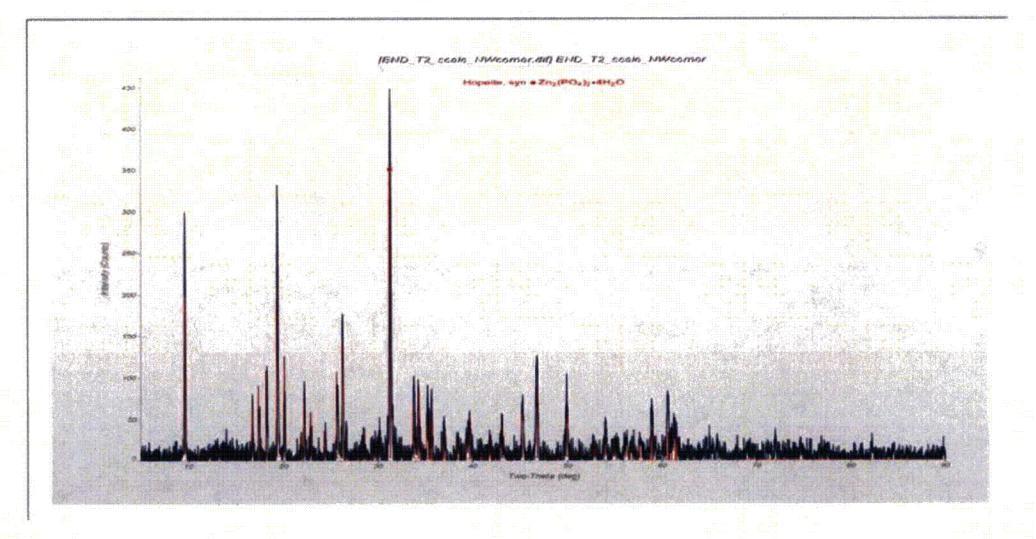
Figure 27: XRD result of chemical product obtained from submerged coupon End Test 2 NW Corner Precipitate

XRD analyses of samples taken from the north east, north west, and south west corners of the tank floor supports that the chemical product in these areas is equivalent to that found on the submerged coupons. It should be noted that the submerged galvanized steel coupons were located on the north side of the tank. The analysis of the product taken from the north east corner produced a diffraction pattern very close to synthetic hopeite (Figure 26) with a FOM of 9.6. The results obtained from the sample taken from the north west corner (Figure 27) also indicate that the product was hopeite. The best FOM of 2.9 determined from this match indicated that product was hopeite with a carbonate group, not the synthetic hopeite. However, the synthetic hopeite was also listed as a close match with a FOM of 4. The sample obtained from the south west corner was very close to the mass limit required for analysis and produced a FOM of 27.8. While this FOM indicates the match was between the sample and the identified standard was not very good, this was the best FOM obtained from the analysis and it identified the material as synthetic hopeite.

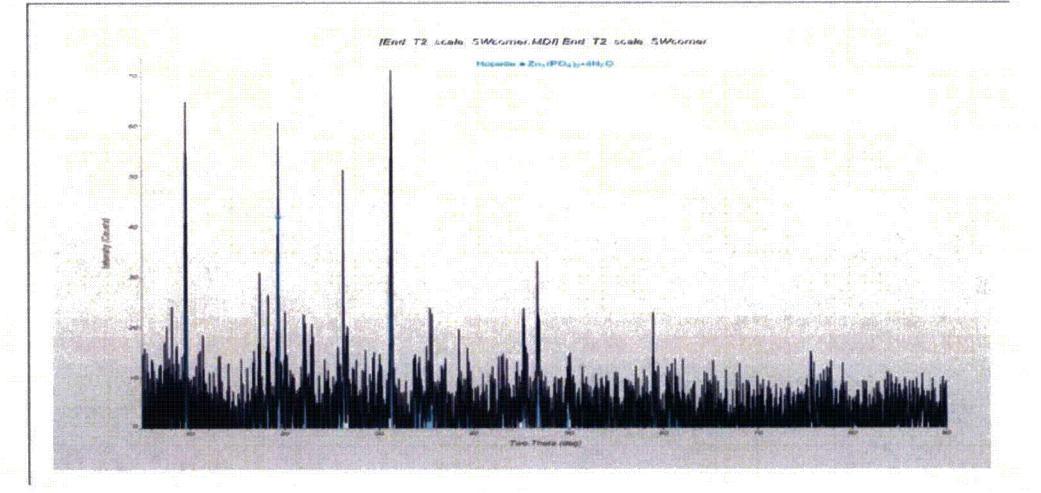
Figure 28: XRD result of chemical product obtained from submerged coupon End Test 2 SW Corner Precipitate

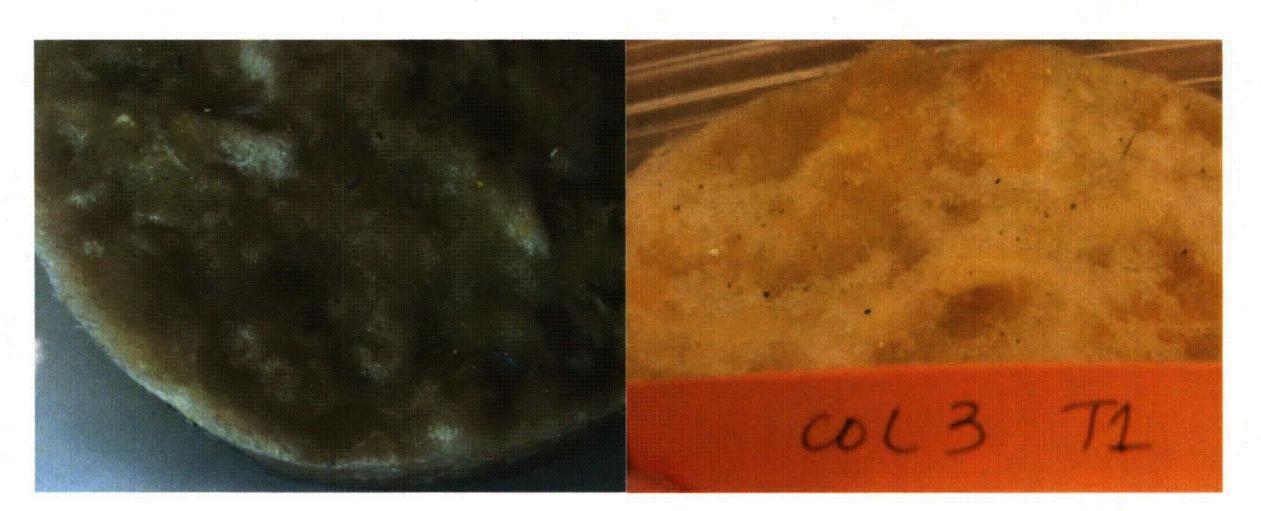
Figure 29: NEI-processed beds LBLOCA C3 (left) and MBLOCA C3 (right) beds after exposure to test solution

The NEI-processed fiber bed was collected on Day 30 and the blender-processed fiber bed was collected on Day 34. This test experienced a continually increasing head loss across the NEI-processed fiber bed which ranged from 0.4-2 inches of water and a head loss across the blender-processed fiber bed of approximately 0.2 inches of water. The appearance of the fiber beds at the end of testing were similar to that found at the end of the MBLOCA test [4] as shown by Figures Figure 29 and Figure 30. Both detector beds had a disperse collection of white, brown and greyish/black particulates on the tops of the beds. Particulate capture within the bed was not observed by the naked eye during dissection of the detector beds.

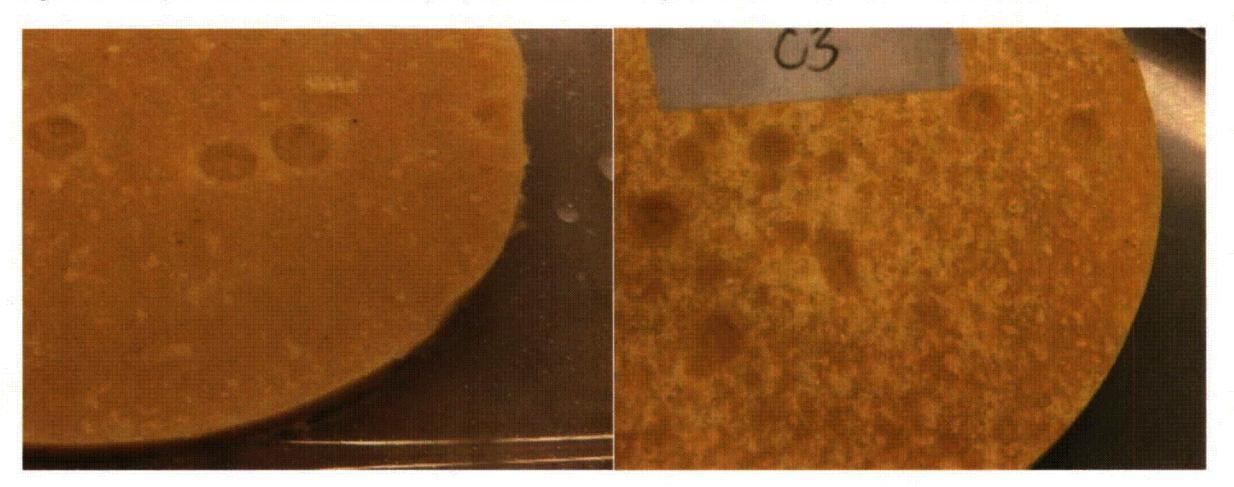
Figure 30: Blender-process beds LBLOCA C2 (left) and MBLOCA C3 (right) beds after exposure to test solution

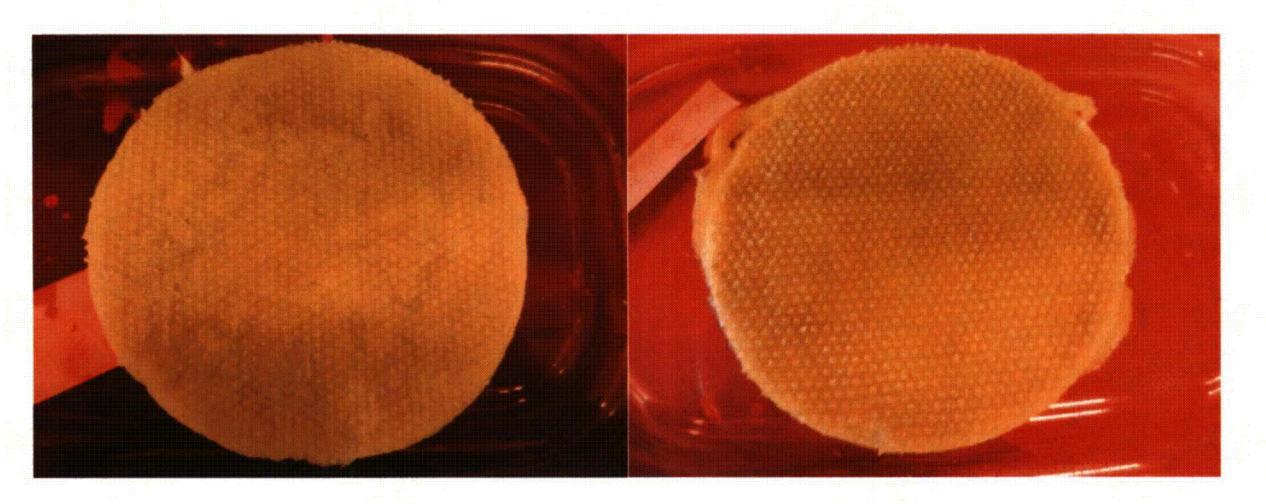
Figure 31: LBLOCA column 3 bottom of NEI-processed (left) and blender processed (right) beds after exposure to test solution

The bottom of both detector beds have a similar pattern which has been observed in past testing as seen as seen in Figure 31. The pattern appears slightly more pronounced on the blender-processed fiber bed than on the NEI-processed fiber bed. When examining the bottom of the beds, areas of nodules appeared to have a slightly different texture than the others and in some cases small craters were noticed on the bottome of the bed as seen in Figure 32.

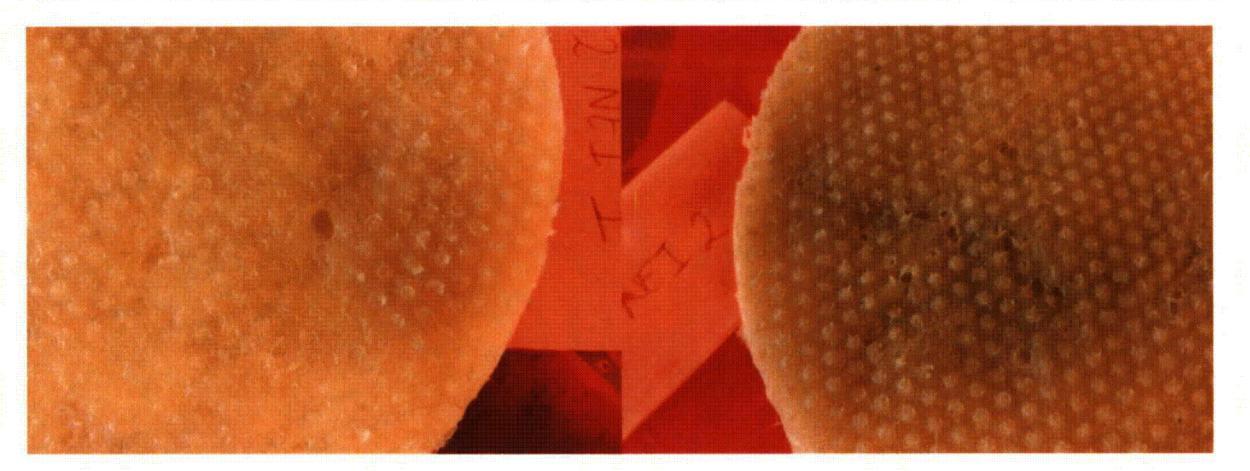
Figure 32: NEI-processed fiber bed bottom of column 1 (Left) and column 2 (right) with missing nodules

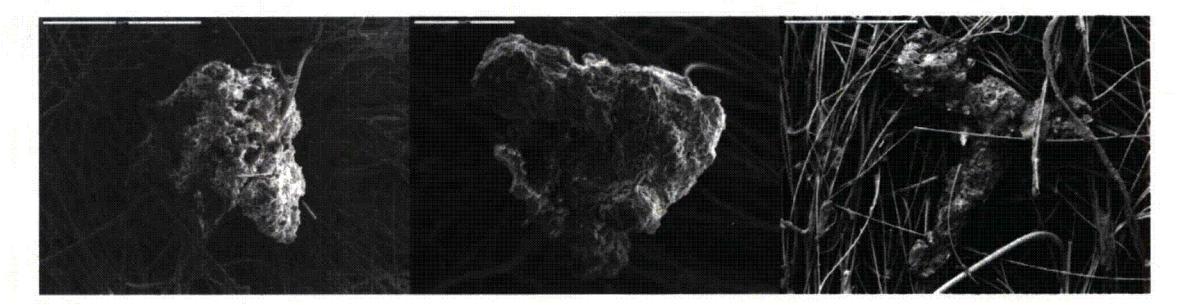
Figure 33: SEM images of a whitish (left), brownish (middle), and greyish particulate captured by the fiber beds

Representative sample areas of fiber with particulate were the taken from the top of the debris beds and evaluated with SEM. As seen in past testing [4], the particulate capture on top of the detector beds had constituents of probable chemical products derived from the solution chemistry. Images of the particle capture are presented by Figure 33. Further details for the SEM analysis of the fiber bed particle capture can be found in Appendix 1.

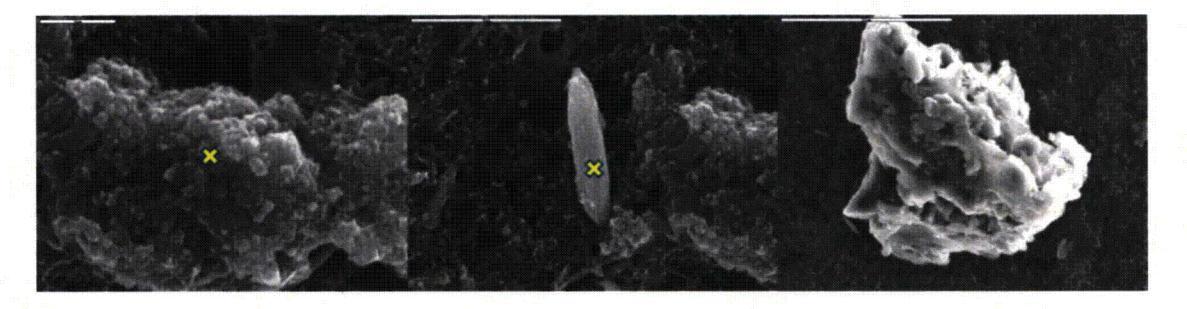
Figure 34: Examples of particles captured by the in-line membrane filters

Regardless of location, the debris captured on the inline membrane filters had constituents indicative of both possible chemical products and equipment debris, Appendix 1. Particles captured appeared both amorphous and defined as shown by Figure 34. Also, most of the membranes evaluated appeared coated with material as seen in Figure 35.

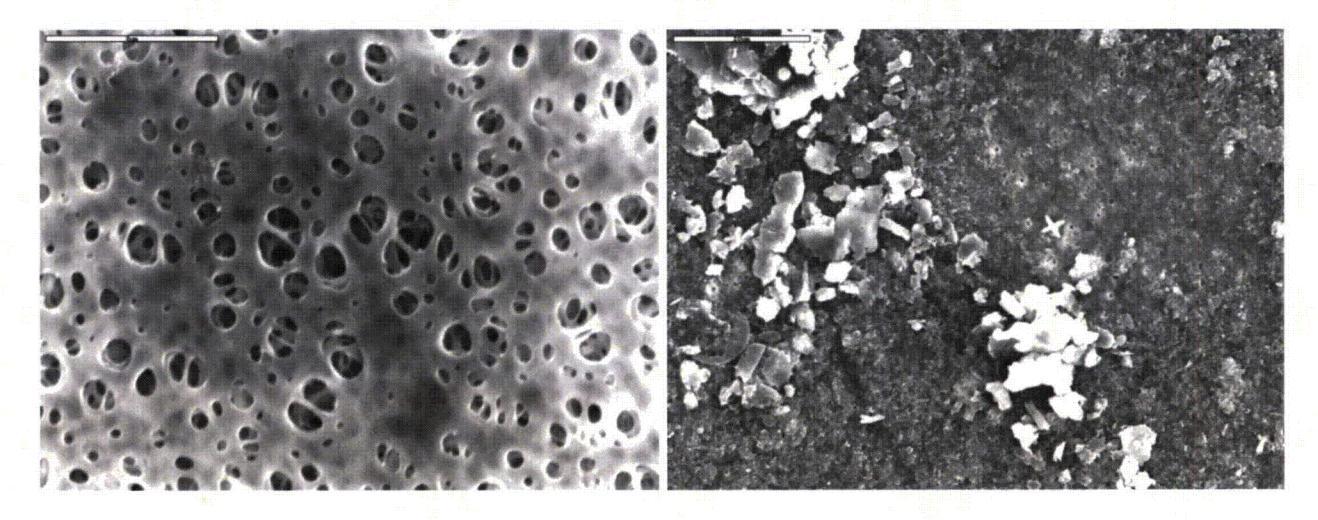
Figure 35: Clean membrane (left) and example of coating observed on most membranes (left) evaluated from test
