ASSESSING THE IMPACTS OF HURRICANE SANDY ON COASTAL HABITATS

Prime Hook National Wildlife Refuge Before and After Sandy

By: The American Littoral Society For: The National Fish and Wildlife Foundation December 17, 2012 · -

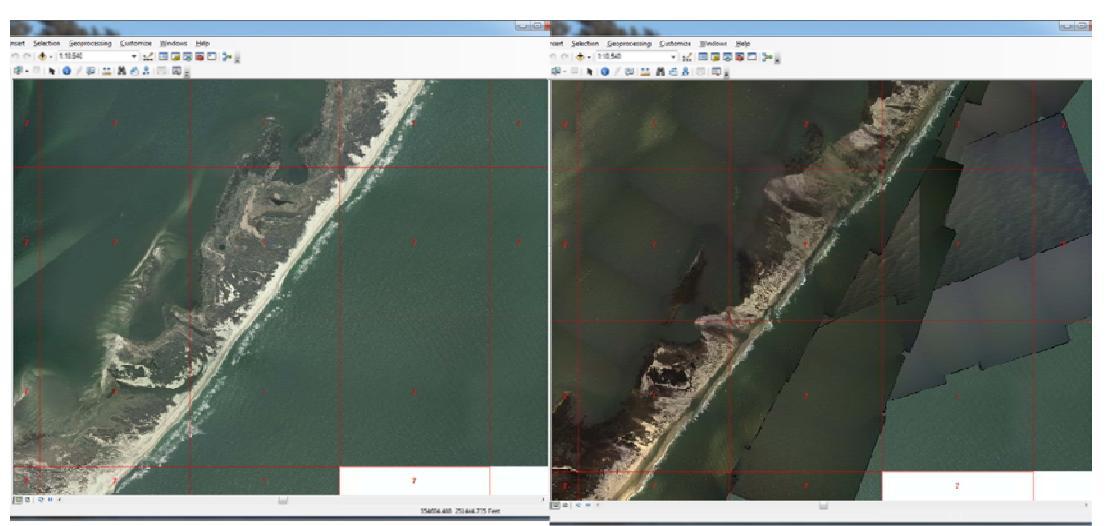
Figure 1. Example of Pre- vs. Post-Imagery for the Holgate section of Forsythe National Wildlife Refuge, New Jersey, showing High Impact with active overwash channels and several hundred feet of landward migration of the barrier island.

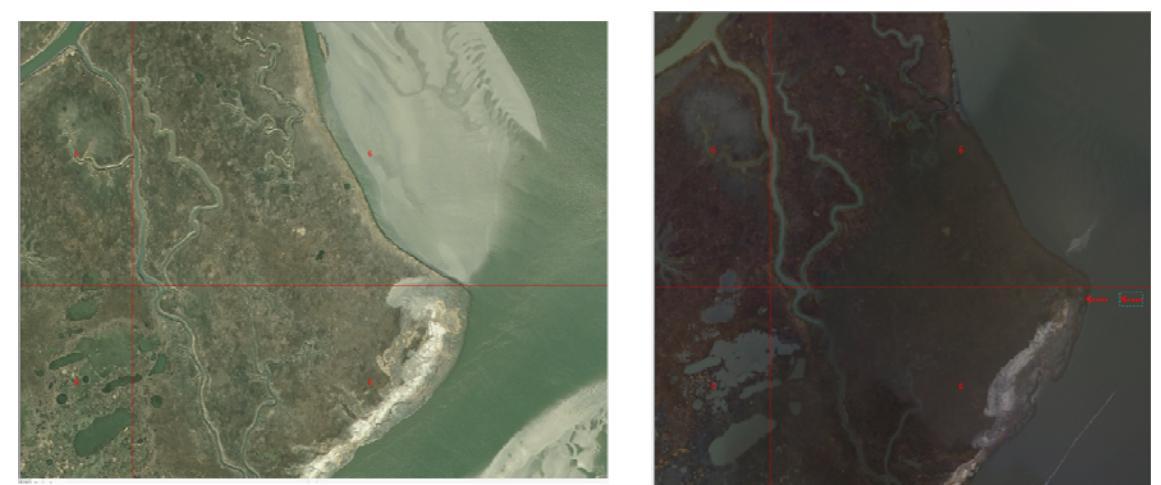
Figure 2. Example of Pre- vs. Post-Imagery for the Brigantine section of Forsythe NWR, NJ showing High Impact with active overwash of sand onto the salt marsh and several hundred feet of landward migration of the marsh edge.

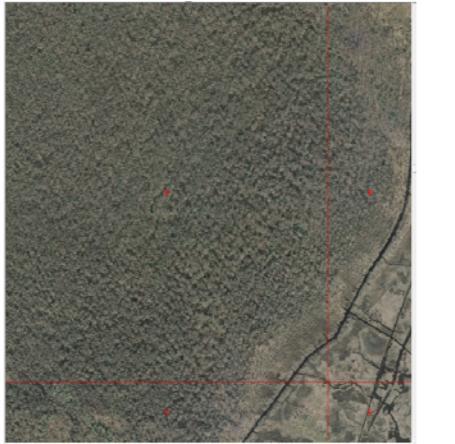
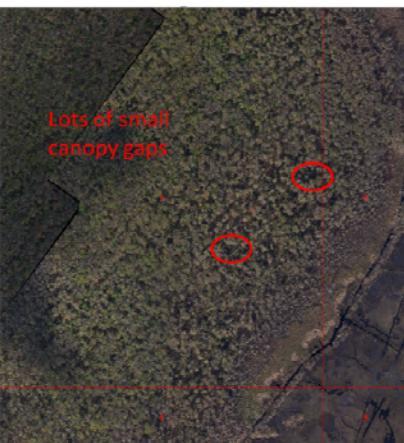
Figure 3. Example of Pre- vs. Post-Imagery for the Brigantine section of Forsythe NWR, NJ showing Moderate Impact to maritime forest areas with numerous small canopy gaps.

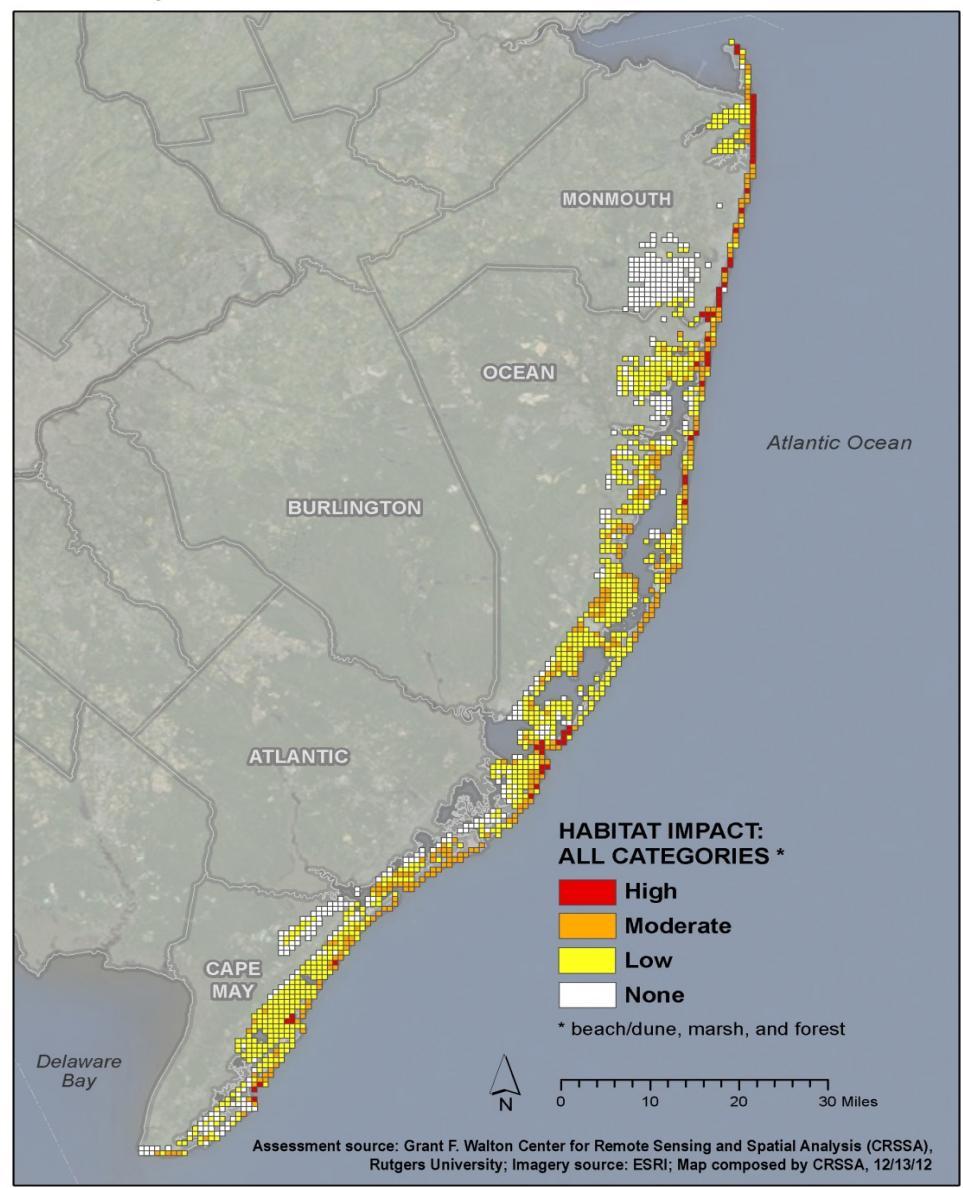
HURRICANE SANDY RAPID ASSESSMENT New Jersey Atlantic Coast

Figure 4. New Jersey Atlantic shoreline study area: map of Hurricane Sandy Damage Assessment for all three categories of habitat dune/beach, tidal marsh and maritime forest.

Beach and dune habitat along the New Jersey Atlantic coastline was particularly hard hit with approximately 65% experiencing Moderate Damage and a few areas showing High Damage (**Table 1**). The "natural" beaches of Little Beach and Holgate, part of the Forsythe National Wildlife Refuge, experienced extensive overwash and erosion resulting in significant landward migration (**Figure 4**). Stone Harbor Point in Cape May County, with its low profile and lack of dunes, experienced extensive overwash. The bayside of Sandy Hook and the shorelines of Raritan and Jamaica Bays experienced Moderate to Low levels of impact (**Figure 5**).

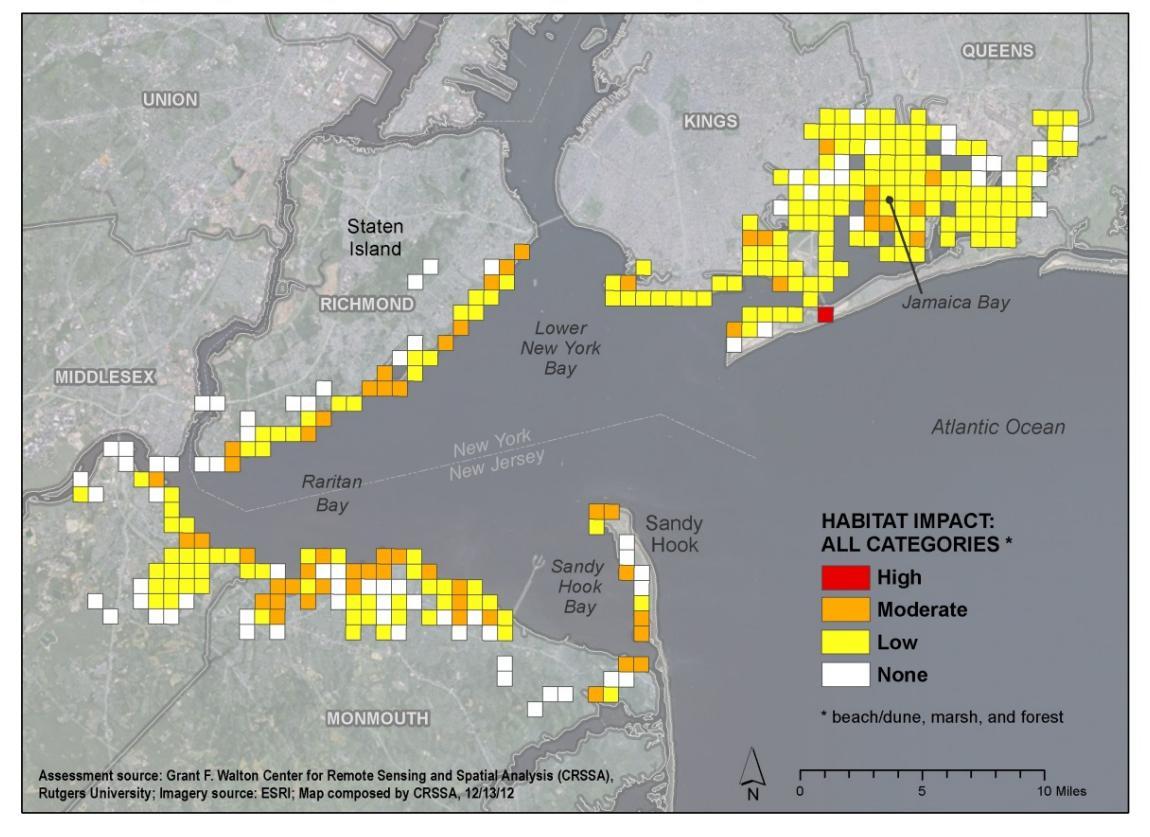
HURRICANE SANDY RAPID ASSESSMENT Raritan Bay, Sandy Hook Bay, Lower New York Bay, Jamaica Bay

Figure 5. New York Harbor- Raritan-Jamaica Bays study area: map of Hurricane Sandy Damage Assessment for all three categories of habitat dune/beach, tidal marsh and maritime forest.

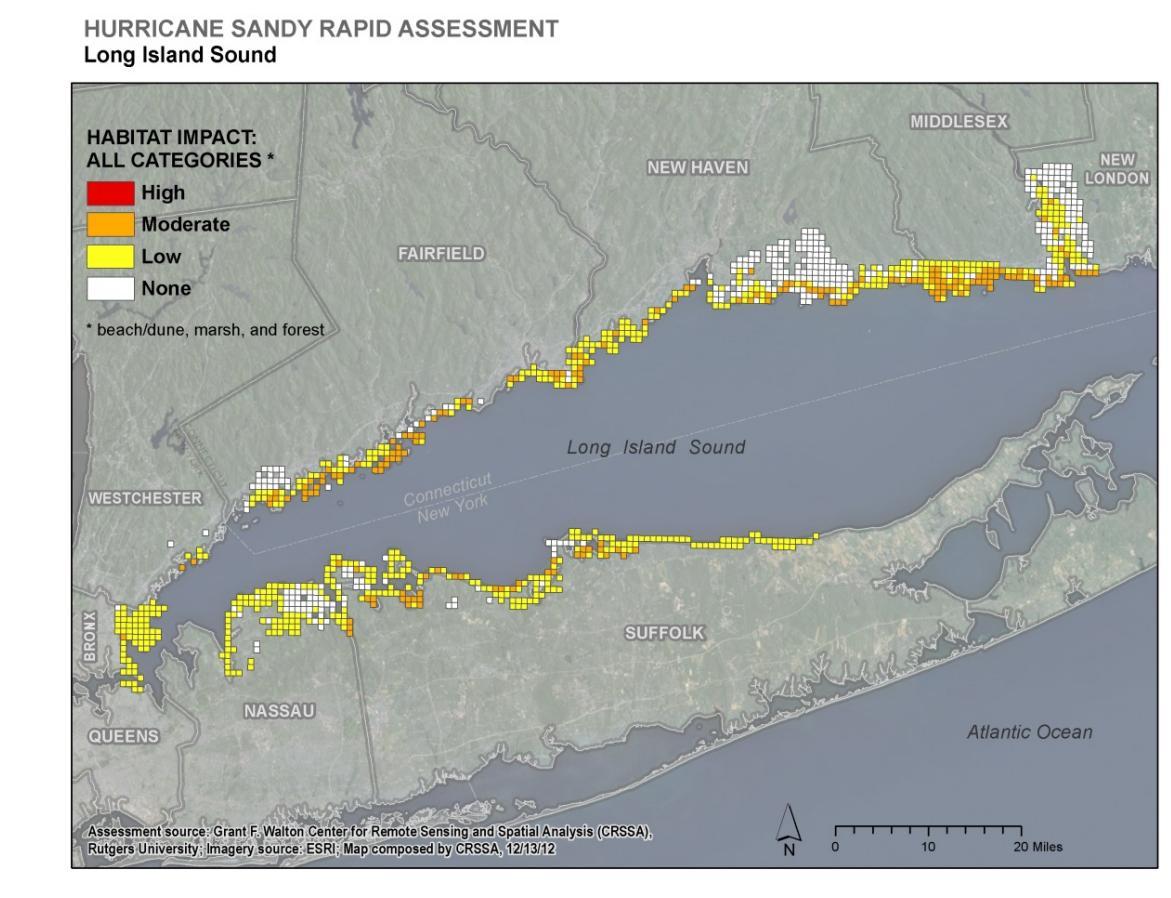
Figure 6. Long Island Sound study area: map of Hurricane Sandy Damage Assessment for all three categories of habitat dune/beach, tidal marsh and maritime forest.

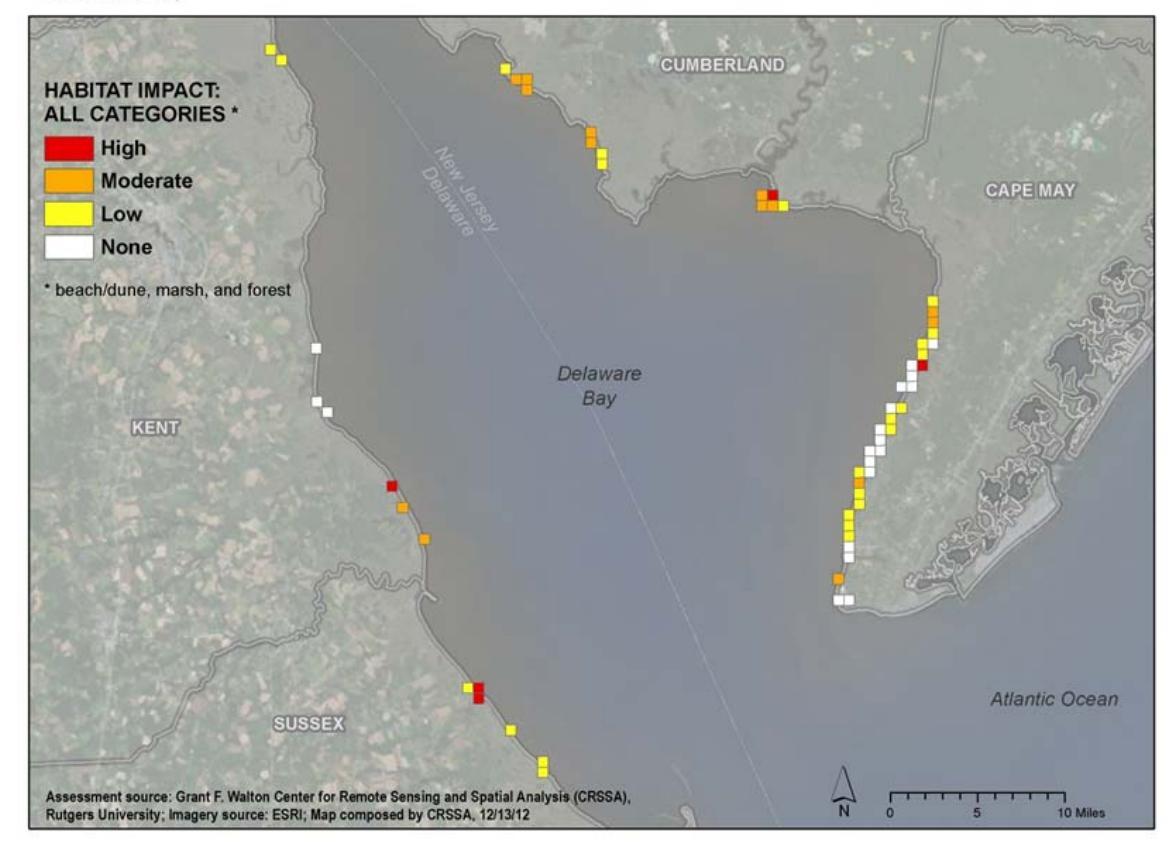
HURRICANE SANDY RAPID ASSESSMENT Delaware Bay

Figure 7. Delaware Bay study area: map of Hurricane Sandy Damage Assessment for all three categories of habitat dune/beach, tidal marsh and maritime forest.
