DIABLO CANYON ISFSI

FIGURE 2.6-2 DIABLO CANYON POWER PLANT AND THE ISFSI AND CTF SITES

FSAR UPDATE
DIABLO CANYON ISFSI
FIGURE 2.6-7 GEOLOGIC MAP OF THE ISFSI STUDY AREA AND TRANSPORT ROUTE VICINITY

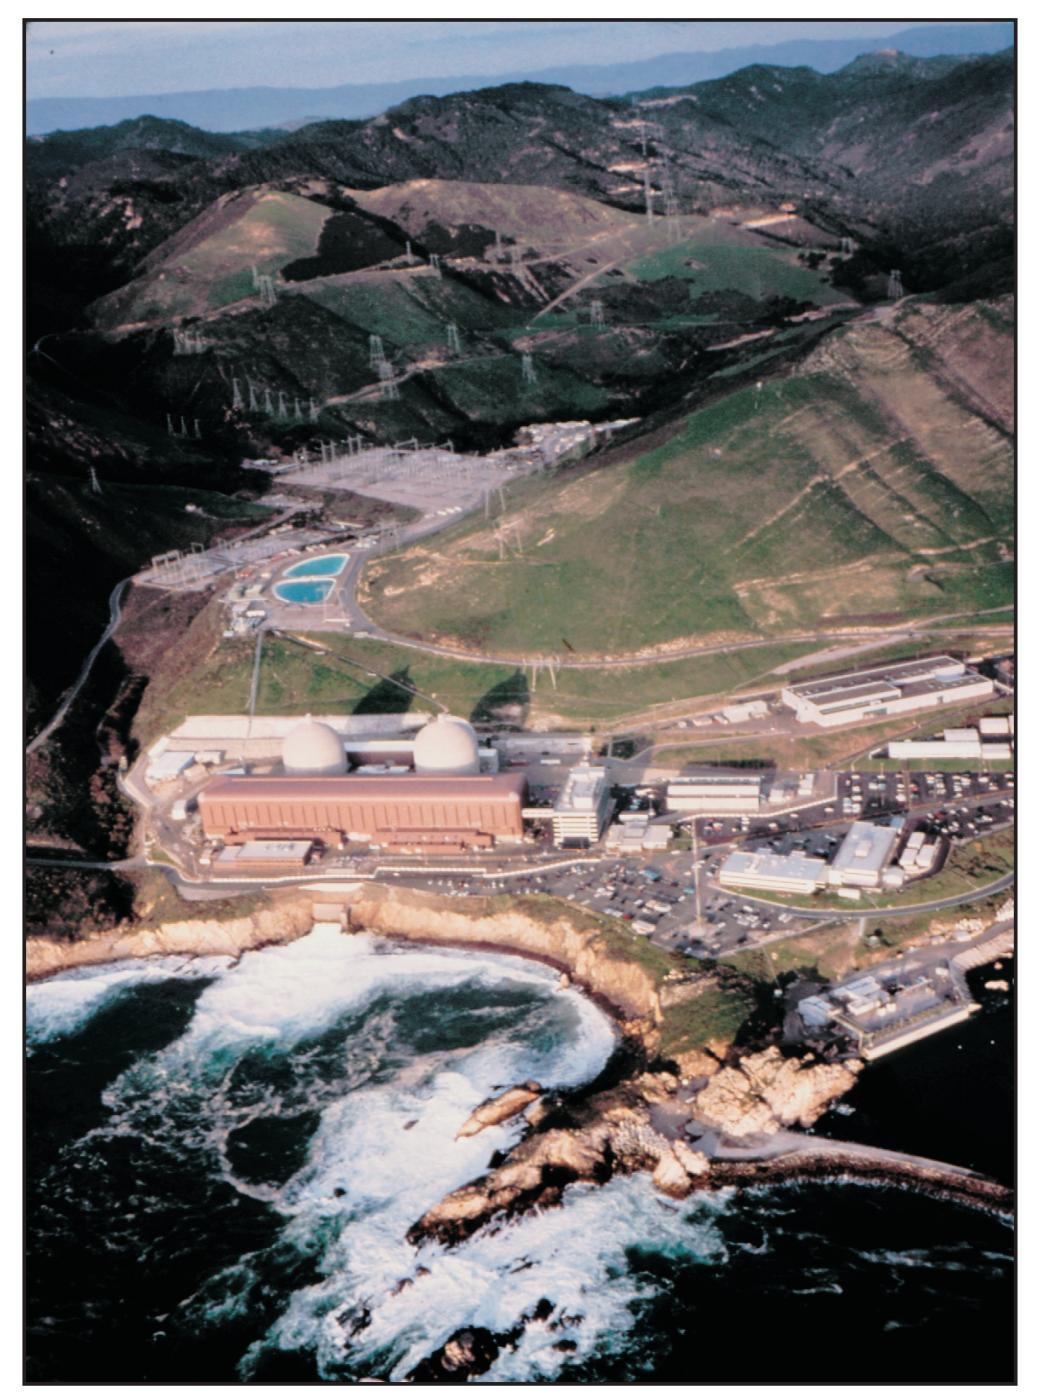
Northeast view of Diablo Canyon Power Plant and the ISFSI and CTF sites. The ISFSI is at the base of the slope to the right of the raw water reservoir. The CTF is directly southwest of the reservoirs. The extent of the 1971 borrow area excavation is indicated by the rocky area on the slope above the reservoir. The power plant and adjacent facilities are constructed on a marine terrace that is covered by Quaternary fan deposits. Photo roll WDP-1.
