ANNUAL REPORT

WASHINGTON STATE UNIVERSITY NUCLEAR RADIATION CENTER

TRIGA REACTOR

Facility License R-76 for the Reporting Period of July 1, 2015 to June 30, 2016

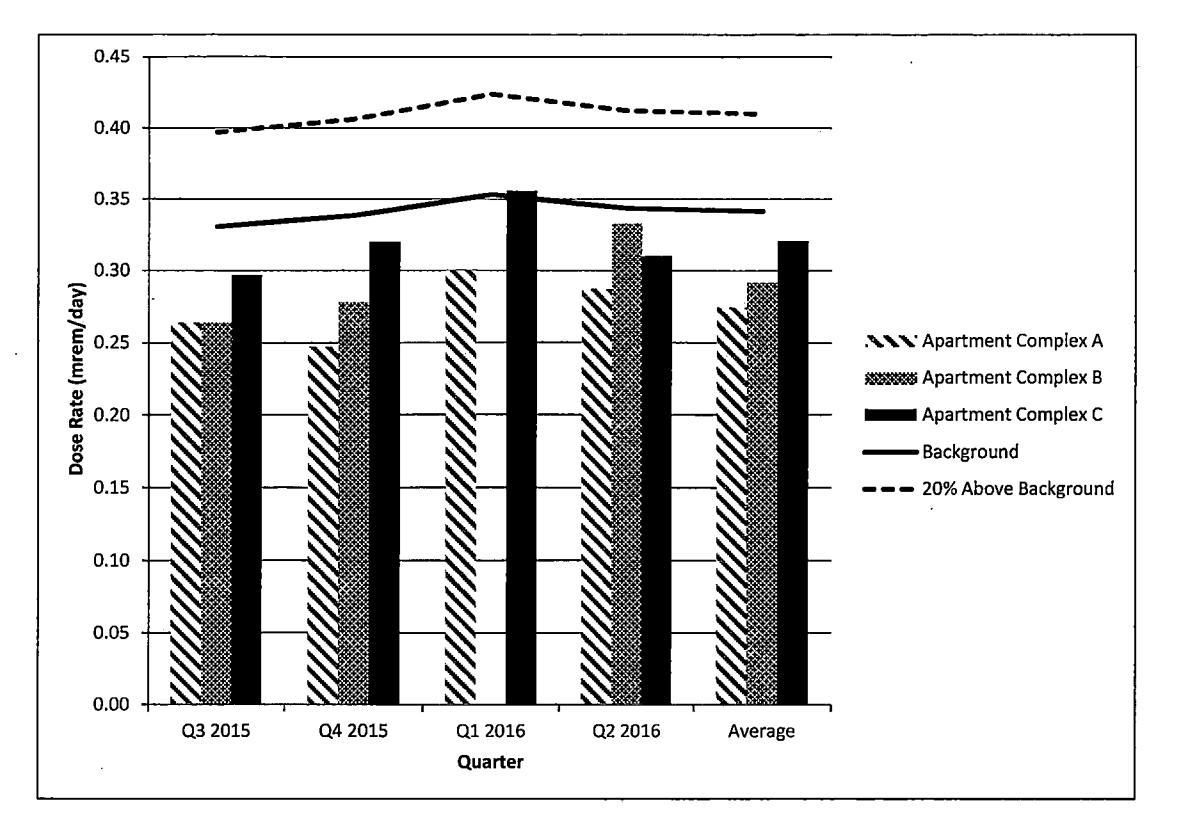
The dose rate for the closest offsite points of extended occupancy can be found in Table X. In Chart I the closest offsite points of extended occupancy are compared to both the background radiation levels and the 20% above background radiation levels from Table XI. Technical Specifications describing ALARA effluent releases in 3.5.2(3) specify annual radiation exposure due to reactor operation, at the closest offsite extended occupancy, shall not, on an annual basis, exceed the average offsite background radiation by more than 20%. For the reporting period, the average background radiation dose rate for off-site locations was 0.34 mrem/day, while the average radiation dose rate at the closest extended occupancy area 600 meters away was 0.29 mrem/day. This result indicates that no exposure level above normal background radiation levels for Q1 2016, TLD 36 was still well below the 20% above background radiation levels required by the Technical Specifications. This result shows that no dose levels exceeded Technical Specifications requirements for an offsite area of extended occupancy.

Environmental Radiation Levels for the Closest Off-site Point of Extended Occupancy as Compared to Background Radiation Levels and 20% Above Background Radiation Levels
