General Electric Company Report GENE-523-A69-0594, dated June 1994, Evaluation of the Indications Found at the H5 Weld Location in the Dresden Unit 3 Shroud.

GENE-523-A69-0594 DRF 137-0010-7 Class II June 1994

# Evaluation of the Indications Found at the H5 Weld Location in the Dresden Unit 3 Shroud

Structural Integrity Report RAM-94-159, Revision 0, dated June 11, 1994, Evaluation of Circumferential Core Shroud Welds at Dresden Unit 3.

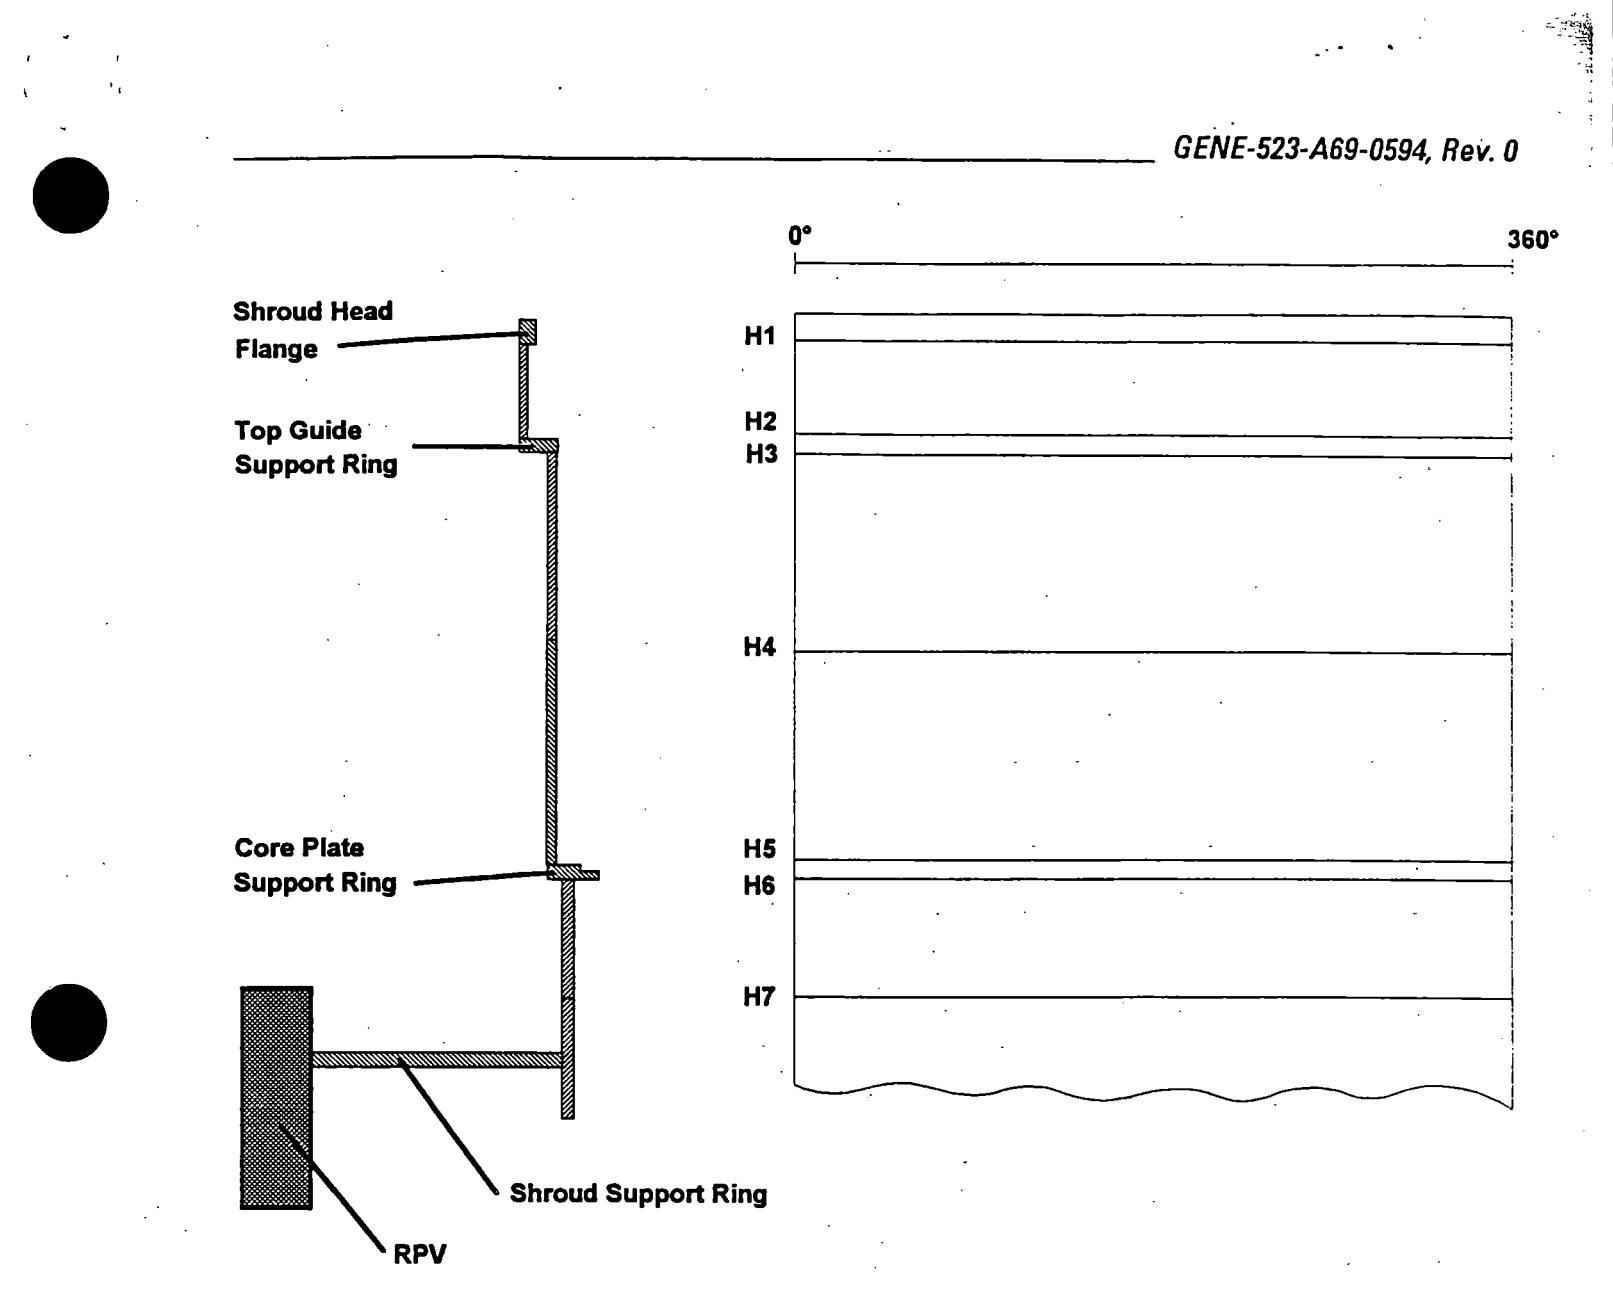
FIGURE 1: DRESDEN UNIT 3 SHROUD HORIZONTAL WELD CONFIGURATION

SIDE VIEW

# "ROLLED-OUT" VIEW

During the current refueling outage at Dresden Unit 3, core shroud inspections were performed in accordance with recommendations given in GE Services Information Letter No. 572, Rev. 1 (SIL 572) [1]. During the initial portion of these inspections, crack indications were visually detected in the vicinity of the H5 weld (see Figure 1). The cracking was located immediately below the H5 weld in the core plate support ring. The indications were predominantly circumferential, and were visible at all accessible locations (approximately 150° of the circumference). Subsequent examination by automated ultrasonic testing (UT) of the indications in all areas of the H5 weld accessible by the UT system confirmed the visual indications to be cracks. Based on the results of automated and manual UT exams and on the results of boat samples taken from the H5 weld location provided by Commonwealth Edison Company (CECo), the probability of detection of flaws deeper than 1.24" on the core plate support ring side of the H5 weld is very high, and no flaws deeper than 1.24" were detected. For this reason, the bounding maximum flaw depth used for the purpose of this structural margin assessment is 1.24" [2].

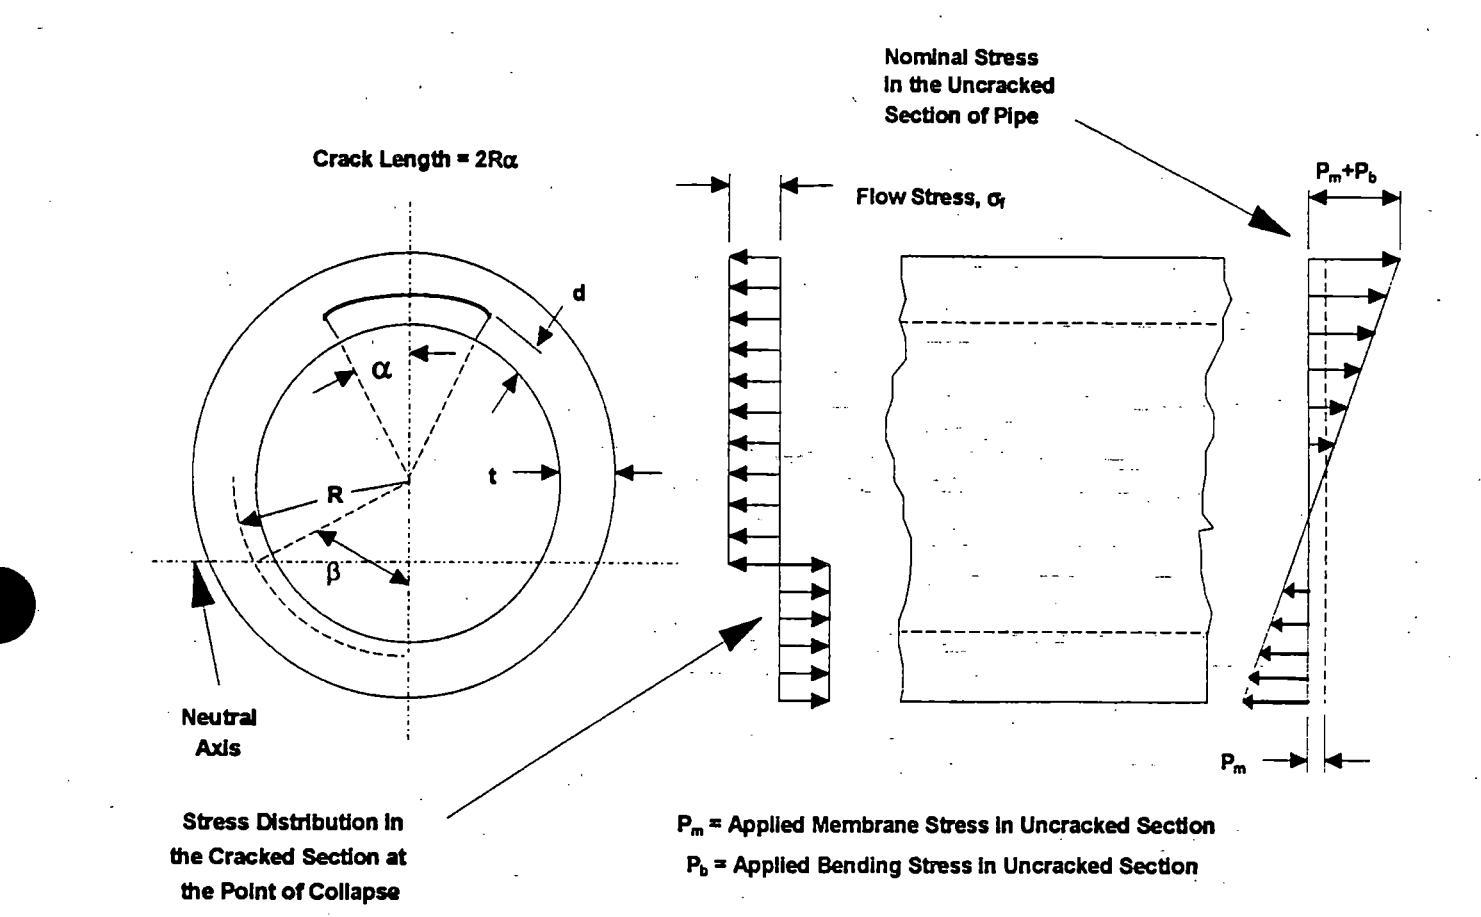
# FIGURE 2: LIMIT LOAD METHODOLOGY

The limit load approach used here is depicted in Figure 2, as obtained from a net section collapse formulation [4,7]. The neutral axis shown in Figure 2 is determined by equilibrating the force resulting from the applied membrane stress,  $P_m$ , in the uncracked cross section with the force resulting from a stress equal to the flow stress in the remaining ligament (uncracked region) at the crack cross section.

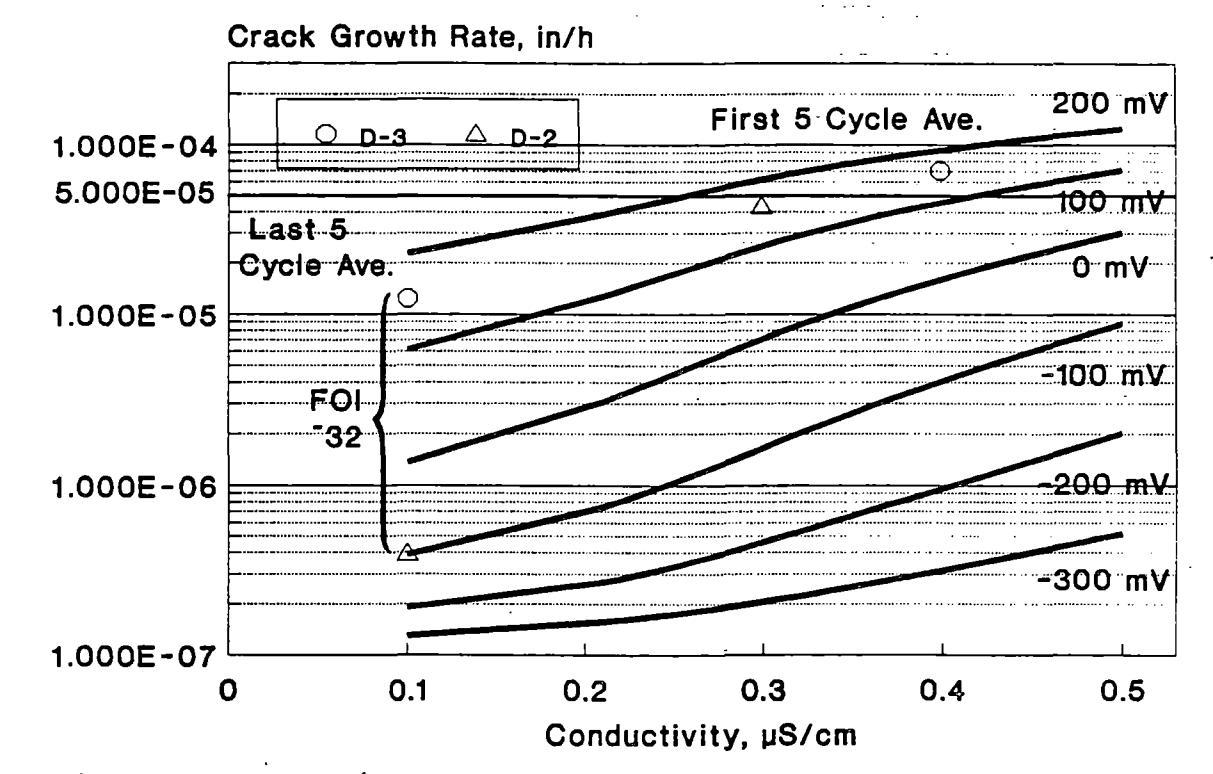
# FIGURE 4: PLEDGE MODEL PREDICTION FOR DRESDEN 2/3

PLEDGE: 15 C/cm2, 20ksi√in

A significant point to be made is that the observed cracking thus far is mainly due to prior operation at relatively high conductivities, including aggressive anions such as sulfates and chlorides. With the increased attention to IGSCC, most boiling water reactor (BWR) plants have dramatically reduced their aggressive anion input, thus assuring that future crack growth rates are much lower than those in the past. Dresden Unit 3 currently operates below 0.1  $\mu$ S/cm conductivity and 5 ppb chloride and sulfate combined. Figure 4 shows the dependence of the predicted growth rate on the conductivity based on the GE predictive model for IGSCC. Figures 5 and 6 show the dependence on sulfate and chloride species [9]. In all cases, the lower sulfate and chloride levels lead to dramatically lower crack growth rates. Thus, any margin assessments based on the two growth rates (5x10<sup>-5</sup> inch/hour for bounding values and 1.24x10<sup>-5</sup> inch/hour based on the GE PLEDGE predictive model) are conservative.

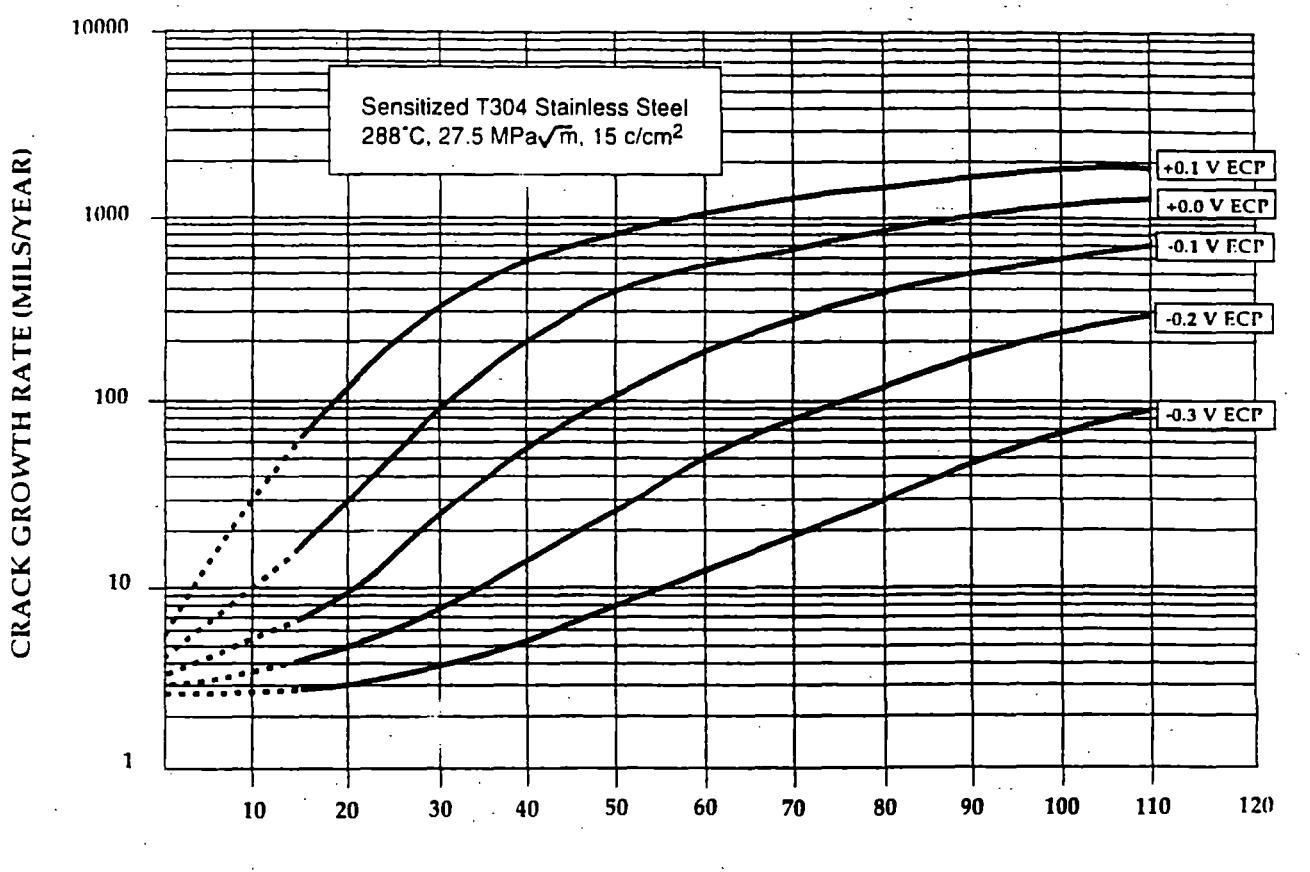
FIGURE 5: CRACK GROWTH RATE AS A FUNCTION OF SULFATE

SULFATE (PPB)

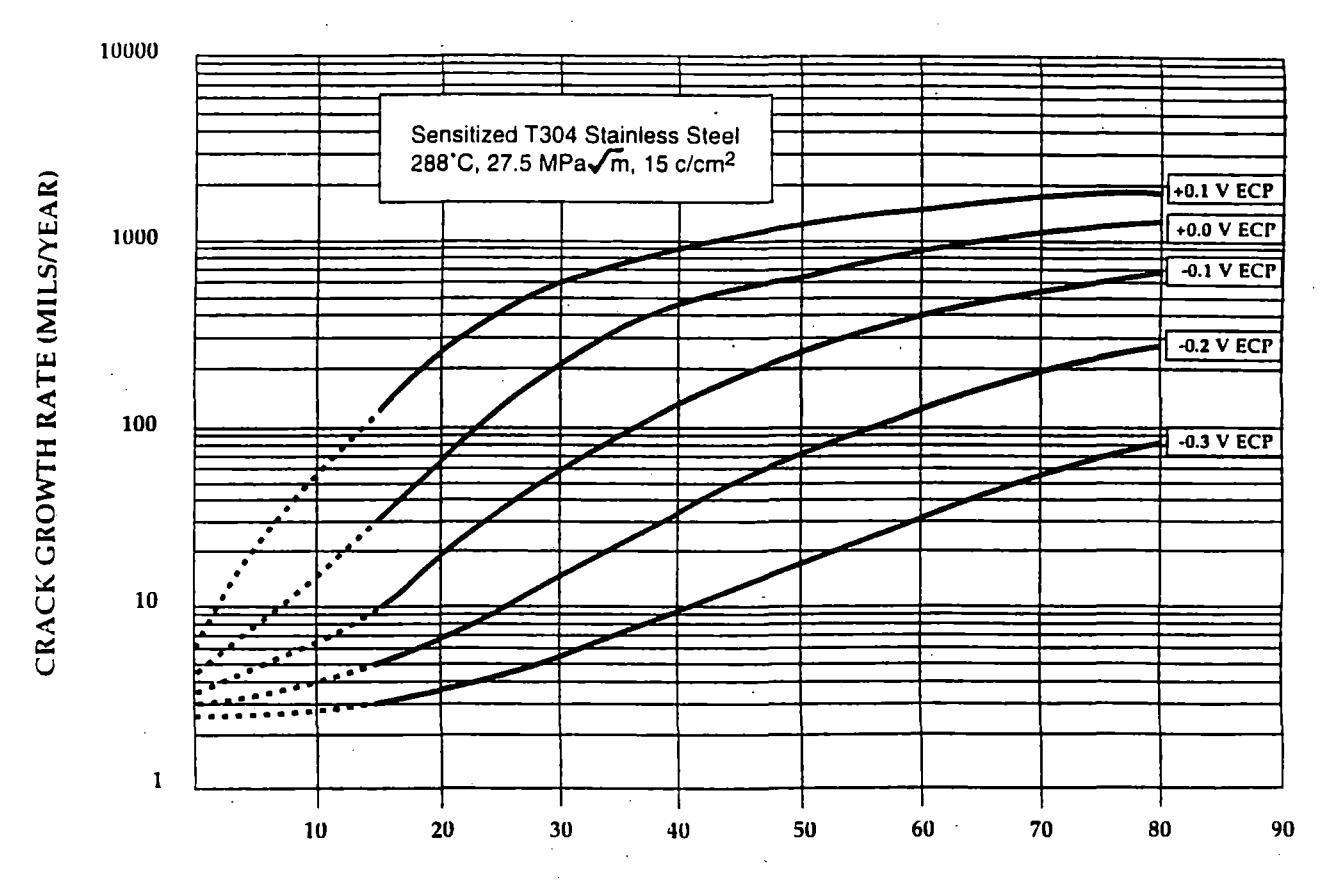
FIGURE 6: CRACK GROWTH RATE AS A FUNCTION OF CHLORIDE

CHLORIDE (PPB)

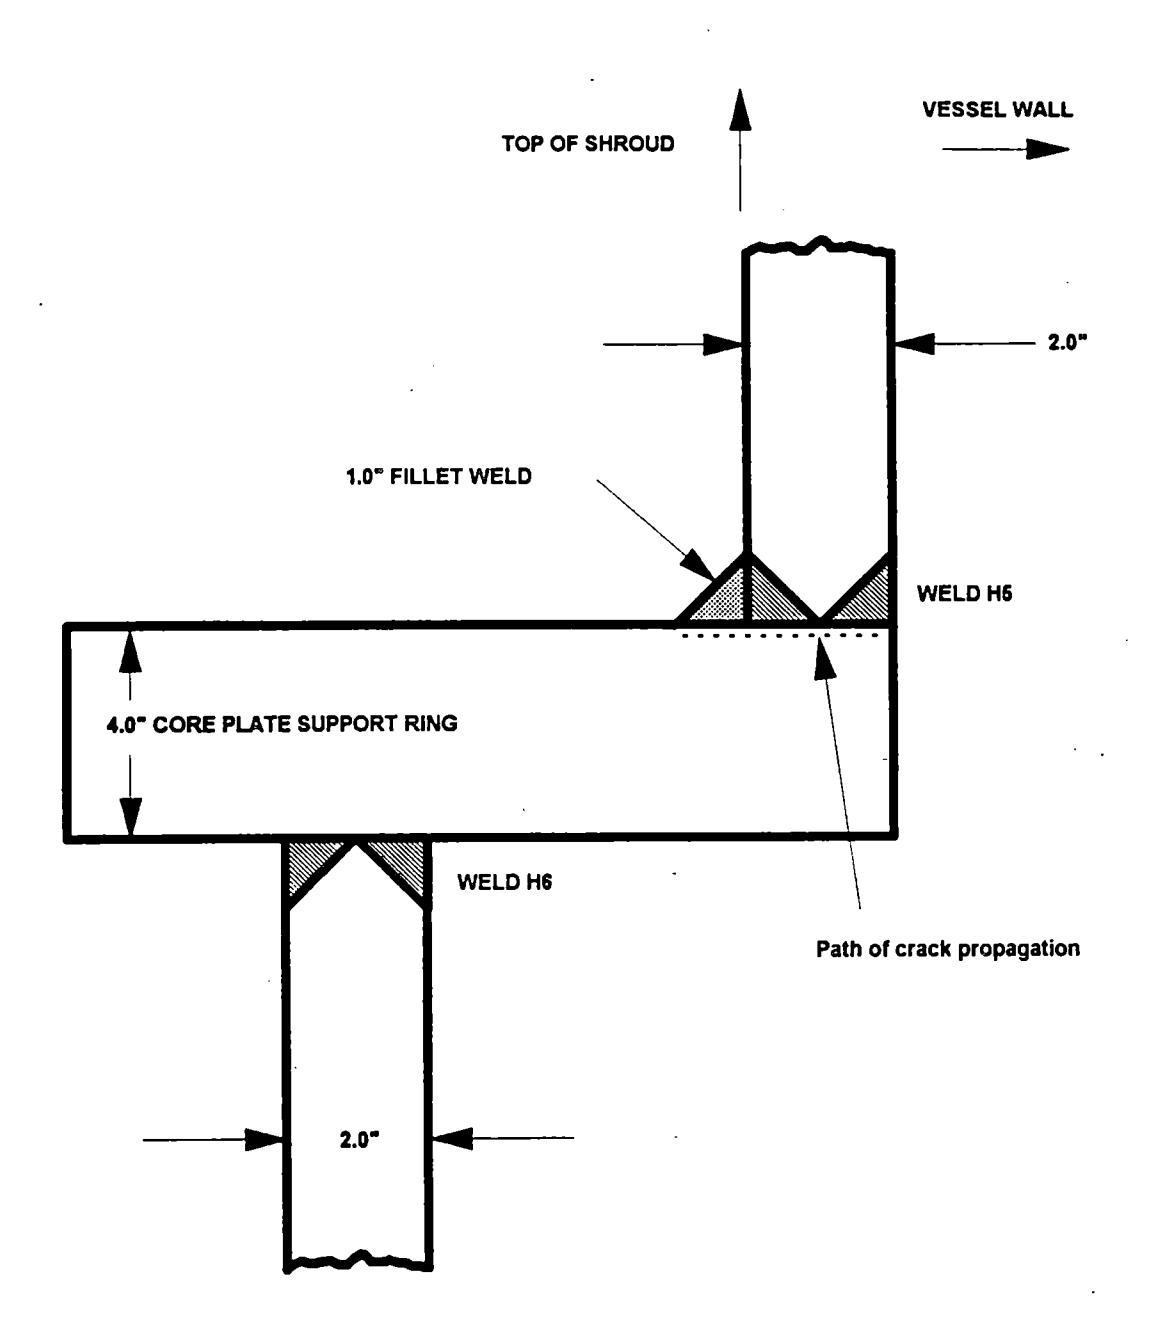
Figure 1: Most Likely Path of Crack Propagation

No credit was taken for the 1" fillet weld in the stress calculations performed in References 1 and 2. All of the calculated stresses were based on the shroud thickness (2 inches) alone. The 1" fillet was only considered in terms of the allowable extent of cracking for crack growth evaluation. This is reasonable since the cracking has only been observed in the core plate support ring rather than in the H5 weld itself. Because of the high end grain susceptibility, the cracking is parallel to the plane of the plate and is driven by the combination of the residual and applied stresses. Considering the inplane growth, it is reasonable to expect that the crack follows the plate orientation as it continues through the weld heat affected zone of the fillet weld before it penetrates the material surface, as shown in Figure 1. Because of higher stress corrosion cracking resistance of the weld metal (due to duplex structure and higher ferrite), the probability

of the crack going into the weld metal (instead of the more susceptible plate material) is much lower.
