SHEARON HARRIS NUCLEAR POWER PLANT, UNIT NOS. 1, 2, 3, AND 4 DOCKET NOS. 50-400, 50-401, 50-402, AND 50-403 GEOLOGICAL FEATURE AT THE WEST WALL OF THE MAIN DAM DIVERSION CONDUIT

This report presents the data obtained from the field and laboratory studies which bear upon definition of the nature of the schist-granite contact.

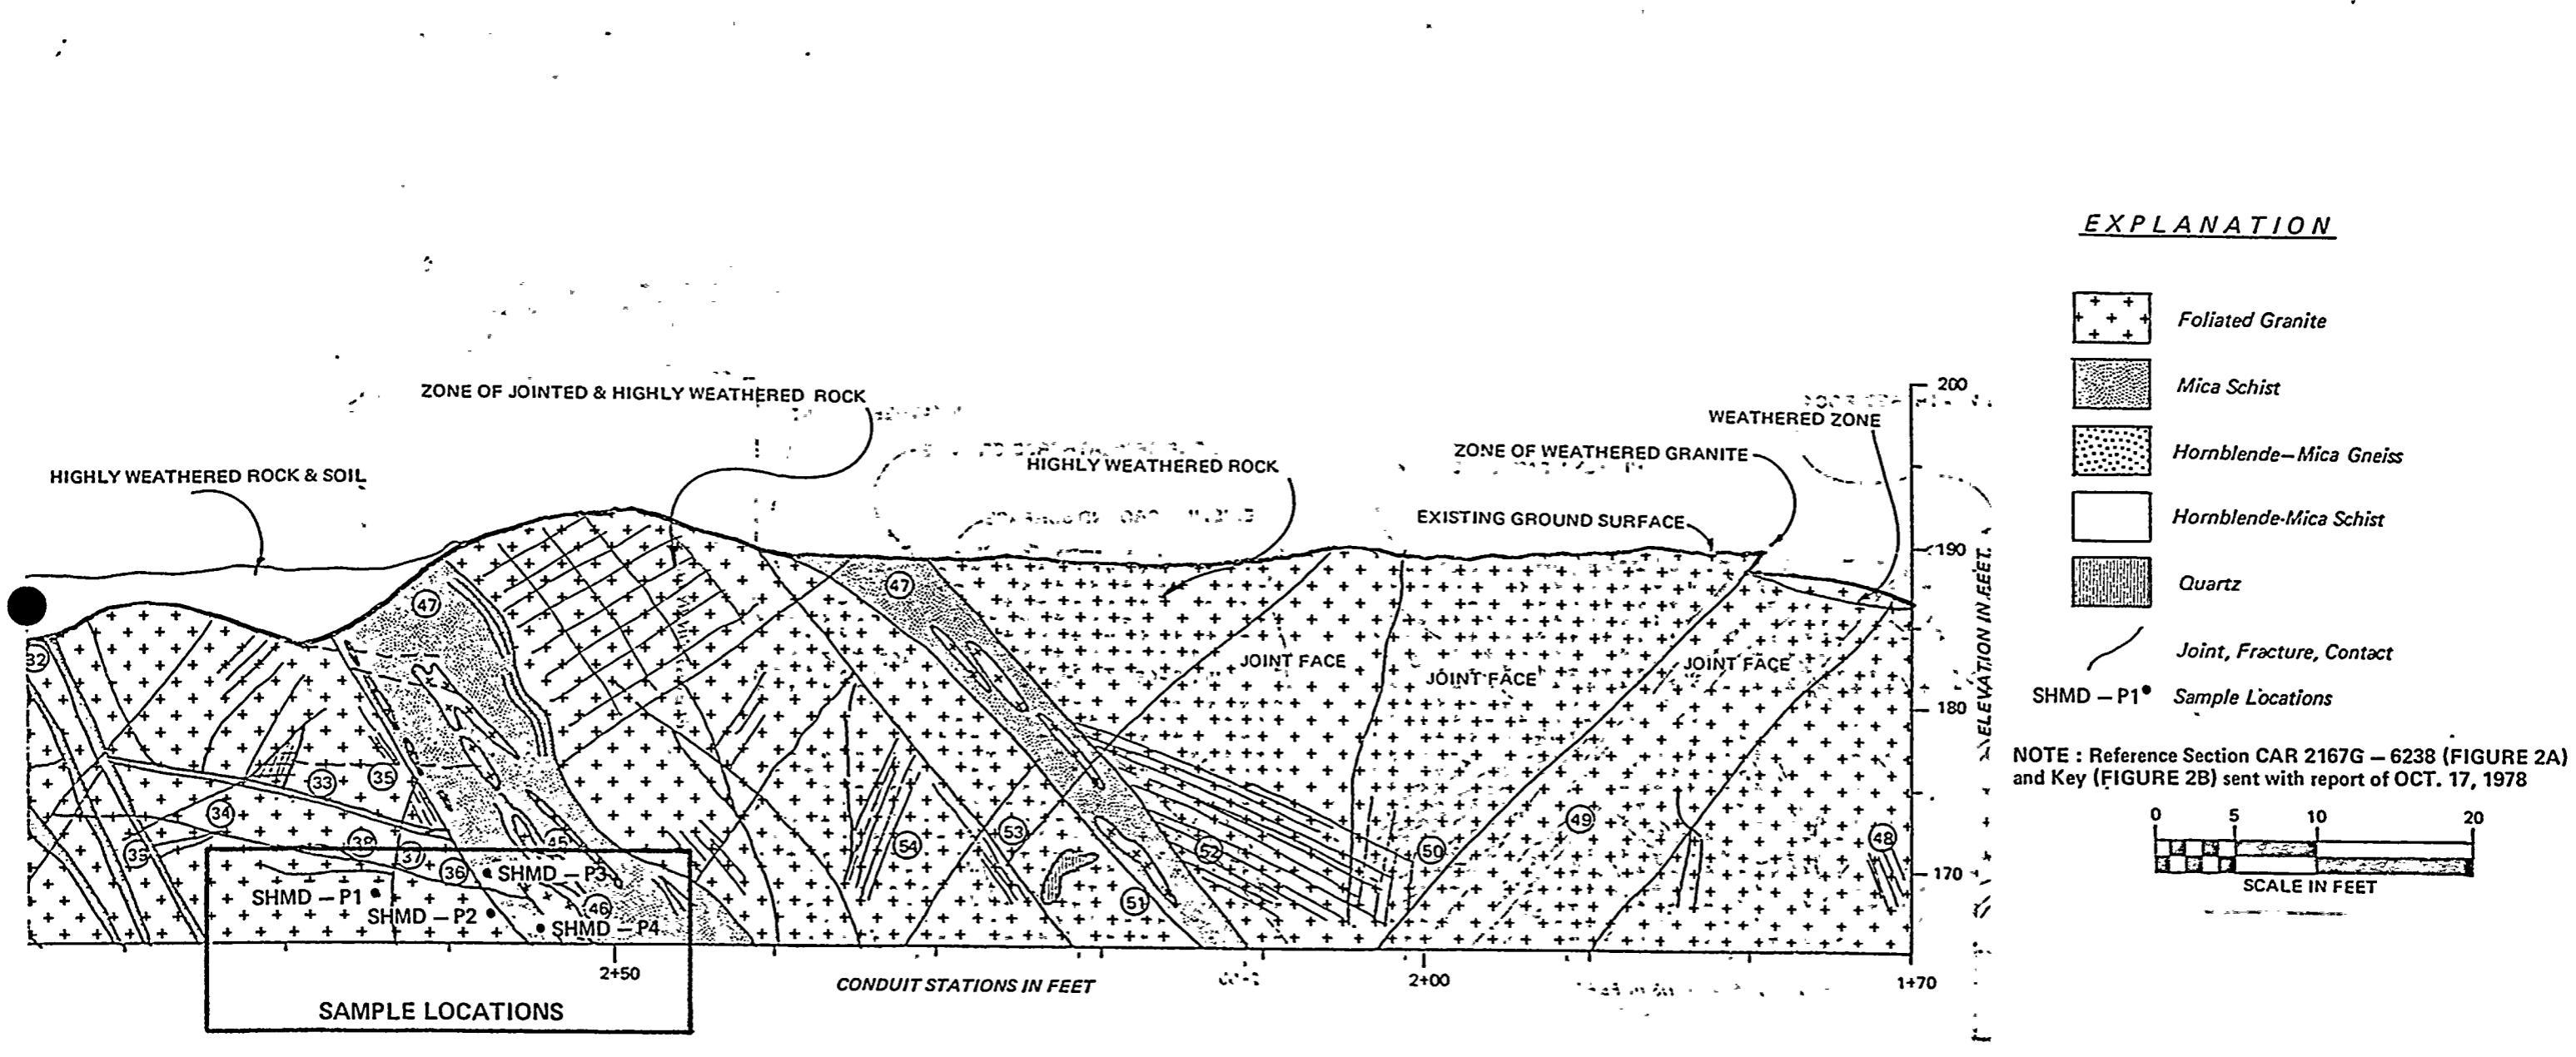
Four specimens were collected for preparation of thin sections as indicated on the attached map of the diversion conduit wall (Figure 1). These four specimens were labeled as follows:

- Figure 1 Map of diversion conduit wall indicating locations of specimens collected across the schistose zone at Station 2+55 for preparation of thin sections.
- Figure 2 Photomicrograph illustrating interlocking boundaries of quartz and feldspar grains in Section SHMD-P1. Note that the mineral grains show no elongation, crushing, or grinding although the specimen is weakly foliated. (Crossed nicols. Magnification of 3.1X.)
- Figure 3 Photomicrograph illustrating elongated quartz with alternating micro-layers of feldspar-biotite on Section SHMD-P2. Only ductile deformation is indicated. The grains show no crushing or grinding characteristic of brittle deformation. (Crossed nicols. Magnification of 3.1X.)

2. The contact itself is not planar but irregular. The planar appearance of the contact on the map (Figure 1) is a function of the map scale and not inaccuracies in the mapping. Lithologic units are not truncated at this contact, which represents only the boundary between lithogically distinctive rock and layers of schist.
