U.S. NUCLEAR REGULATORY COMMISSION REGION I

INSPECTION REPORT

Report No. 030-06171/95-001

RADIOLOGICAL SCOPING SURVEY OF THE FORMER NUCLEAR LAUNDRY RENTAL SERVICES, INC. SITE JEANNETTE, PENNSYLVANIA

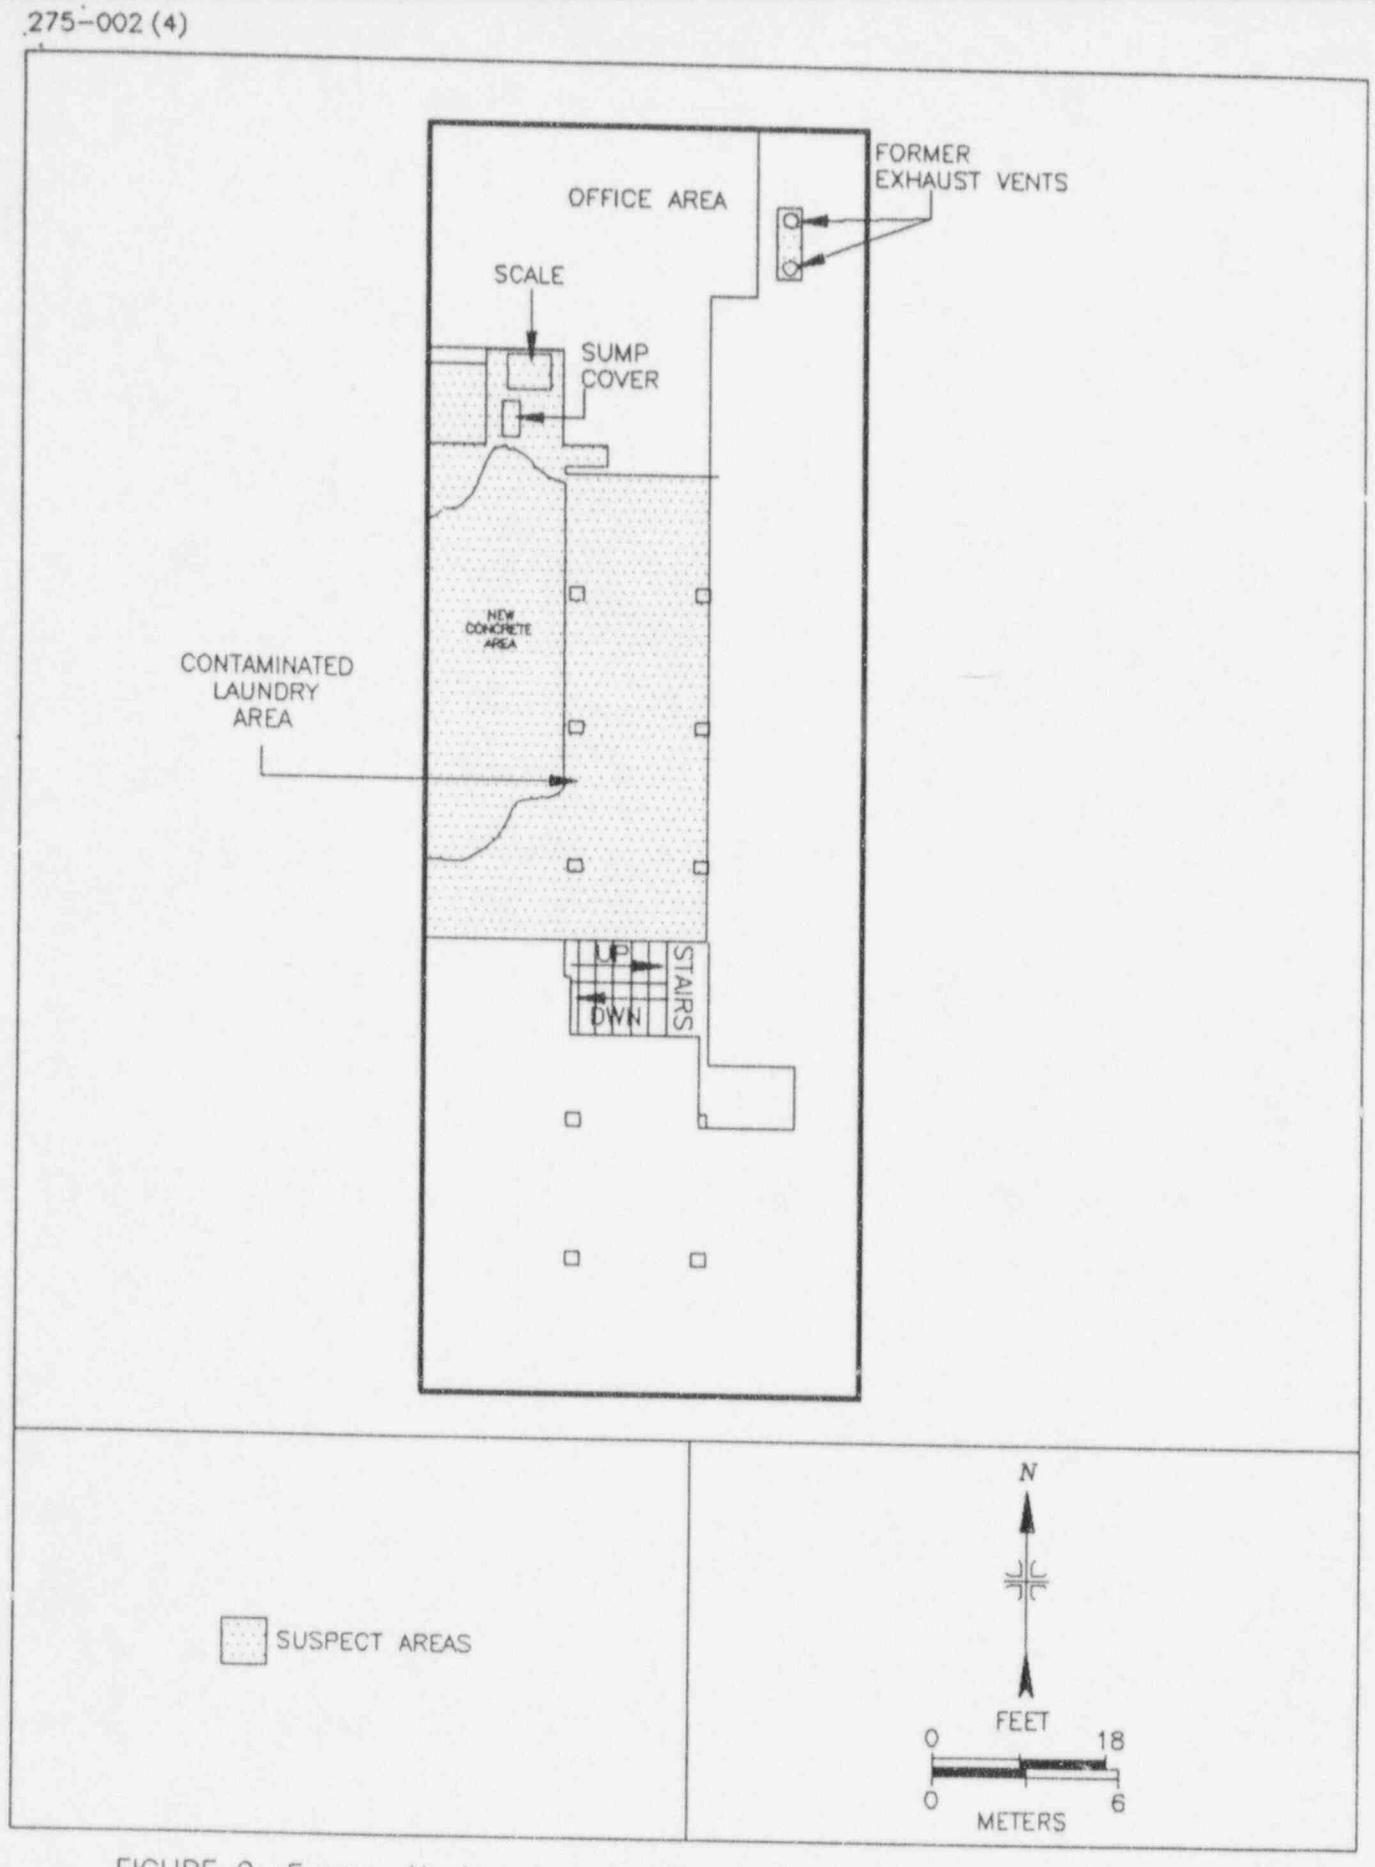
FIGURE 2: Former Nuclear Laundry Rental Services — Main Floor Showing Suspect Areas

The contaminated laundry area of the first level previously occupied by NLRS is located in the westcenter area and contains approximately 170 m² of floor space. The new concrete cap covers approximately 60 m² and was found to be 10 to 15 cm thick after floor coring was performed. A floor scale, an elevator, a side entry room, and the covered access opening to the sump are located at the north end of the area. The ceiling vents are located in the northeast area of the building and were accessed through an attic door, leading to the criginal roof, in the second level office area (Figure 2).

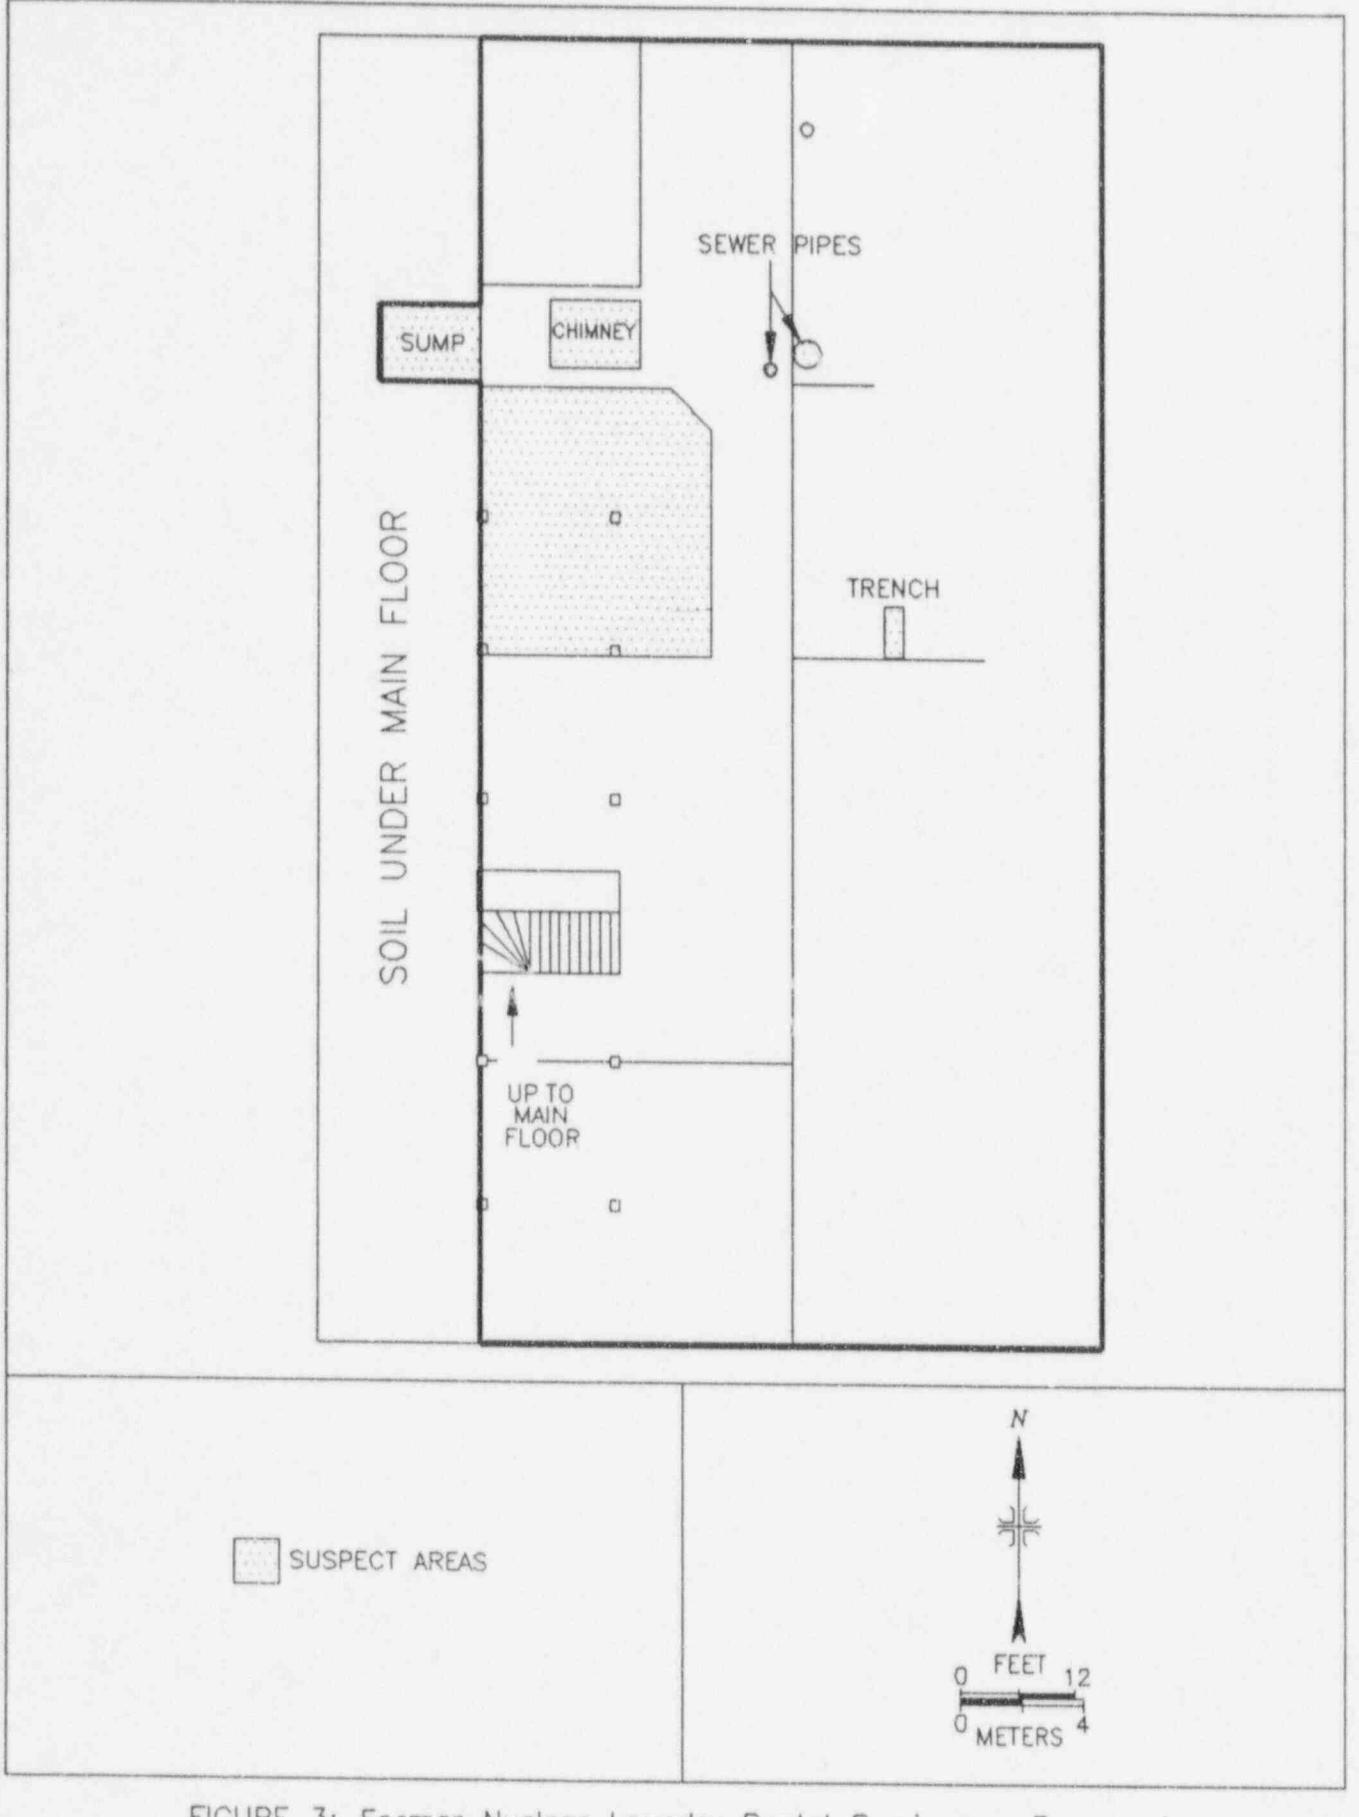
FIGURE 3: Former Nuclear Laundry Rental Services - Basement Showing Suspect Areas

The suspect areas in the basement included in the scoping survey (i.e. the floor pipes, chimney entrance, and the room directly beneath the contaminated laundry area, are shown on Figure 3. The NRC also requested that a basement floor trench (Figure 3) be investigated, during the ESSAP site survey.

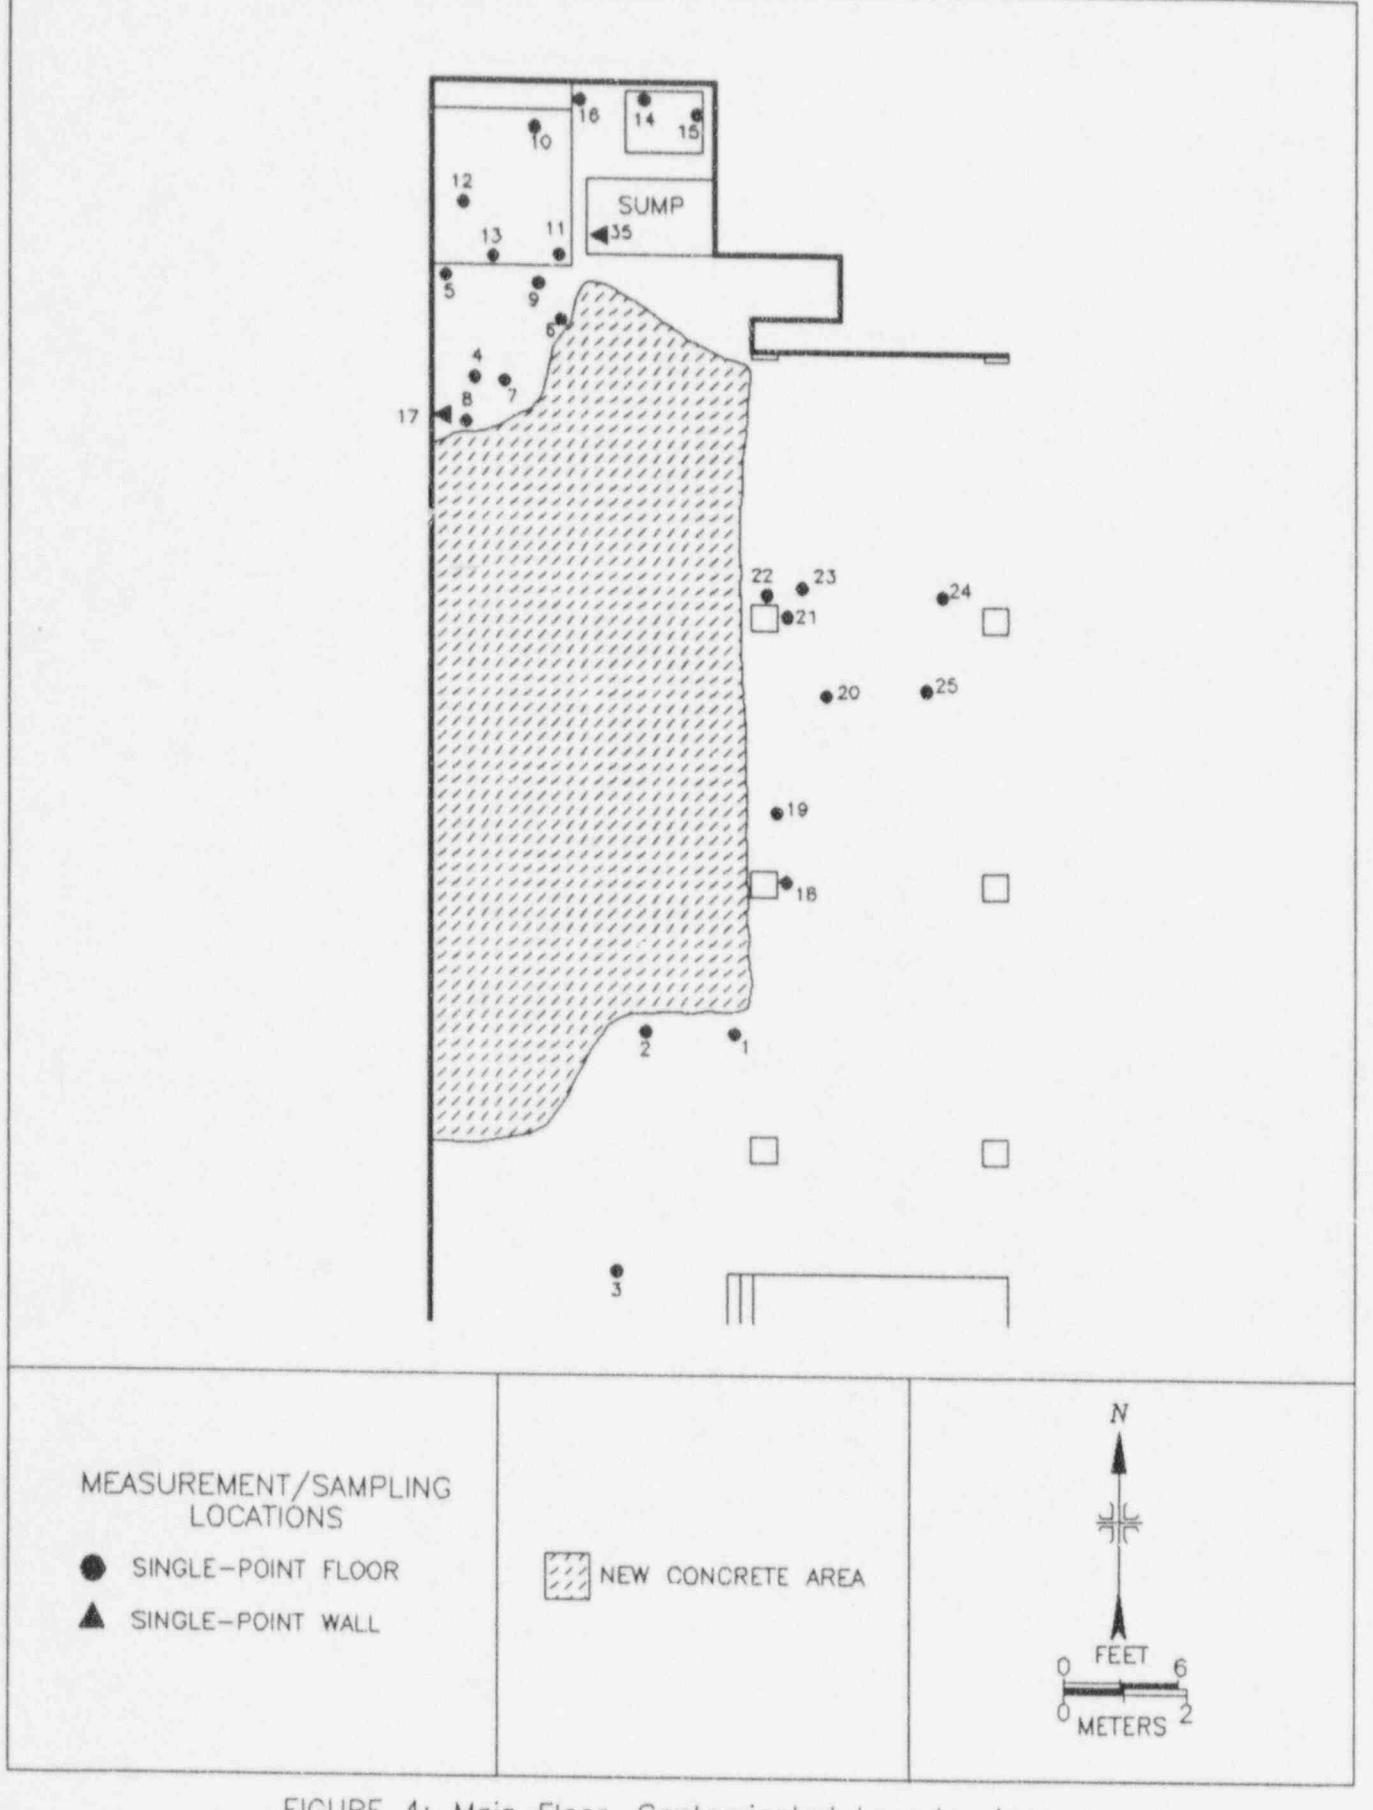
FIGURE 4: Main Floor, Contaminated Laundry Area -Measurement and Sampling Locations

Direct measurements for total beta activity were performed at a total of 34 locations on floors and lower walls of the first floor and basement and at one location on the west wall of the sump. Smears to determine removable activity were performed at each measurement location. Measurement and sampling locations are shown on Figures 4 through 6.

Surface scans identified several isolated locations of elevated beta activity on the floor and lower wall in the contaminated laundry area and on the floor in the suspect basement room. Elevated beta activity was also identified at four additional isolated locations on the floor in non-suspect areas of the first floor, on the west wall of the sump, and in the soil in the basement trench. Elevated gamma activity was detected in the sump soil and debris.

Surface activity levels at 33 of the 35 direct measurement locations exceeded the maximum allowable residual surface activity guideline for Sr-90, ranging from 3,200 to 100,000 dpm/100 cm². Surface activity levels at the remaining two measurement locations exceeded the 1,000 dpm/100 cm² average surface activity guideline with total beta activity of 1,900 and 2,000 dpm/100 cm². Removable activity levels at all direct measurement locations are less than the guideline.

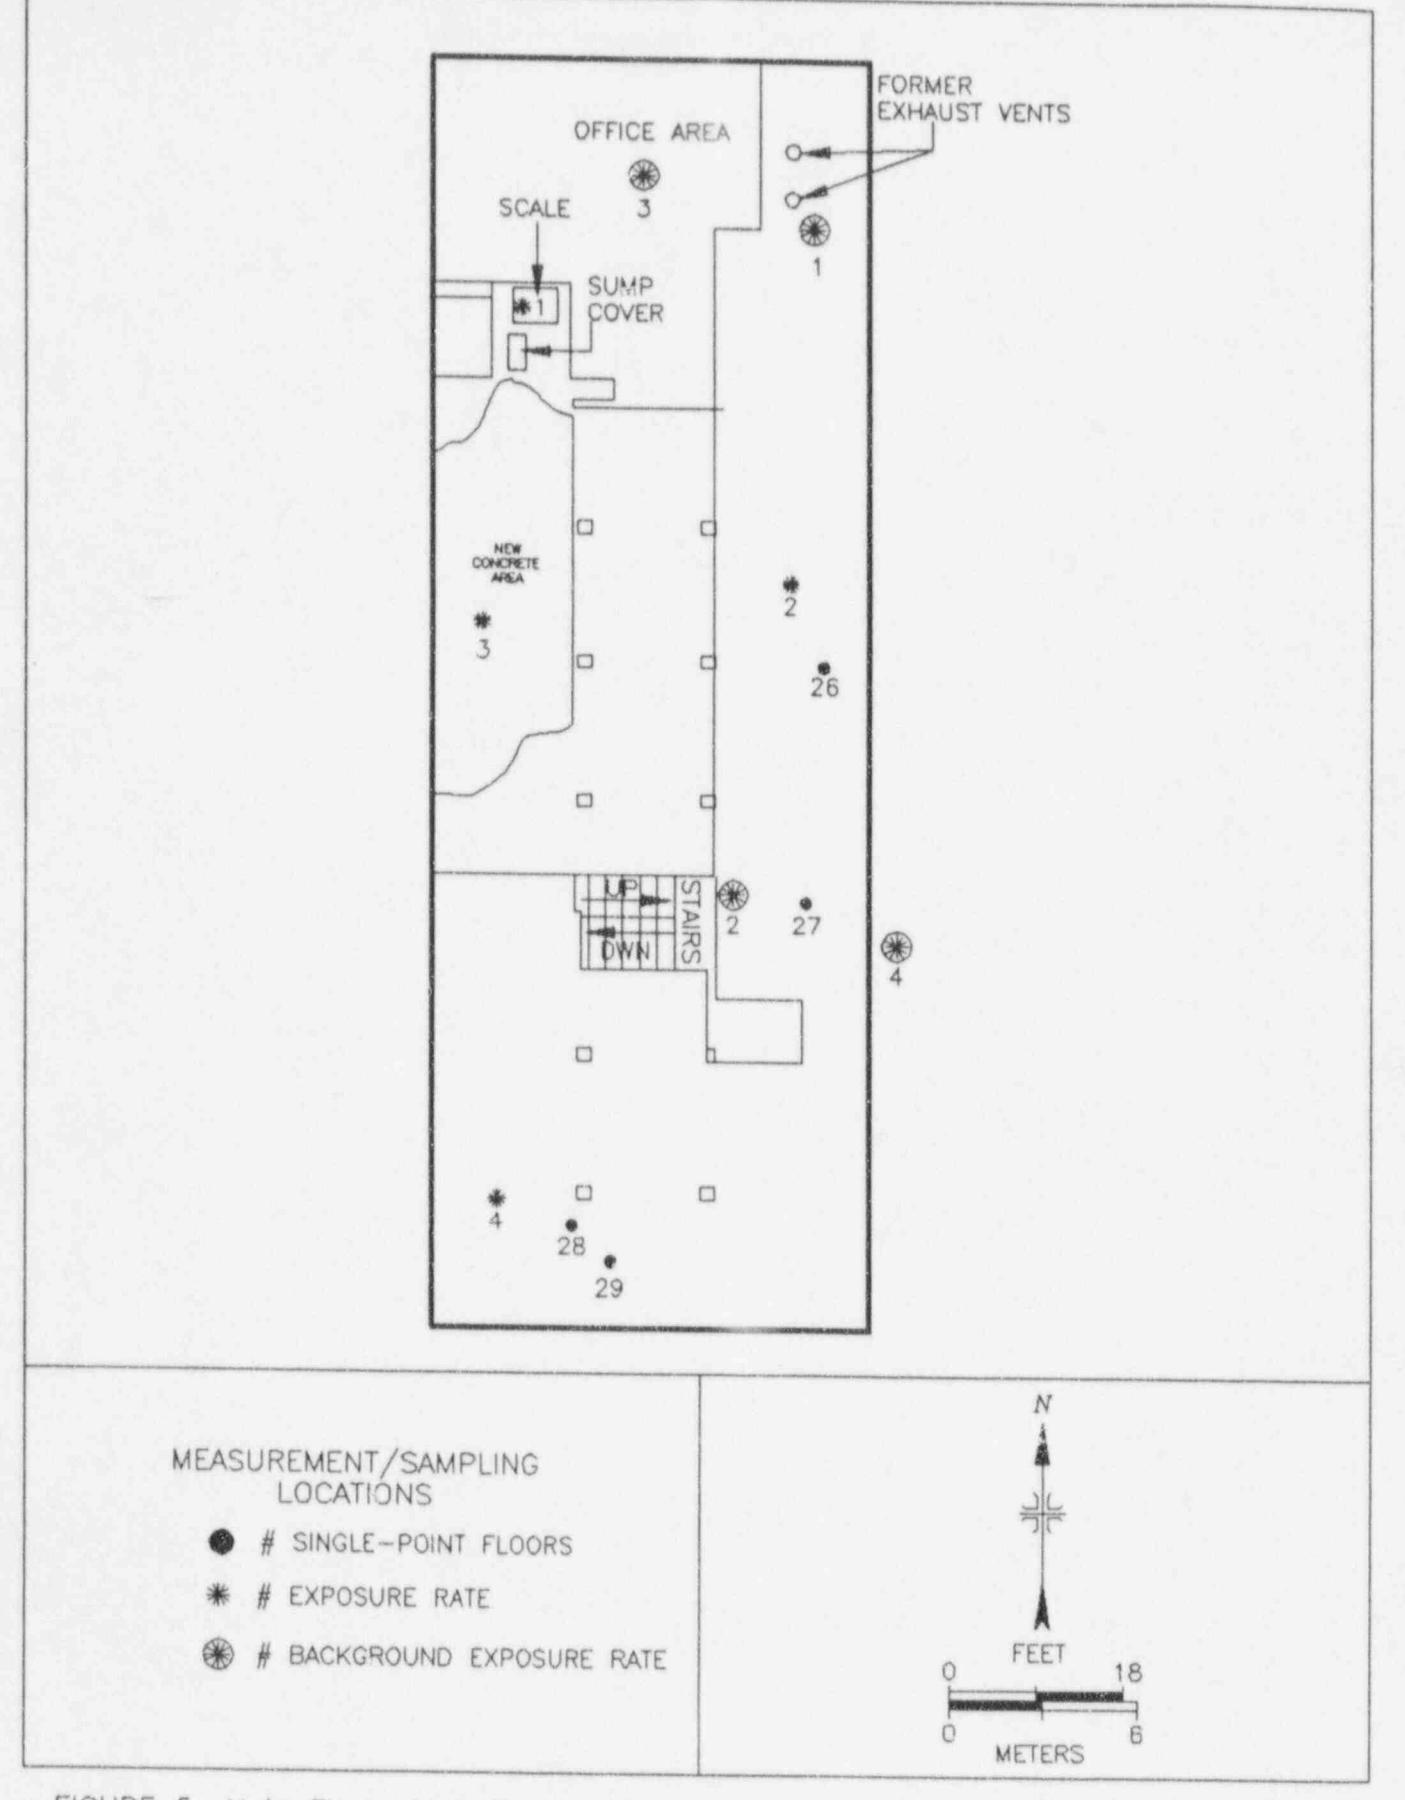
FIGURE 5: Main Floor, Non-Suspect Areas - Measurement and Sampling Locations

Background exposure rate measurements were performed at four locations in non-suspect areas. Site exposure rates were performed at four locations on the first floor, three locations in the basement, and in the sump. Exposure rate measurements were performed at 1 m above the surface using a microrem meter. Background and site exposure rate locations are shown on Figures 5 and 6.

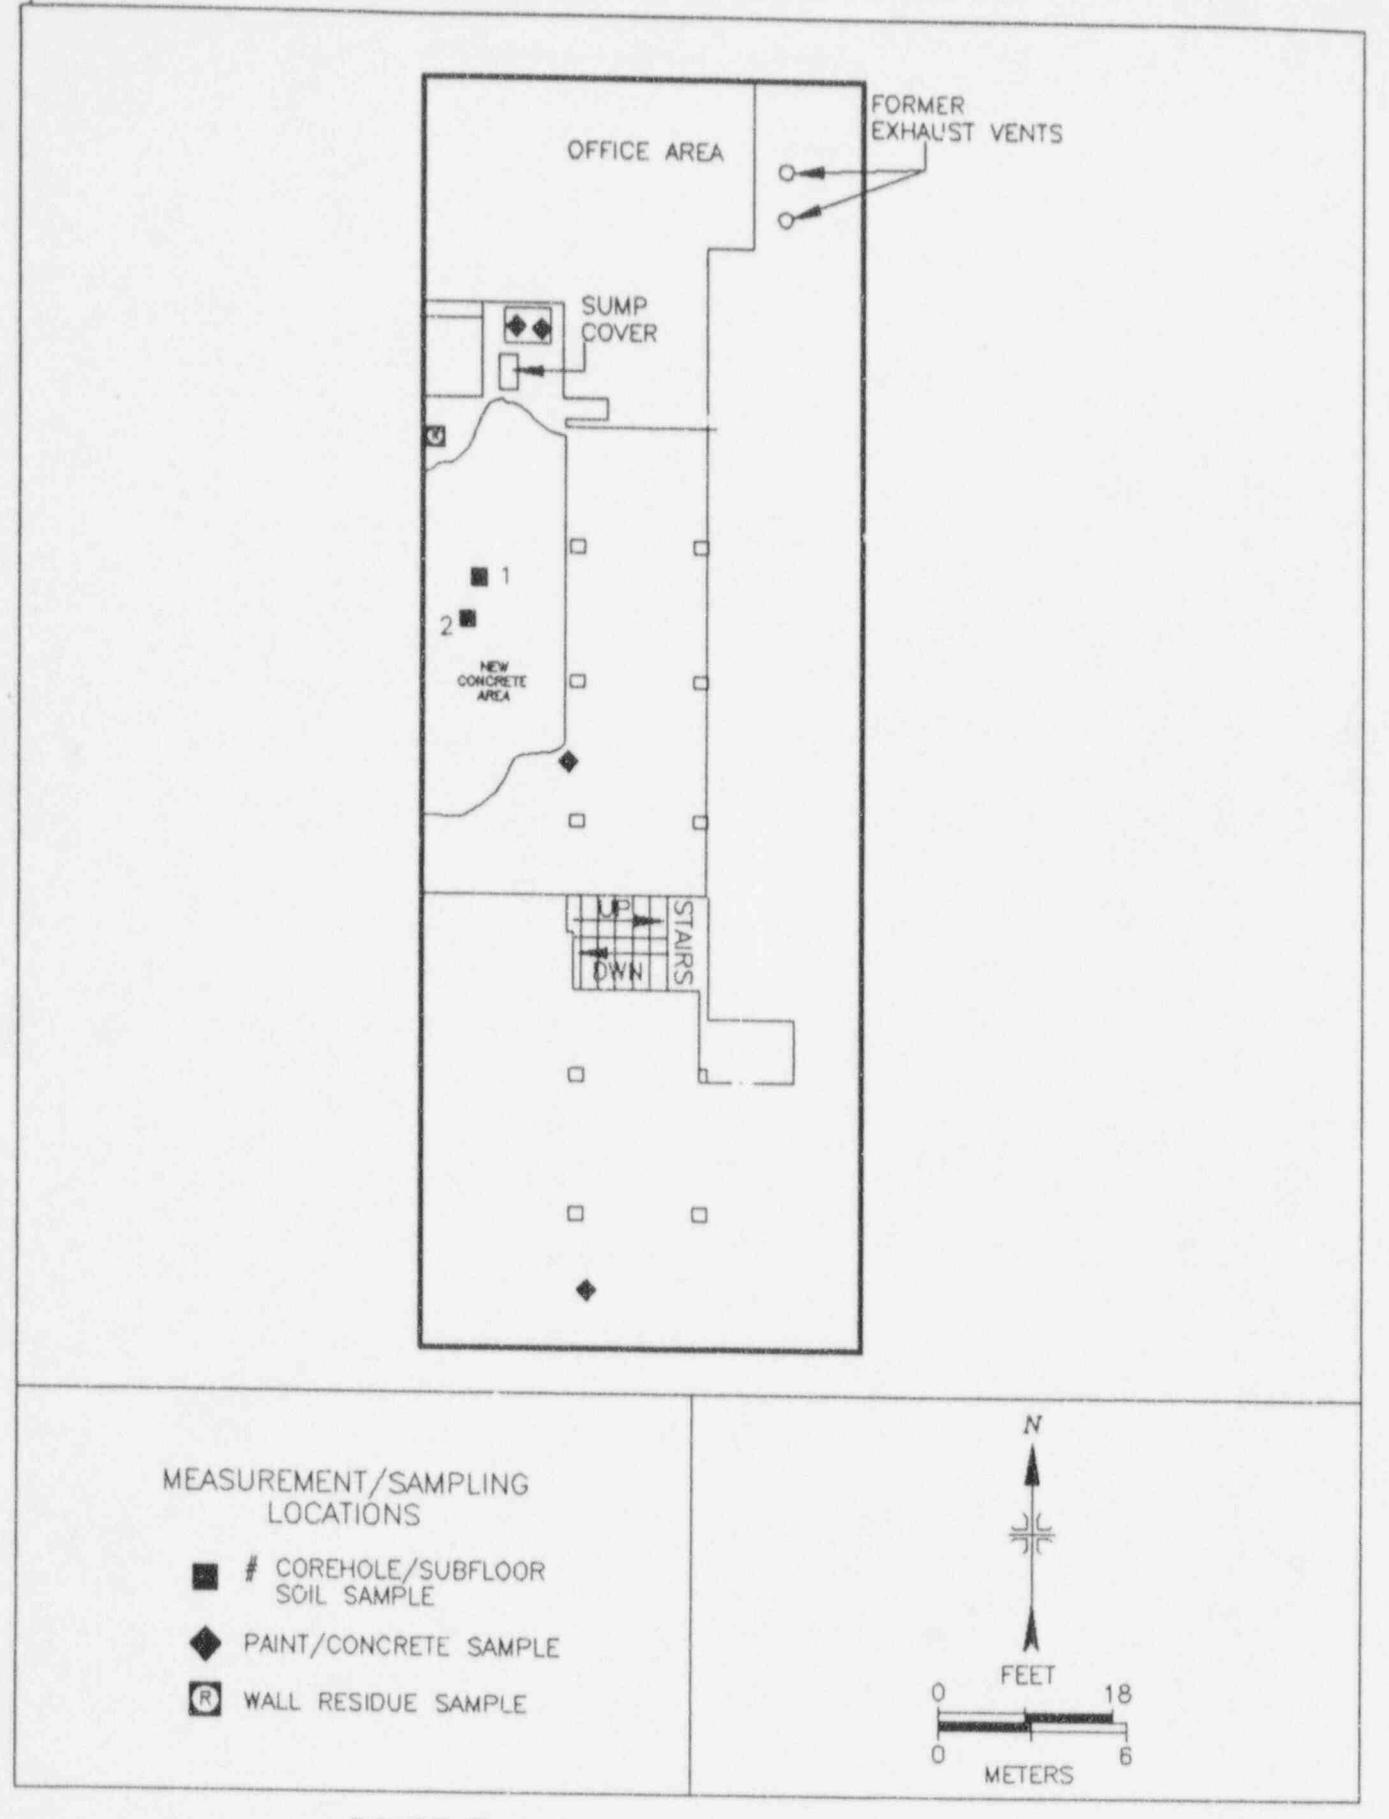
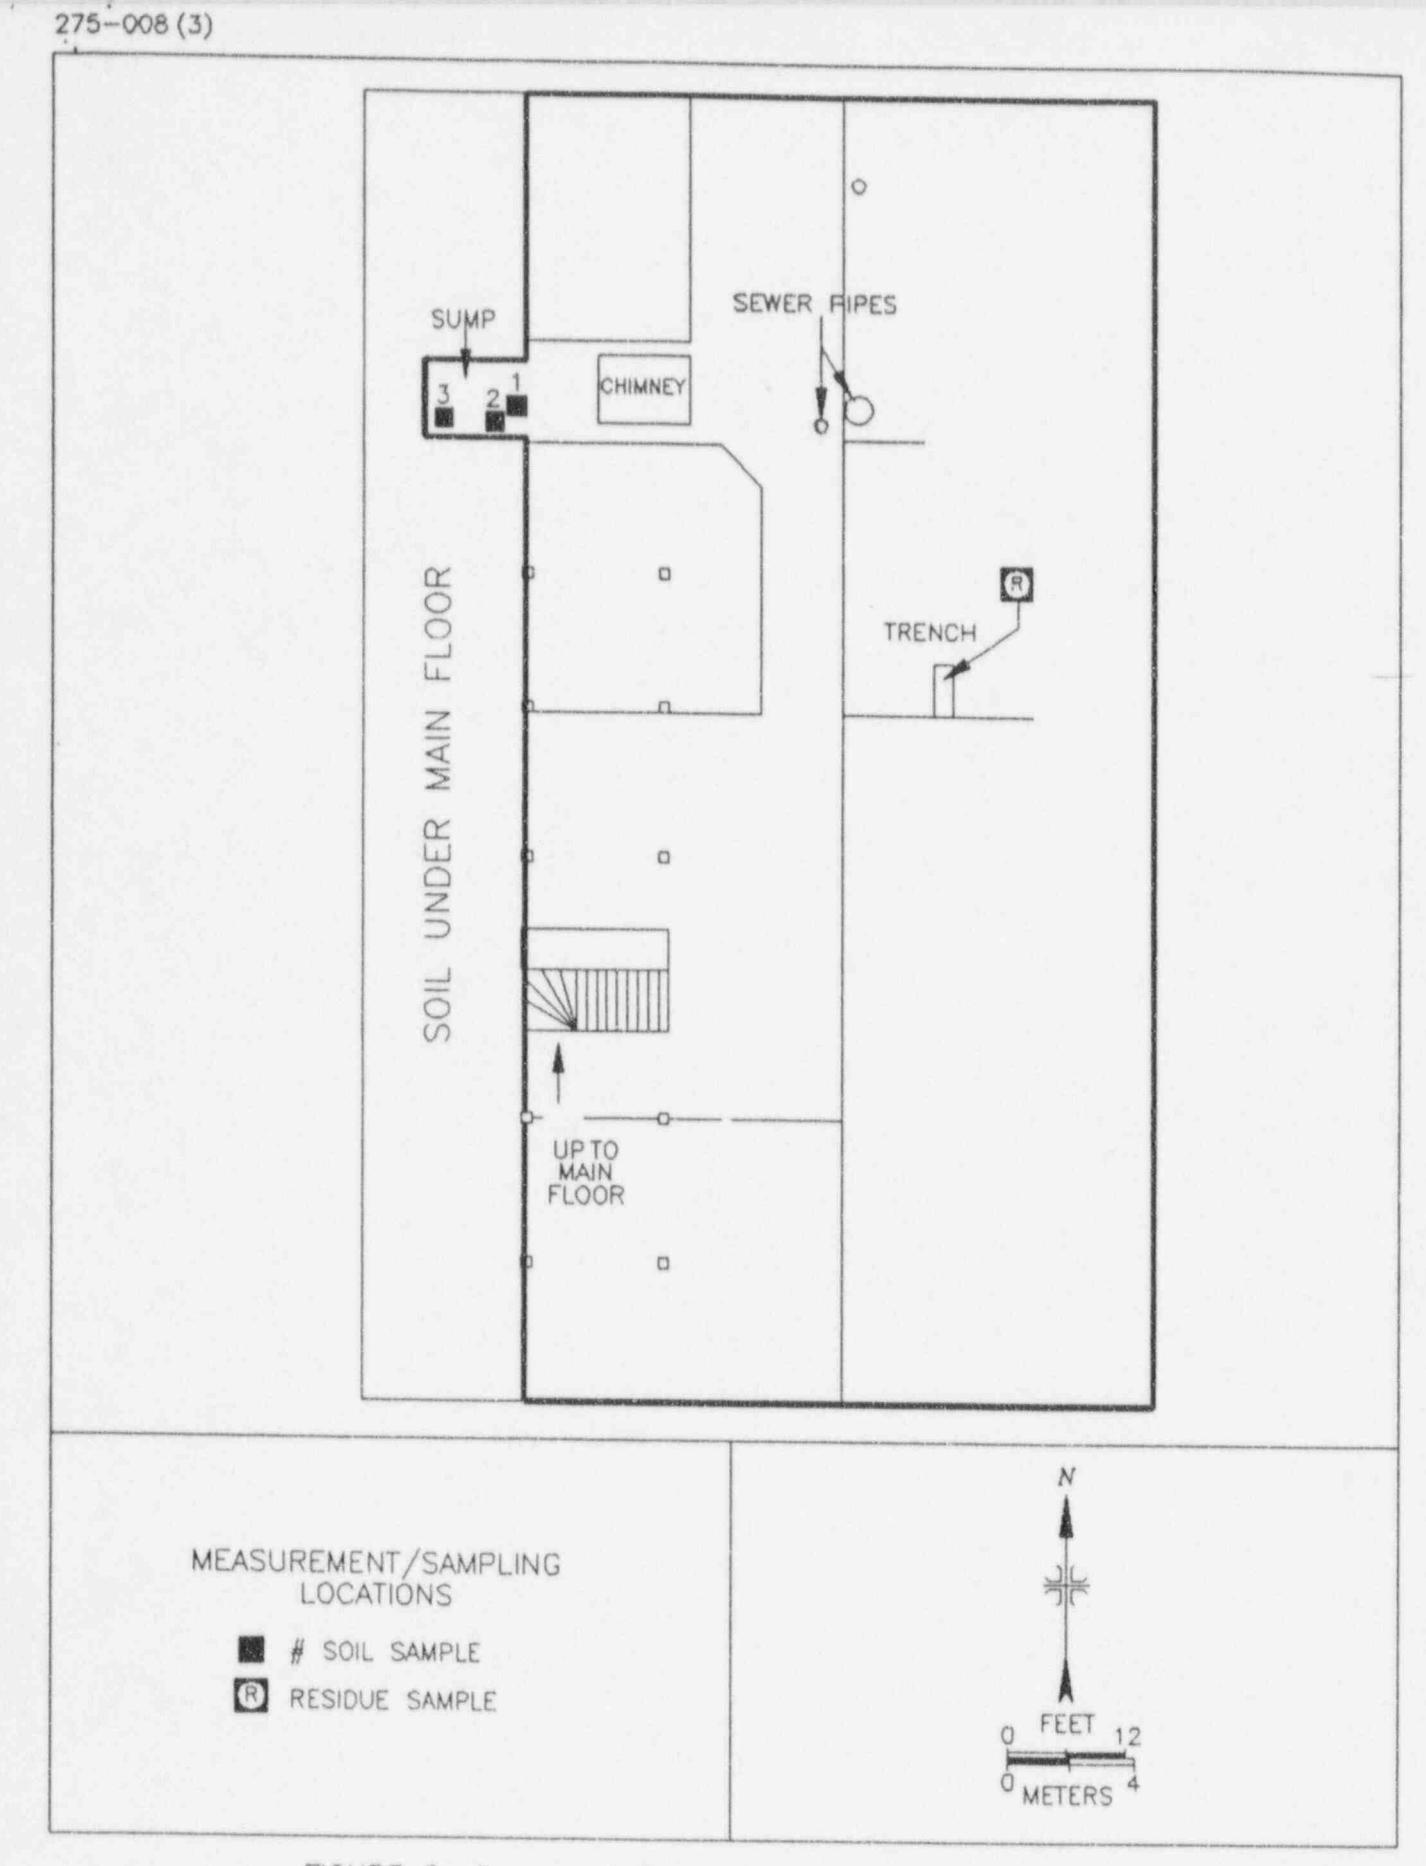
Two soil samples were collected from beneath the new concrete in the contaminated laundry area. Cores were made through the concrete and soil was hand augured from the core hole. Three soil samples were collected from the floor of the sump. One residue/paint sample was collected from the west wall of the contaminated laundry area and one residue sample was collected from a floor trench in the basement. The paint/concrete surface at four of the highest activity direct measurement locations was chipped up and collected as a sample as requested by the NRC site representative. Figures 7 and 8 show sampling locations.

Radionuclide concentrations in soil samples collected from subfloor corings and the sump are presented in Table 3. Concentration ranges for the radionuclides of interest for this site as well as other radionuclides identified by gamma spectrometry analysis are: Co-60, < 0.1 to 3.9 pCi/g; Cs-137, < 0.1 to 18,000 pCi/g; U-235, < 0.1 to 7.9 pCi/g; U-238, 0.9 to 9.1 pCi/g; total uranium, < 3.9 to 188.7 pCi/g; Eu-154, < 0.3 to 320 pCi/g; and Am-241, < 0.1 to 49.2 pCi/g. The large minimum detectable concentrations for U-235 and U-238 for sump sample 2(B) at < 17.6 pCi/g and < 220 pCi/g, respectively, are a result of a short count time and compton effects due to the high concentration of Cs-137 in the sample. Gamma spectrometry results for the residue samples collected from the west wall of the contaminated laundry area and the basement trench, and paint/concrete samples collected from the four locations of elevated beta activity were all less than the minimum detectable concentrations of the procedure.

Alpha spectrometry analysis of the three sump soil samples indicates the presence of enriched uranium with an average U-234: U-235 ratio of 22 to 1. Analysis of the same three samples shows the presence of Pu-238 and Pu-239 with concentrations ranging from 0.1 to 20.1 pCi/g and 0.1 to 12.0 pCi/g, respectively.

The soil concentration guideline for enriched uranium is 30 pCi/g (NRC 1981). All three of the soil samples collected from the sump exceed this guideline. Site-specific soil concentration guidelines for the other radionuclides identified (Eu-152, Am-241, Pu-238 and -239, Cs-137, and Sr-90) at this site have not been established; therefore, a comparison could not be made.
