Subject: Licensee Event Report (LER) 96-012-00

NHC FORM 366 U.S. NU (5-92)											aul	ATOR	NY CC	MMISSIO	N			APP	ROV	FD OM	B NO.	3150	-01	04		A Garage Prove		A. S. Statistical day
																				EXP	RES 5/	91/95						
			LIC	CEN	SEE	EEV	ENT F	REP	PORT (L	ER)						ESTIM INFOF COMN AND F REGU AND T OFFIC	IATED MATIO MENTS IEPORT LATOR O THE E OF N	BURD N CO REGA IS MA Y COI PAPE IANA(DEN I ILEC ARDIN ANAG MMAIS ERWA	PER RE CTION NG BUS CMEN SSION, DRK RE ENT A	SPON PEQU RDEN 1 BRA WASH DUCT	ISE T EST ESTINOH IN 31 TON DGET	0 (50.1 (MA) (MF FON PR(F, W		IPLY DURS 0 T 1 7714 0 205 2T (3 f NG	WITH FOR E RF-L), U 8 55-00 150-0 TON D	THIS WARD ORD NUC 21, 104), IC 201	B D S DLEAR 603.
FACILIT	Y NAME ((1)	~											and the second second second second				DOG	KET	NUME	ER (2))				1	PAGE	E (3)
TITLE	0		CR	YST/	AL I	RIVE	R UNI	r 3	(CR-3)		-						_	0	5	0	0 1	0 :	3	0	2	1	OF	1 2
	Op	erat	tion	Outs	ide I	Desig	gn Basi	s Ca	used by	Batter	y C	harg	gers	Having	Inadeq	uate "	Test F	Resu	ults	Acce	pted	in E	Err	or

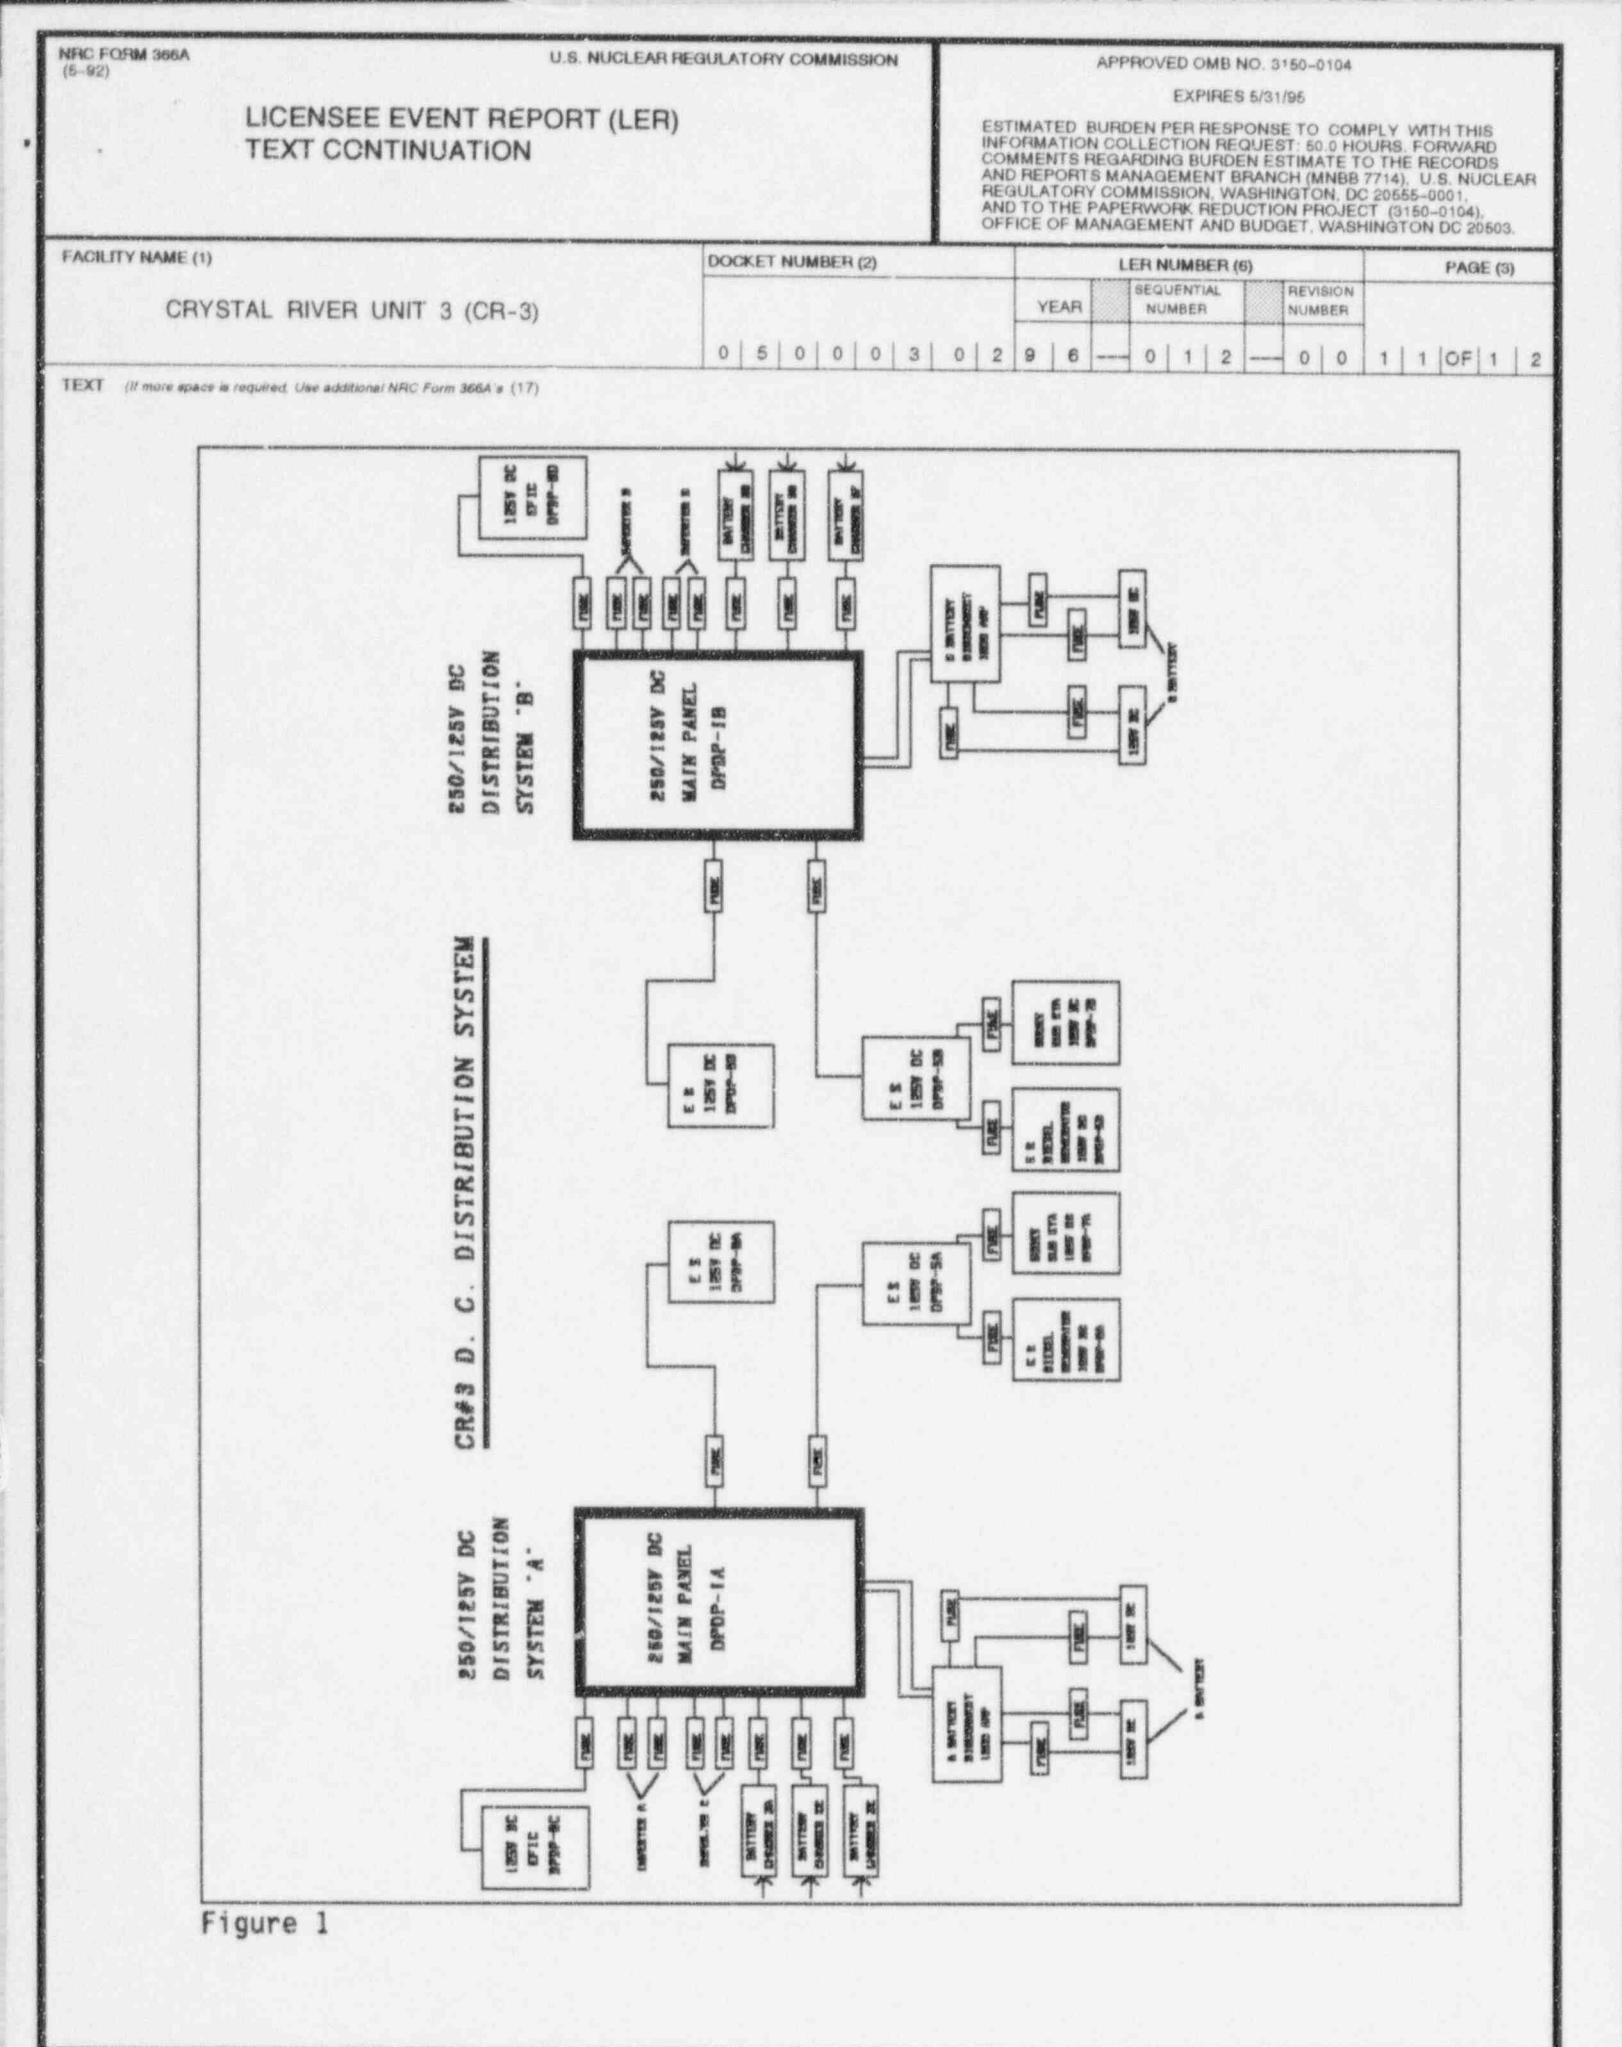
Figure 1 - DC Distribution System Figure 2 - AC Electrical Distribution System

The Class 1E battery chargers are part of the 250/125 Volt DC System. The 250 VDC source is obtained by use of two 125 VDC batteries [EJ,BTRY] connected in series. The Class 1E portion consists of two isolated bus sections, Train "A" and Train "B". Each bus is equipped with three battery chargers for each battery. The battery chargers convert AC power to DC power to maintain the batteries in a fully charged condition while supplying plant DC loads. During normal operation, two of the battery chargers for each bus are in service supplying a float charge to the battery and the third is available to be placed in service in the event one of the normally aligned battery chargers is out of service.

The battery chargers normally supply the DC System load and float charge to the batteries. These loads consist of DC pump motors, switchgear circuit breaker controls, control and instrumentation. In the event of a loss of normal power to the battery charger, the DC loads are automatically powered from the station IE batteries. Credit is taken for Class IE DC Power System operation in most of the Design Basis Accidents, with the most limiting scenario being the Loss of Electric Power Accident. This event, complete loss of all unit AC power, defines the limiting conditions for Class IE DC Power System derign. The DC electrical power system also conforms to the recommendations of Regulatory Guide 1.6 and IEEE-308 "IEEE Criteria for Class IE Electrical Systems for Nuclear Power Generating Stations".

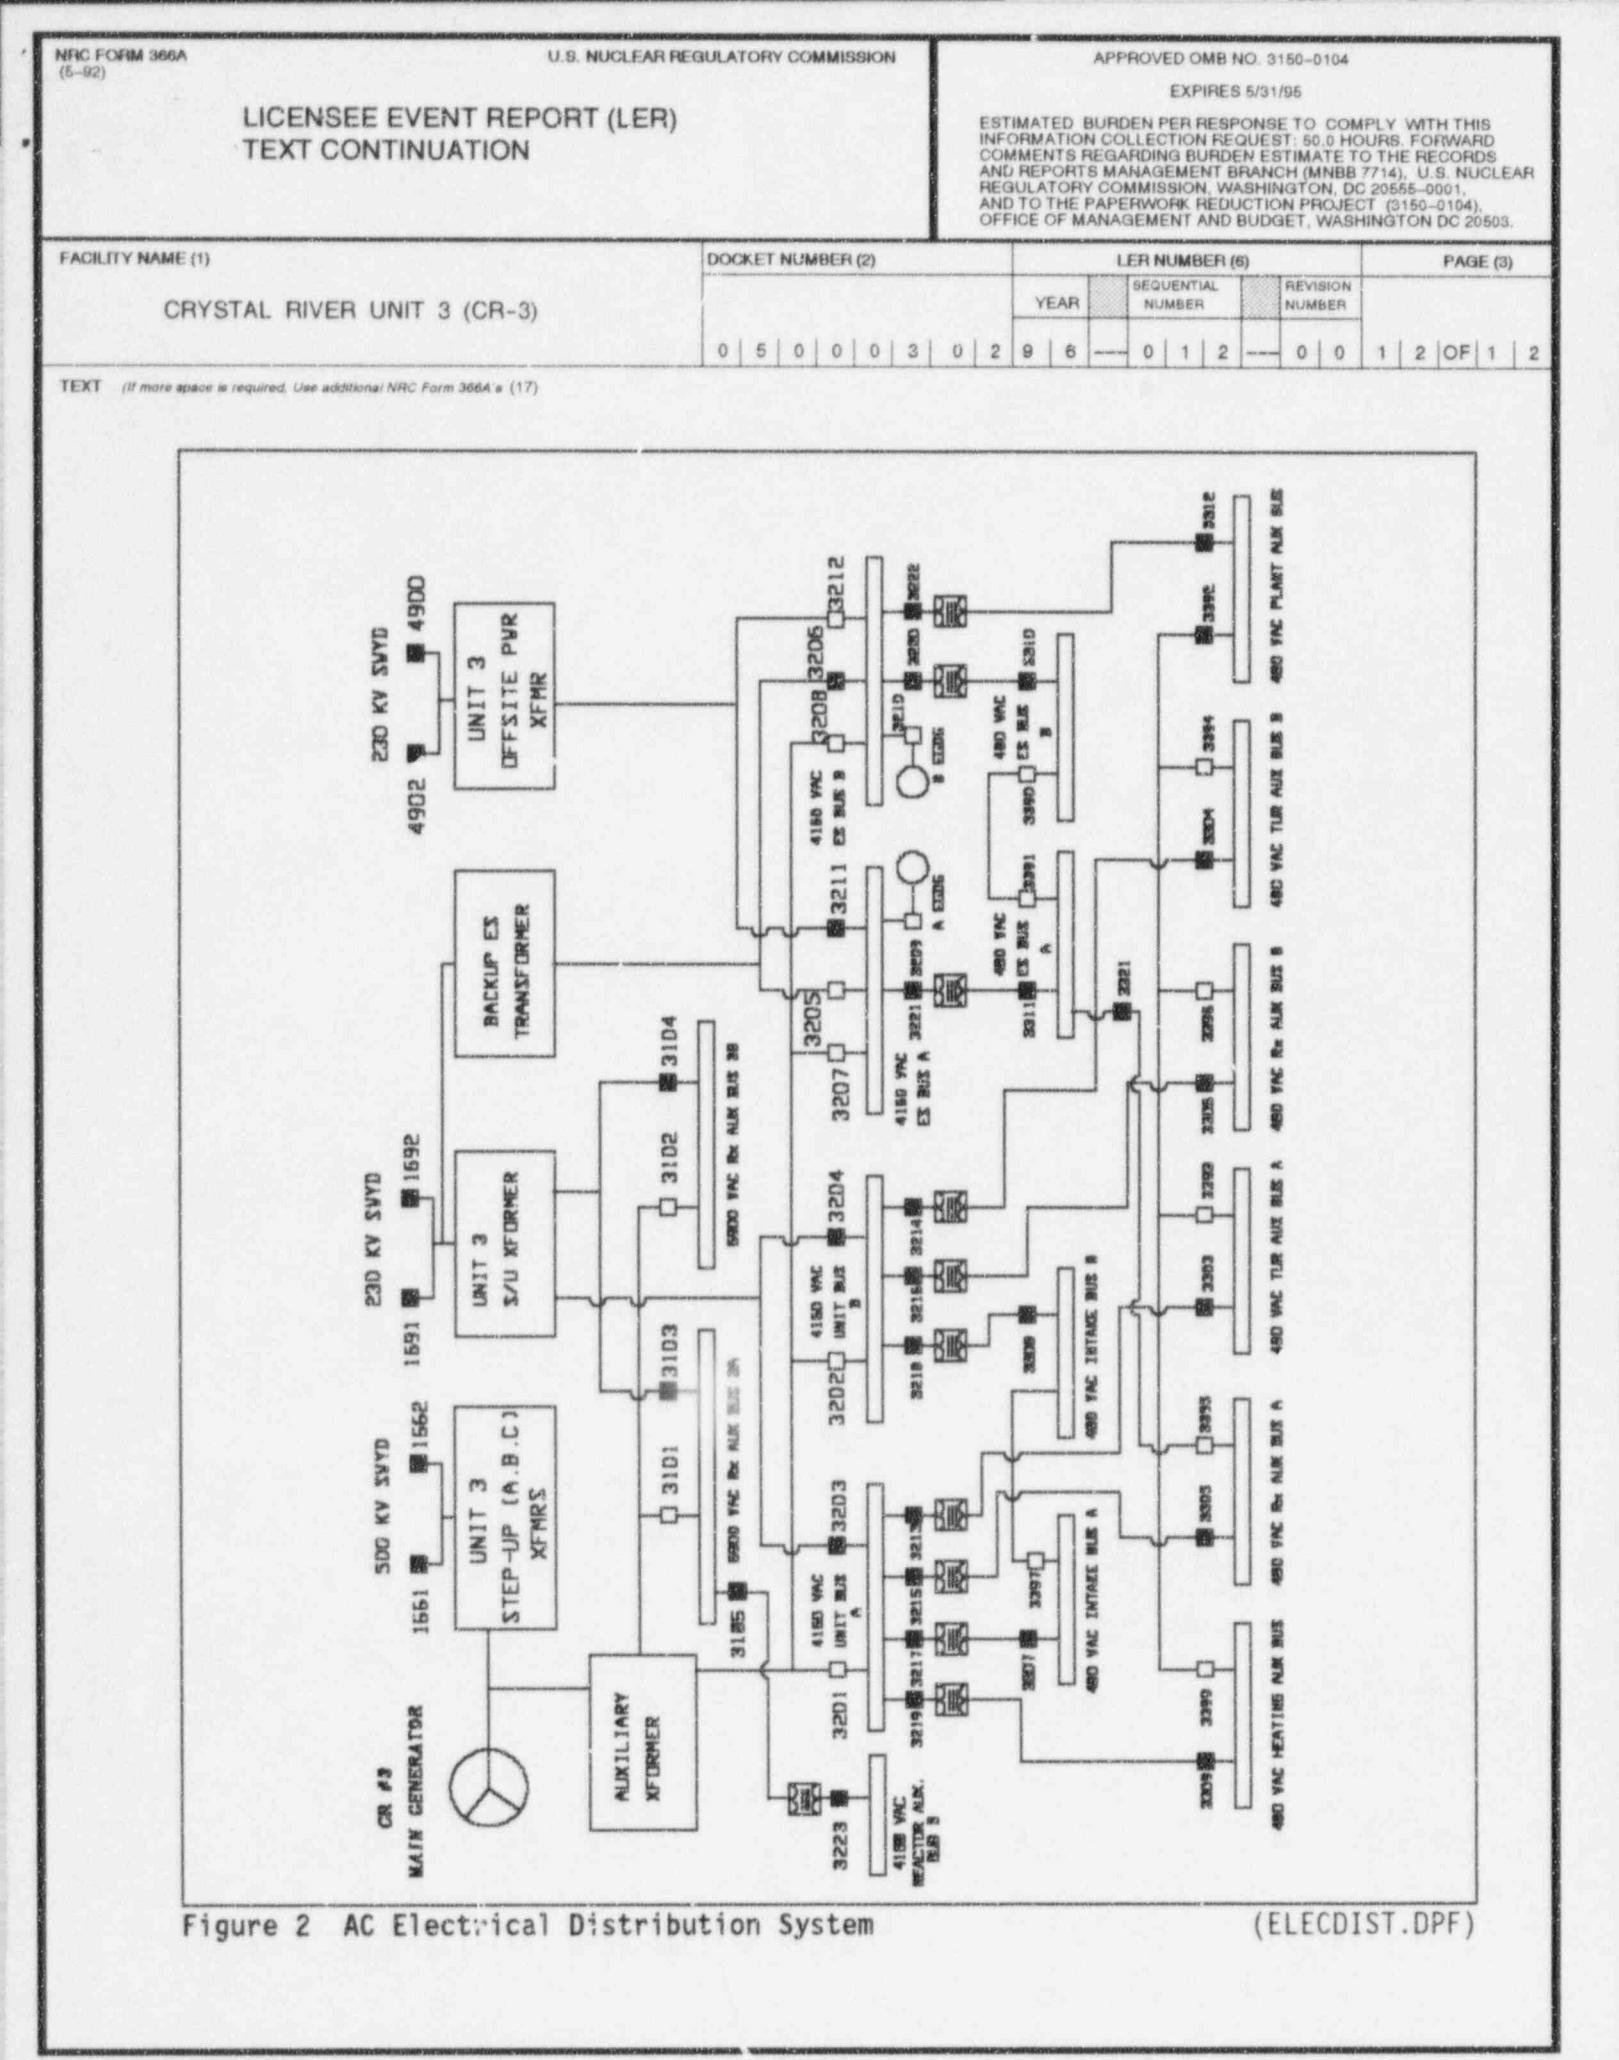
The safety functions of the Class 1E DC Power System are to distribute power from the 480 VAC ES busses to required DC load via the battery chargers and maintain the batteries in a fully charged state prior to, during and following a design basis event. During and following a design basis event when a complete loss of all offsite and onsite AC power occurs, the Class 1E DC Power System provides power from the batteries to supply required DC loads and provides a source of vital 120 VAC power [ED] via the dual input inverters [EE,INVT] (VBIT-1A, 1B, 1C, 1D).

The operational consequences of the slight degradation in DC output regulation of the battery chargers have been evaluated. Prior to 1991, the Start-Up Transformer [EB,XFMR] had both 4160 VAC non-ES Unit Busses and both 4160 VAC ES busses fed from it. With 236.4 kilovolts (KV) in the Switchyard [FK], this gave 400V at the Train "A" battery chargers and 398V at the Train "B" chargers.
