## UNIVERSITY OF CALIFORNIA, LOS ANGELES

ENCLOSED PLEASE FIND A COPY OF 11/5/80 LETTER FROM RALPH SUAREZ OF PEAK TECHNOLOGIES AND HIS ATTACHED DESCRIPTIVE FLYERS ON INFRARED DETECTORS.

NUCLEAR ENERGY LABORATORY

- 1. Appendix A Notice of Violation
- 2. Appendix B Notice of Deviation
- 3. Inspection Report No. 50-142/77-02

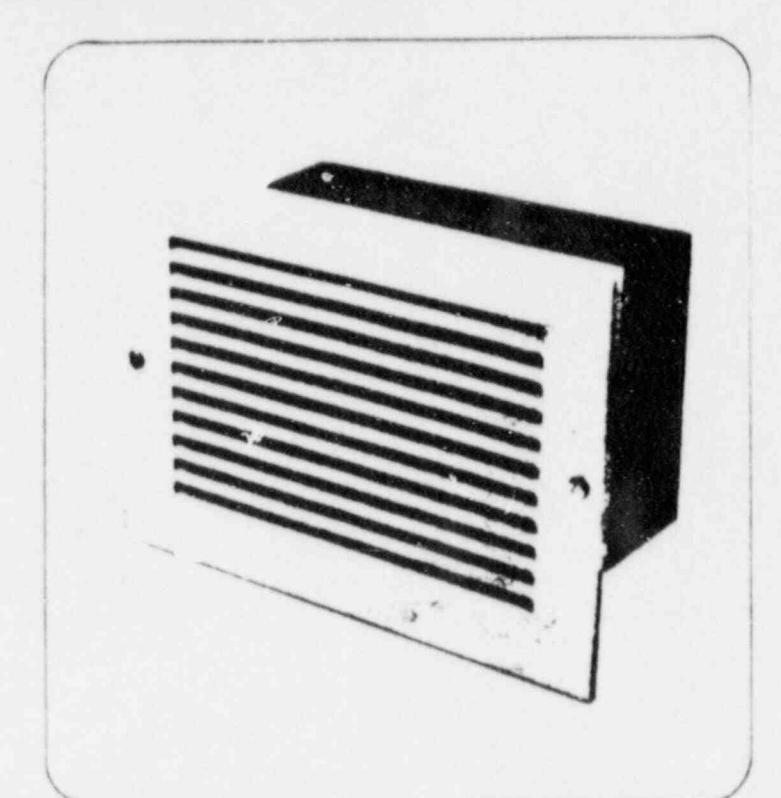
The IR-31 passive infrared intrusion detector features an advanced design using a new, high stability ceramic sensing element. The unit is powered by a 12 volt DC supply, model SPS-301, which will operate up to ten infrared detectors. The optical system has seven high resolution mirrors, giving five main beams covering 85 degrees, and two downward beams for coverage under the unit. An intruder will be detected within the pattern when crossing any one of the seven view zones. Range is 25 feet or more under typical conditions. The detector is completely passive, and emits no signals or light beams. Any number will operate without mutual interference.

The detector works by sensing the difference in temperature between a moving object and the background. As a moving intruder enters or leaves one of the seven zones, the ceramic sensing element responds to the sudden change in infrared energy in that zone, caused by the difference in temperature. An output signal from the sensing element is amplified and used to open a relay contact, thus sending in the alarm.

The IR-31 is a versatile detector suitable for a wide variety of applications, particularly multiple head installations. Each unit has a relay output and operates independently in the system. The detectors are compact, easily mounted, and blend with decor. The stability of the pattern and immunity to air turbulence make it an excellent choice for indoor protection of mercantile premises, offices, homes, and other high value areas. The unit fits into an existing wall and resembles an ordinary heating vent. The housing is held firmly in a rectangular cutout by means of two backing strips.

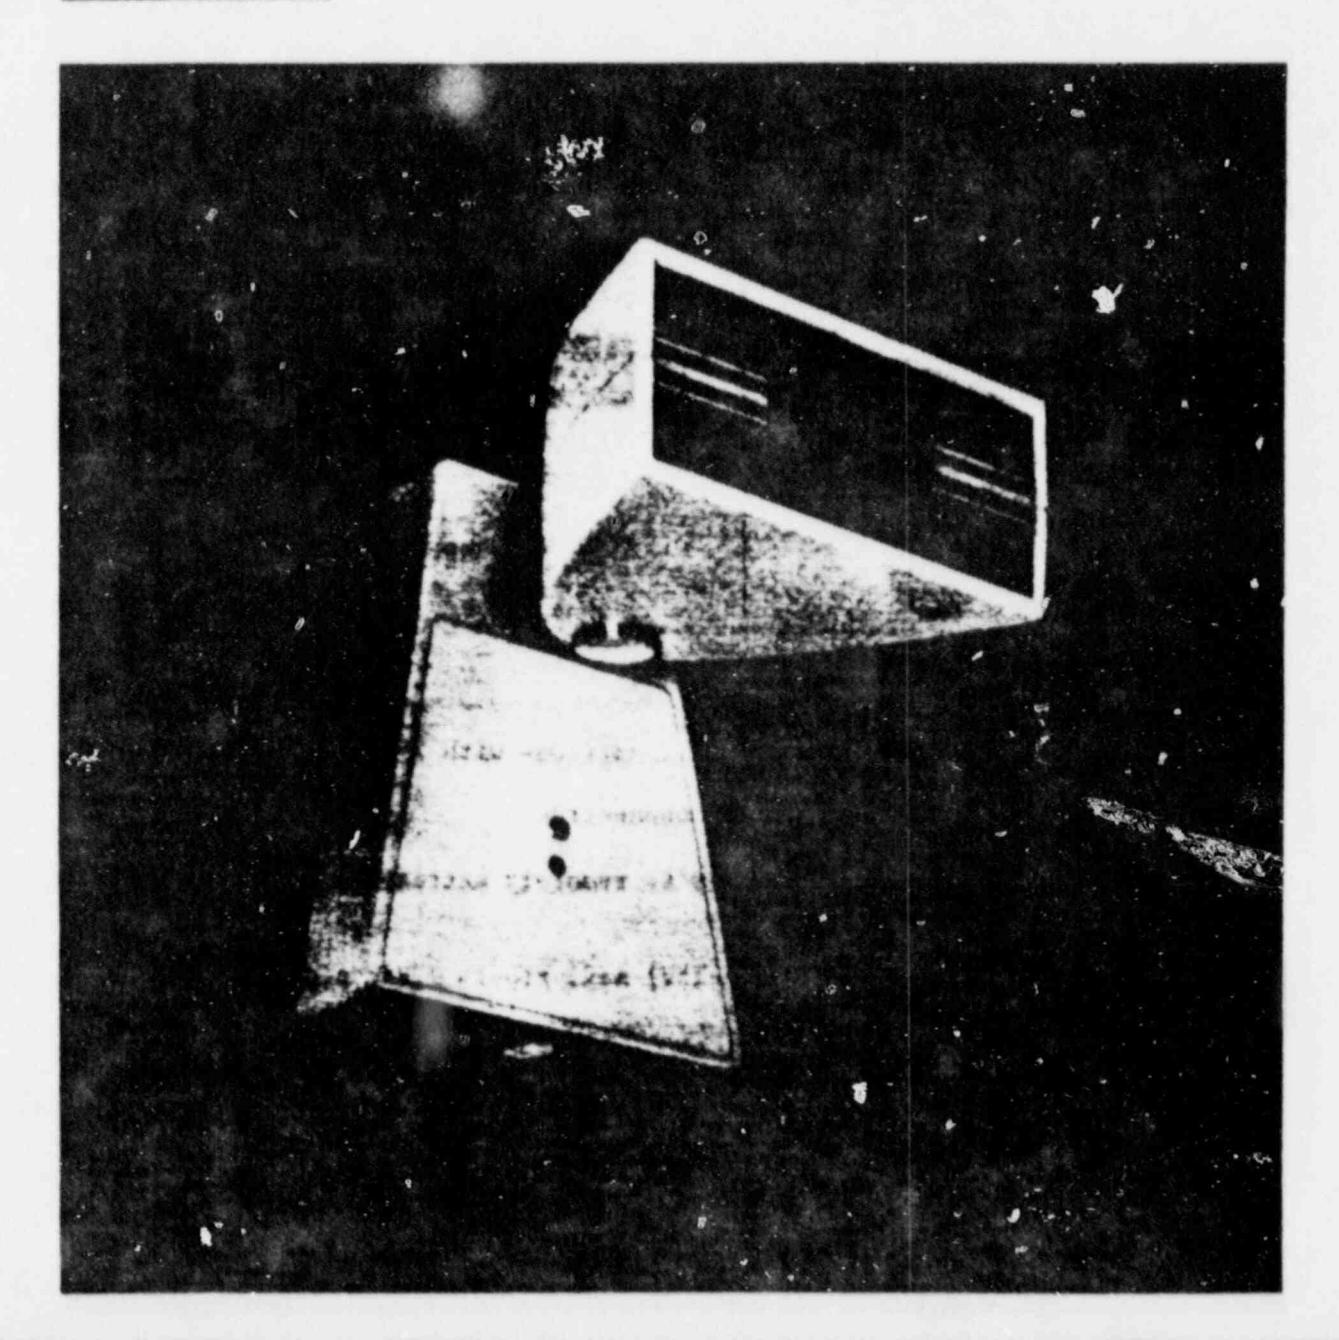
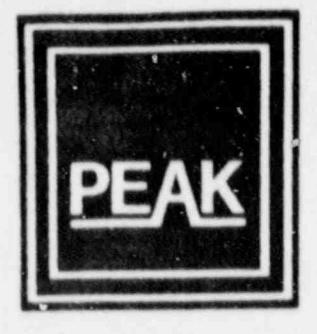
Model IR 1335 is a compact solidstate passive infra-red intruder detector.

This completely passive unit is ideal for corridor, perimeter and roof space protection in offices, factories, schools and warehouses, particularly where air conditioning systems are in operation.

The IR 1335 finds applications in areas that may be unsuitable for other types of detectors such as microwave, ultrasonic or single element PIR units.

Areas bounded by large glazed surfaces or lightweight partitioning materials may be effectively protected since there will be few penetration problems.

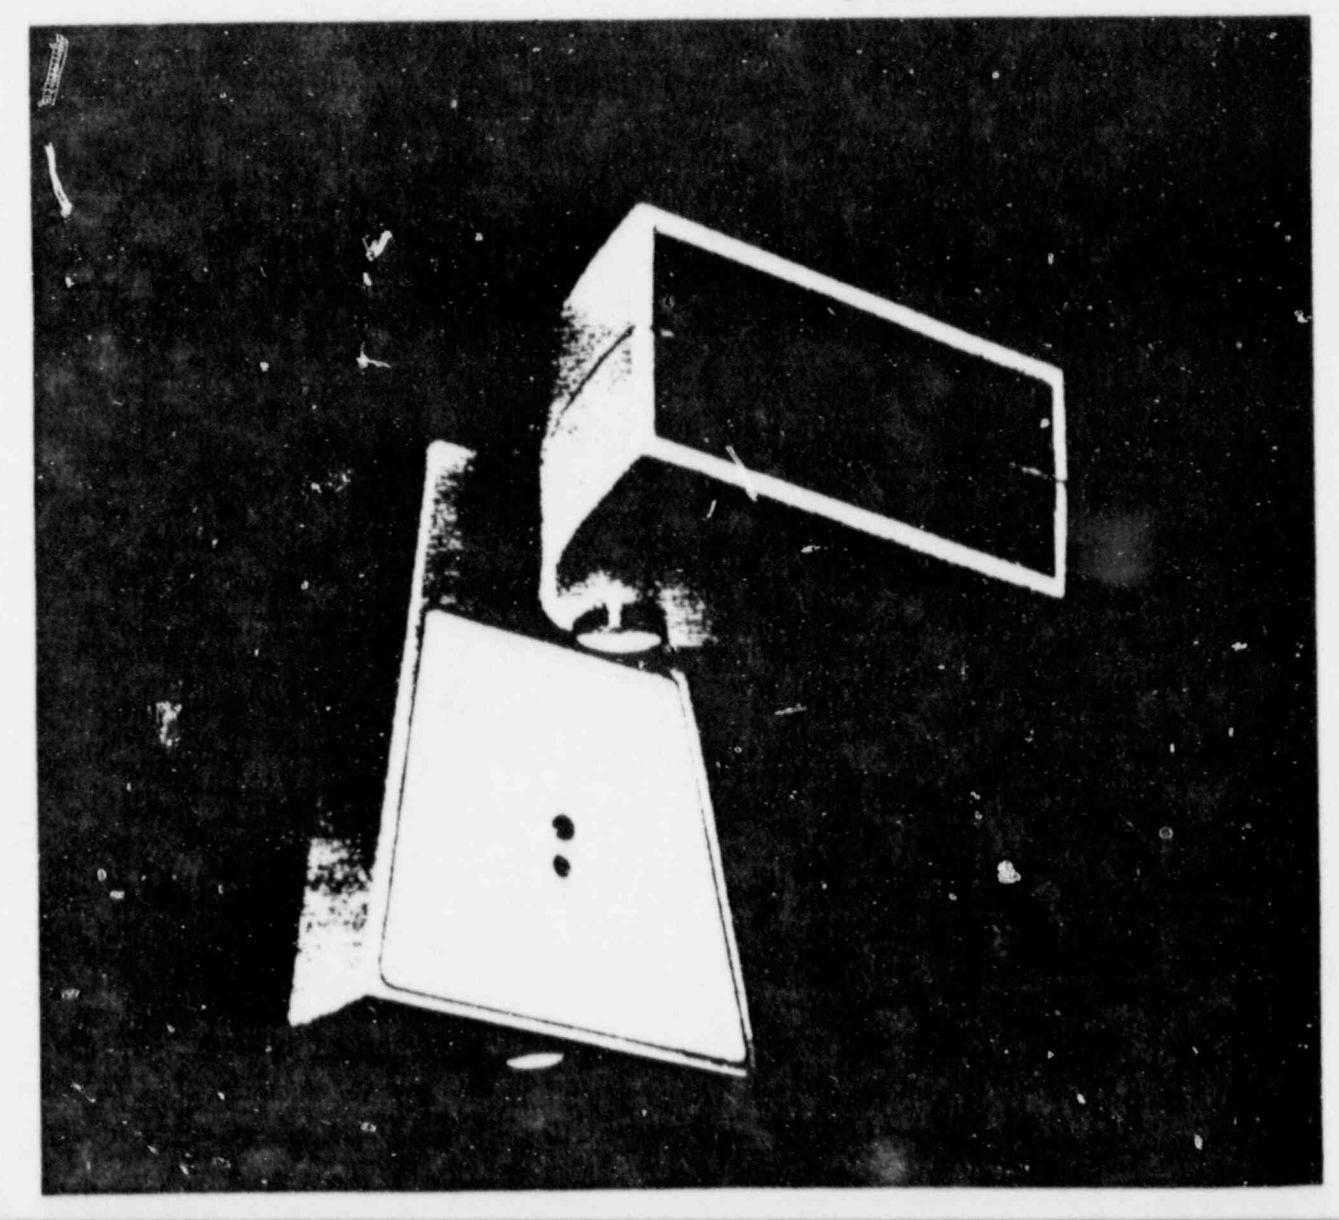
# PÀSSIVE INFRA-RED DETECTOR MULTIBEAM

# Type IR1335

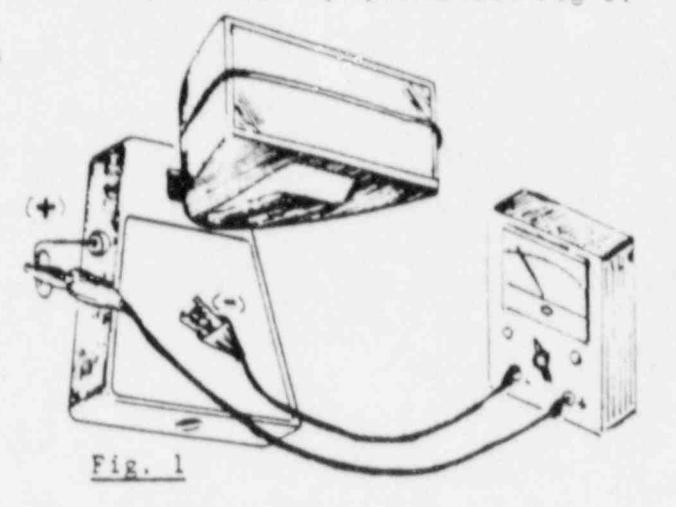
2. Connuct a DC voltmeter to the unit as shown in Fig. 1. Insert the end of a paper clip in the red test jack for the positive (+) lead, and slightly loosen the cover retaining screw and clip the negative (-) lead to the screw head. Set the voltmeter to either a 1 or 3 volt DC range, or to the closest available range between.

3. Allow about 30 seconds for the reading to stabilize. (Do not touch the head while making the reading.) The meter will settle to a print approximately 3/10 volt positive.

4. Observe the reading for one minute. During this time the needle should not swing more than 2/10 volt either way from the stable point. Excessive swing means unit is defective and should be removed from switem and replaced with another unit.
