SOIL EROSION CONTROL PLAN

WHITTAKER CORPORATION GREENVILLE, PA

NES, Inc. 44 Shelter Rock Road Danbury, CT 06810

July 1998

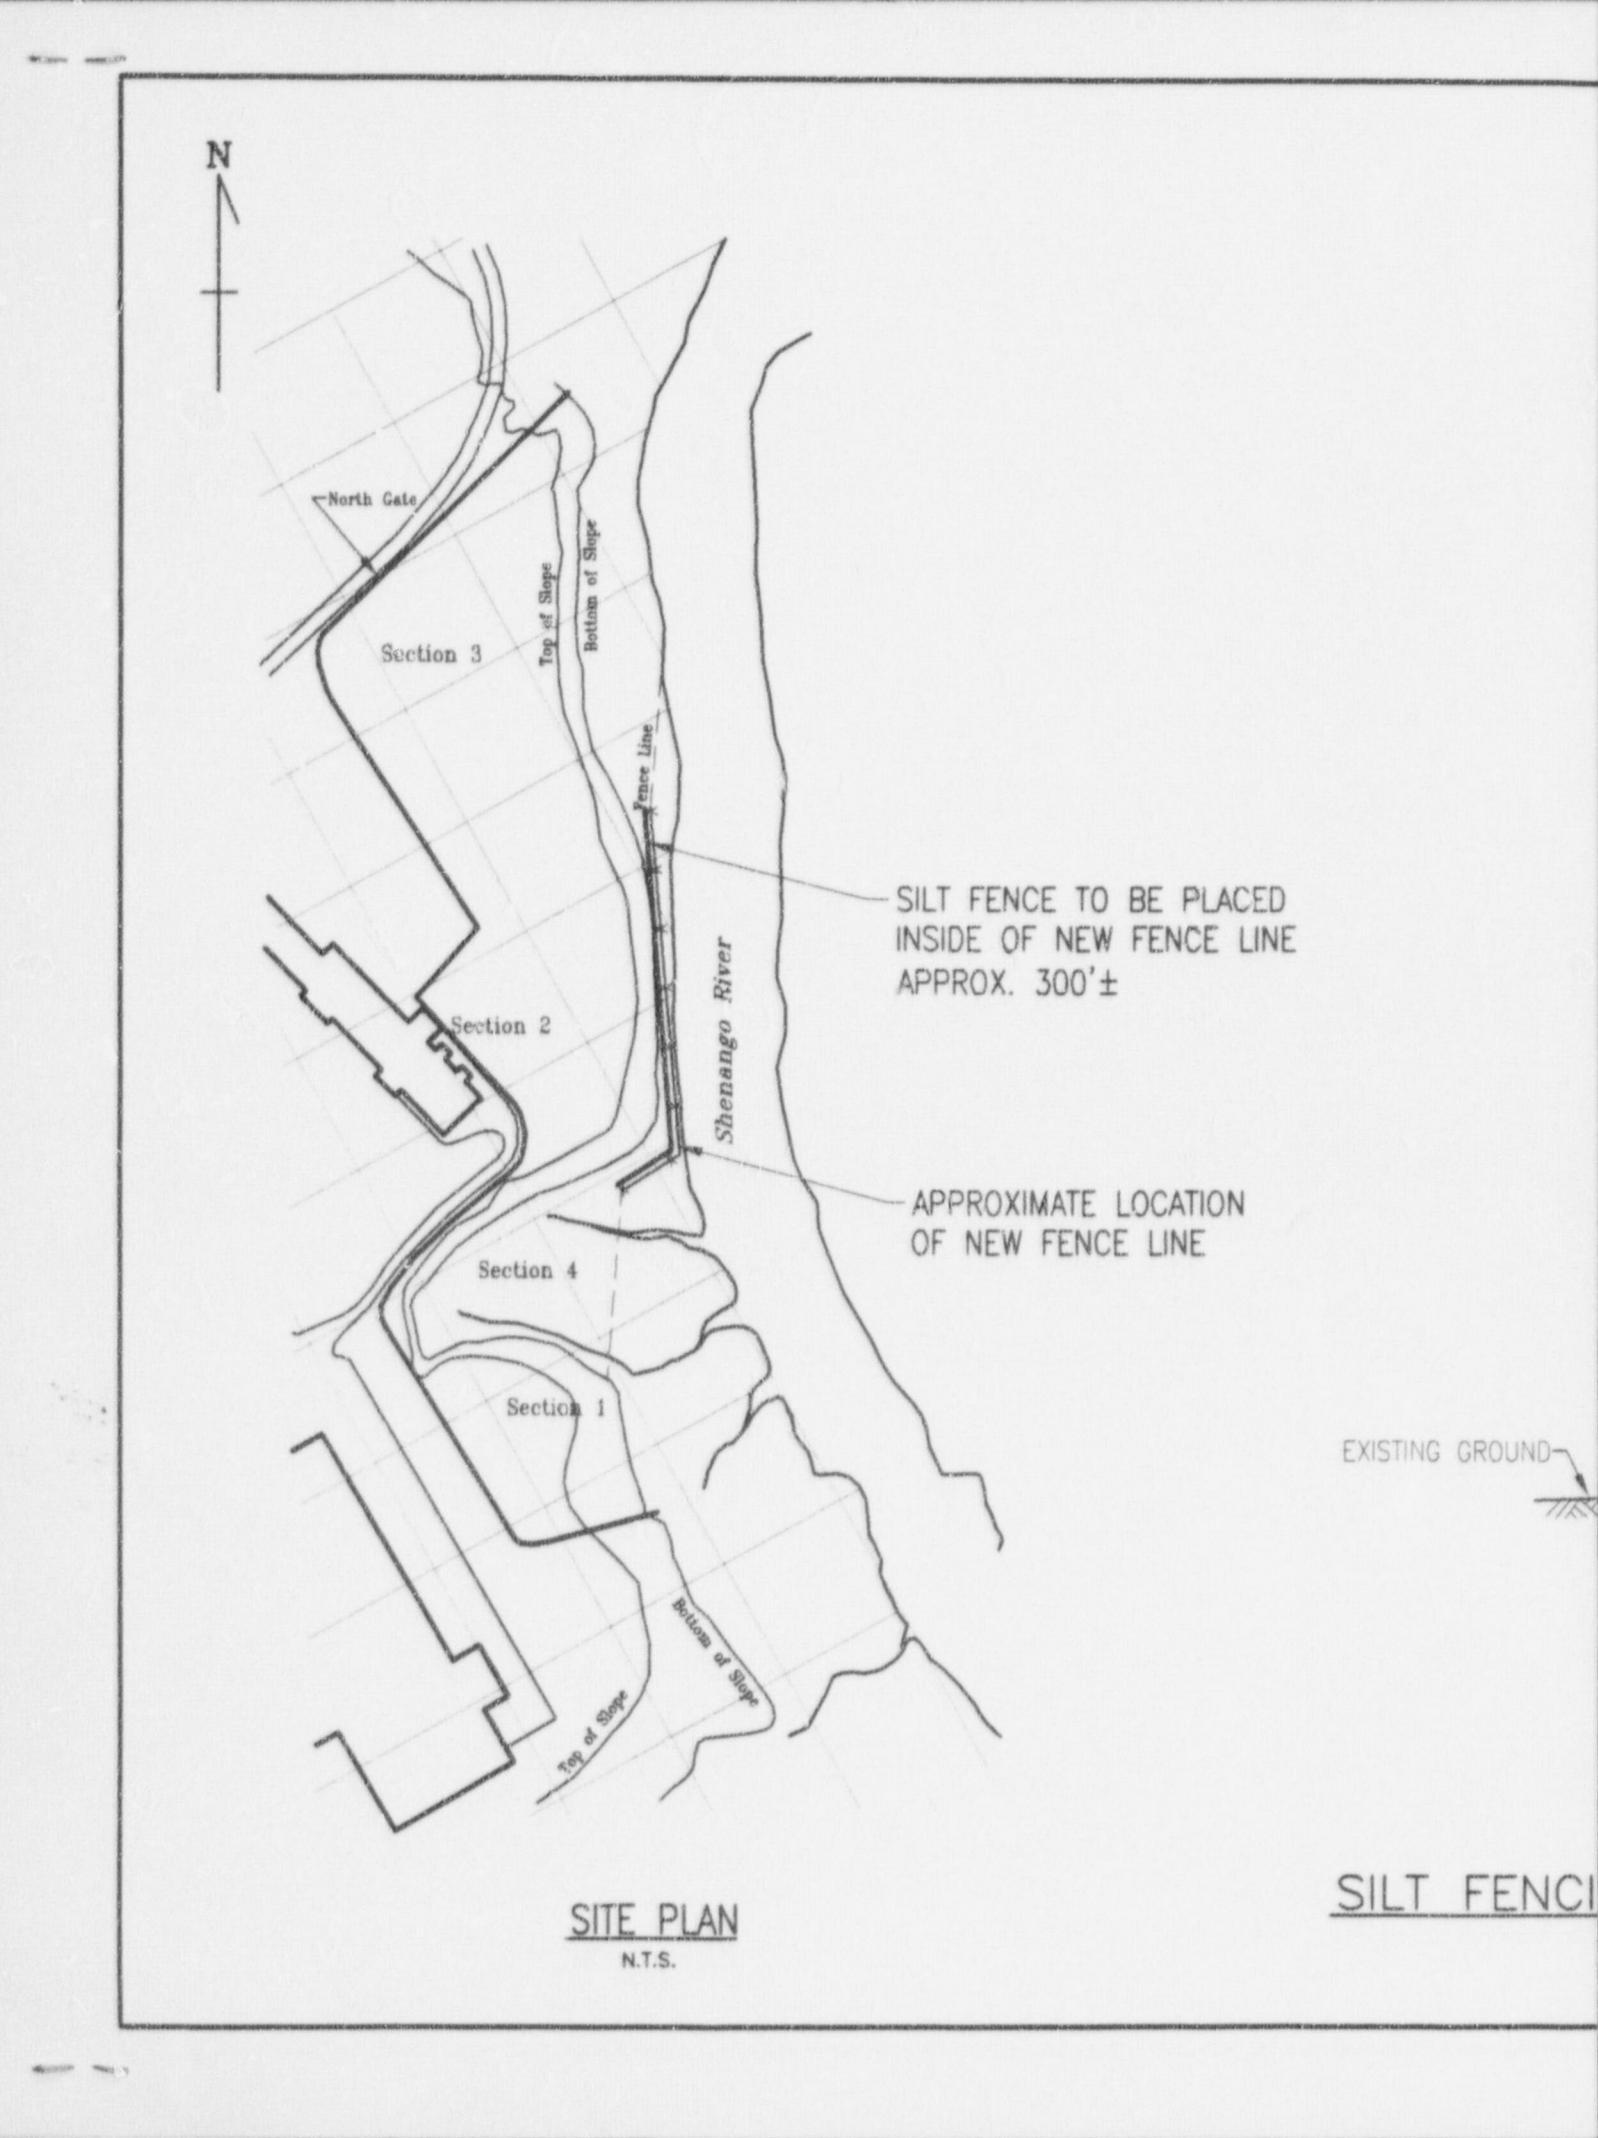
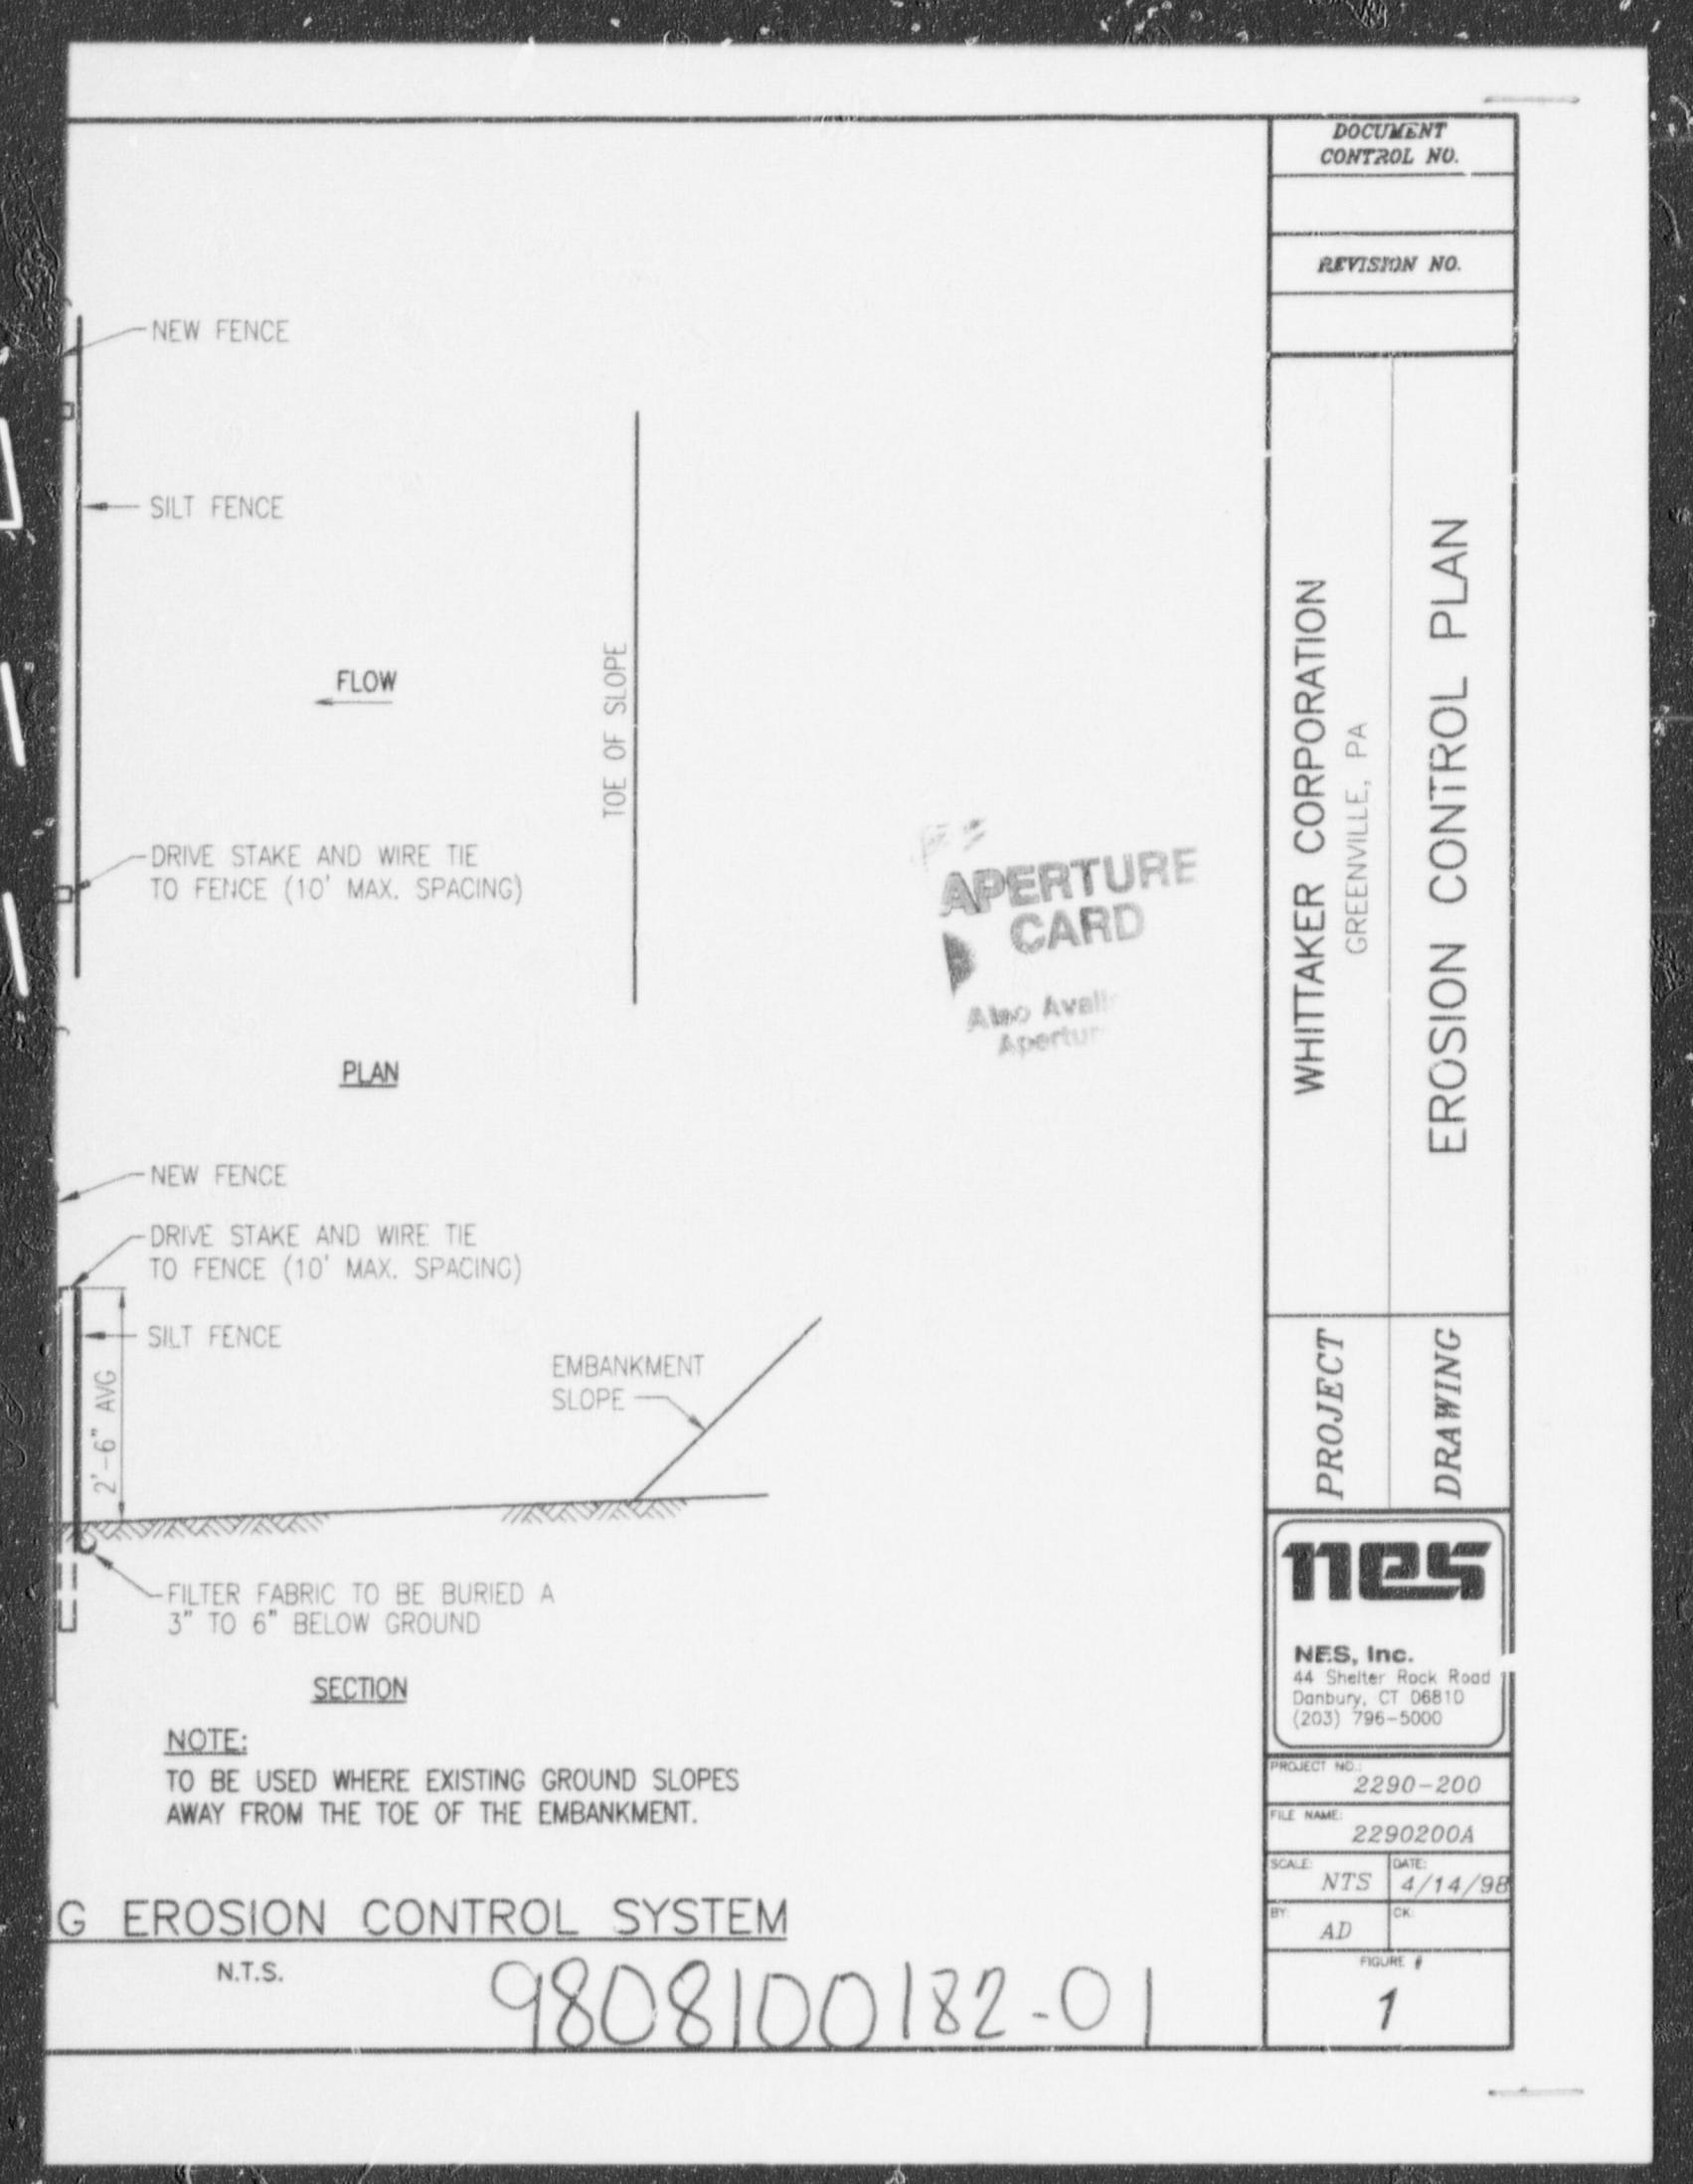
The following erosion control devices shall be implemented where shown on the Soil Erosion Control Plan and elsewhere as deemed necessary. Figure 1 depicts the locations of the erosion controls and details of the type that will be used.

Silt fencing shall be placed as shown in Figure 1. Silt fencing fabric shall be a minimum of two feet (2') in height with stakes three feet (3') in length provided at a maximum spacing of eight feet (8'). The bottom 3 to 6 inches of the silt fencing will be buried as illustrated in Figure 1. The burial of the silt fencing will ensure material does not migrate beneath the fencing.

The Whittaker site is located approximately 3.5 miles south of Greenville, Pennsylvania between the Greenville Metals Plant and the Shenango River. The site is an irregularly shaped parcel of about 6 acres bordering on the west side of the river. The site is broken up into three major areas (see Figure 1): the northern area, consisting of Section 3; the central area, consisting of Sections 2 and 4; and the southern area, consisting of Section 1.
