PWROG Evaluation of the Potential Non-Conservative Fracture Toughness in BWRVIP-100, Rev. 1-A

David Radonovich / J. Brian Hall Westinghouse Electric Company

May 27, 2021

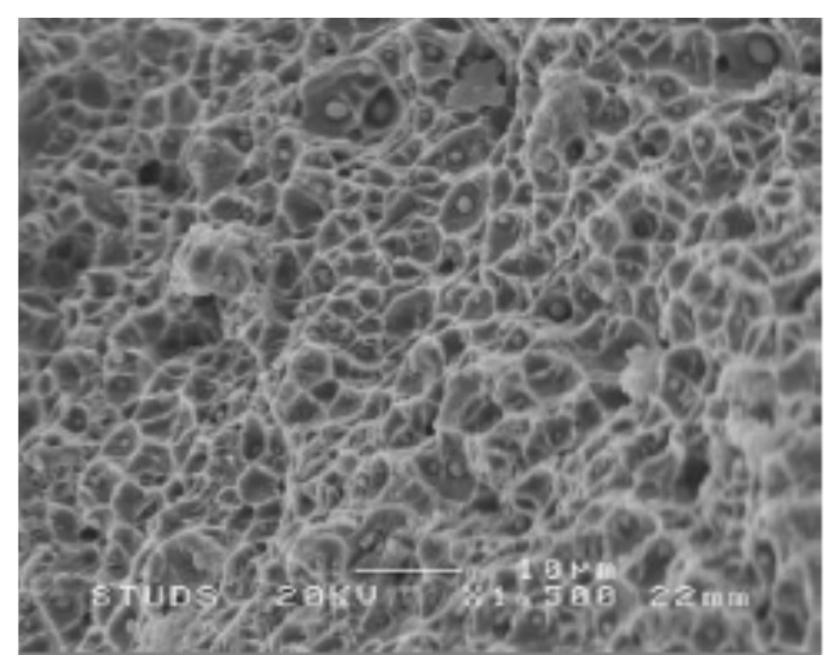
- Irradiated austenitic stainless samples tested in BWRVIP and MRP programs have retained significant ductility
 - Base metal, weld metal, and heat affected zone material
 - Post-test fractographs show primarily ductile-dimple morphology on the fracture surfaces indicating ductile crack growth behavior

Weld Fracture Toughness Specimen W2WFT06 1E21 n/cm² [1.58 dpa] Typical fracture surface morphology MRP-451 EPRI licensed and copyright-protected
