Inspector Training on Corrosion Under Insulation

NRC Weekly Knowledge Management

Presented by Nik Floyd, RI/DORS/EB1

October 13, 2022

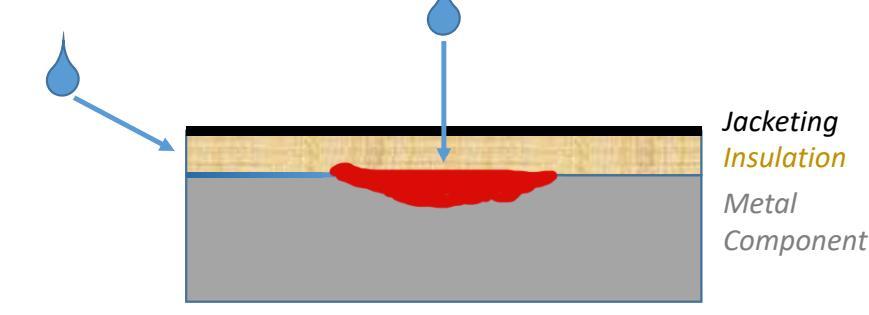
- The external corrosion of a metal component where the corrosion is either masked and/or exacerbated by the insulation.
- Most issues have been observed to occur on uncoated carbon steel.

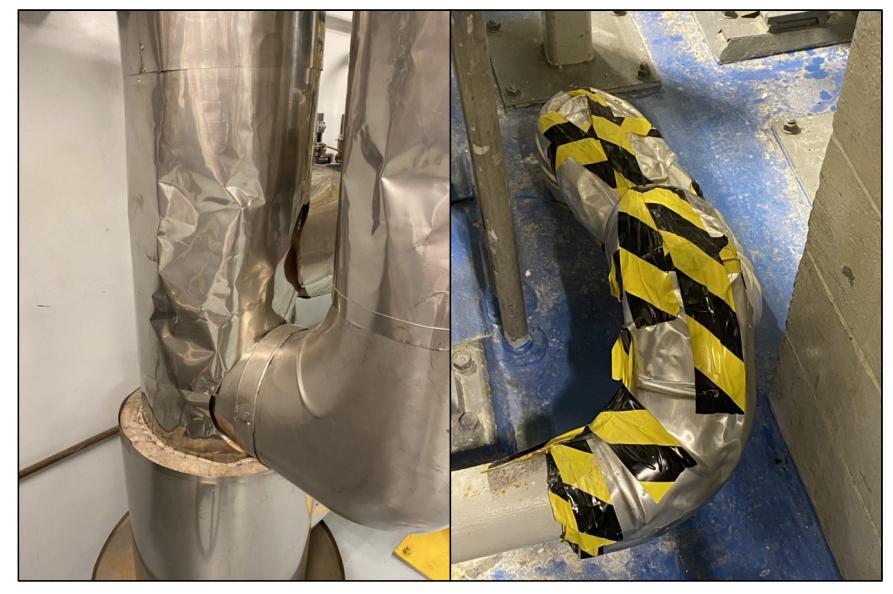
Damaged and Displaced

Caution These are indirect visual indications only. The insulation must be removed to confirm. The requirements for removal vary.

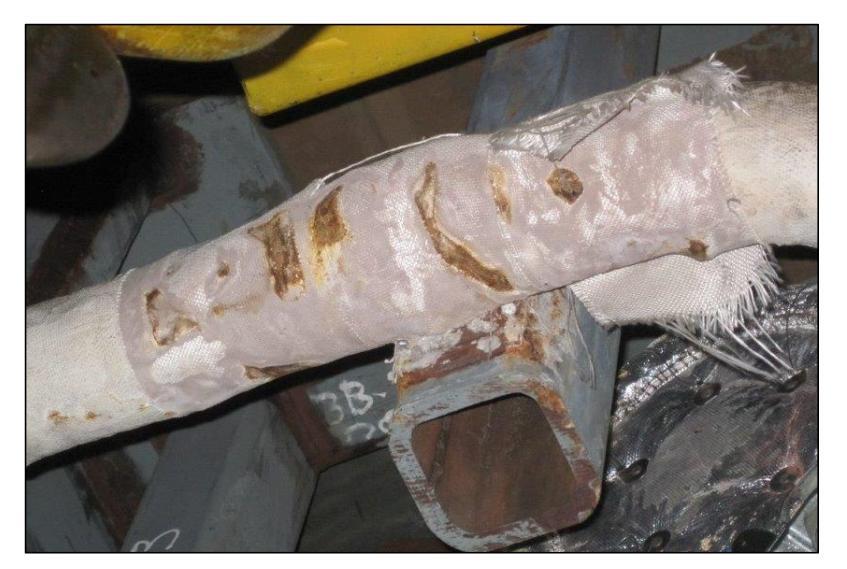
Staining

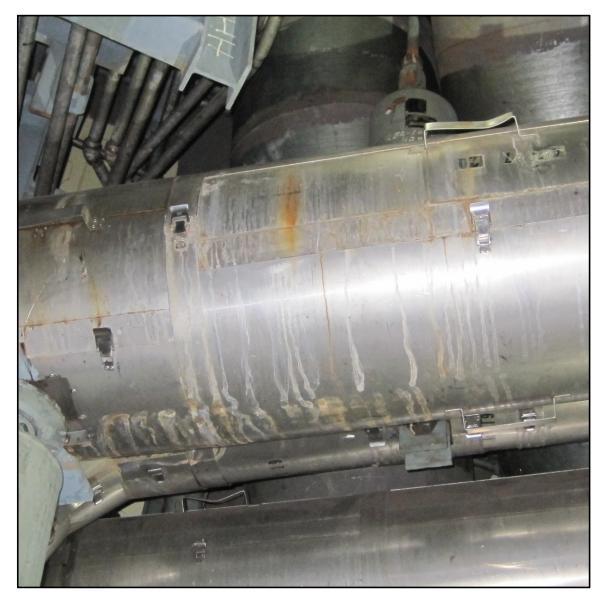
Staining

These are indirect visual indications only. The insulation must be removed to confirm. The requirements for removal vary.

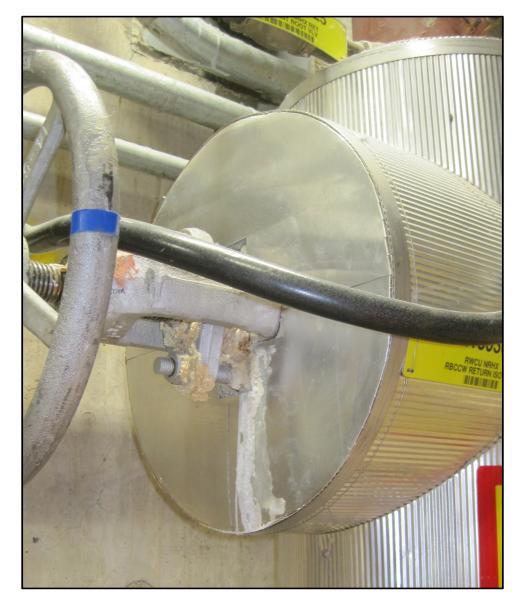
Deposits

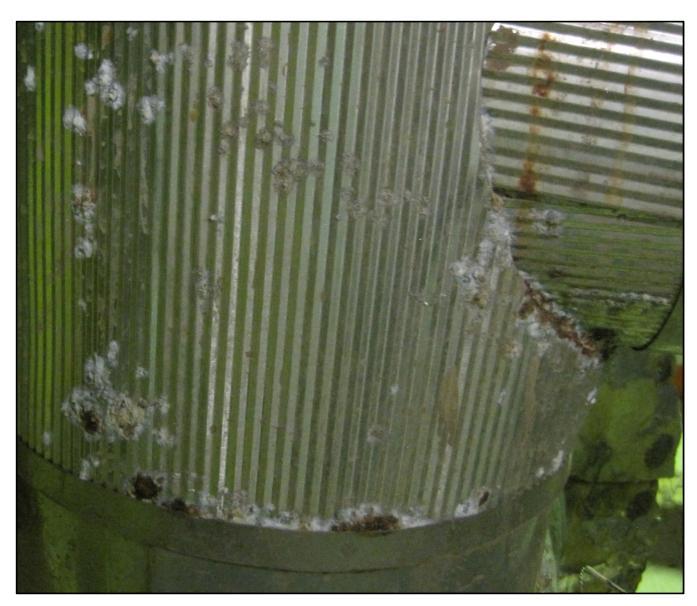
Deposits and Discoloration

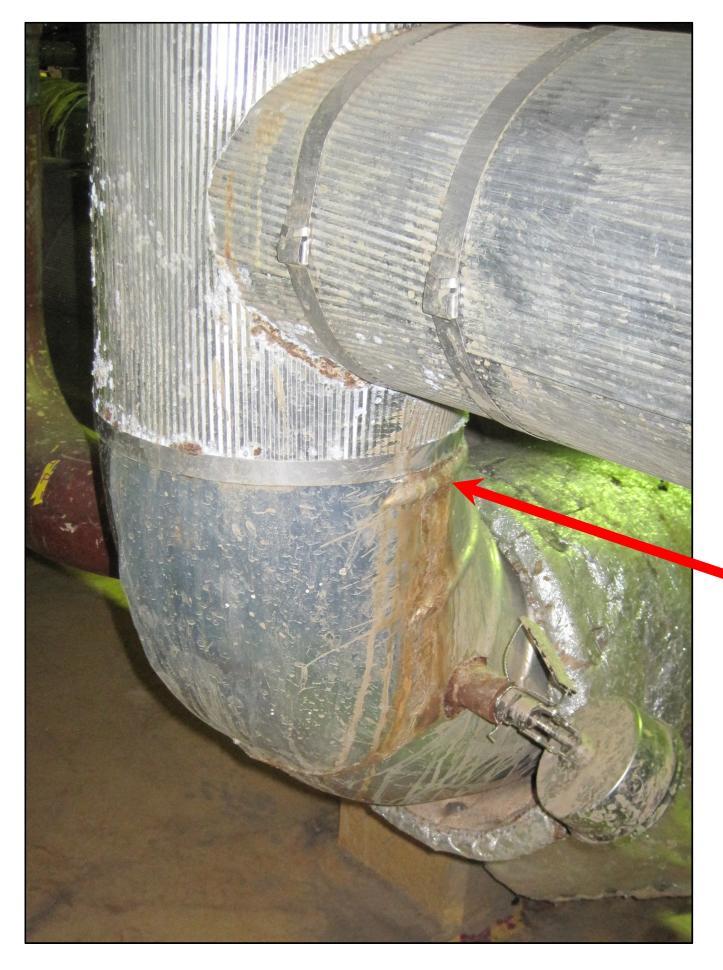
This is one component from the previous slide.

The licensee discovered corrosion and a small, through-wall leak after the insulation was removed.

Leakage was evident from the seam of the insulation and on the floor below.
