#### MEMORANDUM FOR RECORD

SUBJECT: Radiation Control Area (RCA) Addition at Joint Base Lewis-McChord (JBLM)

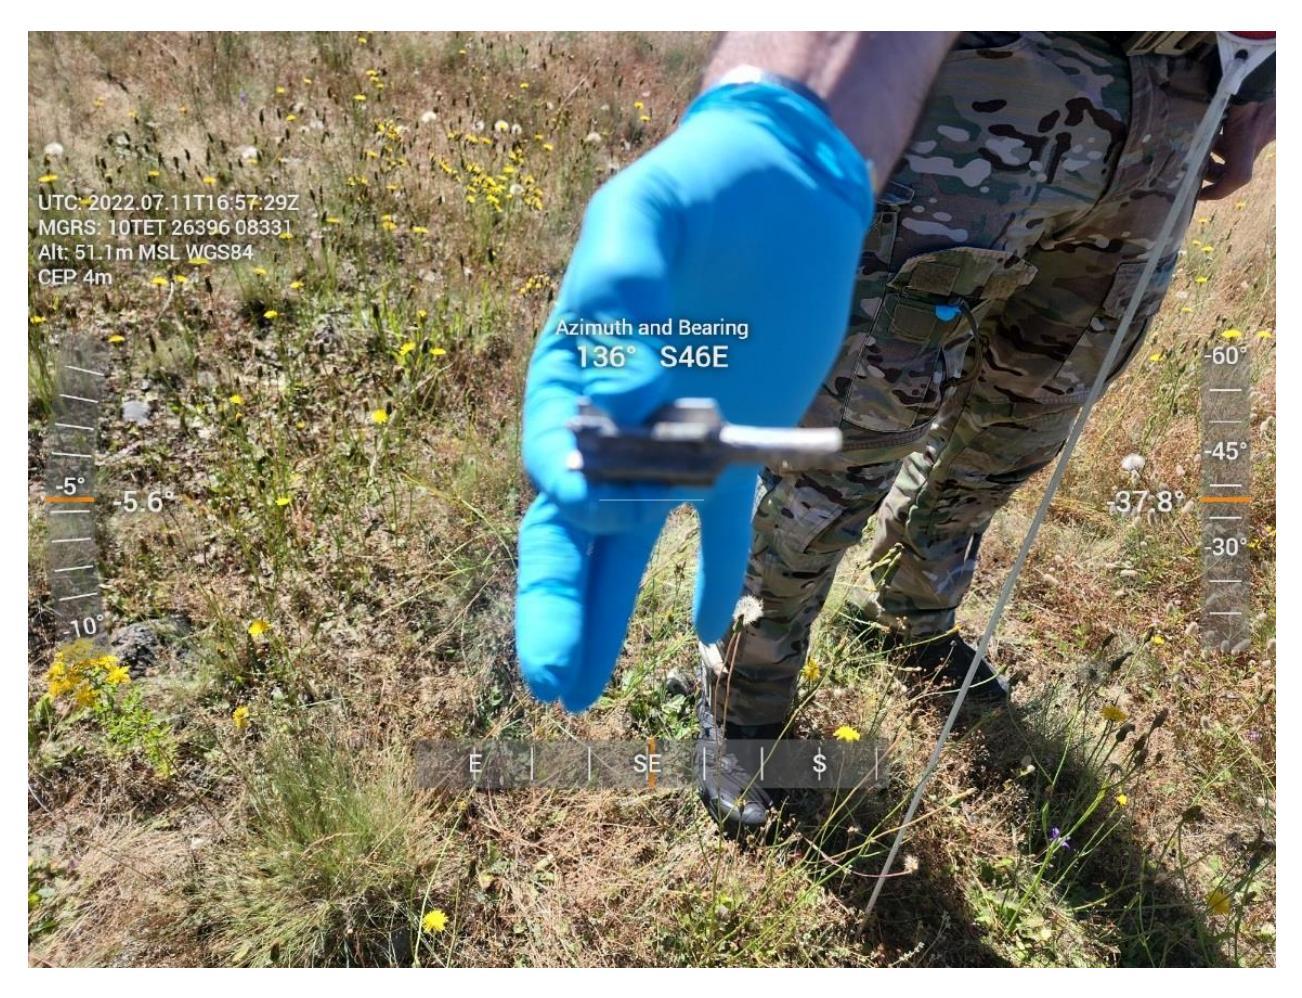
Figure 1. Discovery of the first M101 DU spotting round (tailfin only).

1. On 12 May 2022, the JBLM garrison Radiation Safety Officer (RSO) reported to the License RSO that an explosive ordnance disposal contractor doing range maintenance found remnants of a M101 depleted uranium (DU) spotting round outside an RCA. The License RSO reported this to the Nuclear Regulatory Commission (NRC) Project Officer the same day and extended the boundaries of the RCA as described below pending an amendment to our NRC source material license (#SUC-1593). We applied the same access controls to this extended portion of the RCA that the Radiation Safety Plan (RSP) requires for all RCAs (RSP, sections 3.2 and 15.1). During the next few months, further maintenance activity found three more rounds, one of which consisted of the tailfin only. See Figure 1 through Figure 4.

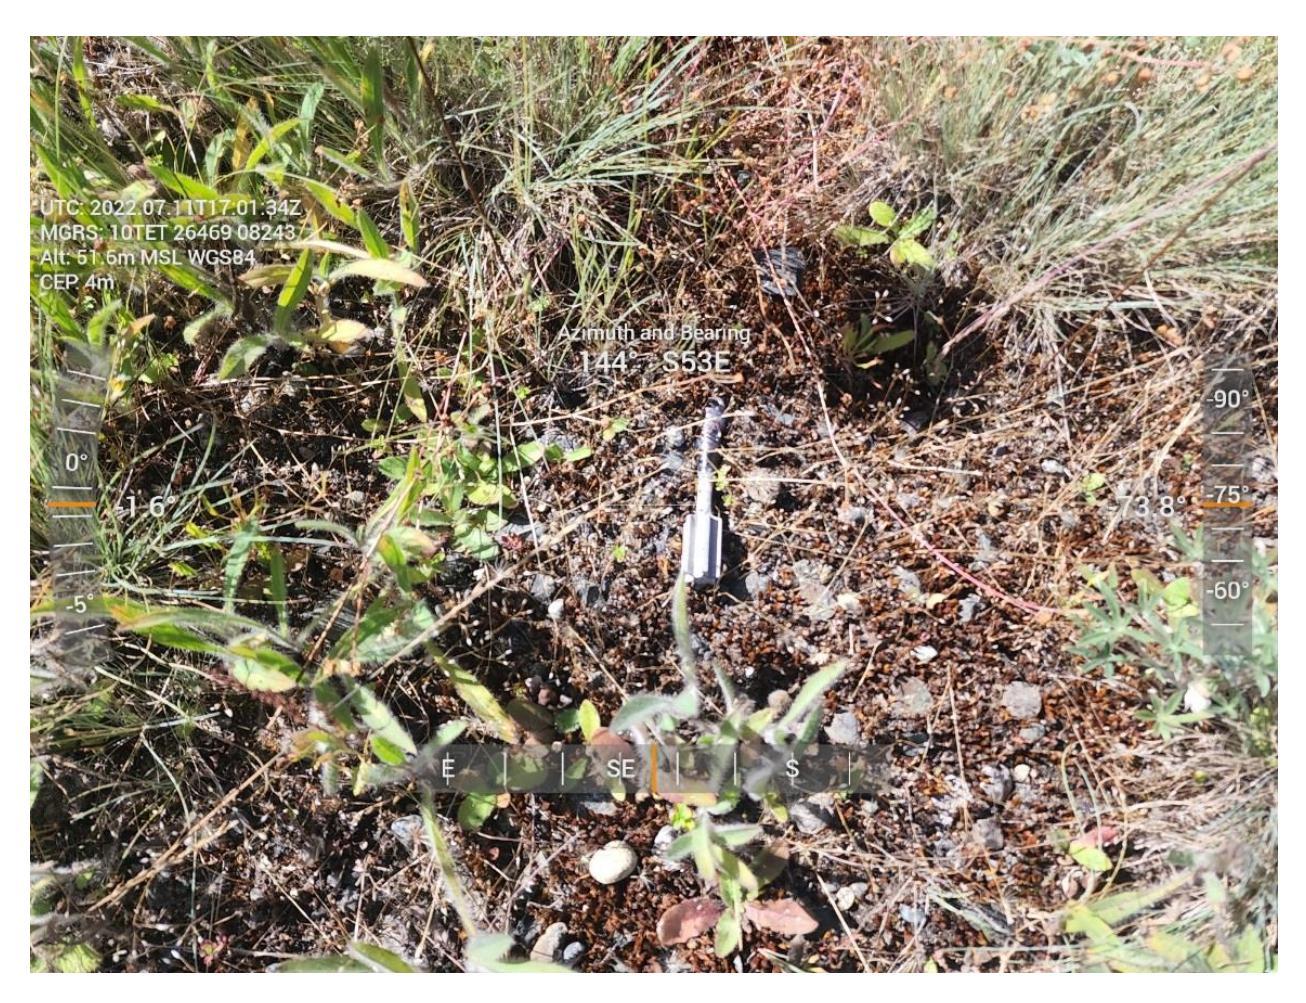
Figure 2. Discovery of the second M101 DU spotting round.

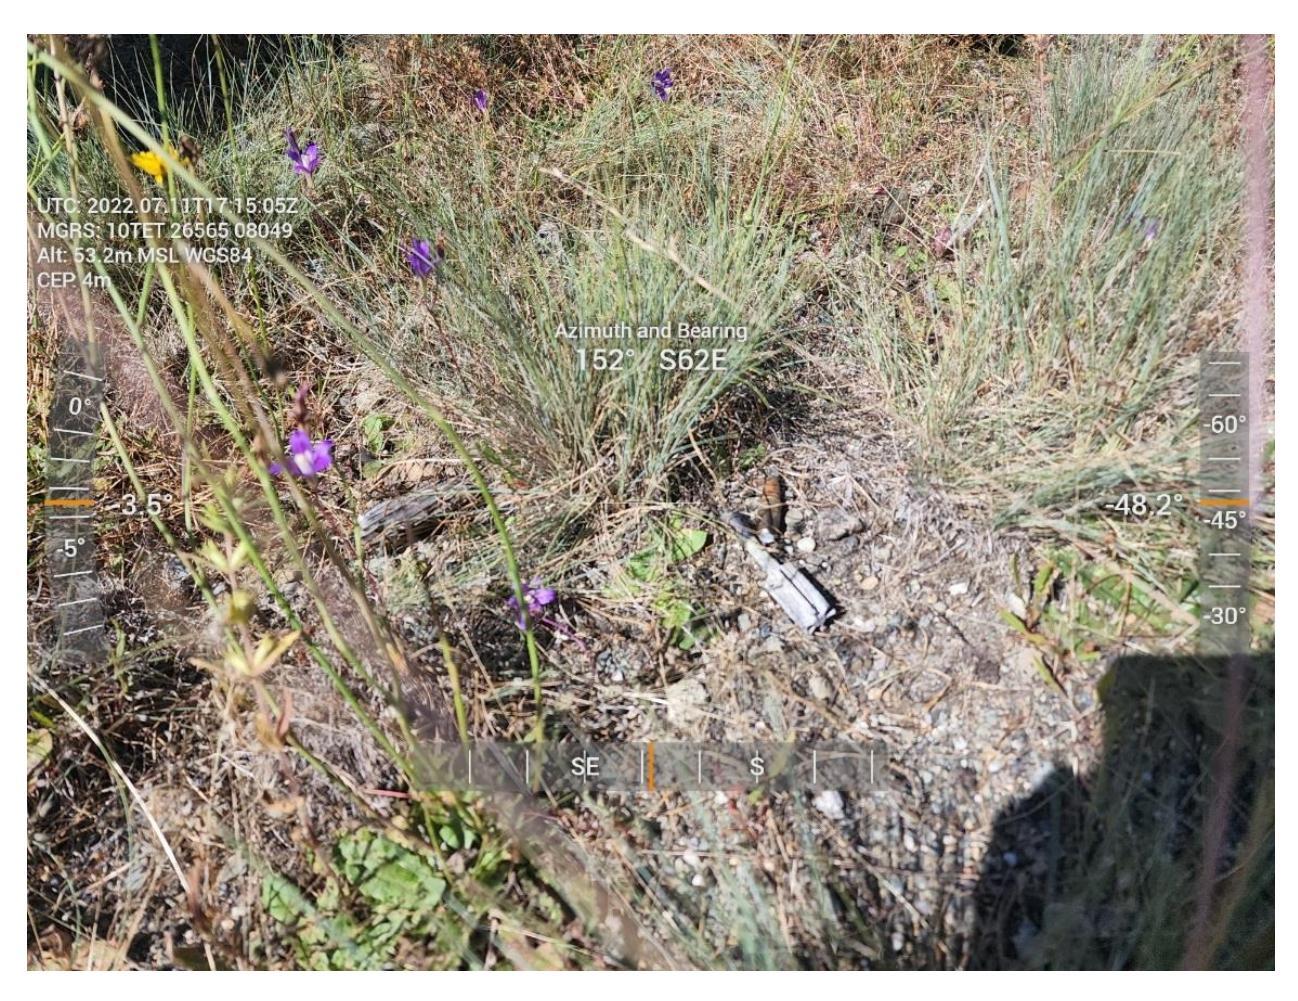
Figure 3. Discovery of the third M101 DU spotting round.

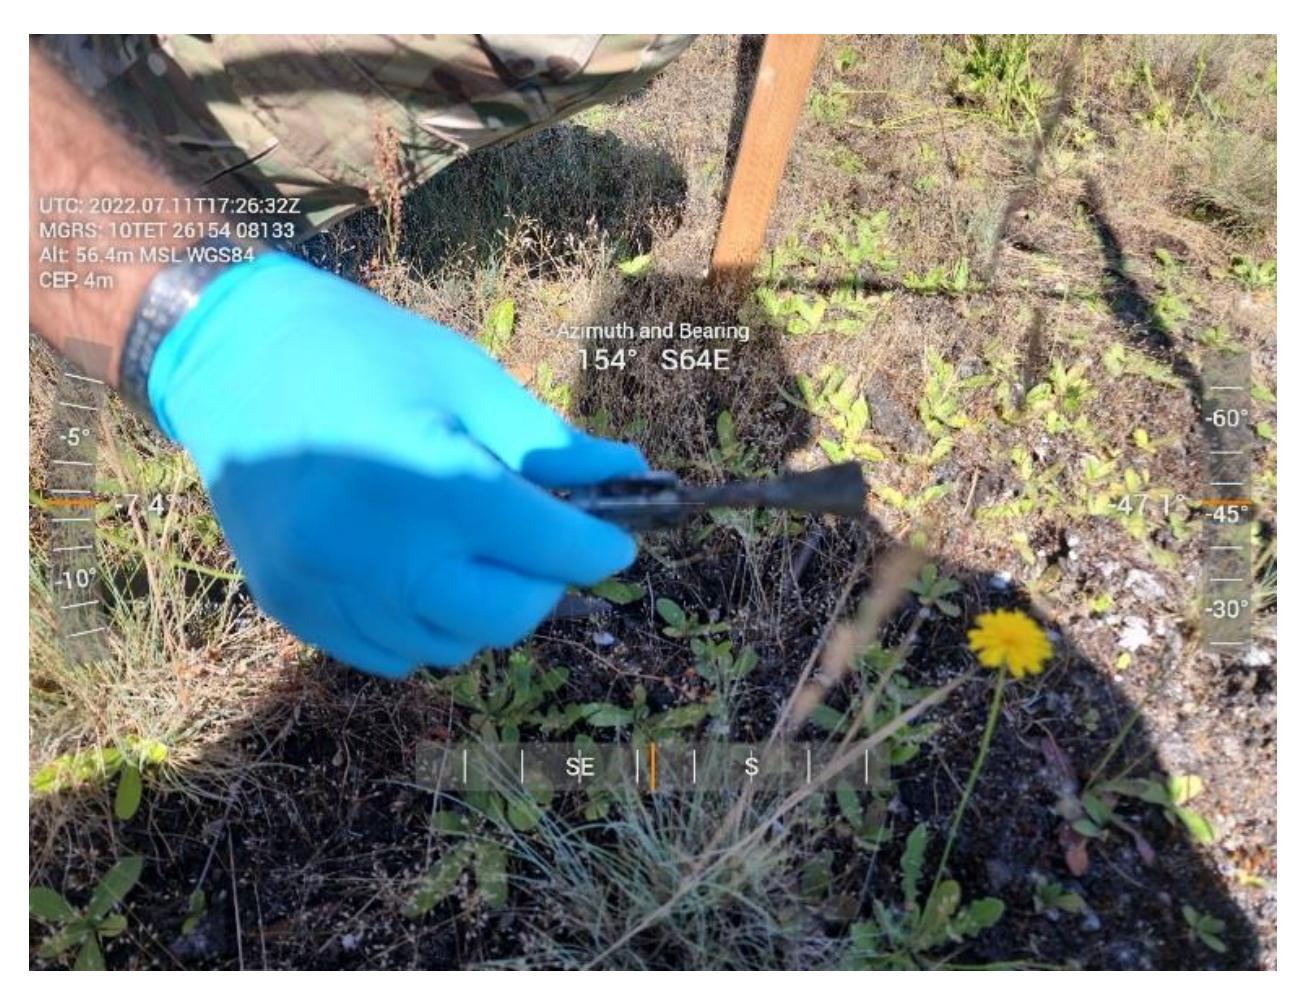
Figure 4. Discovery of the fourth M101 DU spotting round.

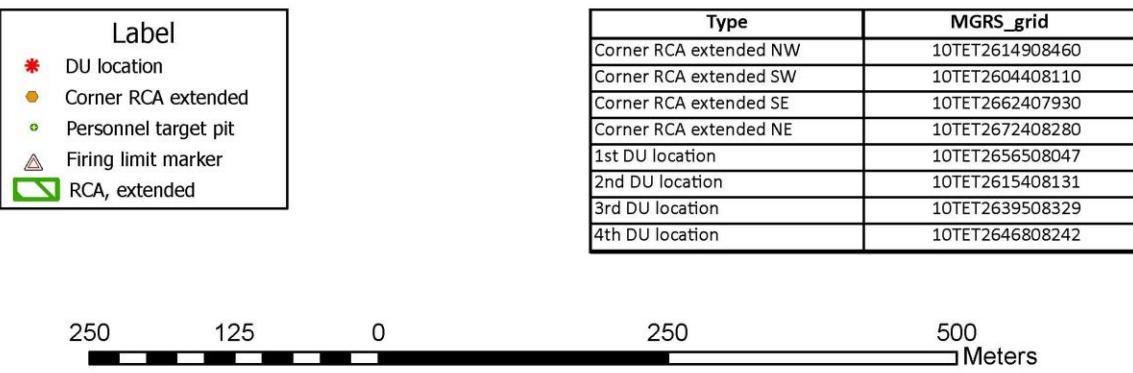
# Range 53 RCA Extended Box

b. The extension (Figure 5) is a rectangle whose sides are perpendicular to the side of the existing RCA where they touch. The three non-touching sides of the extension are set so that no round is closer to a side than about fifty meters. The License RSO chose this distance as a compromise between the competing considerations that the rounds should not be close to the RCA edges and that the added area should minimize future decommissioning costs.

Figure 5. Locations of the four discovered M101 DU spotting rounds and the boundaries of the RCA addition.

c. JBLM garrison staff have posted the extended RCA with CAUTION: RADIOACTIVE MATERIAL signs in accordance with section 14.1 of the RSP.

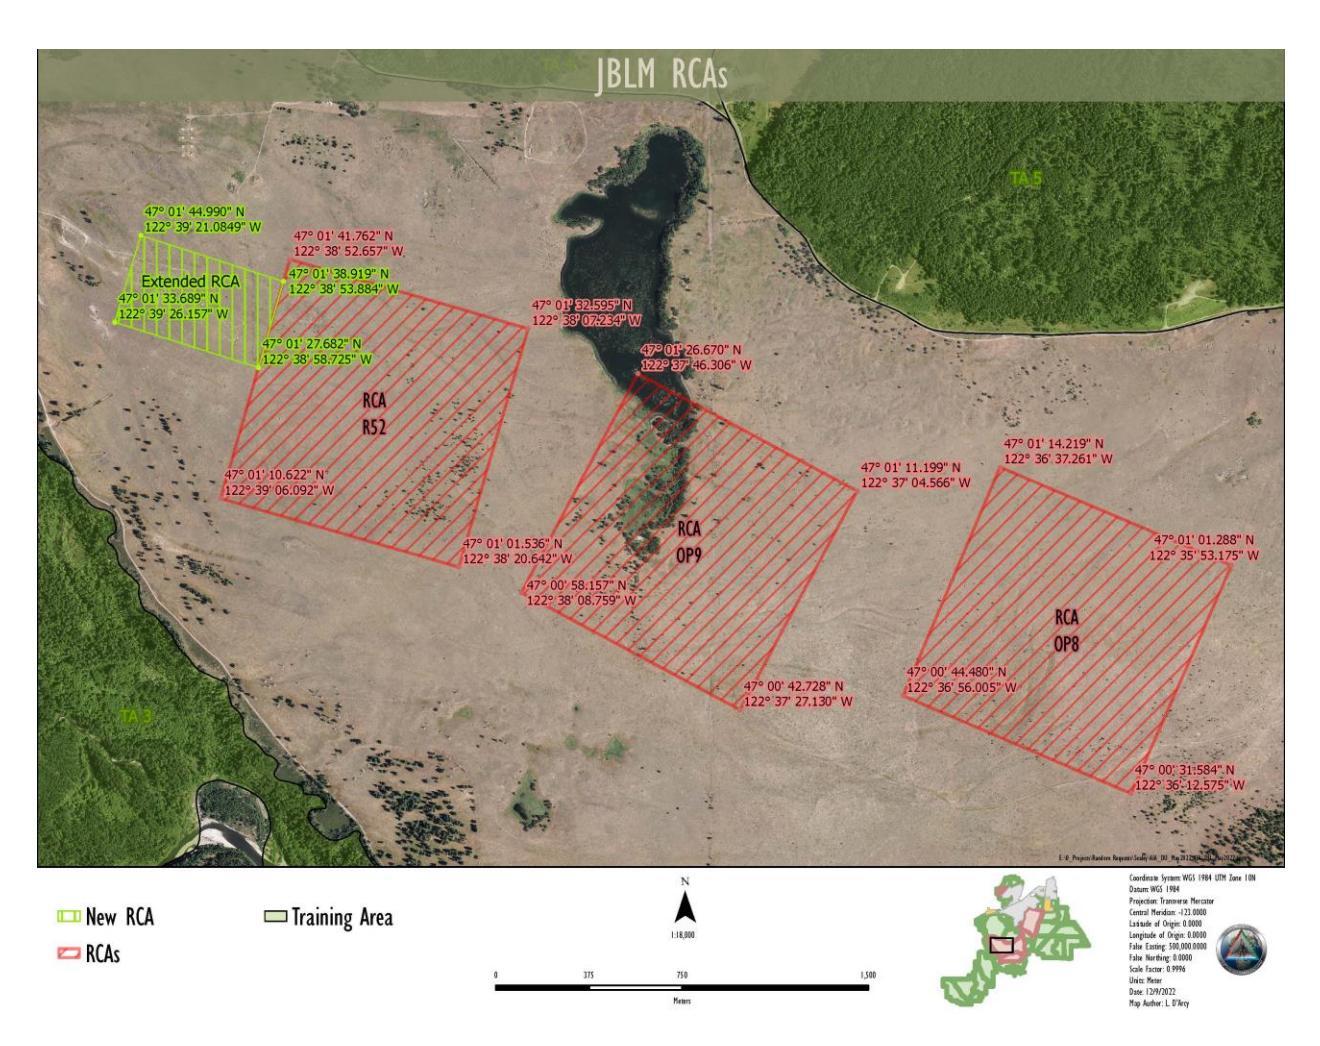
4. JBLM garrison staff prepared a new map (Figure 6) that shows all the RCAs at JBLM, including the new extended RCA. The new map shows the coordinates of the corners of the RCAs and replaces the old map in the revised document, "M101 Impact Area." We are including this revised document in our license amendment #8 application along with, among other things, this memorandum for record.

Figure 6. All RCAs at JBLM with extended RCA at the right.

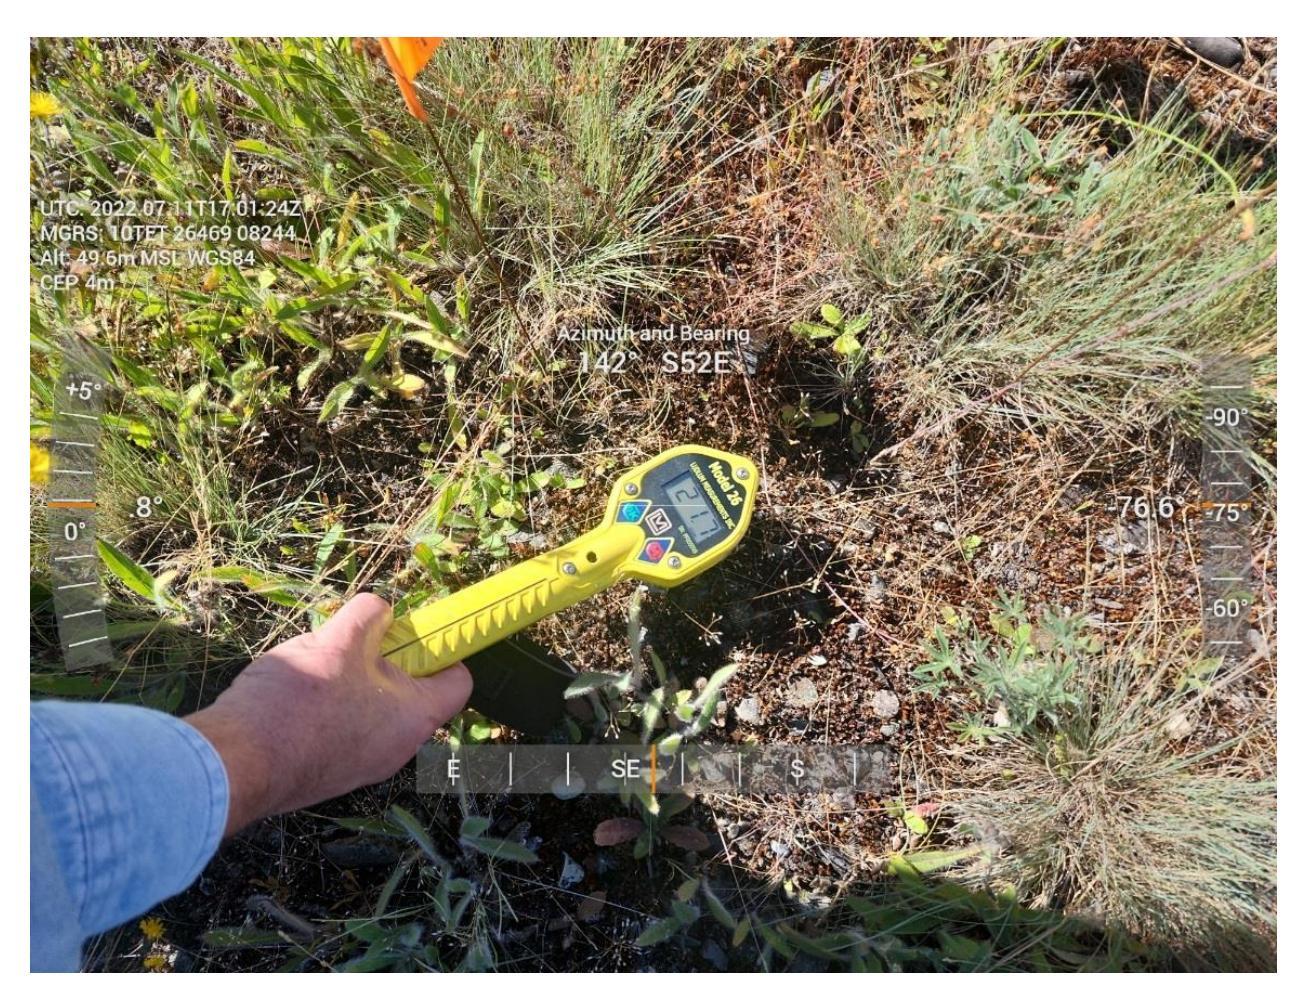
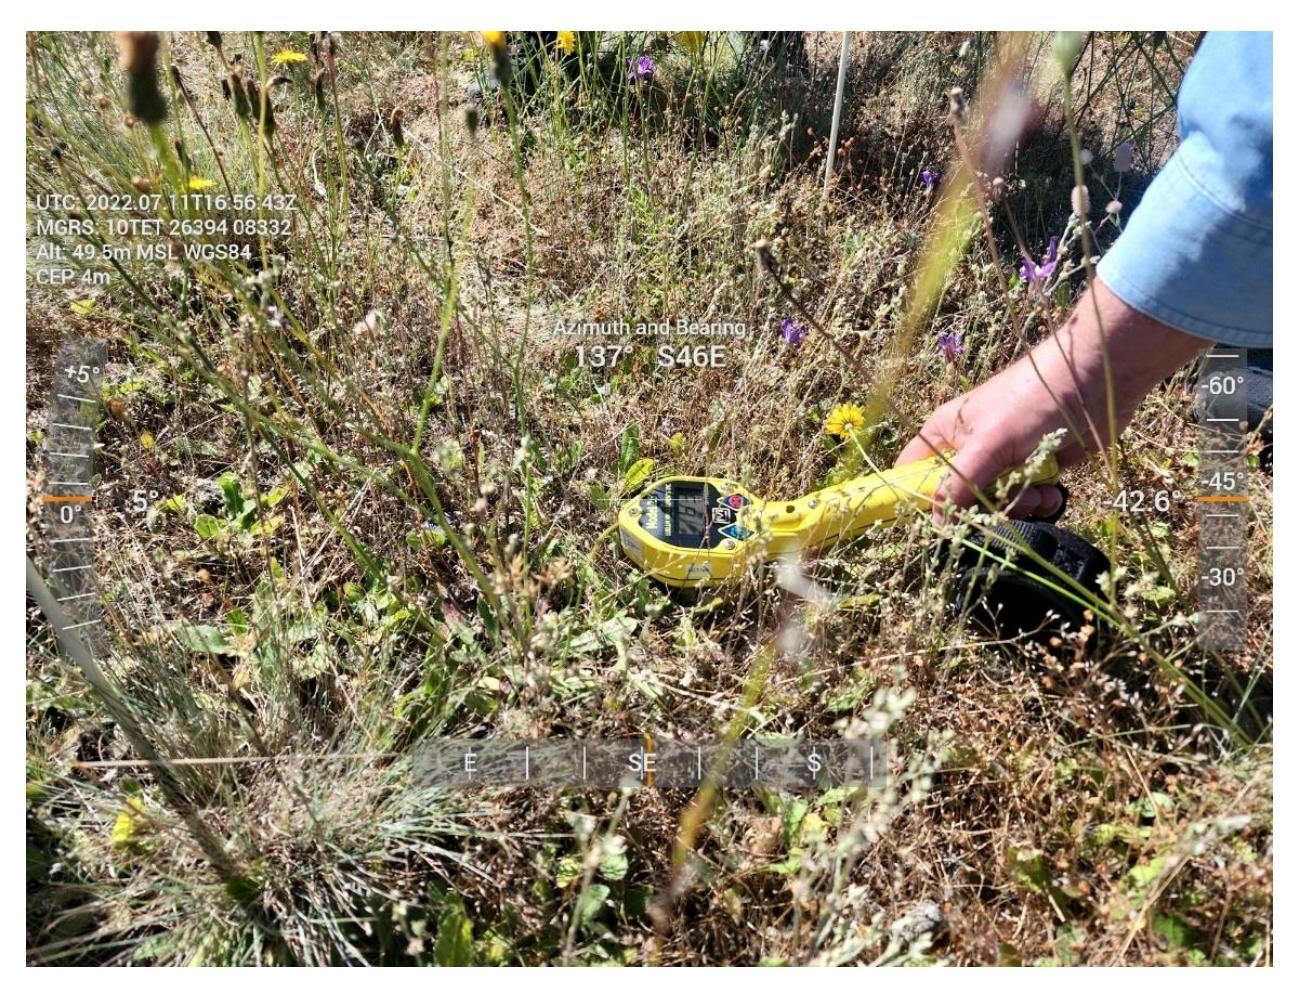
Figure 7. License RSO scanning M101 DU spotting round in situ.

Figure 8. License RSO scanning M101 DU spotting round in situ.

5. JBLM garrison staff and the License RSO retrieved all four rounds during the license annual audit on 22 July 2023 (see Figure 7 and Figure 8). The JBLM garrison RSO is maintaining an inventory of the four rounds in accordance with section 13 of the RSP. We have notified the Chief, Army Low-Level Radioactive Waste Disposal Division, US Army Joint Munitions Command (JMC) and are holding the rounds for JMC's eventual pickup and disposition IAW section 18 of the RSP and with NRC regulations. We will document that pickup and disposition when it occurs.
