NUREG/CR-5870
PNL-8051

Results of LWR Snubber Aging Research

Lake Engineering Company

Pacific Northwest Laboratory

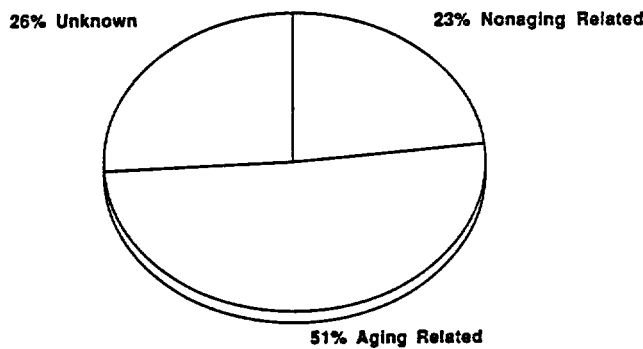
Figure 3.4 Aging-related versus nonaging-related failures in hydraulic snubbers

As shown in Figure 3.2, for hydraulic snubbers, 26 failures were attributed to the *environment* category and 18 were attributed to the *transients and vibration* category. Plant service influences, therefore, accounted for approximately 51% of the total number of aging-related failures (see Figure 3.4).

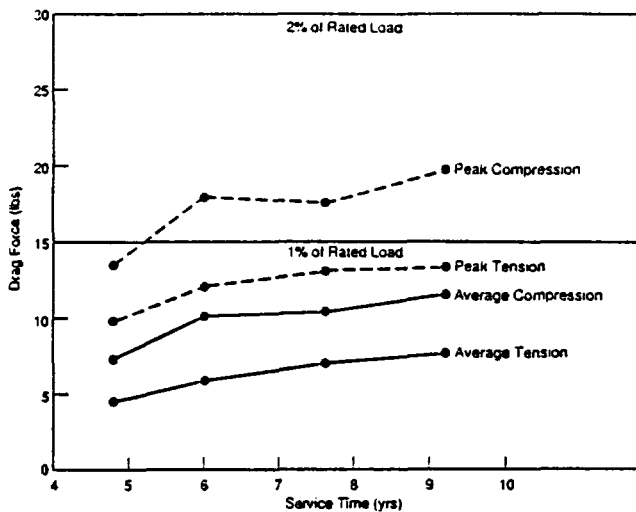
For Site F, data were available for a total of 47 mechanical snubbers of the same size that had been tested on at least two and sometimes three occasions using the same test machine. Peak and average drag force values for each RFO were plotted versus time (see Figure 3.13). Associated data and trending plots for individual snubbers are included in Appendix F. As with Plant D, both average drag force and peak drag force for both the tension and compression directions were evaluated. It should be noted that all snubbers had been in service for approximately five years before the initial test data point was obtained.

Figure 3.13 Average drag force versus service time for 47 mechanical snubbers

As can be observed from Figure 3.13, there appears to be a slight trend toward increasing drag force with service time, at least for one mechanical snubber model and size at this particular plant. The data support the need to monitor snubbers in moderate environments, possibly using a selected number of representative snubbers. However, the magnitude of the drag force value is generally small, i.e., less than 2% of rated load for all but four snubber samples, and less than 3% of rated load for all but one snubber sample.

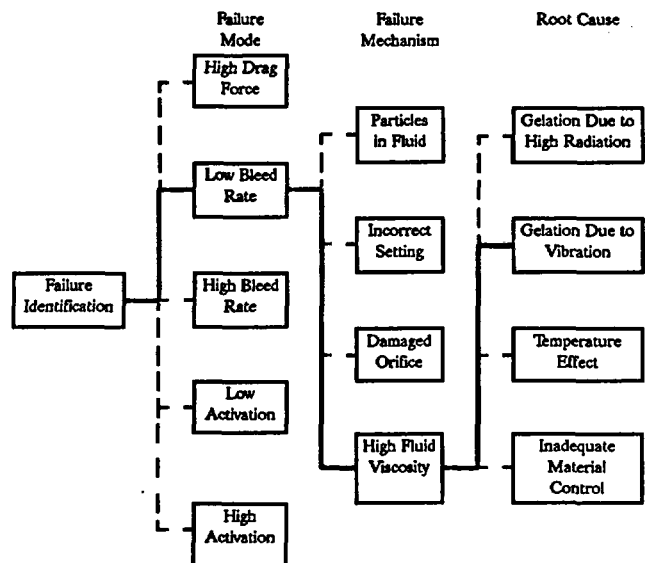
Figure 5.1 Flow chart - typical root cause determination

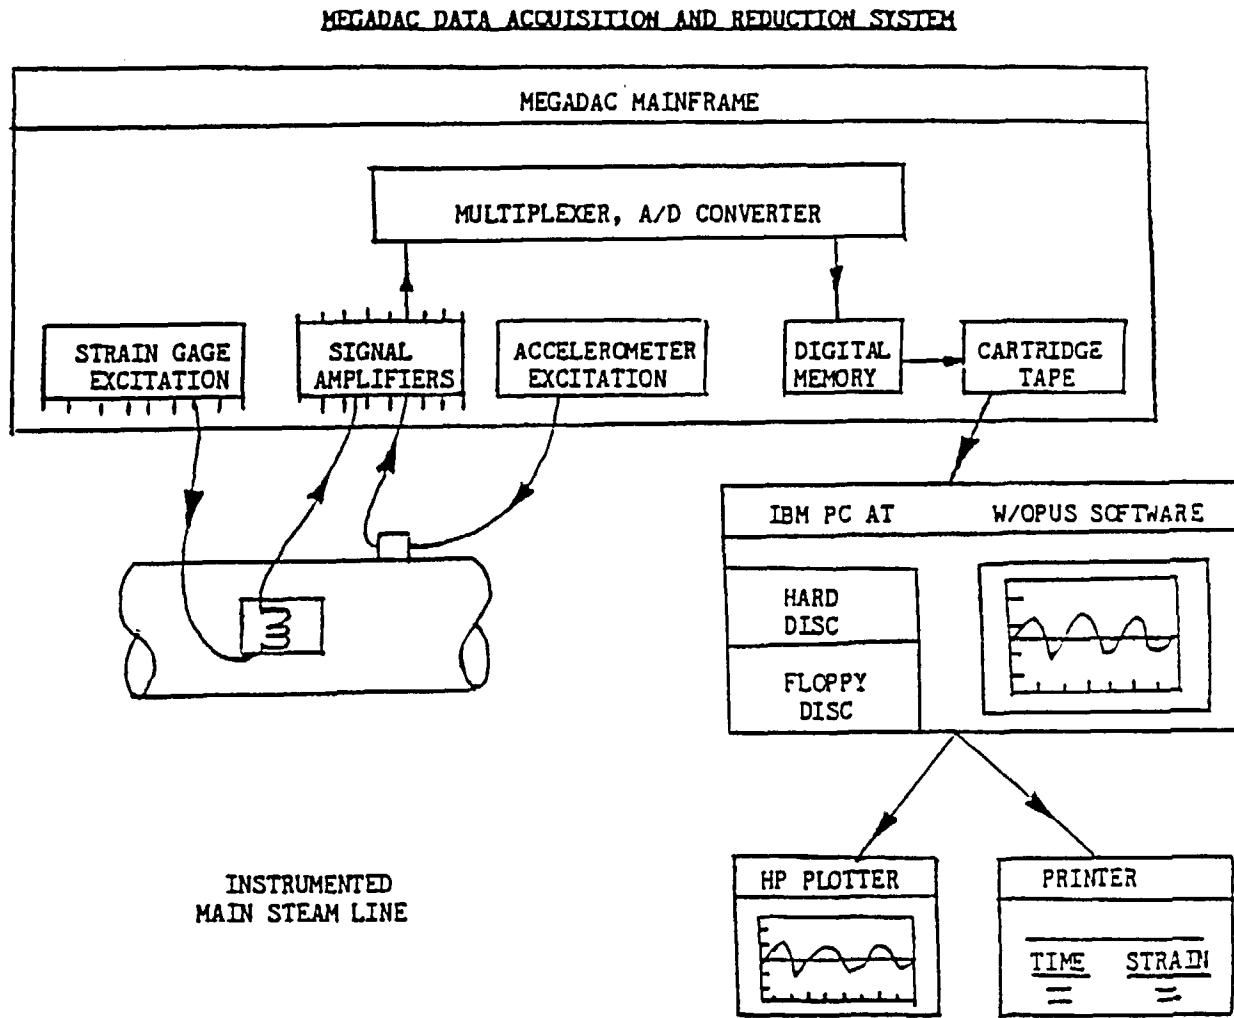
Figure B.3 Acceleration monitoring instrumentation scheme

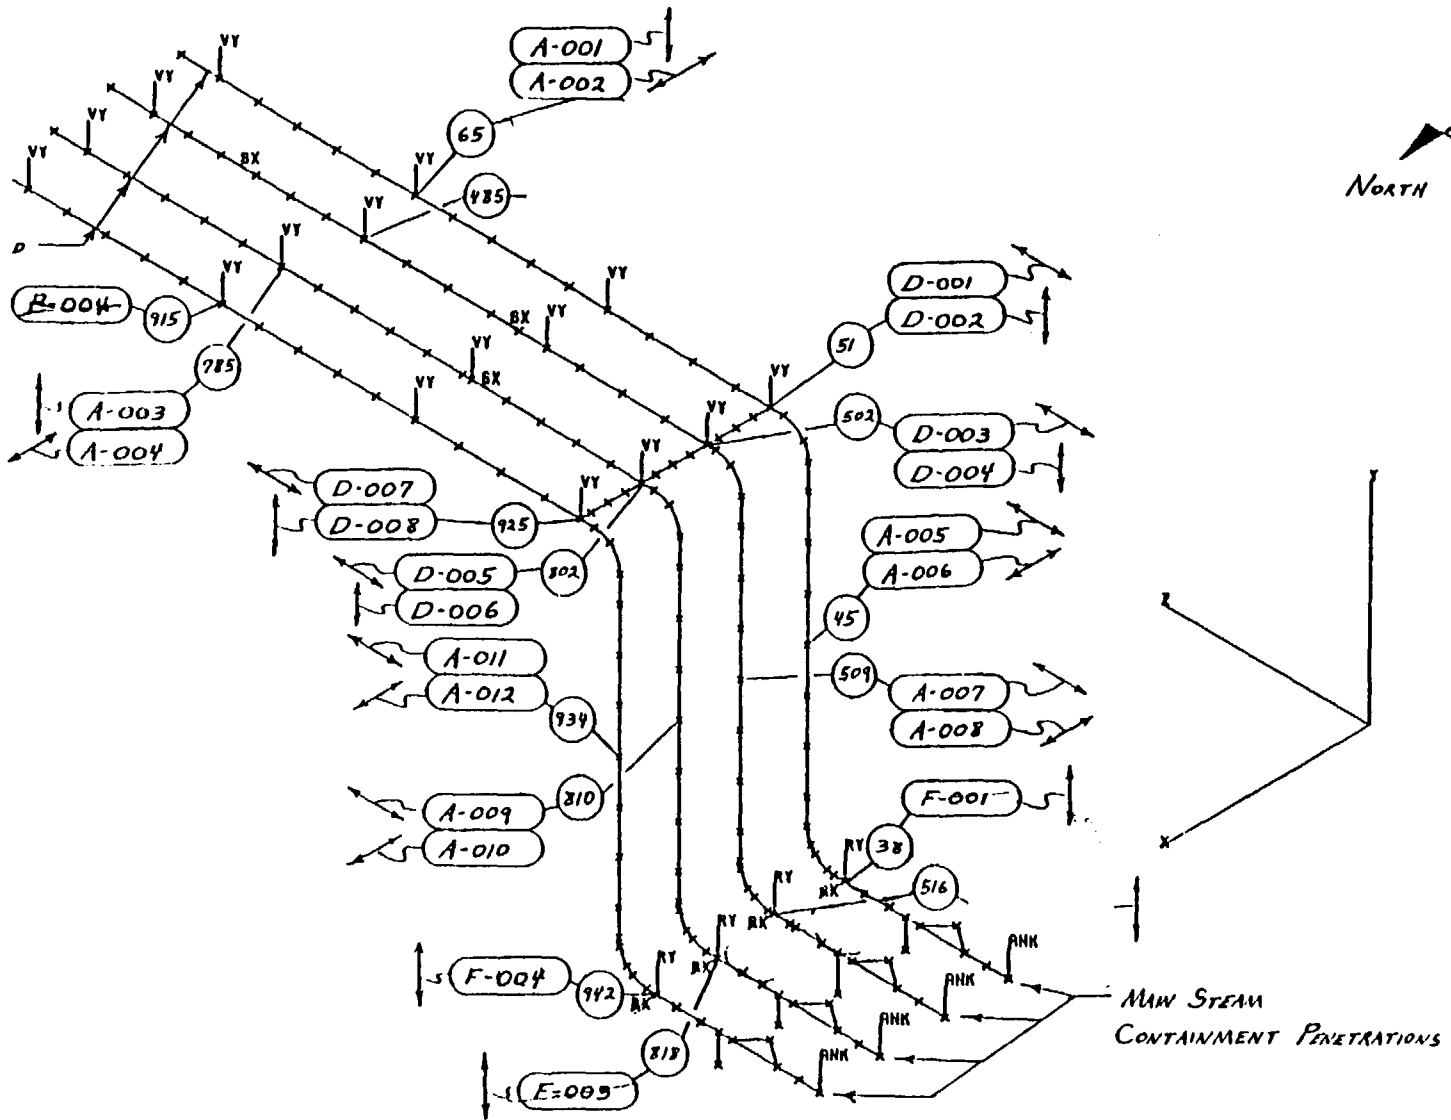
Figure B.4 Typical acceleration location isometric

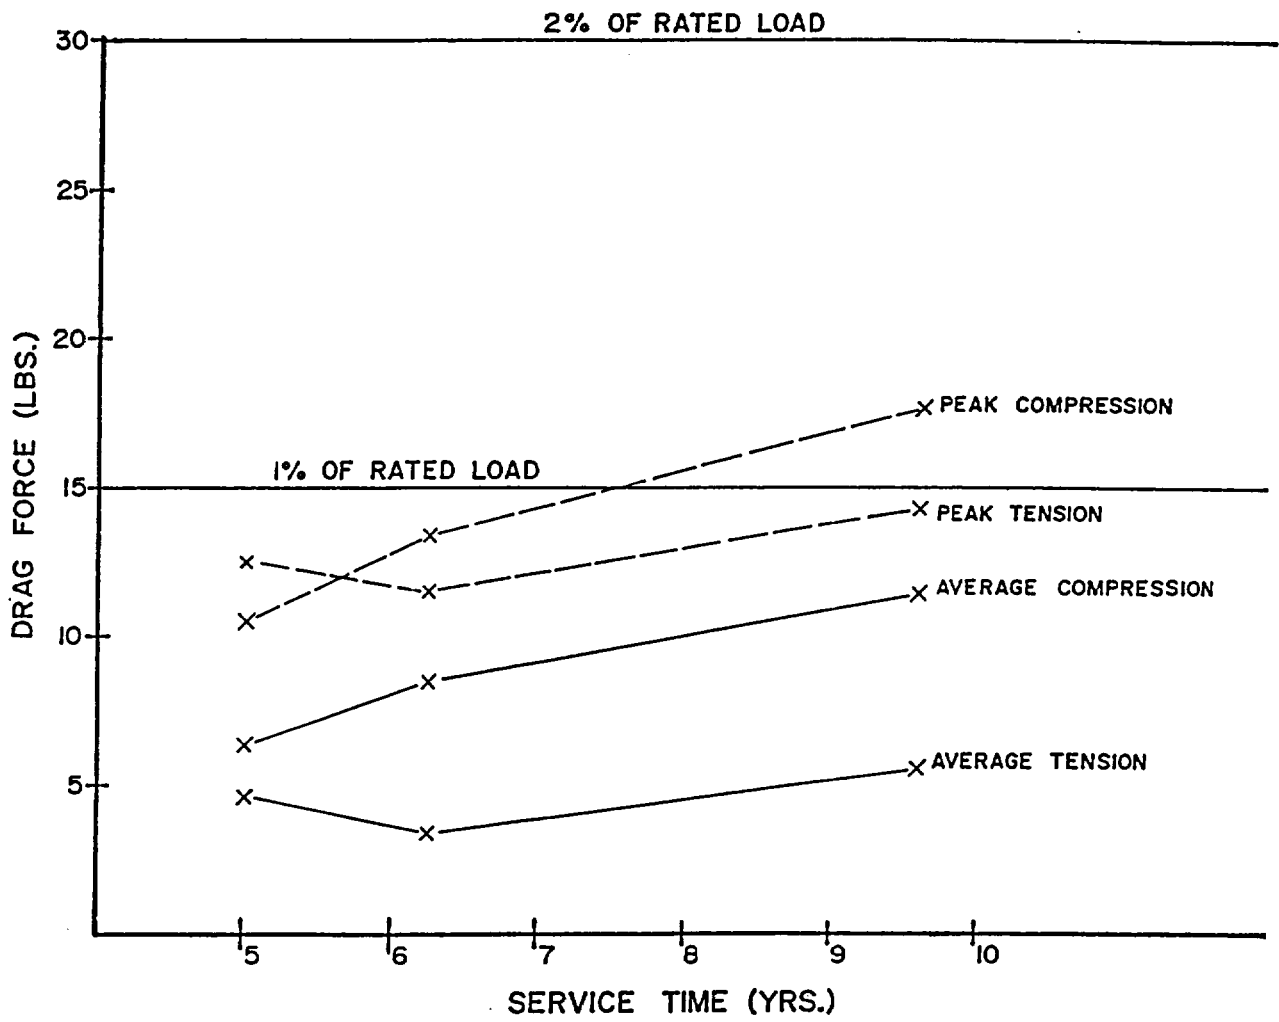
Figure F.4 Drag force vs. service time, Plant F sample C (# 62)

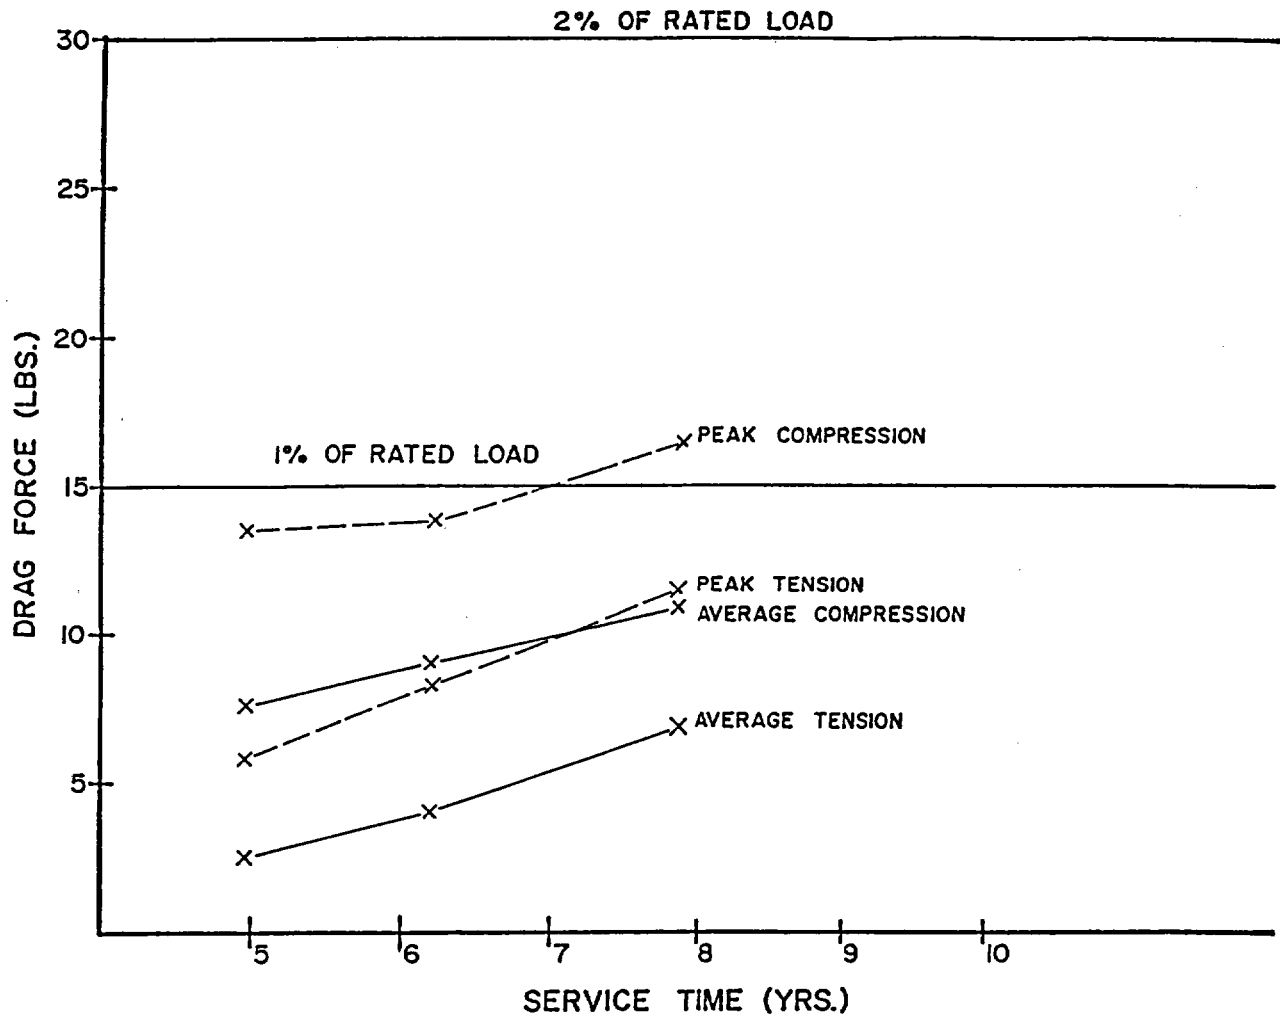
Figure F.5 Drag force vs. service time, Plant F sample D (# 13)

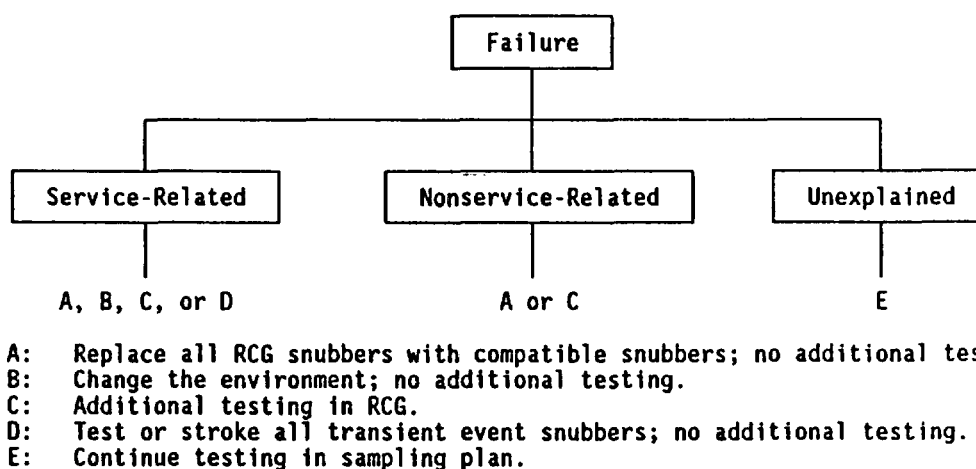
Figure K.2 Proposed failure categorization and corrective action
