Appendix-10
SG Tube Wear Analysis for Unit-2/3

The purpose of this analysis is to evaluate the tube wear depth at the U-bend region due to fluid elastic instability in order to verify the estimated mechanism of the tube wear observed in both of Unit-2 and Unit-3 as mentioned in Section 6.1 and 6.2 of the main report.

SONGS U2C17 Outage - Steam Generator Operational Assessment

SONGS U2C17 Steam Generator Operational Assessment for Tube-to-Tube Wear

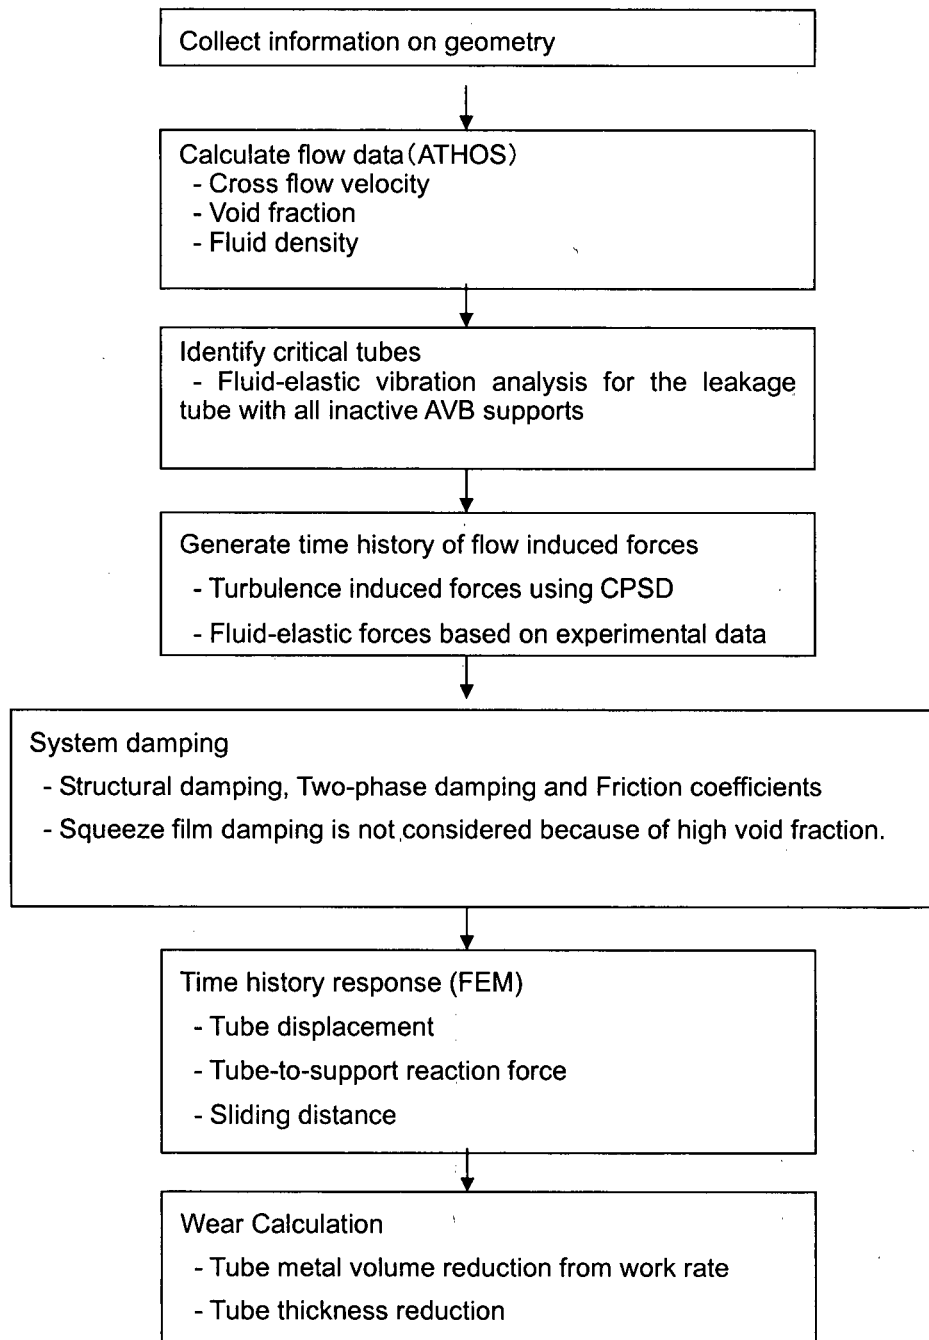
The leaking tube assuming all inactive AVB supports is evaluated. Wear analysis methodology is described in Figure 6.1

Fig. 6-1 Wear Evaluation Flow Chart

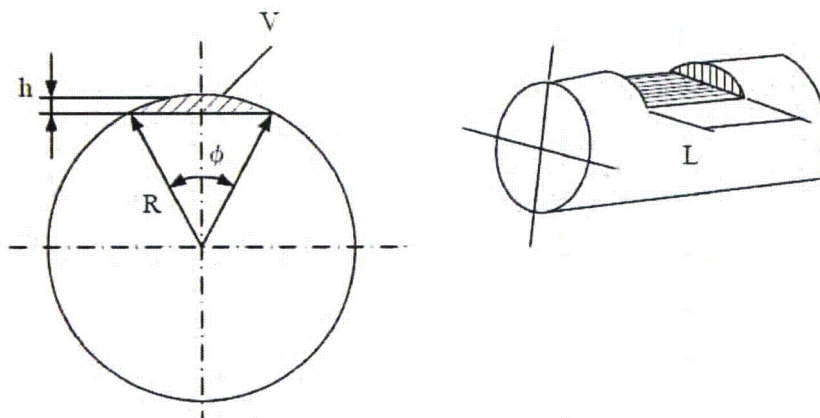
The tube thickness reduction is then calculated using the wear properties and work rate parameter as assuming the wear configuration as shown in Fig.6-4.

The wear width of tube to AVB wear is assumed to be the same as the width of AVB.

Fig. 6-4 Wear shape of tube at the contact point with AVB

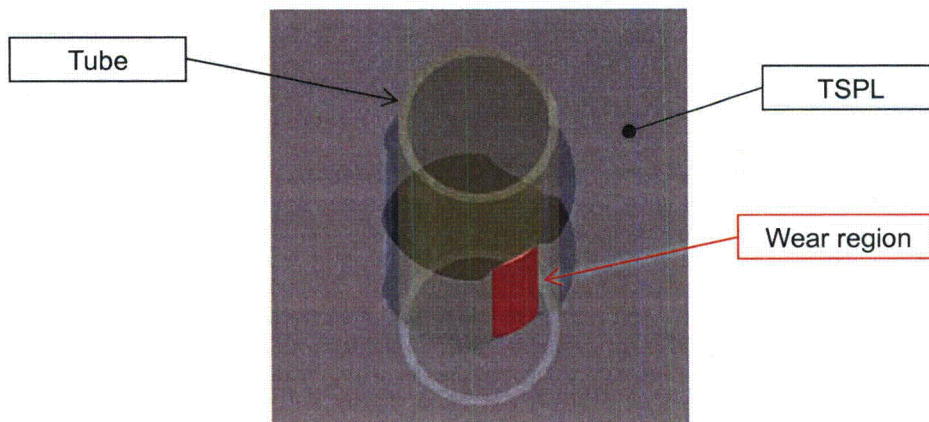
We use the following equation which shows the relation between wear volume and wear depth.

Fig. 6-5 Wear volume evaluation (Wear depth 1.0mm)

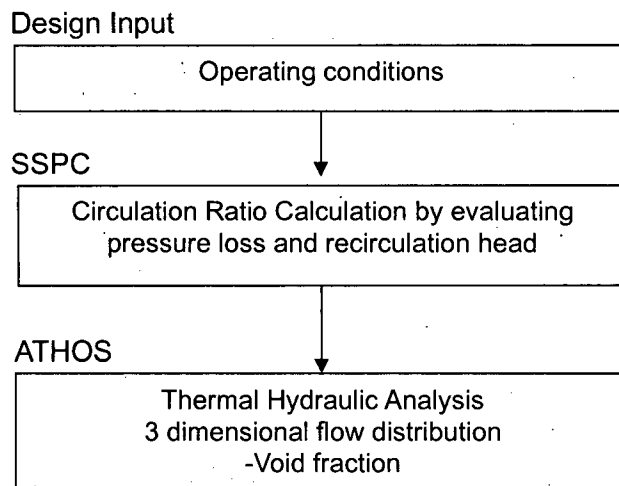
Based on the design input of the operating conditions, the calculation of the circulation ratio is performed by evaluating the pressure loss and the recirculation head with SSPC, which is a 1 dimensional Thermal and Hydraulic parameter calculation code (Ref.22). Using ATHOS/SGAP (Ref.1), the thermal hydraulic analysis is performed to obtain the 3 dimension flow distribution which includes the void fraction.

Fig.6-1 Flow of the evaluation

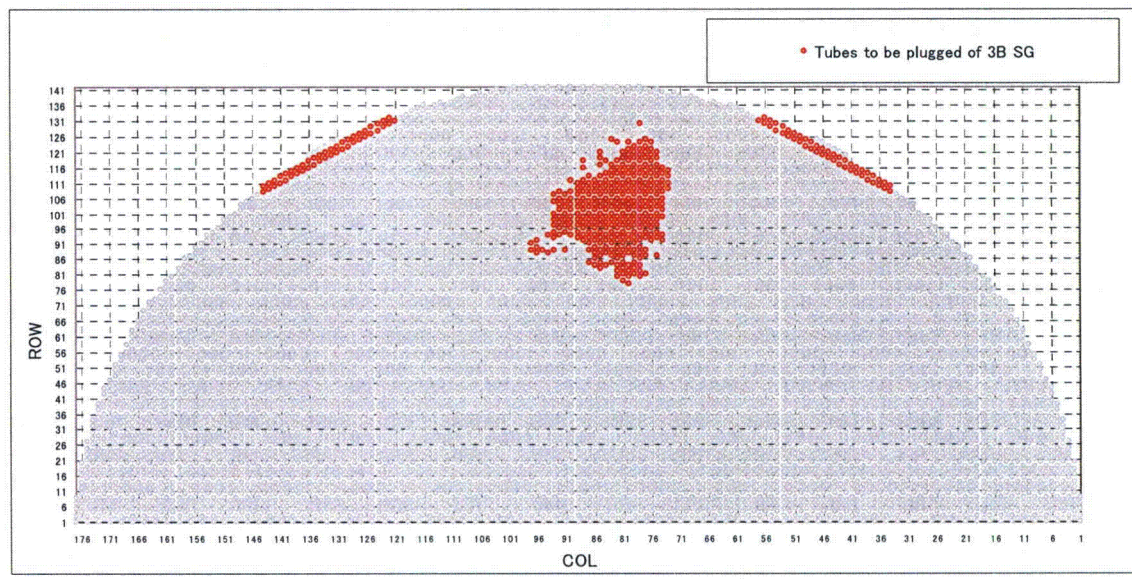
Fig.6-4 shows the the address of tubes to be plugged of 3B SGs. Since ATHOS can only created a symmetrical half model of the tube bundle in referece to the center column of the SG, the asymmetrical plugged tubes can not be modeled. Therefore the pluggged tubes are assumed to be overlapped as shown in Fig.6-5.(see Ref.22)

Fig.6-4 Tubes to be plugged of 3B SG

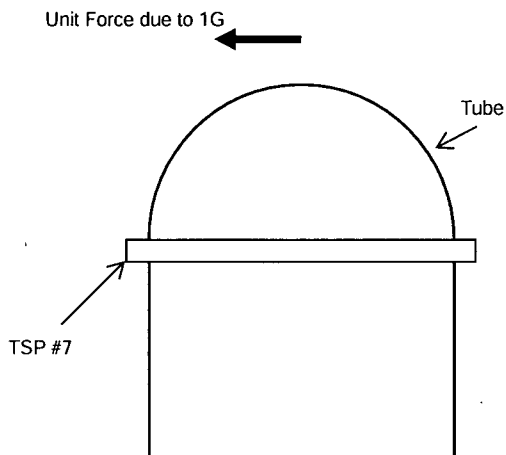
- (1) A unit force due to gravity 1G is applied on the U-bend tube (Figure 6-3) and the tube deformation (δ_1) (Figure 6-4) and the tube stress (σ_1) at #7TSP are calculated by FE analysis.
- (2) The tube deformation to contact the next tube (δ_2) is calculated using the drawing (Figure 6-4).
- (3) The tube stress to contact next tube is calculated by multiplying σ_1 by the ratio of δ_2/δ_1 .
- (4) The stress obtained in (3) is compared to the fatigue limit and is confirmed under the fatigue limit.

Figure 6-3 Loading Condition

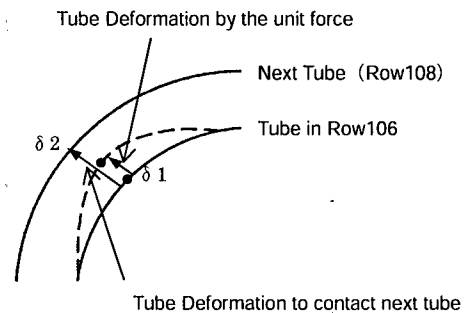
Figure 6-4 Deformation

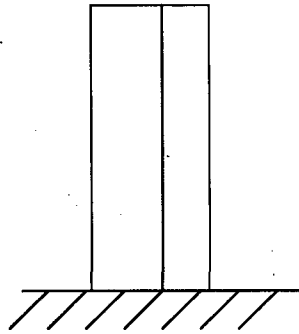
Figure A6.2-1 Mechanical Boundary Condition

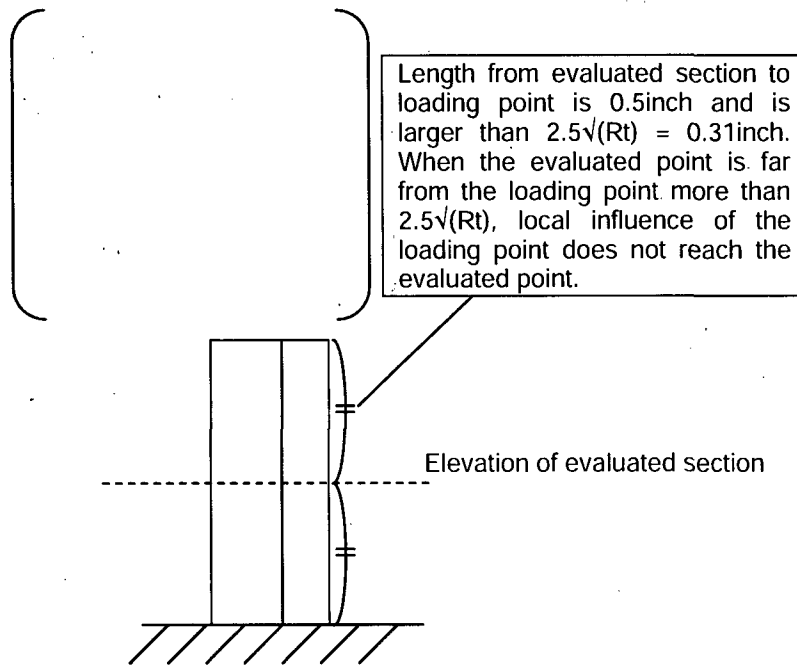
Figure A6.3-1 Loading Condition

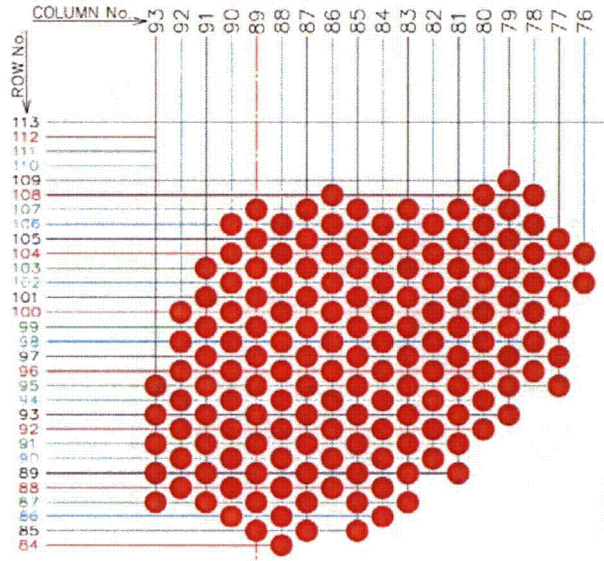
FSW tubes identified in the Unit 3 steam generators are shown in Figures 1 and 2. The FSW tubes are located in a well-defined, contiguous region of the tube bundle from row "X" through row "Y" consecutively for each column. In addition, FSW tubes exhibit specific characteristics in terms of the wear indications in affected tubes. Criteria proposed to select tubes for plugging that are potentially susceptible to FSW (in-plane motion tubes) are based on identifying the specific characteristics in the eddy current inspection data and the steam flow characteristics that could lead to potential susceptibility to the FSW phenomenon.

Figure 1 FSW tubes in Unit-3A

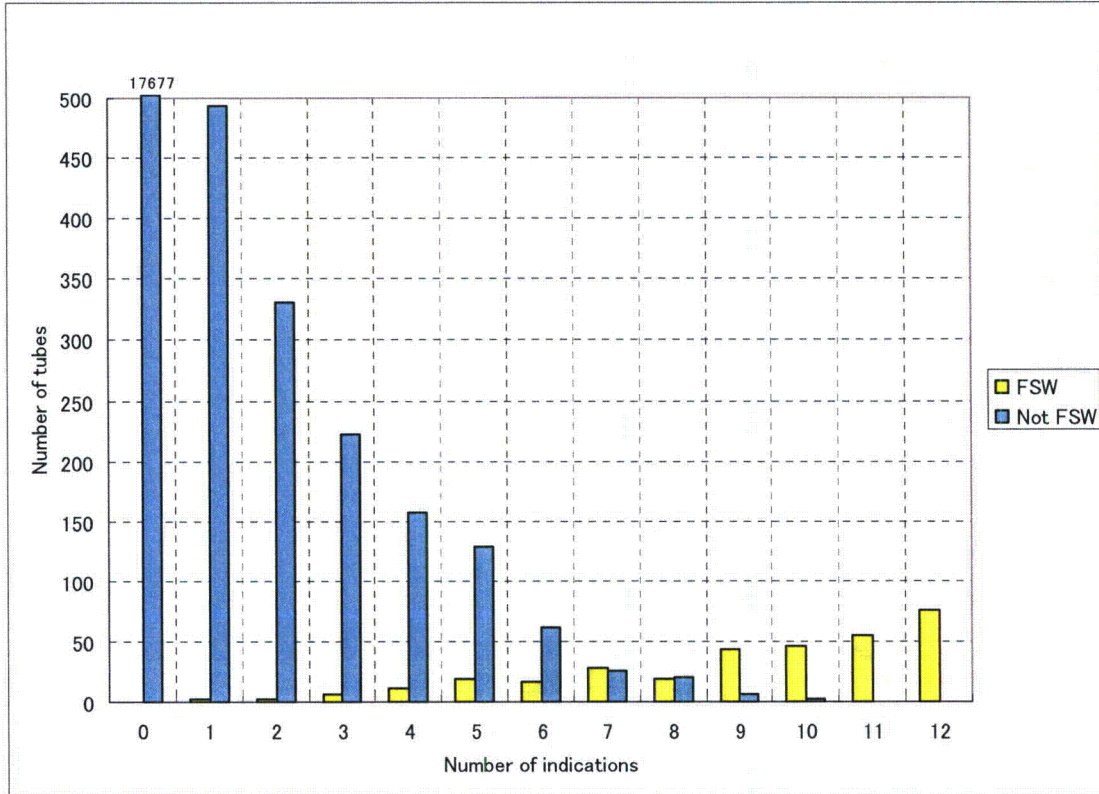
Figure 3 AVB wear indications (COUNT)

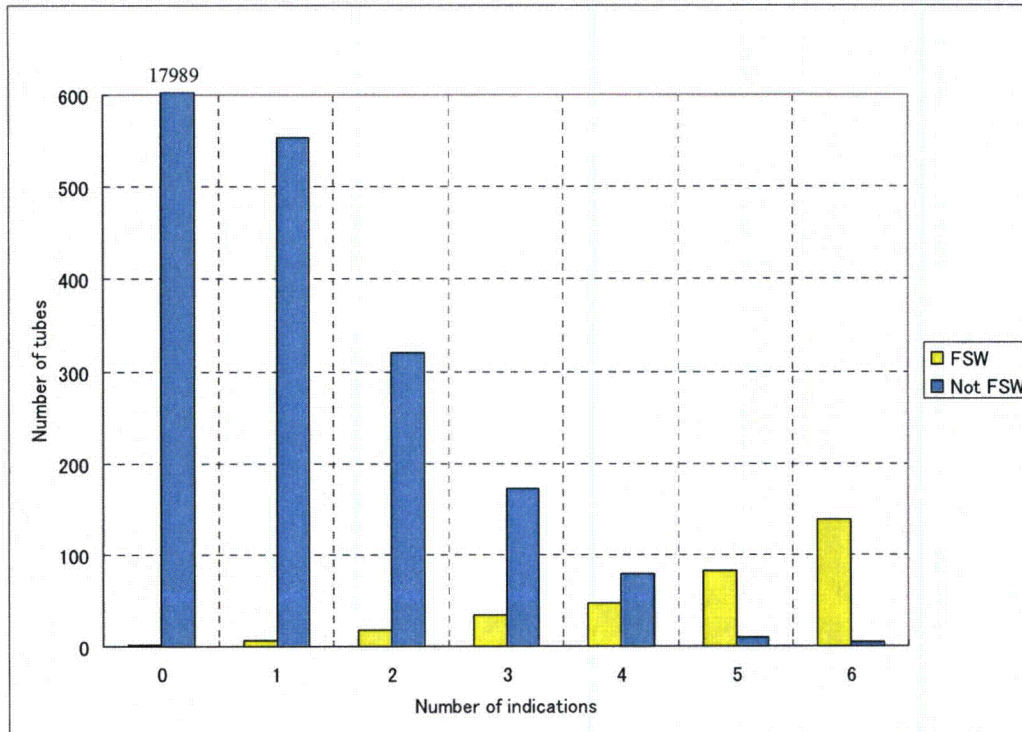
Figure 4 AVB wear indications at hot side (HOT COUNT)

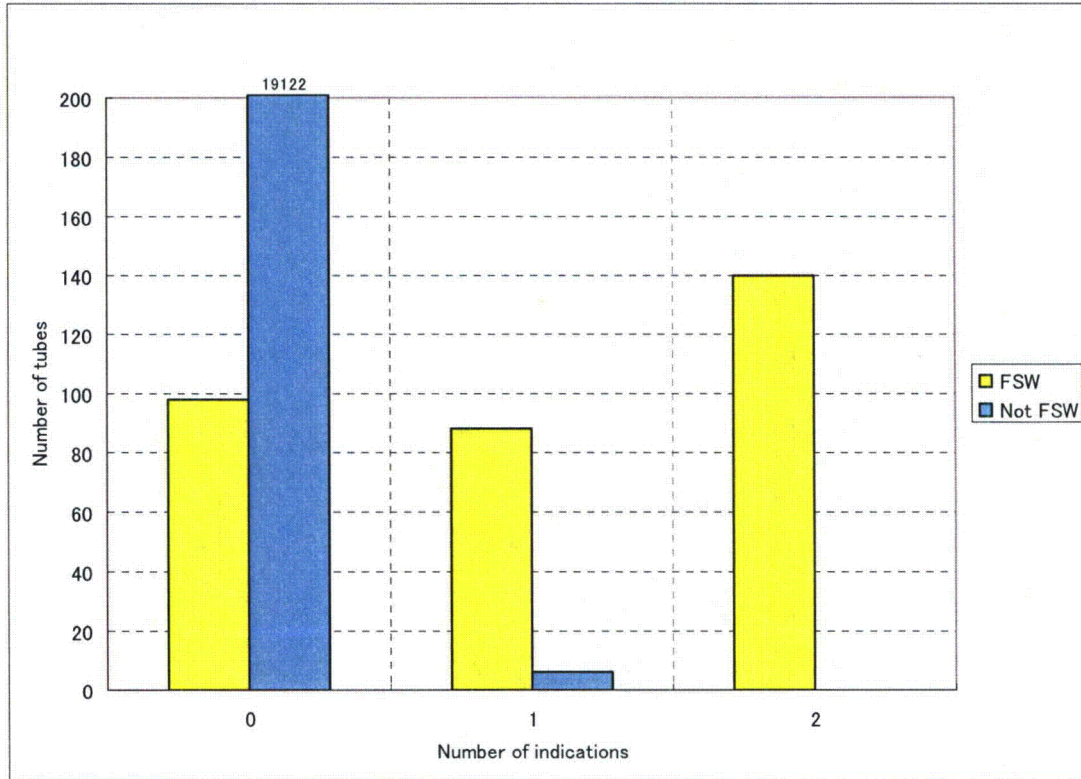
Figure 5 AVB wear indications at B01/B02 or B11/B12 positions (HIGH/LOW)

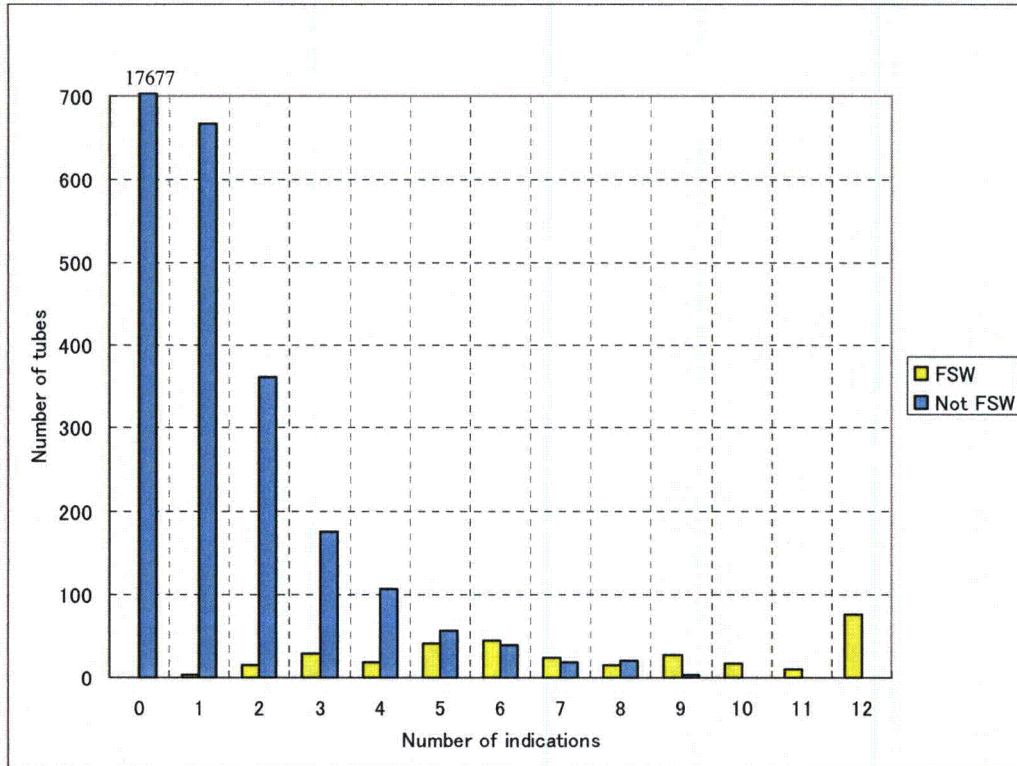
Figure 6 AVB continuous wear indications (CONTINUOUS)

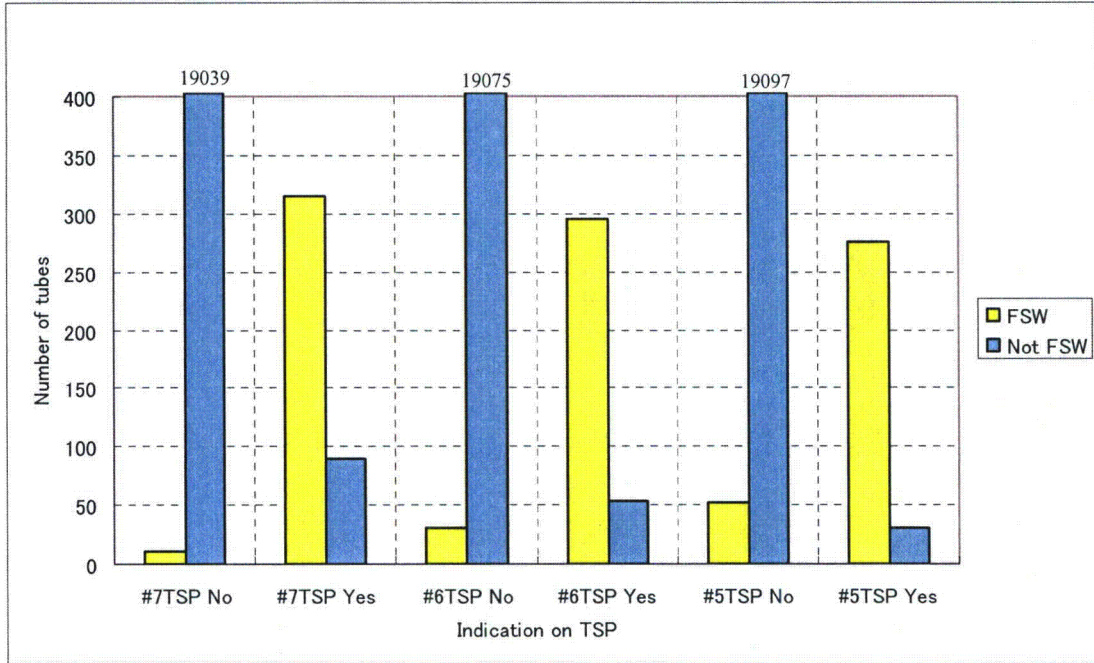
Figure 7 TSP wear (TSP)

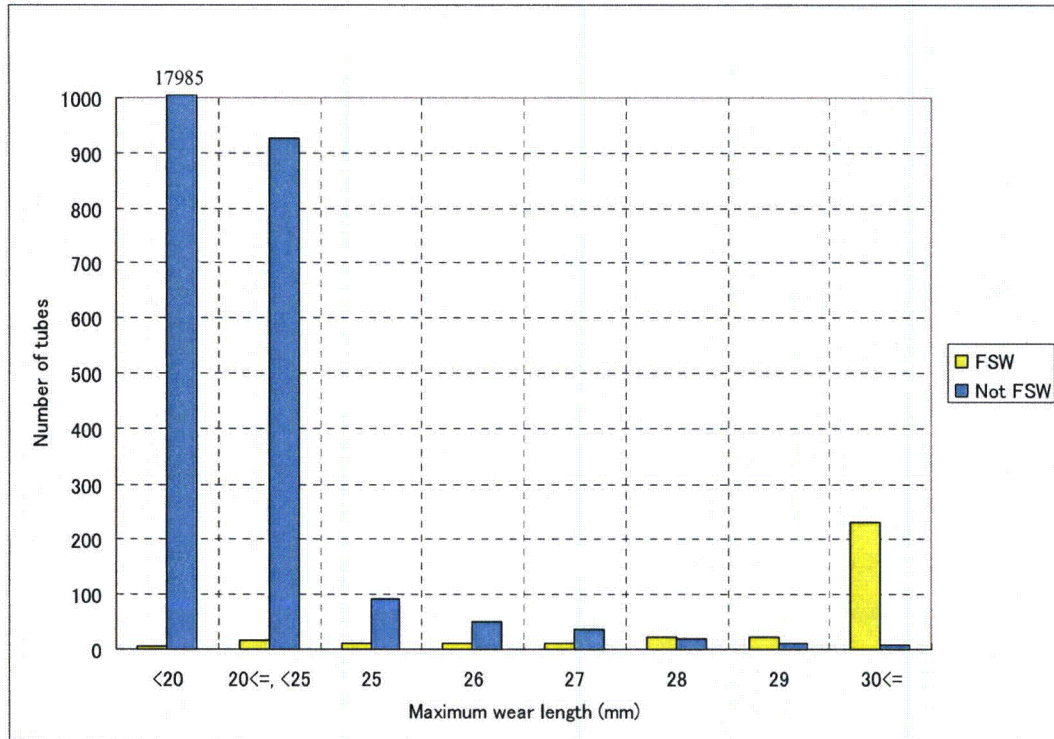
Figure 8 AVB Wear length (LENGTH)

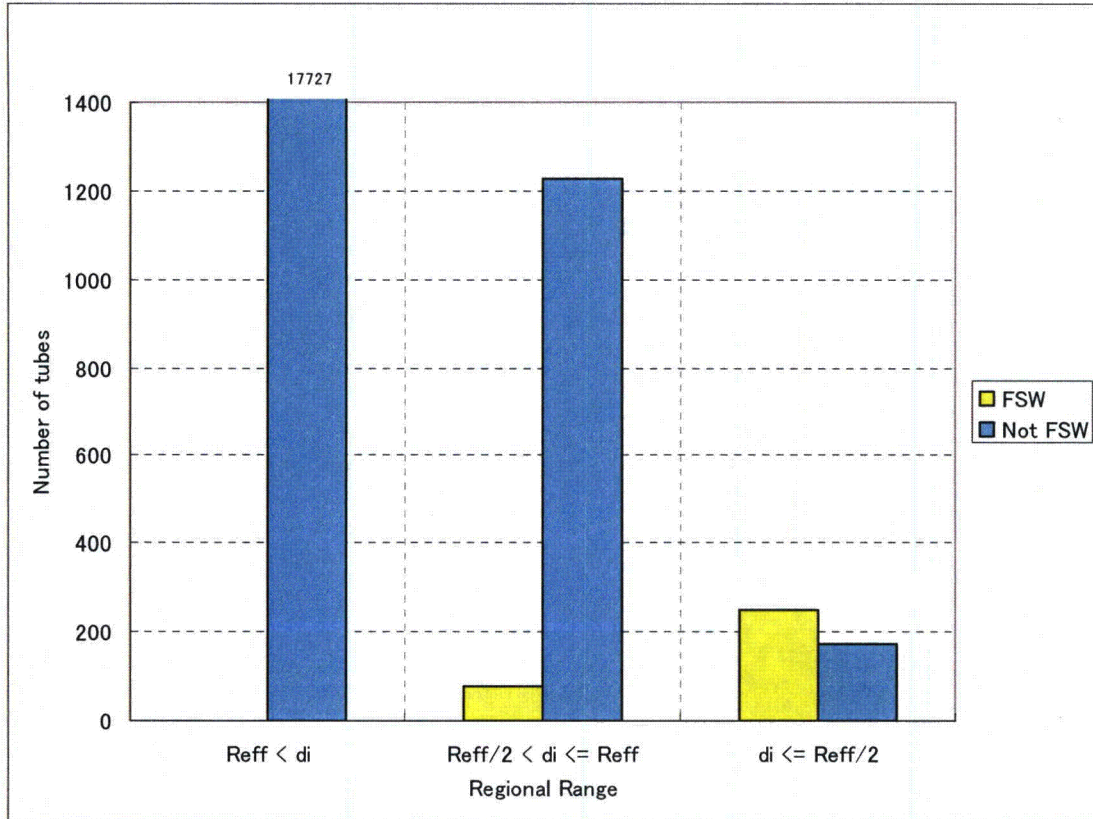
Figure 10 Regional effect (REGION)

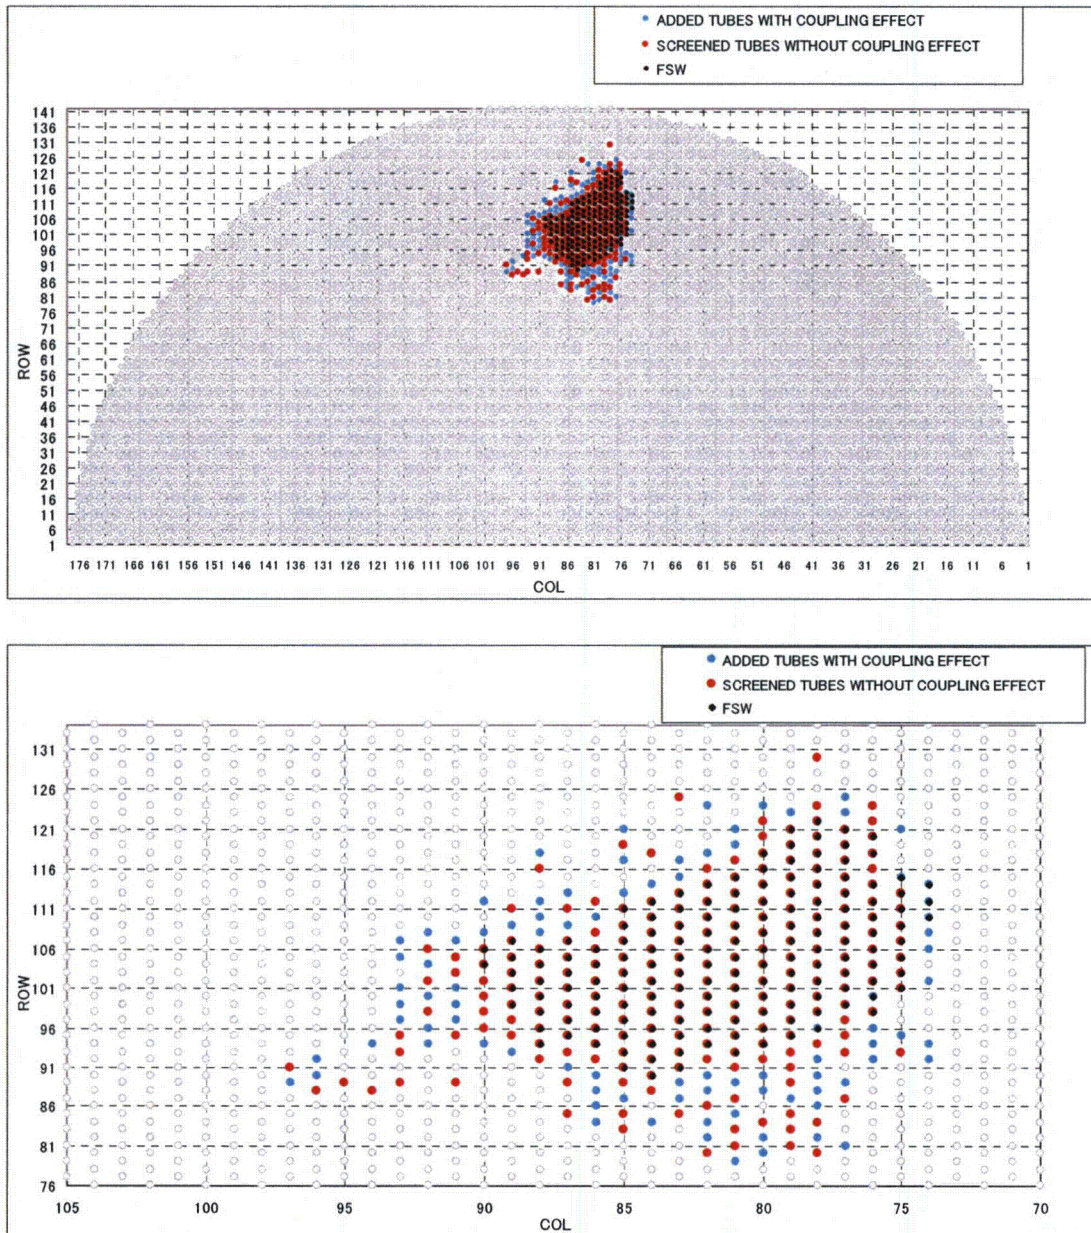
Figure 12 (2/2) False positive check (Unit 3B)

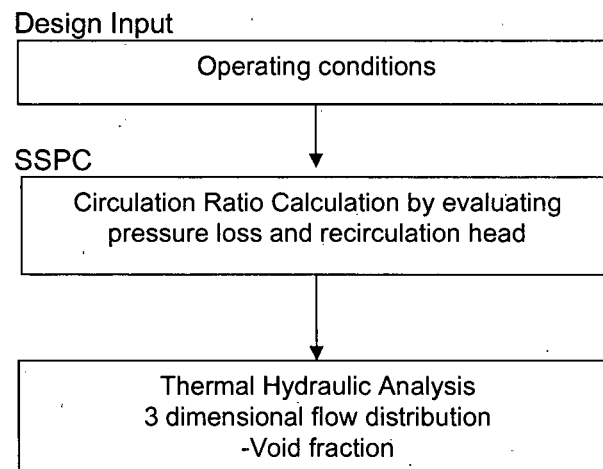
Based on the design input of the operating conditions, the calculation of the circulation ratio is performed by evaluating the pressure loss and the recirculation head with SSPC, which is a 1 dimensional Thermal and Hydraulic parameter calculation code (Ref.20). Using ATHOS/SGAP (Ref. 1 and 21), the thermal hydraulic analysis is performed to obtain the 3 dimension flow distribution which includes the void fraction.

Fig.5-1 Flow of the evaluation

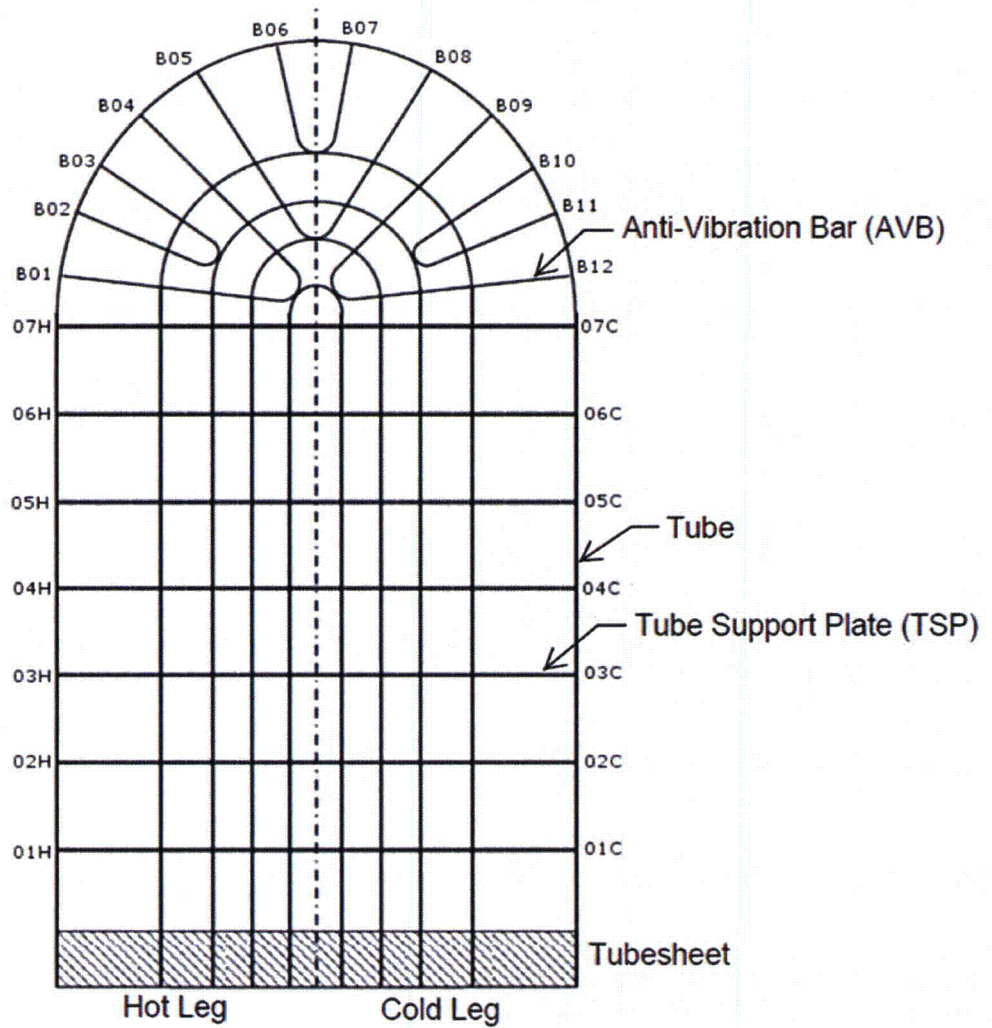
Figure 2-2: Details of AVBs, Retaining Bars, Bridges, and Retainer Bars

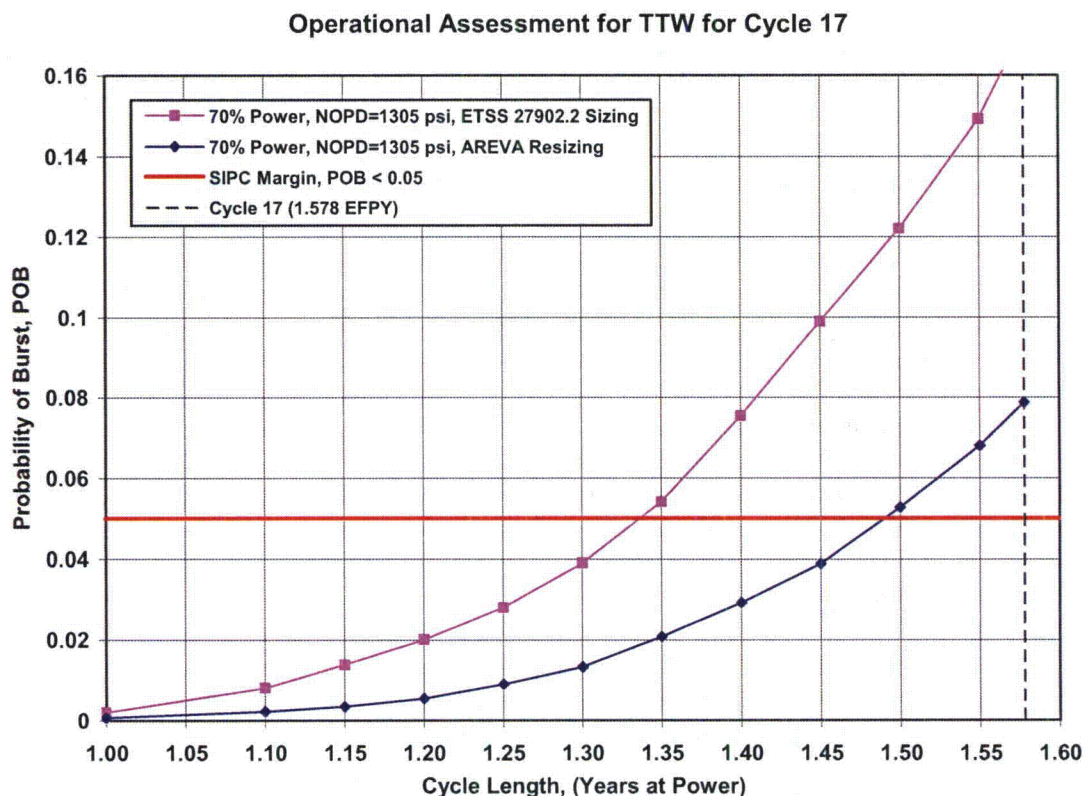
Figure 3-1: Traditional Operational Assessment Results

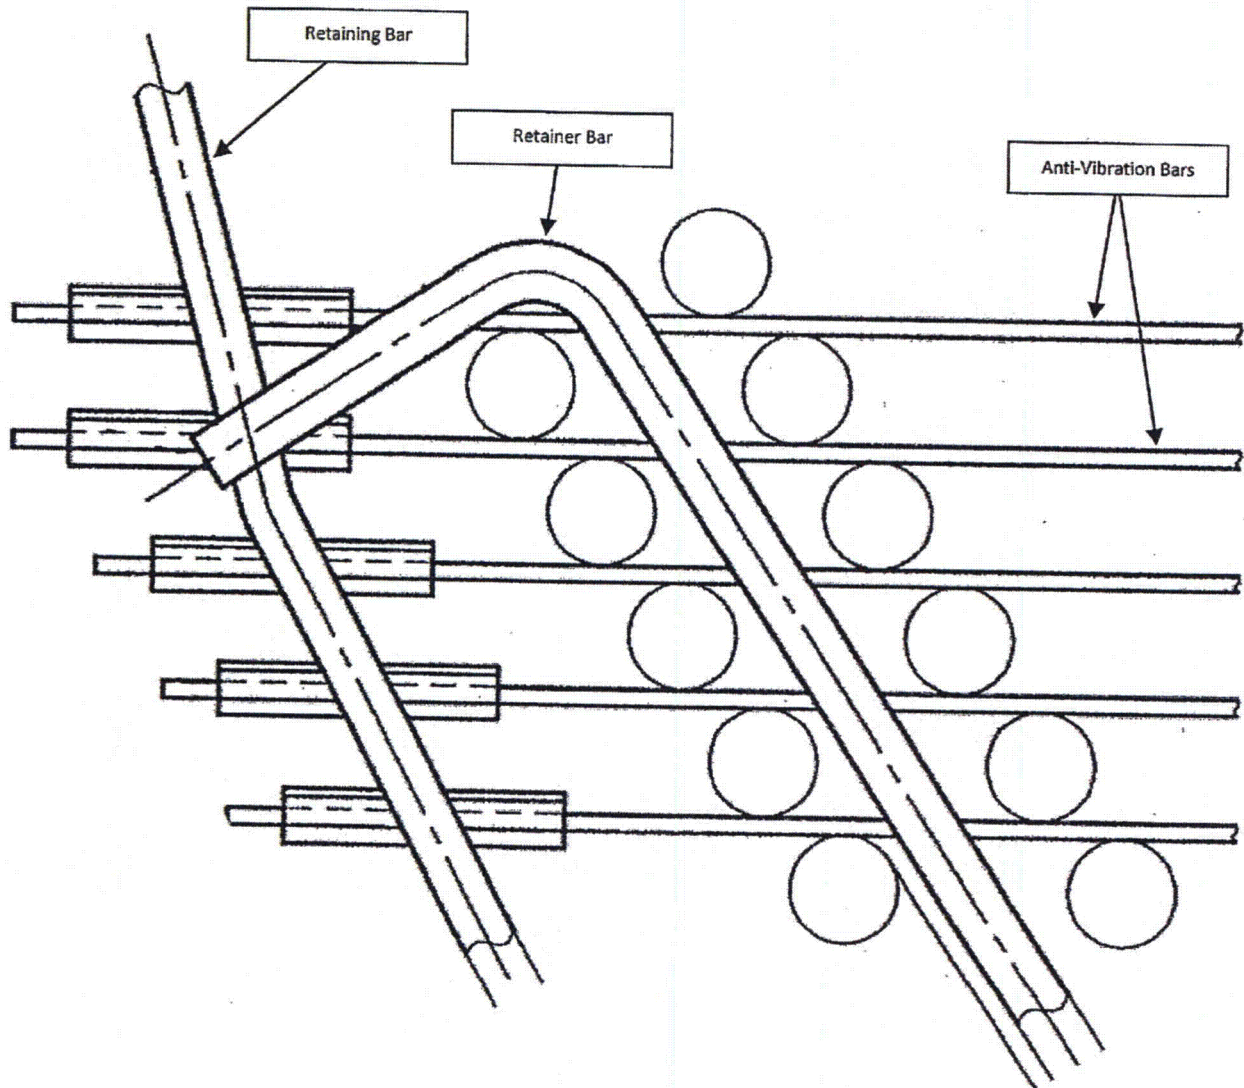
Figure 5-3: Sketch Showing Retainer/Retaining Bar Configuration

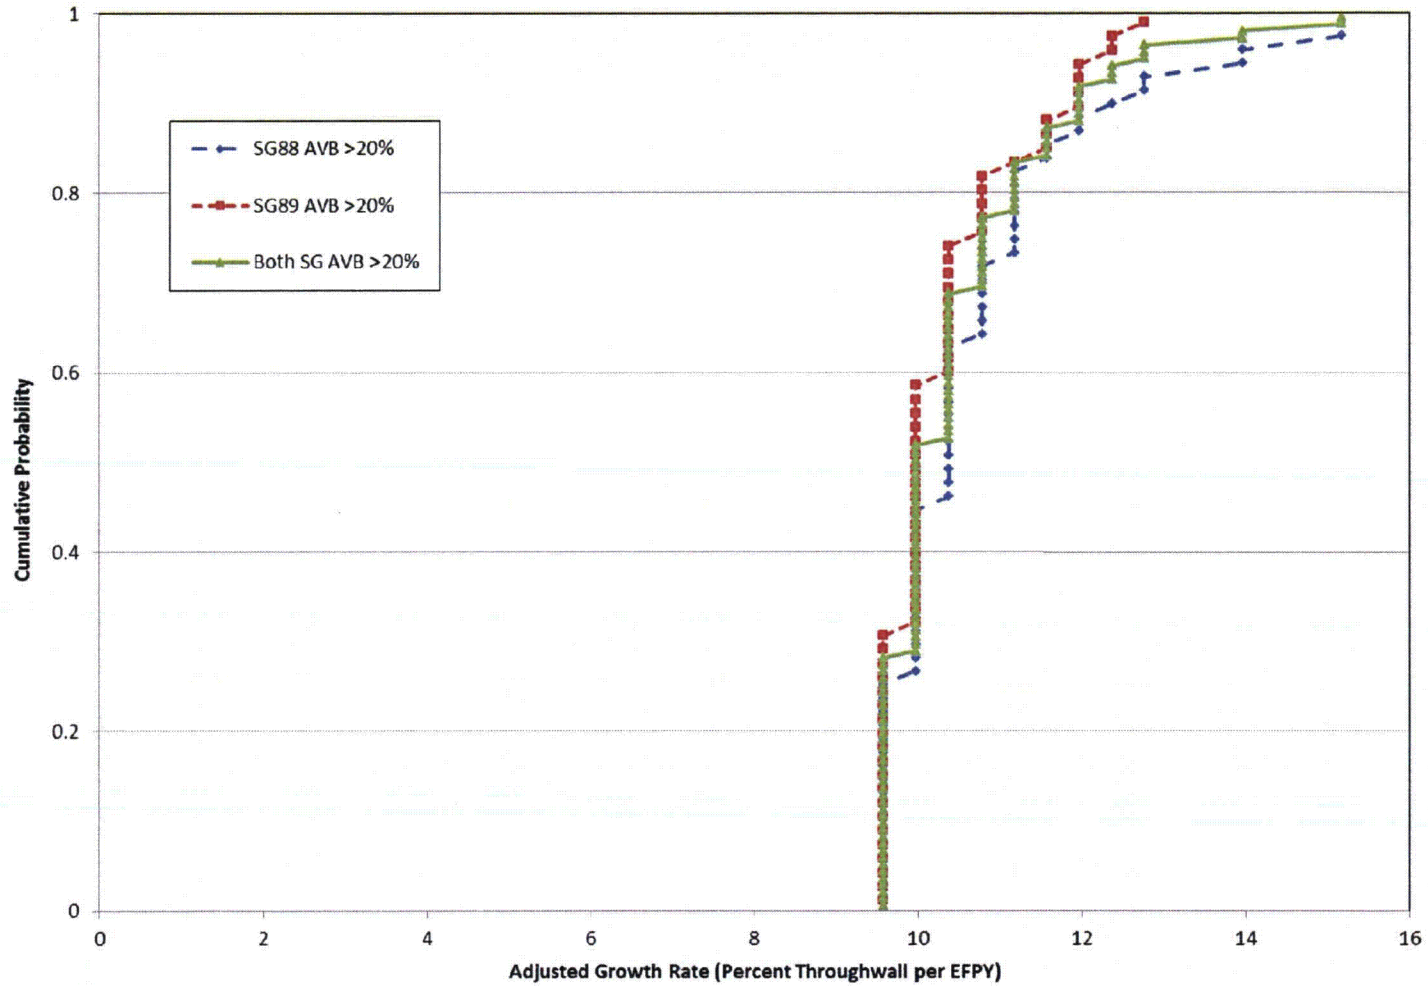
Figure 6-1: Adjusted Growth Rate Distribution, AVB Wear >20%TW

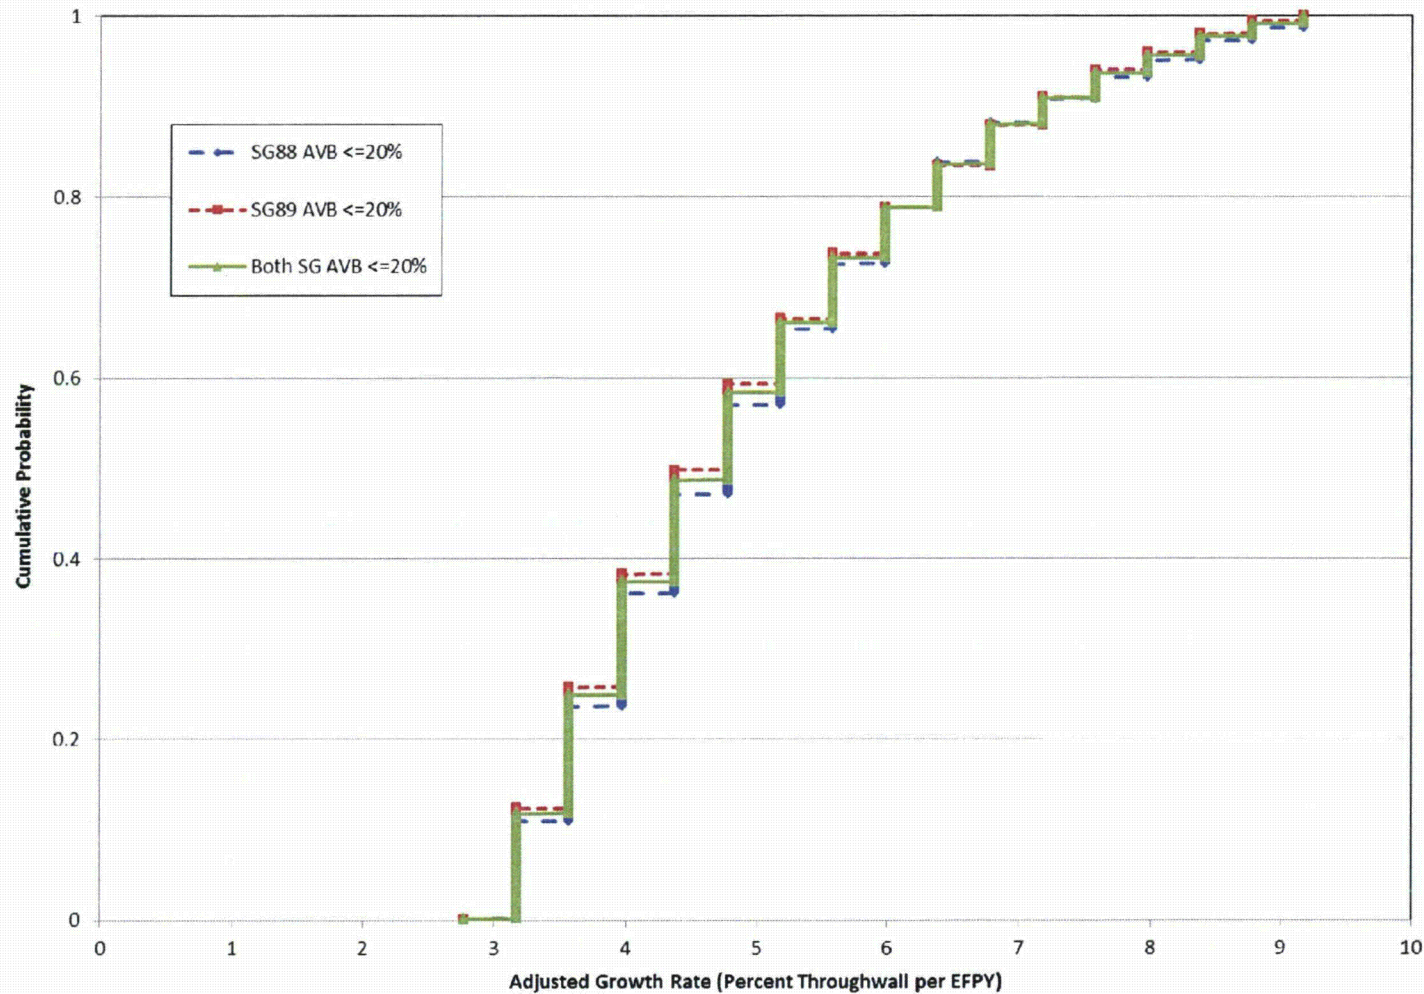
Figure 6-2: Adjusted Growth Rate Distribution, AVB Wear $\leq 20\%$ TW

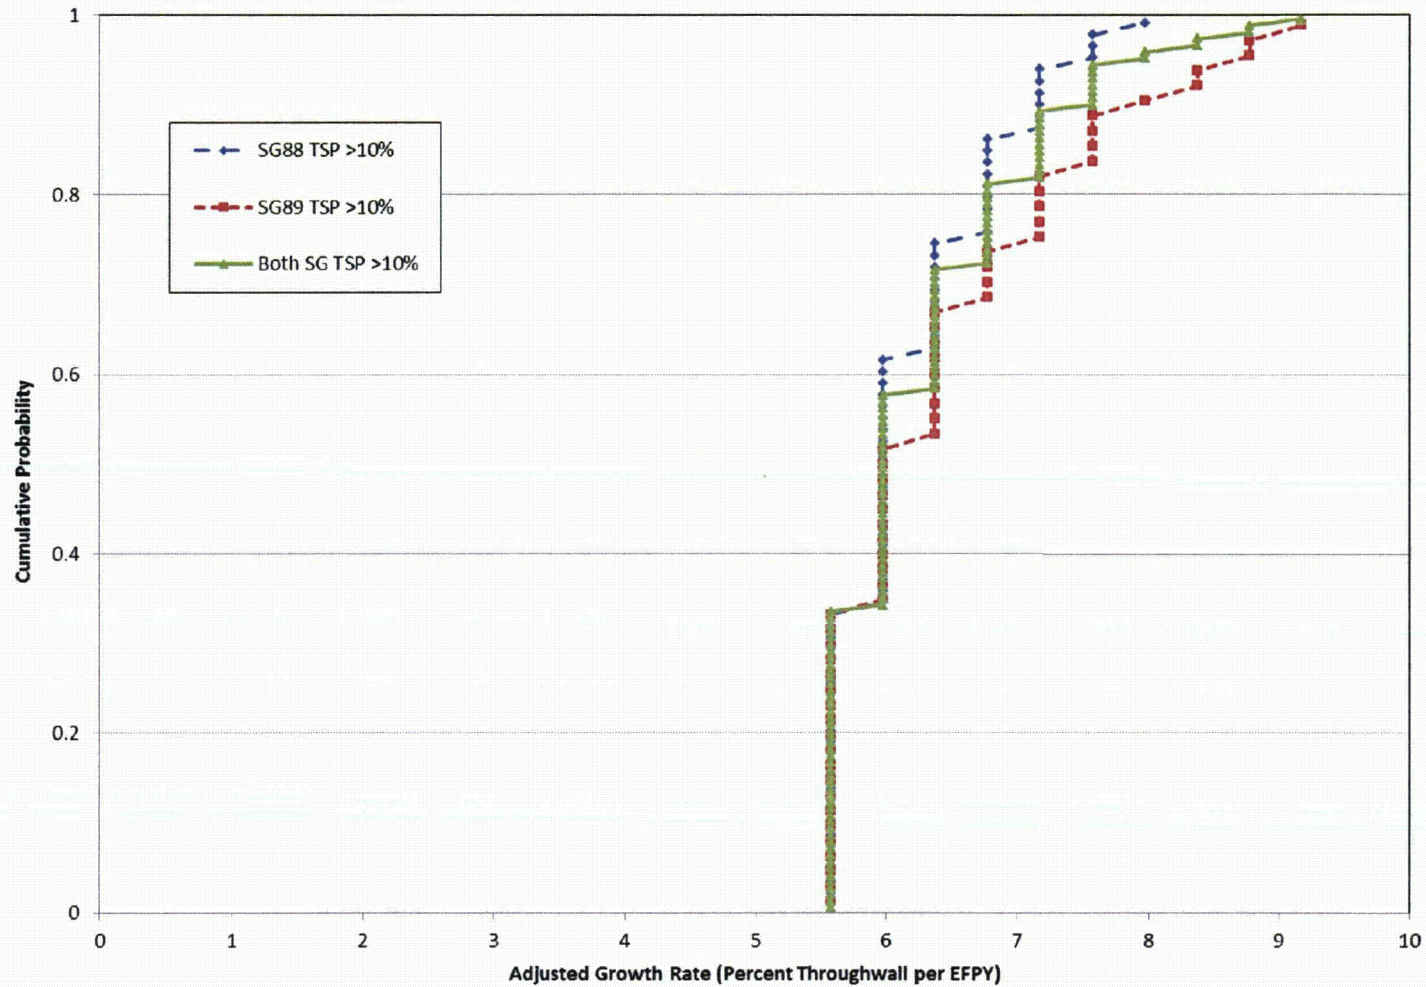
Figure 6-3: Adjusted Growth Rate Distribution, TSP Wear >10%TW

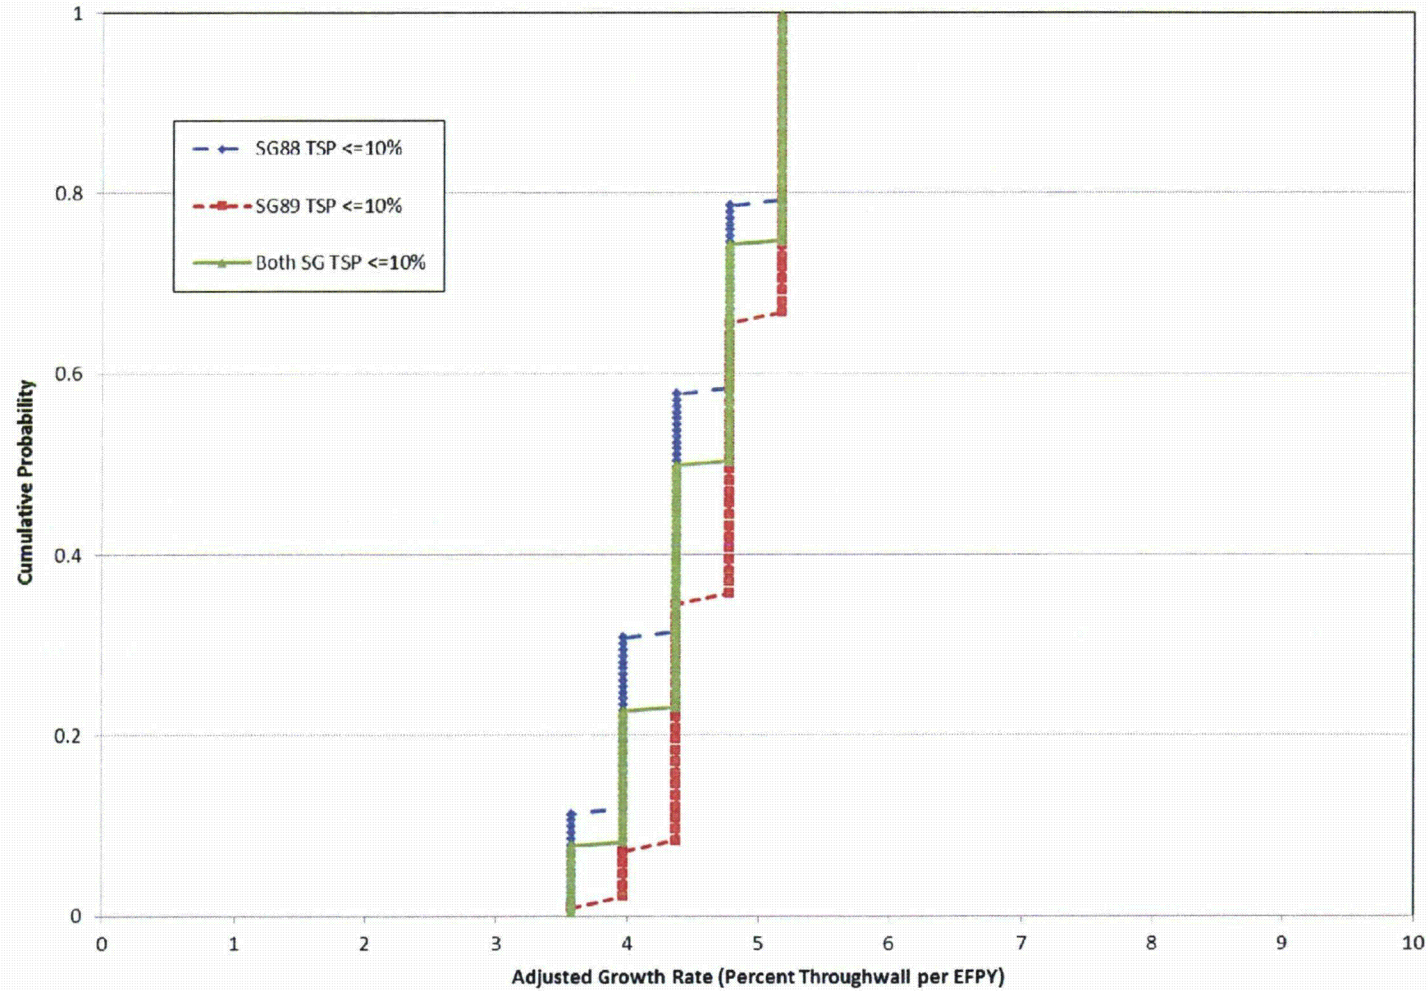
Figure 6-4: Adjusted Growth Rate Distribution, TSP Wear $\leq 10\%$ TW

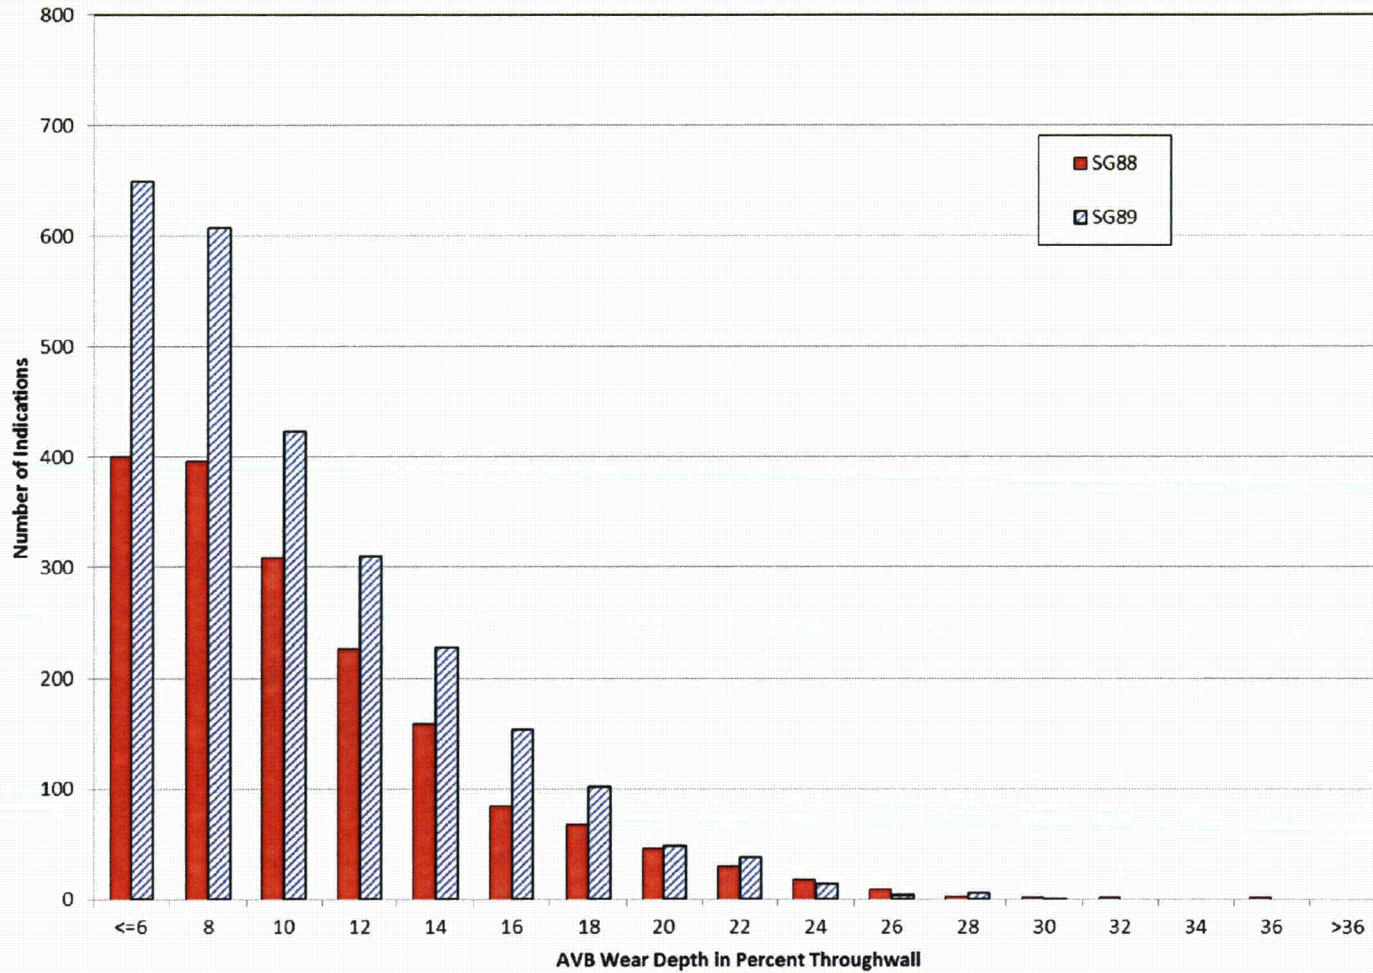
Figure 6-5: AVB Wear Depth Histogram
