Appendix-10
SG Tube Wear Analysis for Unit-2/3

The purpose of this analysis is to evaluate the tube wear depth at the U-bend region due to fluid elastic instability in order to verify the estimated mechanism of the tube wear observed in both of Unit-2 and Unit-3 as mentioned in Section 6.1 and 6.2 of the main report.

SONGS U2C17 Outage - Steam Generator Operational Assessment

SONGS U2C17 Steam Generator Operational Assessment for Tube-to-Tube Wear

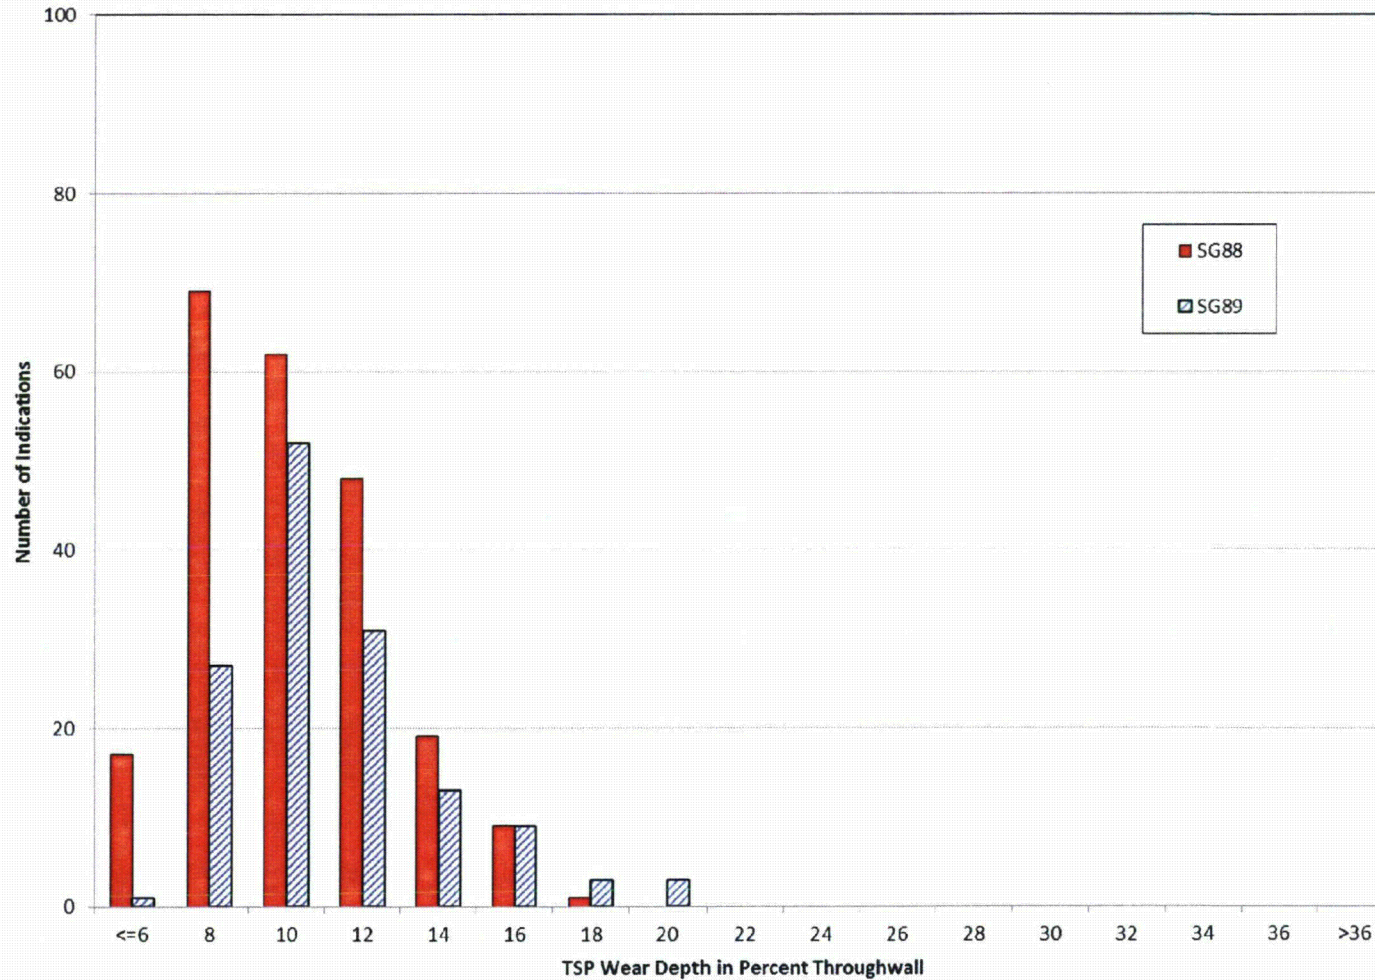
Figure 6-6: TSP Wear Depth Histogram

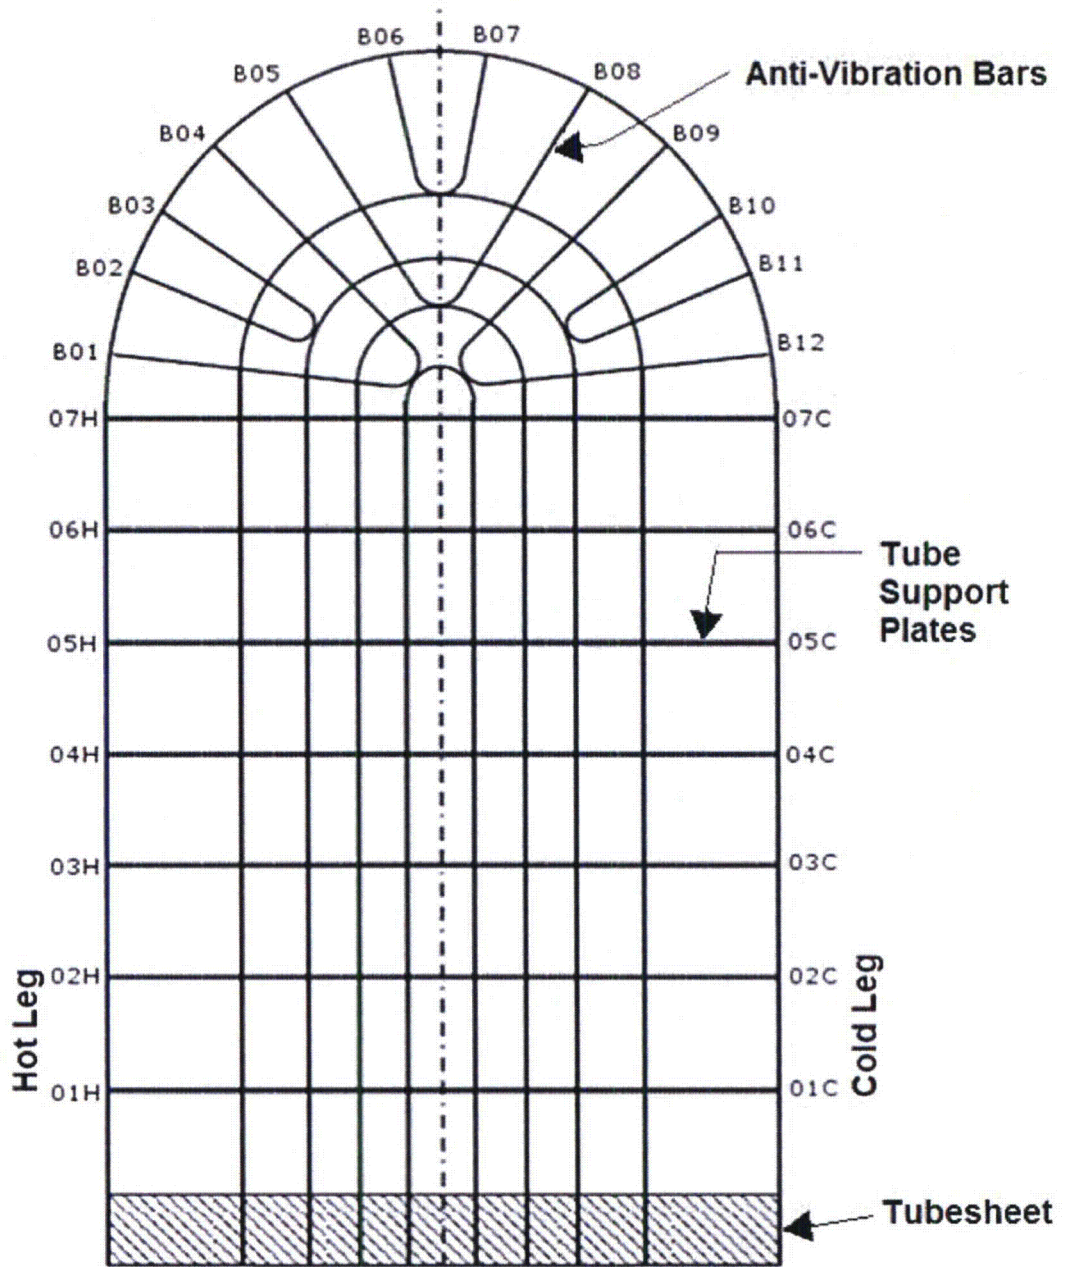
Figure 2-1: AVB Arrangement for SONGS Steam Generators

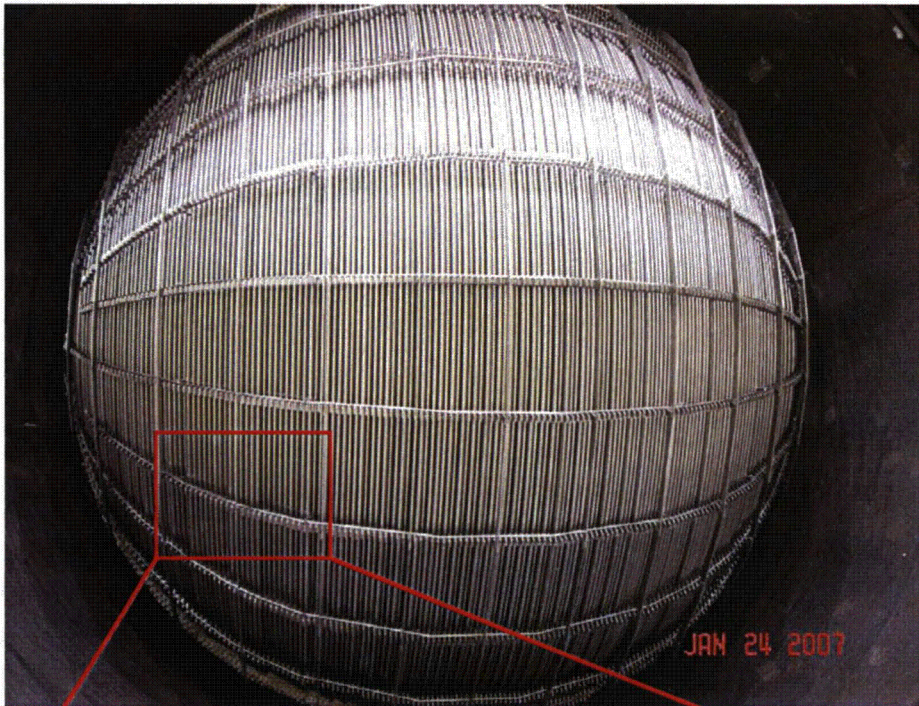
Figure 2-2: View of Top of Bundle
