Aging Assessment of Safety-Related Fuses Used in Low- and Medium-Voltage Applications in Nuclear Power Plants

Brookhaven National Laboratory

Manuscript Completed: January 2002
Date Published: March 2002

Prepared by
R. Lofaro, M. Villaran

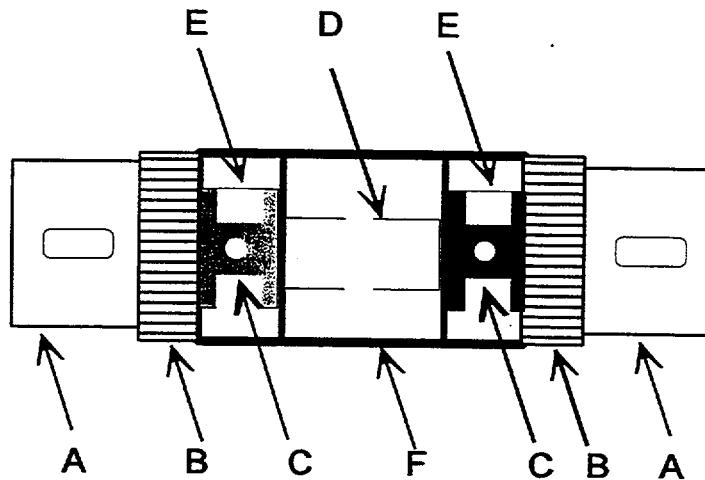
Figure 1 Sample low-voltage fuse construction

A = Fuse Blades	D = Time Delay Element
B = Metal End Caps	E = Filler Material
C = Fusible Elements	F = Fuse Cartridge

The fusible element is constructed of zinc, copper, or silver alloys, and may contain one or more narrow sections. These narrow sections are weak-links that are designed to melt under prescribed conditions. The number of fusible elements and their design are dictated by the specifications of the fuse. Non-current limiting fuses may use one large element, which is suitable for heavy overloads and short circuit currents. This can be combined with a time-delay element to form a "dual-element" fuse (see Figure 1). Current-limiting fuses use multiple elements with several weak-links in each instead of one large element. This use of multiple, smaller elements helps to quickly (within one-half cycle of the event) extinguish the arcs caused by high fault currents, and limit the current passed during a fault.

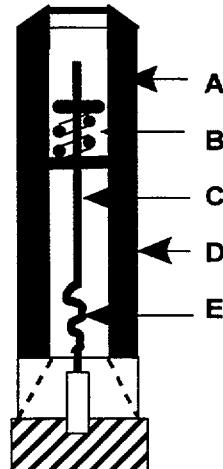
Figure 2 Schematic of expulsion type medium-voltage fuse

A = Solid gas generating material

Another type of medium-voltage fuse is the expulsion fuse, which is also known as the solid-material fuse or boric-acid fuse. This type of fuse generates a gas to help extinguish the arc generated by interruption of a fault current. As the gas is generated it quenches the arc and is expelled from the fuse. The design of this fuse includes an arcing rod that is attached to the fusible element. The arcing rod is spring loaded so that when the fusible element melts, it releases the rod. Spring tension then pushes the rod up through the top of the fuse cartridge and away from the broken end of the fusible element, thus increasing the arc gap. The internal surface of the fuse cartridge is lined with a solid material that generates a deionizing gas when heated by the arc. This gas helps to extinguish the arc, thus breaking the circuit. Figure 2 shows this type of fuse schematically.

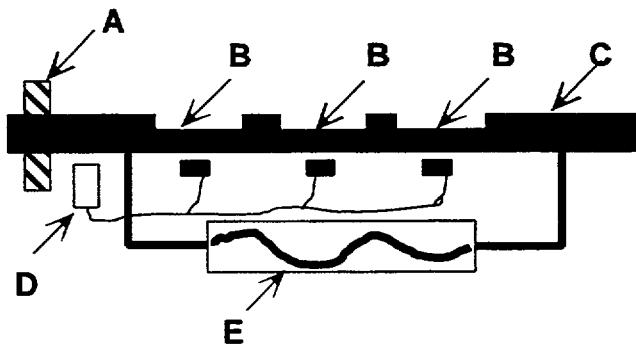
Figure 3 Schematic of one electronic medium-voltage fuse design

- A = Current sensing transformer
- B = Selectively weakened breakpoints with pyrotechnic cutting charge below each
- C = Bus bar (primary fuse conducting path)
- D = Electronic sensing circuitry
- E = Fusible element embedded in sand

Upon an overcurrent condition, a current transformer and electronic sensing circuits sense the overcurrent and initiate a trip signal to activate a device that will disrupt the primary current path. Depending on the fuse design, the primary current path can be disrupted by activating a power cartridge, which generates a gas to drive a piston away from its contact surface, or by detonating explosive charges to force one or more selectively weakened sections of the primary conductor out of place. Once the primary path is broken, all current flows through the fusible element causing it to melt and break the circuit. One electronic fuse design is shown schematically in Figure 3.

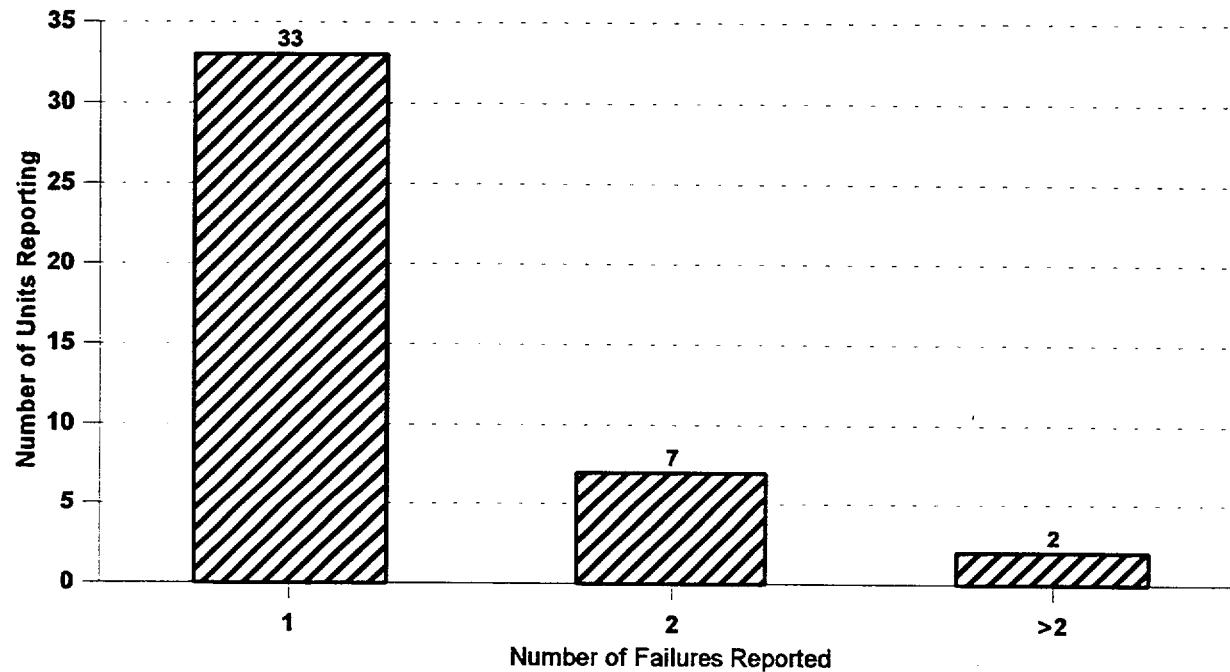
Figure 4 Distribution of age-related fuse failures per unit from LERs

are relatively infrequent. The distribution of age-related failures reported per unit is shown in Figure 4. For the units reporting, the fuse failures were relatively evenly distributed among the units, with no one unit having a majority of the failures. This indicates there is no specific age-related fuse problem at any one plant. In most cases, only one fuse failure per unit was reported.

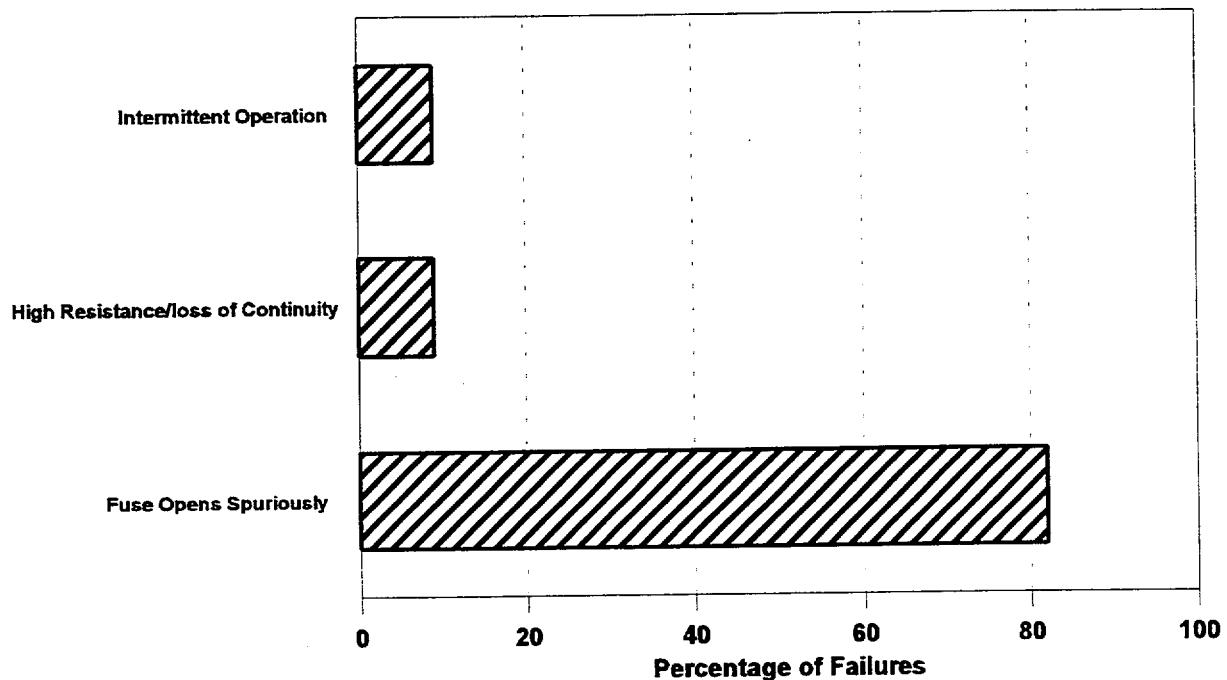
Figure 5 Distribution of fuse failure modes from LERs

The age-related fuse failures were analyzed to identify the predominant aging characteristics of the failures experienced. Figure 5 shows the distribution of failure modes identified. As shown, the predominant failure mode experienced (82%) was "FUSE OPENS SPURIOUSLY," which indicates that the fusible element opened and caused an open circuit when it should not have. The failure mode "HIGH RESISTANCE/LOSS OF CONTINUITY" represented 9% of the failures. These failures typically involved problems with the fuse being loose in the fuse holder due to weakened clips and failing to complete the circuit, and/or degradation of the electrical contact surfaces. The remaining events (9%) involved the failure mode "INTERMITTENT OPERATION" of the fuse, which were typically due to loose fuse holder clips or a broken solder joint between the fuse element and end cap. No events were identified involving any of the other potential fuse failure modes identified previously.

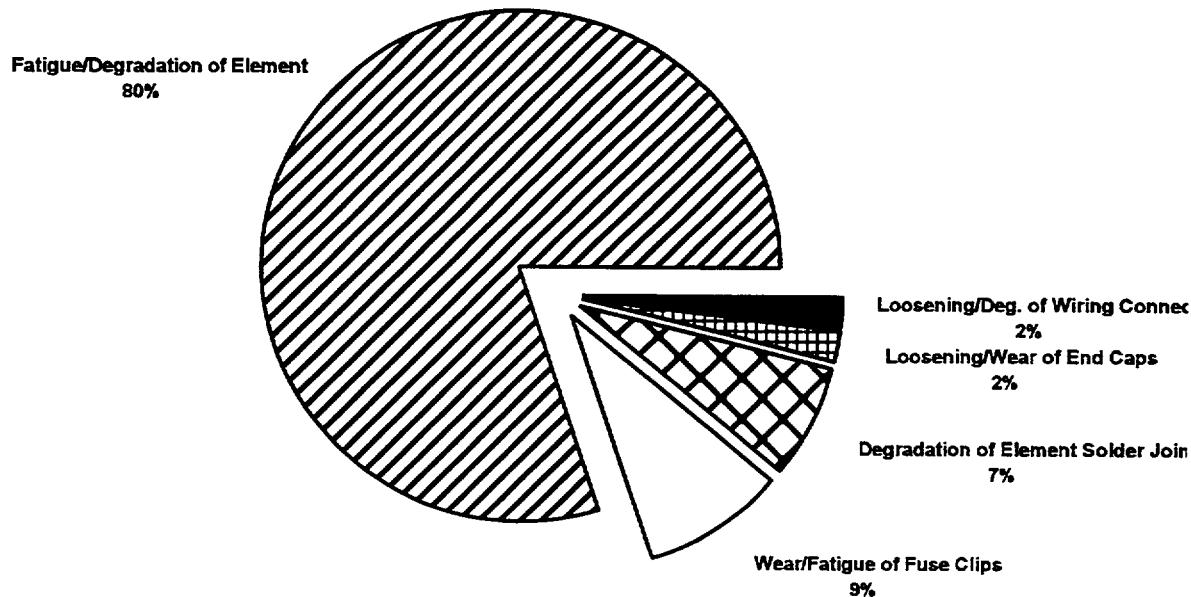
Figure 6 Fuse failure mechanisms from LERs

The predominant failure mechanism (80%) was found to be "FATIGUE/ DEGRADATION" of the fusible link, which led to failure of the fuse. Fatigue is typically due to degradation over a period of time from exposure to elevated temperature, voltage transients, or short duration over-current conditions. It can lead to weakening of the fuse element, or a reduction in cross section, which reduces its current carrying capacity. Other less frequent failure mechanisms found were "WEAR/FATIGUE" of the fuse holder clips (9%) or "DEGRADATION" of the end

cap to fuse element solder joint (7%). Fatigue of the fuse holder clips can typically occur due to repeated insertion and removal of the fuses, such as during maintenance or surveillance testing. Degradation of the solder joint was found to occur in several cases due to cold solder joints that degraded during subsequent operation. The remaining failures were due to loosening/degradation of the wiring connections to the fuse holder, and loosening/ wear of the end caps on the fuse itself. The percentage of failures related to each of the failure mechanisms is shown in Figure 6.

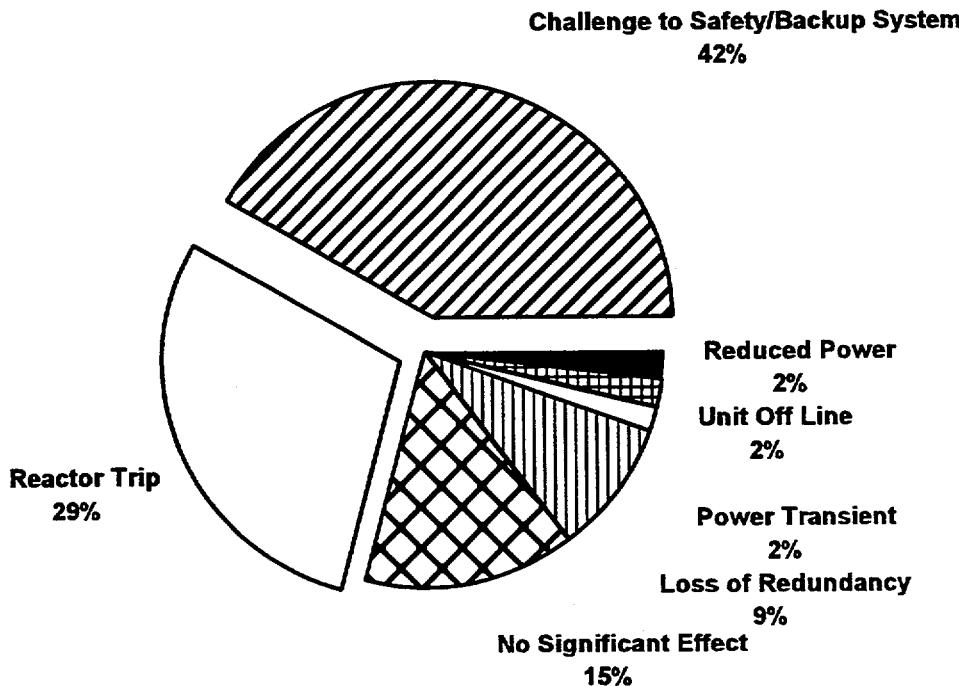
Figure 7 Effect of fuse failures on plant performance from LERs

The various effects of the fuse failures on plant performance are shown in Figure 7. The predominant effect (42%) was found to be a challenge to a safety or backup system. This is expected from this database since any actuation of an engineered safety feature is reportable as an LER. Typical examples of these events are the following:

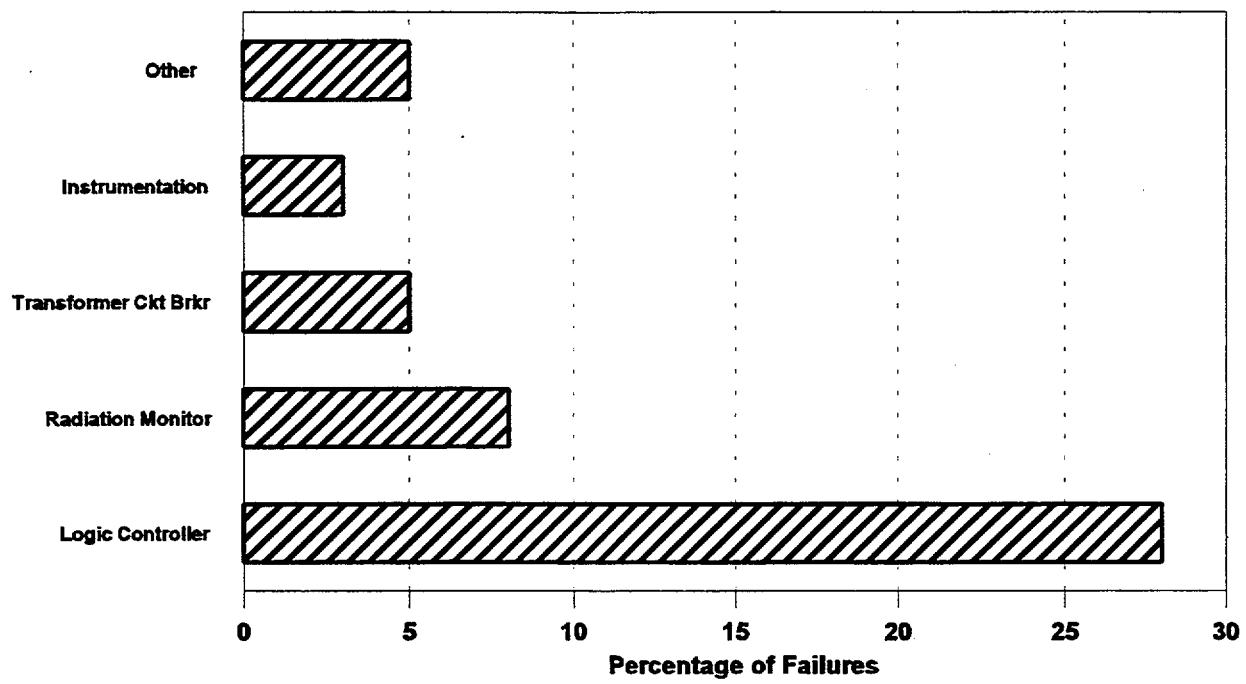
Figure 8 Distribution of applications for failed fuses from LERs

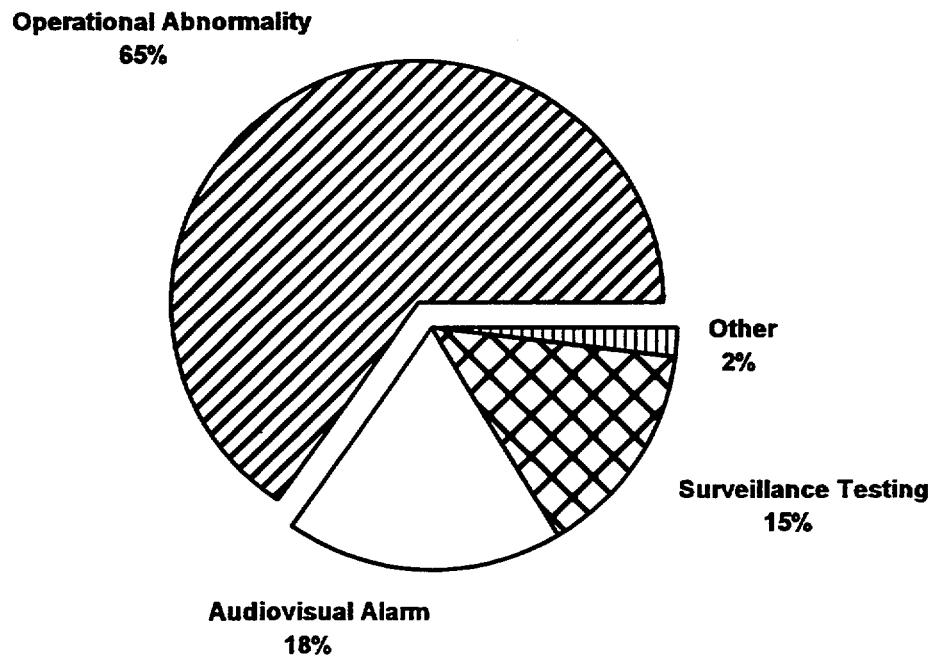
Figure 9 Fuse failure detection methods from LERs

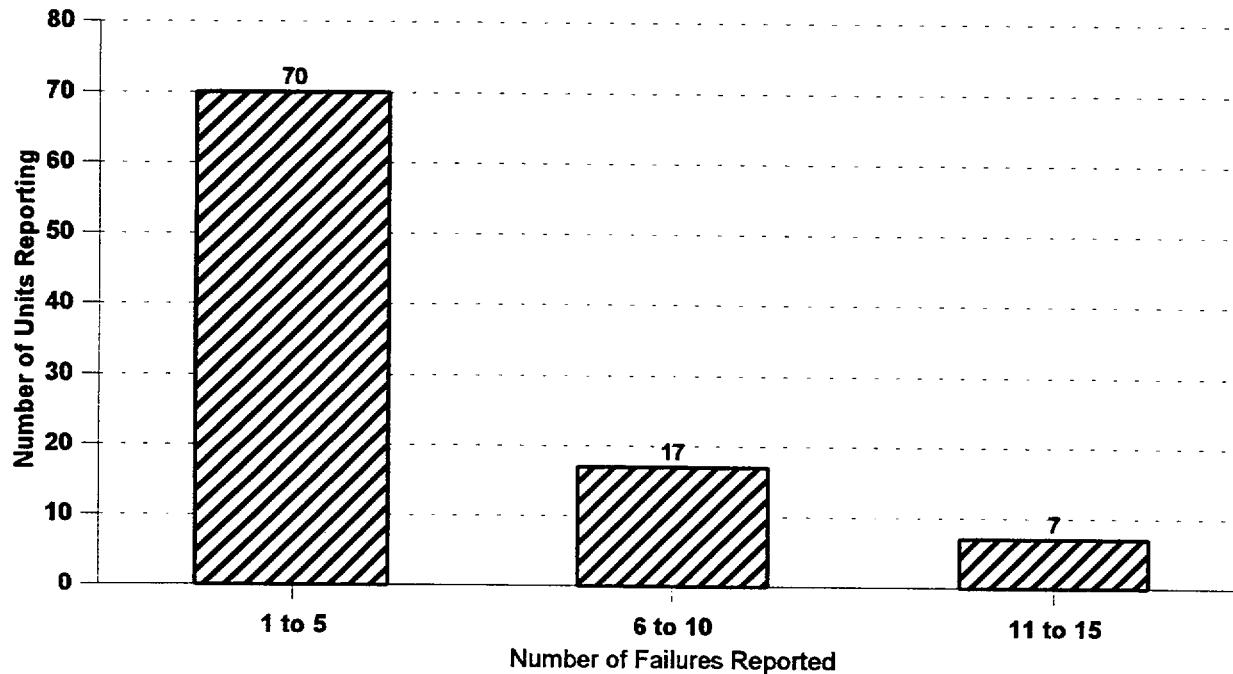
Figure 10 Distribution of age-related fuse failures per unit from NPRDS

among the failures reported to the NPRDS was relatively low. The failure reports reviewed for this program represented 94 nuclear units. The distribution of age-related failures reported per nuclear unit is shown in Figure 10.

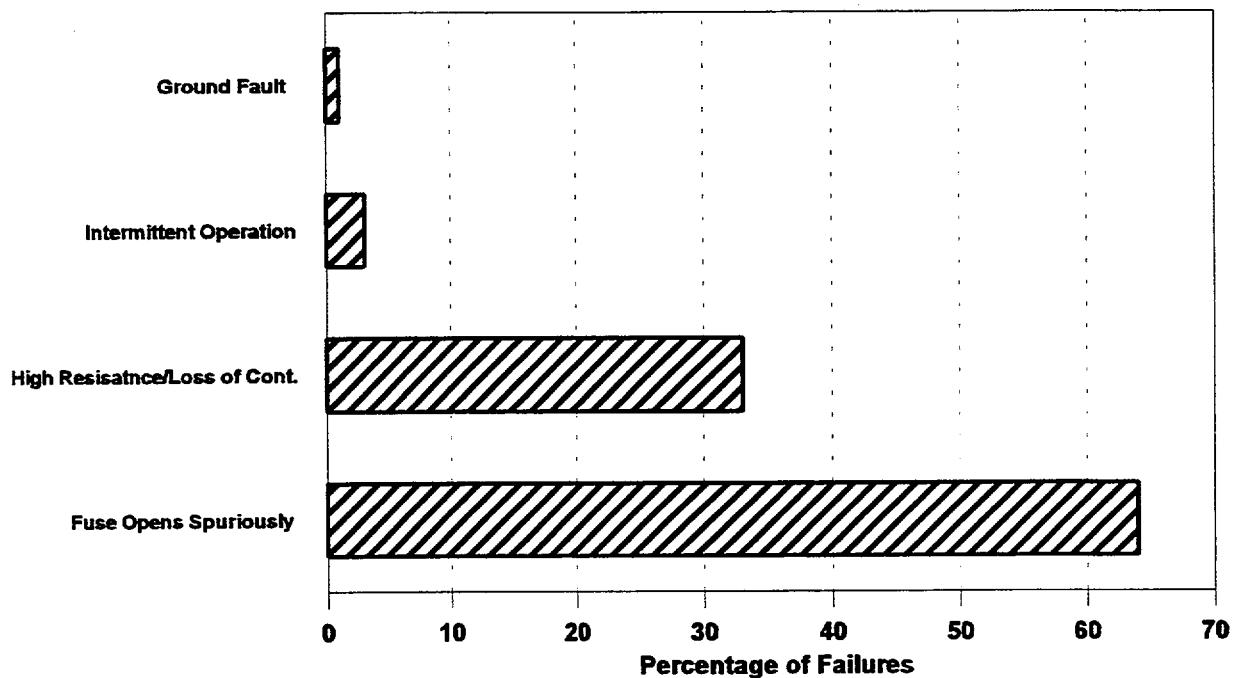
Figure 11 Distribution of fuse failure modes from NPRDS

The fuse failures identified as age-related were analyzed to determine the predominant aging characteristics of the failures experienced. Figure 11 shows the distribution of failure modes encountered during the review. As shown, the predominant failure mode experienced (64%) was "FUSE OPENS SPURIOUSLY," which indicates that the fusible element opened and caused an open circuit when it should not have. The failure mode "HIGH RESISTANCE/LOSS OF CONTINUITY," which represented 33% of the age-related failures reported, was significant in that it was a failure mode of the fuse holder. These failures typically involved: problems with the fuse being loose in the fuse holder due to weakened, broken, or misaligned clips; degraded or open electrical connection between fuse and holder; degraded or open electrical connection between the fuse holder and its wiring terminations; broken fuse holder parts; and failing to complete the circuit.

A small number of events (2.5%) involved the failure mode "INTERMITTENT OPERATION" of the fuse, which were typically caused by loose fuse holder clips or faulty fuse holder wiring terminations. Finally, less than 1% of the events involved the "GROUND FAULT" failure mode, which was usually caused by dirt or contamination on a high voltage fuse/fuse holder assembly faulting to ground. It should be noted that latter three failure modes, representing more than 35% of the age-related events reviewed, involved failures of the fuse holder assembly and its terminal connections. No events were reviewed involving any of the other potential fuse failure modes identified previously.

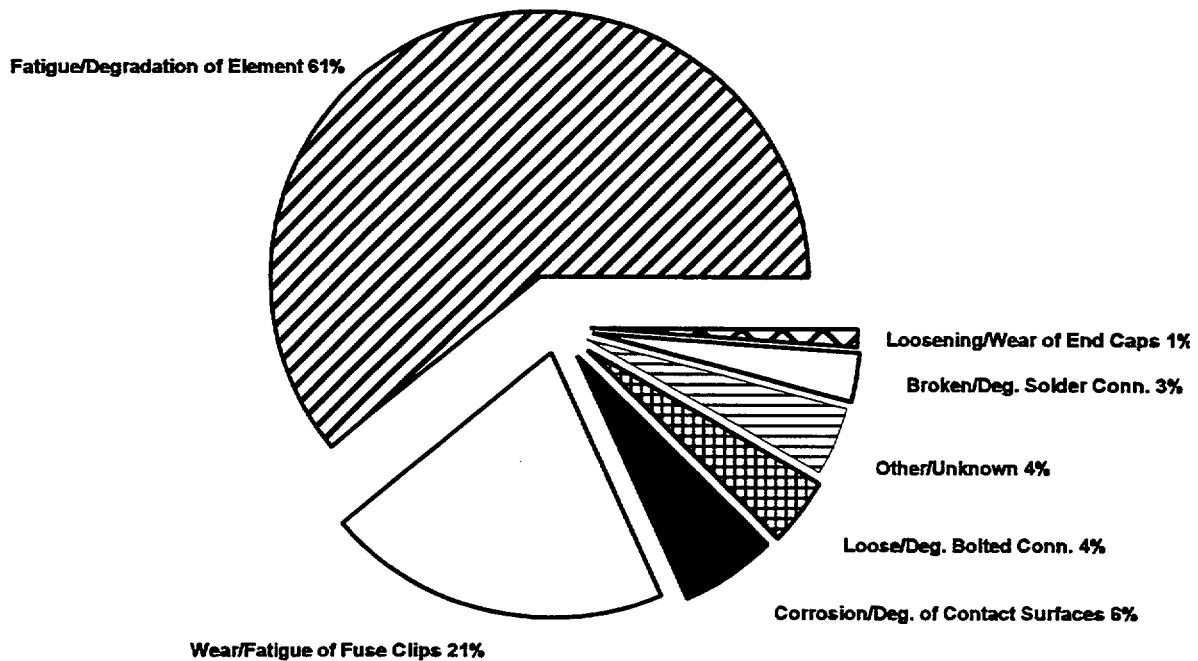
Figure 12 Fuse failure mechanisms from NPRDS

The predominant failure mechanism (61%) was found to be "FATIGUE/DEGRADATION OF ELEMENT," i.e., of the fusible element or link, which led to unexpected failure of the fuse. This is to be distinguished from the normal opening of the fusible link when the fuse is exposed to overcurrent conditions for a prescribed time. Fatigue is typically due to the degradation of the metallic fuse element over time as a result of exposure to elevated temperature, voltage transients, or short duration overcurrent conditions. It can lead to weakening of the fuse element, or a reduction in cross section, which reduces its current carrying capacity.

A second important failure mechanism was "WEAR/FATIGUE OF FUSE CLIPS" (21%). Fatigue of the fuse holder clips can typically occur due to high temperature, mechanical stress, and repeated insertion and removal of the fuses, such as during maintenance or surveillance testing. Other less frequently cited failure mechanisms found were "CORROSION/DEGRADATION OF CONTACT SURFACES" (6%), loose, broken, or degraded soldered (3%) or bolted/screwed (4%) wiring connections, and "LOOSENING/WEAR OF END CAPS" (1%). The remainder of the failure mechanisms (approximately 4%) included a variety of mechanisms, such as, contamination, moisture intrusion, fatigue or breakage of fuse holder base, or unknown. The percentage of failures related to each of the failure mechanisms is shown in Figure 12.

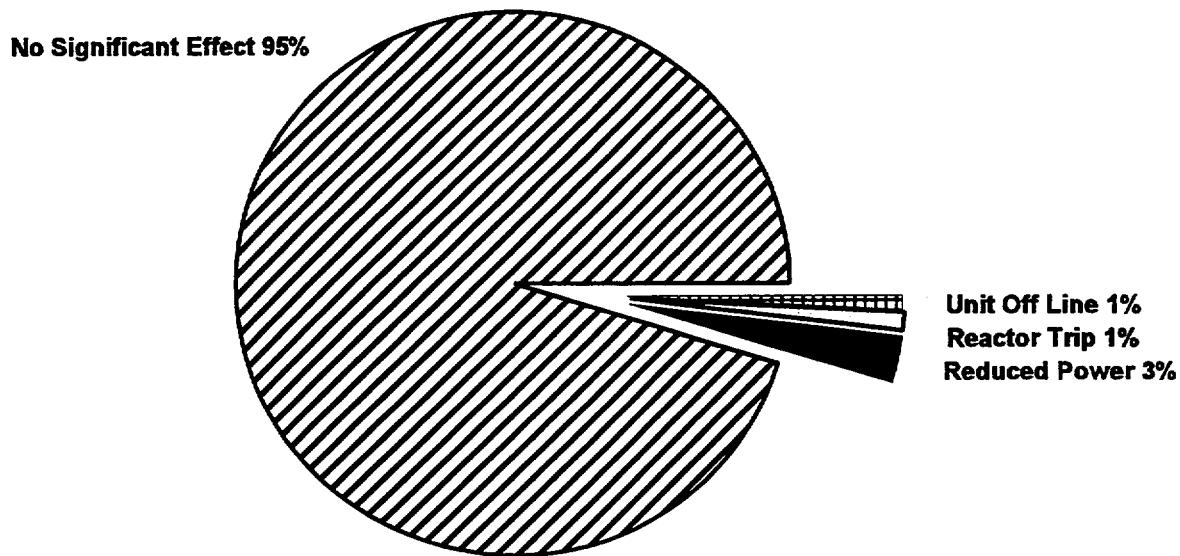
Figure 13 Effect of fuse failures on plant performance from NPRDS

The effects of fuse failures on plant performance are shown on Figure 13. In contrast to the LER data base, which by its nature involves events that have the most serious effects on nuclear plant operation, the NPRDS is a general equipment and component failure data base. Hence, most of the fuse failures reported to NPRDS resulted in "NO SIGNIFICANT EFFECT" (95%) on plant operation. Among the fuse failures reviewed, 3% resulted in "REDUCED POWER" operations, 1% resulted in a "REACTOR TRIP", and 1% resulted in the taking the "UNIT OFF LINE."

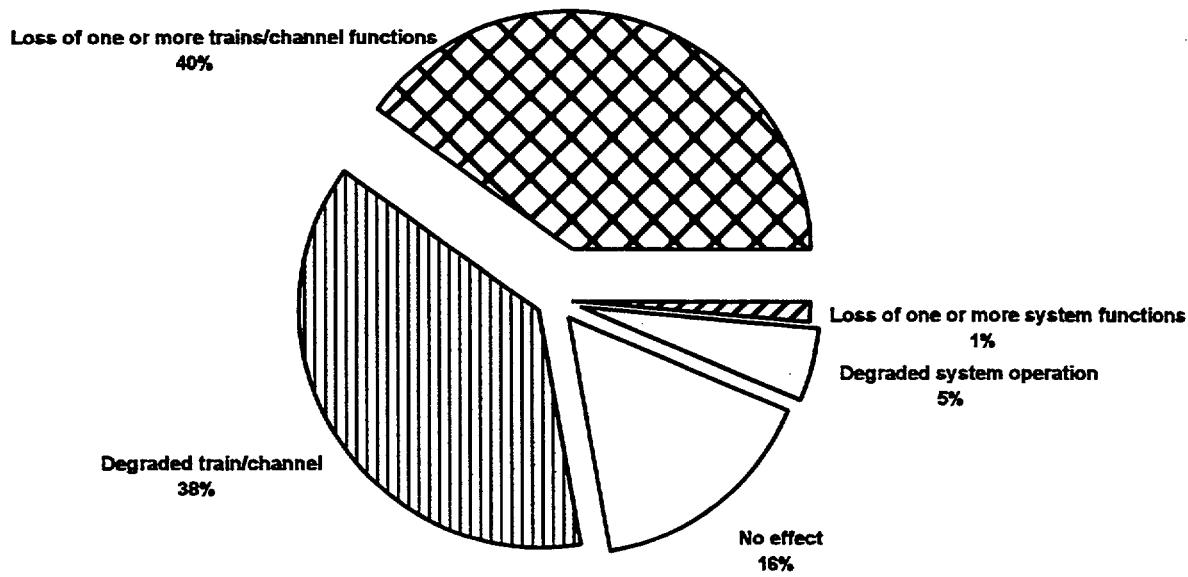
Figure 14 Effect of fuse failures on system performance from NPRDS

Another measure of the significance of fuse failures can be found by looking at the effect of a fuse failure upon the system in which it is located. This information is included as part of the NPRDS failure report and is shown on Figure 14 for fuse failures. More than three-fourths of the failures result in either "DEGRADED TRAIN/CHANNEL" (38%) or the "LOSS OF ONE OR MORE TRAINS/CHANNEL FUNCTIONS" (40%). Another 5% of the fuse failures caused "DEGRADED SYSTEM OPERATION," and the "LOSS OF ONE OR MORE SYSTEM FUNCTIONS" was reported in 1% of the failures. Finally, in 16% of the fuse failures reported to NPRDS, the plants indicated that there was "NO EFFECT" at all on the system in which the problem was found.

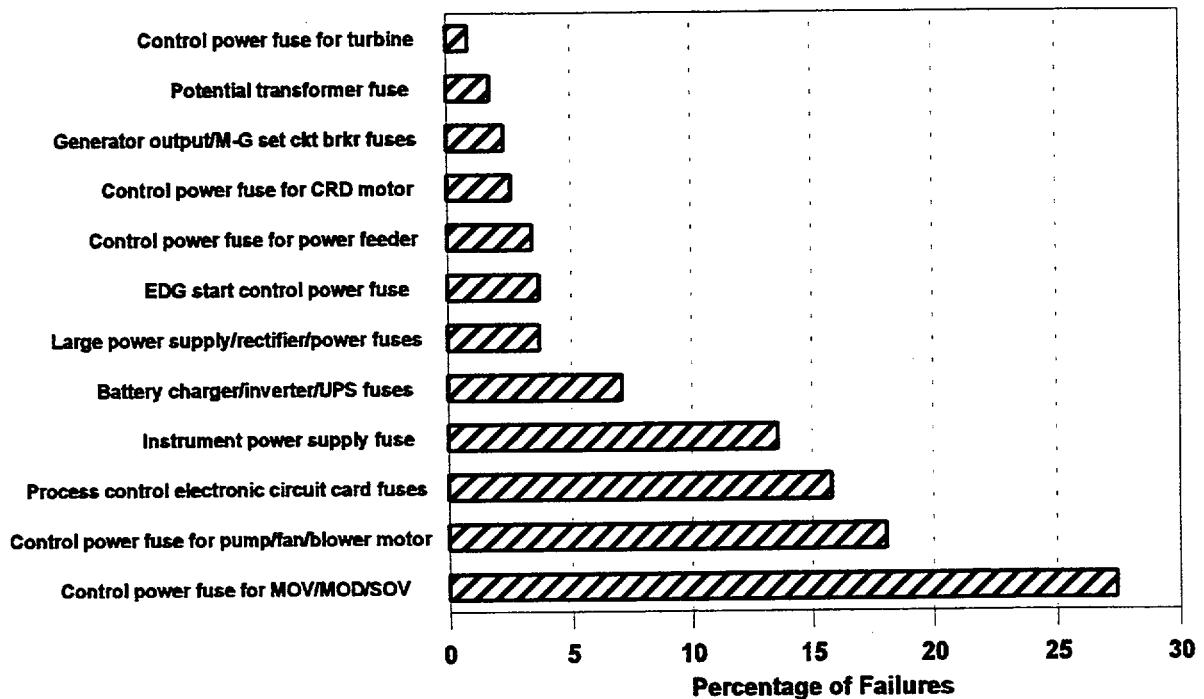
Figure 15 Distribution of applications for failed fuses reported to NPRDS

Another important piece of information found in the NPRDS data is the application in which the failed fuse assembly was being used. These data can provide insight into how fuse failures may affect plant operation and safety, and suggest approaches that may be taken to mitigate the effects of fuse failures. The fuse application data are presented in Figure 15. The most common application involved control power fuses for motor operated valves and dampers (23%) or solenoid operated valves (5%). Control power fuses for electric drive motors for pumps, fans, and blowers were involved in 18% of the failure reports. Also significant were

electronic circuit card fuses for process control circuits and systems (16%) and closely related were instrument power supply fuses (14%). Finally, a fairly large number of fuse failures occurred in large power supply/rectifier applications (4%) and in battery chargers/inverters/uninterruptible power supplies (7%). The latter application was the subject of an earlier BNL study on the operating experience and aging-seismic assessment of battery chargers and inverters (reported in NUREG/CR-4564 and NUREG/CR-5051), which included an examination of the fuse failures experienced in this equipment that were potentially the result of elevated operating temperatures.

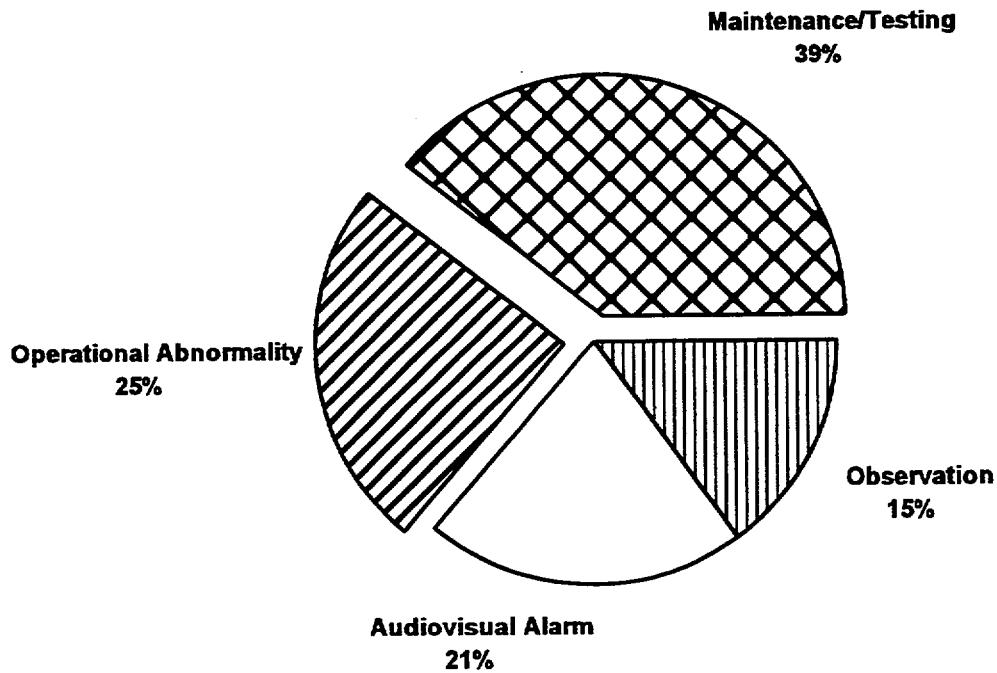
Figure 16 Fuse failure detection methods from NPRDS

The NPRDS data were also sorted to identify the predominant methods for detection of fuse failures. This information can sometimes show whether the methods and techniques being used to discover degraded or failed fuses are well-matched with the predominant failure mechanisms encountered for this component. The NPRDS failure detection data are shown on Figure 16. The greatest number of fuse failures were detected during "MAINTENANCE" and "TESTING" activities (39%) and by "OBSERVATION" (15%) by plant operating and maintenance personnel. This is significant because it reflects proactive efforts on the part of licensees to find these failures before they can cause more serious problems. Another 25% of the NPRDS failures were detected by "OPERATIONAL ABNORMALITIES." This category would include failures to operate when required, off-normal performance, loss of position

indication, or loss of control power indication. Finally, "AUDIOVISUAL ALARMS" accounted for the detection of 21% of the fuse failures. It should be noted that several NPRDS reports

mentioned that imaging infrared thermography surveys were used to identify incipient fuse and fuse holder failures. Licensees are taking advantage of this technology to detect hot spots that could indicate potential fuse assembly failures.

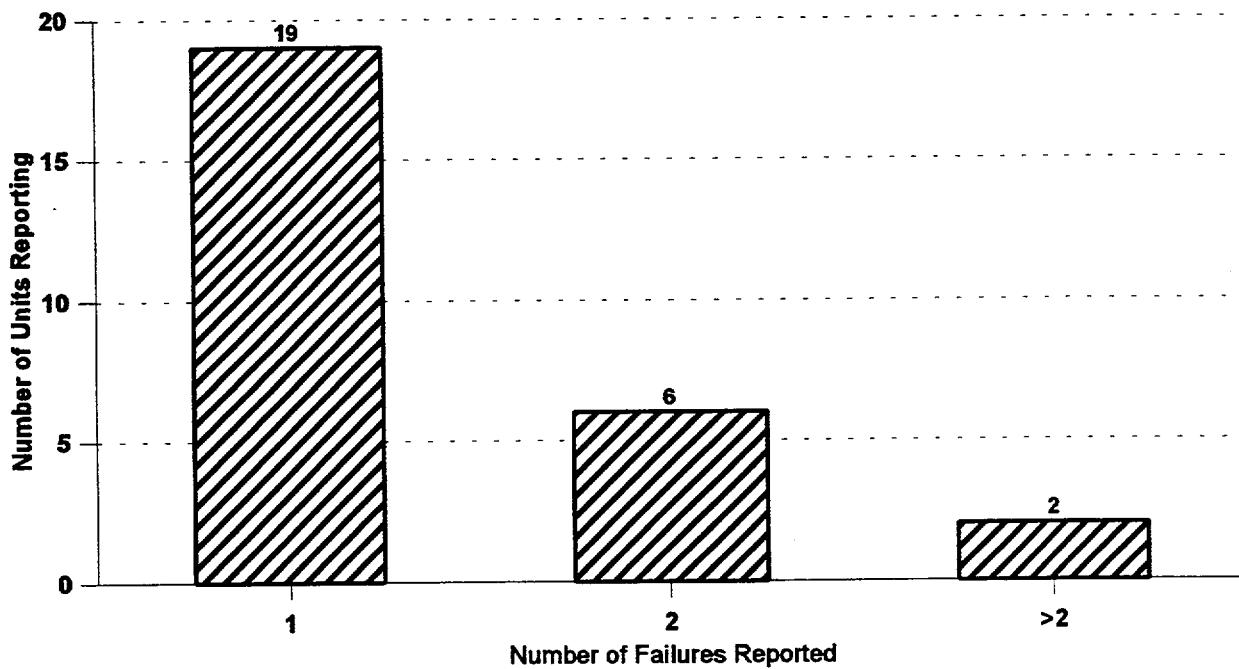
Figure 17 Distribution of age-related fuse failures per unit from EPIX

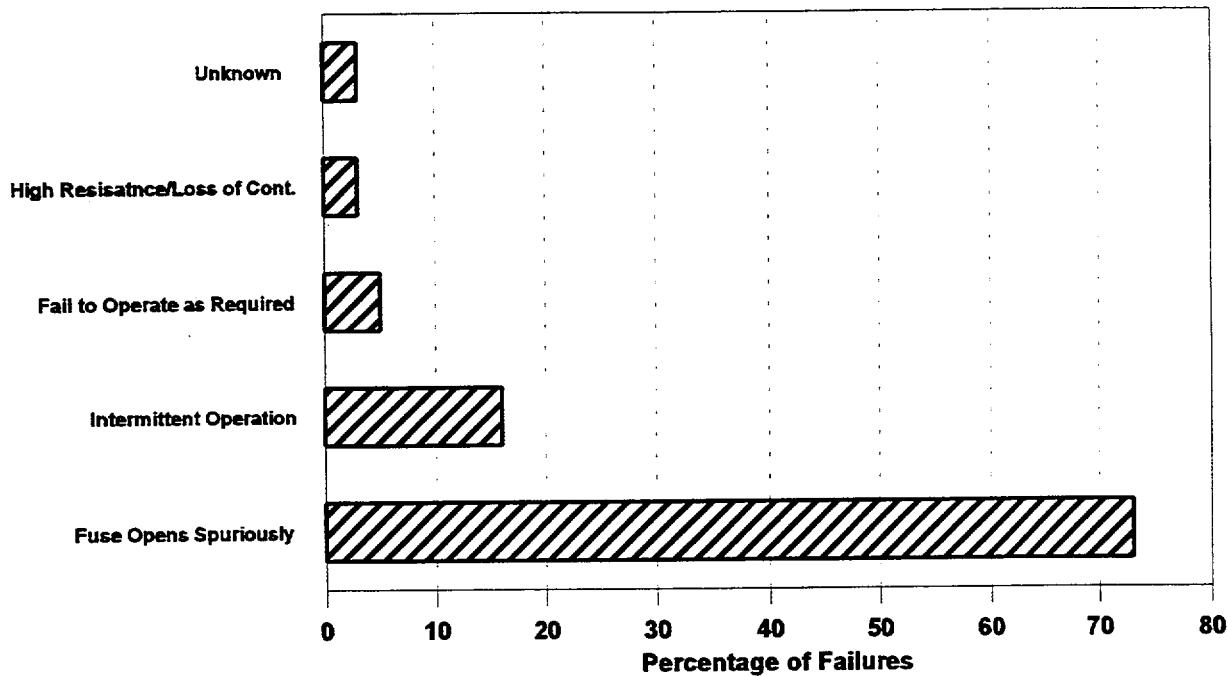
Figure 18 Distribution of fuse failure modes from EPIX

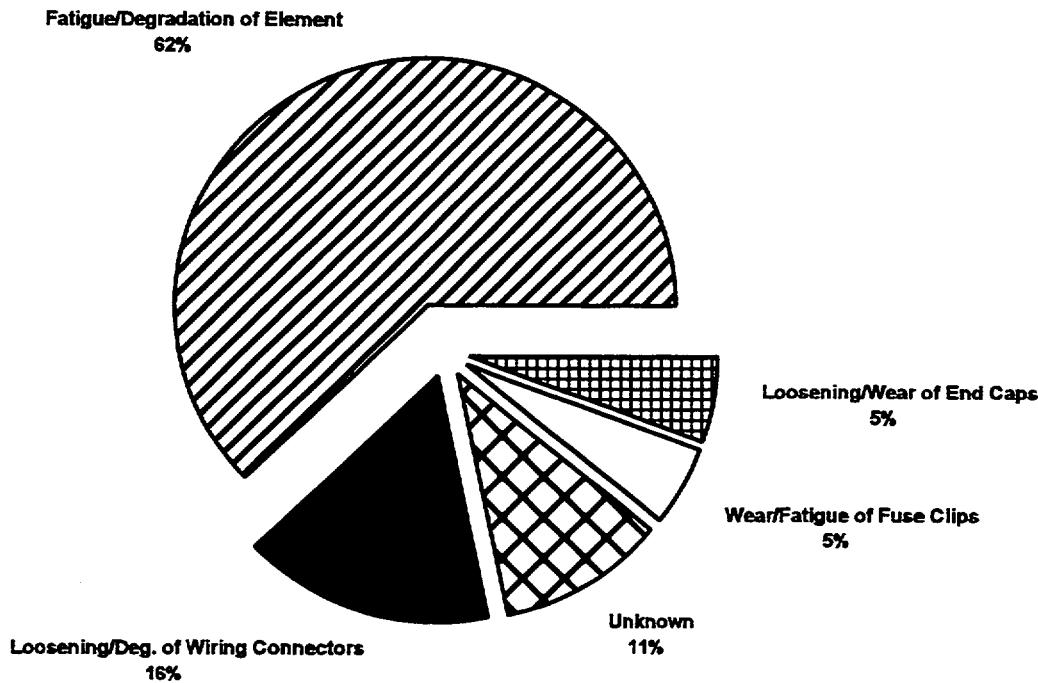
Figure 19 Fuse failure mechanisms from EPIX

The predominant fuse failure mechanism was "FATIGUE/DEGRADATION OF THE FUSIBLE ELEMENT," which accounted for 62% of the failures. This is consistent with the predominant failure mechanism found in the NPRDS data. Again, for failures attributed to aging in which no information on the failure mechanism was presented in the report, and the fuse is described as "blown," it was assumed for purposes of this evaluation that the mechanism was fatigue of the fusible element. Other less frequently found mechanisms were "LOOSENING/DEGRADATION OF THE WIRING CONNECTIONS" (16%), "MECHANICAL WEAR/FATIGUE OF FUSE HOLDER CLIPS" which caused loosening of the fuse in the fuse holder (5%), and "LOOSENING/ DEGRADATION OF THE FUSE END CAPS" (5%). These results are summarized in Figure 19.

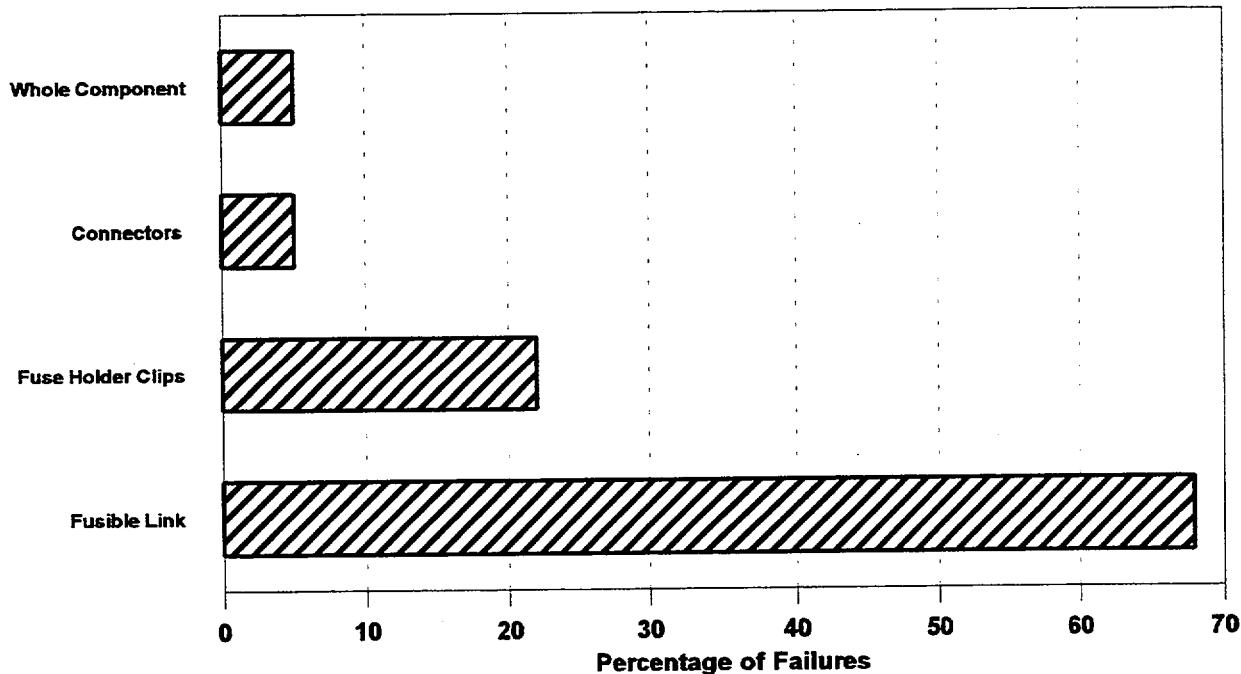
Figure 20 Distribution of fuse subcomponents failed from EPIX

In analyzing the subcomponent that failed in the fuse assembly, the “FUSIBLE LINK” is the major contributor (68% of the total failures). This is followed by the “FUSE HOLDER CLIPS” (22%), which failed as a result of fatigue, wear, and embrittlement. “CONNECTORS” failed 5% of the time and involved disconnection of the connector to the fuse holder and, in one case, fusion of the connector itself. Another 5% of the failures were attributed to the whole fuse assembly, which was deemed to be a generally faulty component. These results are summarized in Figure 20.

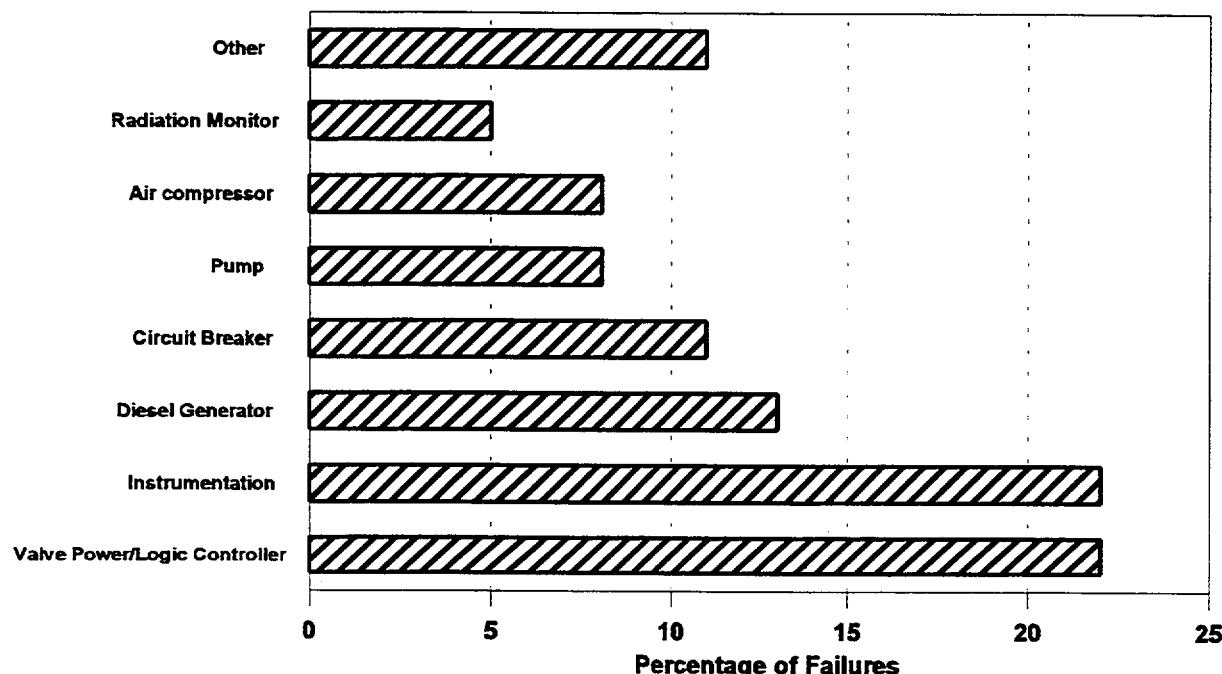
Figure 21 Distribution of applications for failed fuses from EPIX

The applications for which fuses failed by age-related mechanisms were analyzed in detail. In 22% of the EPIX listings, fuse failure resulted in the non-operability of valves. These fuses

were either in a logic controller or in a power circuit for the valve. Another 22% of the fuse failures caused failure of instrumentation circuits. The applications for the fuse failures are summarized in Figure 21.

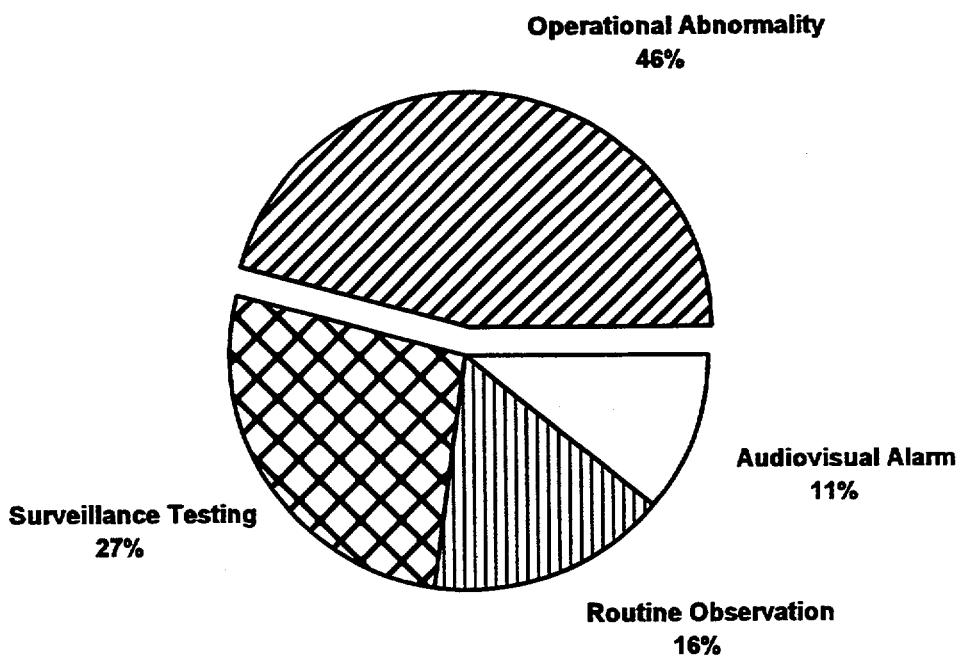
Figure 22 Fuse failure detection methods from EPIX

Figure 22 shows the fuse failure detection methods that were identified from the EPIX system data. “OPERATIONAL ABNORMALITIES” detected 46% of the fuse failures, and a large fraction of failures were detected by “SURVEILLANCE TESTING” (27%). “ROUTINE OBSERVATION” (16%) and “AUDIOVISUAL ALARMS” (11%) were the remaining detection methods.

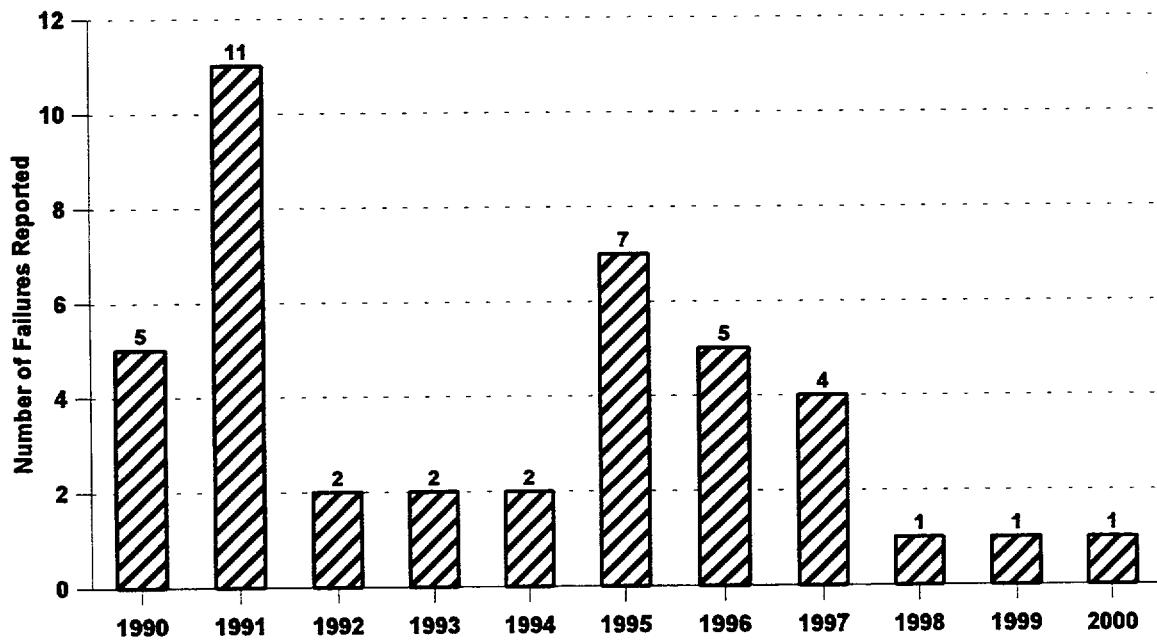
Figure 23 Number of age-related fuse failures reported per year as LERs

The LER data were sorted to obtain fuse failures per year over the past ten years. If the number of fuse failures per year was increasing, this could indicate a potential problem with management of fuse aging. However, the results presented in Figure 23 show no discernible trend in the number of reported fuse failures. The relatively large number of fuse failures reported in 1991 is followed by a decline in 1992. This could reflect the increased attention to fuse control programs suggested in NRC Information Notice 91-51. At that time, a number of

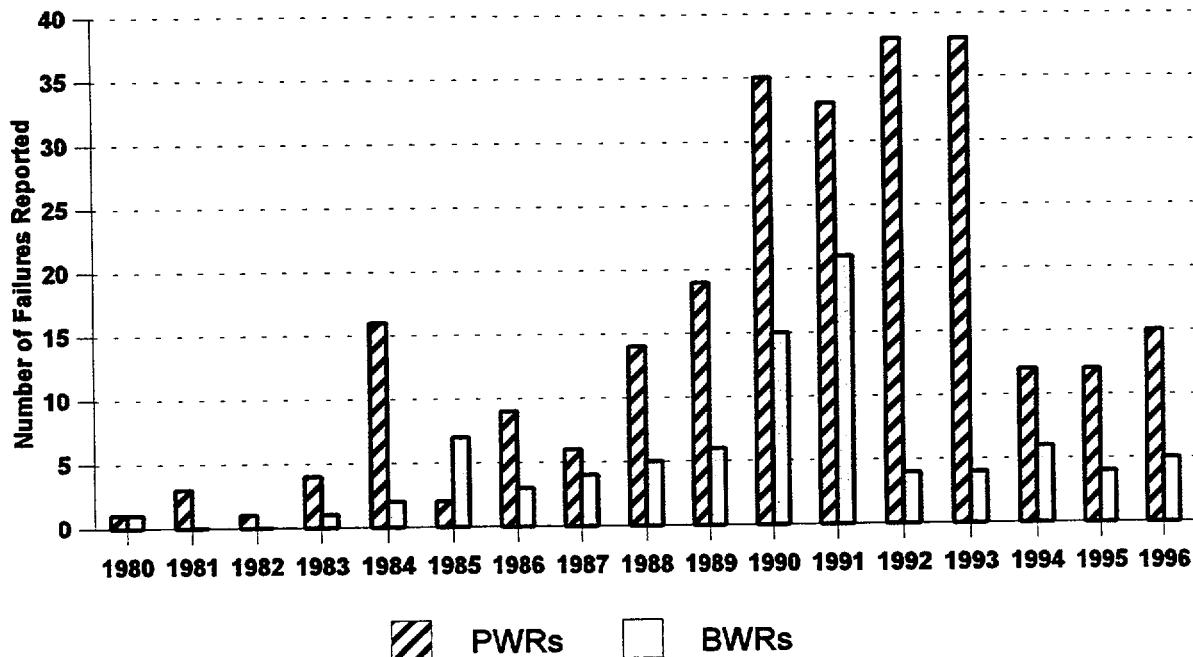
Figure 24 Number of age-related fuse failures reported per year to NPPRDS

Figure 24 also shows a large number of fuse failures reported at PWRs in 1992 and 1993, and generally, after that time, a greater number of fuse failures than for BWRs. Since the total quantity of fuse failures reported in any given year would depend on the number of nuclear units that were operating during that year, the data were normalized by dividing the annual failure totals by the number of operating nuclear units in each year. The resulting plot of fuse failures per unit year showed that the rate of age-related fuse failures was nearly the same for BWRs and PWRs throughout the period except for the years 1991 and 1992, where the rate was more than double for PWRs. To examine this more closely, the data for PWRs was sorted by nuclear steam supply system (NSSS) vendor, and normalized by dividing the annual totals by the number of operating nuclear units in each year. The results of this analysis are presented in Figure 25.

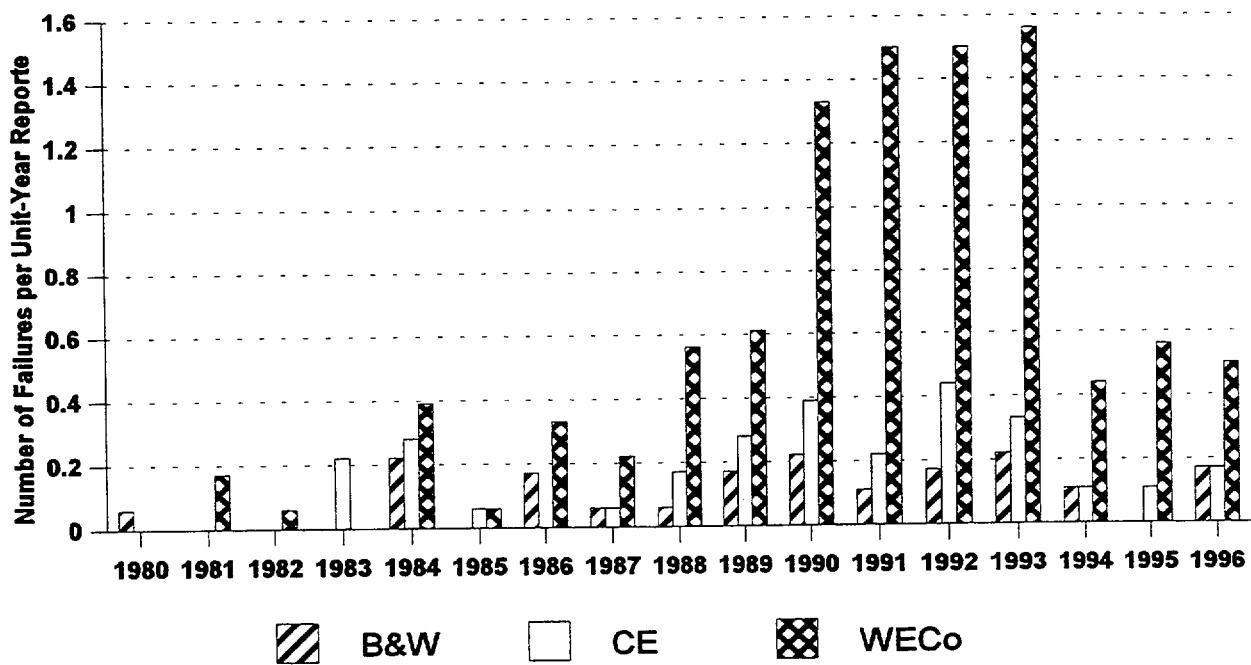
Figure 25 Number of age-related fuse failures per unit-year for PWRs reported to NPPRDS

Figure 25 indicates that Westinghouse (WECO) PWRs had a higher rate of age-related fuse failures per unit year than the Combustion Engineering (CE) and Babcock & Wilcox (B&W) reactors throughout the period shown. During the years 1990 through 1993, the rate for Westinghouse reactors was more than four times that reported at the CE and B&W PWRs. Some of this difference may be attributed to the heightened awareness for fuse maintenance and inspection following IN 91-51 on fuse control programs. More likely, problems with incorrectly sized fuses in Westinghouse System 7300 printed circuit cards, as reported in NRC IN 93-87, contributed to the higher rate of age-related fuse failures per unit year. This is supported by the data which show that more than one third of the fuse failures reported in the years 1991-93 were in applications involving the process control system circuit cards or their power supply cards. From 1994 on, the number of failures per unit year for the Westinghouse plants dropped dramatically, however it still remained higher than for the CE and B&W units.
