Aging Assessment of Safety-Related Fuses Used in Low- and Medium-Voltage Applications in Nuclear Power Plants

Brookhaven National Laboratory

Manuscript Completed: January 2002
Date Published: March 2002

Prepared by
R. Lofaro, M. Villaran

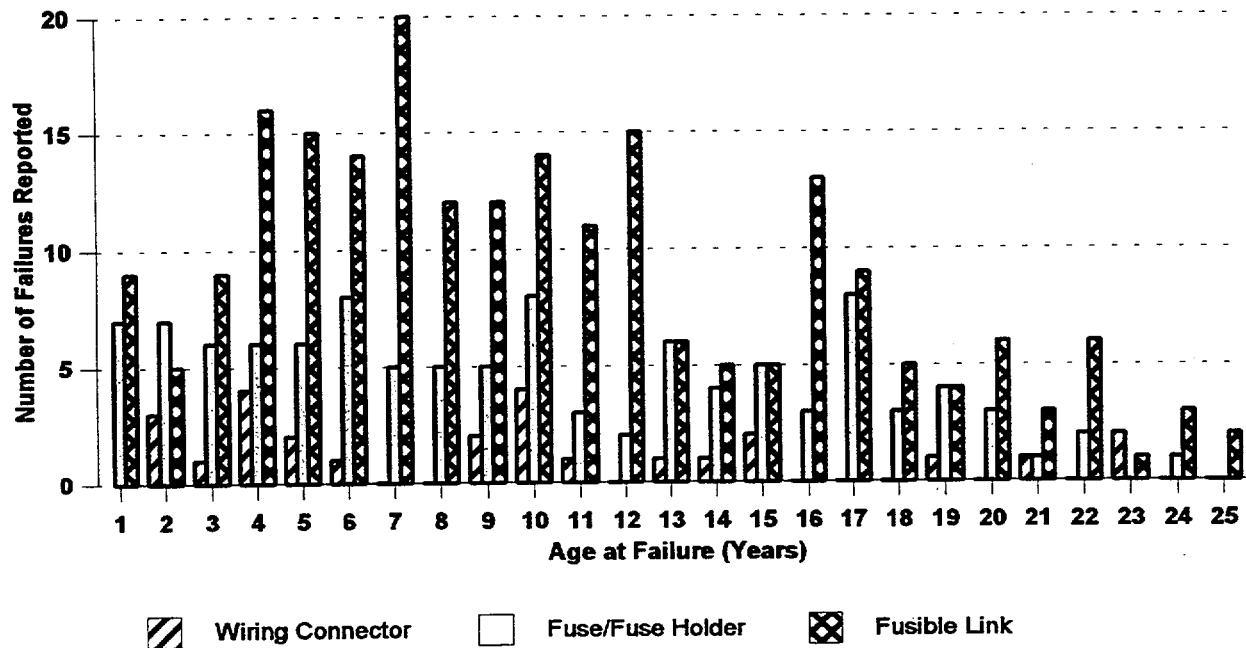
Figure 26 Number of age-related fuse failures grouped by major subcomponent reported to NPRDS

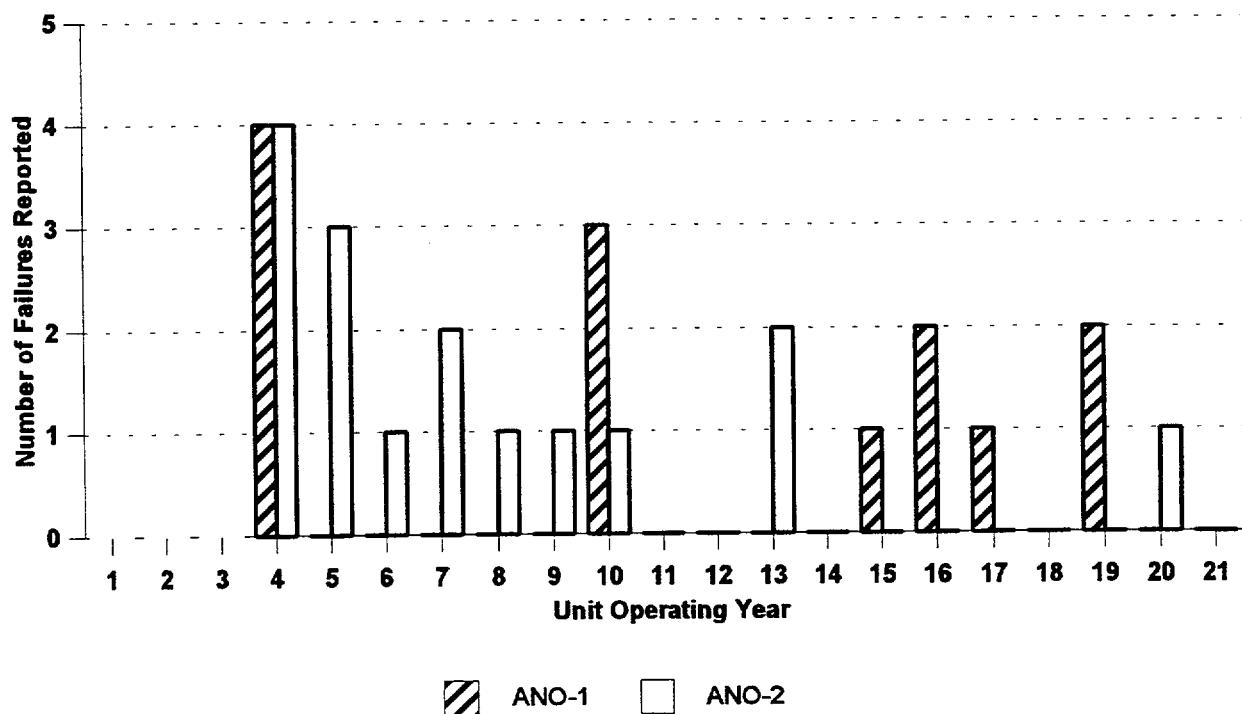
Figure 27 Age-related fuse failures at ANO 1 & 2 grouped by unit year - NPRDS & EPIX

Another approach to searching for trends in the fuse failures data base was to look at all of the failures for a particular plant over an extended period of time. This was done for the Arkansas Nuclear One (ANO) plant for the period from 1980 through 1996 using the NPRDS database, and from 1997 to 2000 using the EPIX database. Since there are two nuclear units at this plant, a greater population of fuses could be examined in which the policies and procedures with regard to fuses would be similar. This review included nine age-related failures from ANO Unit 1 (out of 29 NPRDS reports reviewed), 15 age-related failures from ANO Unit 2 (out of 23 NPRDS reports reviewed), and one age-related failure from each unit from the EPIX data base. The age-related failures from the NPRDS and EPIX reviews were then grouped by the unit year of commercial operation (rather than by calendar year) in order to place the data from the two nuclear units on a comparable time scale. These resulting groupings are plotted on Figure 27.

From Figure 27 it can be seen that most of the failures for ANO Unit 2 occurred during the early years of the plant operation, during the fourth through the tenth years of operation. There were four age-related fuse failures at ANO Unit 2, occurring in four different systems, in the fourth year of operation. As seen in the figure, the number of failures at Unit 2 per unit year decreased over the next few years to the point where only sporadic fuse problems were reported after the tenth year of operation. One fuse failure in the fifth year of operation at Unit 2 occurred in a control power fuse to a control element assembly (reactor control rod drive) and resulted in a reactor trip.

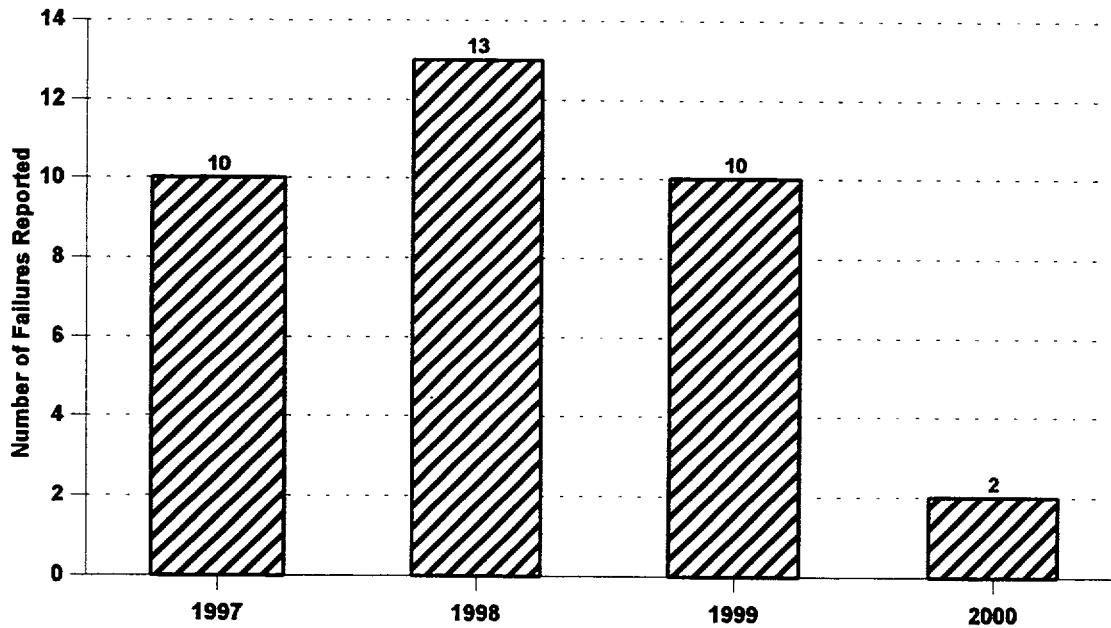
Figure 28 Number of age-related fuse failures reported per year to EPIX

Fuse failures by year, as reported to the EPIX system are given in Figure 28. Since the EPIX system was initiated in 1997 to replace the NPRDS database, it contained only four years of operating experience. Therefore, extracting insights by trending this data is somewhat uncertain at the time this analysis was performed. Nevertheless, the data were evaluated for completeness. As shown, in the years 1997, 1998, and 1999, the number of age-related fuse failures was relatively constant, and no discernable trends are evident. In the year 2000, only two fuse failures occurred, which may be due to incomplete data entry into the database at the time of this study. The current year 2001 is not included in this evaluation since it is a partial year.

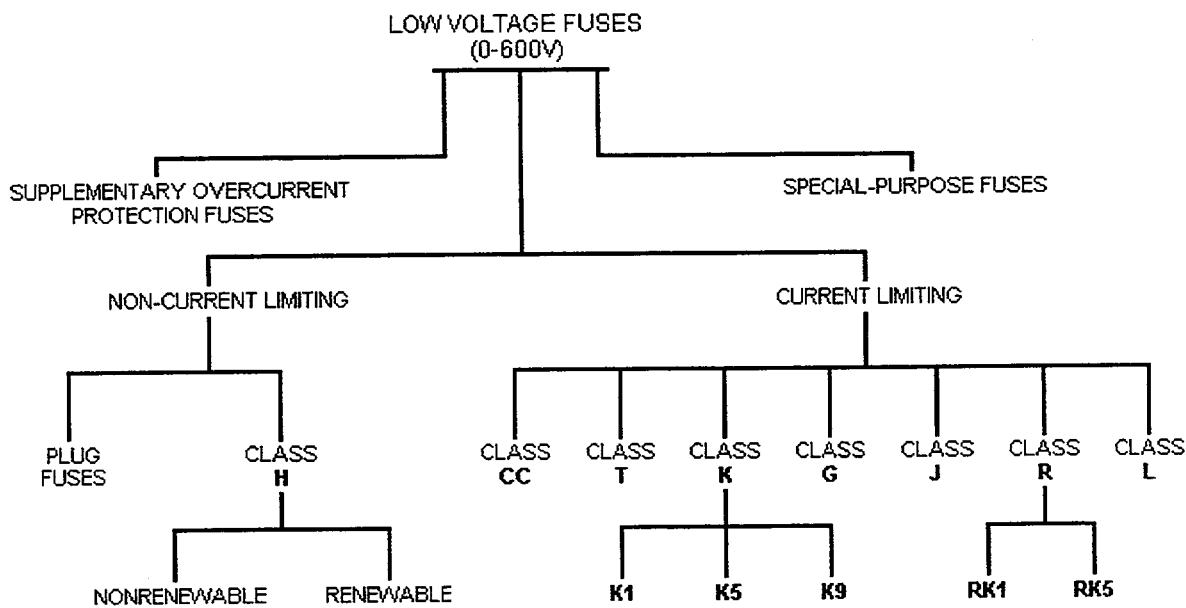
Figure A-1 Underwriters Laboratories, Inc. fuse classifications

The National Electrical Manufacturers Association (NEMA) and the Underwriters Laboratories (UL) have set standards that govern the manufacture, performance, size, and testing of fuses. Most fuse types are labeled and identified by their UL classification which are summarized in Figure A-1. The most common classes of fuses for nuclear power plant applications are discussed in the following paragraphs.
