## **NUCLEAR REGULATORY COMMISSION**

Title:               ACRS Plant Operations and Fire Protection  
                          Subcommittee

Date:                July 24, 2014

# Davis-Besse Steam Generator Replacement Inspection

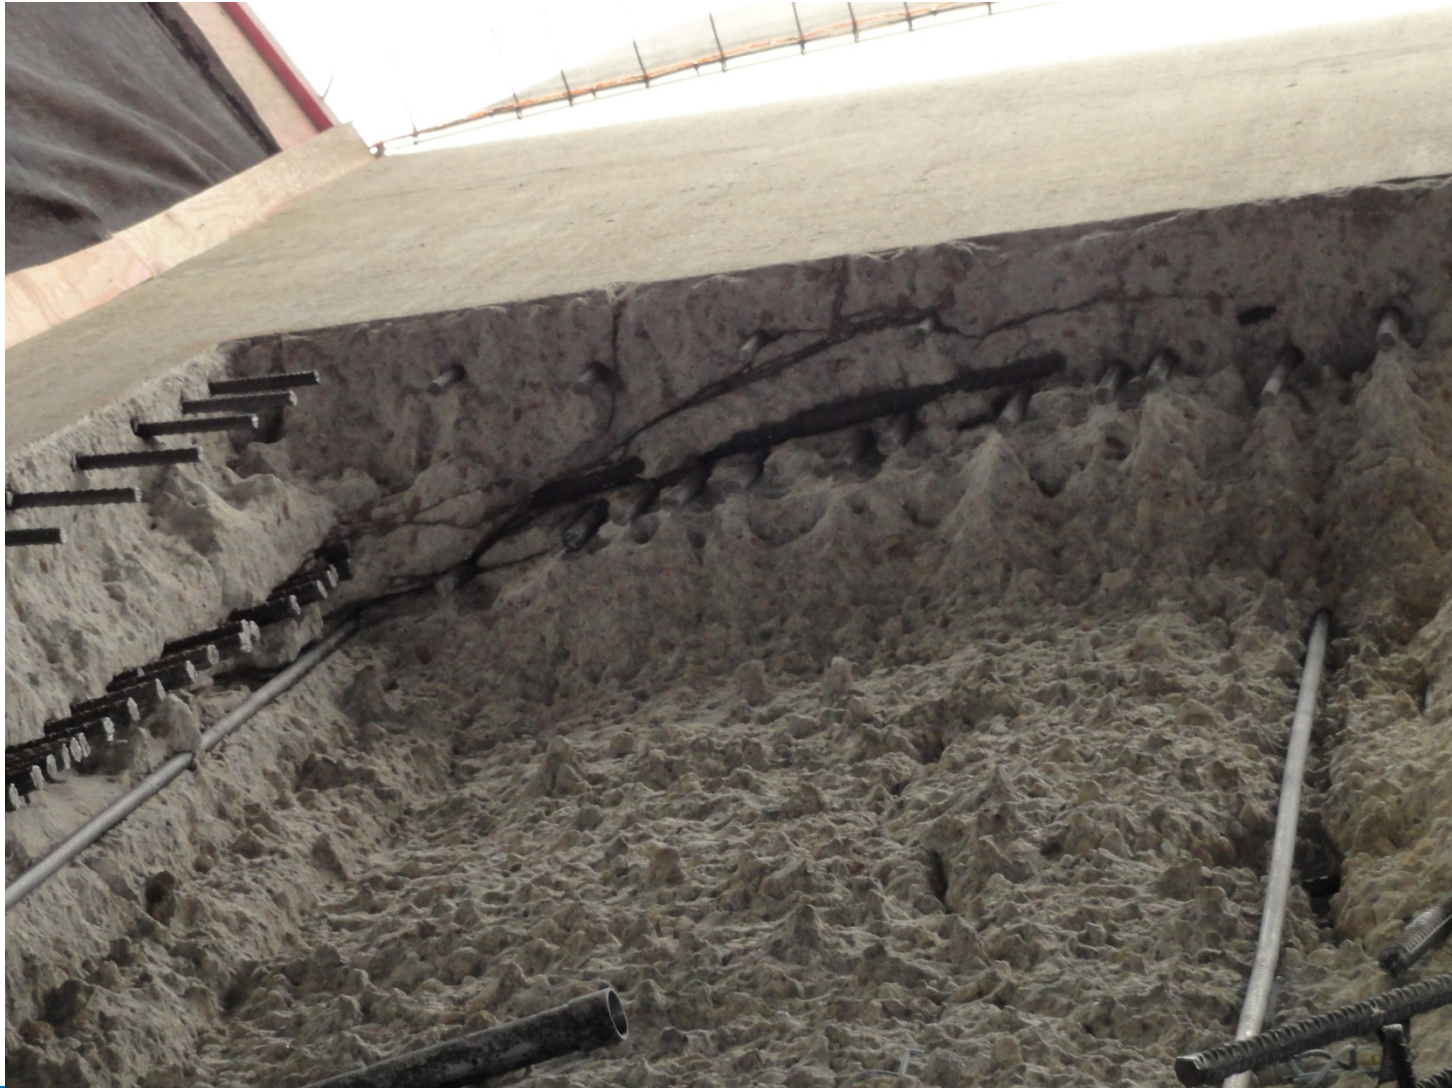
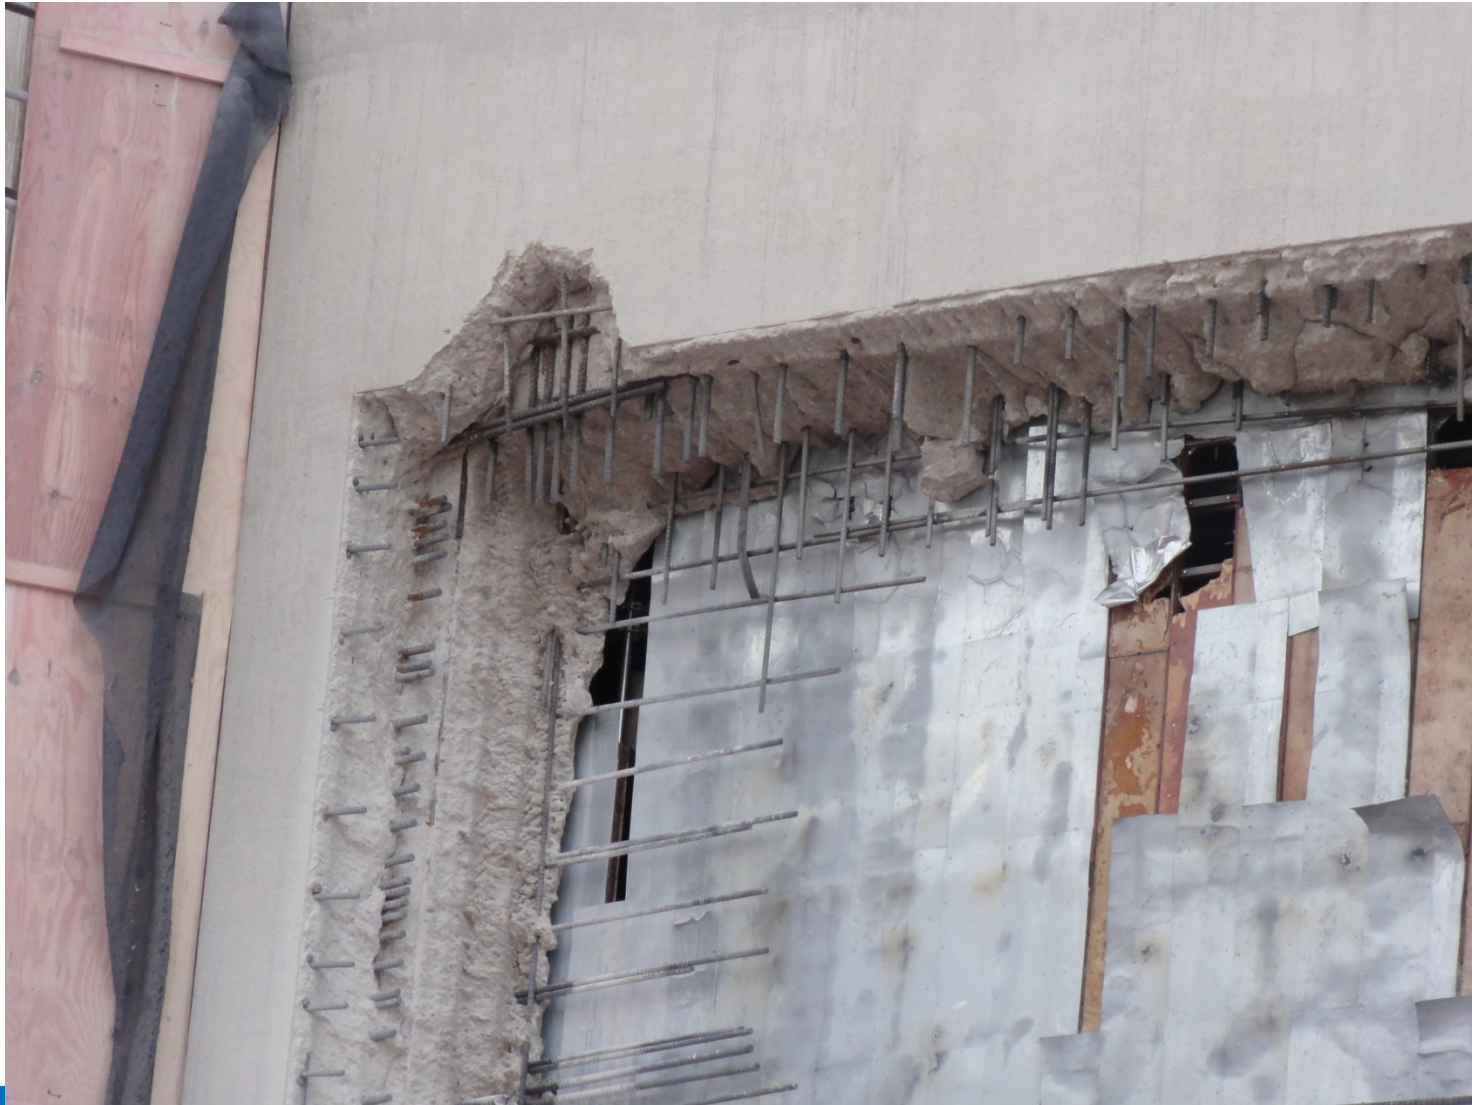
# SB Laminar Cracking

- Rebar spacing  $\leq 6''$  contributed to crack propagation outside shoulder region

- Monitor Existing Core Bores for Crack Growth
