# **Presentation to the Commission**

## **Summer Units 2 and 3 COL Application Review**

### **Safety Evaluation Report Panel 2**

October 12, 2011

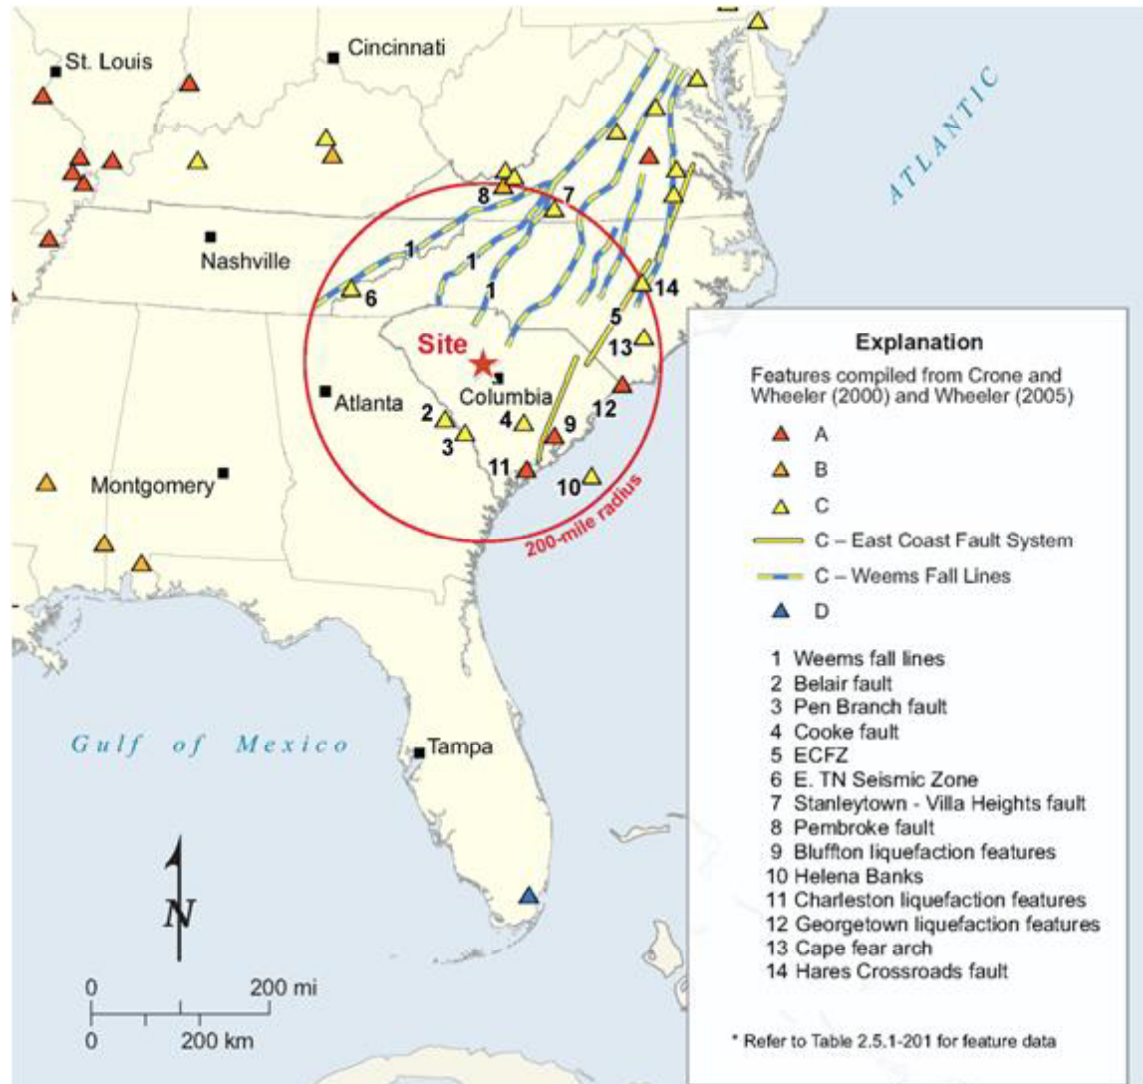
Potential Quaternary Features in the VCSNS Site Region (AFSER Figure 2.5.1-2 after FSAR Figure 2.5.1-215)

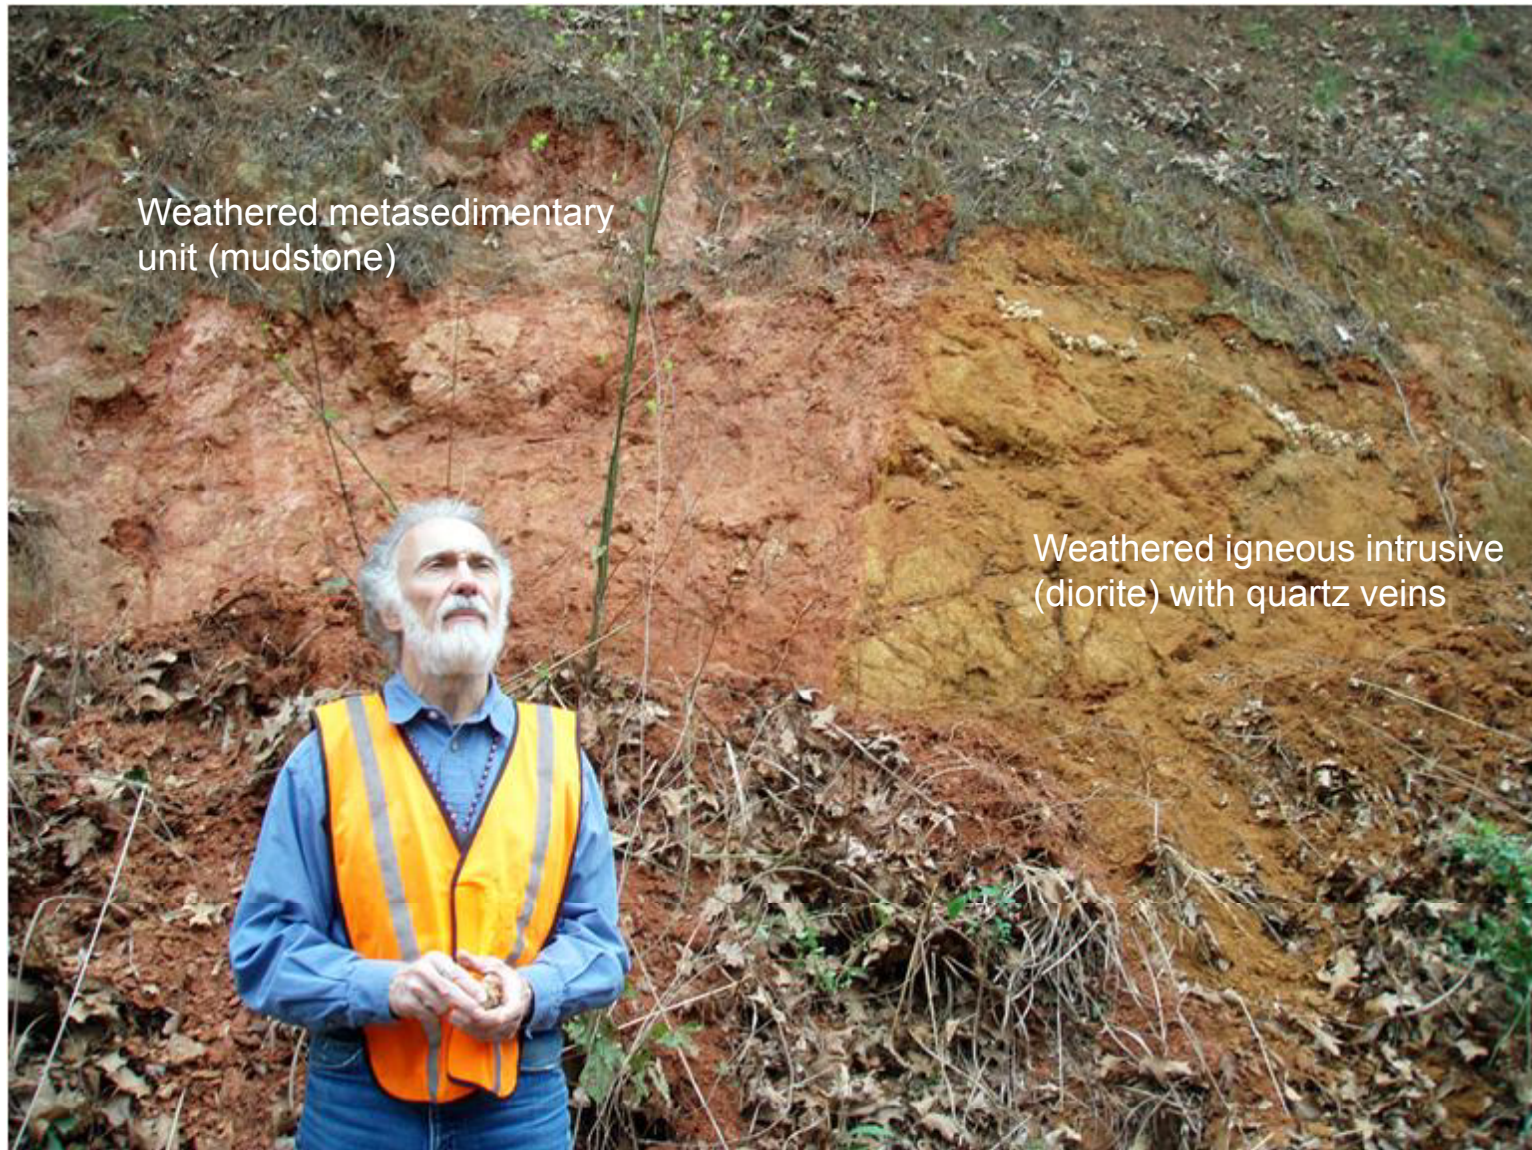
Exposure of the Wateree Creek fault (206-144 Ma in age), located 3 km (2 mi) south of the VCSNS site

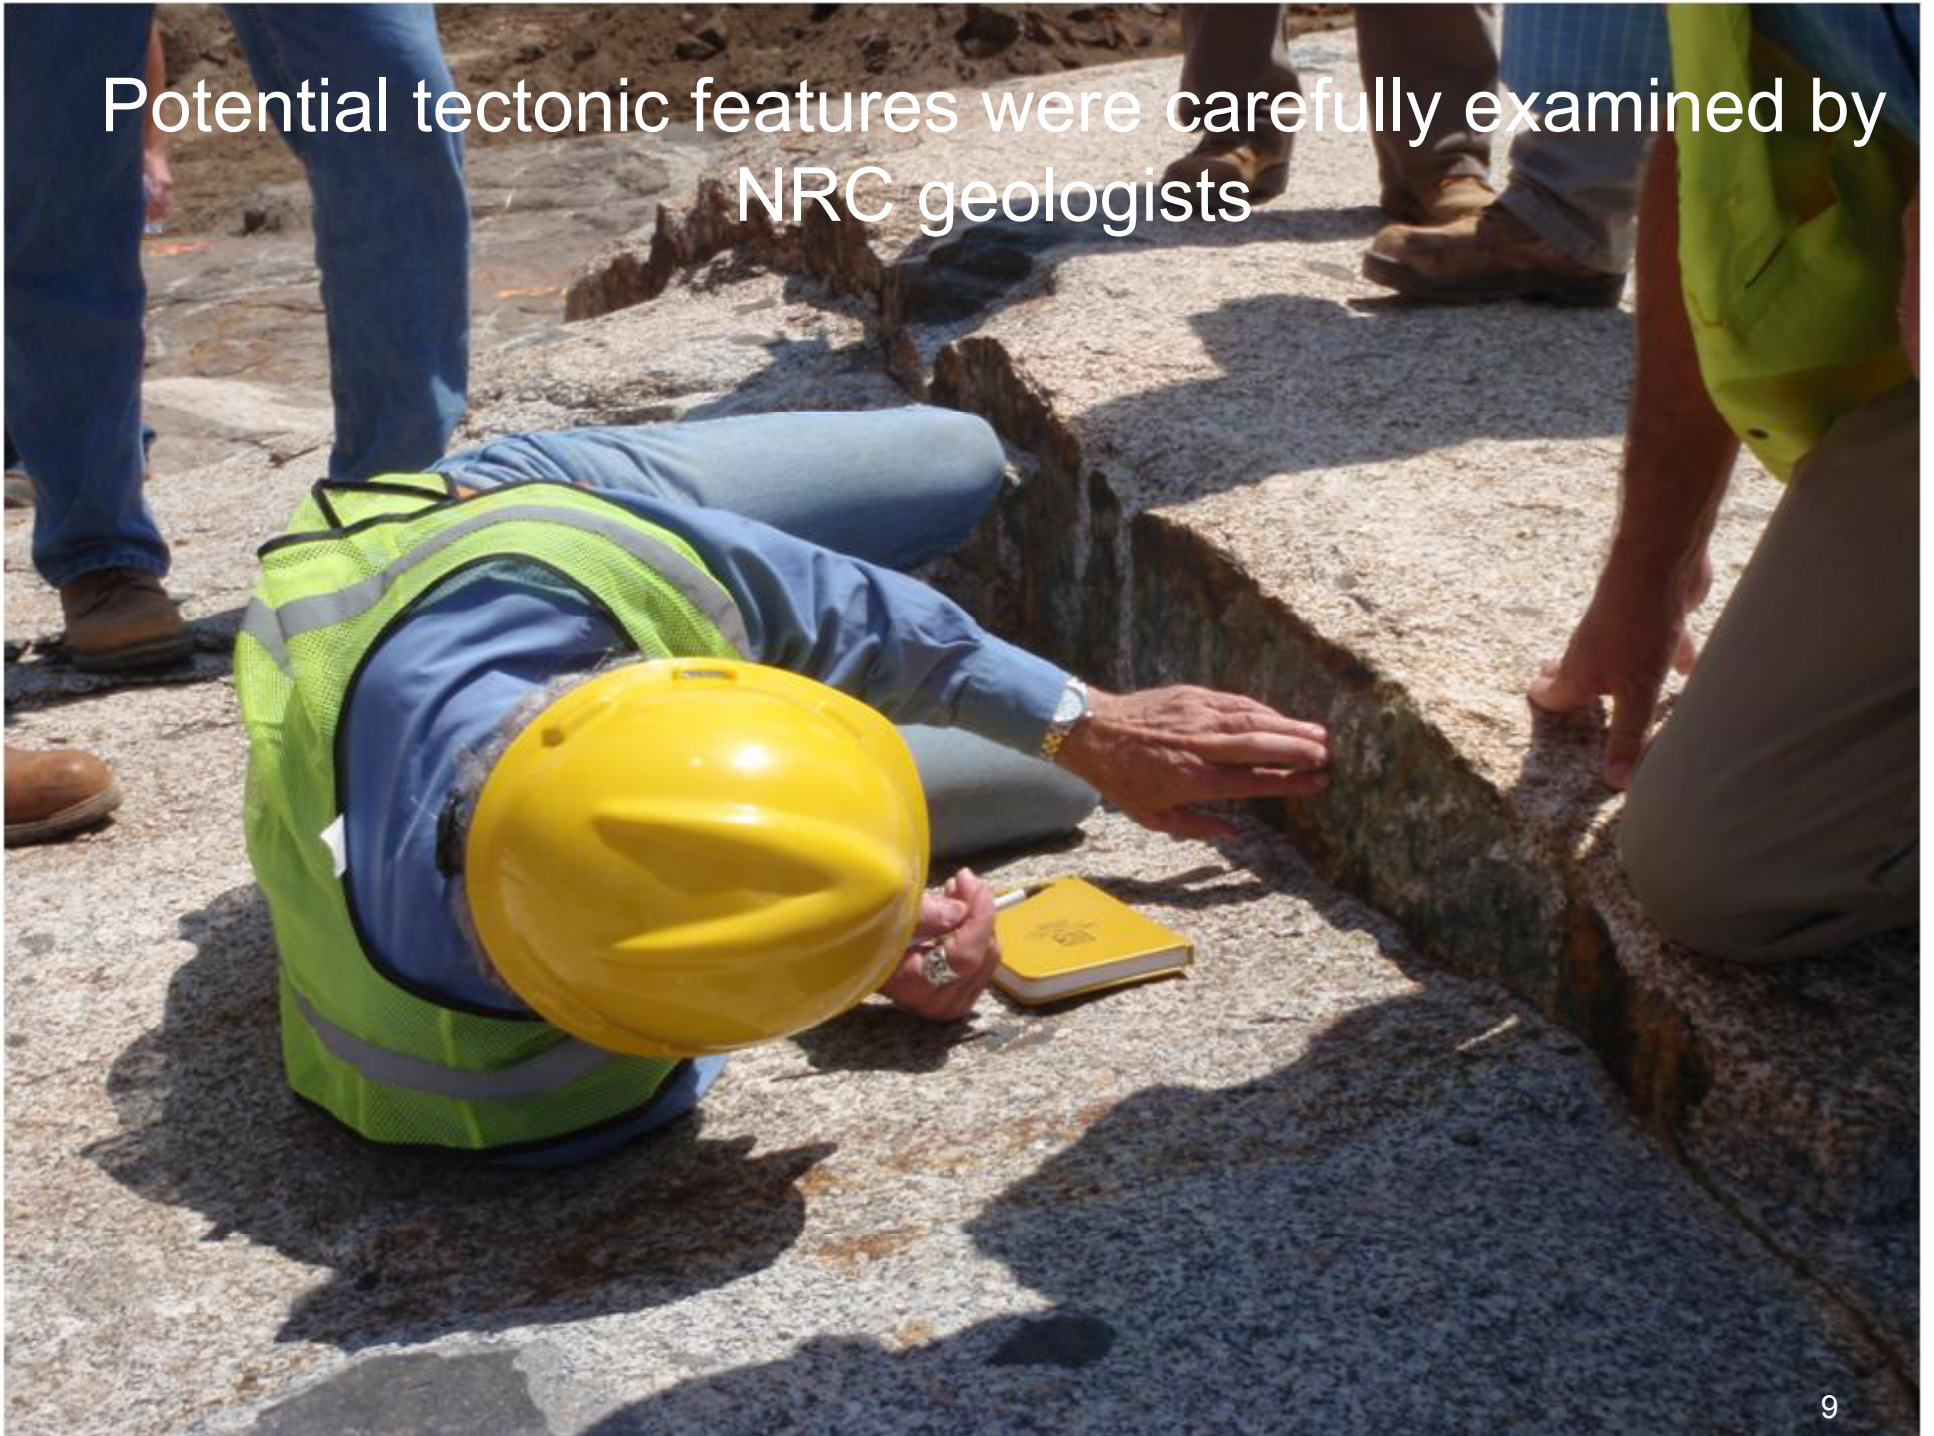
Potential tectonic features were carefully examined by NRC geologists

- **Geologic mapping of the Unit 2 excavation to assess the presence of tectonic features**
  - In August 2010 and April 2011, the staff directly examined geologic features being mapped by the applicant in the Unit 2 excavation to ensure that no capable tectonic structures existed therein.
  - Based on direct examination the staff found the FSAR descriptions of the geology to be consistent with field observations and that no capable tectonic structures, or other potentially detrimental geologic features, occur in the Unit 2 excavation
  - On the basis of these trips, a geologic mapping license condition is unnecessary for Summer Unit 2
  - The staff proposes including the geologic mapping license condition for Summer Unit 3 pending the staff's observations of the Unit 3 excavation
