5.0 SUMP POOL DEBRIS TRANSPORT

5.1 Overview of Mechanics

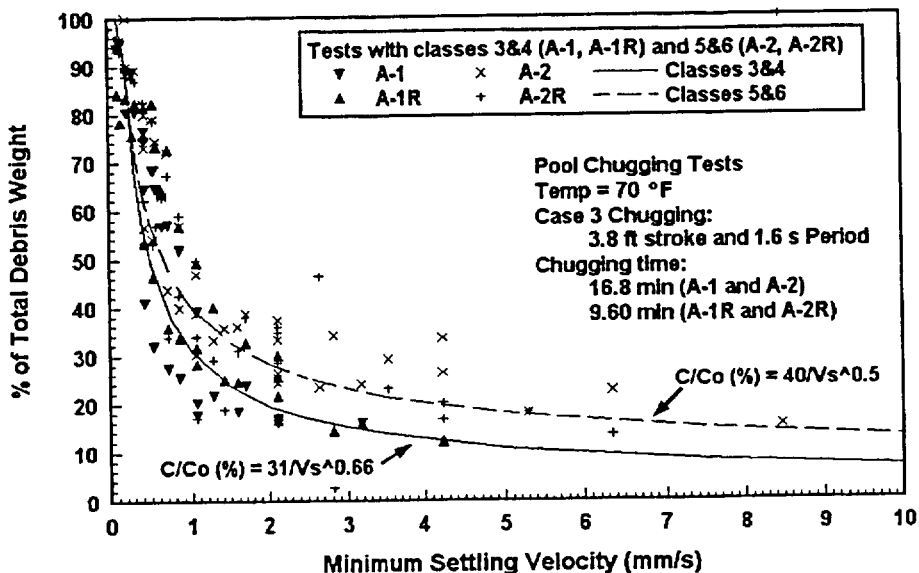
Figure 5-3 Fibrous Debris Terminal Settling Velocities

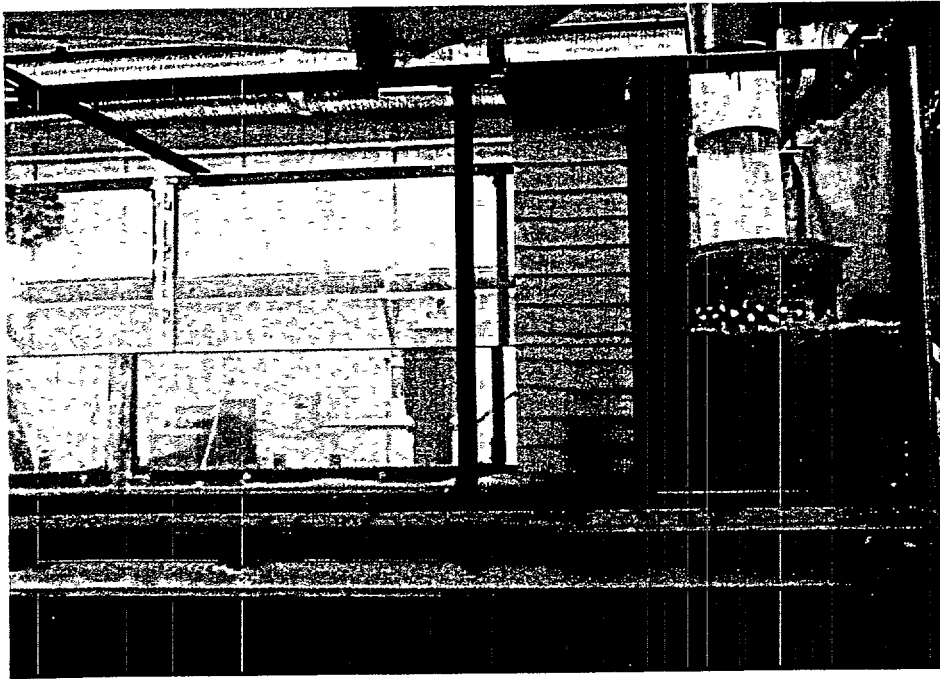
Figure 5-7 Photo of Large UNM Flume Inlet Flow Conditioning Apparatus

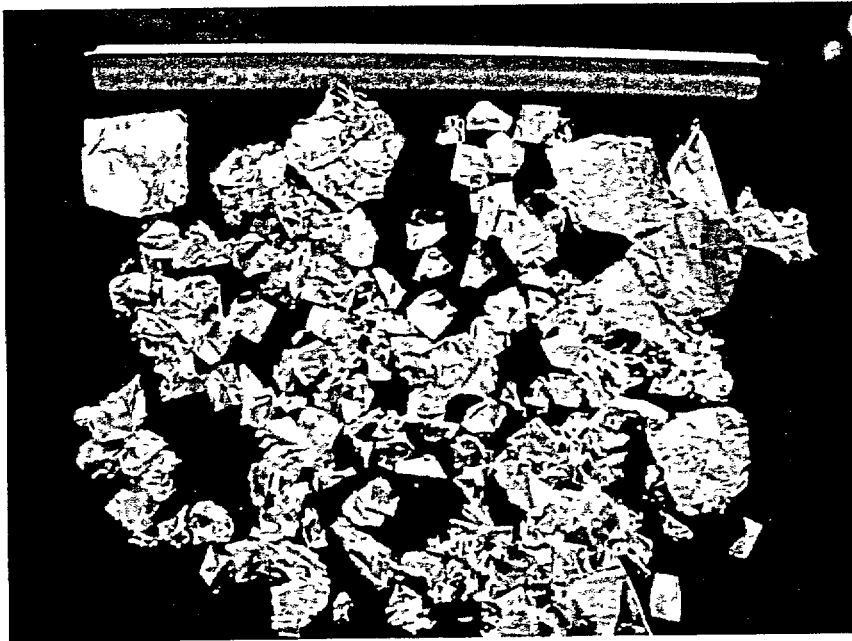
Figure 5-9 Typical Test Sample of Aluminum RMI Insulation Debris

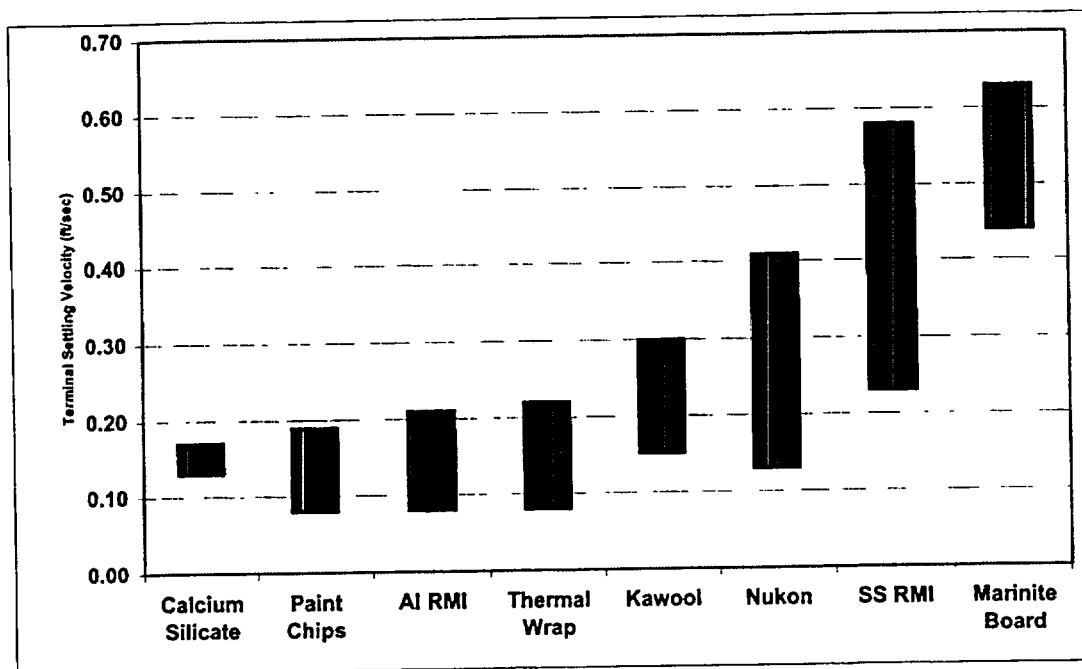
Figure 5-11 Comparison of Terminal Settling Velocities

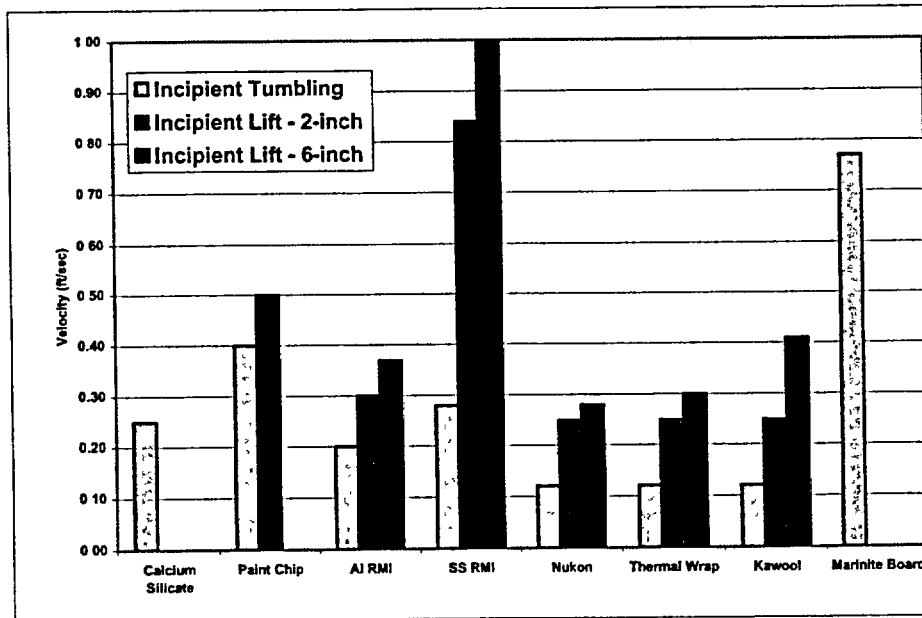
Figure 5-13 Comparison of Incipient Lift Velocities to Incipient Tumbling Velocities

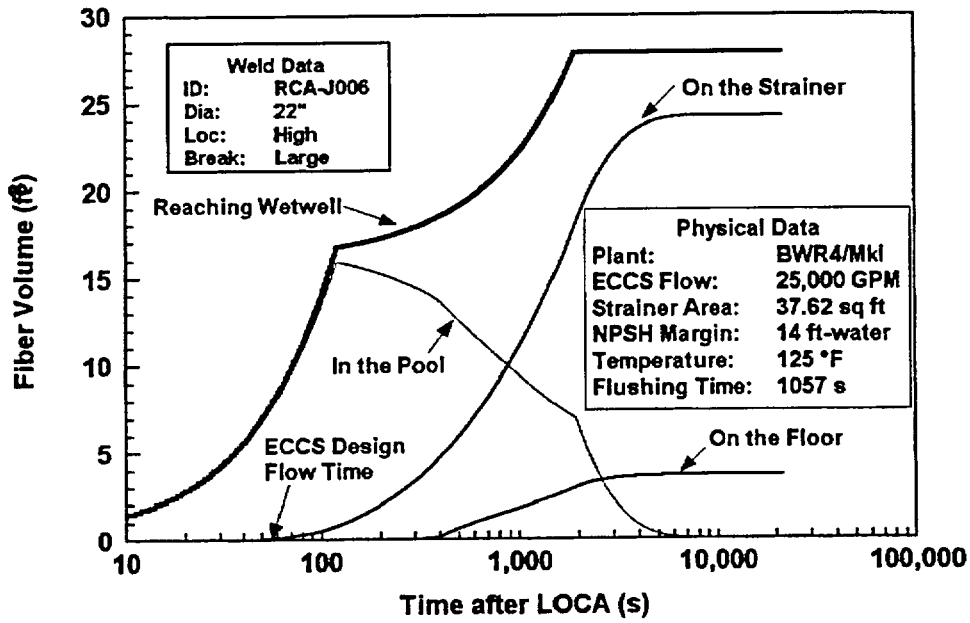
Figure 5-22 Typical Fibrous Debris Transport in the Suppression Pool

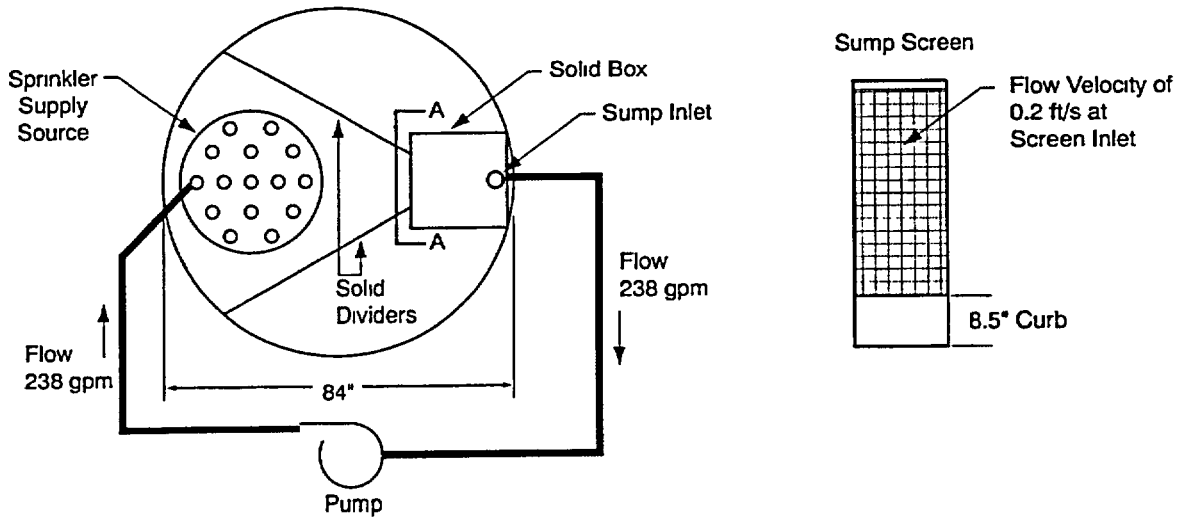
Figure 5-23 Configuration of Millstone-2 Debris-Transport Experiment

The debris-transport experiments employed a downsized representation of the Millstone-2 containment floor and sump complete with a sample sump screen and a physically representative curb. Figure 5-23 shows the experimental configuration. The experiments were conducted in a walled-off sector of a 1300-gal. cylindrical tank.

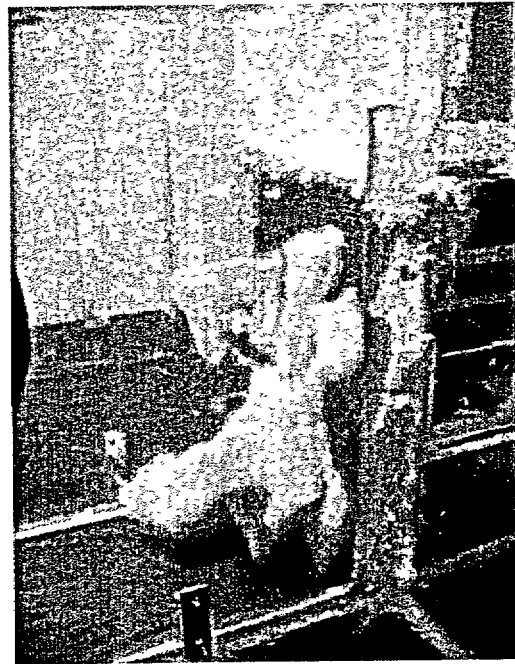
Figure 6-4 Photographs of Debris Accumulation on a 1-ft x 1-ft Vertical Screen in a Large Linear Flume [Ref. 6.3] (The photo shown in each frame corresponds to accumulation pattern shown in the same frame of Figure 6-3.)

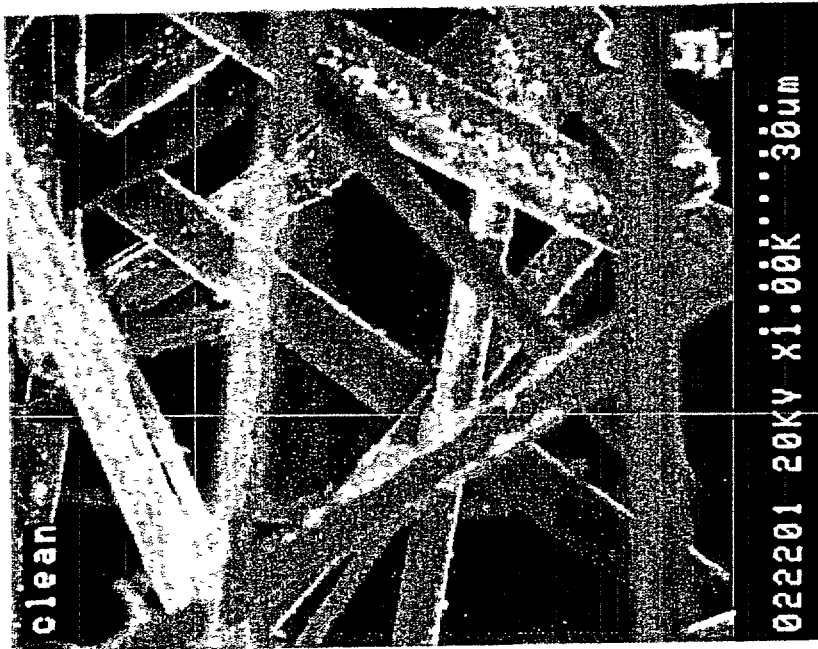
Figure 7-1(a) High-Resolution Scanning Electron Microscope Image of Fibrous Debris

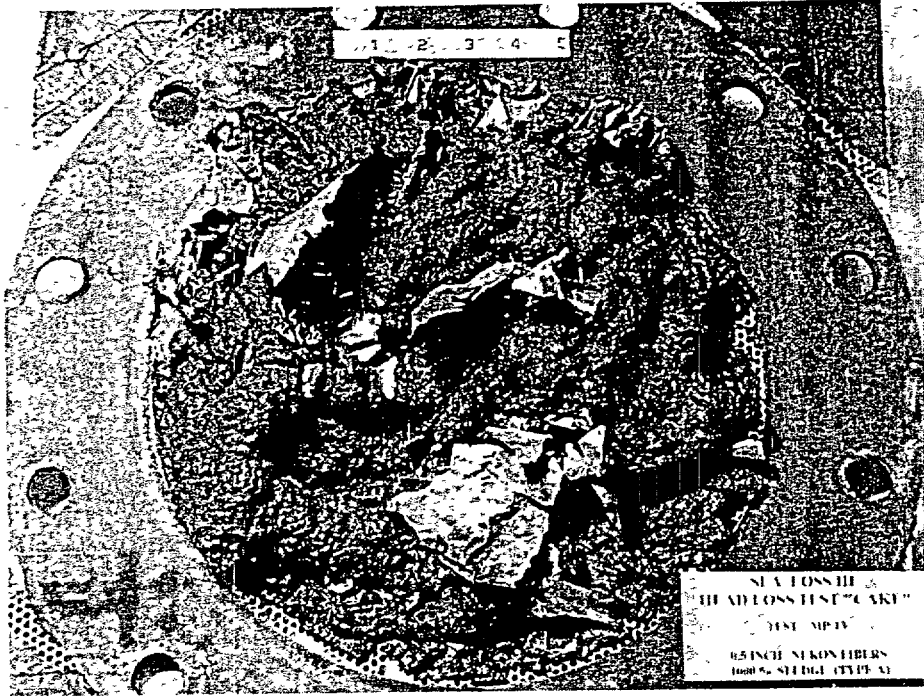
Figure 7-4(a) RMI/Fiber/Sludge Post Head Loss Test Debris Bed

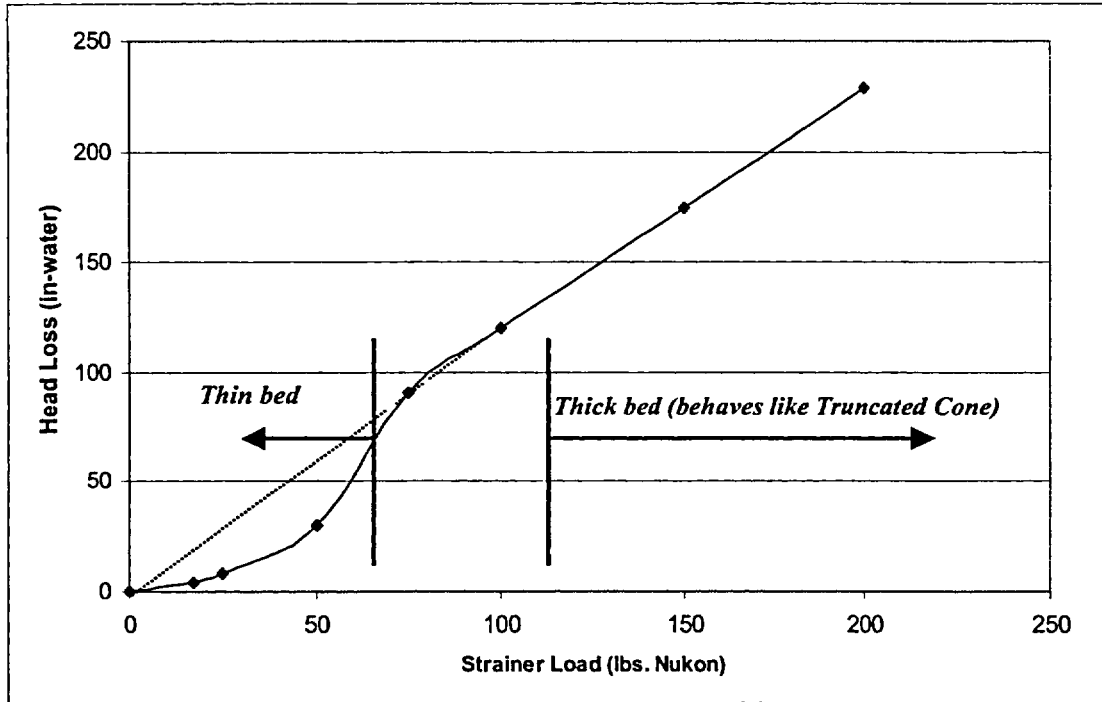
Figure 7-12 Measured Head Loss as Function of Strainer Debris Loading for Specialty Strainers

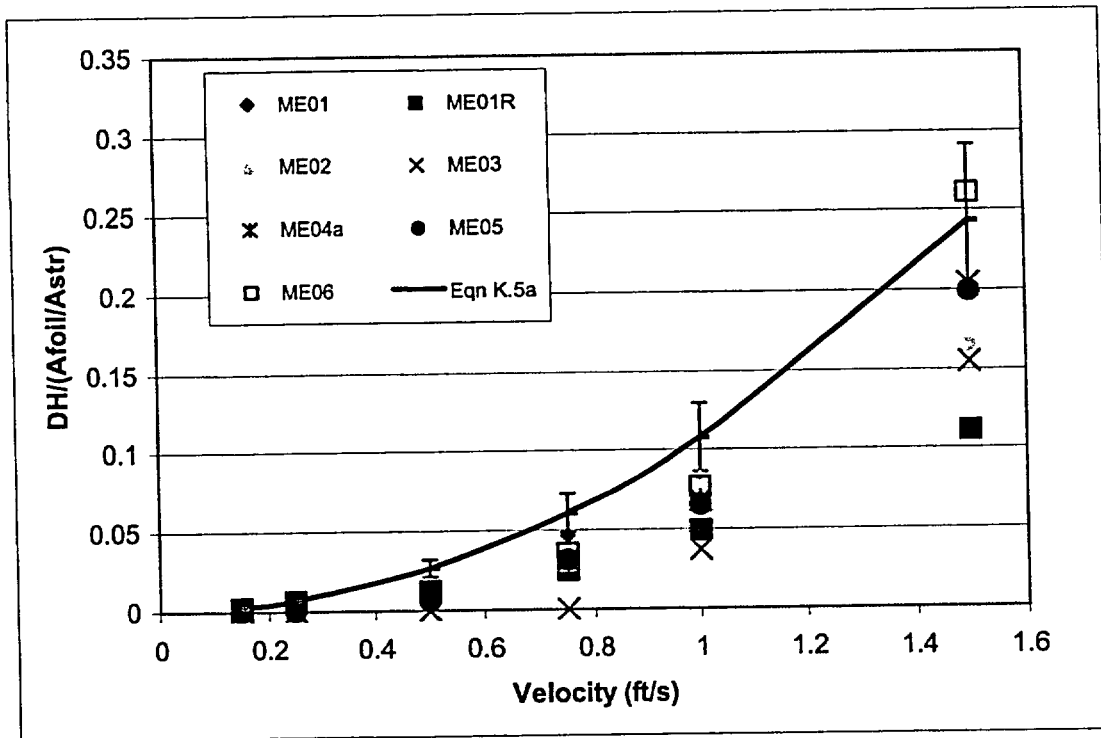
Figure 7-16 Comparison of NRC/ARL Test Data with LANL Correlation

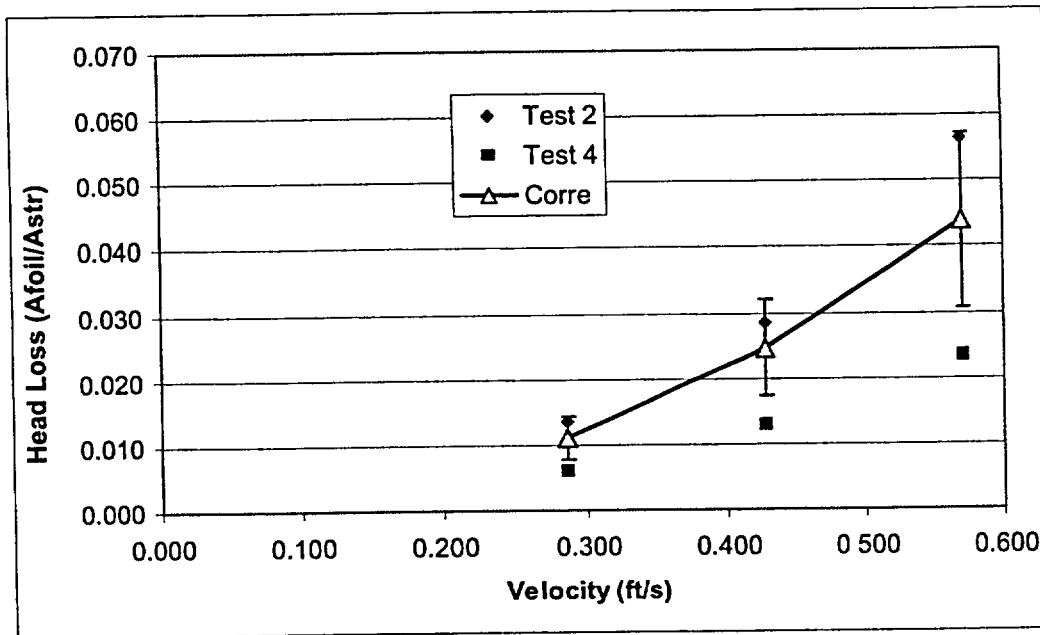
Figure 7-18 Comparison of LANL RMI Correlation Predictions for Truncated Cone Strainer with the Experimental Data Obtained from LaSalle Tests

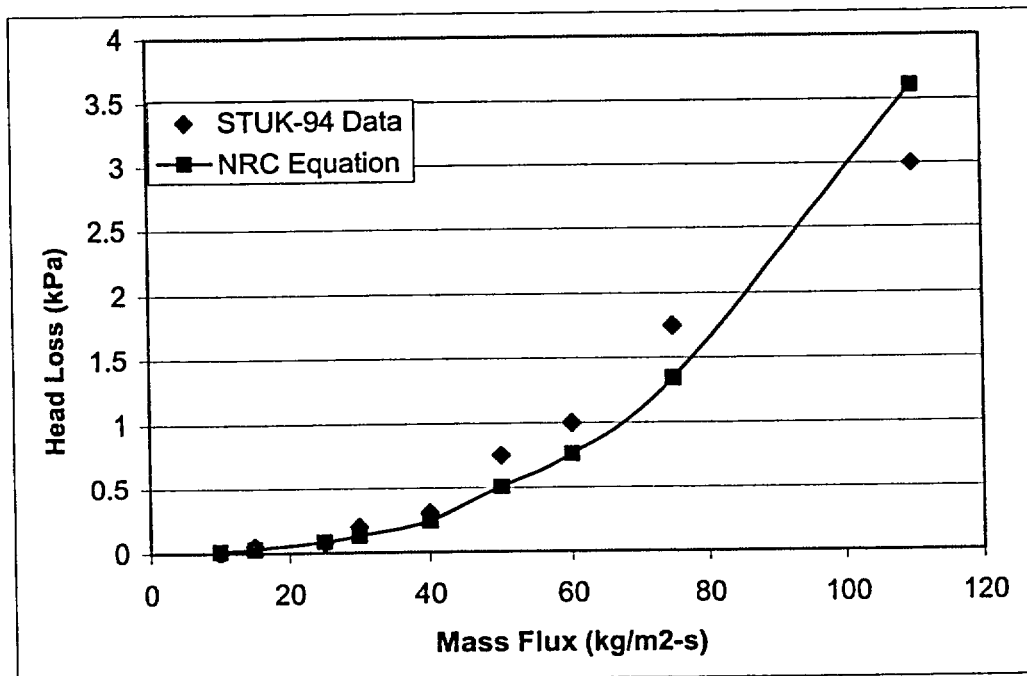
Figure 7-19 Comparison of LANL RMI Predictions with the STUK Head Loss Data

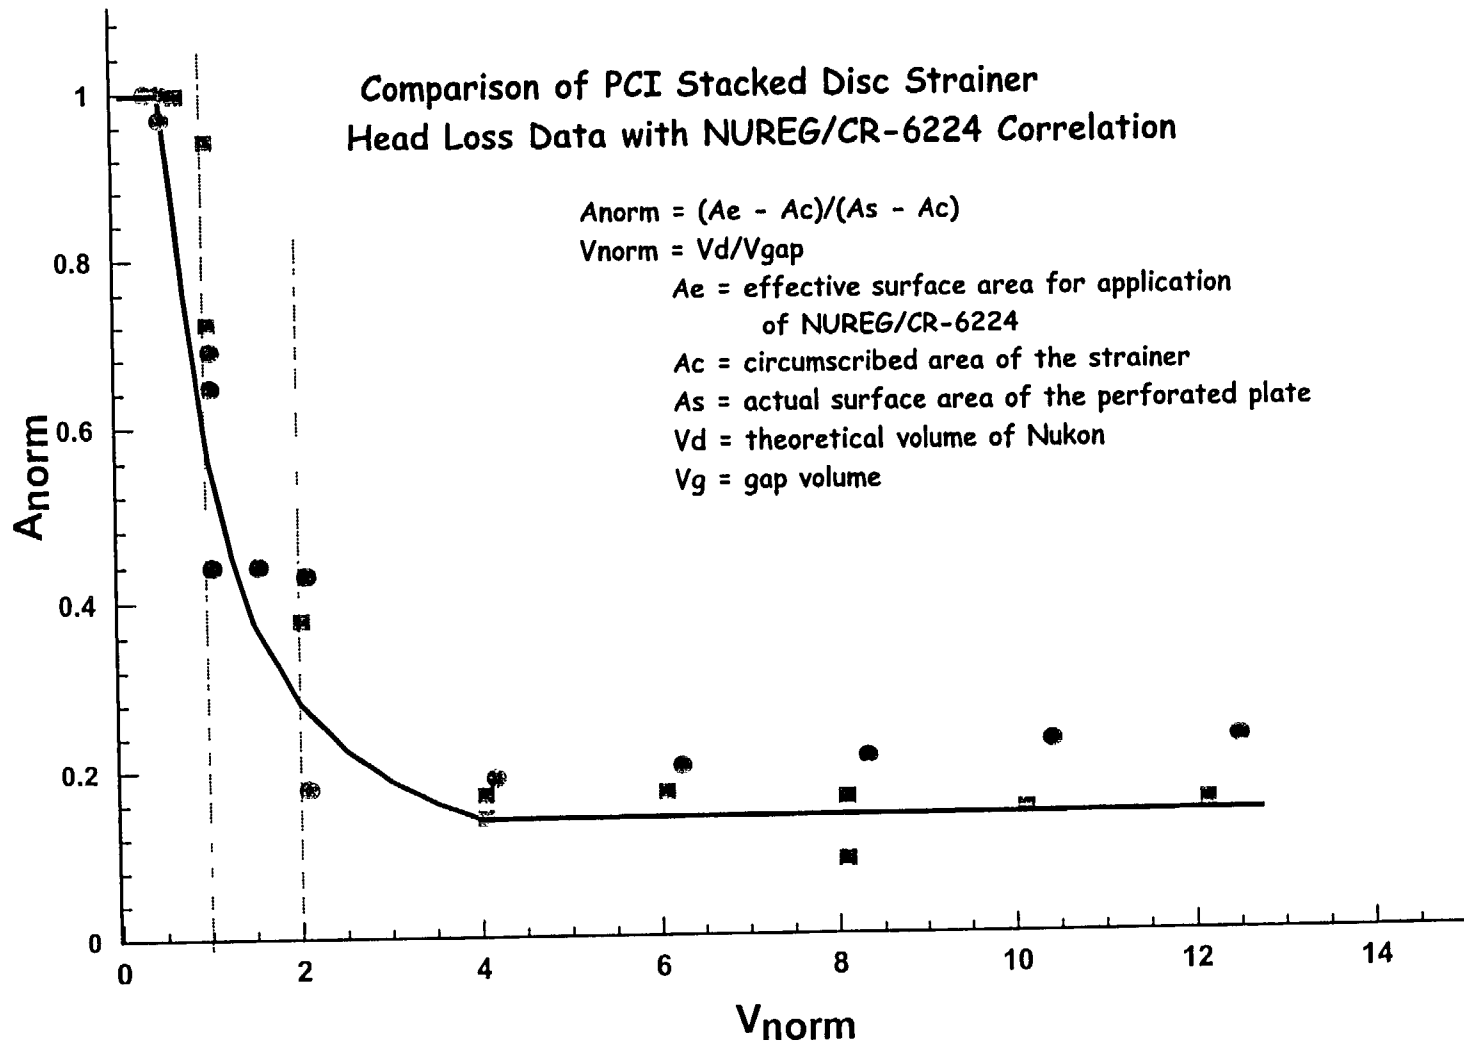
Figure 7-22 Dimensionless Representation of Stacked-Disk Strainer Effective Area as a Function of Debris Volume

Although these equations appear complex, they can be solved easily. The results of the comparison are presented in Figures 7-21 and 7-22. As shown in these figures, the NUREG/CR-6224⁷⁻² correlation can predict the head loss data for PCI strainers fairly accurately (within $\pm 25\%$).
