NUREG/CR-6943
PNNL-16472

A Study of Remote Visual Methods to Detect Cracking in Reactor Components

Pacific Northwest National Laboratory

**U.S. Nuclear Regulatory Commission
Office of Nuclear Regulatory Research
Washington, DC 20555-0001**

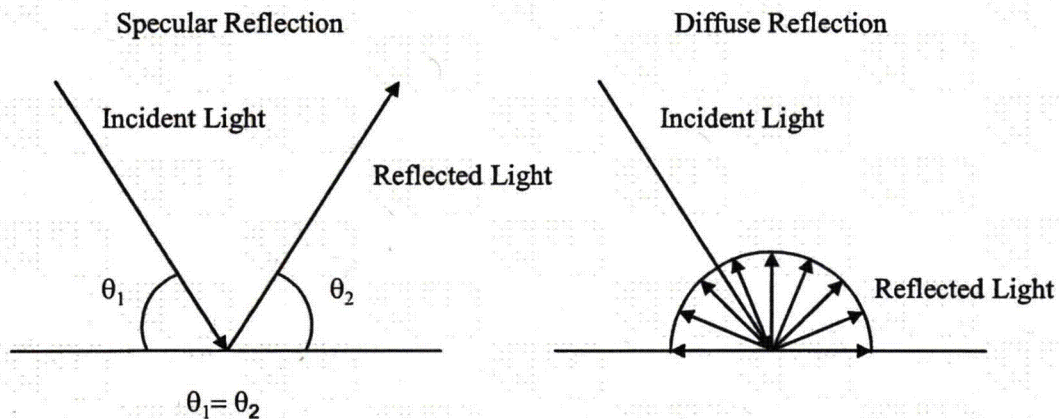
Figure 2.8 Specular and Diffuse Reflection. When light strikes a highly specular surface (left), the light is reflected away at the incident angle. When light strikes a diffusely reflecting surface (right), it reflects isotropically.

Light reflection from a given surface has two modes, specular and diffuse. In specular reflection, light reflects from the surface at the same angle as the angle of incidence. In diffuse reflection, the light reflected from the surface has no relation to the angle of incidence and is emitted isotropically. The two modes of reflection are shown in Figure 2.8.

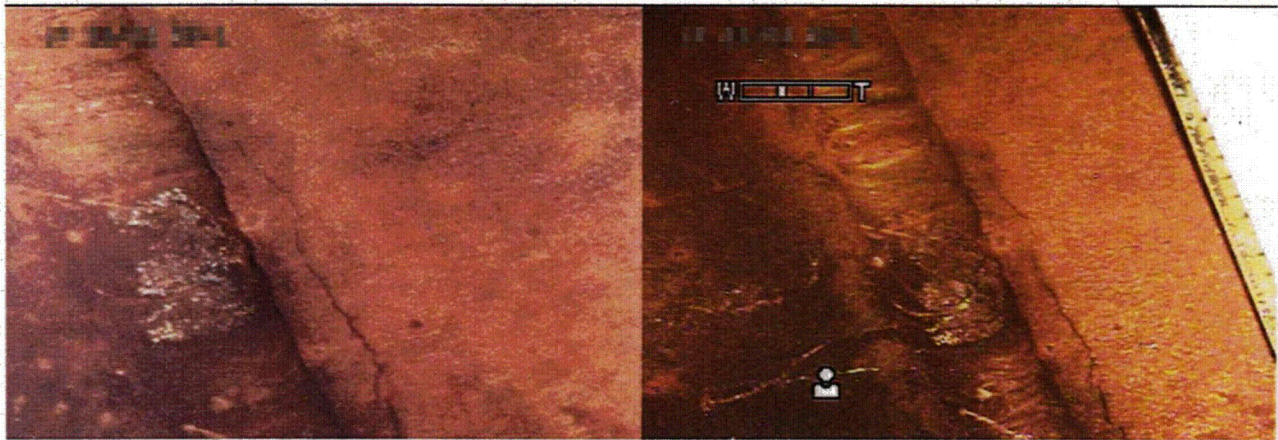
Figure 6.3 A Crack Before (left image) and After (right image) Cleaning Loose Oxide Layer from Surface

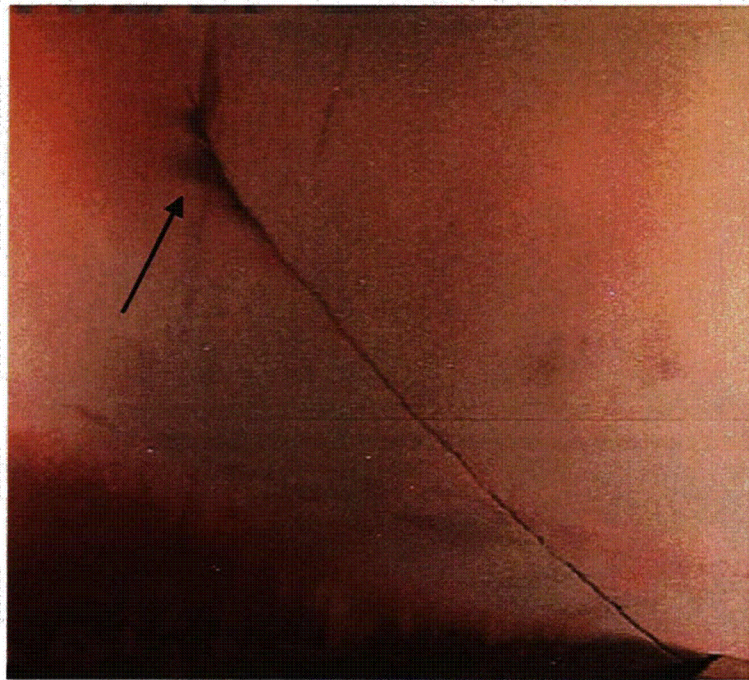
Figure 6.4 Mechanical Fatigue Crack with Black Oxide Decorating One End of Crack

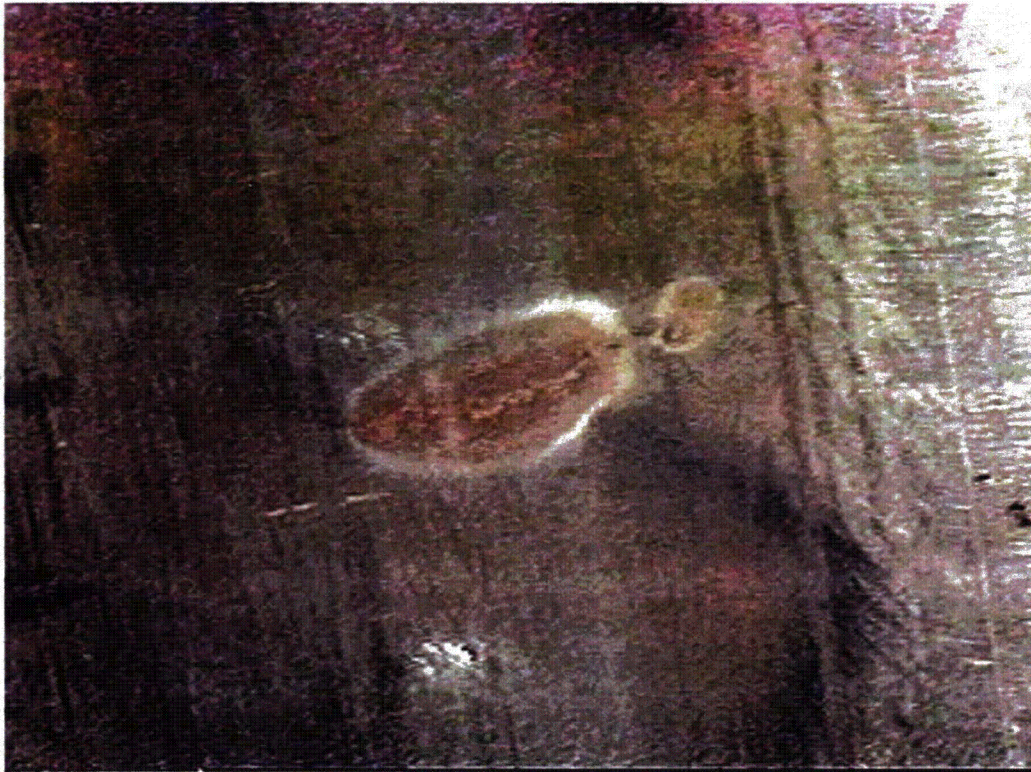
Figure 6.6 Stress Corrosion Crack Through Stainless Steel Made More Visible by Oxide Decoration

Another example of a crack that was made more visible by oxides is shown in Figure 6.6. In this case, the component had stainless steel cladding over carbon steel. When the stainless cladding cracked through, the carbon steel oxidized, and the resulting oxide bled through the crack, decorating the surface of the stainless steel. This oxide decoration draws attention to the cracked region. While the crack is faintly visible without the oxide, the oxide decoration does help in crack detection.
