WSRC-TR-2000-00079

**Degradation and Failure Characteristics of  
NPP Containment Protective Coating Systems (U)  
Interim Report**

Division of Engineering Technology  
Office of Nuclear Regulatory Research  
U.S. Nuclear Regulatory Commission  
Washington, DC 20555  
NRC Job Code W6959

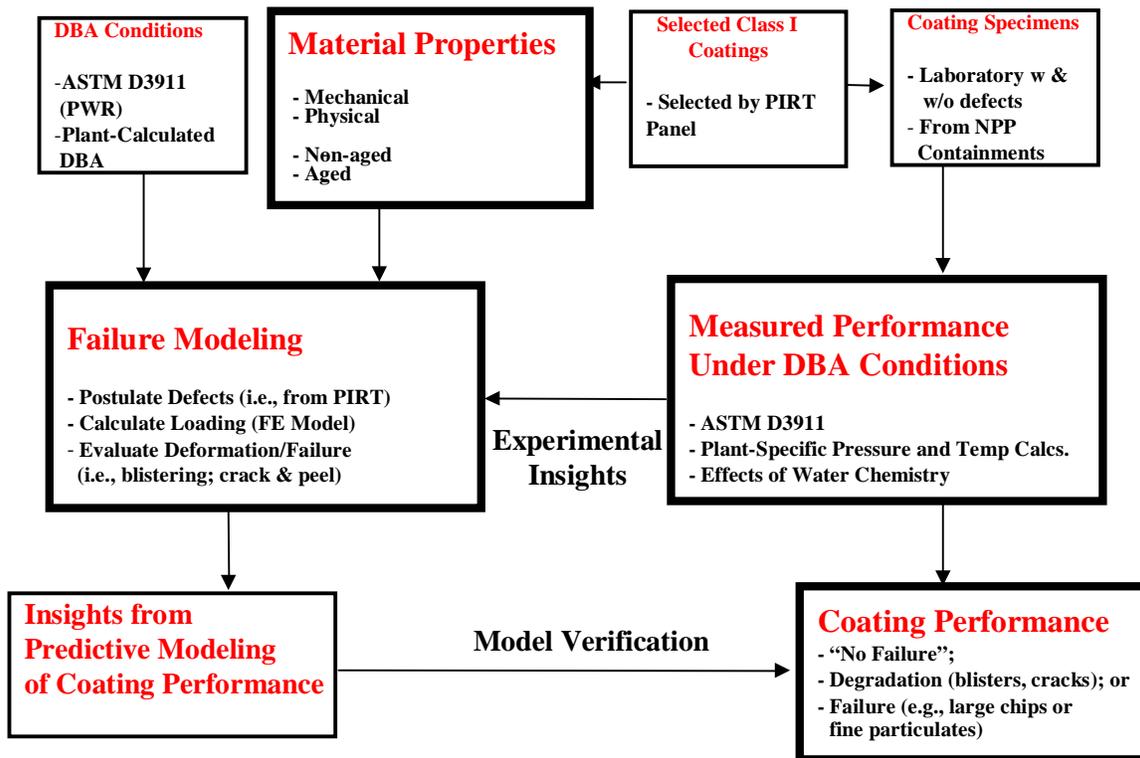
Figure 2-1. Task Logic Diagram for SRTC Project

The four principal program elements are: a) measuring key coating materials properties, b) developing a predictive coatings failure model, c) subjecting selected coatings to design basis accident conditions, or simulated LOCA conditions, and measuring performance, and d) providing insights into the performance of Service Level I coatings and, if failures occur, identifying debris source characteristics which include size, shape, and amount (per unit exposed area).

Materials properties are required input to analytical models of coating deformation and failure (see Figure 2-1). The input parameters used for coating System 5 are contained in Table 2-3. The table also includes several property parameters, not used directly as inputs to modeling, that provide a quantitative measure of the effects of aging and DBA exposure conditions on the potential for coating failure. One such parameter being measured in the research program is the adhesion strength; it is a simple measurement with sensitivity to detect differences in specimens tested at various conditions of temperature, wetness, and irradiation exposure. A reduction in the adhesion strength indicates an increase in potential for failure. The properties have been categorized as either “properties for loading” or “properties for mechanical response.” The properties for loading are those used to calculate the stress distribution in the coating system; the properties for mechanical response are those used to calculate deformation of the coating system. The steps in analytical modeling are outlined in section 2.2.

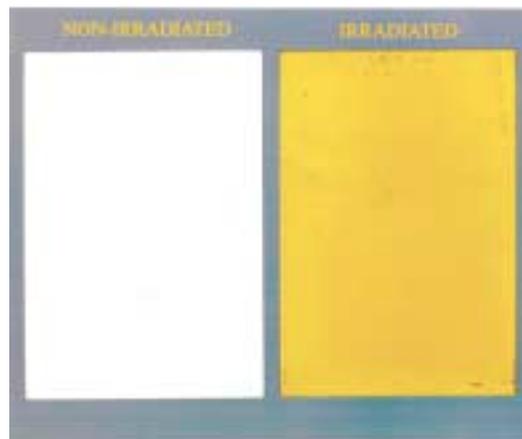
**Figure 2-4. Laboratory Plate Specimens Coated with Amercoat® 370 before (plate on left) and after (plate on right) Exposure to 10<sup>9</sup> Rad per ASTM D4082 -95**

Carbon steel plates, 4”x6”x ¼” are coated and used as laboratory specimens for both the mechanical tests (adhesion strength tests (i.e., pull tests) and adhesion energy tests (i.e., G-tests)) and for DBA testing. Figure 2.4 shows a plate specimen with the System 5 coating before and after the irradiation aging treatment. The irradiation aging treatment is described in detail in Appendix B.

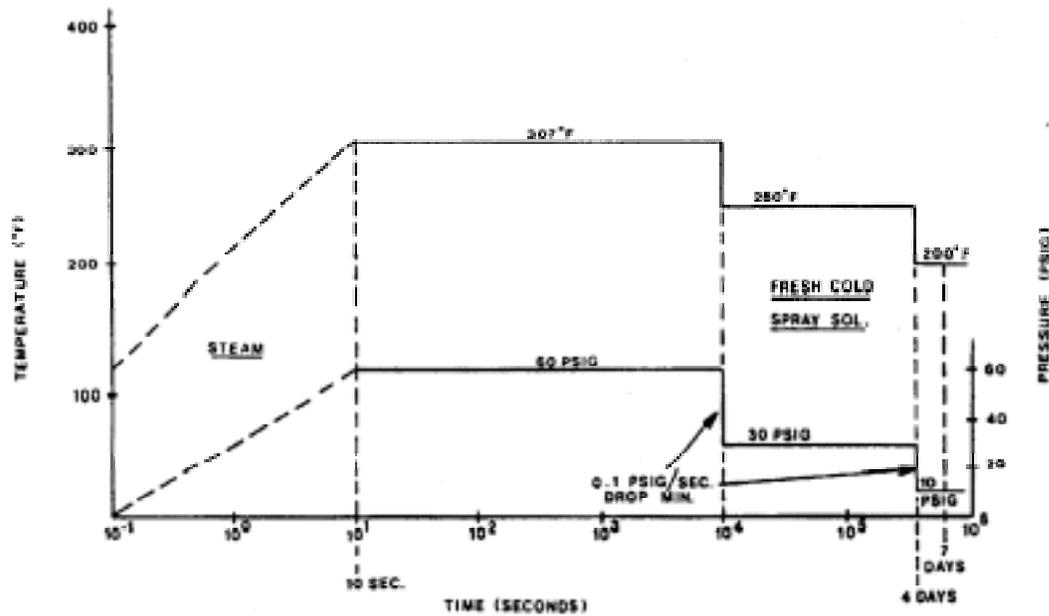
Figure 2-5. "Full DBA" Profile for PWR per ASTM D3911-95

There are three DBA profiles investigated in this study. The standard DBA temperature and pressure profile for qualification of coating system is given in ASTM standard D3911-95 [2.6] and is termed the “full DBA profile” in this report. Figure 2-5 below shows this profile, which is run for a total exposure period of approximately one week.

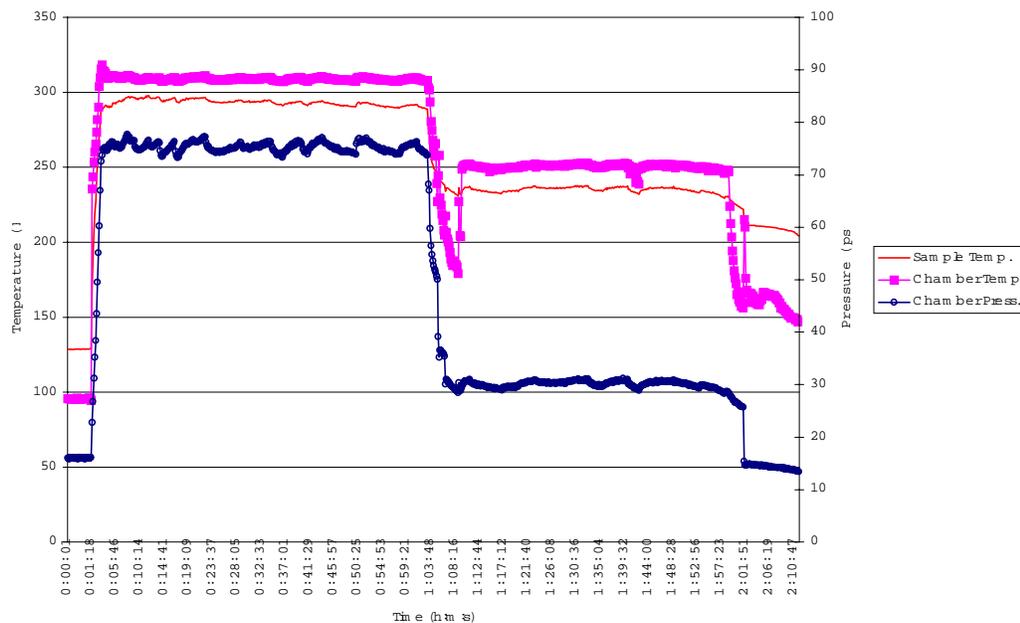
Figure 2-6. "Abbreviated DBA" Profile

An abbreviated version of the DBA profile was used in the program to facilitate acquisition of data quickly to determine insights and to allow many tests to be performed in the SRTC Mini-Environmental Test Chamber. A description of the unique facility which is fully-equipped for video monitoring and recording and data logging is provided in Appendix D of this report. A typical "abbreviated DBA" profile, shown in Figure 2-6 captures the initial transient features in the full DBA profile. The exposure period of this profile is nominally 3 hours at controlled temperature and pressure.

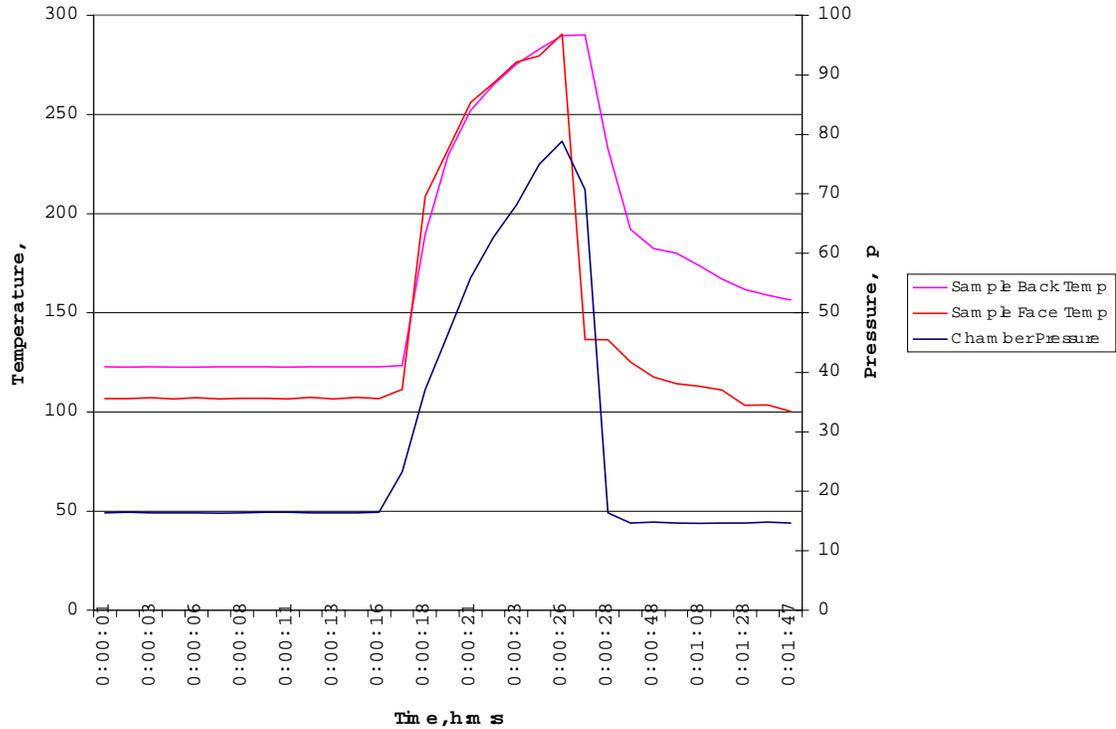
**Figure 2-7. “Pulse DBA” Profile to Simulate a Plant-Specific DBA Temperature/Pressure Profile**

A “pulse DBA” was used in the program to investigate the performance of a coating under severe heat-up and cool-down pulse. Figure 2-7 shows a typical pulse profile in the DBA testing. Calculations of plant-specific transients typically contain this feature, which is not incorporated in the D3911-95 DBA profile.

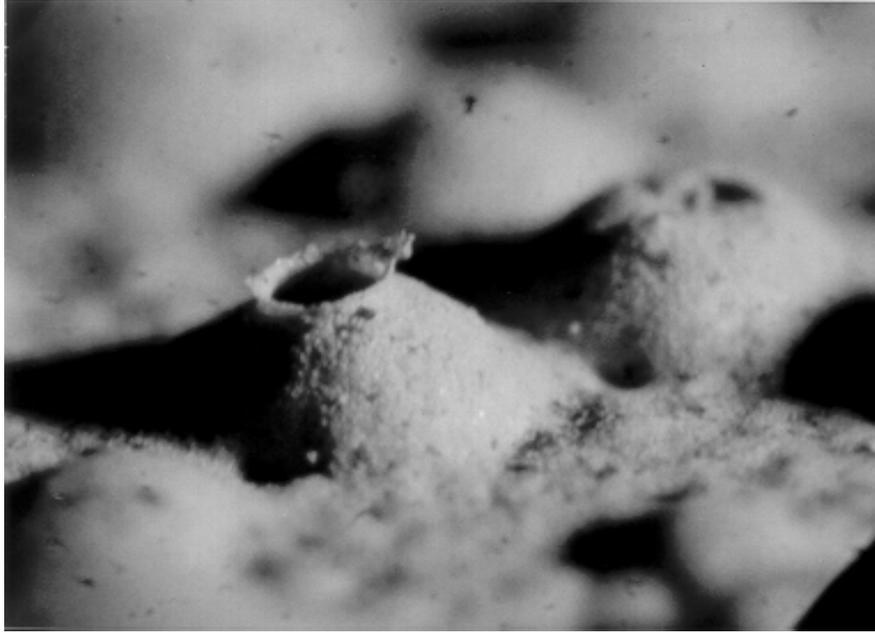
**Figure 2-8. Blister Formation in Near-Surface Region of Amercoat® 370 Following Irradiation to  $10^9$  Rad and a Water Soak.**

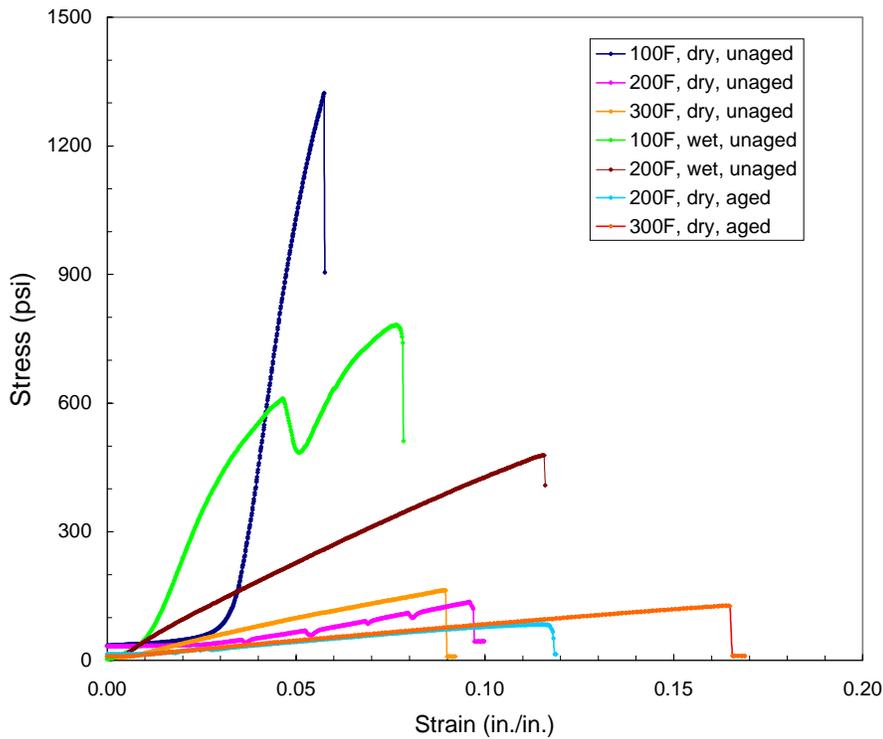
**Figure 3-1. Free-film tensile test results for Amercoat® 370. The large dip in the 100°F, wet, unaged curve and the small ones in the 200°F, dry, unaged curve were caused by the functioning of the oven heater.**

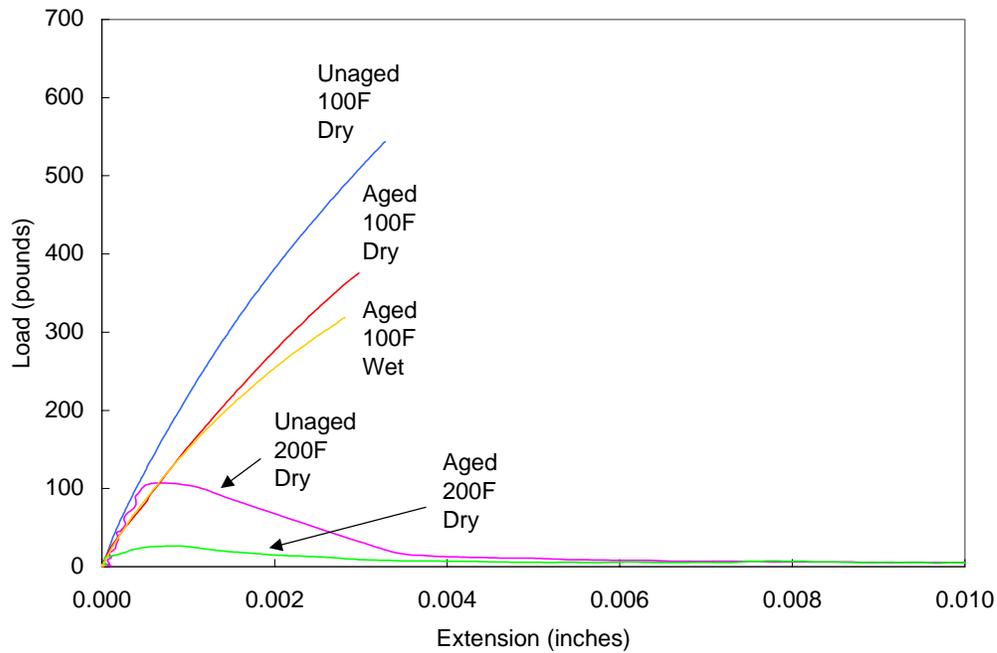
**Figure 3-2. Adhesion pull test results for System 5**

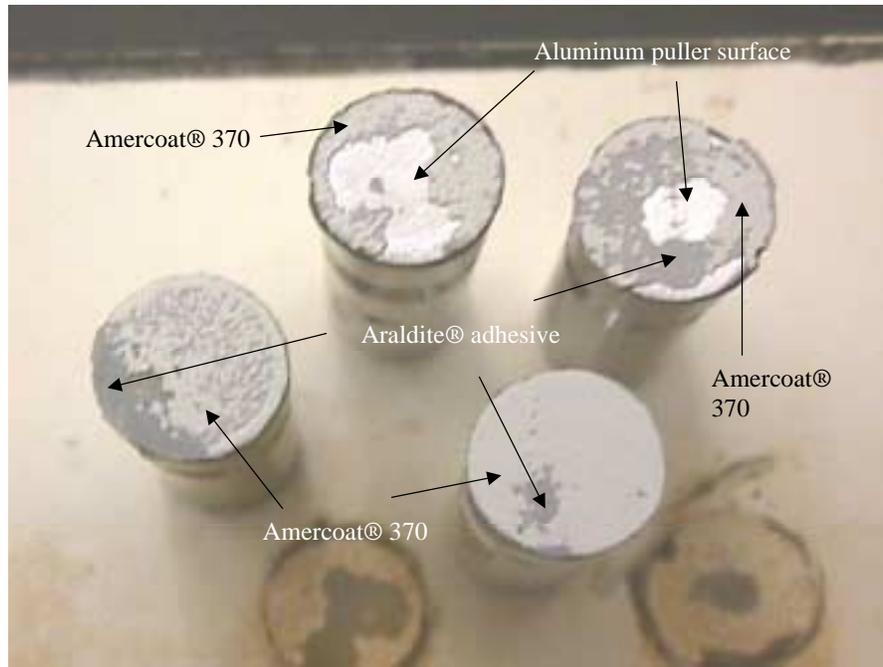
**Figure 3-3. Half-inch-diameter puller fracture surfaces showing the mixed modes of separation from a System 5 test coupon: clockwise from left, 100°F wet, 300°F dry, 200°F dry, and 100°F dry.**

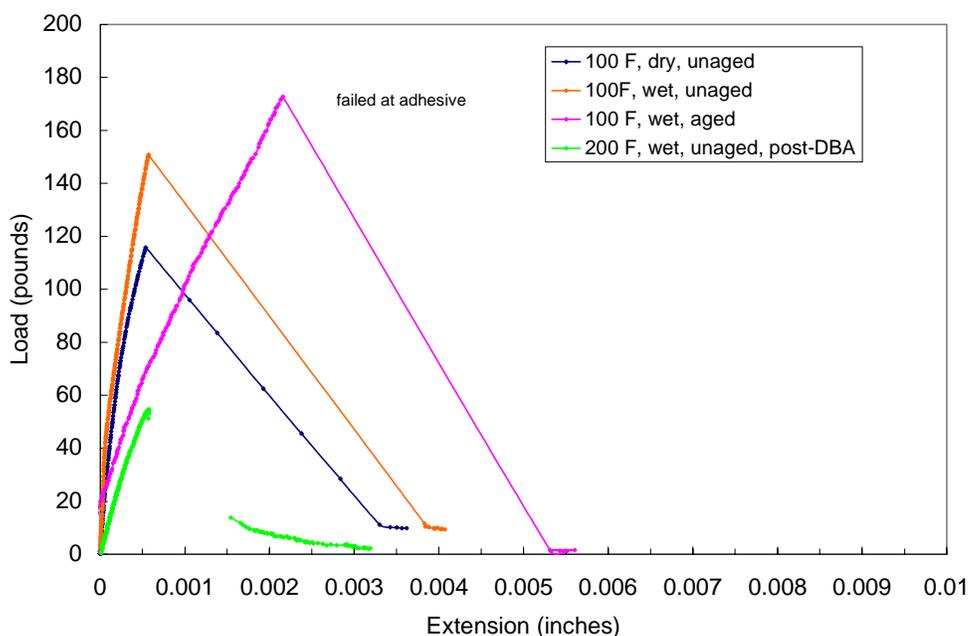
Figure 3-4. Adhesion G-value test results for System 5

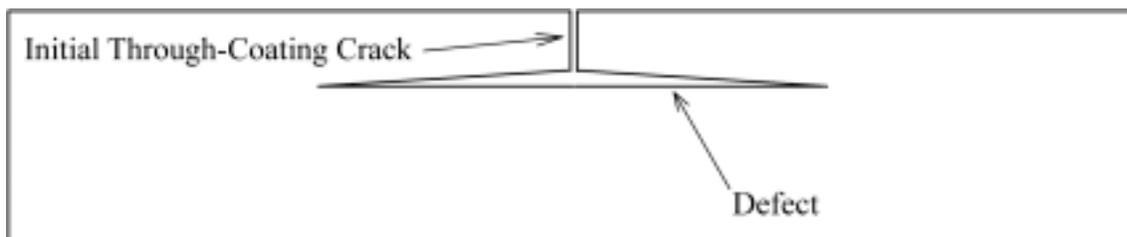
**Figure 3-6. Mode 2 Analysis model**

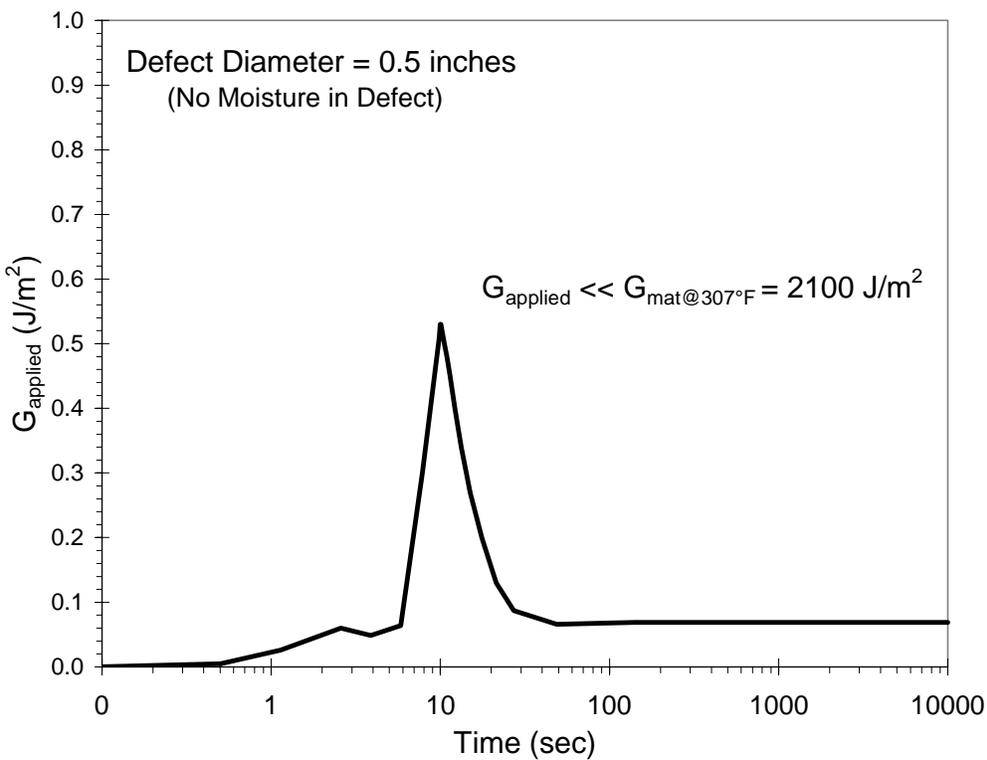
**Figure 3-7. Applied G-Values at the Edge of a dry Defect (Diameter 1/2") during DBA Test.**

In the stress analyses, the Young' modulus was assumed to remain unchanged when the temperature was beyond 200°F. However, the value of  $G_{\text{material}}$  was extrapolated to higher temperatures (say, 307°F as seen in Figure 3-8) to demonstrate its assumed temperature dependency.

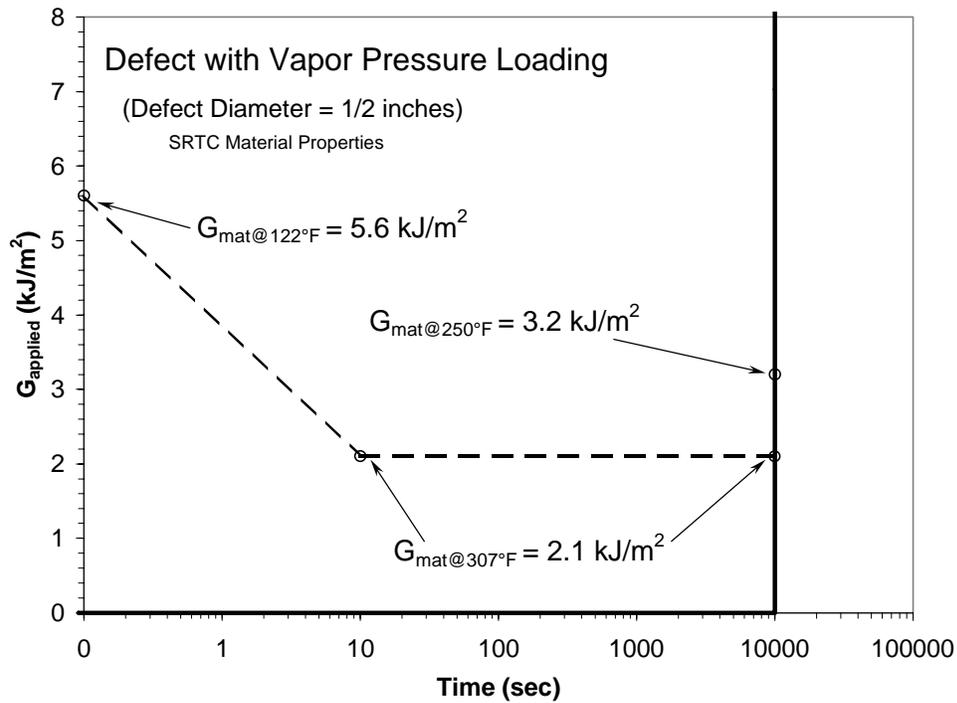
Figure 3-8. Applied G-Values at the Edge of a Vapor Pressurized Defect (Diameter 1/2") during DBA Test (Logarithmic Time Scale).

For a Mode 1 defect with entrapped moisture, the defect will be subject to vapor pressure loading when the saturated vapor pressure inside the defect overcomes the ambient pressure prescribed by the DBA testing. This would occur when the DBA test begins to spray cool water in the test chamber so the ambient pressure drops accordingly. The value of  $G_{\text{applied}}$  rapidly jumps to a high value associated with a blister formation. This can be seen in Figure 3-8. The variation of  $G_{\text{material}}$  was also plotted. The intersection point of the  $G_{\text{applied}}$  and  $G_{\text{material}}$  defines the time of delamination. A linear time scale between 10,010 and 10,015 seconds is used in Figure 3-9. It can be seen that the delamination would occur at 2.3 seconds after the DBA begins the cooling phase. Again, the extrapolated  $G_{\text{material}}$  was used to demonstrate the temperature dependency.

A smaller defect with 1/8” diameter was also analyzed. Figures 3-10 and 3-11 show that the delamination will not occur because the peak value of  $G_{\text{applied}}$  is below the  $G_{\text{material}}$ . Note that in Figure 3-10, the vanishingly small  $G_{\text{applied}}$  peak is visible near the end of heating stage (10 seconds). This small peak is due to the buckling of the material above the defect as a result of thermal expansion mismatch. This small peak is invisible in Figure 3-8 because of the graphical scale.

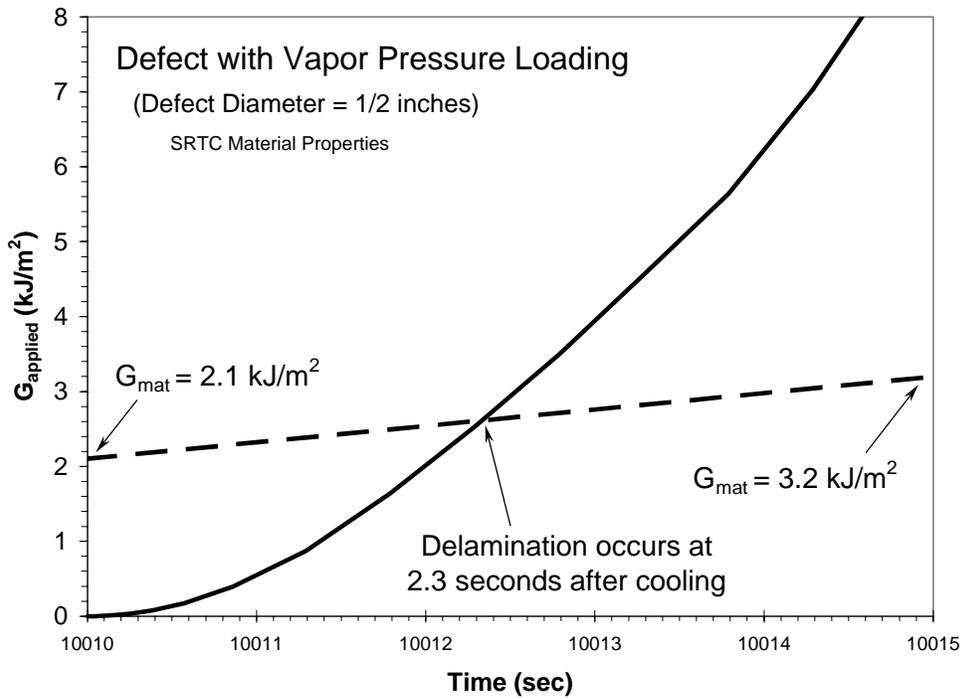
Figure 3-9. Applied G-Values at the Edge of a Vapor Pressurized Defect (Diameter 1/2") during Cooling Phase in DBA Test (Linear Time Scale).

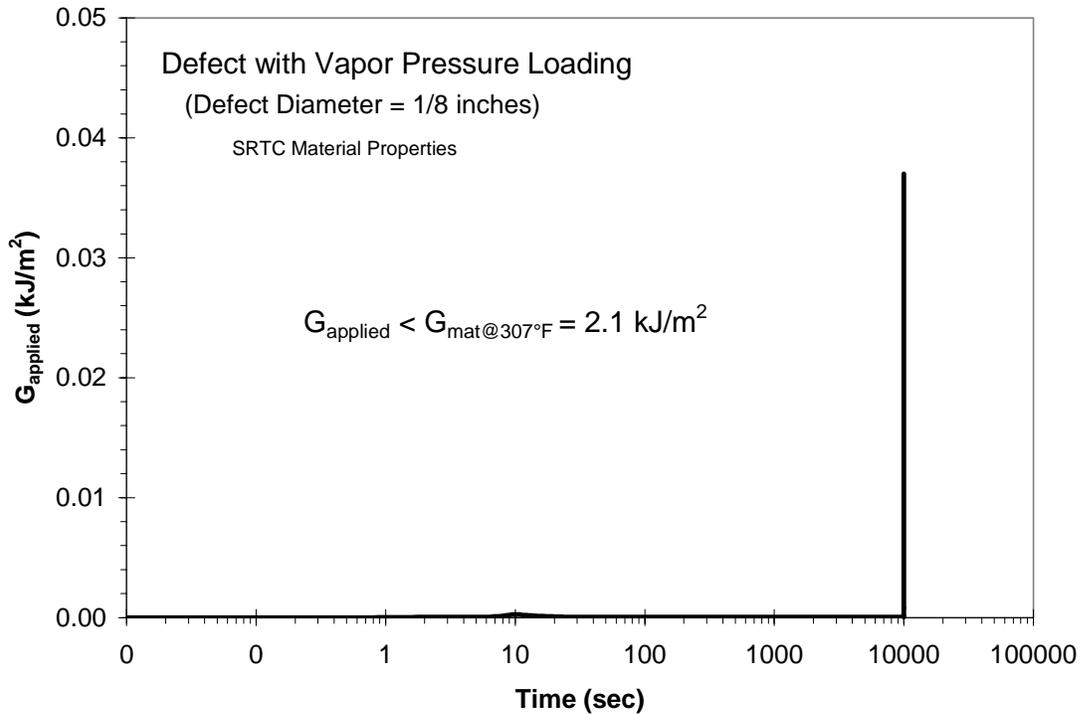
**Figure 3-10. Applied G-Values at the Edge of a Small Vapor Pressurized Defect (Diameter 1/8”) during DBA Test (Logarithmic Time Scale).**

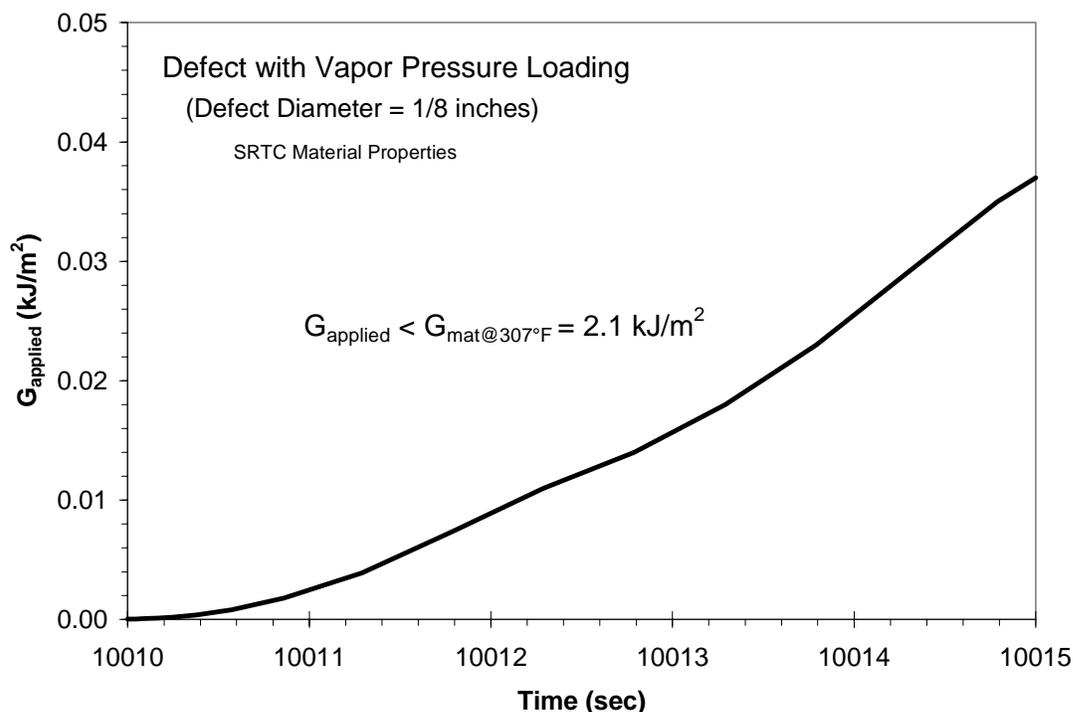
**Figure 3-11. Applied G-Values at the Edge of a Small Vapor Pressurized Defect (Diameter 1/8") during Cooling Phase in DBA Test (Linear Time Scale).**

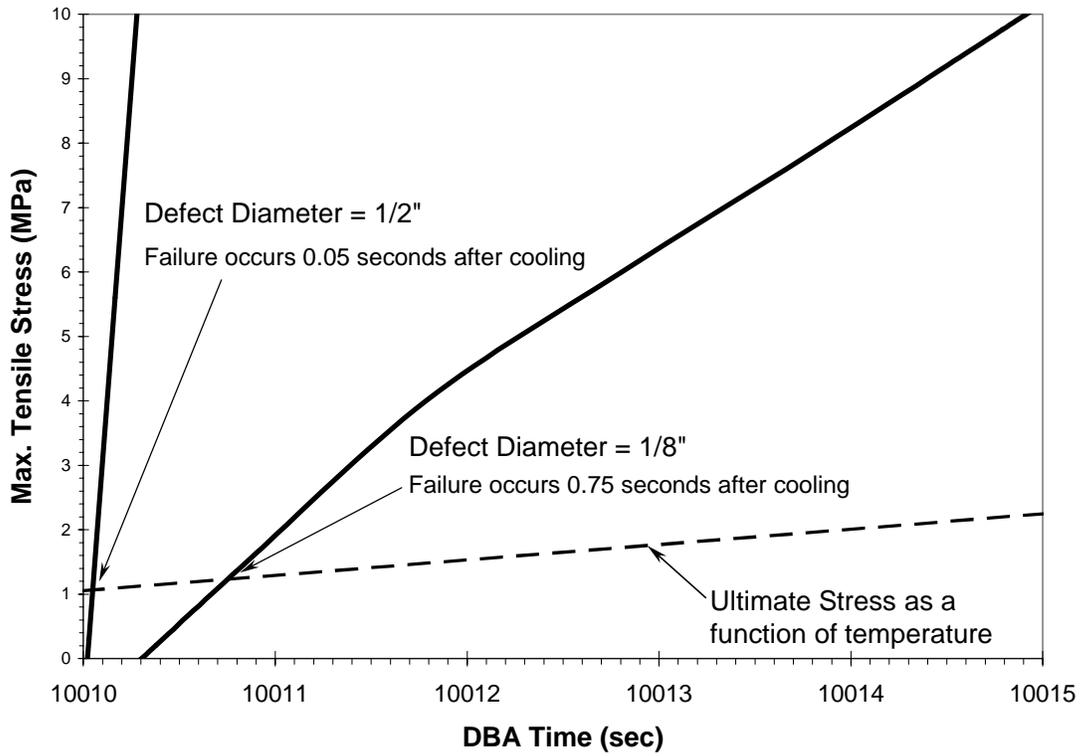
Figure 3-12. Failure of Mode 1 Defects based on Peak Stress Criterion

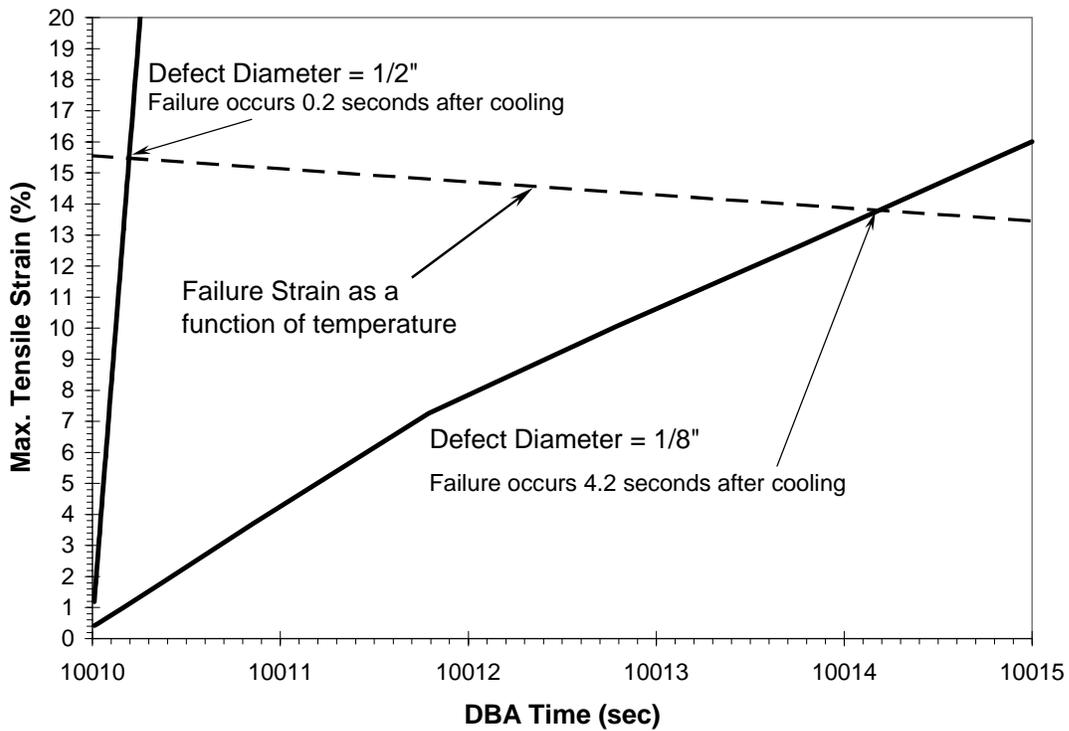
Figure 3-13. Failure of Mode 1 Defects based on Failure Strain Criterion

Figure 3-13 shows the results using the failure strain criterion. It indicates that the Amercoat<sup>®</sup> 370 coating would fail at 0.2 and 4.2 seconds, respectively, after the cooling begins.

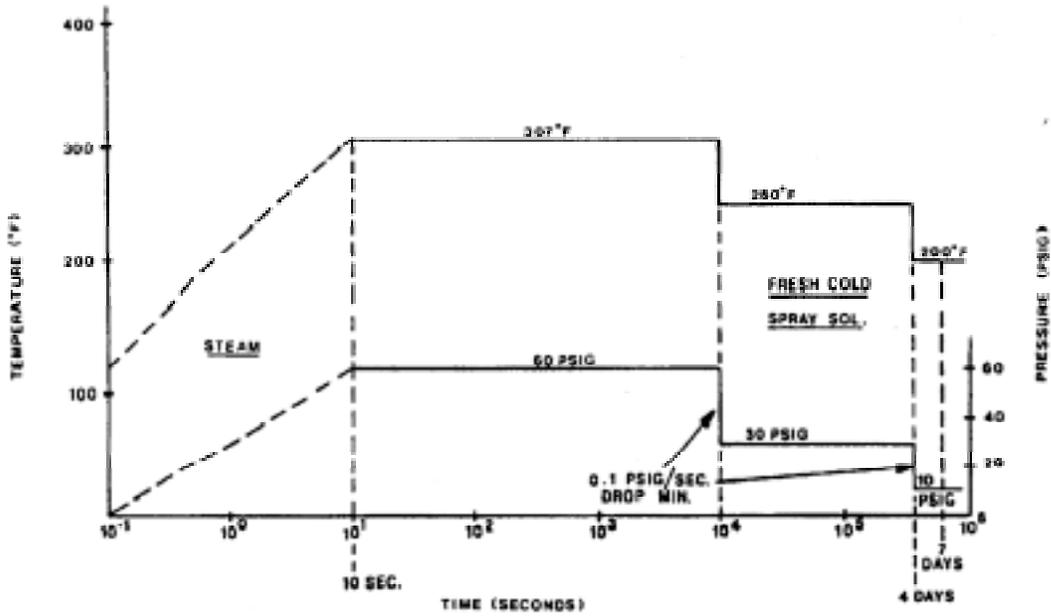
**Figure 3-14. Typical Pressurized Water Reactor Design Basis Accident (DBA) Testing Parameters (from ASTM D3911-95). (Note: The ASTM figure contains an error: 30 psig should be 15 psig, which is equivalent to 30 psia).**

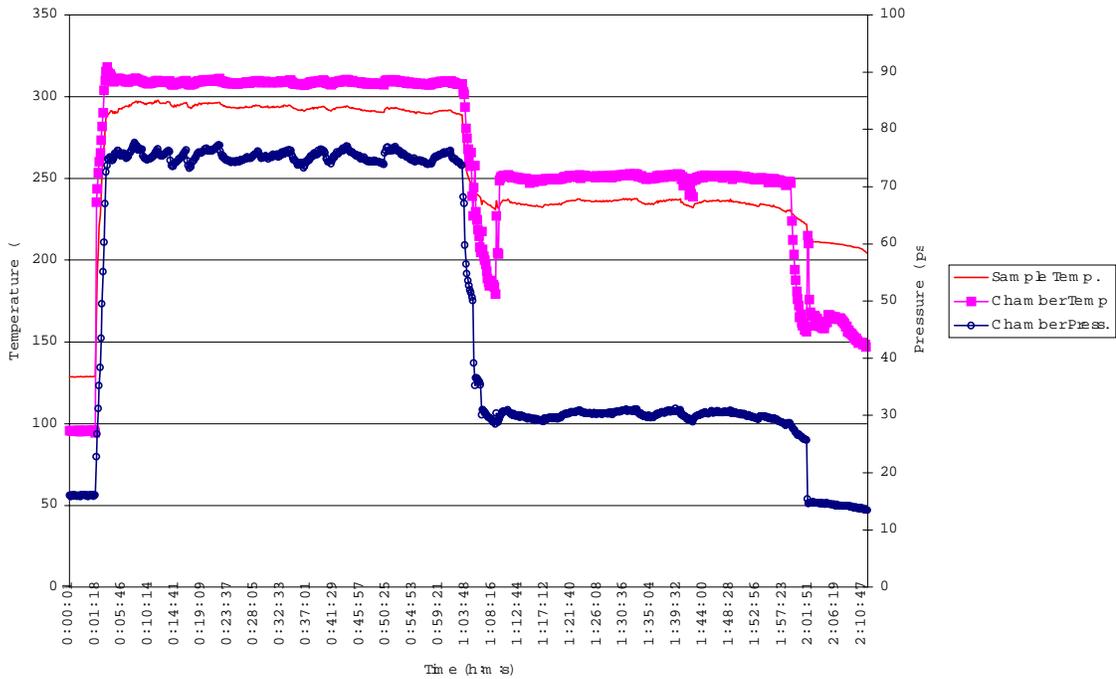
**Figure 3-15. Temperature-pressure Profile Used in SRTC "Abbreviated DBA" Tests.**

Computer modeling has revealed rapid temperature-pressure transients to be the likely times for coating failure to occur (see Section 3.2). Transients are present in the temperature-pressure profile specified in ASTM D3911-95 during reductions in steam pressure from 75 psia to 30 psia, and again during reduction from 30 psia to 25 psia (Figure 3-14). The “abbreviated DBA” has been used to duplicate these high-stress transients, while minimizing specimen time-at-temperature to allow examination of a large number of samples (Figure 3-15).

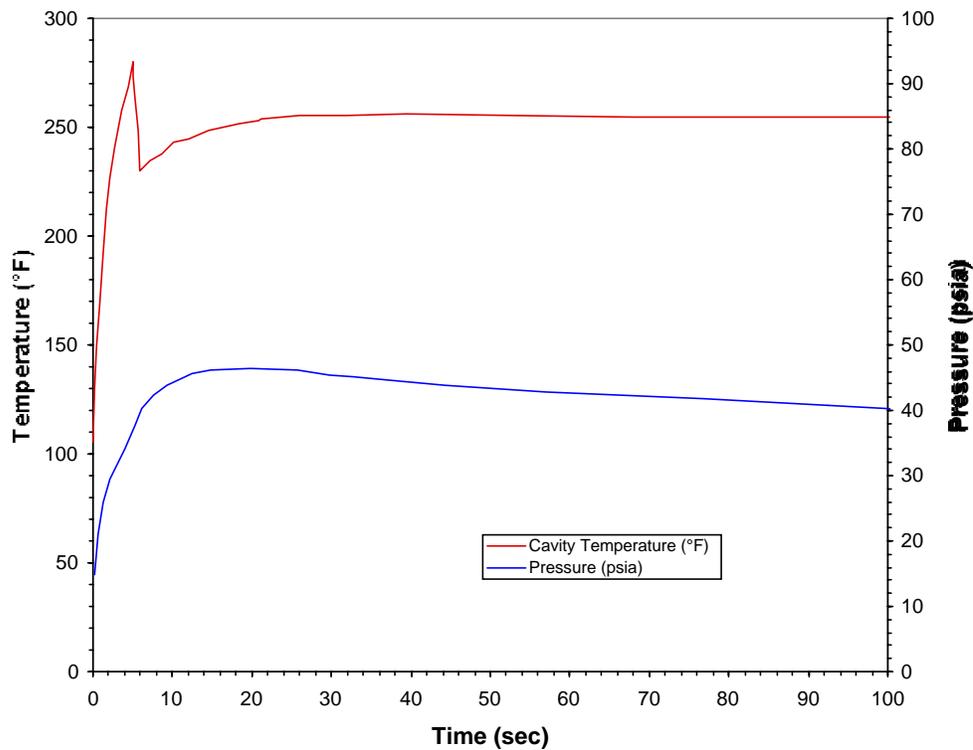
Figure 3-16. Zion Plant-specific Temperature-Pressure Pulse Simulation using MELCOR

Computer modeling has indicated a susceptibility to failure of a polyamide epoxy coating during a rapid pulse transient, if water were present beneath the coating (see Section 3.2). A similar rapid transient has been simulated in nuclear power plants using the MELCOR computer model (Figure 3-16). To examine System 5 coating performance in this type of event, the SRTC coatings performance evaluation system was used to subject a non-aged System 5 specimen to a rapid temperature-pressure pulse (Figure 3-17). A specimen containing Type 1 non-bond defects was used in the test. No evidence of coating failure was observed.

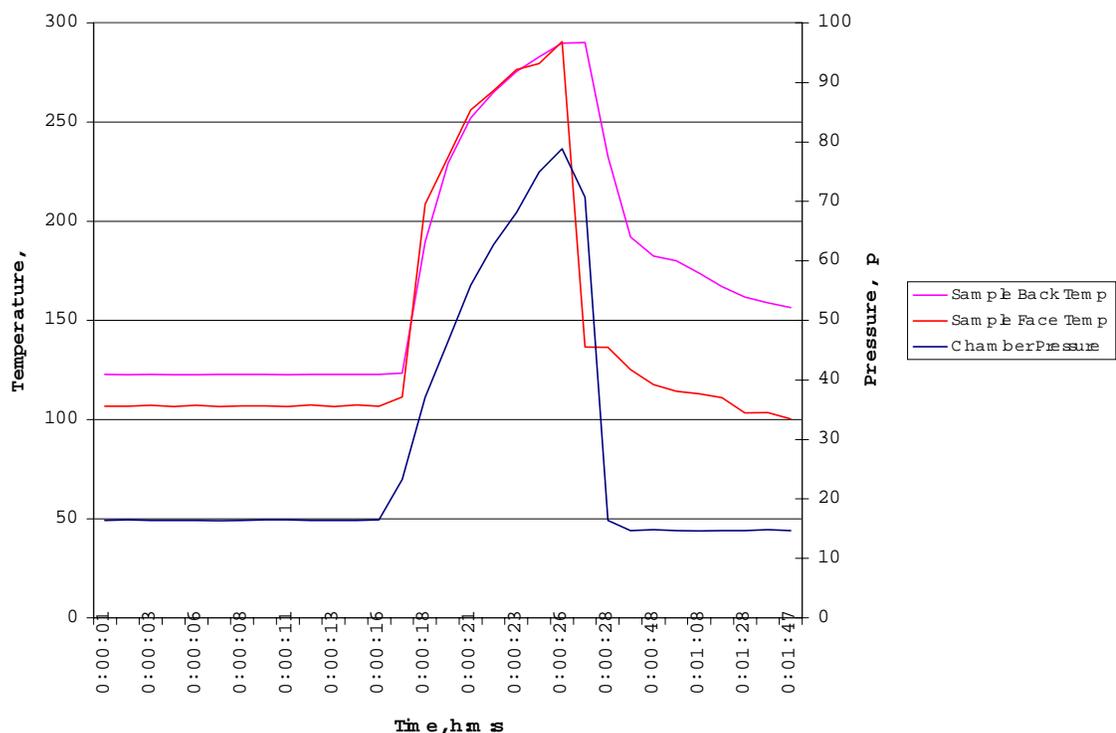
Figure 3-17. Temperature-Pressure Curves from SRTC Pulse Test

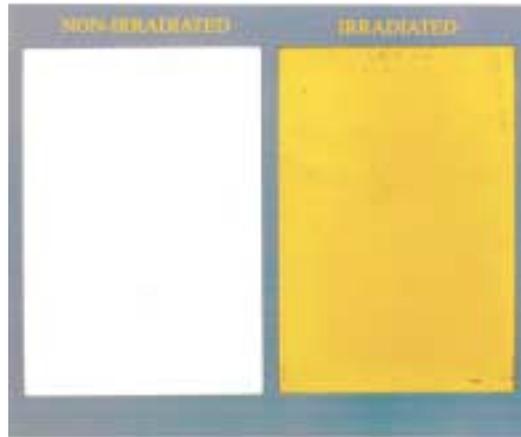
**Figure 3-18. System 5 coupons before (left) and after (right) irradiation to  $10^9$  Rad**

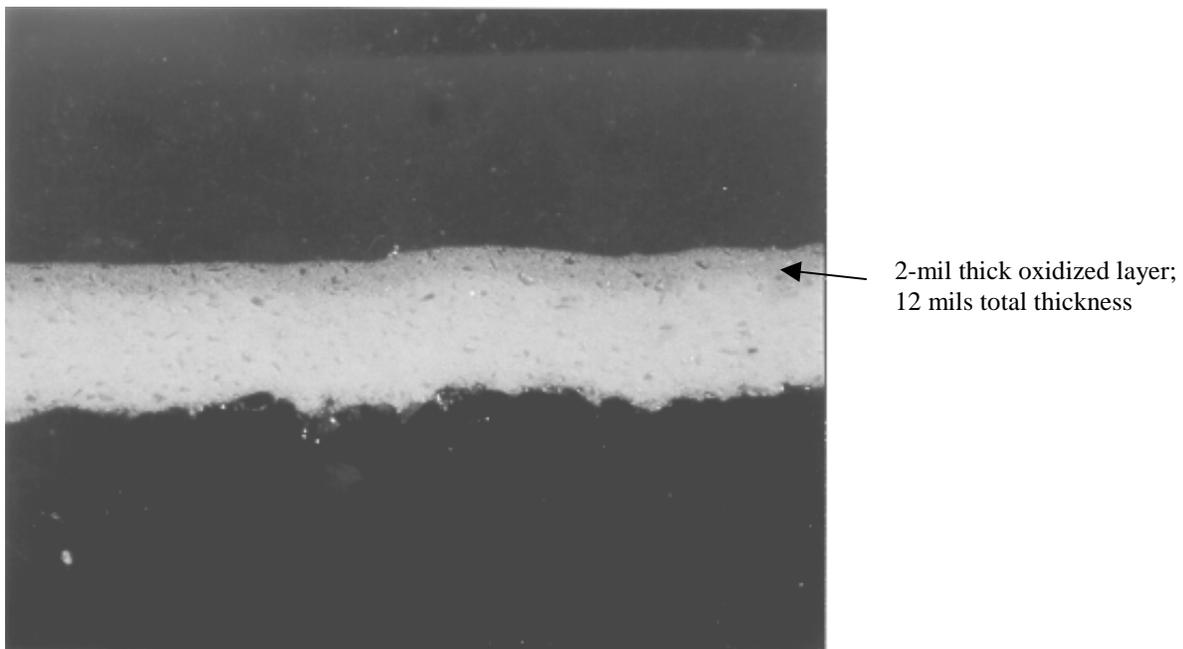
**Figure 3-19. Cross-section of System 5 coating, irradiated to  $10^9$  Rad, original optical magnification 64X.**

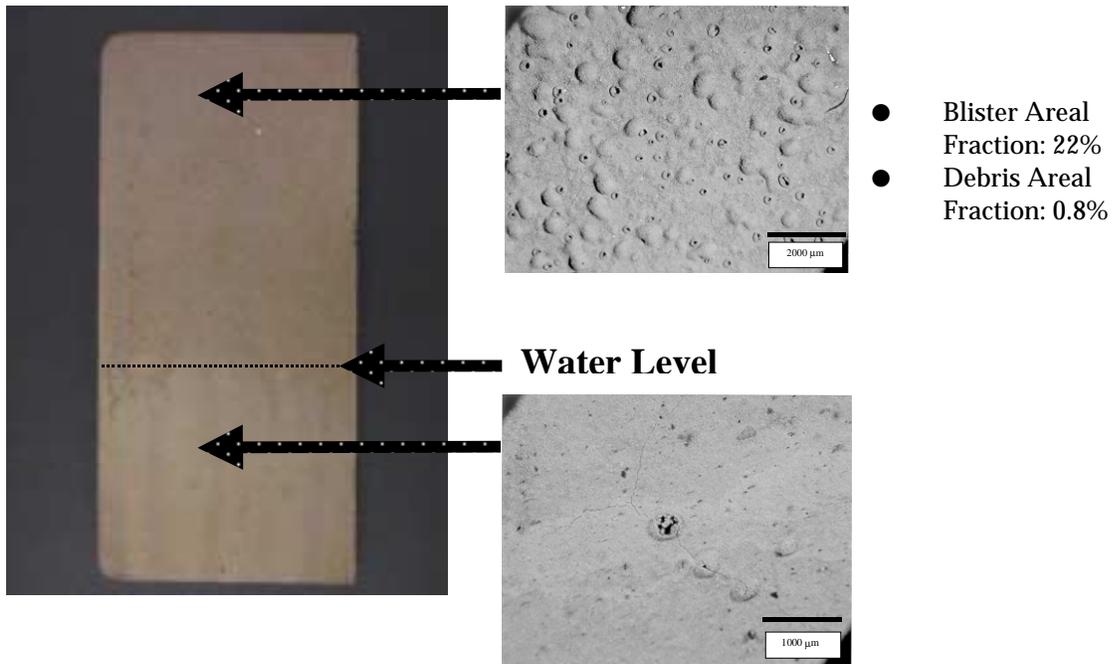
Figure 3-20. Aged System 5 coupon showing incipient mode 1 and mode 2 failures

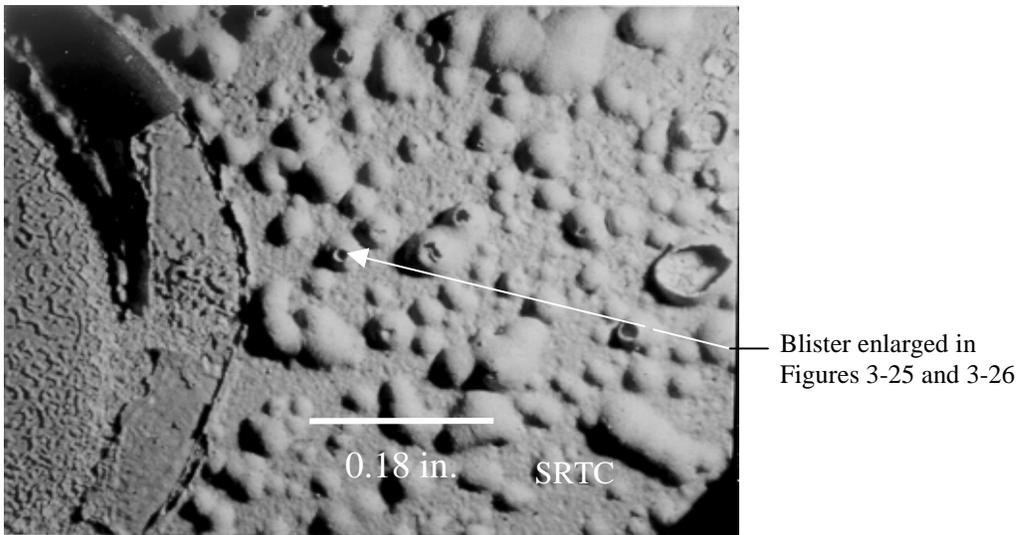
Figure 3-21. Micrograph of blistering formed on System 5.

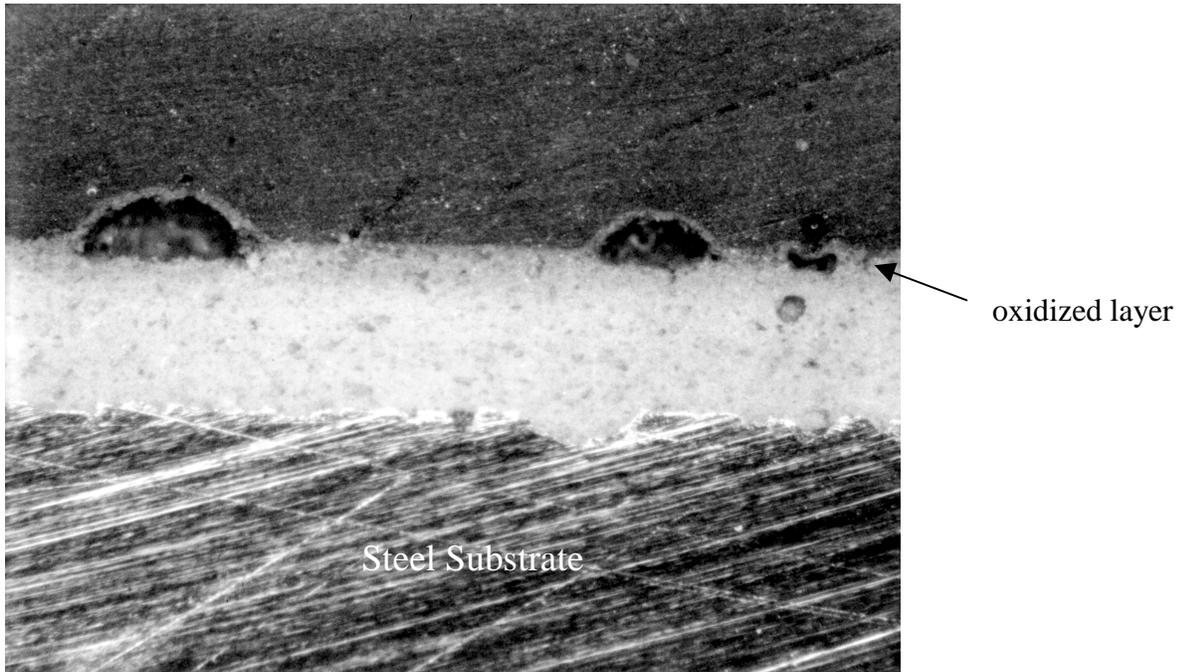
**Figure 3-22. Cross-section of System 5 aged, DBA-tested showing blister formation in near-surface, oxidized layer.**

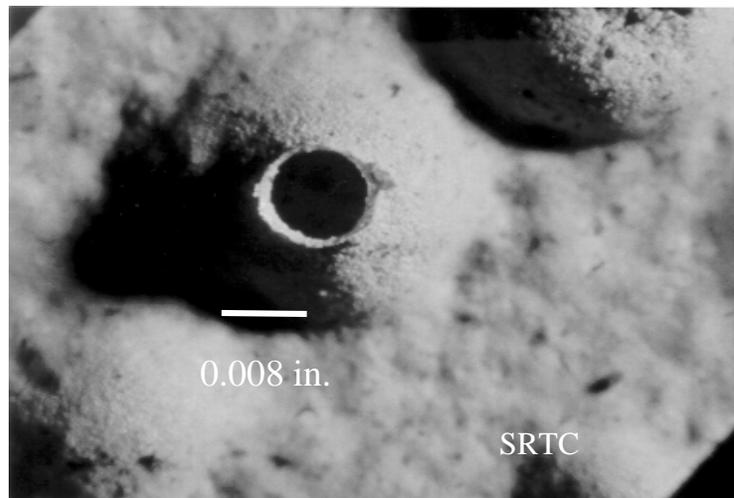
**Figure 3-23. Ruptured blister, original magnification at 64X. Blister thickness is of the order of 1 mil.**

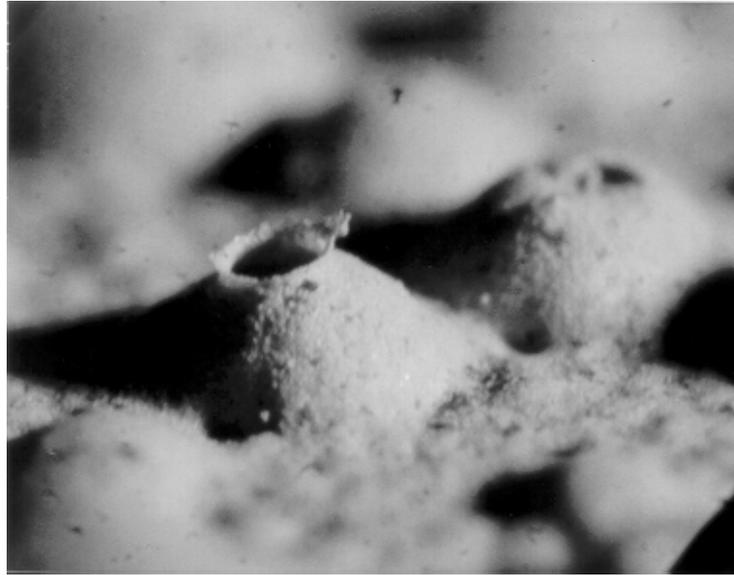
**Figure 3-24. Ruptured blister of Figure3-24 in profile; blister is 15 mils tall, original magnification 64X.**

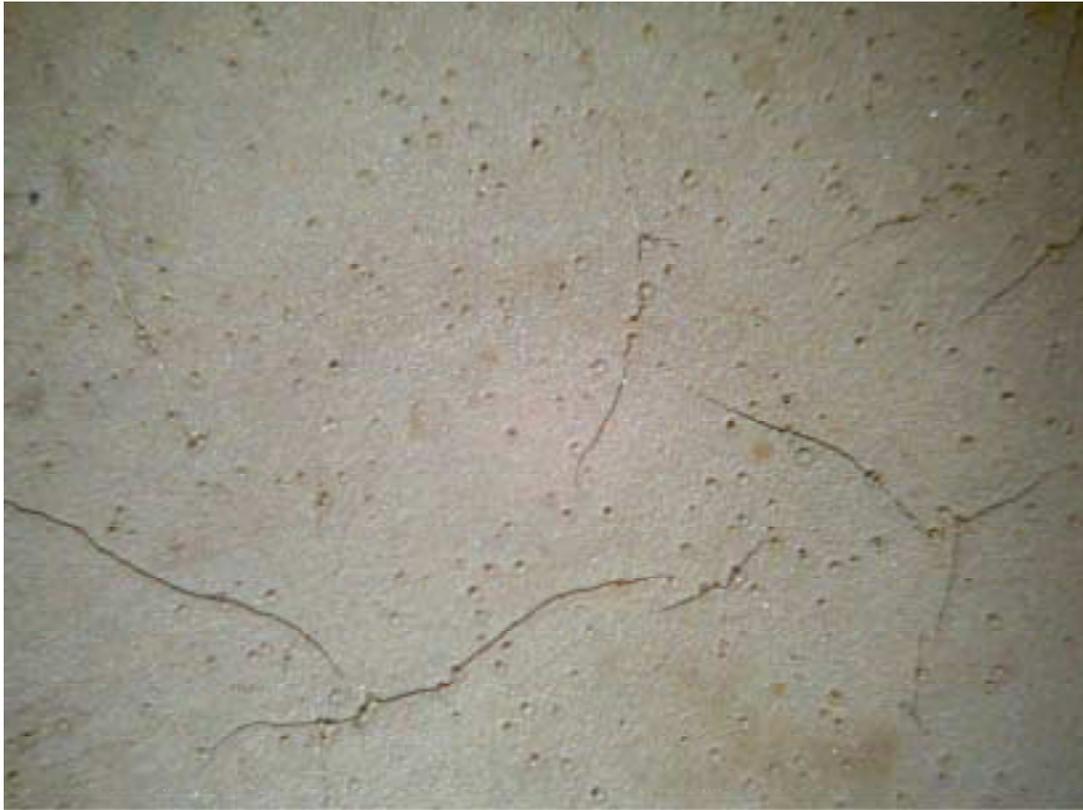
**Figure 3-25. Cracking in System 5 following “Full DBA” test (Mag 7X).**

The incipient mode 2 failure is illustrated in Figure 3-25, which shows a pattern of checking (cracking that does not penetrate to the steel substrate) on a portion of the System 5 coupon. The coupon had been adhesion tested (black adhesive is visible at the right) in air at temperatures up to 300°F and then subject to an abbreviated DBA test. The shallow penetration of the cracks could be seen at a free coating edge created by the milling of a type 2 defect. The depth appeared to only a few mils, which suggests that again it is in the putative oxidized layer that this failure mode propagated. These observations indicate the substantial role that aging may play in the development of coating failures.

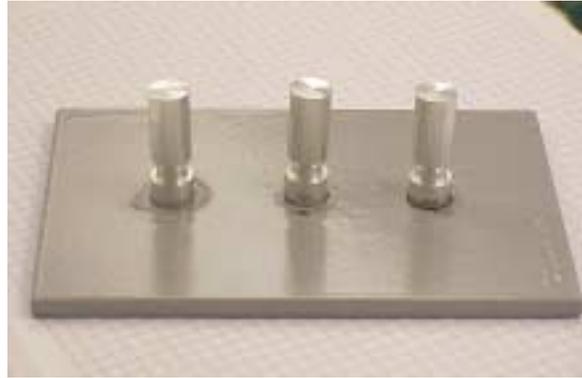
**Figure A-1. Aluminum pullers affixed to a test coupon with epoxy adhesive.**
