WSRC-TR-2000-00079

**Degradation and Failure Characteristics of  
NPP Containment Protective Coating Systems (U)  
Interim Report**

Division of Engineering Technology  
Office of Nuclear Regulatory Research  
U.S. Nuclear Regulatory Commission  
Washington, DC 20555  
NRC Job Code W6959

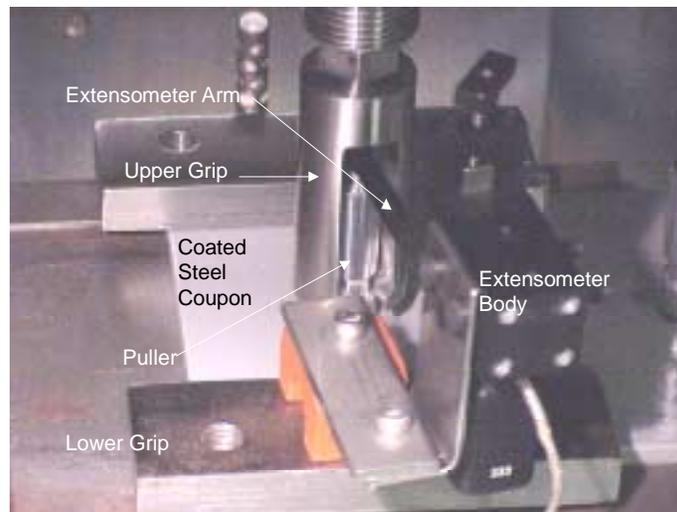
**Figure A-2. Extensometer and grip for aluminum puller.**

The upper grip for the pullers (design adapted from ASTM D5179-98 also) was machined with a pocket to accommodate the extensometer arm (Figure A-2). The upper grip was rigidly attached to a pull rod that was connected through a universal joint to a 20,000-lb load cell mounted in the Instron's fixed, upper crosshead. The lower grip held the 4-in. by 6-in. by 0.25-in. coupons and was connected rigidly to the Instron's moving crosshead. Threaded couplings with backing nuts were used to make rigid the connections between the upper pull rod and the upper grip and between the lower pull rod and the lower grip (Figure A-3). Two flexible couplings remained in the load chain: the universal joint through which the upper pull rod is connected to the Instron's load cell and the connection between the upper grip and the stud. These allow necessary motion for alignment, yet they require little force (compared to the load supported by the coating) to "set" themselves. A plumb bob was used to position the puller on the load axis. These steps ensure that the puller is pulled normally to the coupon (Figure A-4). The lower grip was equipped with a rectangular metal pan 1 in. in height that was filled with water to keep a test specimen wetted when experimental conditions demanded.

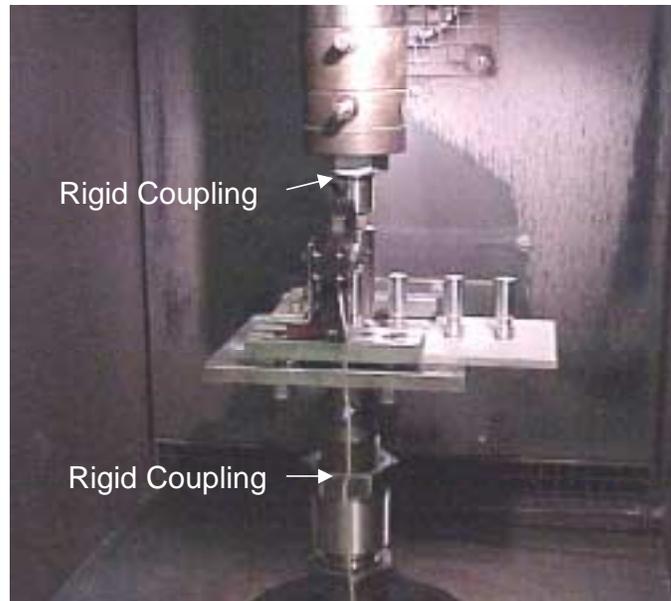
**Figure A-3. Rigid coupling of upper and lower grips to Instron.**

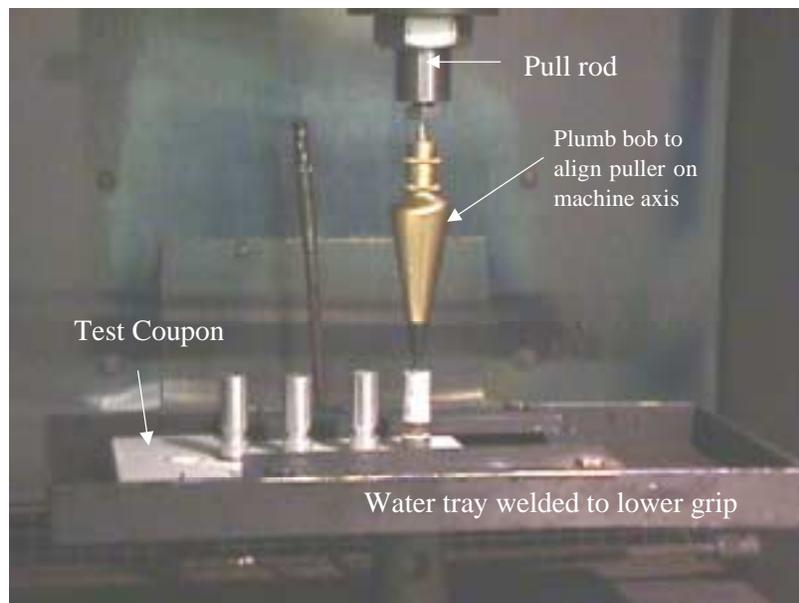
**Figure A-4. Plumb bob arrangement to locate center of puller on Instron load axis.**

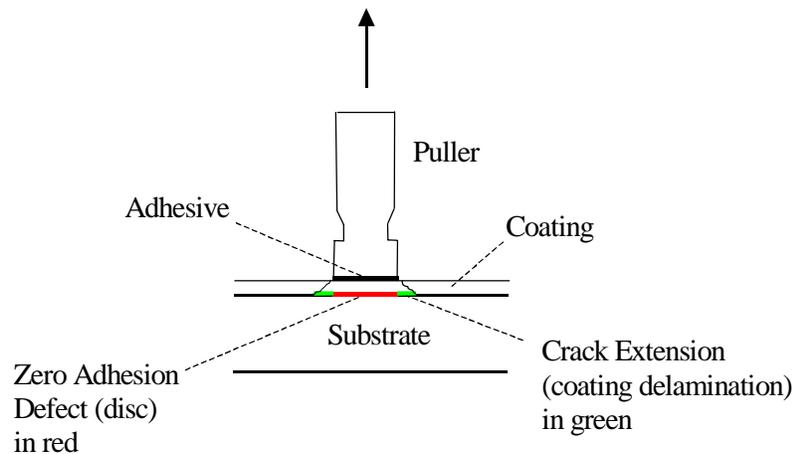
**Figure A-5. Schematic diagram of the adhesion G-value test.**

The concept of the adhesion G-value test is shown in Figure A-5. As the puller is displaced from the coupon surface the zero-adhesion (so-called type 1) defect propagates radially until failure. The zero adhesion defect is created on the substrate by the build-up of polytetrafluoroethylene (PTFE). The process for this is shown in Figure A-6. Half-inch diameter holes are cut in a flexible magnetic mask material. The mask is placed in careful alignment on a clean, blasted steel coupon. PTFE is delivered to the steel surface by an aerosol spray of PTFE dry lubricant in multiple applications to build up a dense white color. The prepared coupon is then coated with primer and topcoat. The same mask is used to guide the attachment of the pullers.

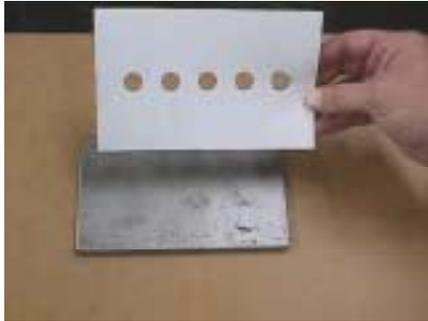
Flexible magnetic mask with 0.5 in. diam. holes

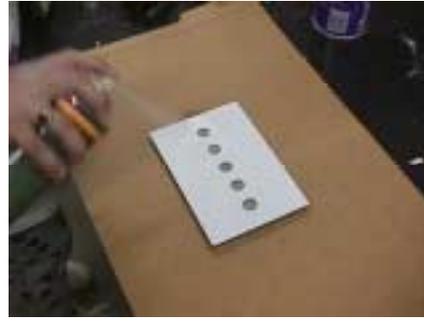
Polytetrafluoroethylene spray

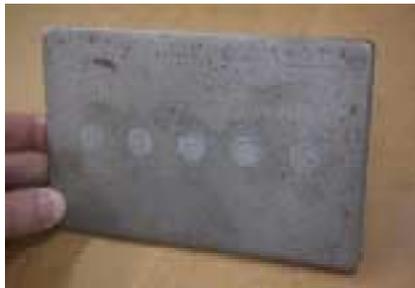
PTFE discs on steel coupon

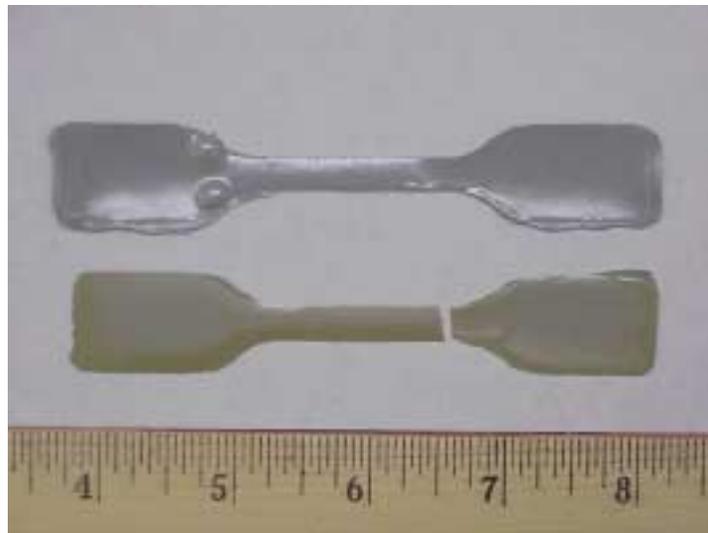
**Figure A-7. Tensile specimens of Amercoat 370, as cured (above) and irradiated and tested to failure (below).**

The tensile test employed so-called dogbone-shaped flat specimens that were cut from cured coating applied to a polyethylene sheet or that were molded on the sheet by spraying coating through a mask. The molded specimens were 4.5 inches in length overall with a 1.5-in.-long by 0.25-in.-wide gage section (Figure A-7). Specimens were pulled to failure at a crosshead speed of 0.02 in. per minute.

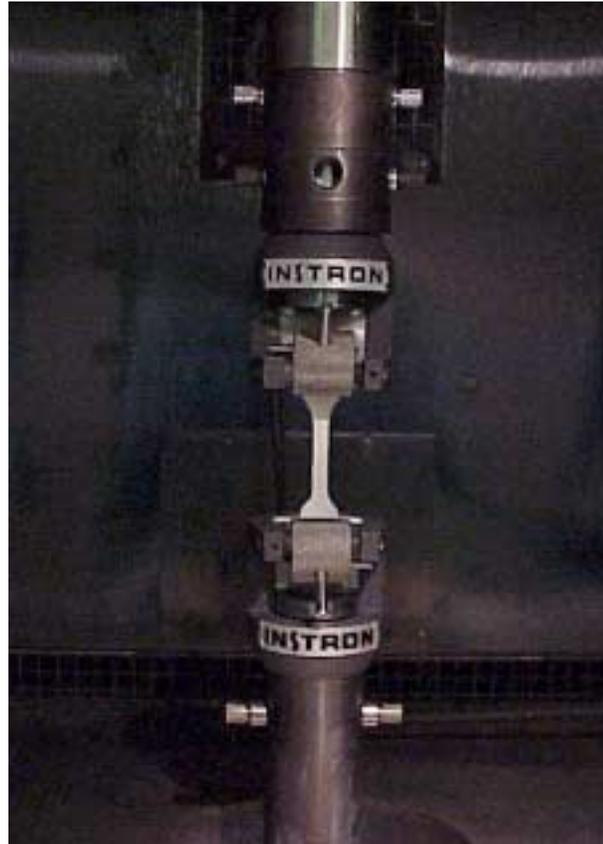
**Figure A-8. Tensile specimen fixed in knurled grips.**

The specimens were securely held in knurled grips designed for relatively soft materials (Figure A-8).

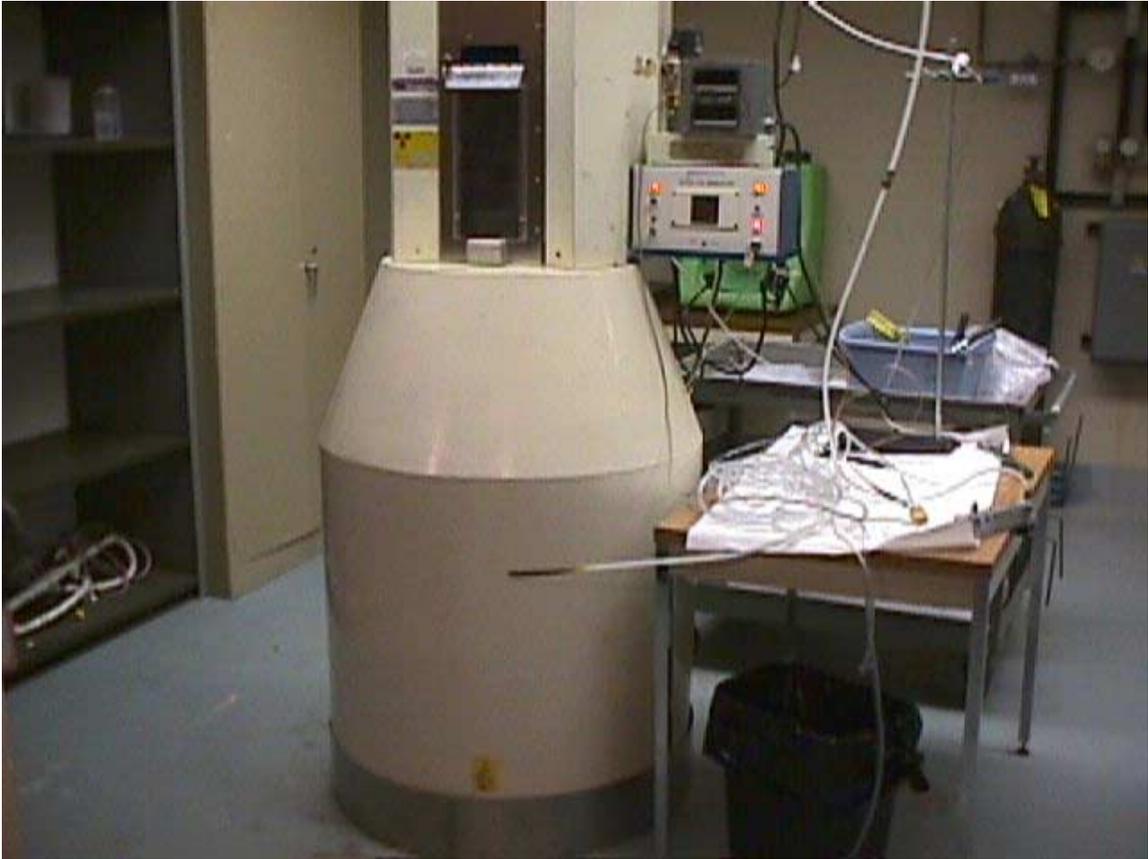
**Figure B-1. GammaCell 220**

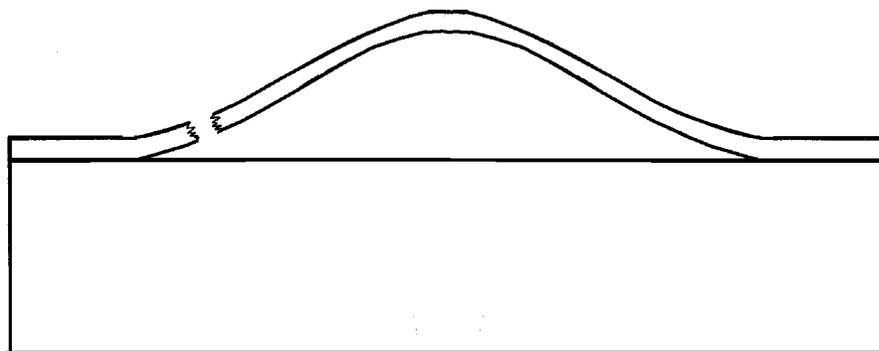
**Figure C-2. Mode 1 Coating Failure**

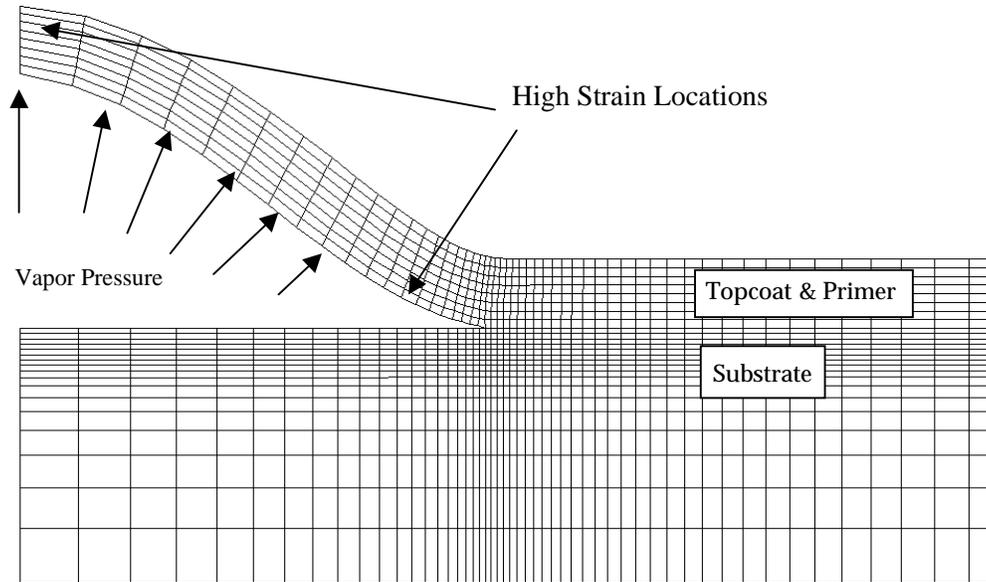
**Figure C-3. Blistering due to buckling and/or vapor pressure loading**

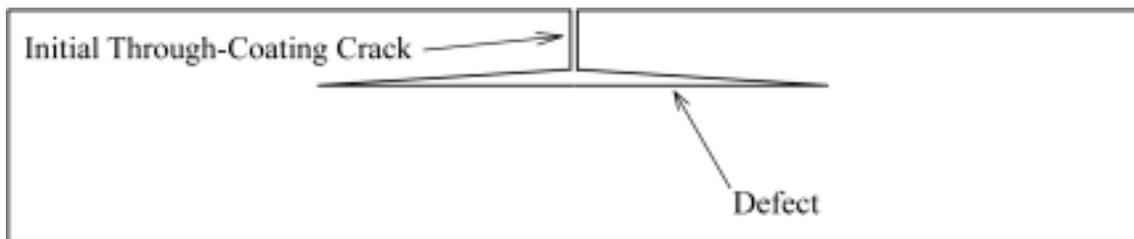
**Figure C-4. Model for Mode 2 Coating Defect Analysis**

A scratch-like crack penetrates through the topcoat to the primer or the substrate is assumed to exist. The main defect within the coating layer is perpendicular to this through-coating crack and is parallel to the coating layers (Figure C-4). Under the conditions of temperature variation and thermal expansion mismatch, this defect may peel back and the defect may grow when  $G_{\text{applied}} \geq G_{\text{material}}$ . Eventually it will fall off the NPP containment wall when the condition  $\epsilon_{\text{applied}} \geq \epsilon_f$  or  $\sigma_{\text{applied}} \geq \sigma_{\text{ult}}$  is met. A deformed shape near the peel-back defect calculated by the finite element method is shown in Figure C-5.

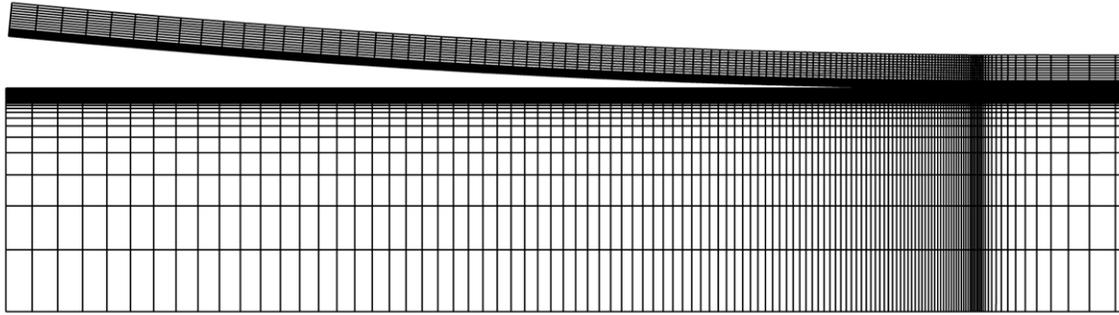
**Figure C-5 - Peel-Back due to thermal expansion mismatch ( $\alpha_{\text{topcoat}} < \alpha_{\text{primer}}$ )**

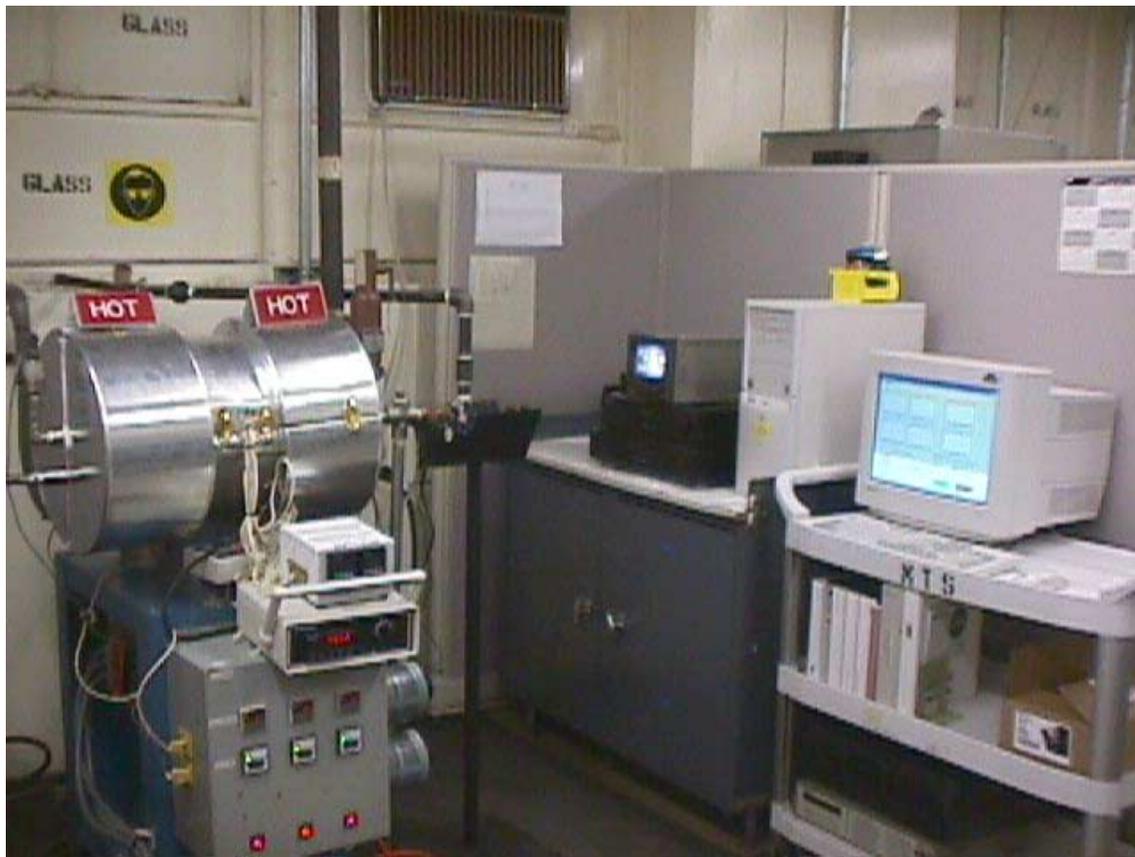
**Figure D-1. SRTC Coatings Performance Evaluation System**

The SRTC coatings performance evaluation system (Figure D-1) is used to examine the performance of NPP coatings in conditions simulating those expected to exist in a DBA LOCA. Figure D-2 shows a test specimen being placed into the coatings performance evaluation system. It is currently being used to simulate DBA conditions specified in ASTM D3911-95 (Figure D-3). However, most of the SRTC tests have been abbreviated to permit examination of a large number of samples (Figure D-4).

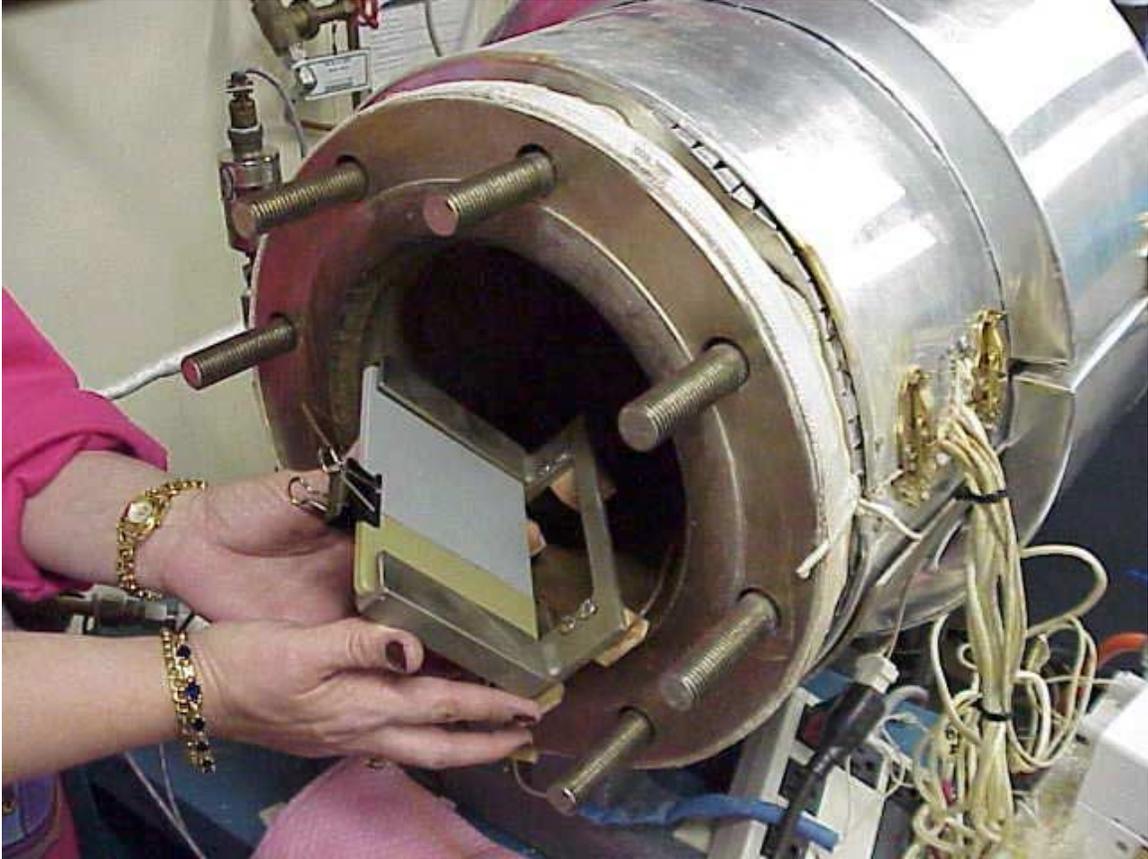
Figure D-2. Test Specimen being placed into the Coatings Performance Evaluation System

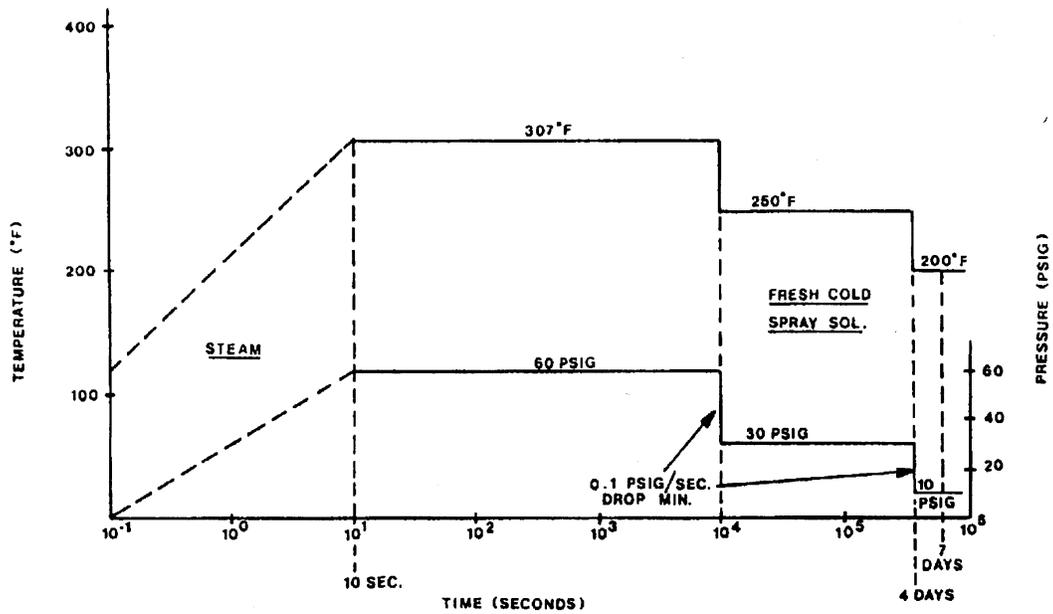
Figure D-3. Typical Pressurized Water Reactor Design Basis Accident (DBA) Testing Parameters (from ASTM D3911-95). (Note: The ASTM figure contains an error: 30 psig should be 15 psig, which is equivalent to 30 psia).

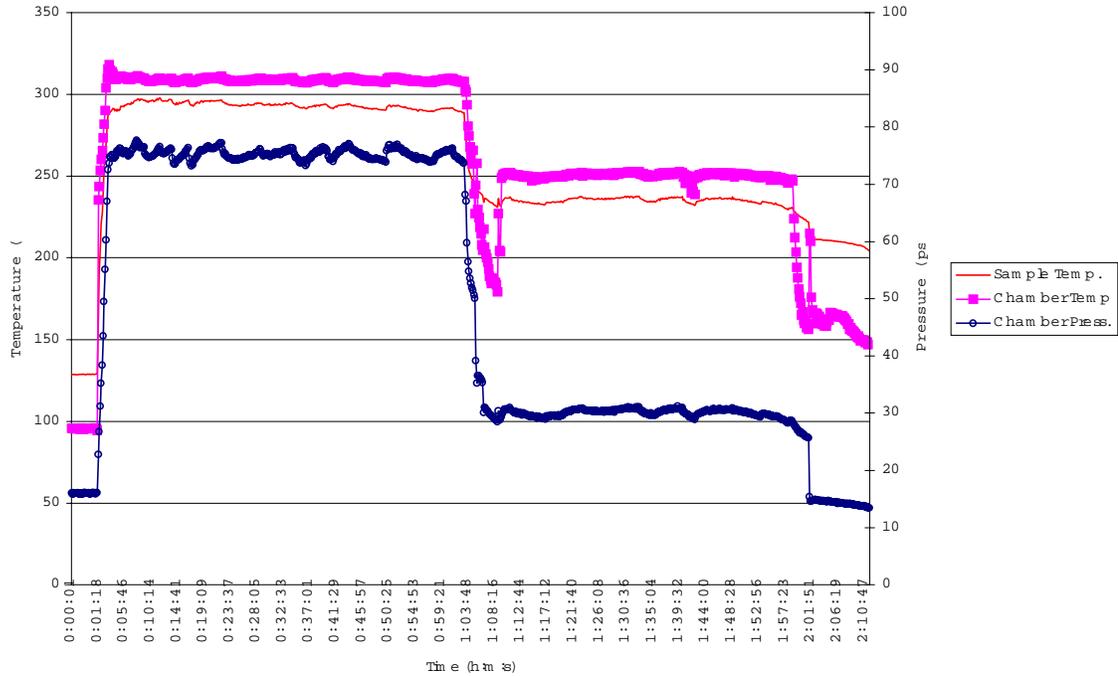
**Figure D-4. Typical SRS “Abbreviated DBA” Cycle. Note: Sample cool-down time has been omitted from the figure.**

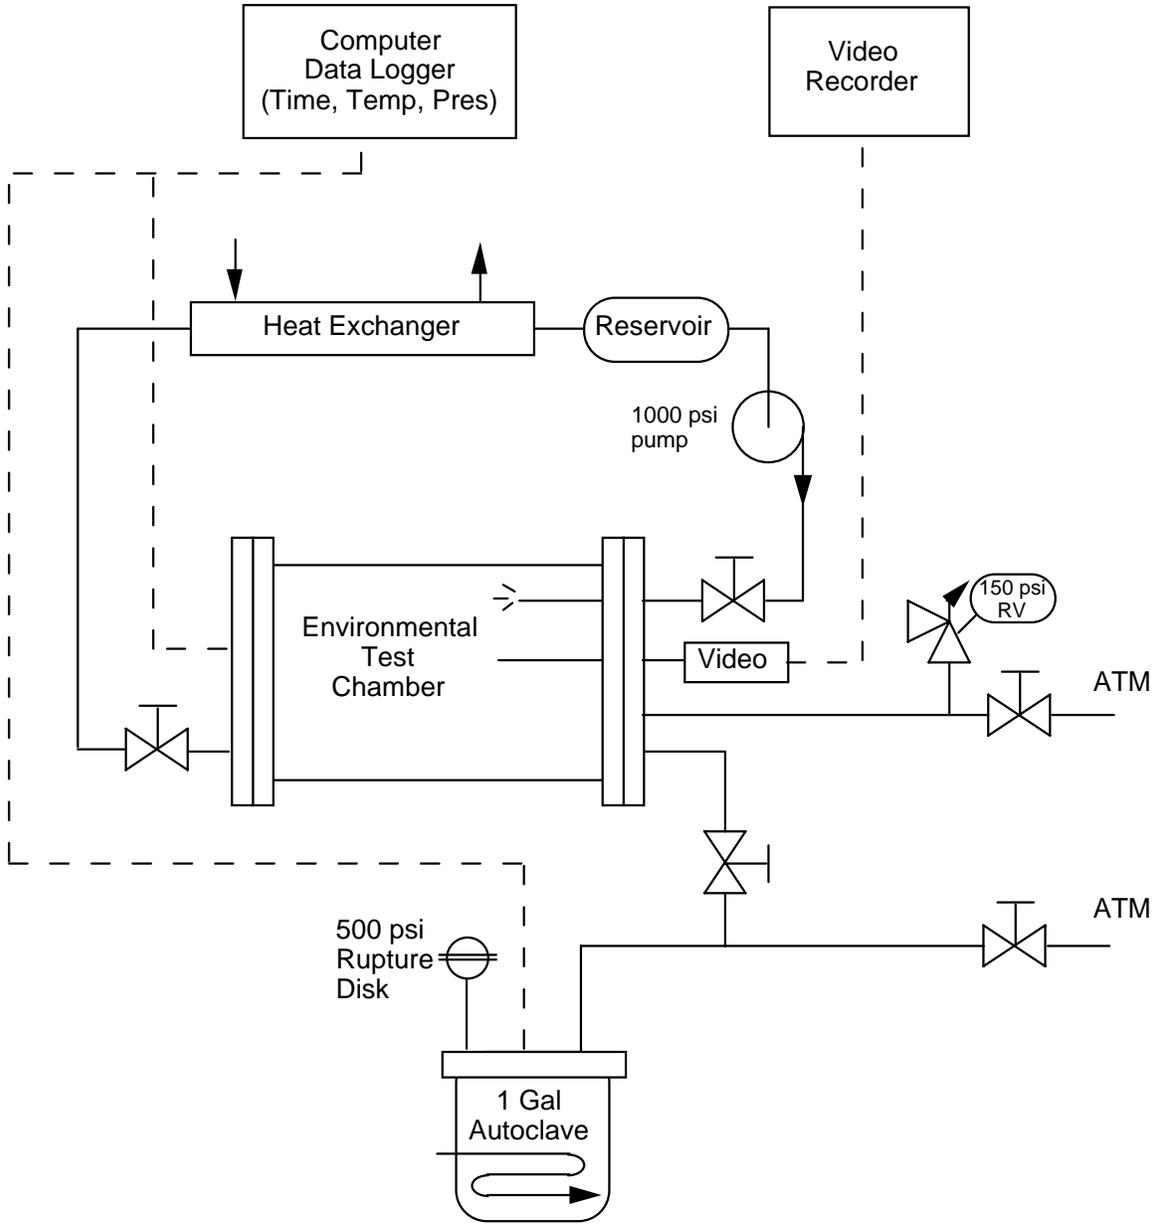
Figure D-5. Process schematic of coatings performance evaluation system

The cool-down phase of the ASTM D3911-95 DBA cycle, which simulates activation of the emergency spray cooling headers in the NPP, is facilitated by a spray system installed in the test chamber. The system consists of a 1000 psi Baldor pump, a heat exchanger to cool the spray solution that is recirculated from the bottom of the chamber, and a storage reservoir. Solution is supplied to the chamber through 0.25-inch diameter tubing. Two metering jet spray nozzles are installed in the chamber, each providing up to 0.030 gpm in a fine mist. Other spray configurations and rates are possible. All materials are Type 316 stainless steel to provide corrosion resistance to various spray solution compositions.

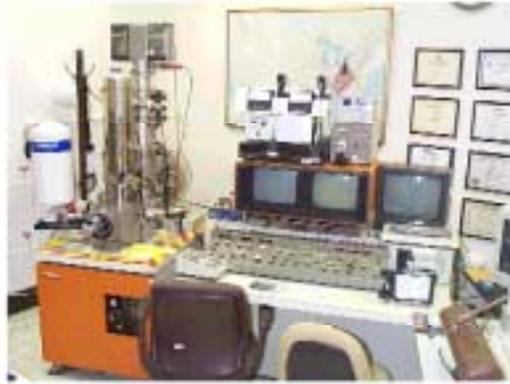
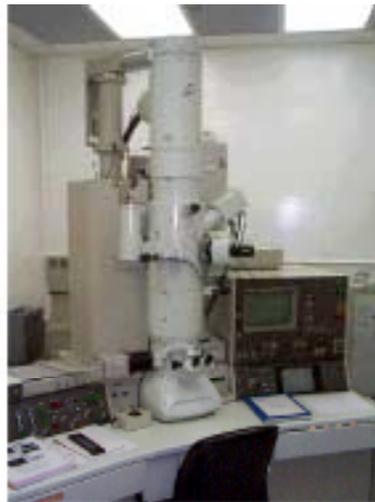
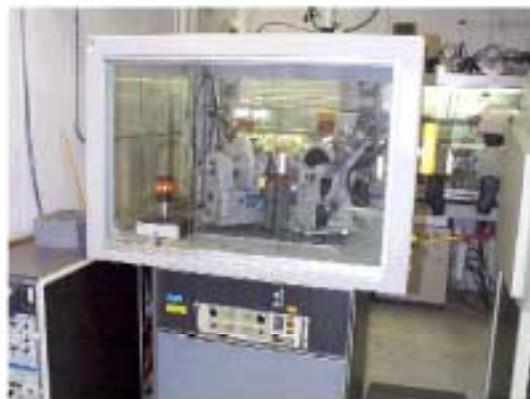
**Figure F-1. SRTC Analytical Capabilities: Scanning Electron Microscope (top), Transmission Electron Microscope (middle), and X-ray Diffraction Unit (bottom)**

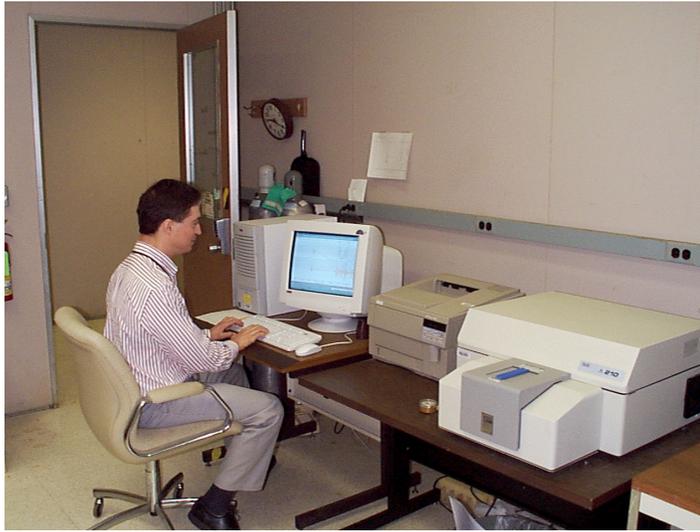
**Figure F-2. FT-IR Spectrophotometry Equipment**

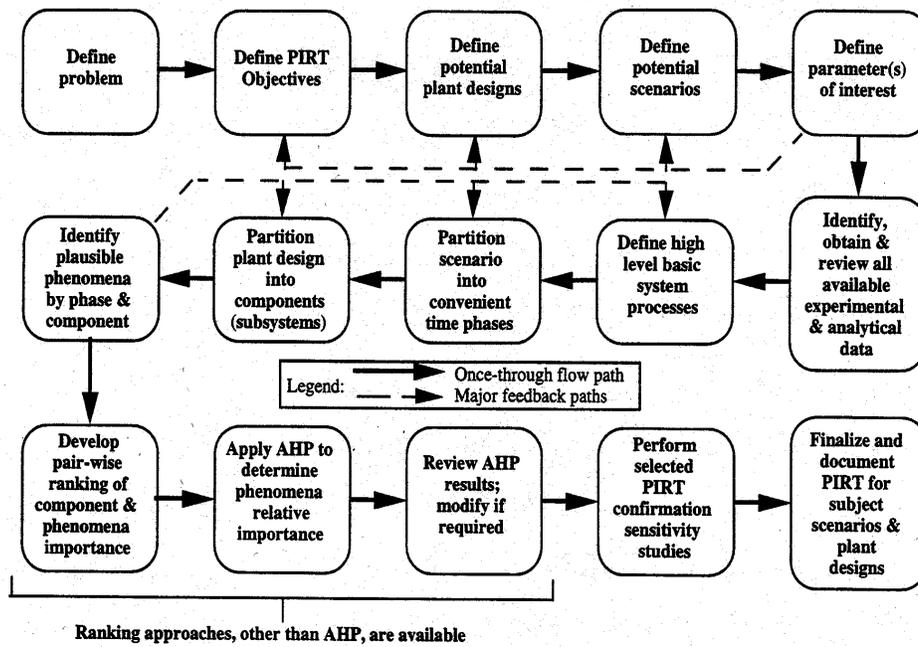
Figure G-1. PIRT Process

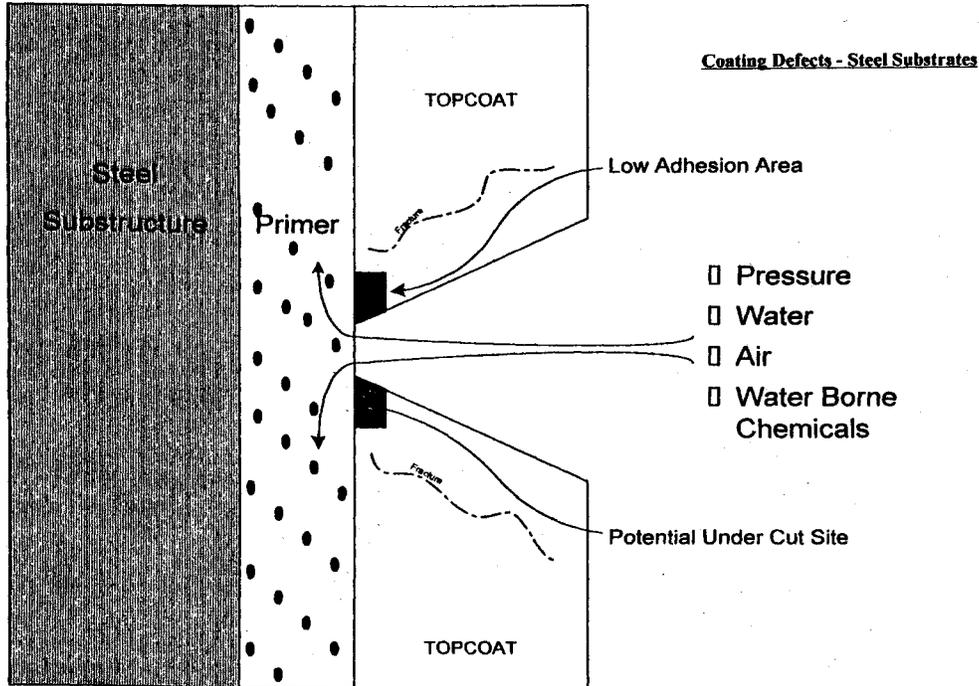
Figure G-2. Coating Defects and Phenomena of Importance
