SUBJECT: ARKANSAS NUCLEAR ONE, UNIT 2 RE: PROPOSED LICENSE
AMENDMENT ON SETPOINT CHANGES AND RELATED ITEMS FOR
THE REPLACEMENT STEAM GENERATORS (TAC NO. MA7299)

Code Weld Repair of Pressurizer Heater Penetration

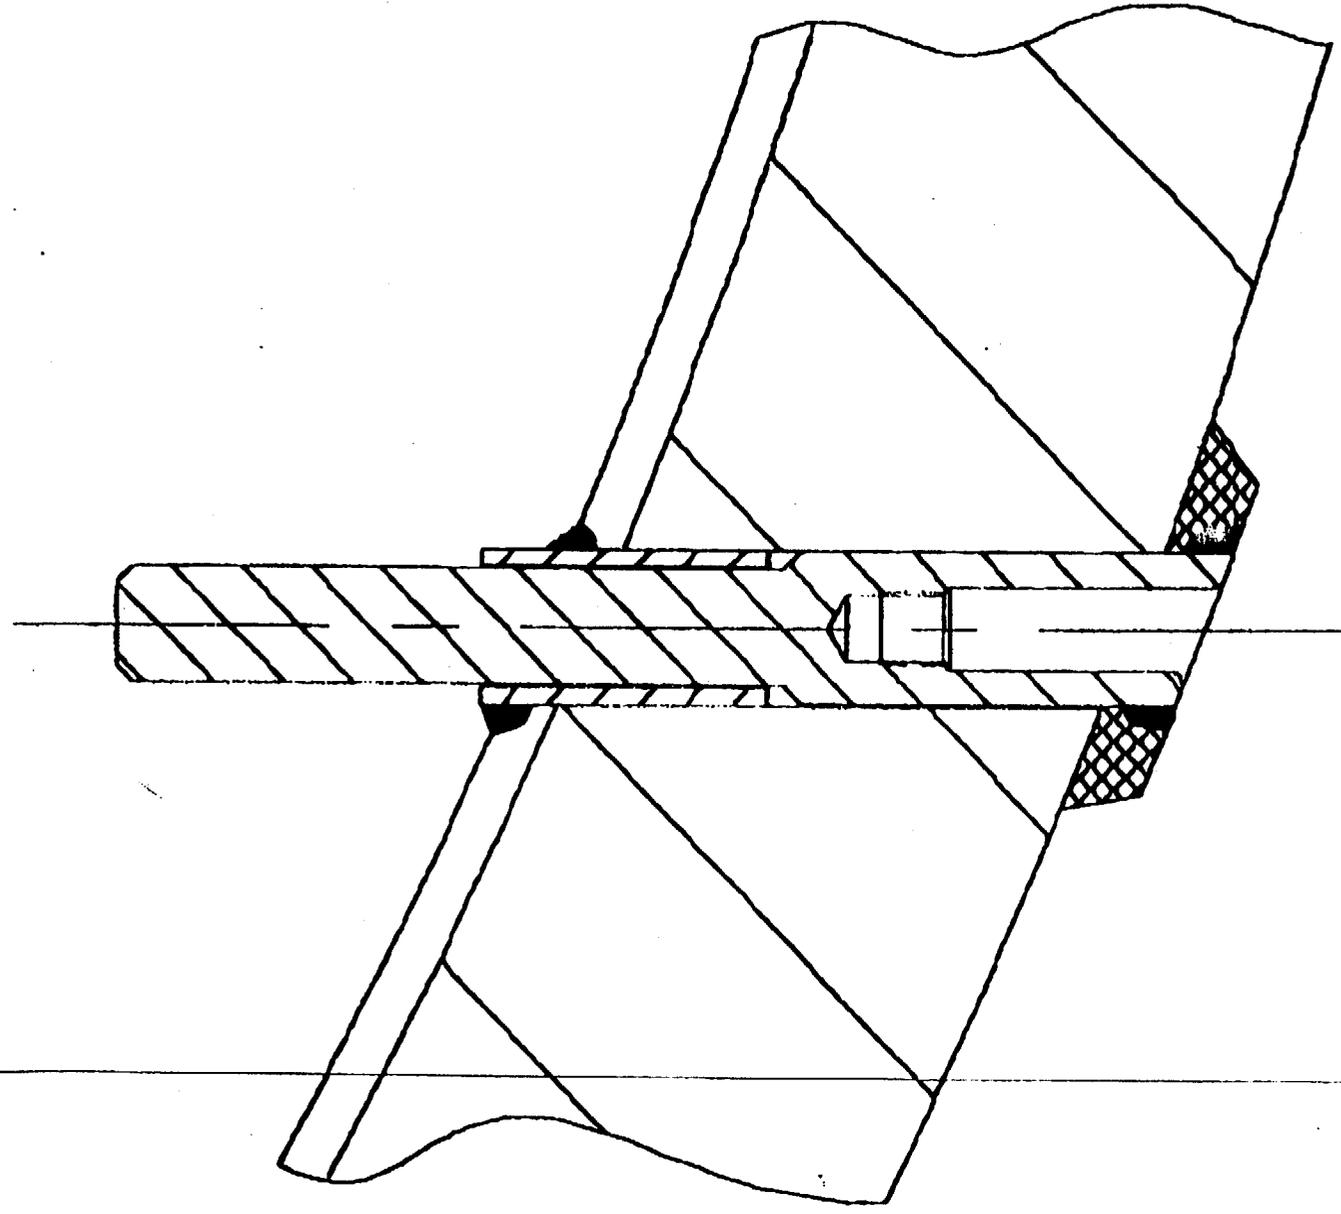
FIGURE 1

As shown in Figure 1 the repair consists of partially removing the existing heater sleeve and replacing it with a dummy heater welded to the outside of the head. The end configuration meets the requirements of NB-3300 and specifically is intended to be a Category D attachment to a Class 1 pressure vessel. Figure 2 shows the dummy sleeve (manufactured in accordance with NB-2000) inserted and ground flush with the OD of the head. The dummy heater does not bottom out against the existing heater sleeve.

The hole meets the reinforcement requirements of NB 3330. Install Plug flush with vessel.

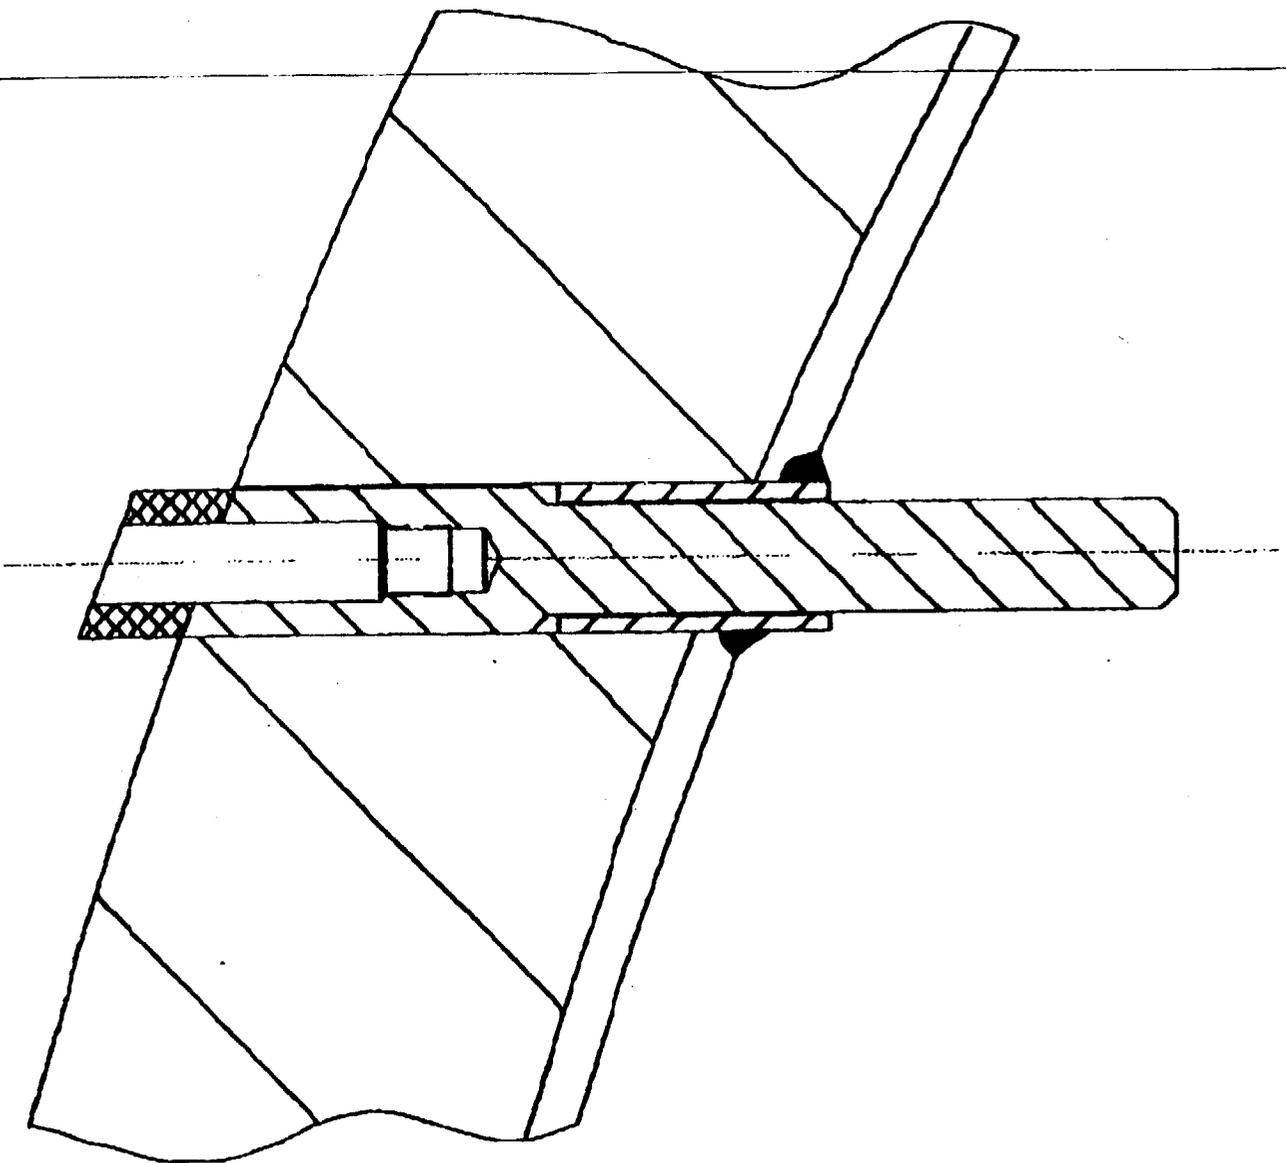
FIGURE 3

Figure 3 illustrates performing a weld build-up on the end of the nozzle. Note this is an artificial step but this could have been performed in accordance with NB-4130 "Repair of Material" the volumetric requirement of NB-2539.4 (Radiography) is not performed but an Ultrasonic examination in accordance with IWA-4530. NB-2500 has no specific provision for substituting UT for RT but this is common practice for Section XI repairs. Also remember this is an artificial step for illustration purposes.

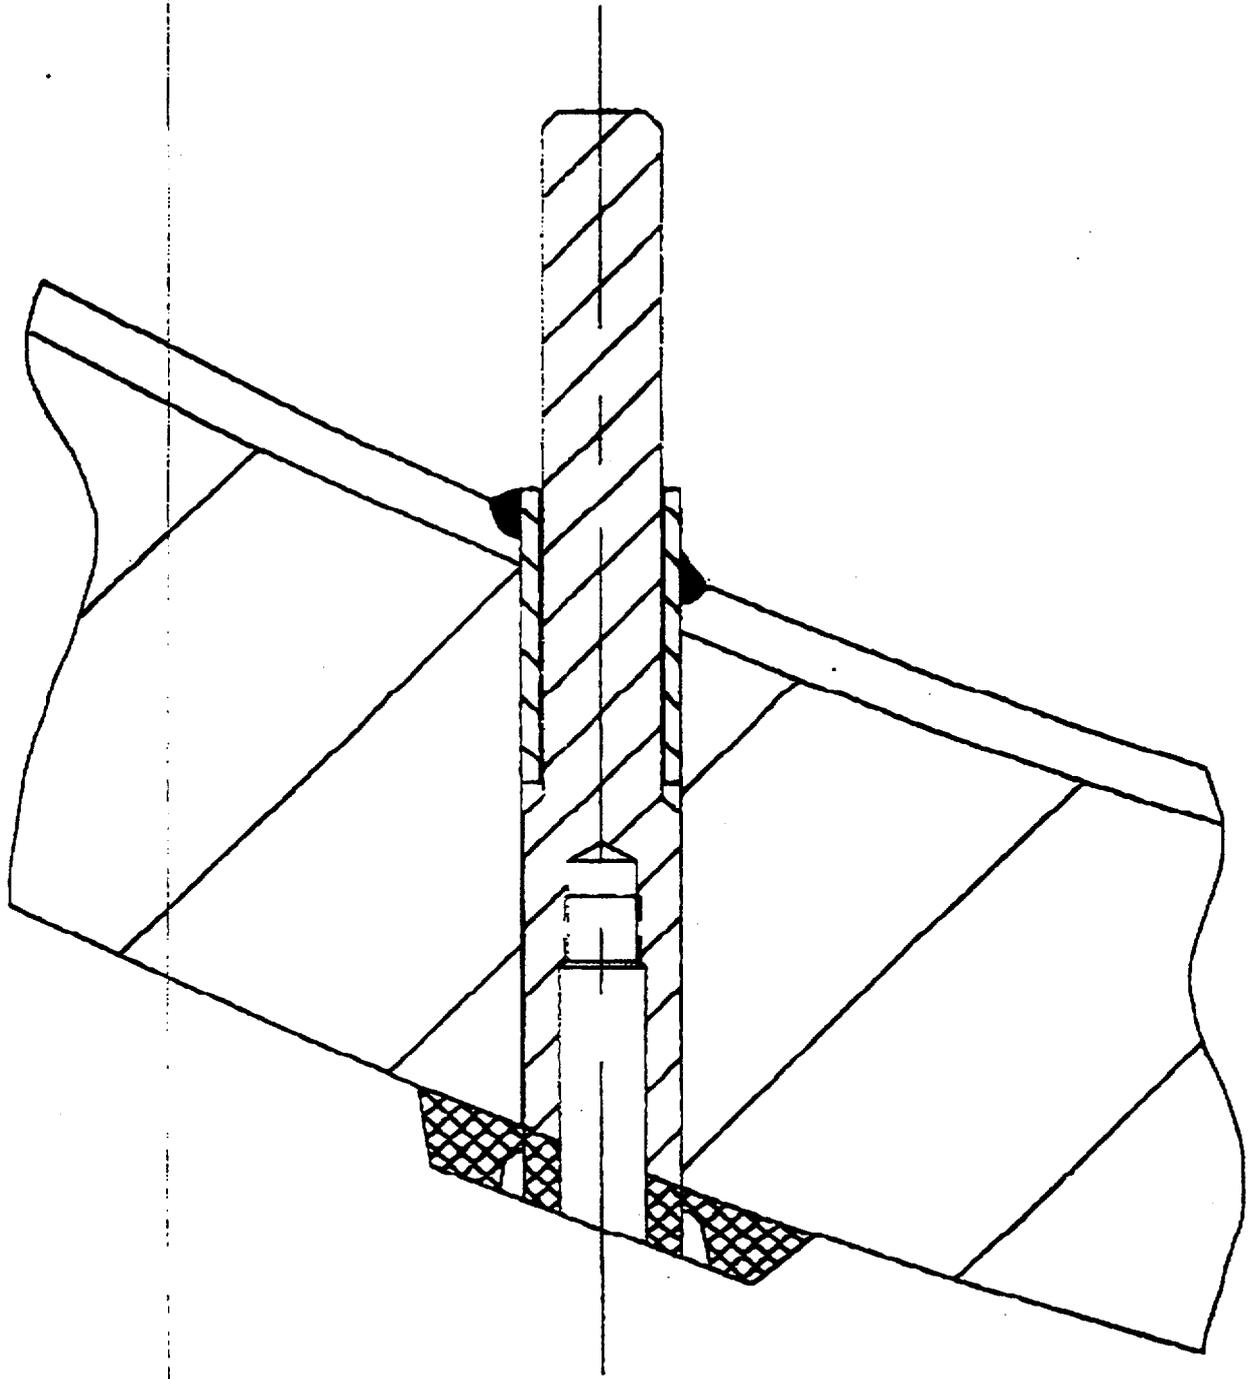
FIGURE 4

Figure 4 illustrates construction of the weld pad in accordance with IWA-4530 leaving a J-prep adjacent to the nozzle which has dimensions sufficient to meet the partial penetration weld requirements of NB-3352.4 and Figure NB-4244(d)-1 (a). The penetration and repair geometry also meet the reinforcement requirements of NB-3300.

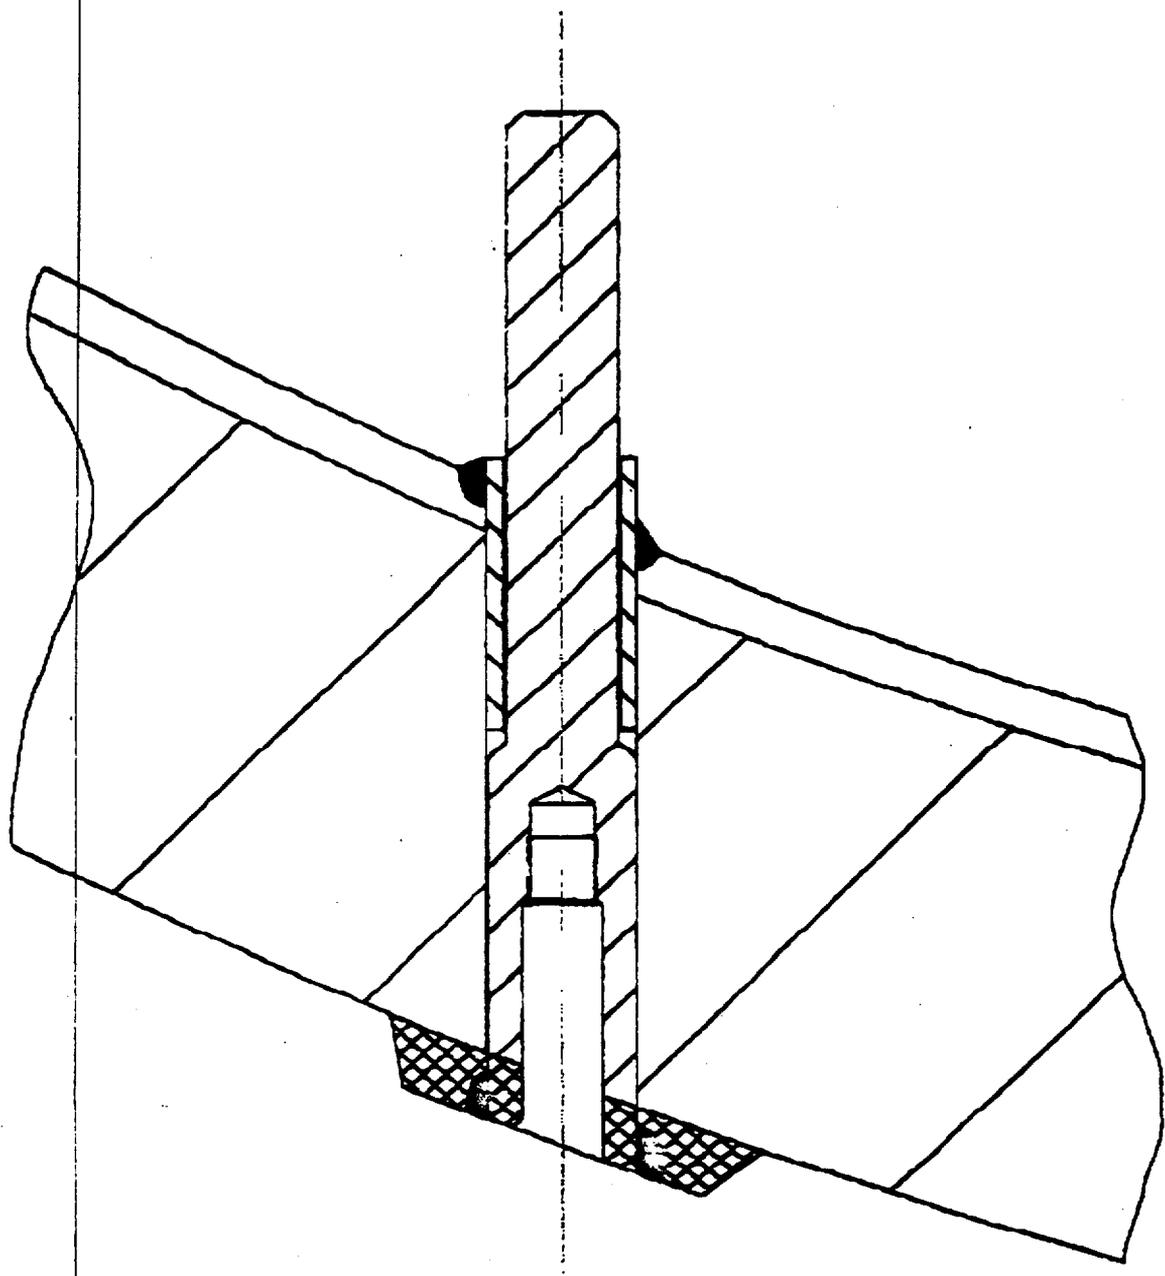
FIGURE 5

Figure 5 illustrates filling the J-prep in accordance with the Code WPS and again the weld meets all of the sizing and NDE requirements Section III and Section XI as applicable.

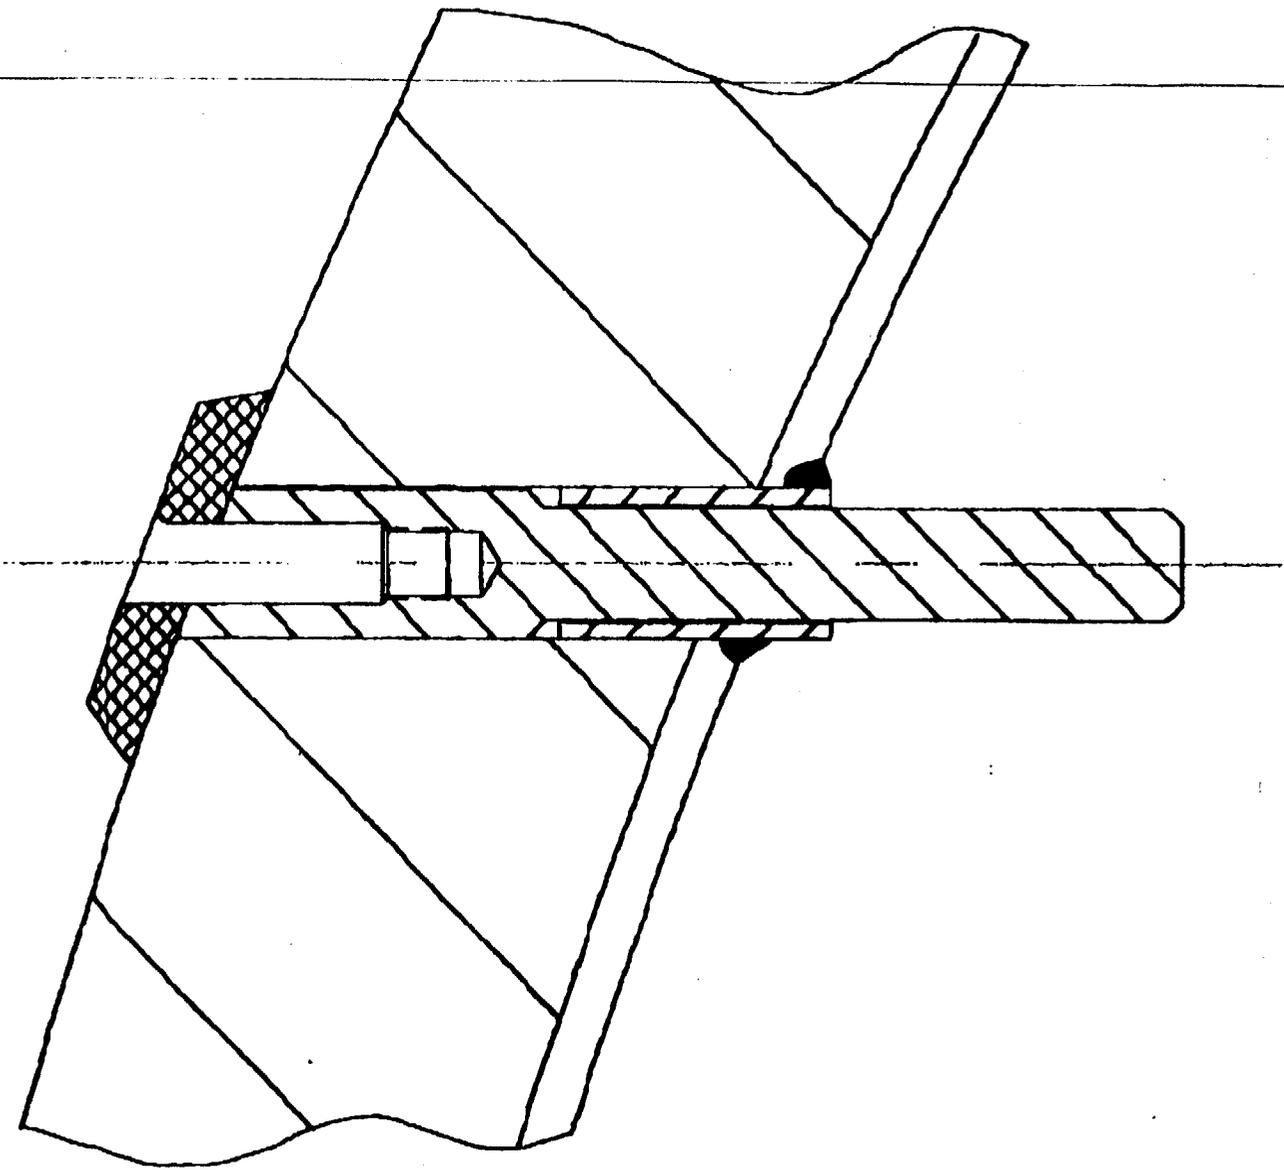
FIGURE 6

The final Figure 6 illustrated the actual as finished weld which is welded continuously except for the stops required for intermediate NDE. Again the pad satisfies at least the NDE requirements of a partial penetration weld in accordance with NB-5260 (dye penetrant) and the additional requirements of IWA-4500 UT of final configuration).

It is therefore concluded that the repair meets all of the applicable requirements of Section III and XI.
