Re: Decommissioning Plan and Cost Estimate for license no. 37-00030-02

Decommissioning Cost Estimate
for Safety Light Corporation
Bloomsburg, Pennsylvania
NRC Material License No. 37-00030-02

Prepared by:
GTS Duratek
Radioactive Solutions
628 Gallaher Rd.
Kingston, TN 37763

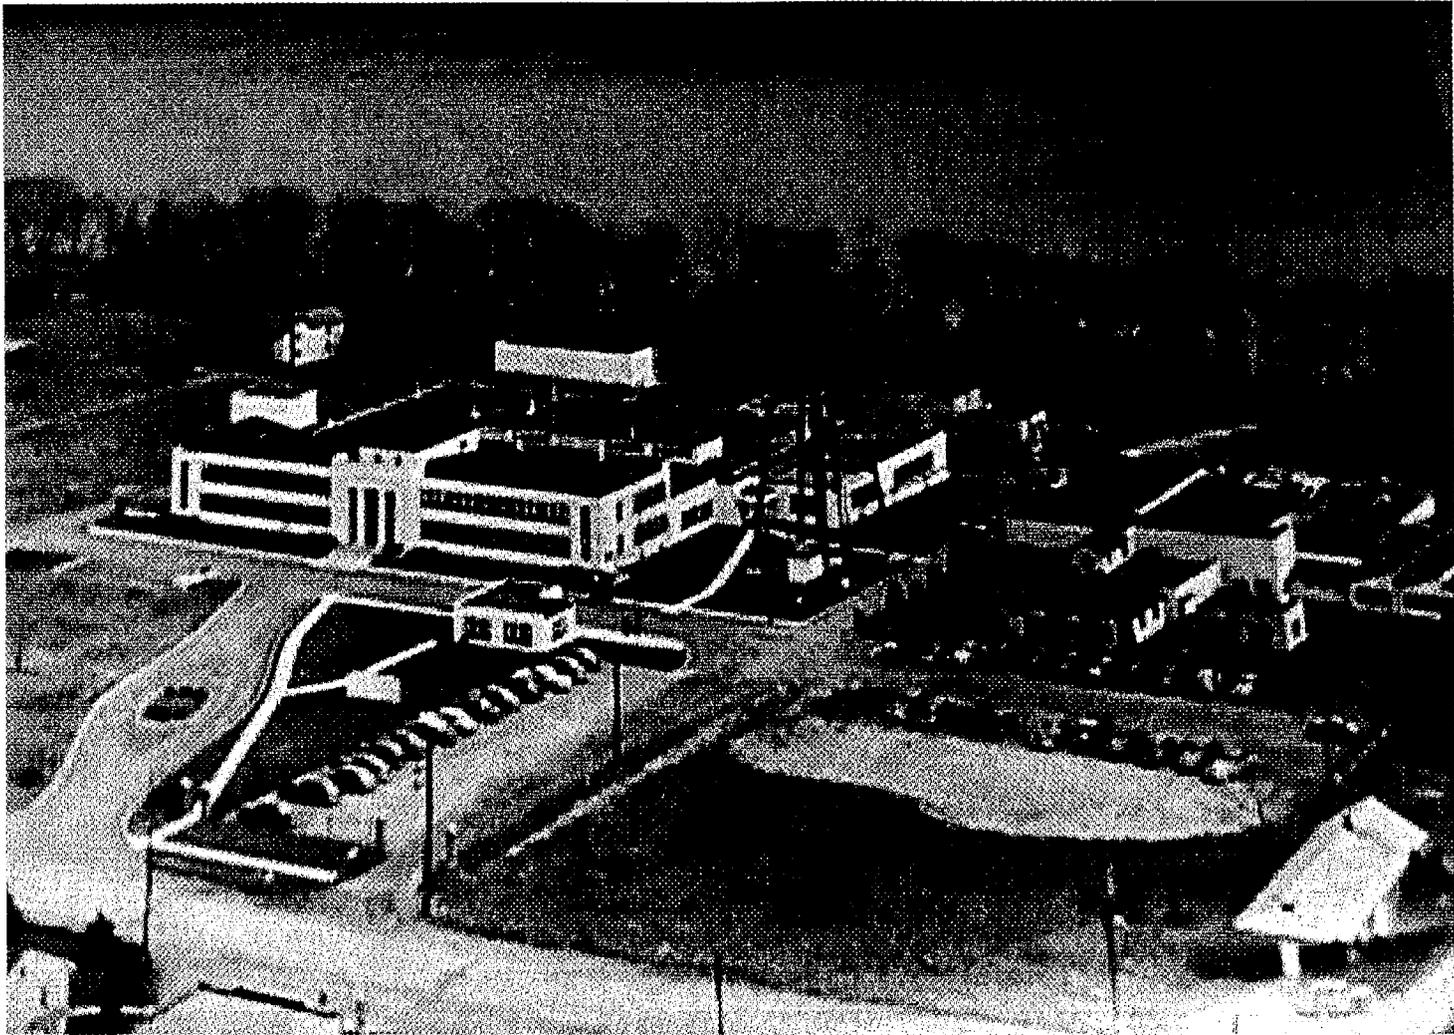
Figure 2-1 Safety Light Facility

An old aerial photograph of the site appears in Figure 2-1, Safety Light Facility. Figure 2-2, Plan of Safety Light Facility shows existing buildings and features. This decommissioning cost estimate does not address the nuclear building, machine shop, solid waste building, and liquid waste building, which support current operations under NRC License 37-00030-08.

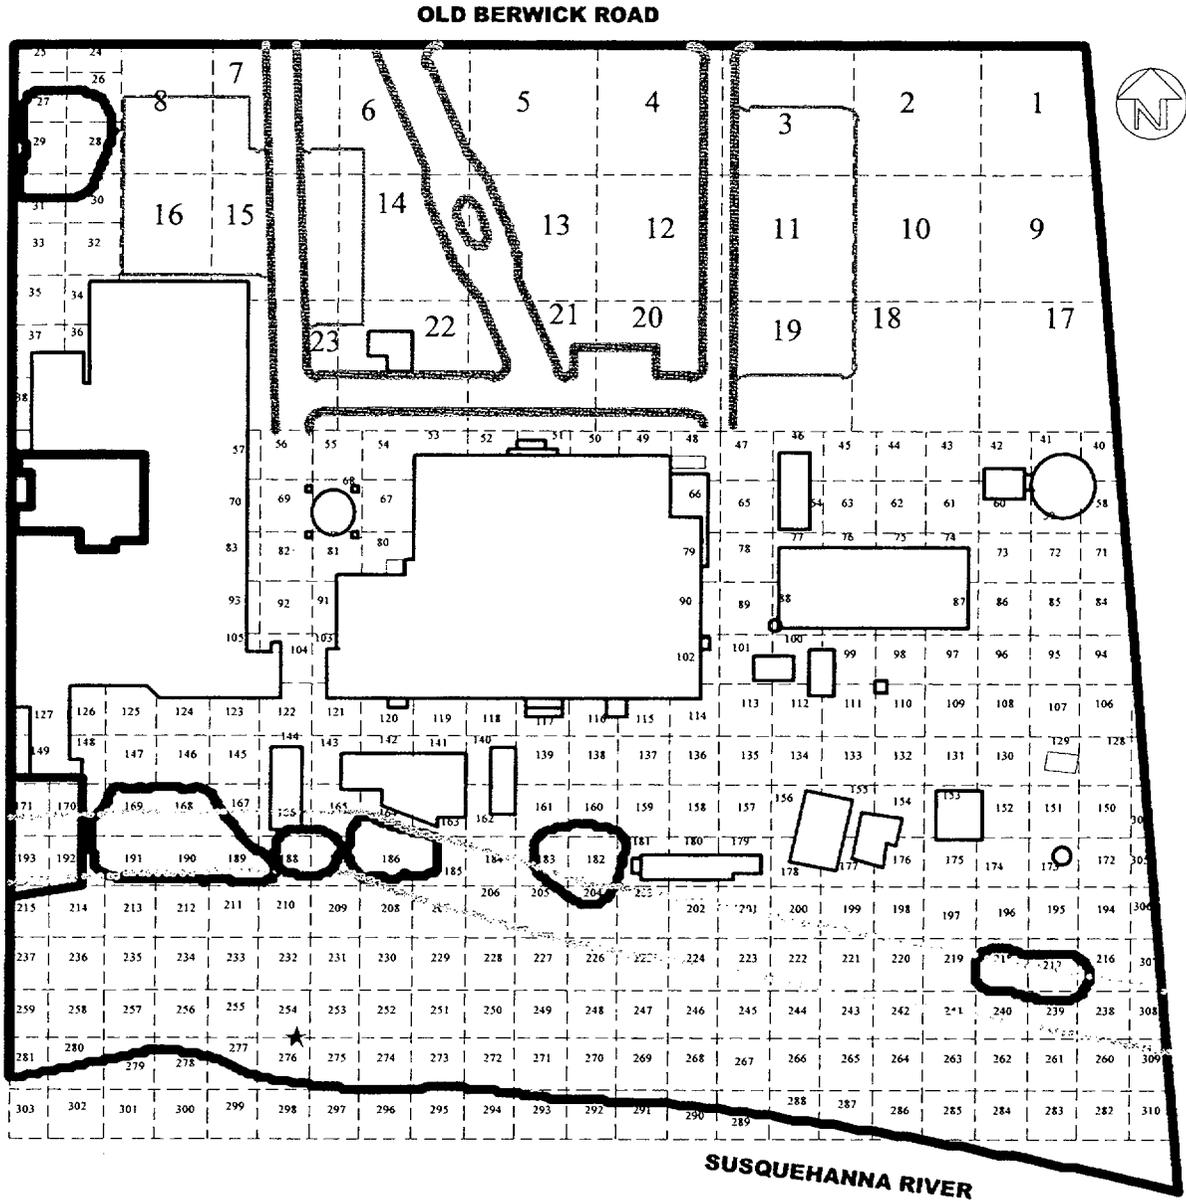
Figure 3-1 Outdoor Grid Pattern for the Safety Light Facility

The 1995 site characterization (Monserco 1996) included direct measurements of accessible structures and equipment and soil and water sampling. The principle radionuclides of interest are cesium-137, radium-226, and americium-241. Cobalt-60, strontium-90, polonium-210, and tritium were also detected. The outdoor area surveys were performed after establishing a grid pattern for the site. This grid pattern is shown in Figure 3-1. Figures 3-2 and 3-3 show the relative cesium-137 and radium-226 activity found in surface soils by survey grid.
