The Radiological Accident in Istanbul

The objective of this report is to compile information about the causes of the accident, the subsequent emergency response and the medical aspects of the overexposures. The information is intended for the use of national authorities and regulatory

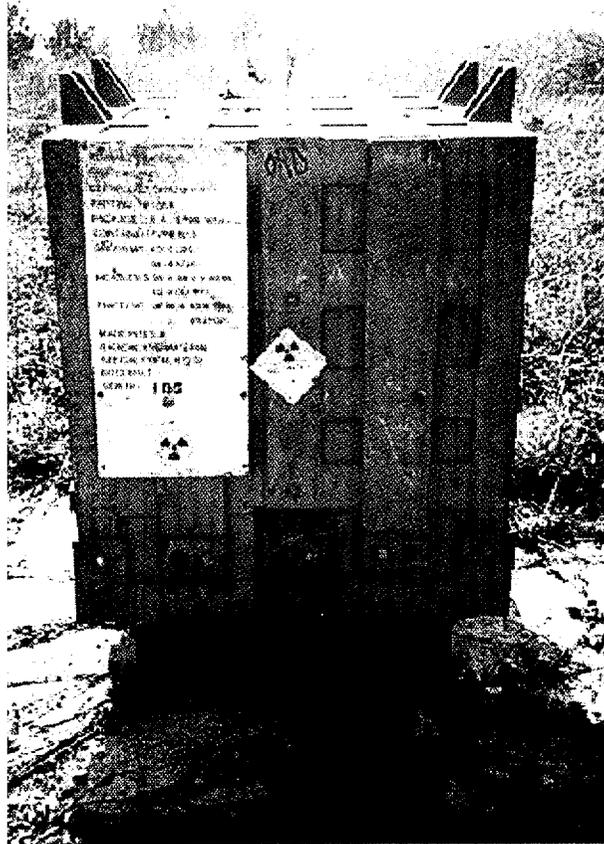
Photograph 1. Type B (U) transport package.

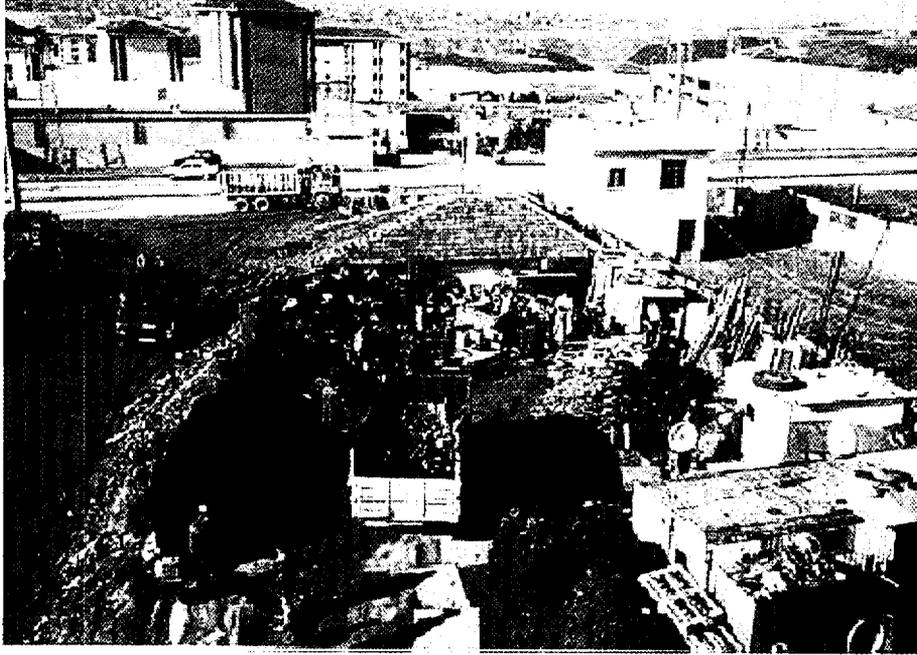
Photograph 10. The scrapyard (Ziya Gökalp).

- (14) The unshielded source(s) is/are thought to have remained in the yard until 27 or 28 December 1998. The scrap metal (apart from the lead: see item (16)) was then loaded by hand and with a shovel onto a truck and taken to a larger scrap metal dealer in the same area, Ziya Gökalp (see Fig. 5 and Photograph 10).

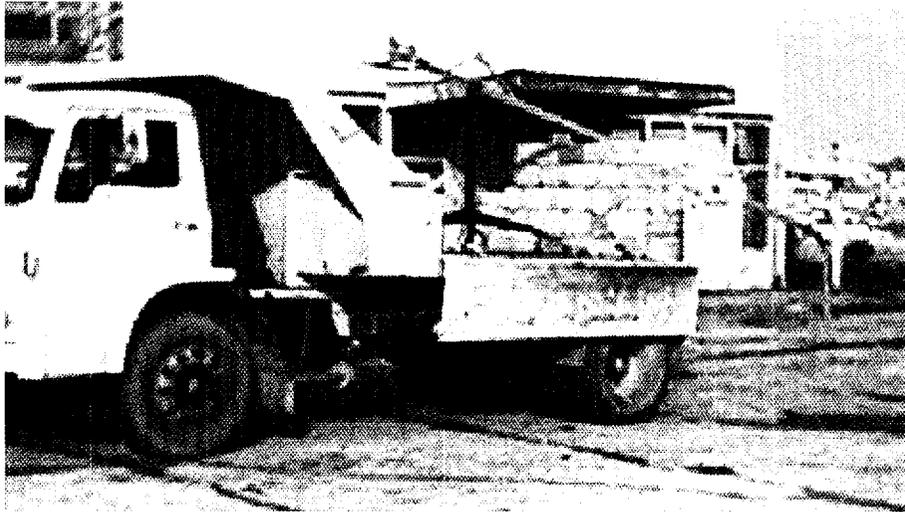
Photograph 13. Truck equipped with a ratemeter to measure high dose rates.

- (2) A radiation detector capable of measuring very high dose rates was attached to the end of a long boom. This was mounted on the back of a truck and a 50 cm thick wall of barite concrete blocks was assembled to shield the boom operator (Photograph 13). The truck was reversed into the yard and the detector was used to locate the source.

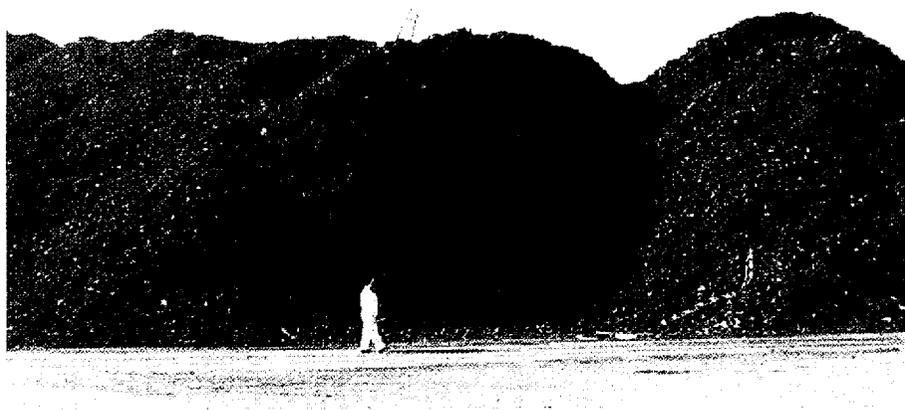
Photograph 15. Scrap metal pile in the field of the smelting factory in Izmit.

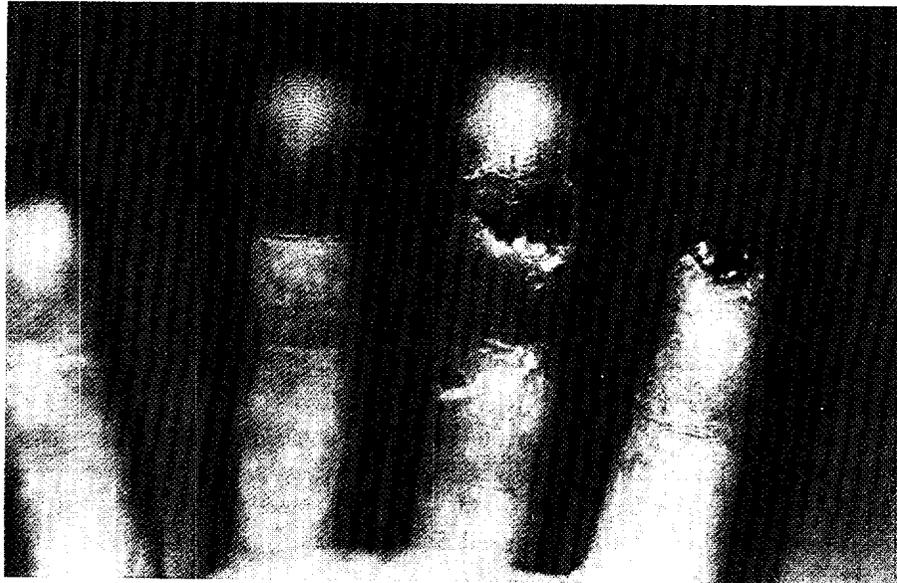
Photograph 17. Ulcerated third finger of patient 1 MI 14 months after an acute radiation exposure in Istanbul on 13 December 1998. The first phalanx of the second finger was amputated in November 1999. Since then some ulcerative–necrotic changes have developed.

- In April 1999, an X ray examination of the right hand showed a slightly thinner bone tip of the first phalanx of the second finger, where the skin had also become thinner.
- In July 1999, the three phase bone scintigraphy showed slightly decreased perfusion and X rays revealed osteoporosis and soft tissue atrophy on the tip of the first phalanx of the second finger. Flexion limitation of the proximal interphalangeal joint was noticed. There was no sign of infection or pain.

Abnormal sensation on the tip of the second finger was expressed. The other fingers were functioning normally.
