SUBJECT: Oconee Nuclear Station - Unit 1
Docket No. 50-269
Request to use an Alternative to ASME Boiler and
Pressure Vessel Code, Section XI in accordance with
10 CFR 50.55a(a) (3) (i)

Request for Alternative, Serial Number 00-04

Request for Alternative to the Requirements of the
ASME Boiler and Pressure Vessel Code, Section XI

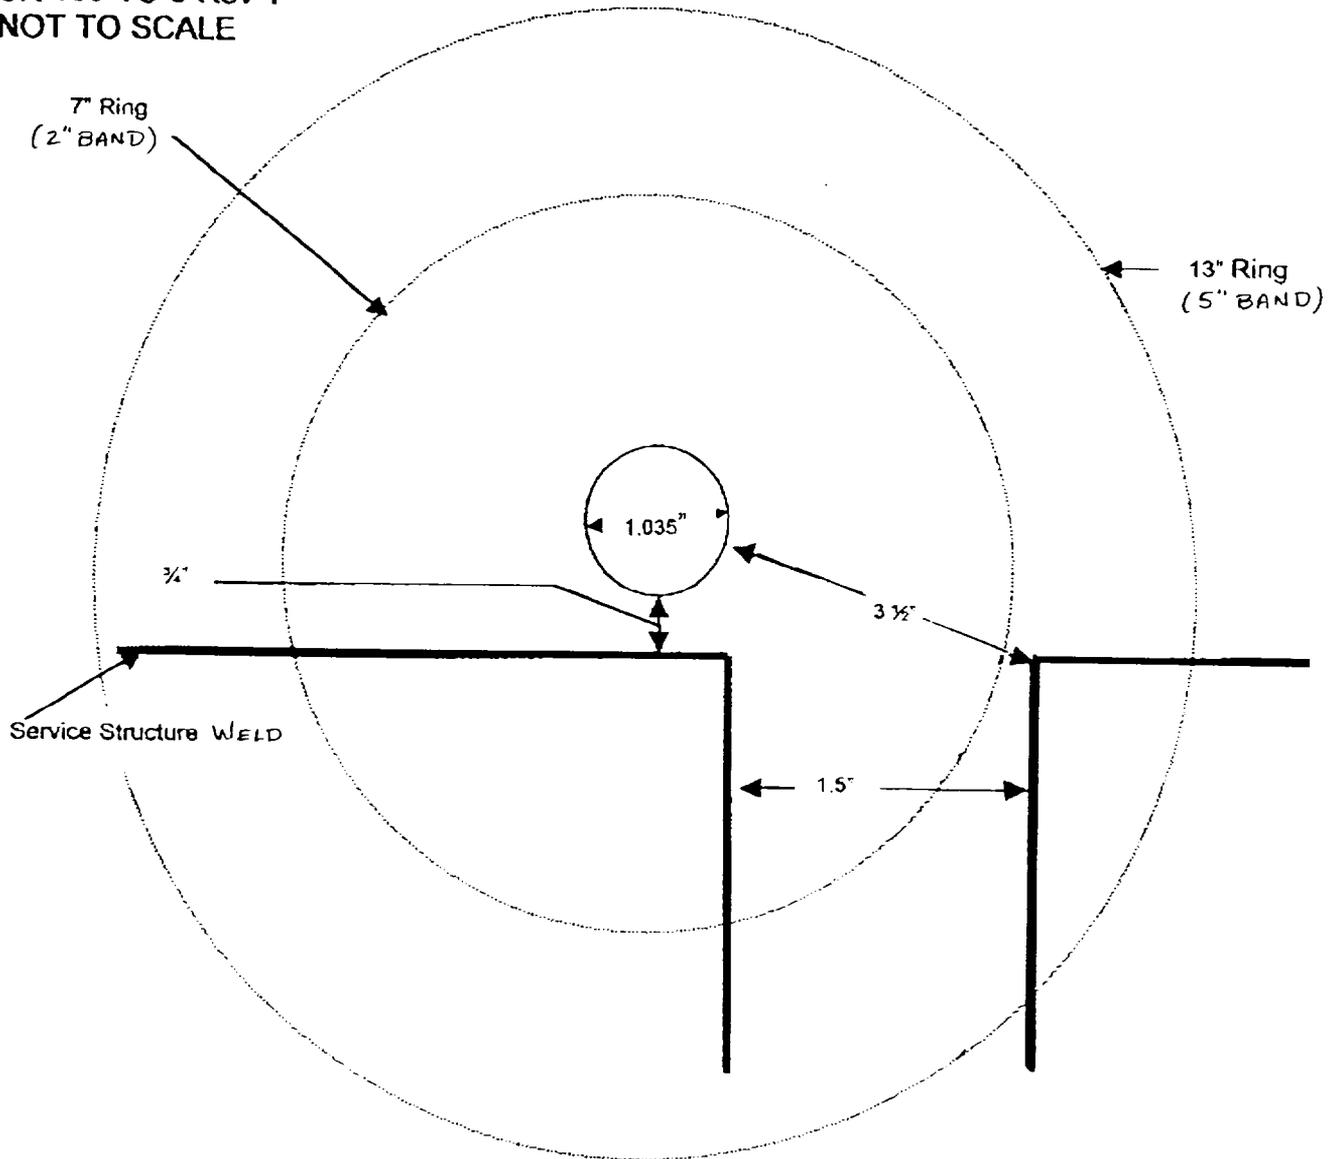
Thermocouple #5
SK-100-TC-5 Rev 1
NOT TO SCALE

Diagrams of band surrounding the two repair areas are provided on the following two pages.

LUG WELD

Service structure
SUPPORT WELD

1. Within the band around the weld repair, as defined by IWA-4500 (e) (2), several interference(s) exist that would prevent using the liquid penetrant examination method over 100% of the band area. It is proposed that the band area exclusive of the interferences will be examined by the liquid penetrant method. A diagram of the band area surrounding the thermocouple nozzle penetrations #2 and #5 repair areas showing the interferences is attached.
