# Assessment of Environmental Qualification Practices and Condition Monitoring Techniques for Low-Voltage Electric Cables

Condition Monitoring Test Results

Brookhaven National Laboratory

U.S. Nuclear Regulatory Commission  
Office of Nuclear Regulatory Research  
Washington, DC 20555-0001

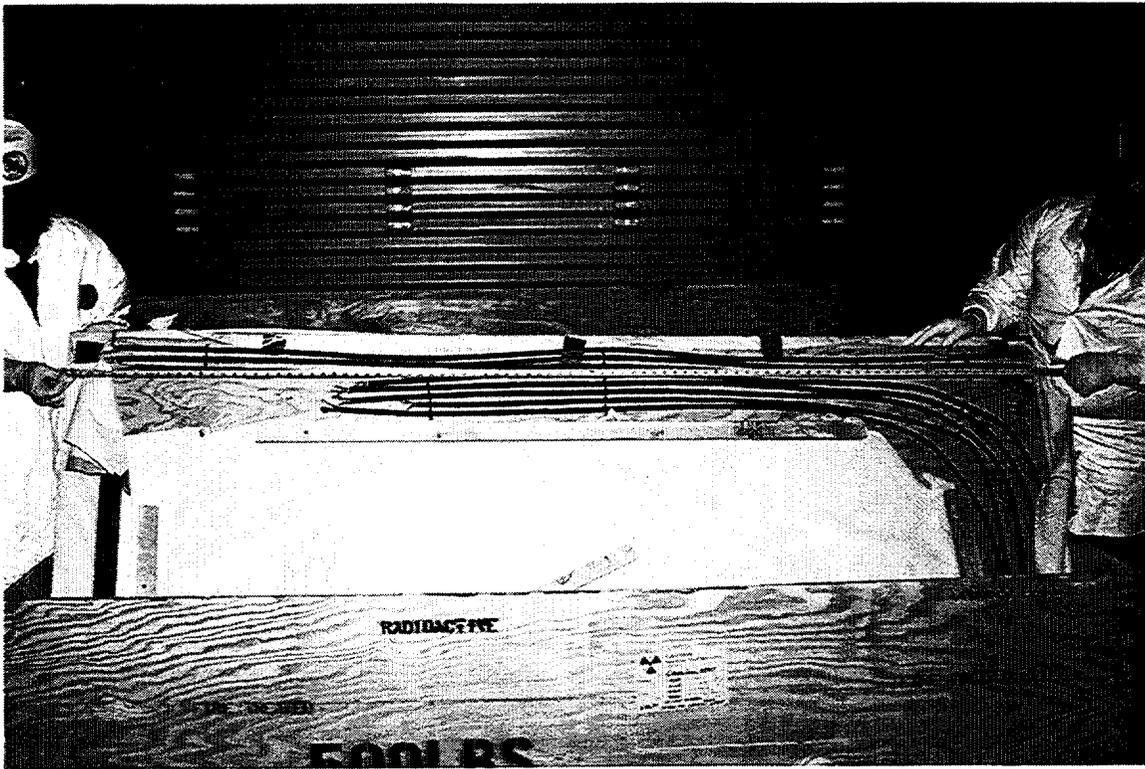
**Figure 2.1 Naturally aged cables installed on plywood boards to protect them during shipping**

Depending upon the cable (unaged or naturally aged), different types of packaging were utilized to protect the cables during transport between the plant site and BNL. Naturally aged cables which were installed in a straight configuration were transported in PVC tubes which were capped at both ends. Naturally aged cables with bends were attached to sheets of plywood to immobilize them and maintain their installed configuration, then placed in wooden crates to protect them during shipping (Figure 2.1). Unaged cables were coiled according to acceptable handling practices, and shipped in barrels, crates, or on pallets. Prior to removal from the plant site, each cable was radiologically surveyed to detect any fixed or loose contamination.

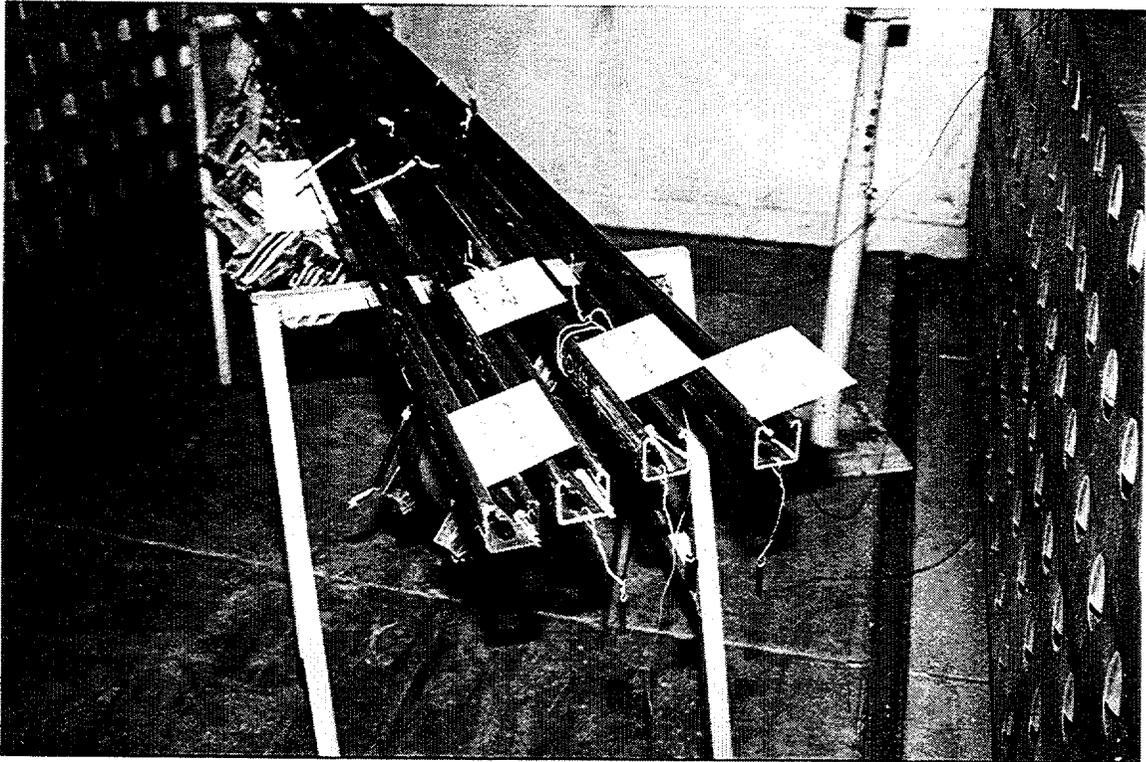
**Figure 2.2** Typical long specimens installed in Unistrut® shown in thermal aging oven

Several of the long cable specimens were placed in individual steel Unistrut® channels to simulate a typical physical configuration of cables installed in a power plant, i.e., straight horizontal cable trays or conduit. The Unistrut® channels also served to protect the cable specimens from damage during handling. Approximately one inch of insulation was removed from the conductors on both ends to allow splices to be made to facility wiring to energize the long specimens. The cables were held in place using Tefzel® tie wraps, which were applied by hand just tight enough to hold the cable snugly and prevent it from moving. Figure 2.2 is an end view of four typical Unistrut® channels with individual long cable specimens on a test fixture in the thermal aging chamber.

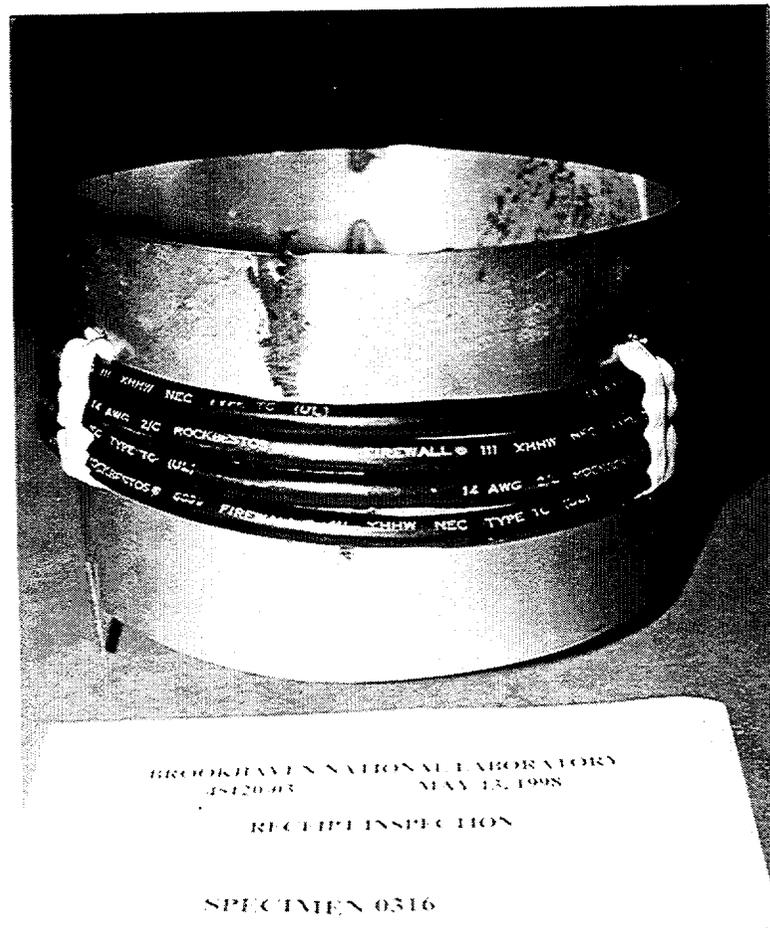
**Figure 2.3 Typical long specimen installed on a mandrel**

The remaining long specimens were installed on stainless steel mandrels to simulate actual qualification testing. The specimens were tied to the mandrel using stainless steel wire, which was also applied by hand just tight enough to hold the cable snugly and prevent it from moving. A piece of fiberglass tape was placed between the stainless steel wire and the test specimen to prevent the wire from cutting into the test specimen jacket. Figure 2.3 shows a typical long specimen mounted on a mandrel.

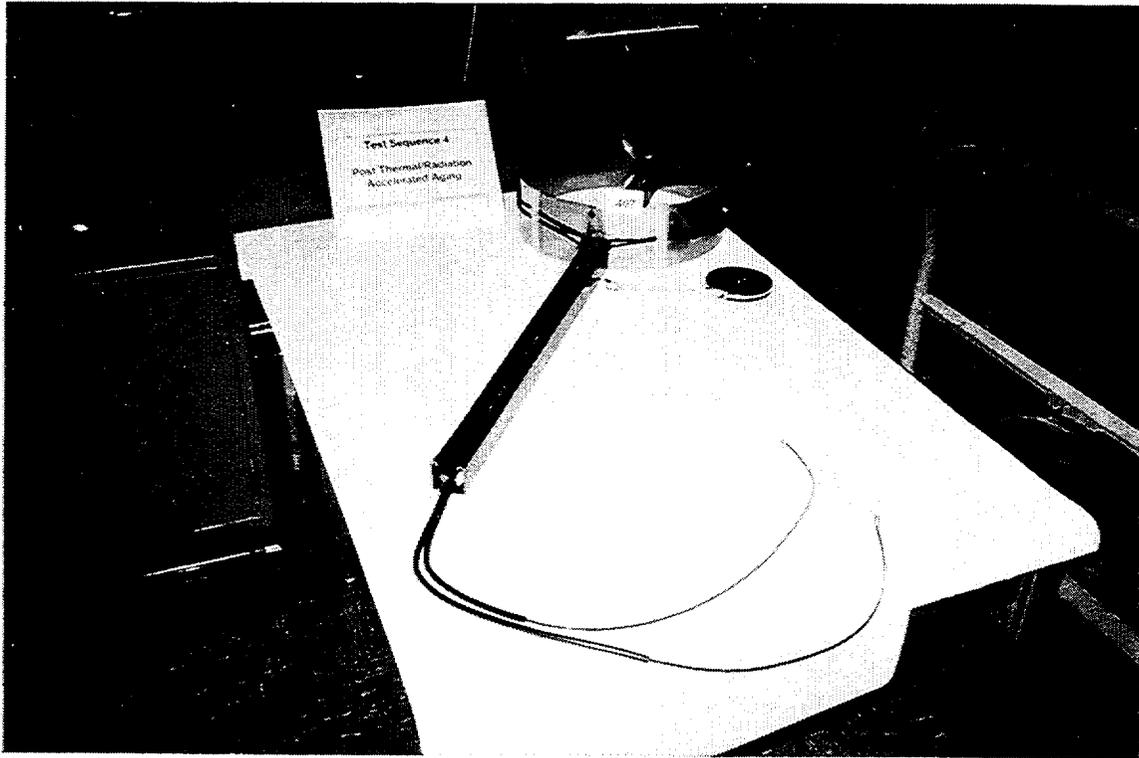
**Figure 2.4 Typical specimen mounted on a mandrel with a modified design for tests 4, 5 and 6**

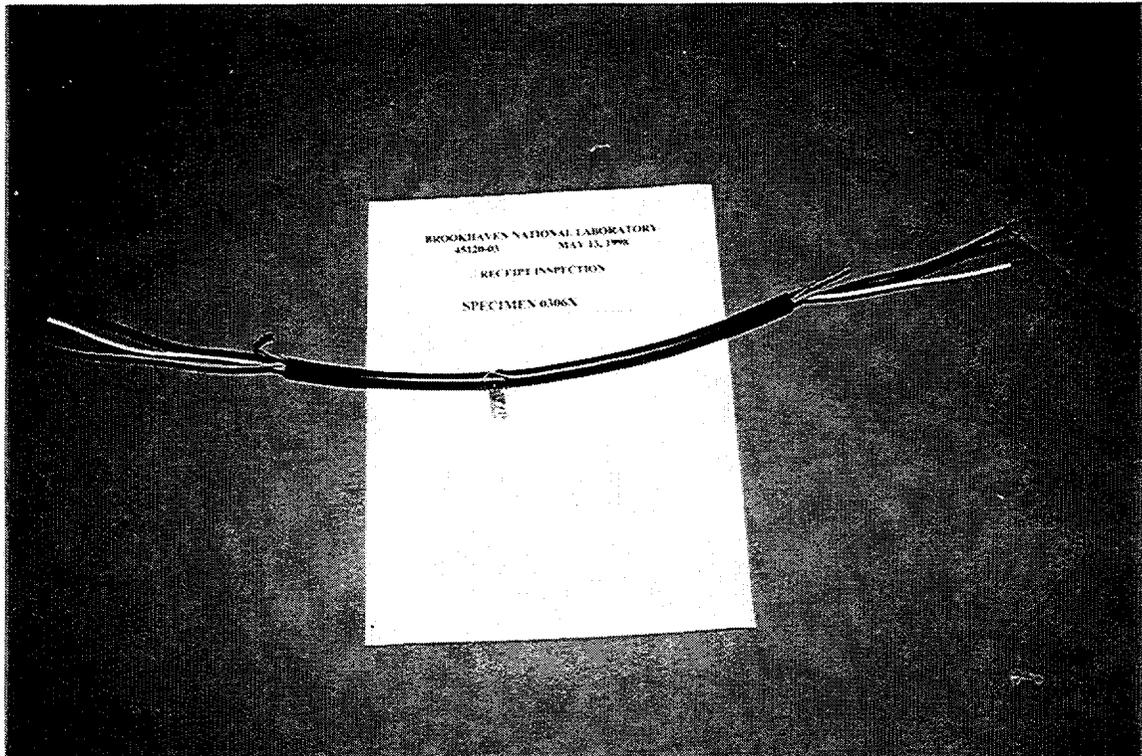
**Figure 2.6 Typical 2-foot specimen for indenter testing**

A 2-foot specimen was prepared to accompany each long specimen throughout the pre-aging and LOCA testing process for indenter testing, as previously discussed. These specimens carried the same 4-digit number as the "parent" specimen, but with an "X" suffix; e.g., 0101X. A stainless-steel tag with the specimen's 4-digit number engraved on it was tied to each specimen using stainless-steel wire to ensure positive identification through all phases of testing. The tag wire was wound loosely around the test specimen to prevent it from damaging the test specimen jacket.

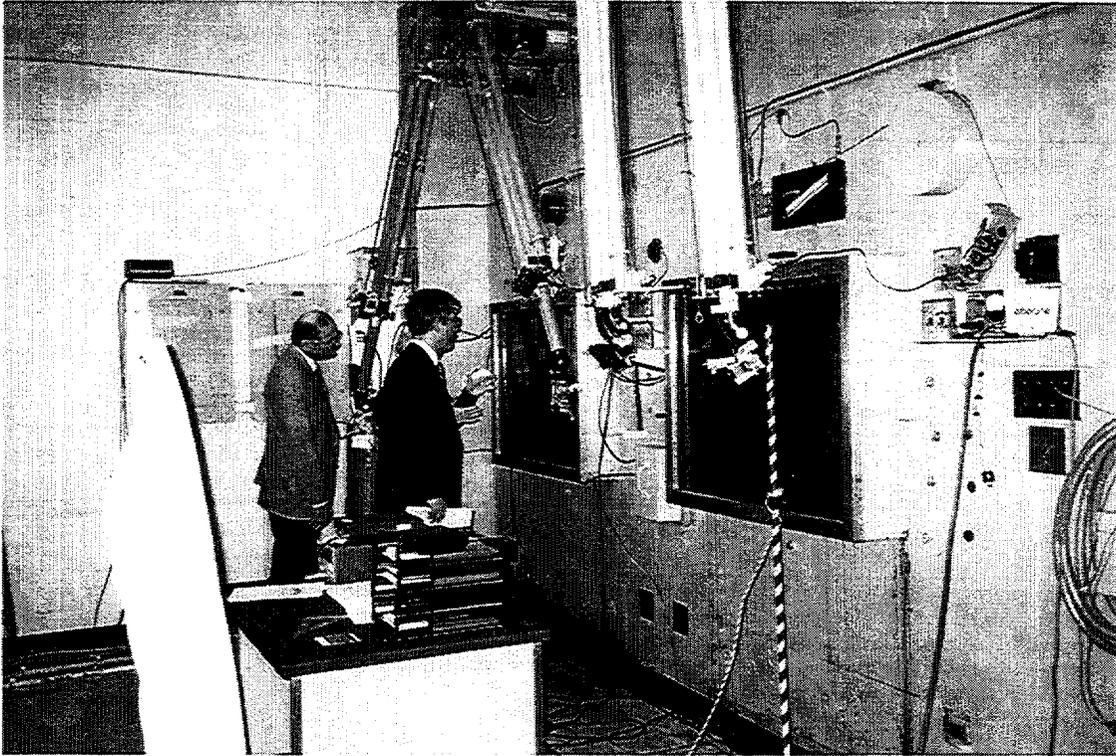
Figure 2.7 Hot cell used for irradiation of specimens at Georgia Institute of Technology

A photograph of the hot cell in which the specimens were irradiated is shown in Figure 2.7. As shown, the hot cell is large enough to accommodate the long specimens in their Unistrut® support channels. Figure 2.8 presents a schematic of the hot cell with a typical arrangement of long specimens in Unistrut® stacked upon each other, with the open portion of the channels facing the sources. The individual source holders without the sources were first positioned on the test bench at the required distance to provide the desired dose rate. For the mandrel mounted specimens, several mandrels were stacked on top of each other and the source holders were placed at the appropriate distance around the outside circumference of the specimens to irradiate them. The individually identified Cobalt-60 sources are kept in a source storage pool adjacent to the hot cell. After the specimens and source holders were properly placed, the designated sources were transferred from the storage pool into the hot cell by the operator using manipulator arms. The specific sources to be used, and the positions of the sources with respect to the target cable specimens, were calculated and verified by the hot cell engineer prior to the irradiation run. All irradiations were performed in accordance with Georgia Institute of Technology procedures under a 10 CFR 50, Appendix B Quality Assurance program.

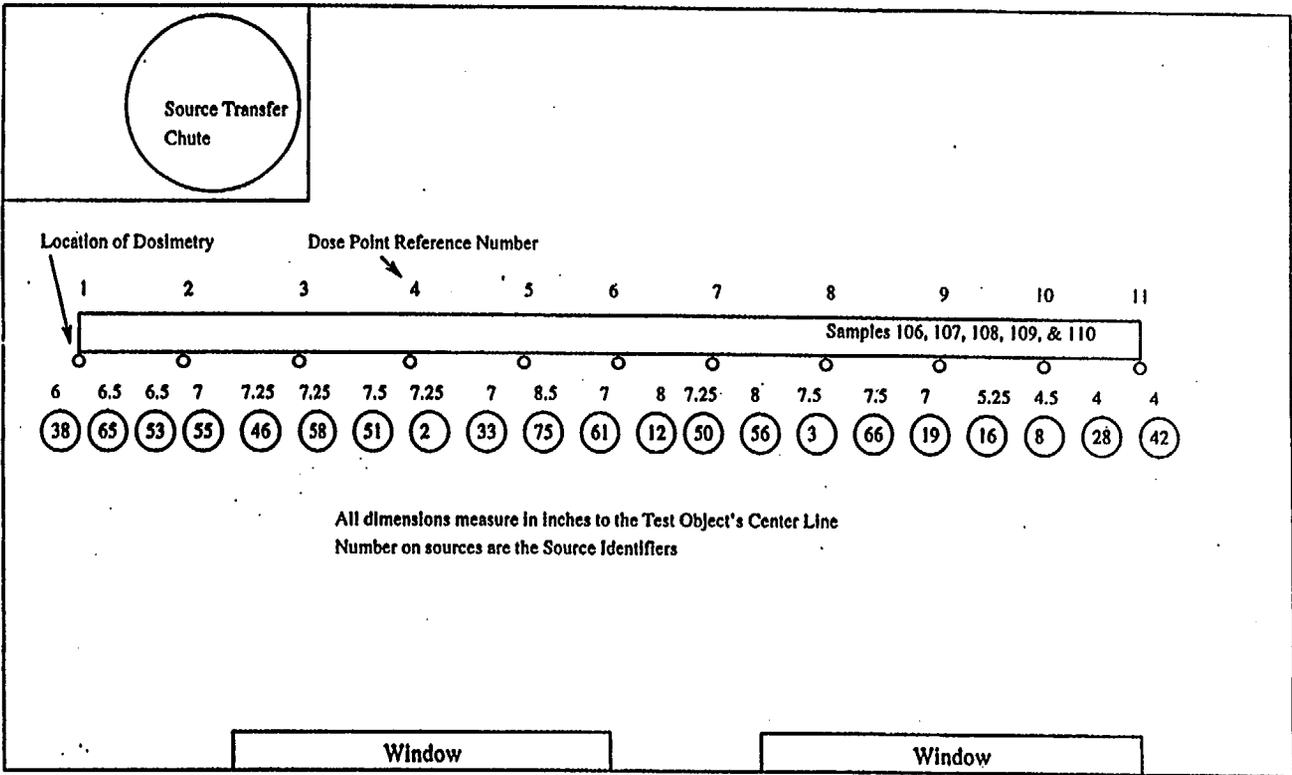
Figure 2.8 Diagram of the Hot Cell at Georgia Institute of Technology with typical arrangement of long specimens

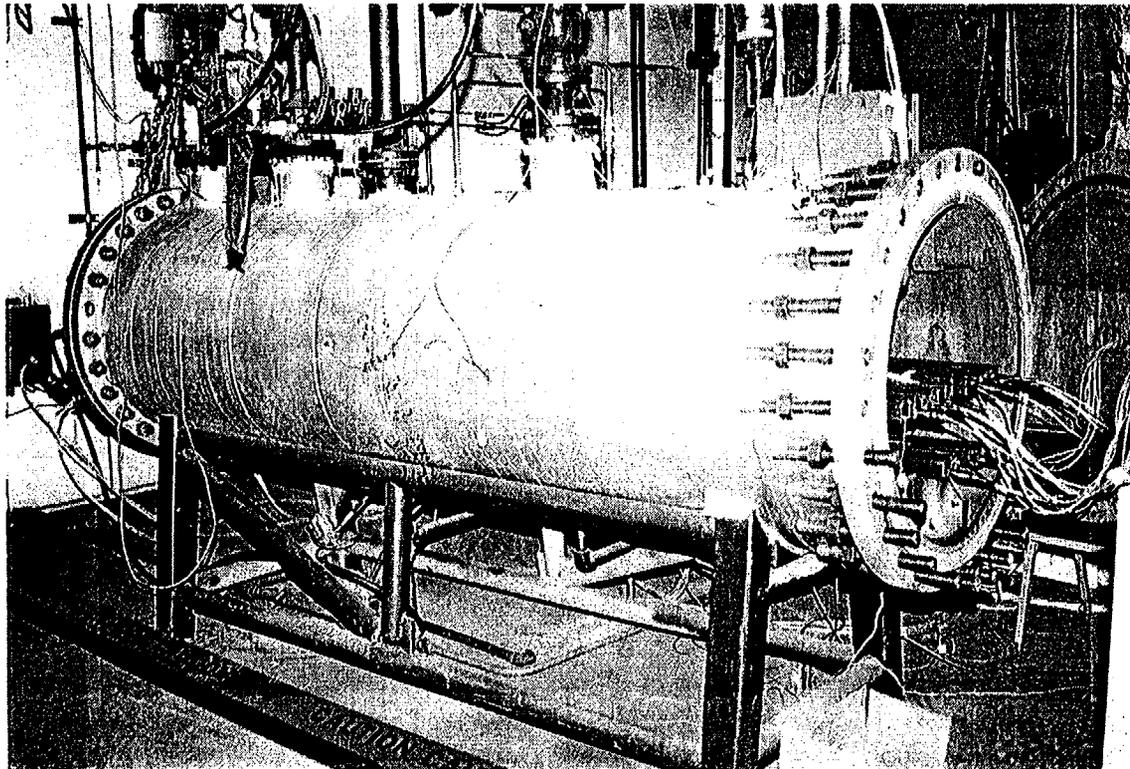
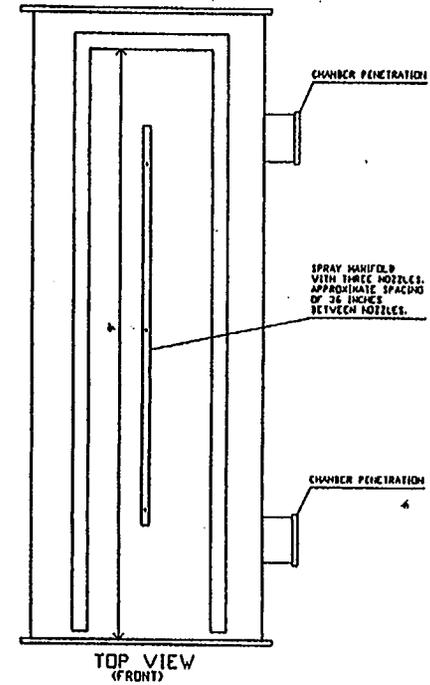
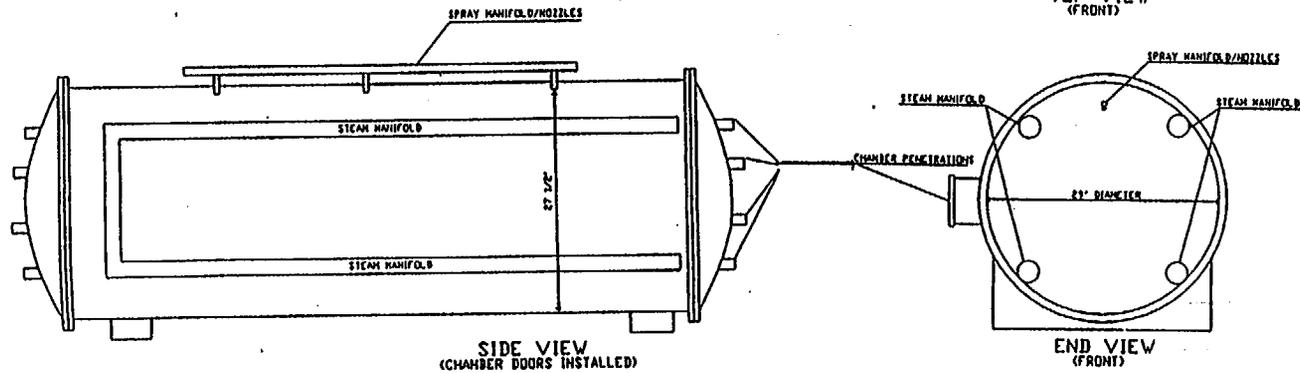
Figure 2.9 Photograph and diagram of the LOCA test chamber at Wyle Laboratories used for Tests 1, 2 and 3

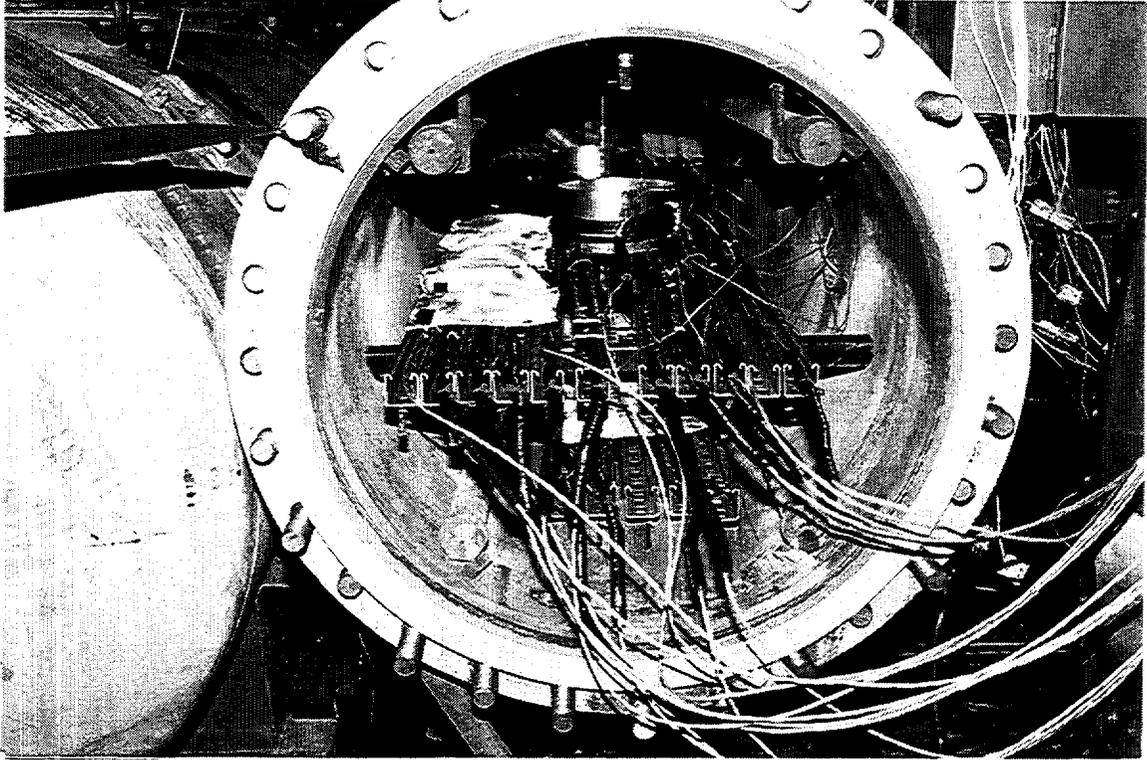
Figure 2.10 End view of the LOCA test chamber with the cable specimens loaded prior to testing

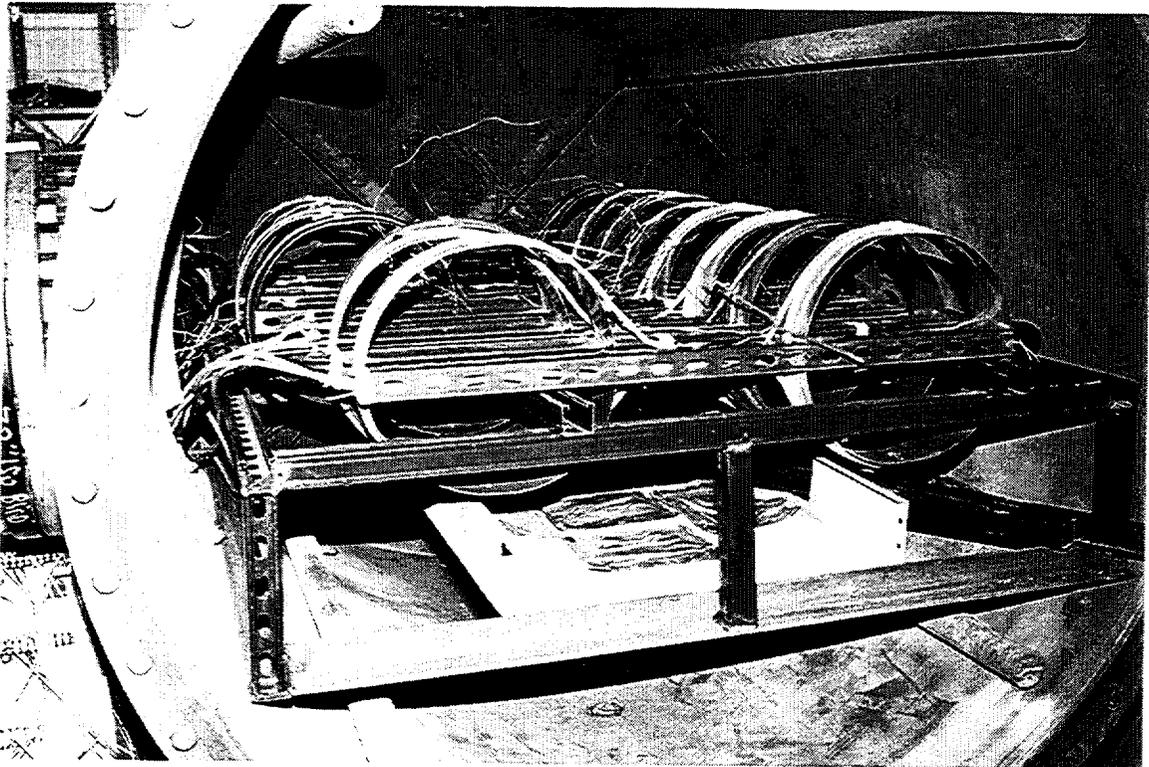
Figure 2.11 End view of large diameter LOCA chamber used for tests 4, 5 and 6

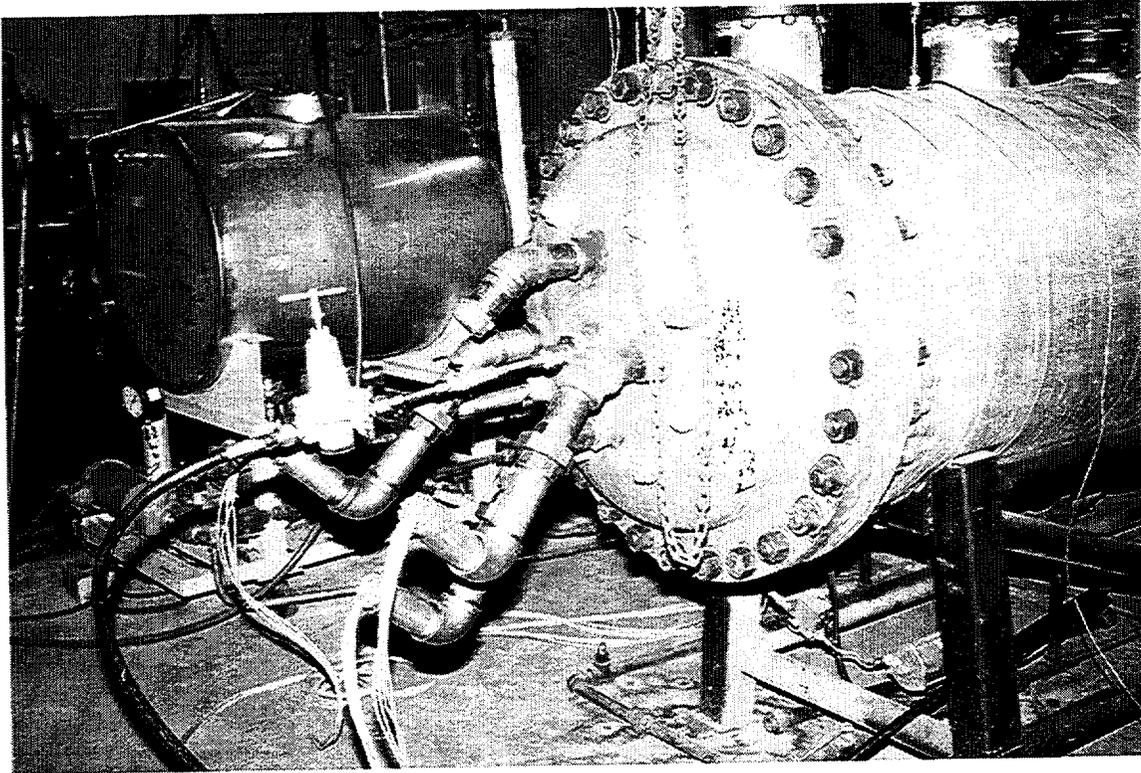
Figure 2.12 Facility lead wires extending through the penetrations on the end of the LOCA test chamber

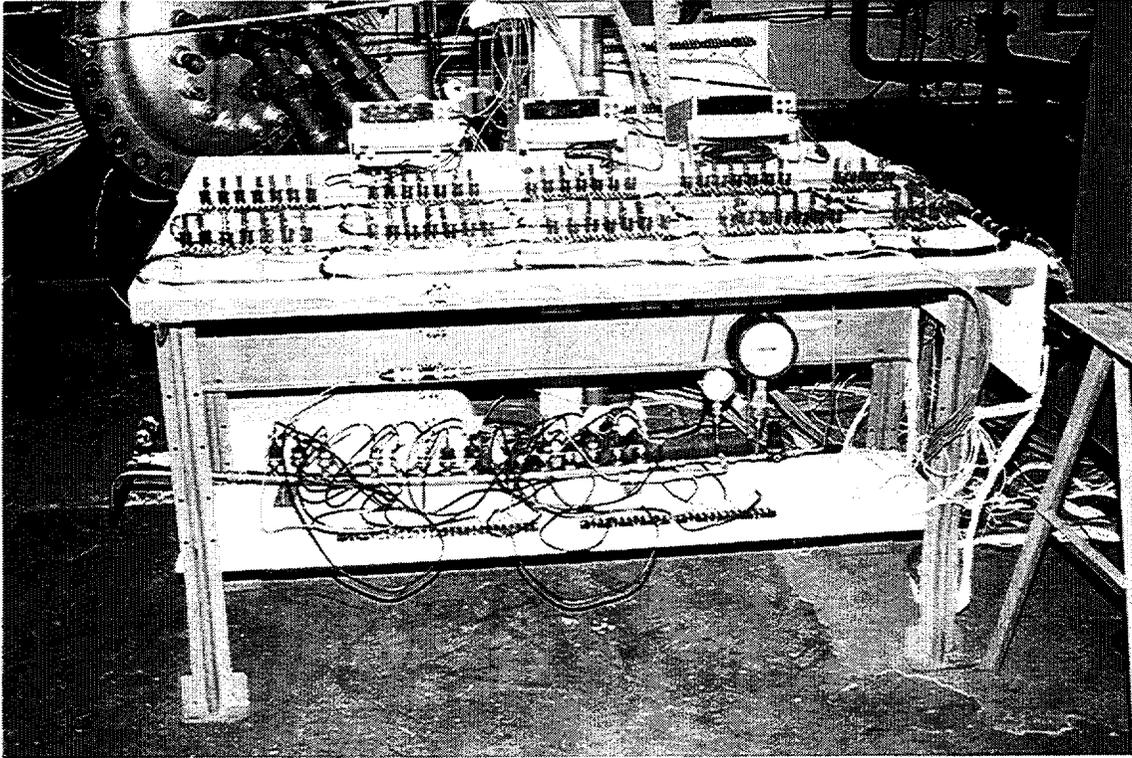
**Figure 2.15** Test bench with hard-wired monitoring circuits and simulated pressure instrumentation loops

the chamber leads of each long cable specimen to simulate a 4-20 mA instrumentation loop circuit. The pressure source tank and header with sixteen pressure transmitters can be seen under the test bench in Figure 2.15. The short specimens in the stainless steel baskets were not powered since they were to be used for materials condition monitoring.

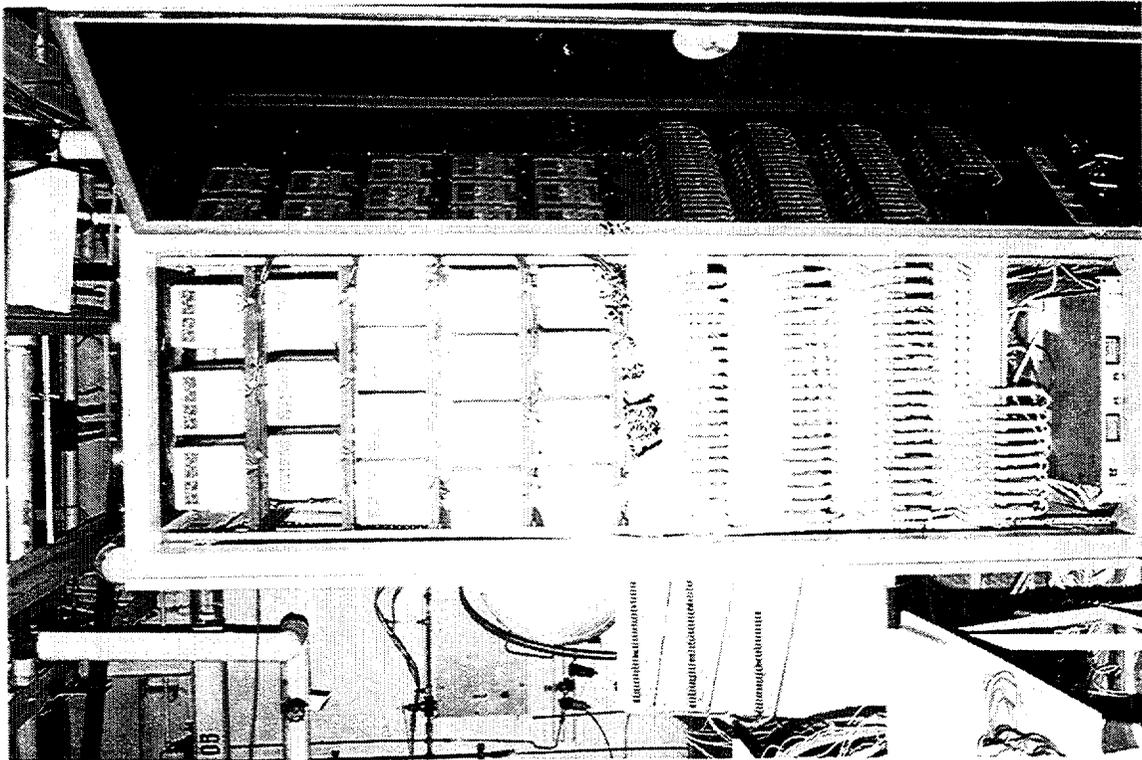
Figure 2.16 Specimen powering and monitoring equipment

Periodically throughout the test sequence, testing was halted and condition monitoring data were obtained. These data were used to determine the condition of the test specimens at each stage of the test and to evaluate the effectiveness of the different CM techniques. Each of these hold points, identified by a capital letter, corresponds to a different condition for the cable specimens. The test results reported herein are presented based on these condition monitoring (CM) points, which are defined in Table 2.4.

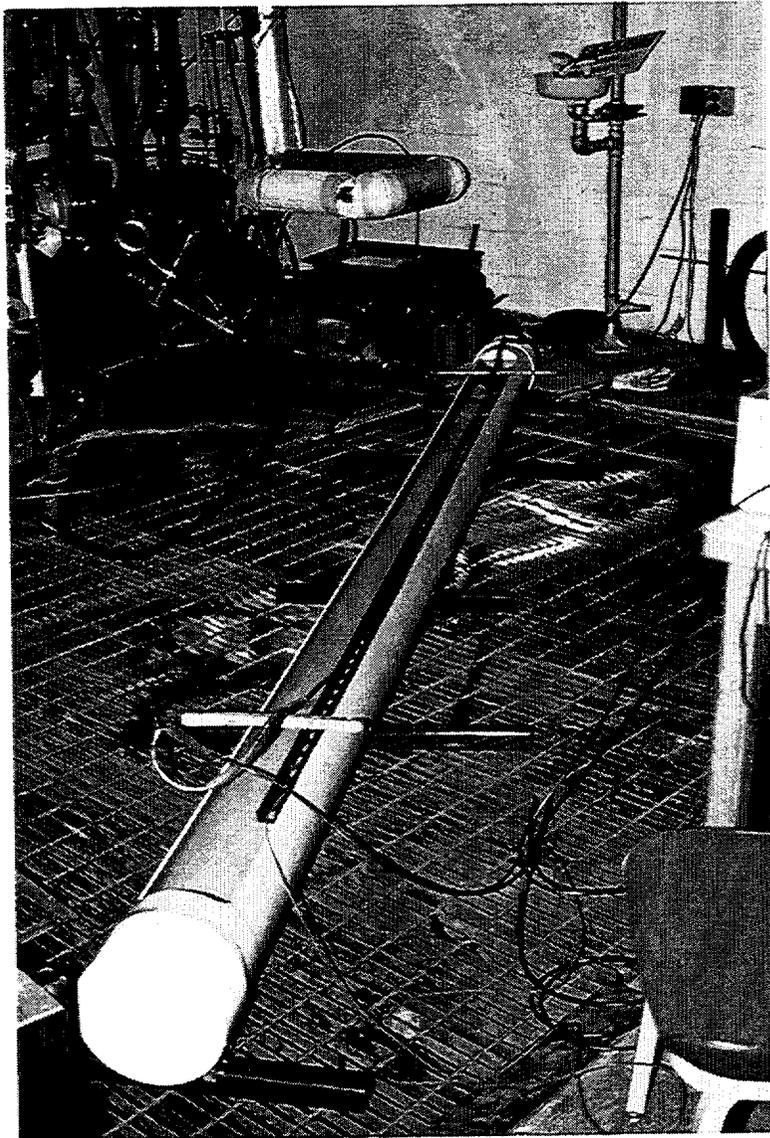
**Figure 2.17** Test setup for the submerged voltage withstand test

In performing this test, the test voltage was initially set to zero volts, then was gradually increased to 2,400 volts. The acceptance criteria used was for the test specimen to hold 2,400 volts for five minutes without exceeding a leakage current of 10 milliamps, which was the maximum leakage current measurable with the test equipment used. If the leakage current exceeded 10 mA during the rise to 2,400 volts, or during the hold period, the test was terminated and the specimen was considered failed. The test setup for performing the submerged voltage withstand test on the straight specimens is shown in Figure 2.17.

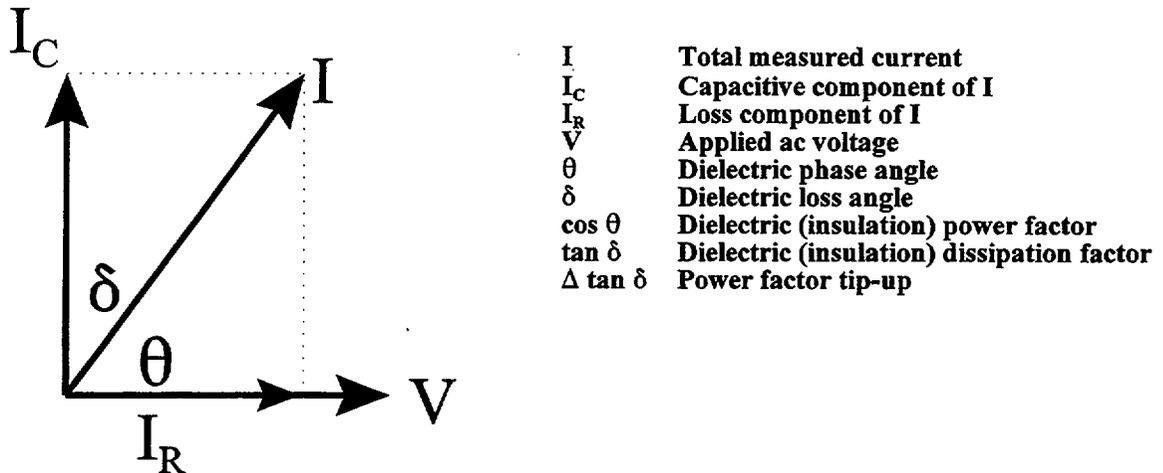
Figure 3.1 Insulation power factor relationship

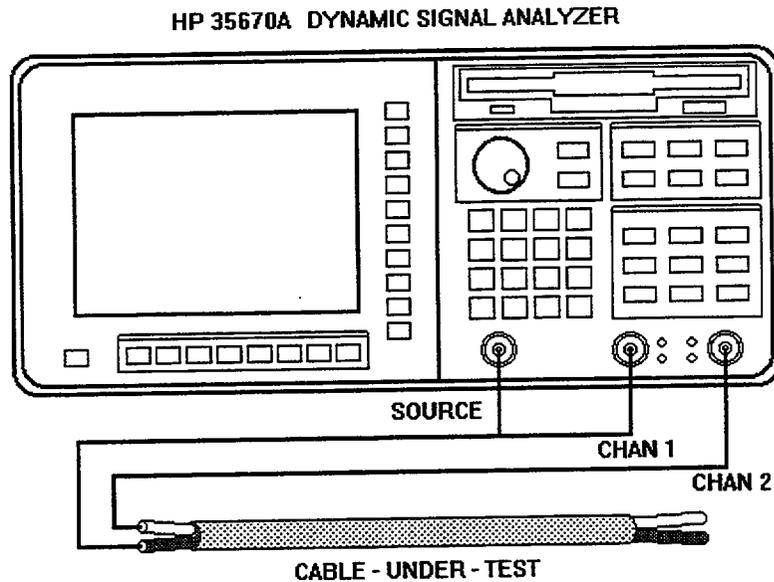
**Figure 3.2 Test setup for dielectric loss measurement**

Dielectric loss measurements for the cable specimens were made using a calibrated two-channel Hewlett Packard HP 35670A Dynamic Signal Analyzer with swept sine option. An internal source provided the applied ac voltage signal to the test specimens, and an internal disk drive allowed the data to be stored for later analysis. A simplified diagram of the test setup with this instrument is given in Figure 3.2.

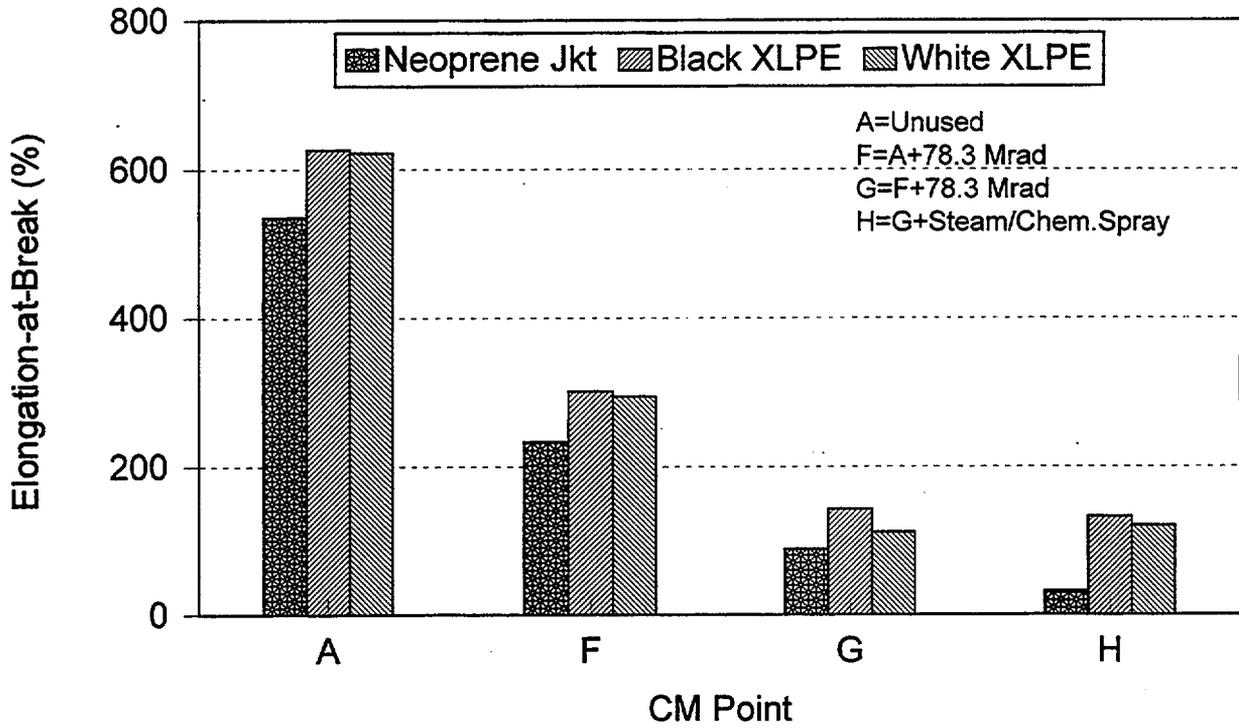
Figure 4.1 Effect of LOCA testing on EAB for Rockbestos cable PNI79RB188 (Group 1.1, Specimen 0101)

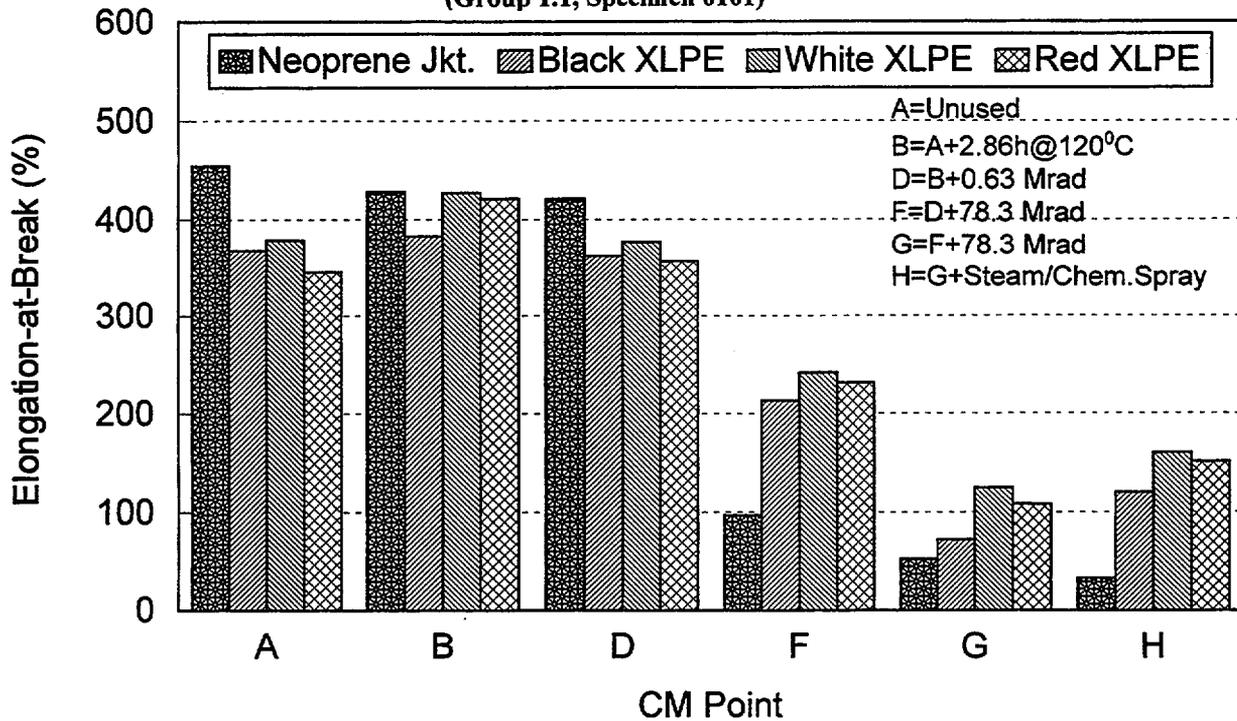
Figure 4.2 Effect of aging and LOCA testing on EAB for Rockbestos cable PNI85RB191 (Group 1.2, Specimen 0106) artificially aged to 10 years service

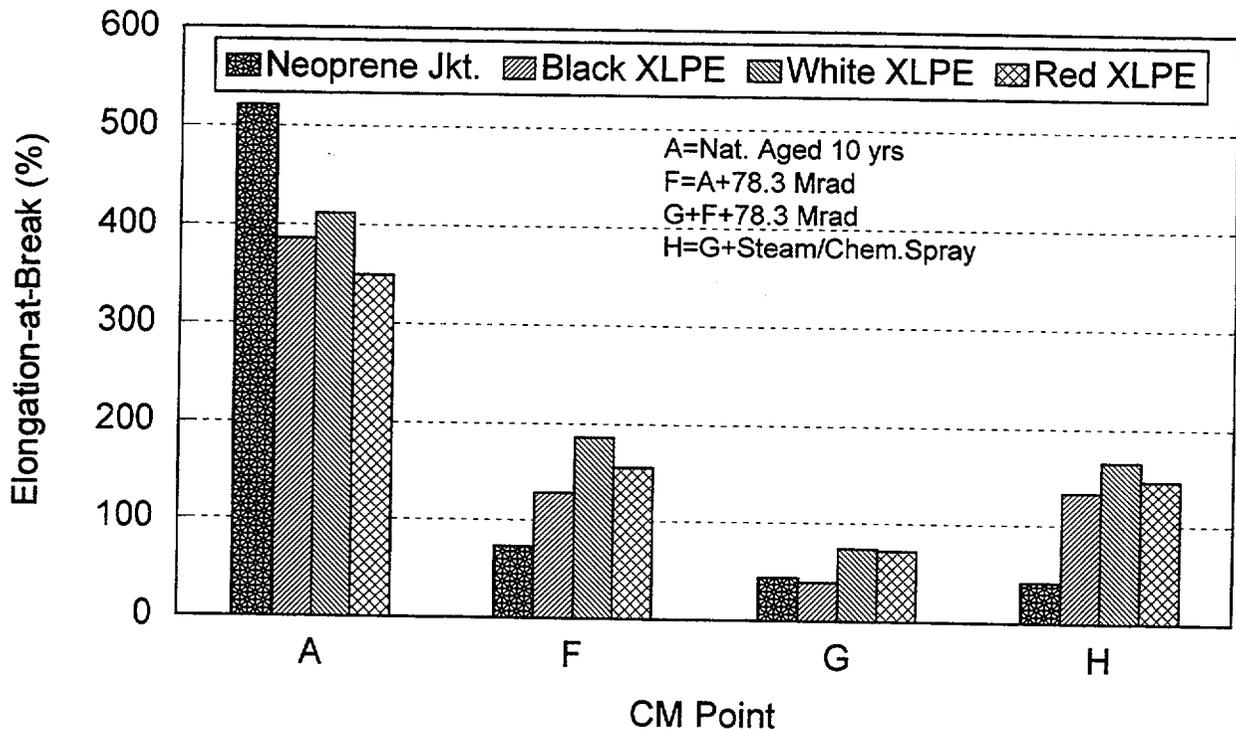
**Figure 4.3 Effect of LOCA testing on the EAB of Rockbestos cable PAP86RB267 (Group 1.3, Specimen 0111) naturally aged for 10 years**

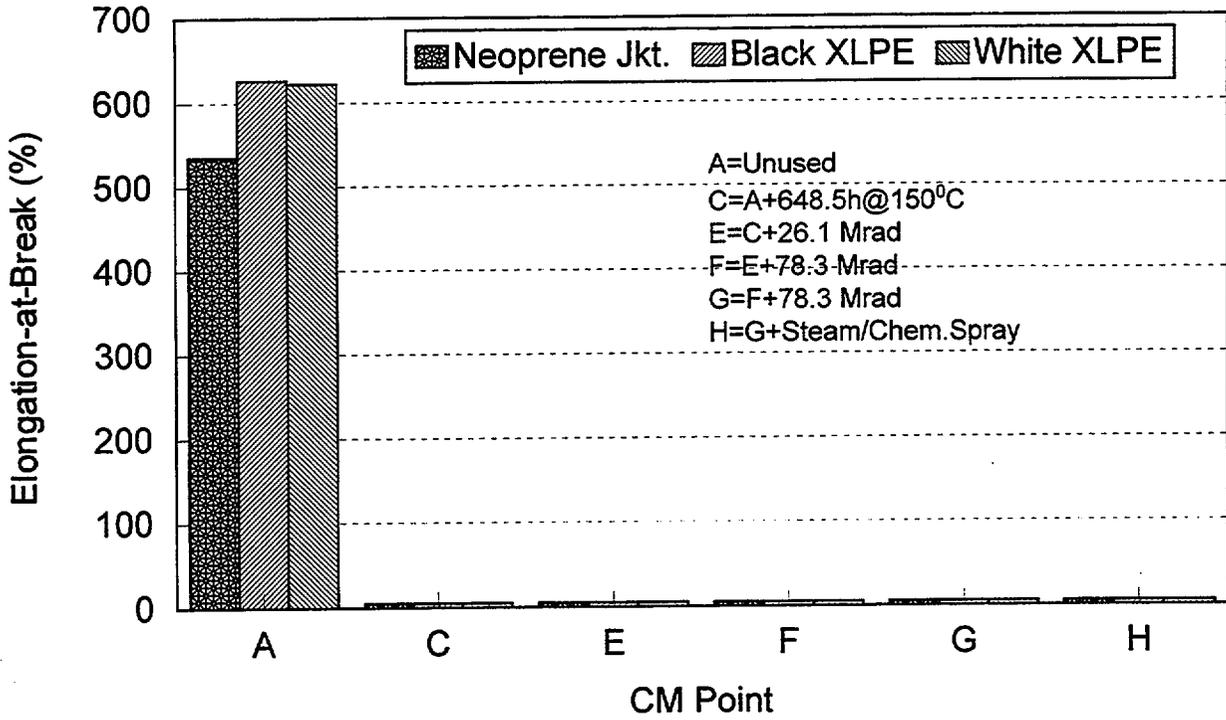
Figure 4.4 Effect of aging and LOCA testing on the EAB of Rockbestos cable PNI79RB188 (Test 1.4, Specimen 0112) artificially aged to one-half of the 40 year qualified life

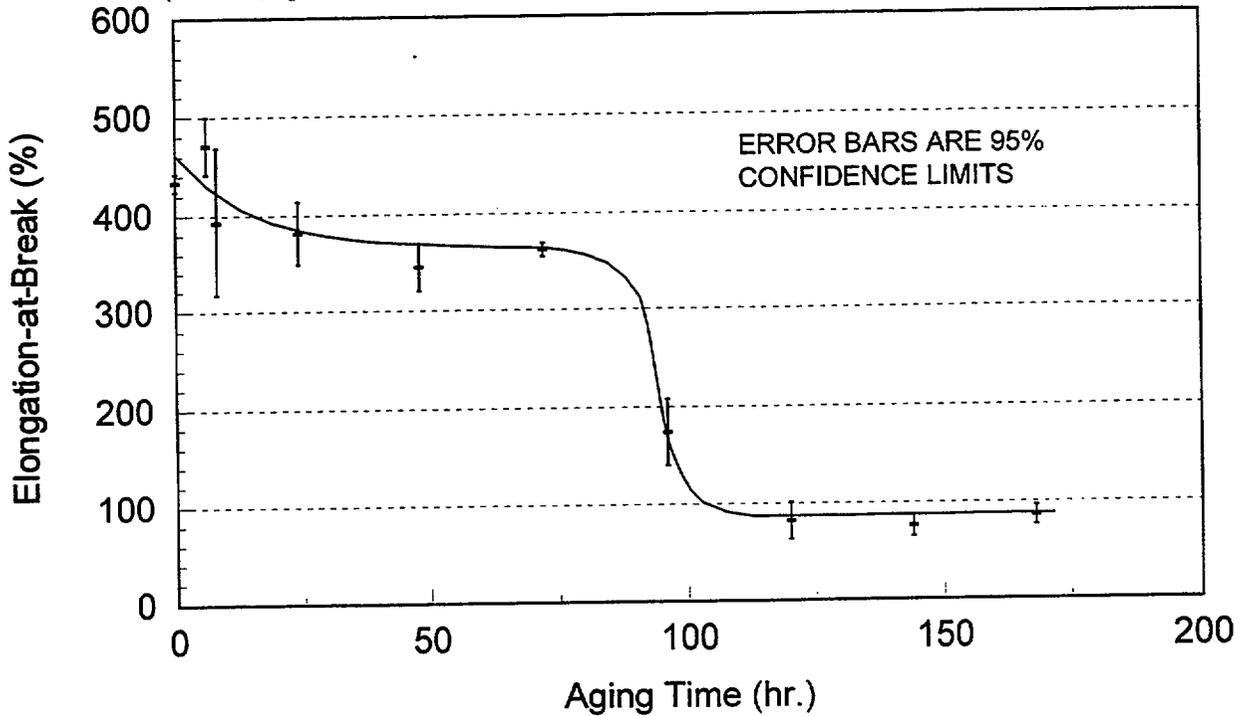
Figure 4.5 Effect of thermal aging at 350°F (177°C) in air on the EAB of Rockbestos white XLPE insulation (PNI85RB191)

Some additional research was carried out to determine more quantitatively how thermal aging affects the ductility of XLPE insulation. Figure 4.5, prepared from data taken from Appendix A, shows the EAB for white XLPE aged in air at 350°F (177°C). For the shortest aging time of 6 hours, the EAB increases by about 10 percent compared to the unaged condition. As aging continues, EAB slowly decreases with aging time up to about 75 hours. Then the ductility shows a much faster loss, and appears to become stable at about 80 percent. Experiments using a differential scanning calorimeter, which will be described later in Section 4.3 of this report, show that, at about 95 hours, all of the antioxidants in the XLPE have become depleted. At this point, rapid oxidation of the insulation begins. Since the calculated depletion time is close to the time at which the EAB begins to decrease, it is a strong indication that antioxidants, up to the point that they are completely depleted, are very effective in minimizing losses in ductility. However, as Table 4.2 and Appendix A show, severe thermal aging and heavy irradiation may eventually reduce the EAB to a few percent.

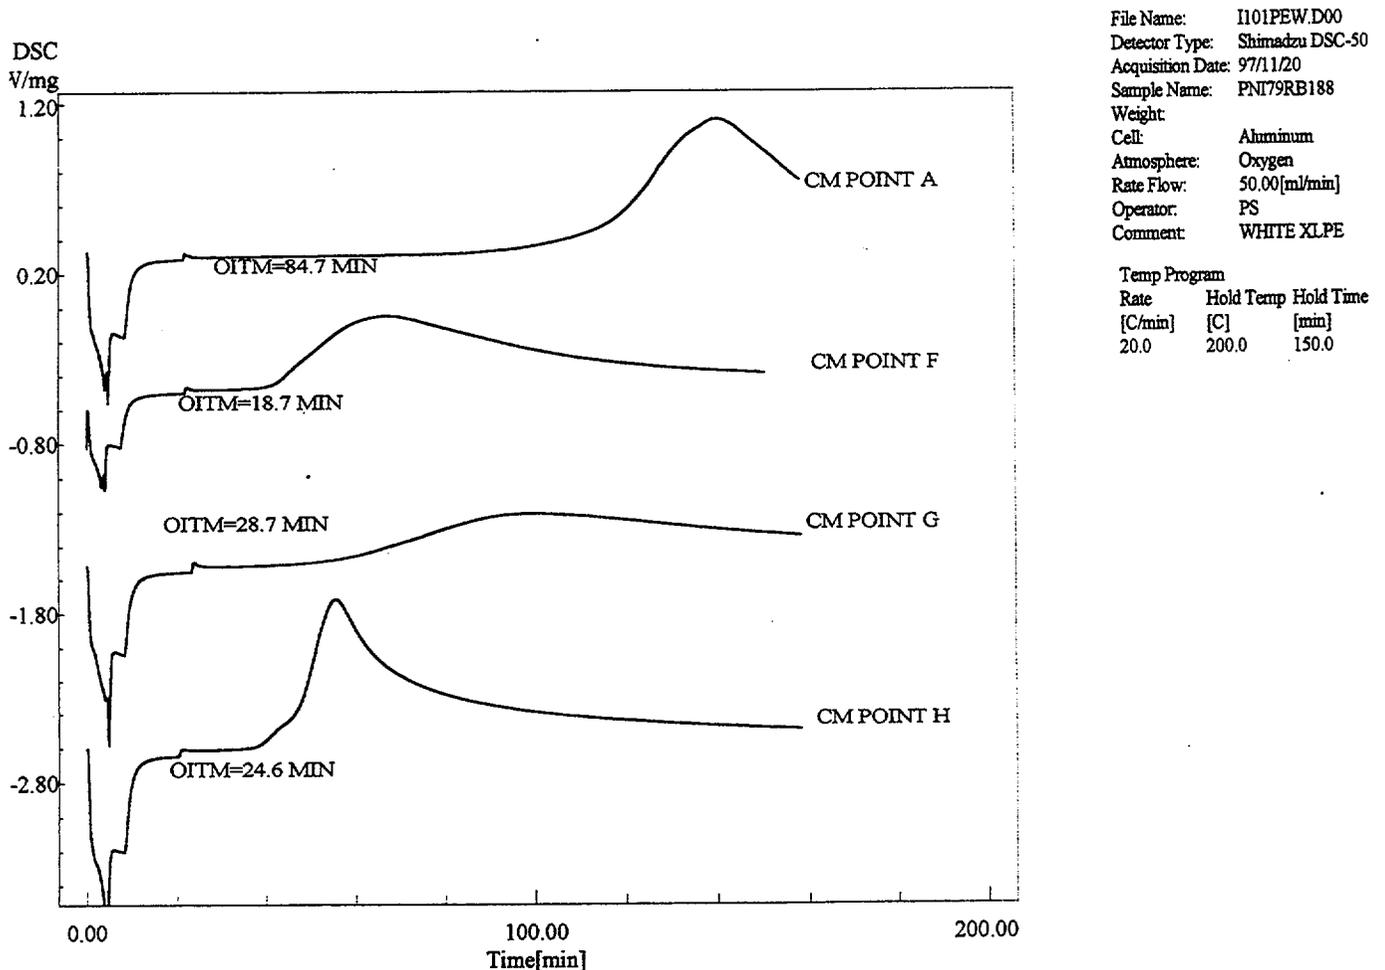
Figure 4.6 OITM for white XLPE at 392°F (200°C) for Rockbestos cable PNI79RB188 (Group 1.1, Specimen 0101)
