# Assessment of Environmental Qualification Practices and Condition Monitoring Techniques for Low-Voltage Electric Cables

Condition Monitoring Test Results

Brookhaven National Laboratory

U.S. Nuclear Regulatory Commission  
Office of Nuclear Regulatory Research  
Washington, DC 20555-0001

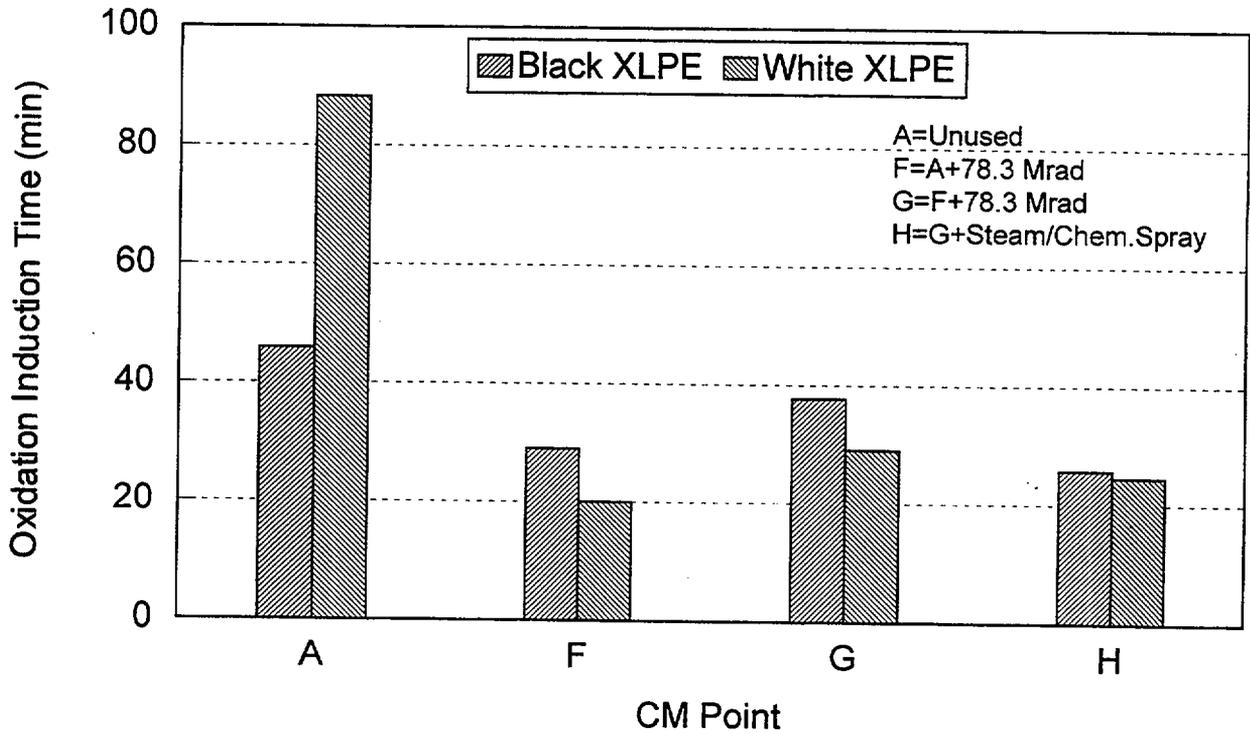
Figure 4.7 OITM for XLPE at 392°F (200°C) for Rockbestos cable PNI79RB188 (Group 1.1, Specimen 0101) as a function of LOCA testing

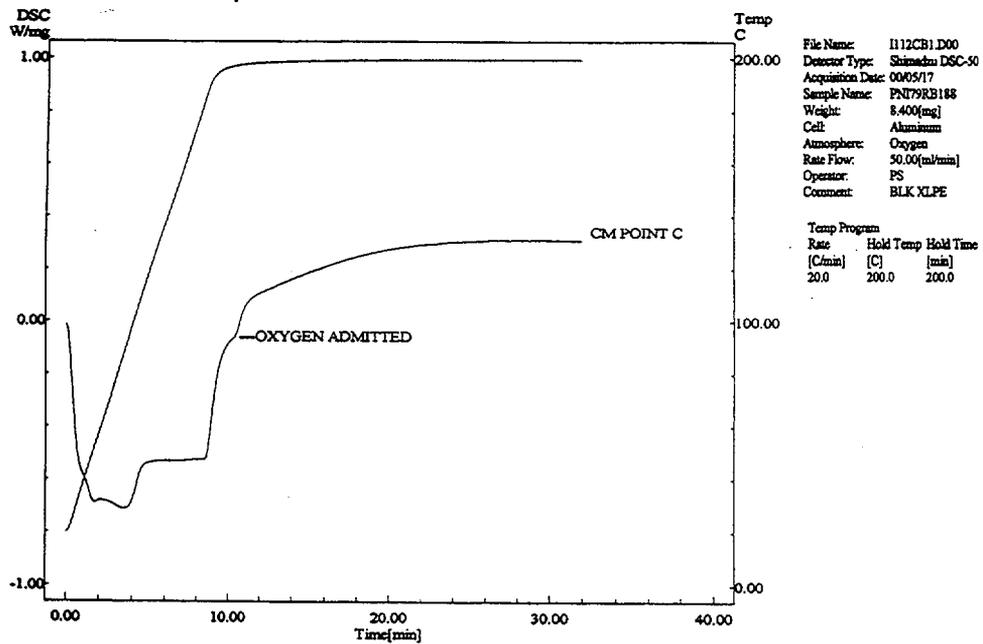
Figure 4.8 OITM at 392°F (200°C) for black XLPE from Rockbestos cable PNI79RB188 (Group 1.4, Specimen 0112)

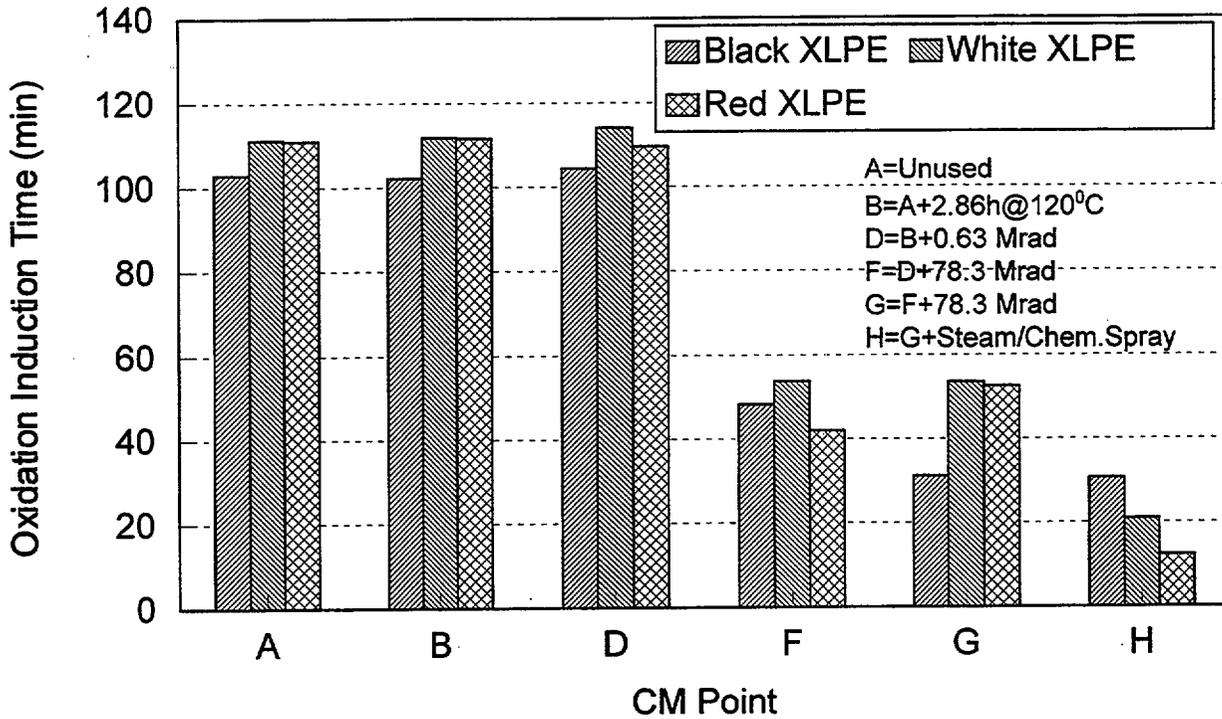
**Figure 4.9 OITM for XLPE at 428°F (220°C) for Rockbestos cable PNI85RB191 (Group 1.2, Specimen 0106) artificially aged to 10-years service**

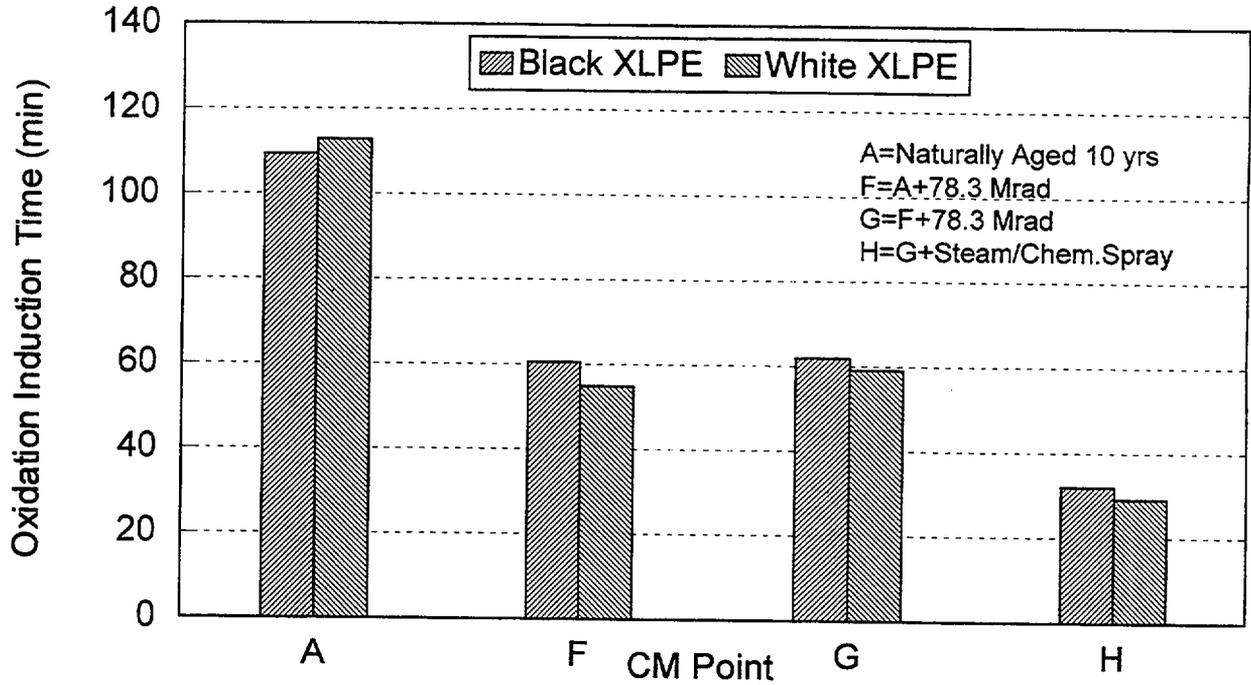
Figure 4.10 OITM for XLPE at 428°F (220°C) for Rockbestos cable PAP86RB267 (Group 1.3, Specimen 0111) naturally aged for 10 years

For Rockbestos sample PNI85RB191 (Group 1.2, Specimen 0106) accelerated aging was carried out to simulate a 10-year natural aging period (Figure 4.9). The thermal and radiation aging treatments (CM points B and D, respectively) cause little change in the OITM compared to the unaged insulation. Note that the black insulation has slightly less oxidation resistance (lower OITM) compared to the white and red XLPE. The OITM is reduced significantly after the LOCA testing protocols. A comparison with the data for the 10-year naturally-aged insulation in Figure 4.10 shows that there is excellent agreement with the artificially-aged XLPE (compare CM point D in Figure 4.9 to CM point A in Figure 4.10).

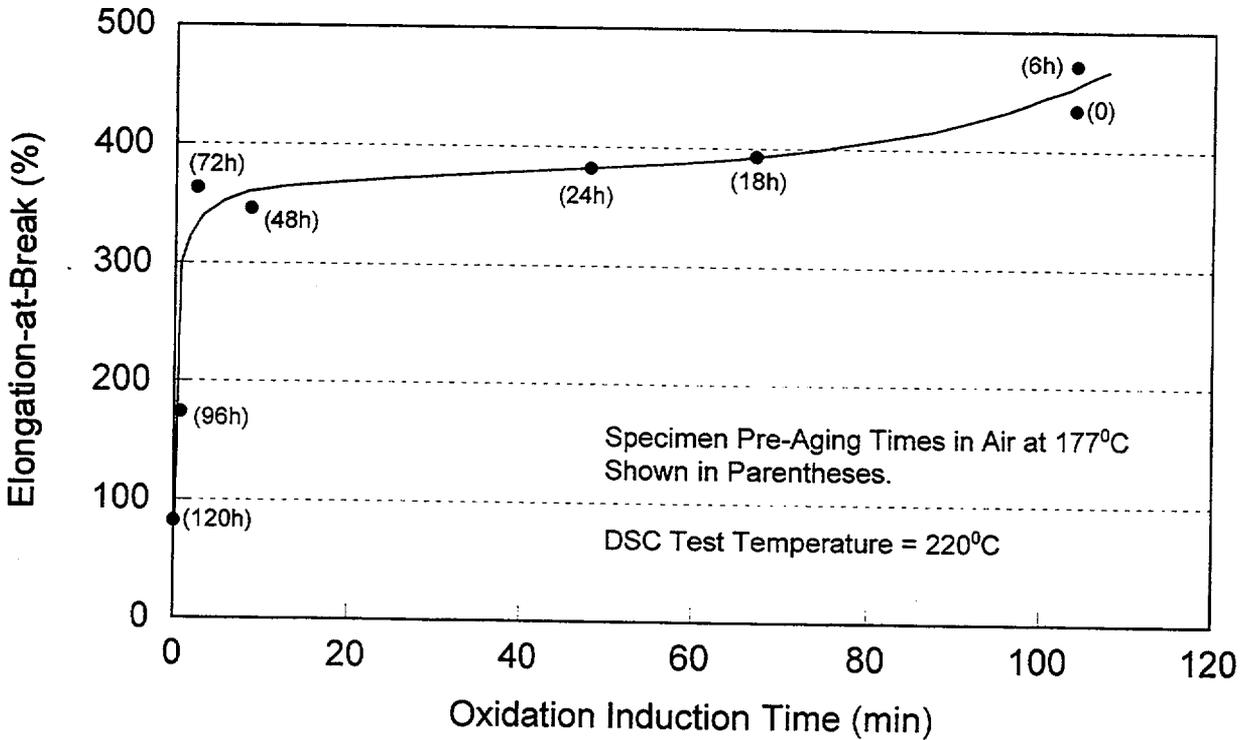
Figure 4.11 Correlation between OITM and EAB for white XLPE from Rockbestos cable PNI85RB191 as a function of thermal pre-aging time in air at 350°F (177°C)

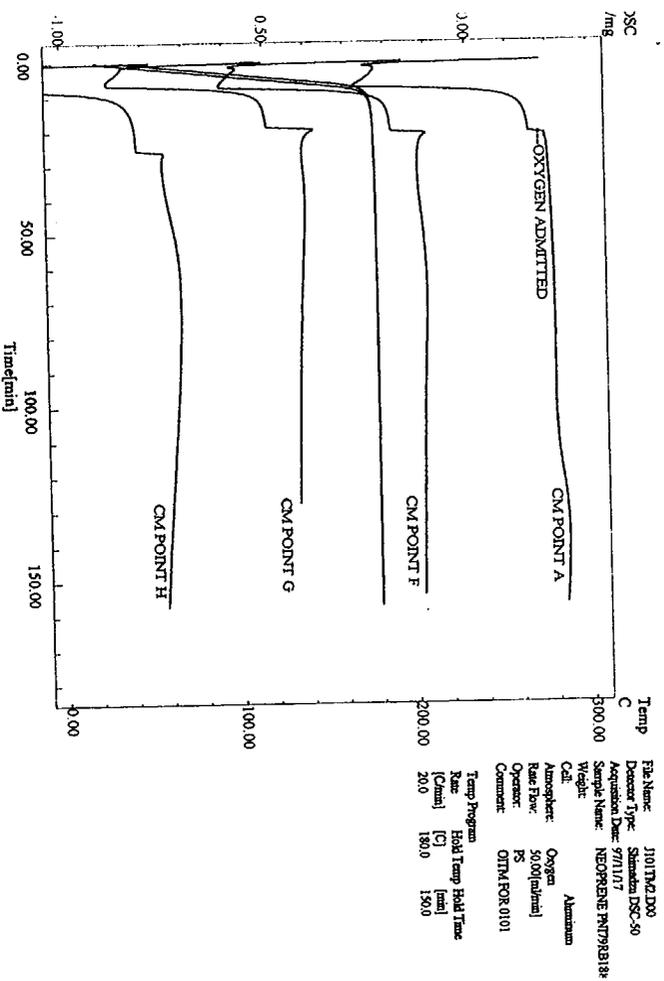
Figure 4.12 OITM thermogram for Neoprene® jacket at 356°F (180°C) from Rockbestos cable PN179RB188 (Group 1.1, Specimen 0101)

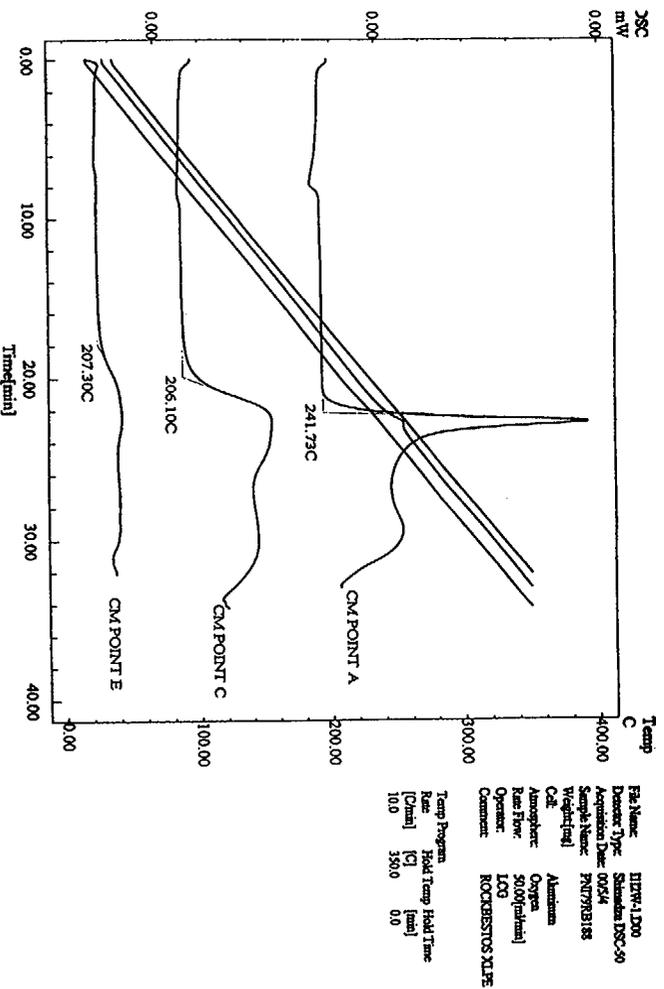
Figure 4.13 OITP for Rockbestos XLPE (Group 1.4, Specimen 0112) as a function of service aging protocols

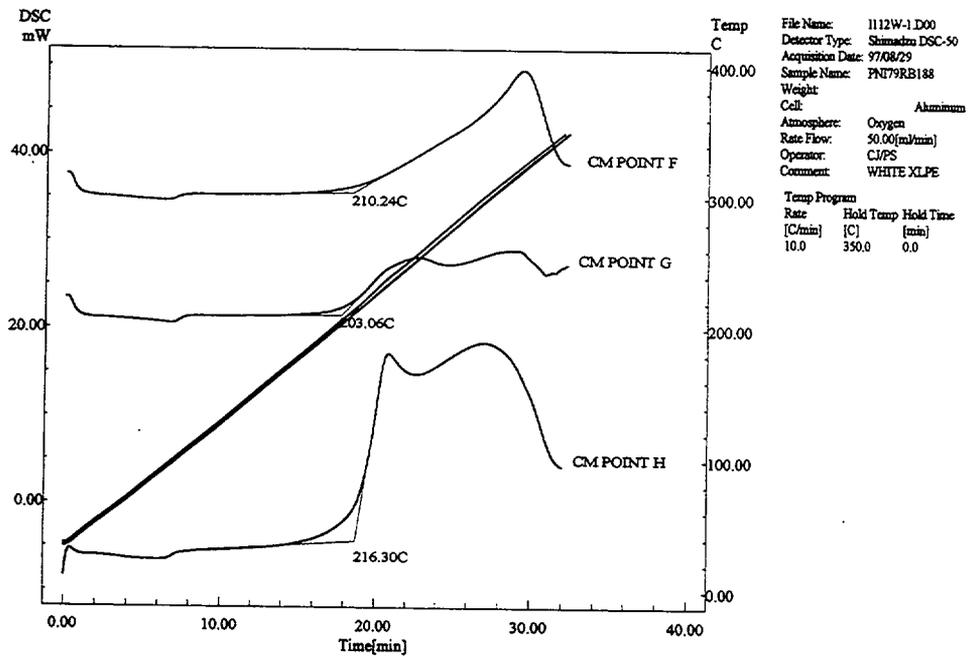
Figure 4.14 OITP for Rockbestos XLPE (Group 1.4, Specimen 0112) as a function of LOCA testing protocols

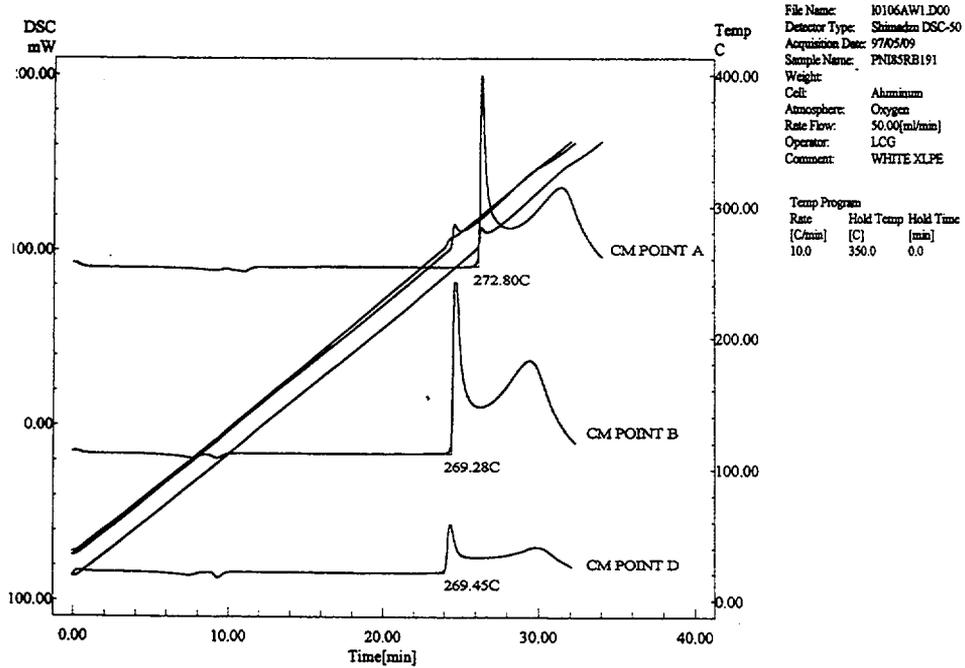
Figure 4.15 OITP for Rockbestos white XLPE (Group 1.2, Specimen 0106) as a function of service aging protocols

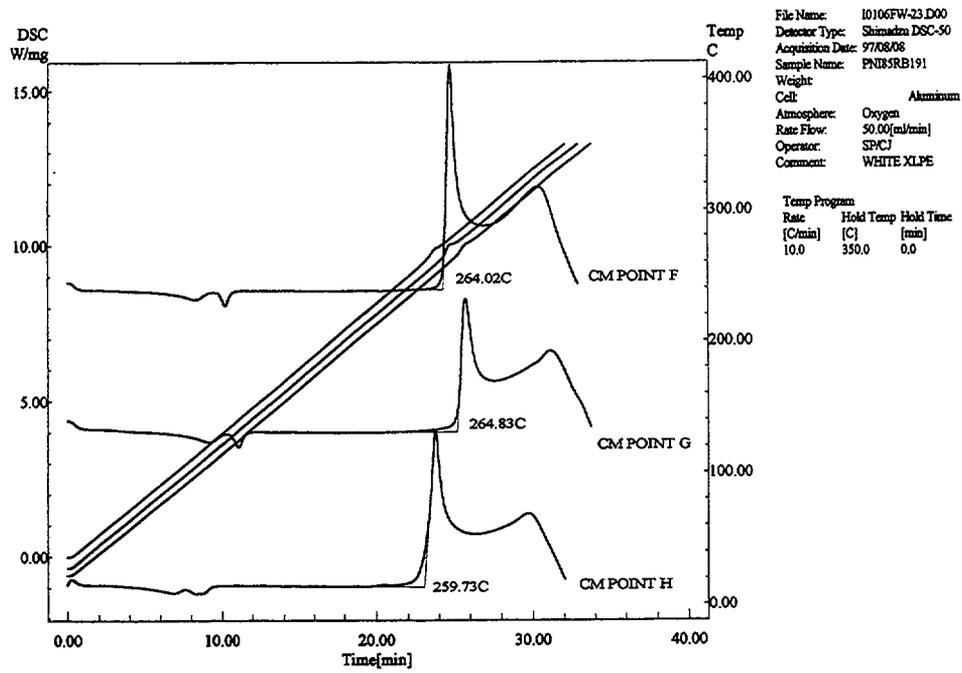
Figure 4.16 OITP for Rockbestos white XLPE (Group 1.2, Specimen 0106) as a function of LOCA testing protocols

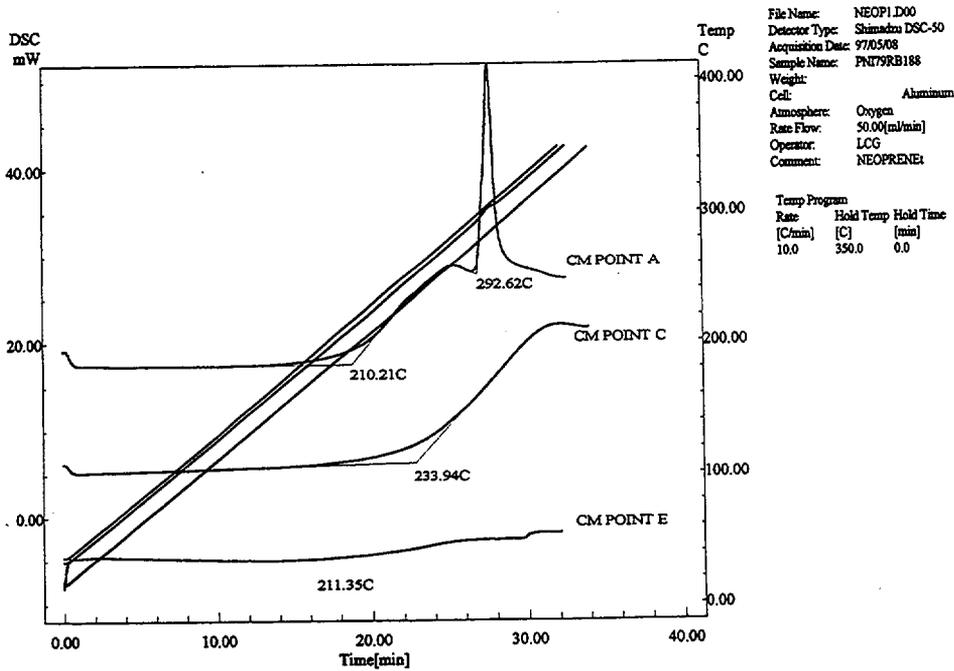
Figure 4.17 OITP for Rockbestos Neoprene® jacket (Group 1.4, Specimen 0112) as a function of service aging protocols

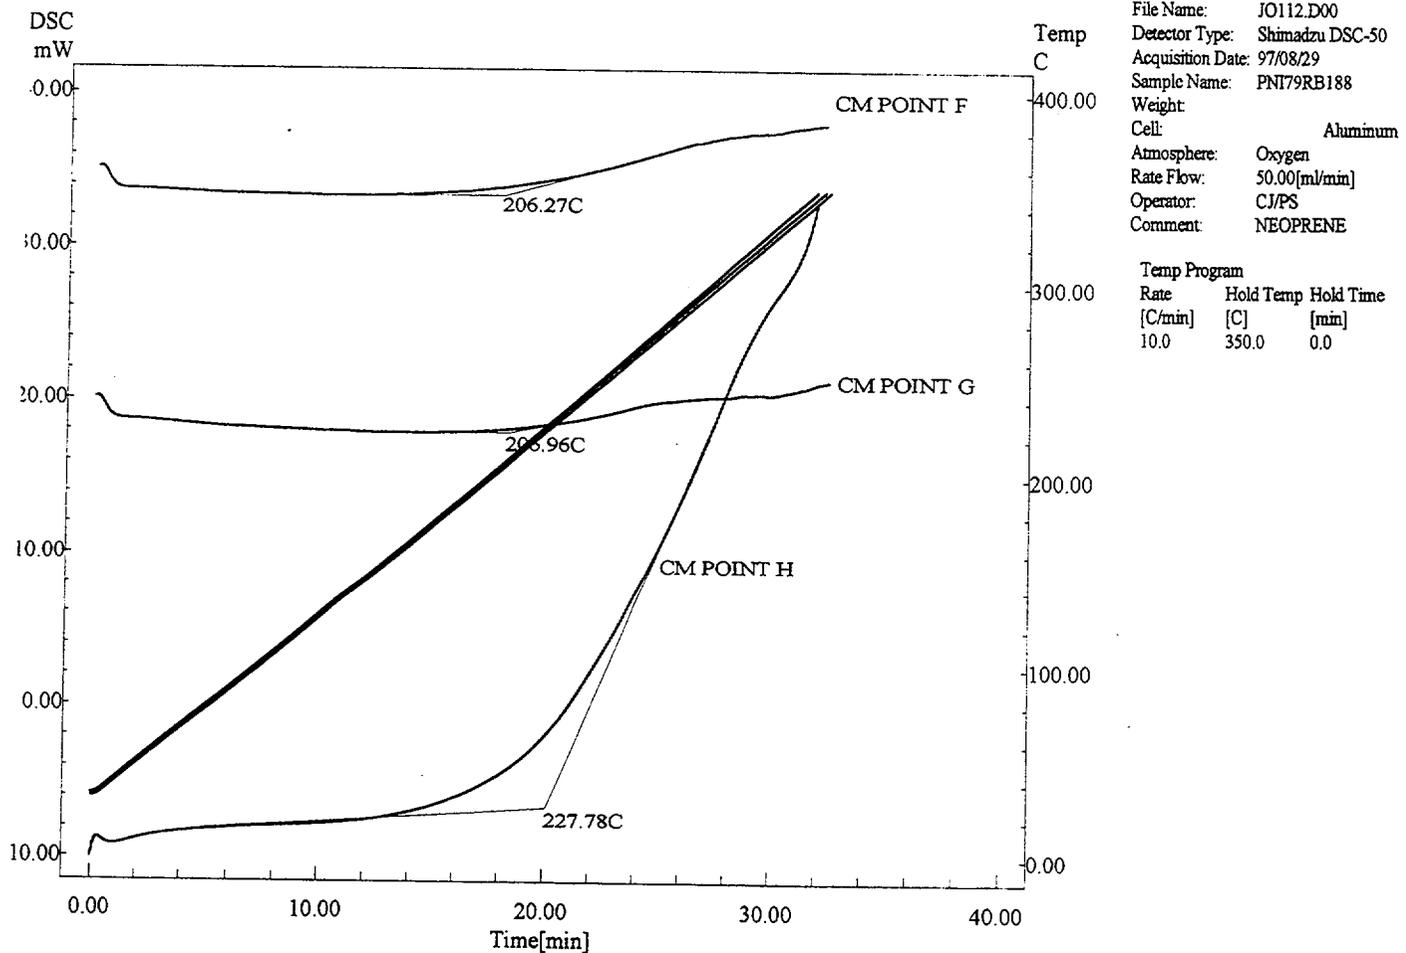
**Figure 4.18 OITP for Rockbestos Neoprene® jacket (Group 1.4, Specimen 0112) as a function of LOCA testing protocols**

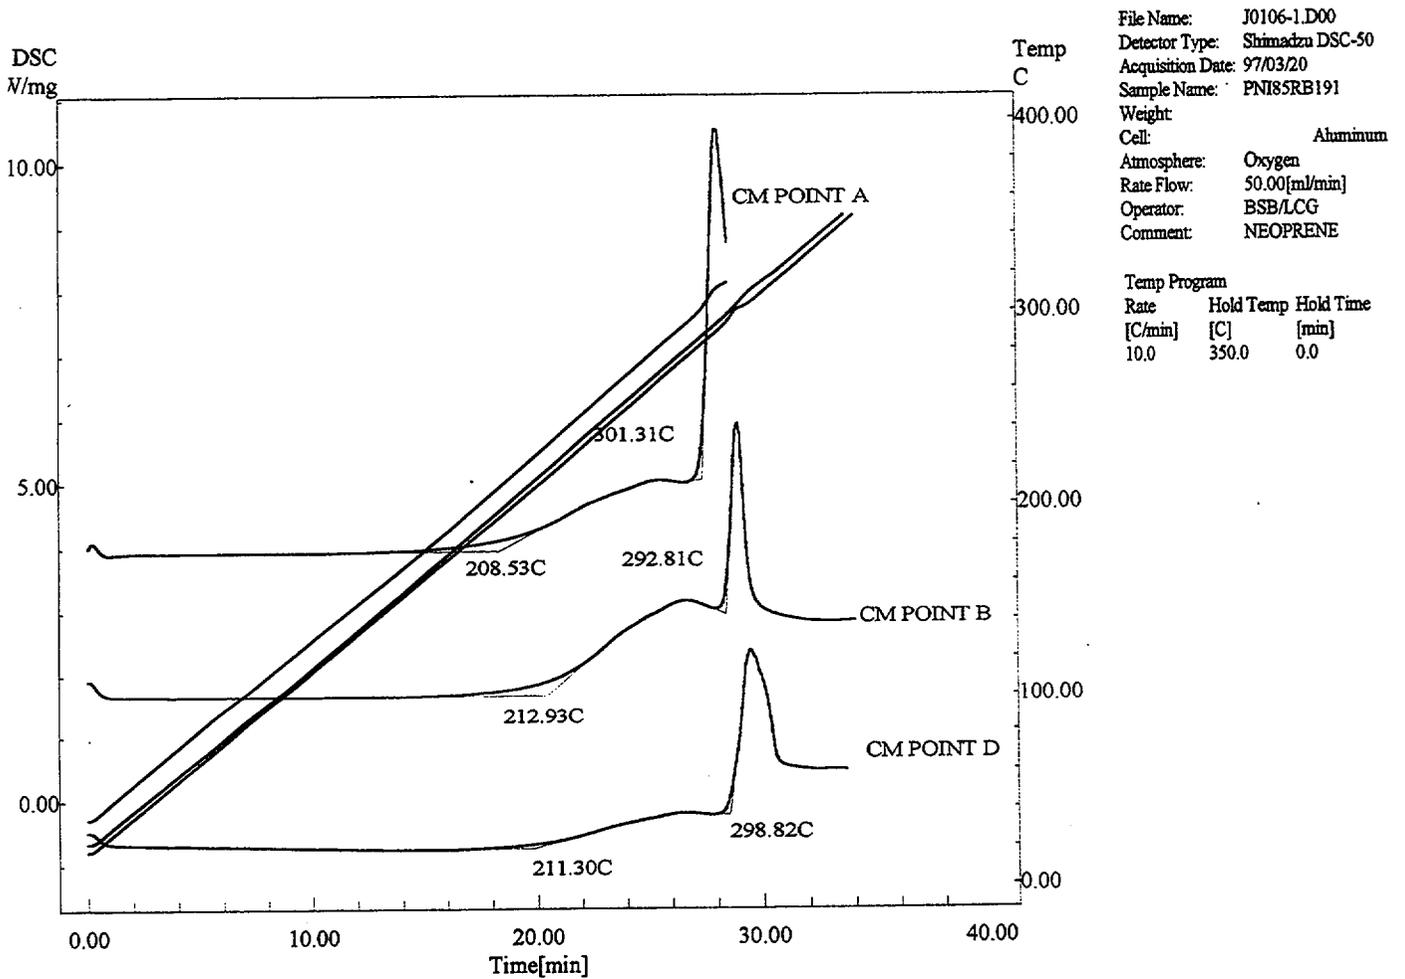
**Figure 4.19 OITP for Rockbestos Neoprene® jacket (Group 1.2, Specimen 0106) as a function of service testing protocols**

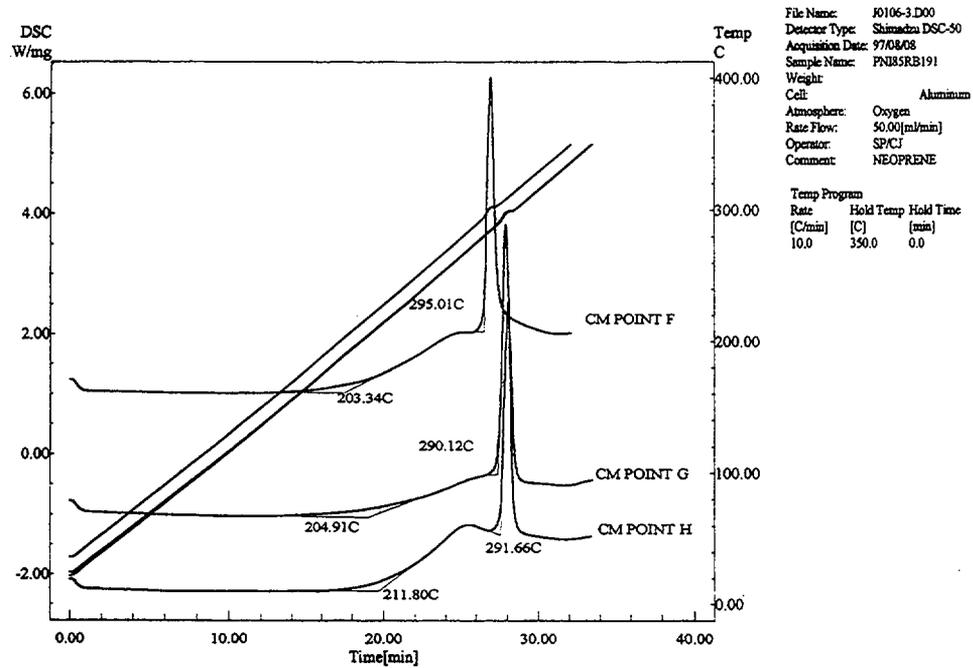
Figure 4.20 OITP for Rockbestos Neoprene® jacket (Group 1.2, Specimen 0106) as a function of LOCA testing protocols

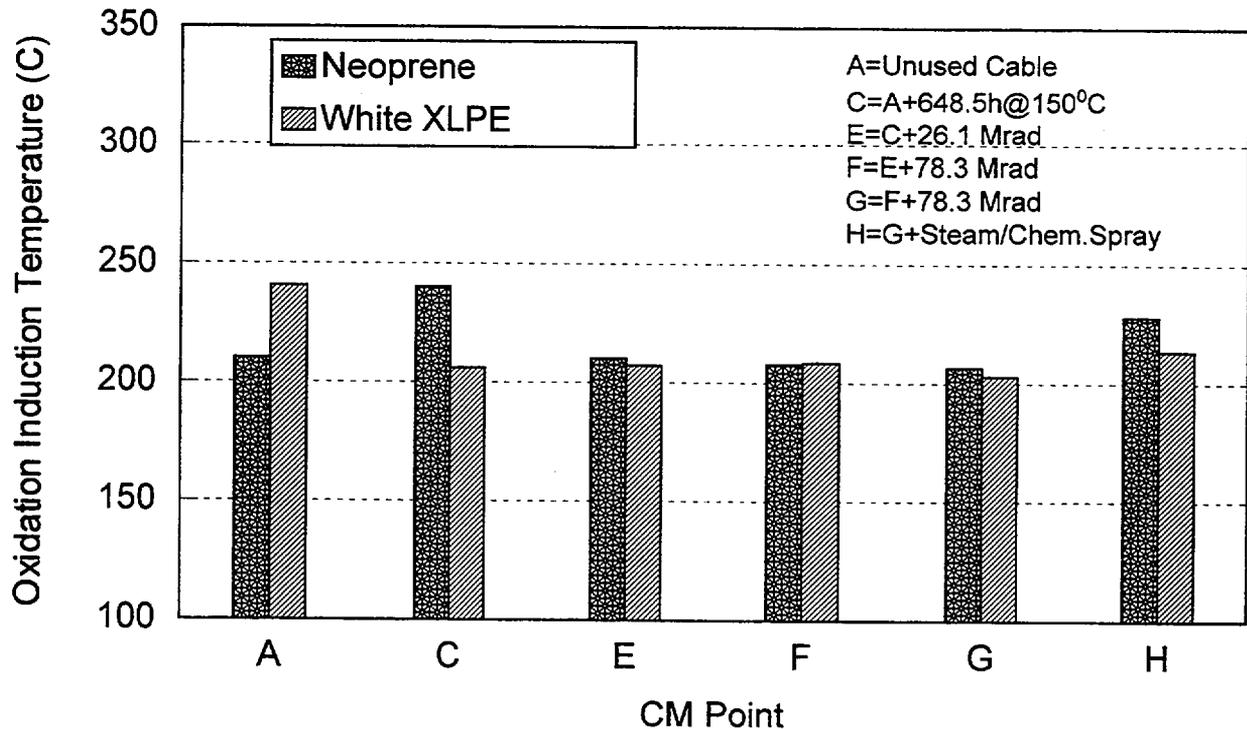
Figure 4.21 Effect of service aging and LOCA testing on the OITP of Rockbestos cable PNB79RB188 (Group 1.4, Specimen 0112)

As mentioned above, the insulation for the two-conductor cable (Group 1.4, Specimen 0112 in Figure 4.21) shows a large decrease in OITP after thermal aging (CM point C) but irradiation does not cause any major additional losses. For the three-conductor cable (Group 3.2, Specimen 0303 shown in Figure 4.22) which was given a service aging protocol to simulate 10-years of natural aging, the OITP remains essentially unchanged. These observations are associated with the presence or depletion of antioxidants in the insulation. If the thermal aging treatment is insufficient

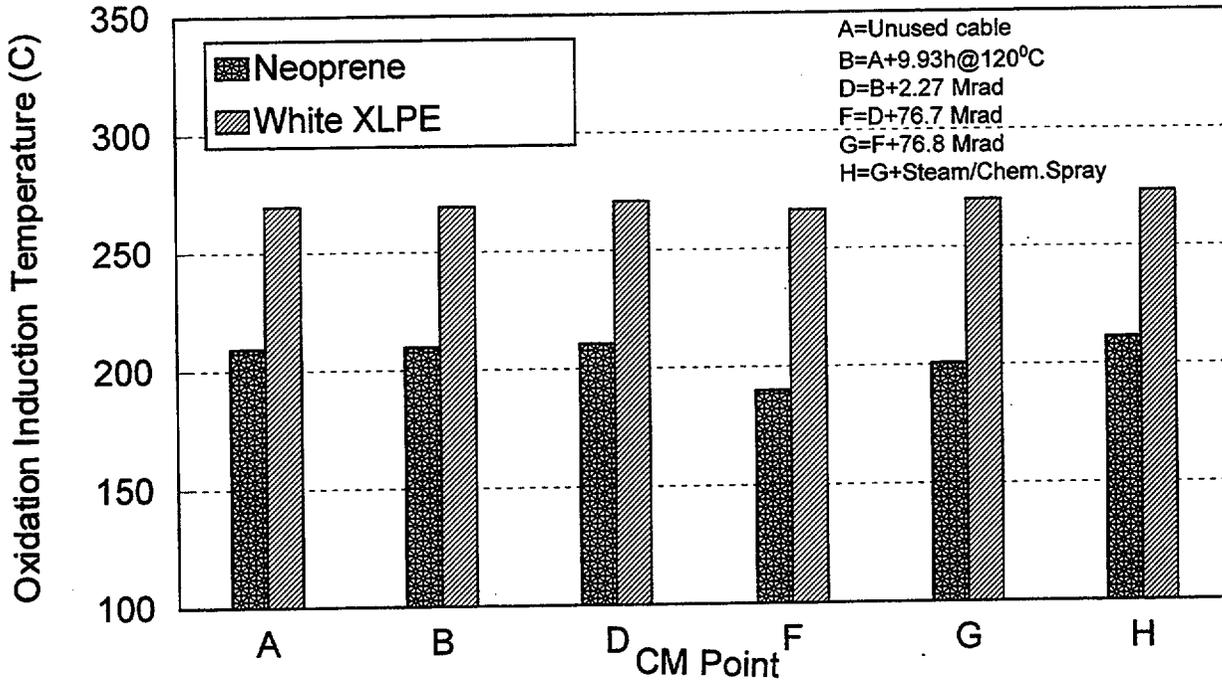
Figure 4.22 Effect of service aging and LOCA testing on the OITP of Rockbestos cable PNI85RB191 (Group 3.2, Specimen 0303)

Figure 4.23 shows OITP results for Rockbestos cable (Group 1.3, Specimen 0111) that was naturally aged for 10-years in a power plant. A comparison of the results for CM point A in Figure 4.23 for the naturally-aged cable to CM point D in Figure 4.22, which represents cable artificially aged to simulate 10-years of service, shows close agreement.

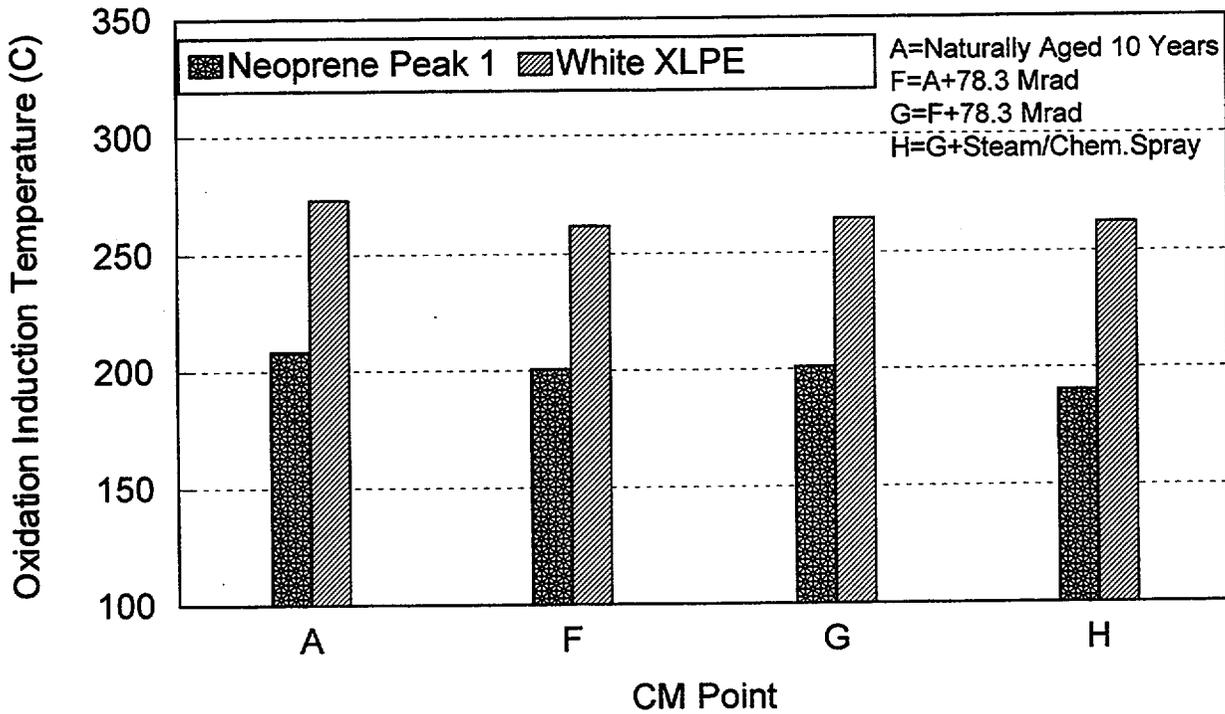
Figure 4.23 Effect of LOCA testing on the OITP of 10-year naturally aged Rockbestos cable PAP86RB267 (Group 1.3, Specimen 0111)

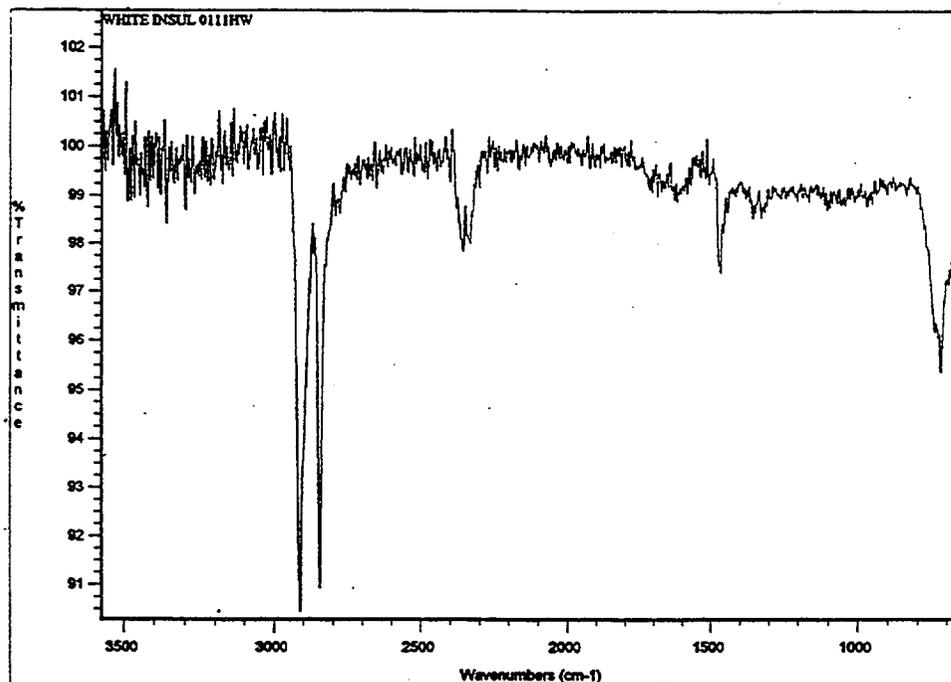
Figure 4.24 FTIR spectrum for ten-year naturally aged white XLPE from Rockbestos cable PAP86RB267 (Group 1.3, Specimen 0111) after receiving 157.5 Mrad of LOCA radiation and steam/chemical spray

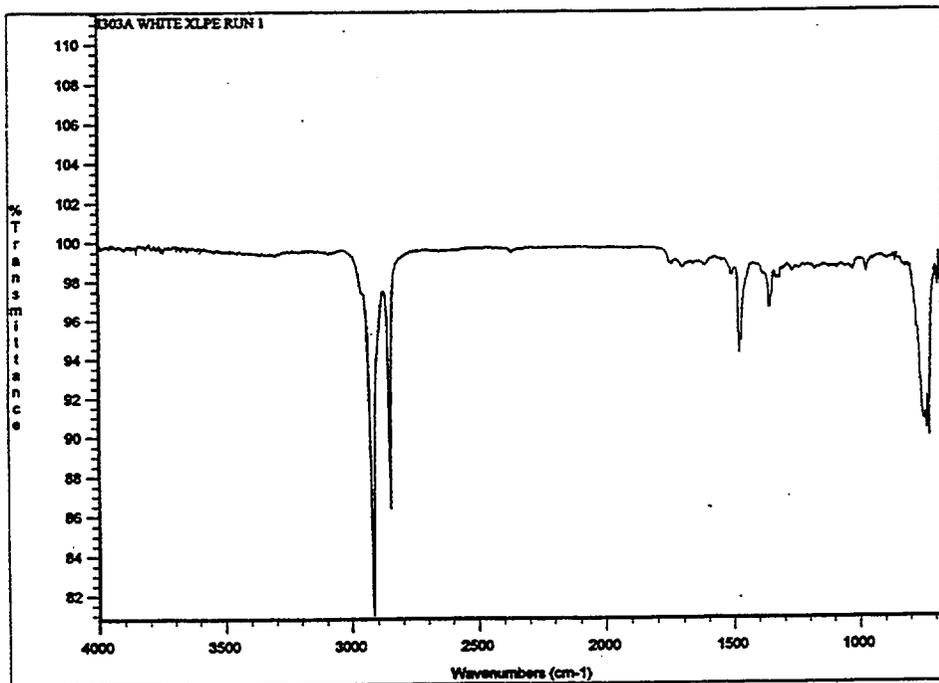
Figure 4.25 FTIR spectrum for unaged white XLPE from Rockbestos cable PNI85RB191 (Group 3.2, Specimen 0303) using the "Thunderdome<sup>®</sup>" attachment

In order to overcome the difficulty with poor optical contact, a new "Thunderdome<sup>®</sup>" crystal attachment for the spectroscope was purchased from the Nicolet Instrument Corp. It operates under the ATR (Attenuated Total Reflectance) mode. During test, the specimen is placed on top of the concave crystal and pressure is applied using a ratchet controlled pressure tower to force the specimen against the crystal with a large preset contact pressure. Because only about a 2 mm diameter surface disc of material is involved, excellent optical contact is obtained reproducibly. Figure 4.25 shows a typical spectrum for as-received white XLPE (test sequence 3, Group 3.2, Specimen 0303). Note the much cleaner spectrum compared to that obtained for the zinc selenide crystal shown in Figure 4.24. All subsequent tests in this program were, therefore, conducted with the "Thunderdome<sup>®</sup>". Appendix D gives the FTIR results obtained. Note that the data are given simply as peak heights on the transmittance spectra, taking into account subtraction of the baseline value of the spectrum at the peak location. The percent transmittance is merely 100 minus the peak height given in Appendix D. Figure 4.26 shows a series of FTIR tests on white XLPE (test sequence 3, Group 3.2, Specimen 0303), which had received a service aging protocol that simulated 10 years of natural aging. This included 9.93 hrs of aging at 250°F (120°C) (CM point B), followed by 2.27 Mrad of radiation (CM point D). At CM points F and G the specimen received 76.6 and 76.7 Mrad of LOCA radiation, respectively, followed by steam/chemical spraying (CM point H). Unfortunately, the carbonyl peak at wavenumber 1730  $\text{cm}^{-1}$  could not usually be detected by the Thunderdome<sup>®</sup>. It was, therefore, decided to measure the transmittance at wavenumber 2916  $\text{cm}^{-1}$  to determine if it could be correlated with aging of XLPE. The service aging treatments and the LOCA radiation exposures caused small increases in transmittance indicating that the number of  $-\text{CH}_2$  bonds is decreasing (see Figure 4.27). However, the steam/chemical spray causes the transmittance to drop slightly from the LOCA radiation (CM point G) value.

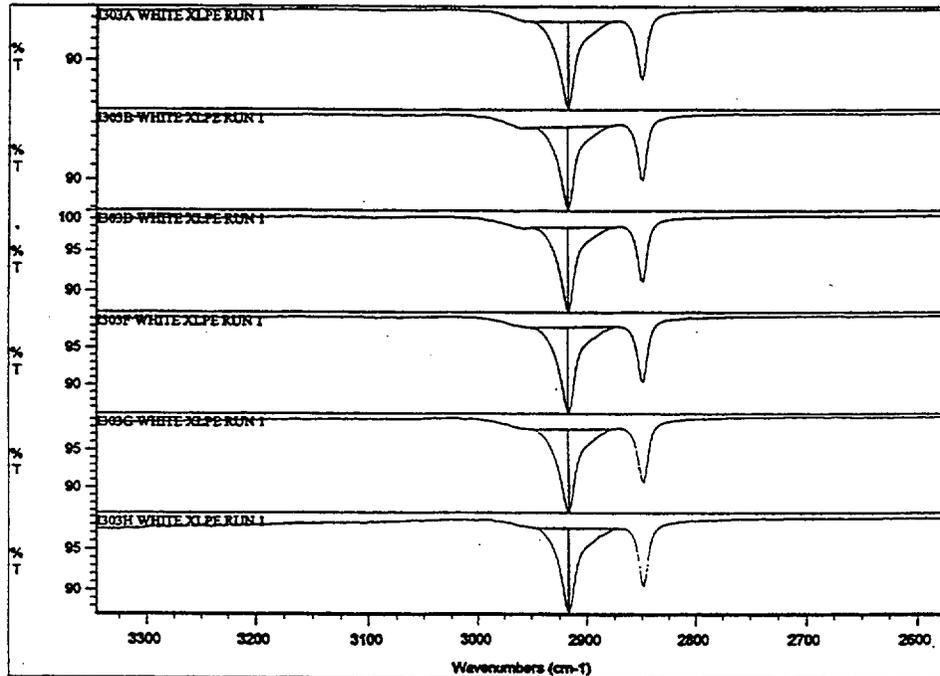
**Figure 4.26 FTIR spectra for artificially aged white XLPE from Rockbestos cable PNI85RB191(Group 3.2, Specimen 0303) as a function of CM point**

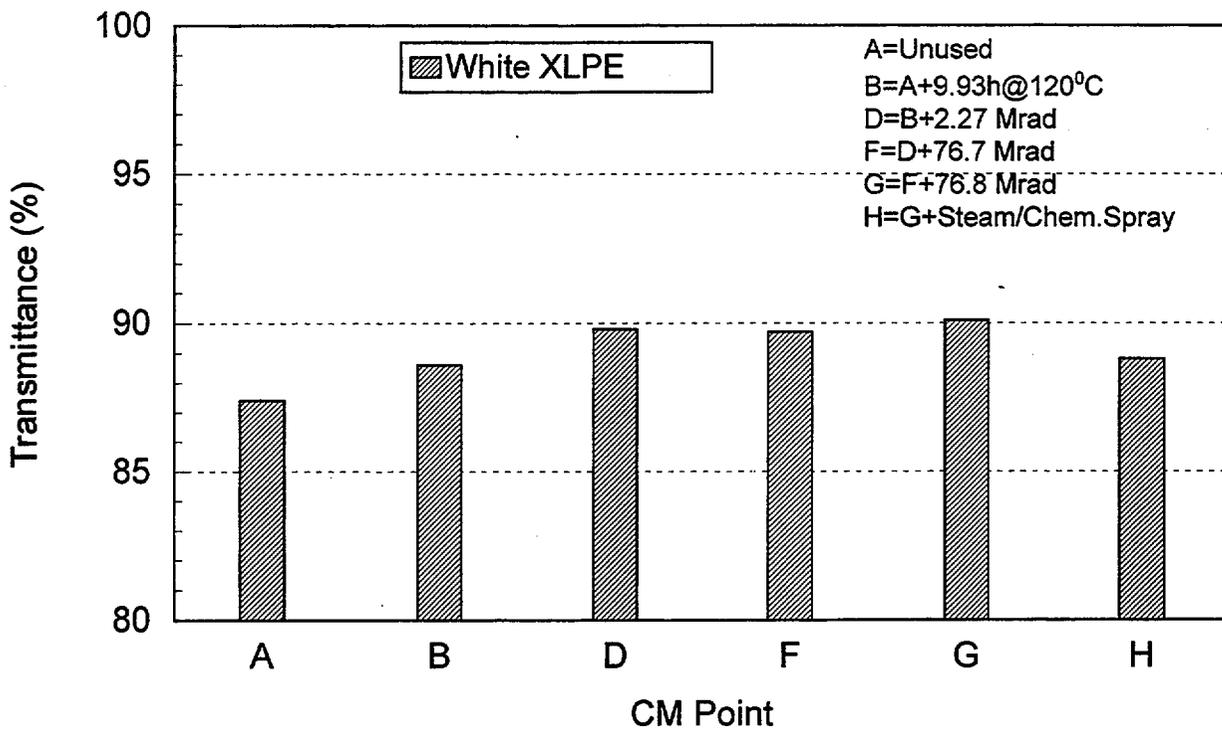
Figure 4.27 FTIR results for artificially aged white XLPE from Rockbestos cable PNI85RB191 (Group 3.2, Specimen 0303) as a function of CM point

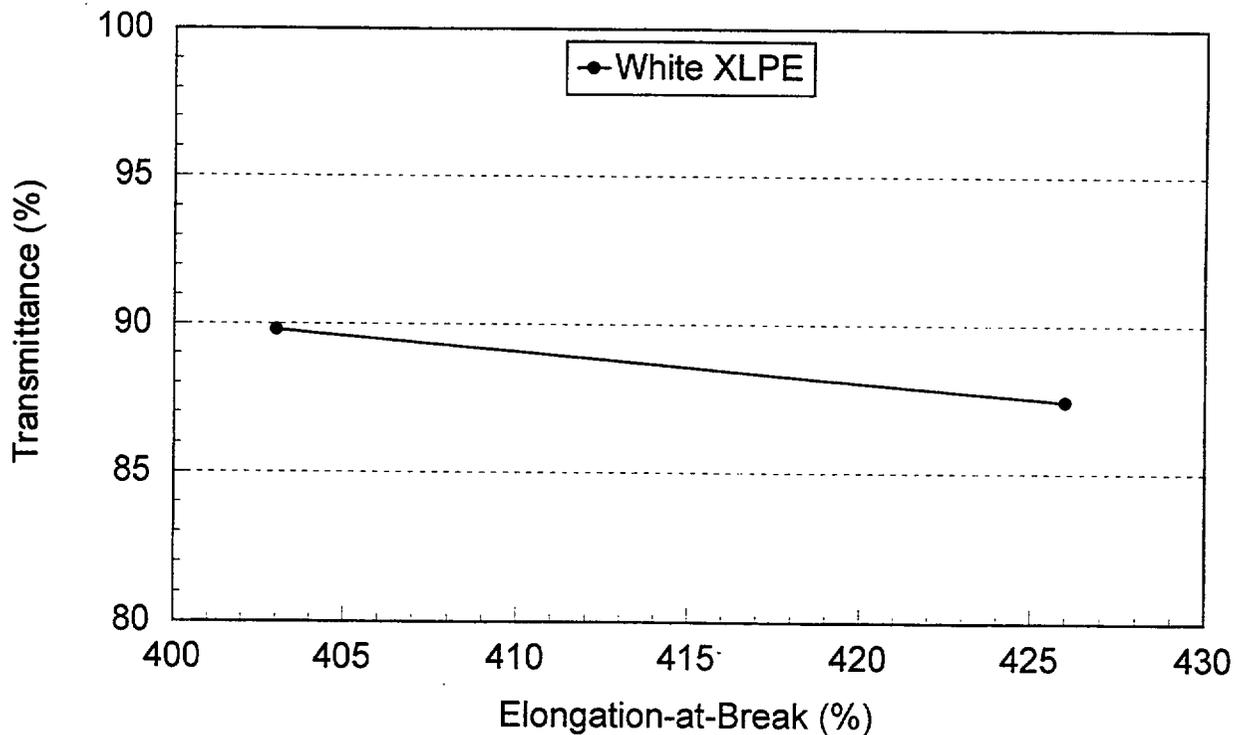
**Figure 4.28 FTIR results for artificially aged white XLPE from Rockbestos cable PNI85RB191 (Group 3.2, Specimen 0303) as a function of elongation-at-break**

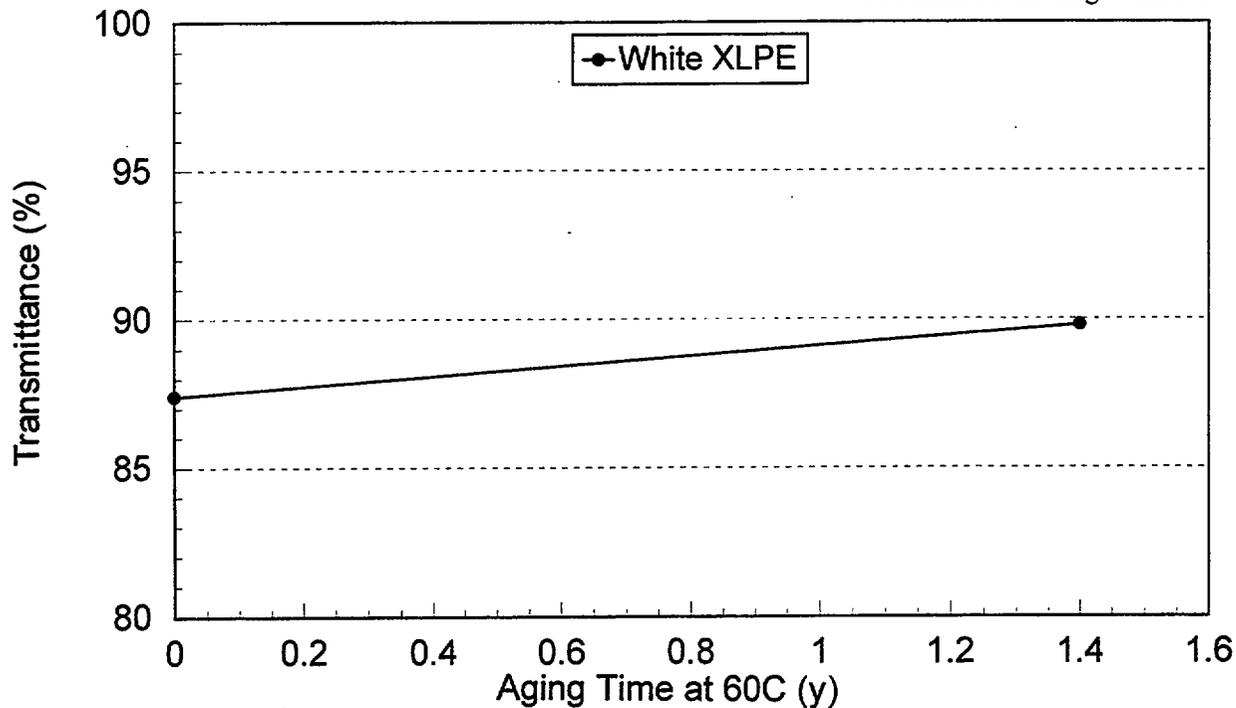
Figure 4.29 FTIR results for white XLPE from Rockbestos cable PNI85RB191 (Group 3.2, Specimen 0303) as a function of aging time at 140°F (60°C)

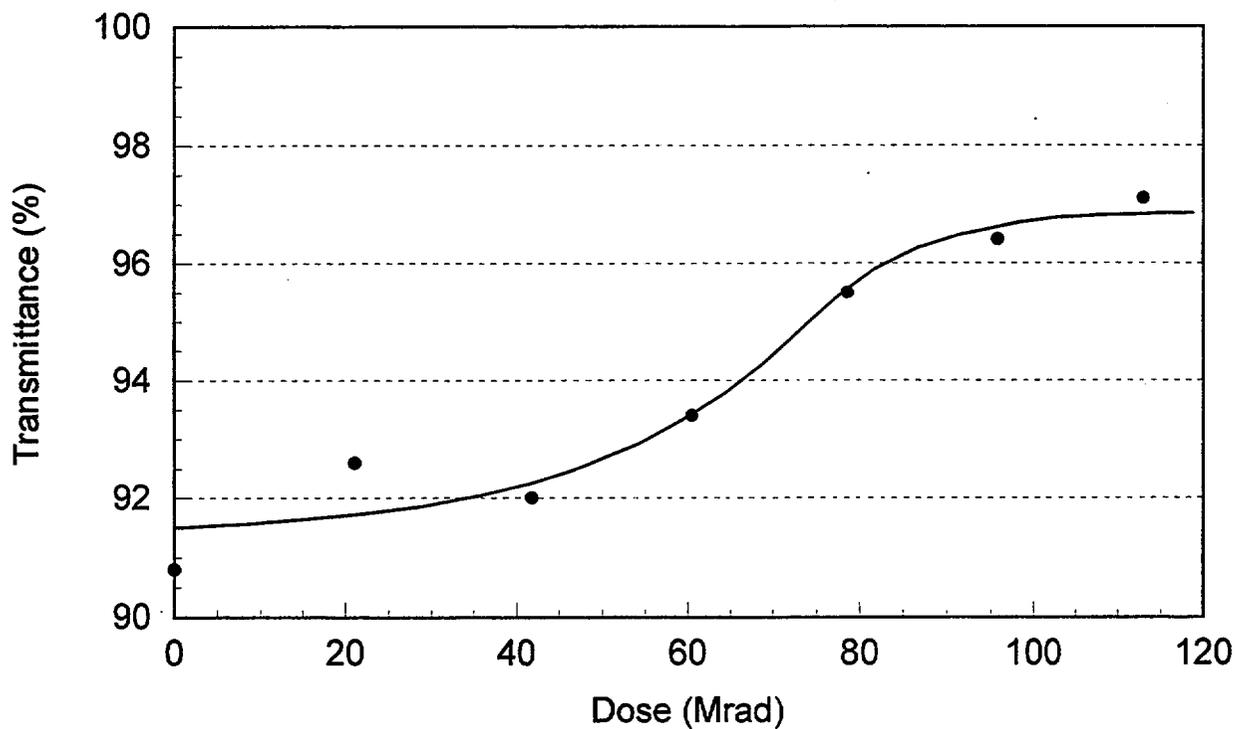
Figure 4.30 FTIR results for black XLPE form Rockbestos cable PNI79RB188 as a function of gamma radiation dose in air at 50°F (10°C)

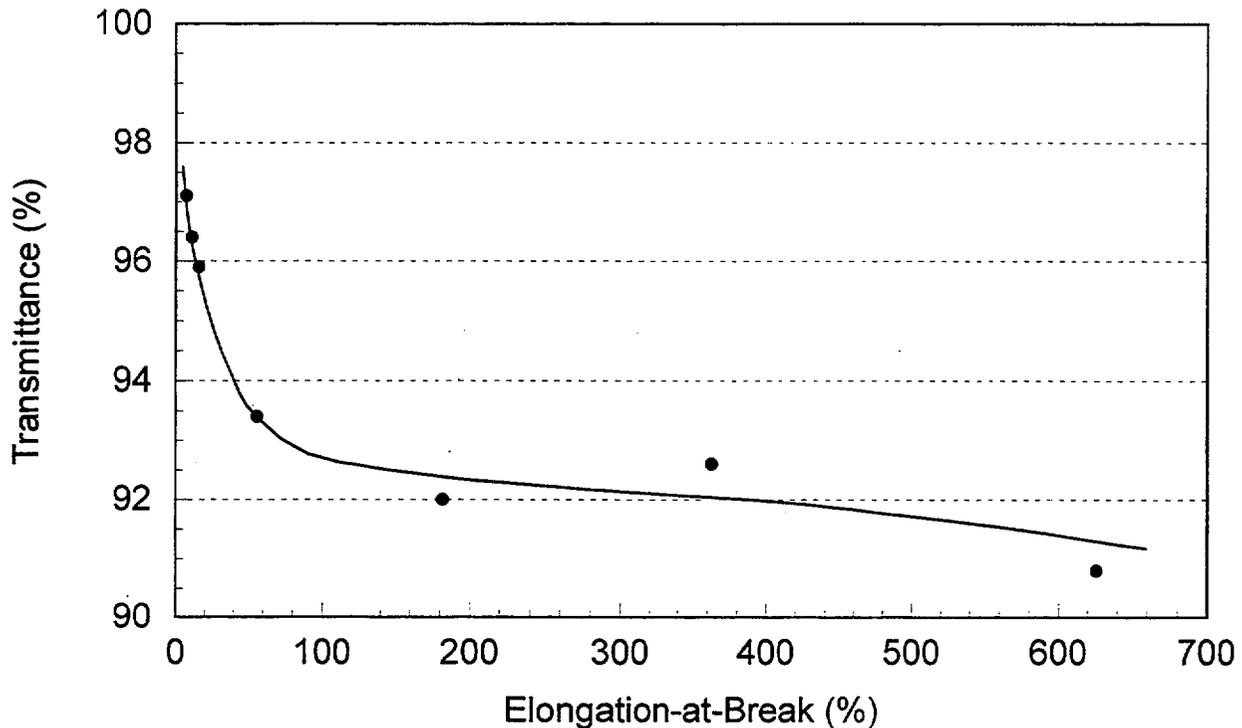
**Figure 4.31** Correlation between FTIR transmittance and elongation-at-break for irradiated black cross-linked polyethylene from Rockbestos cable PNI79RB188
